**REPORT OF GEOTECHNICAL INVESTIGATION
RIVERSIDE COMMUNITY HOSPITAL
RIVERSIDE, CALIFORNIA**

We are pleased to submit this geotechnical investigation report for the planned improvements to the Community Hospital campus in Riverside, California. The following report summarizes the findings of our subsurface investigation and field infiltration tests, provides our conclusions regarding the geologic constraints to development, and provides geotechnical recommendations for remedial grading, shoring, foundations, slabs, retaining walls and pavement section design.

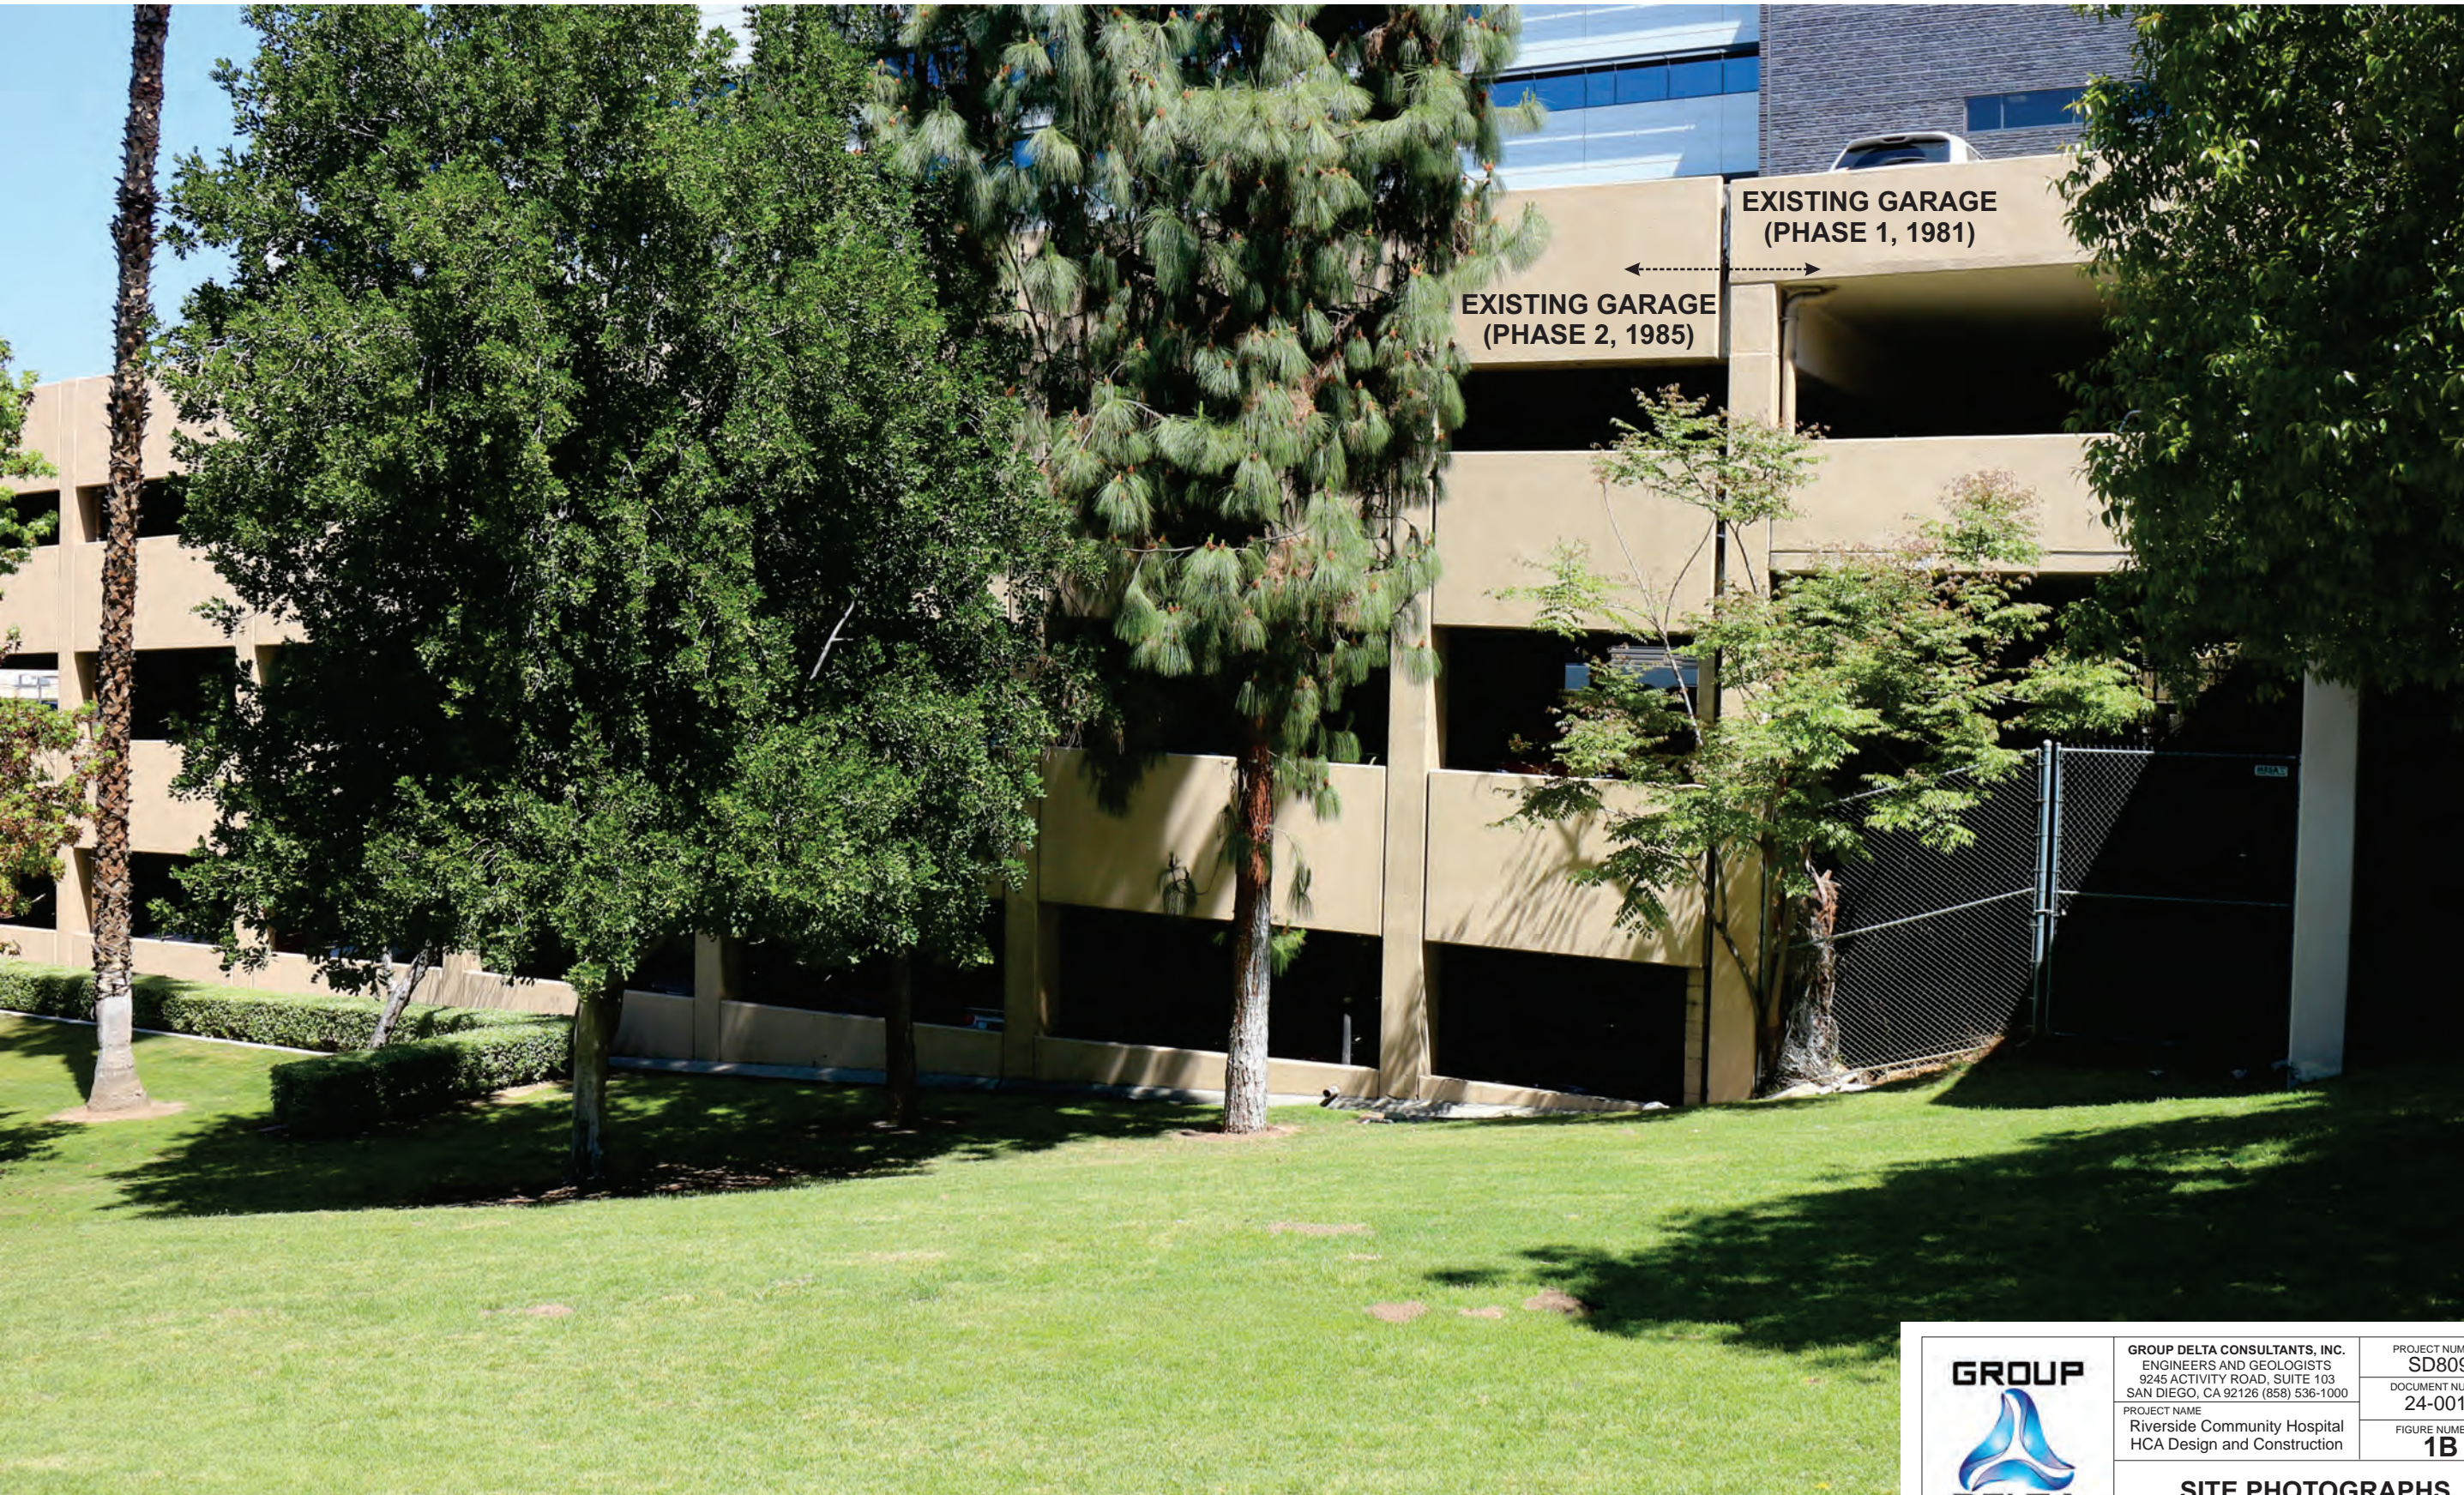
FIGURE NUMBER
1B

Within the interior of the existing parking structure at the new Tower site, we observed relatively few cracks within the reinforced concrete columns and beams. The western portion of the slab-on-grade for the garage addition did have a few minor cracks (Crandall, 1985). Fairly extensive cracks were also observed around the perimeter of the structure. The concrete sidewalk along the eastern edge of the MOB immediately southwest of the Tower site was extensively cracked. The asphalt concrete pavements in this area also had extensive alligator cracking. Note that the western part of the Tower site is situated over compressible Young Alluvium. The patterns of cracking we observed in this area appear to be consistent with soil settlement.

The eastern portion of the existing garage at the Tower site is raised above grade and supported by concrete beams, columns and pile foundations (Crandall, 1981). This initial garage structure also appears to have performed fairly well to date, with only a few signs of cracking. However, the slope beneath this portion of the garage does show considerable signs of piping and soil erosion. One of the reinforced concrete beams in this area was longitudinally cracked with indications of seepage and corrosion of the steel reinforcement (i.e. rust stains). There are also indications of settlement of the asphalt concrete pavement located immediately east of the pile supported garage. Extensive cracks were also observed around the elevator tower in the northwest corner of the initial garage structure. Finally, the soldier pile shoring between the garage and Tower C is exposed along the staircase between these structures and appears to have been partially demolished.

**SITE PHOTOGRAPHS
(TOWER SITE)**

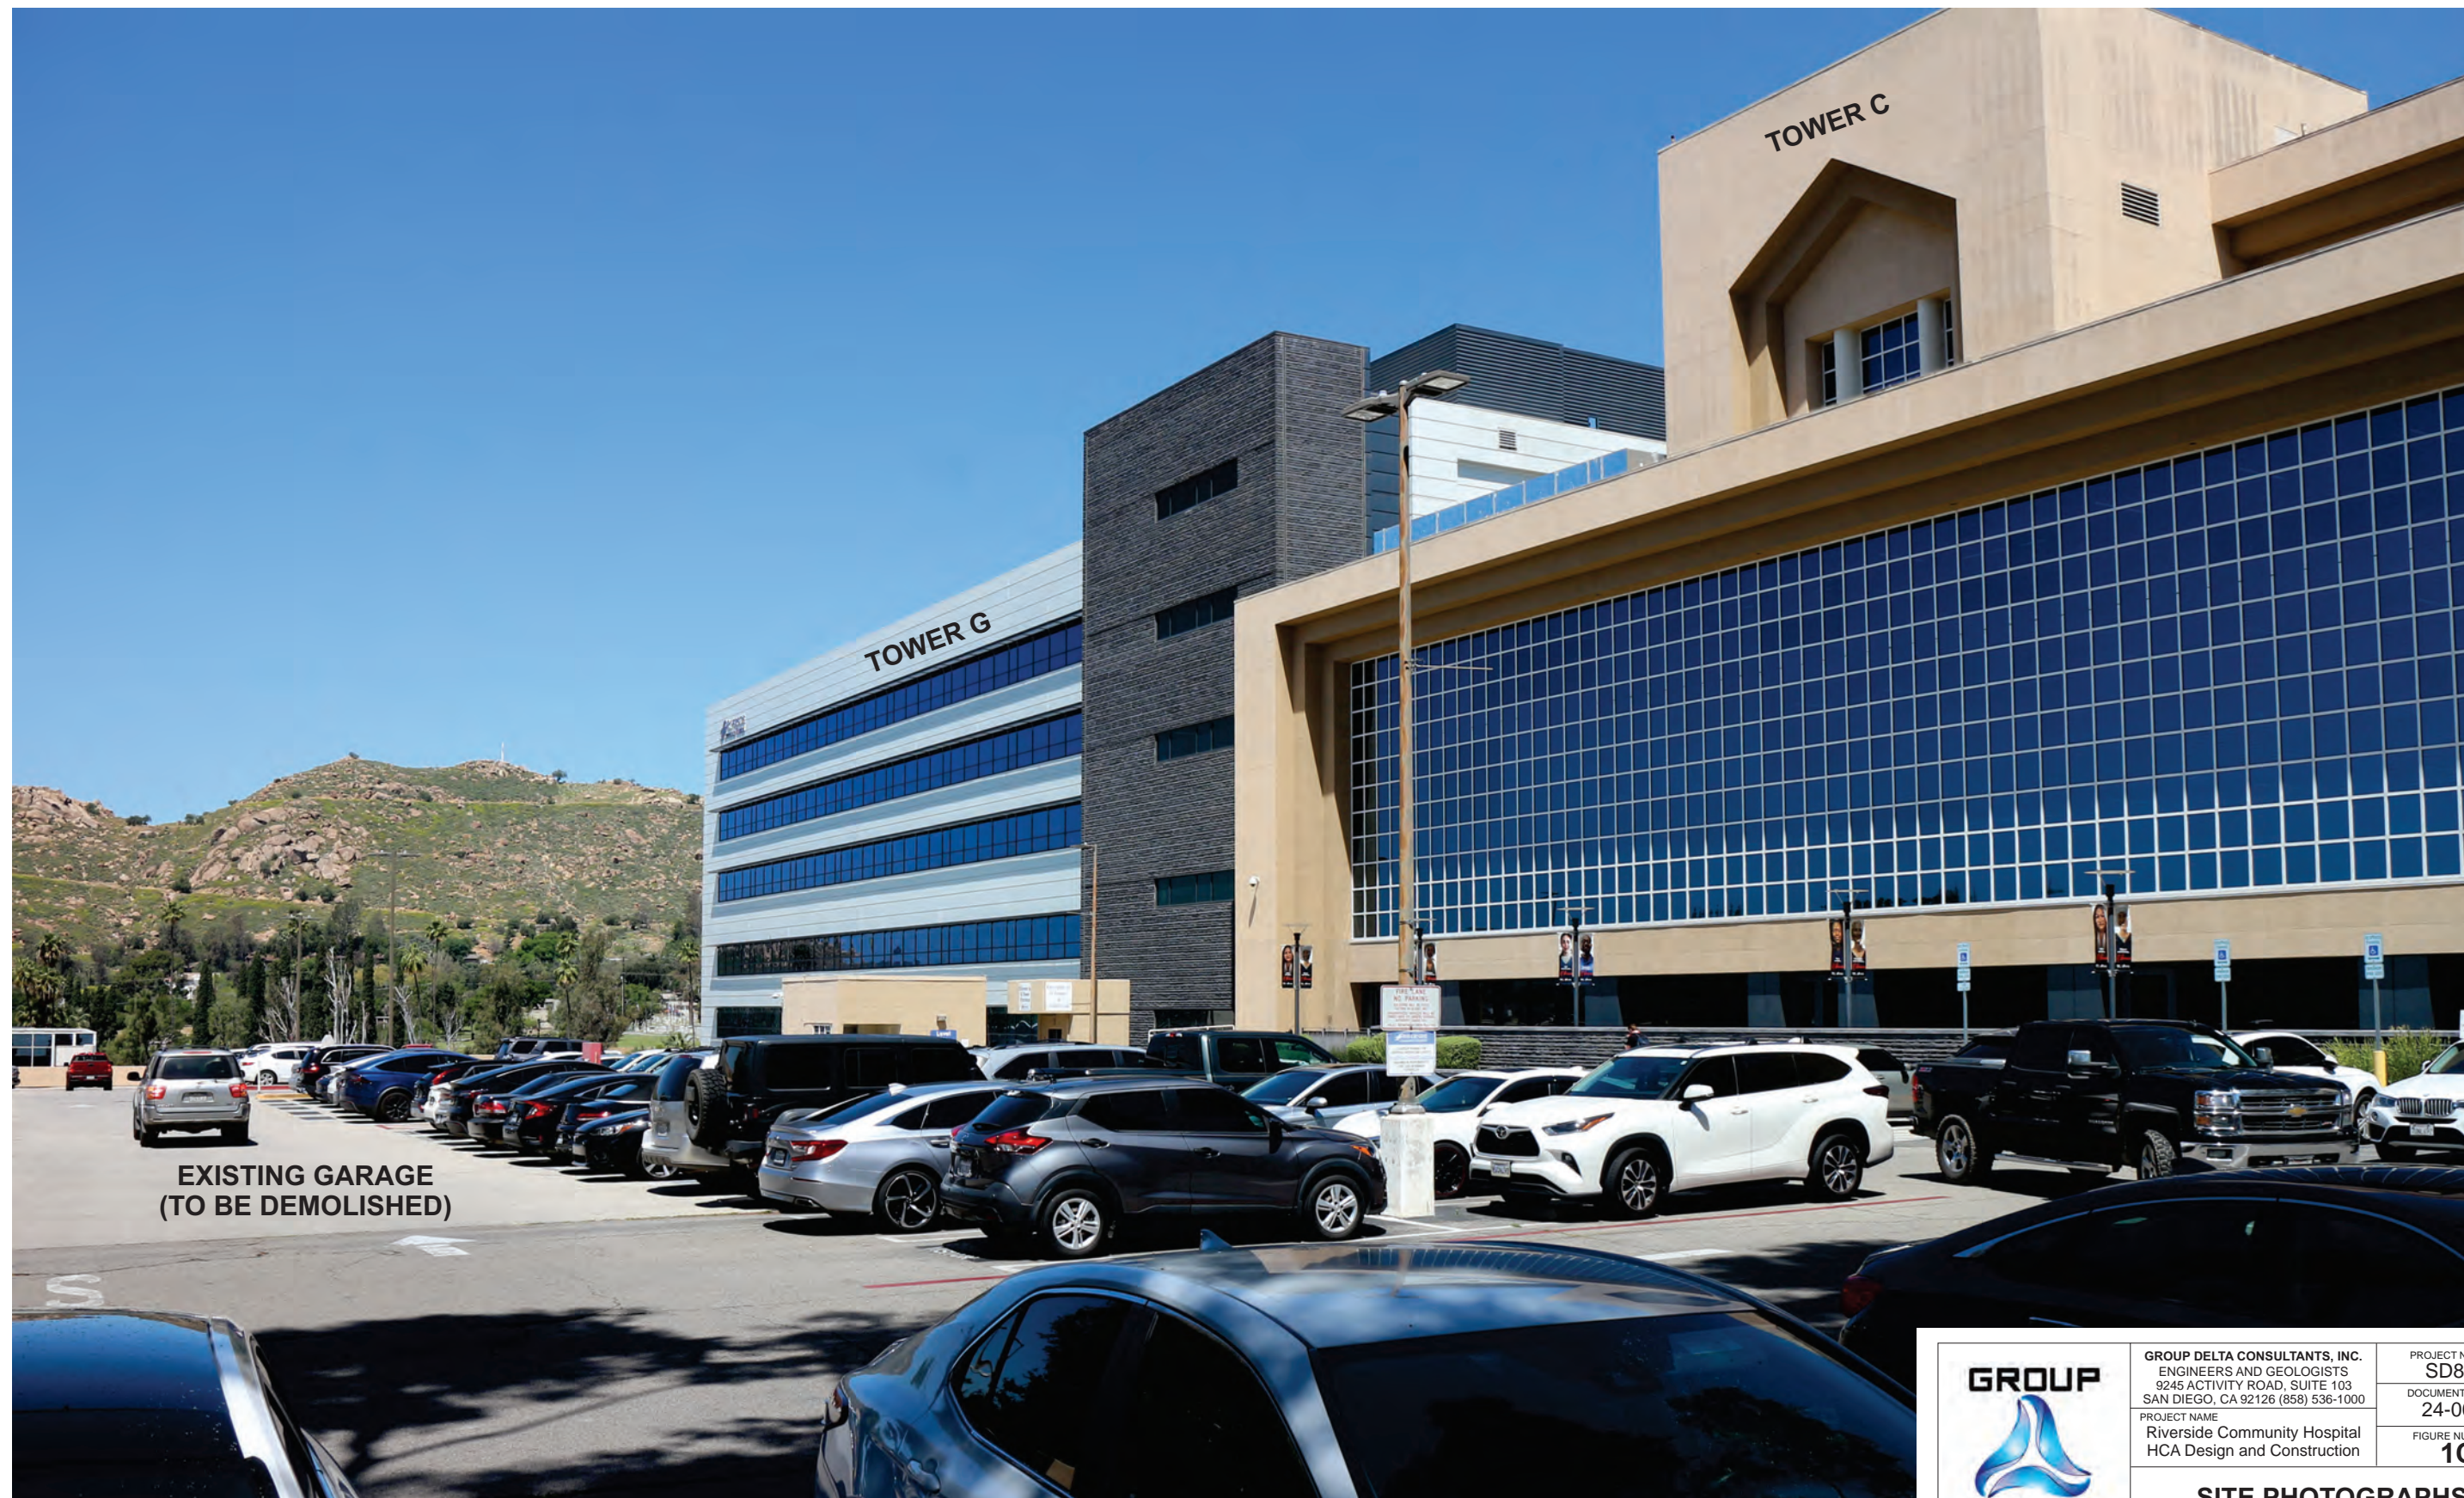
PROJECT NUMBER
SD809
DOCUMENT NUMBER
24-0011
FIGURE NUMBER
1C

EXISTING GARAGE
(TO BE DEMOLISHED)

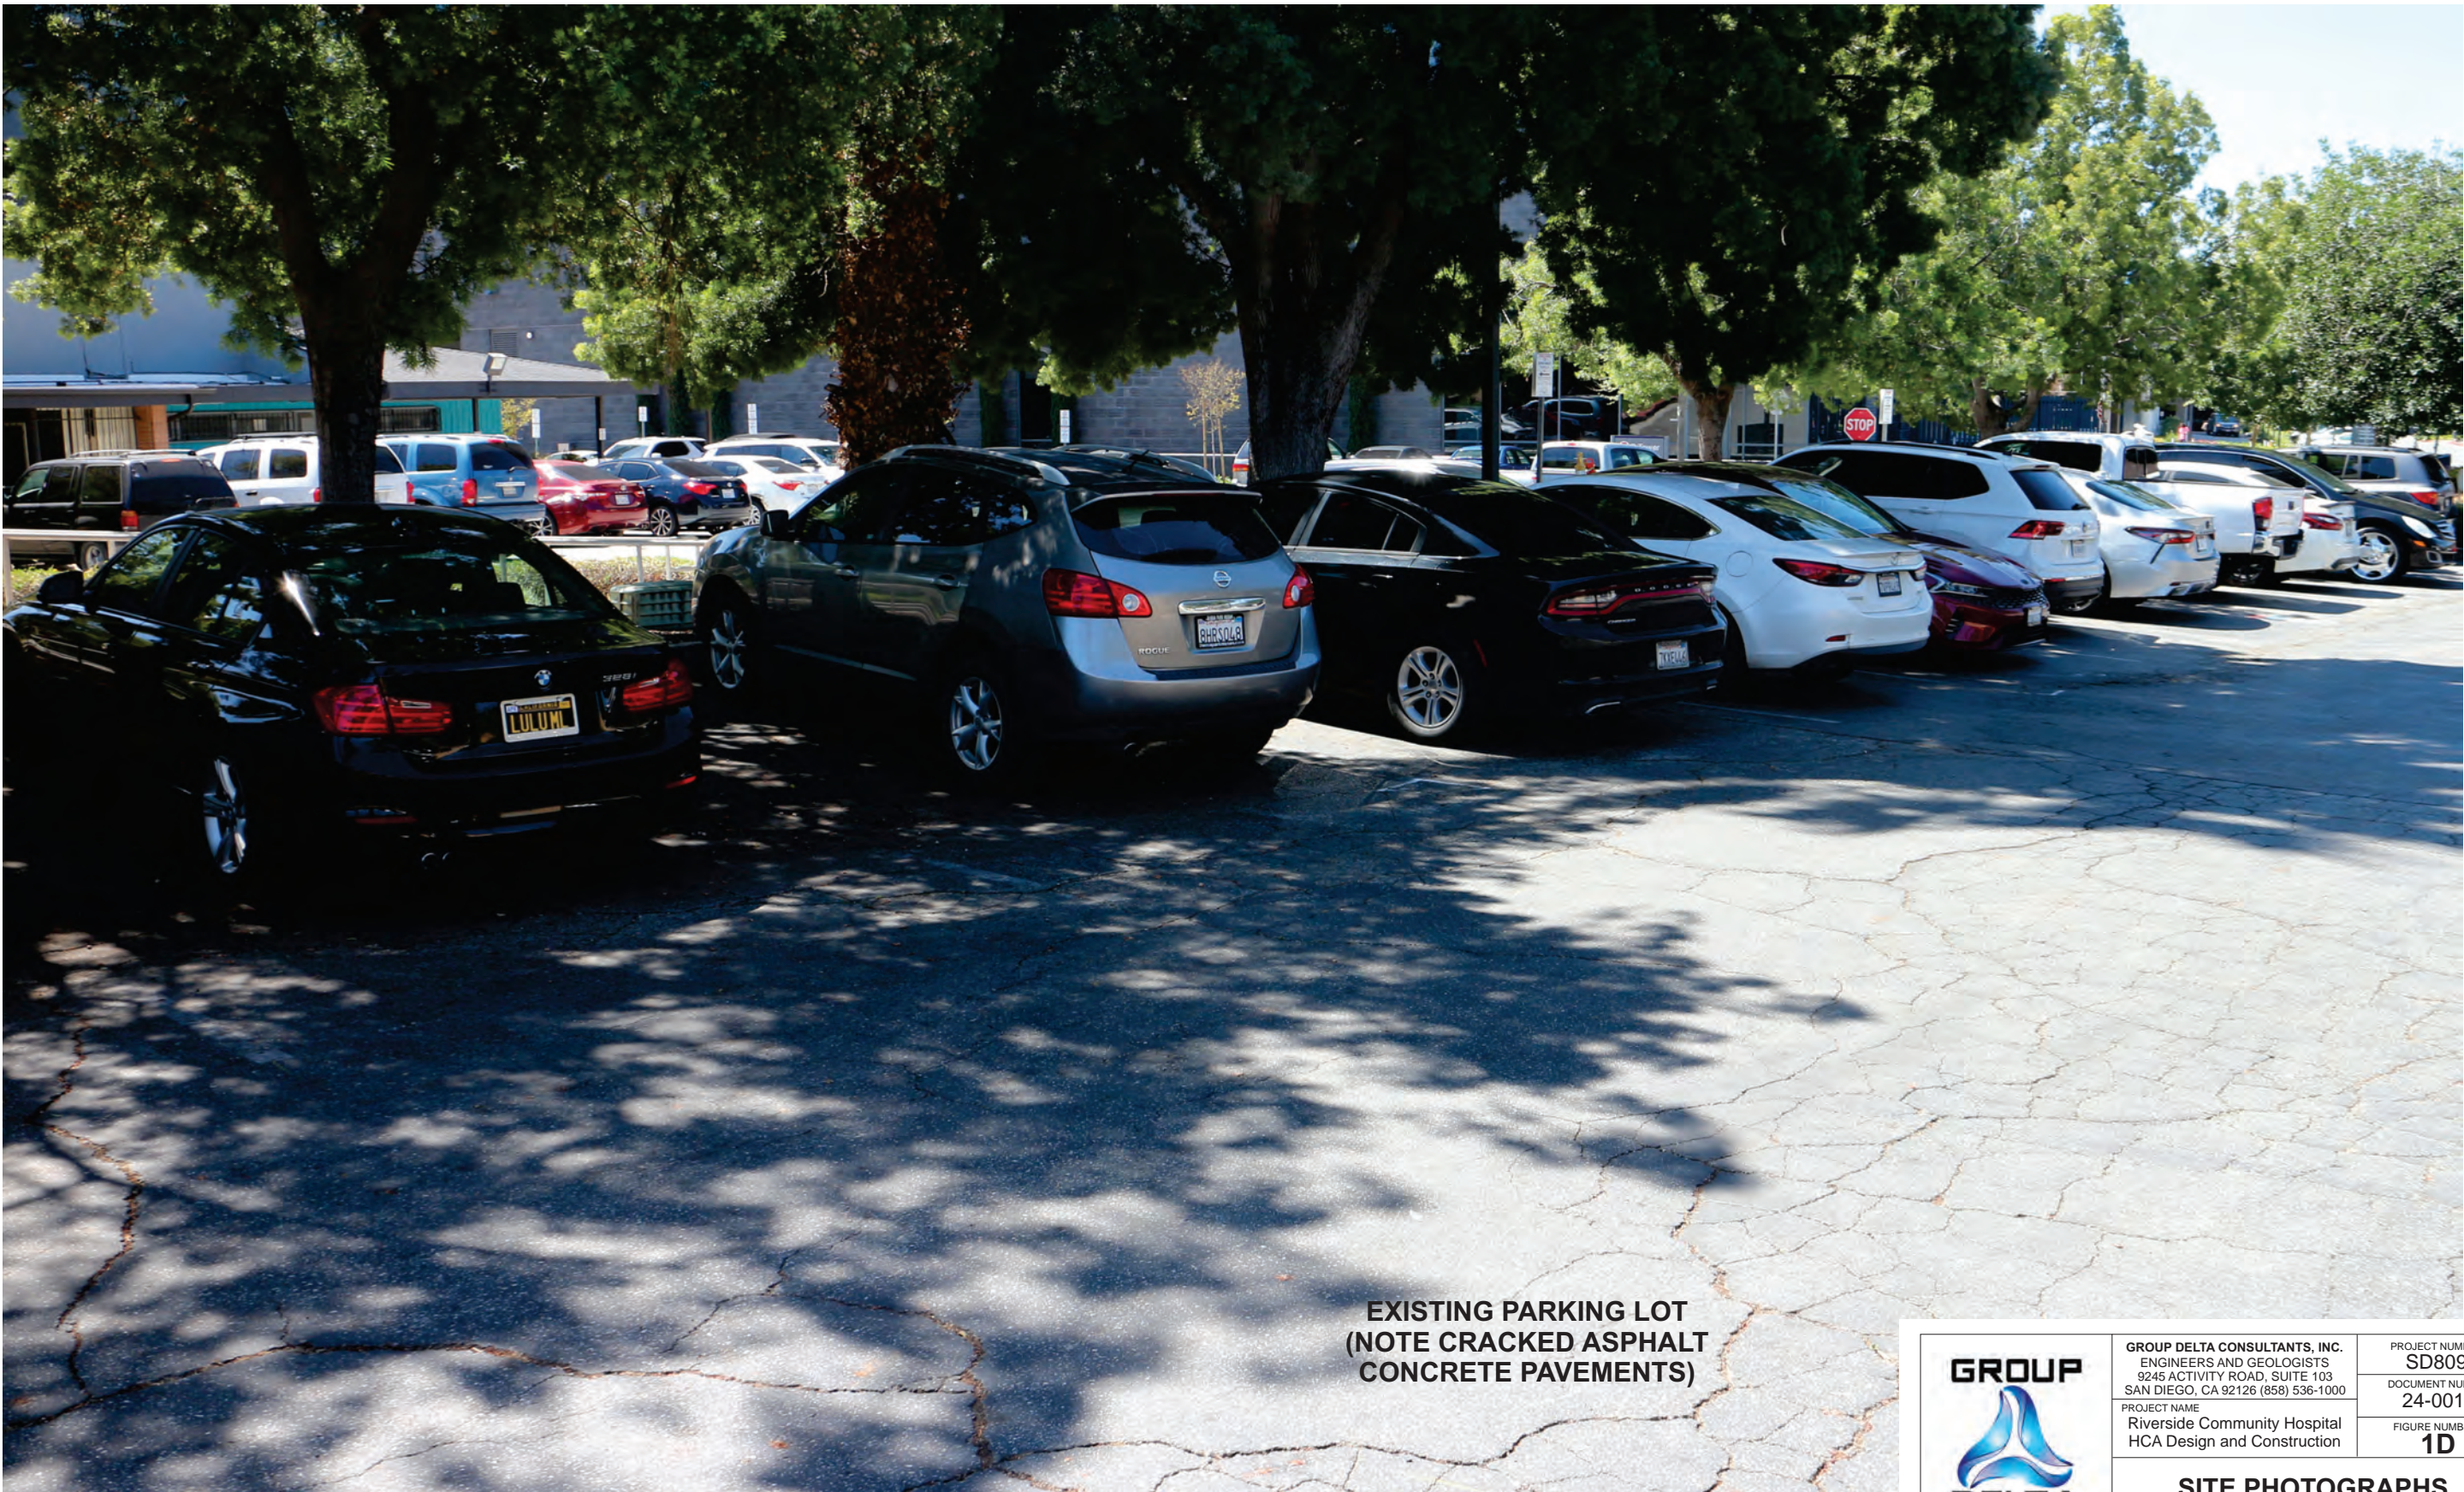
PROJECT NUMBER
SD809
DOCUMENT NUMBER
24-0011
FIGURE NUMBER
1D

In comparison to the Tower site, the existing structures at the new Garage site show numerous signs of cracking and distress. The existing 4-inch-thick concrete pavements which surround the Brockton Auto Clinic are cracked on a relatively tight spacing. The 2-inch-thick asphalt concrete parking lot in the northern portion of the Garage site is also extensively cracked (see Figure 1D). The extensive cracking of these surface improvements may be related to an inadequate initial pavement section design. However, these cracks may also be related to soil settlement.

**EXISTING PARKING LOT
(NOTE CRACKED ASPHALT
CONCRETE PAVEMENTS)**

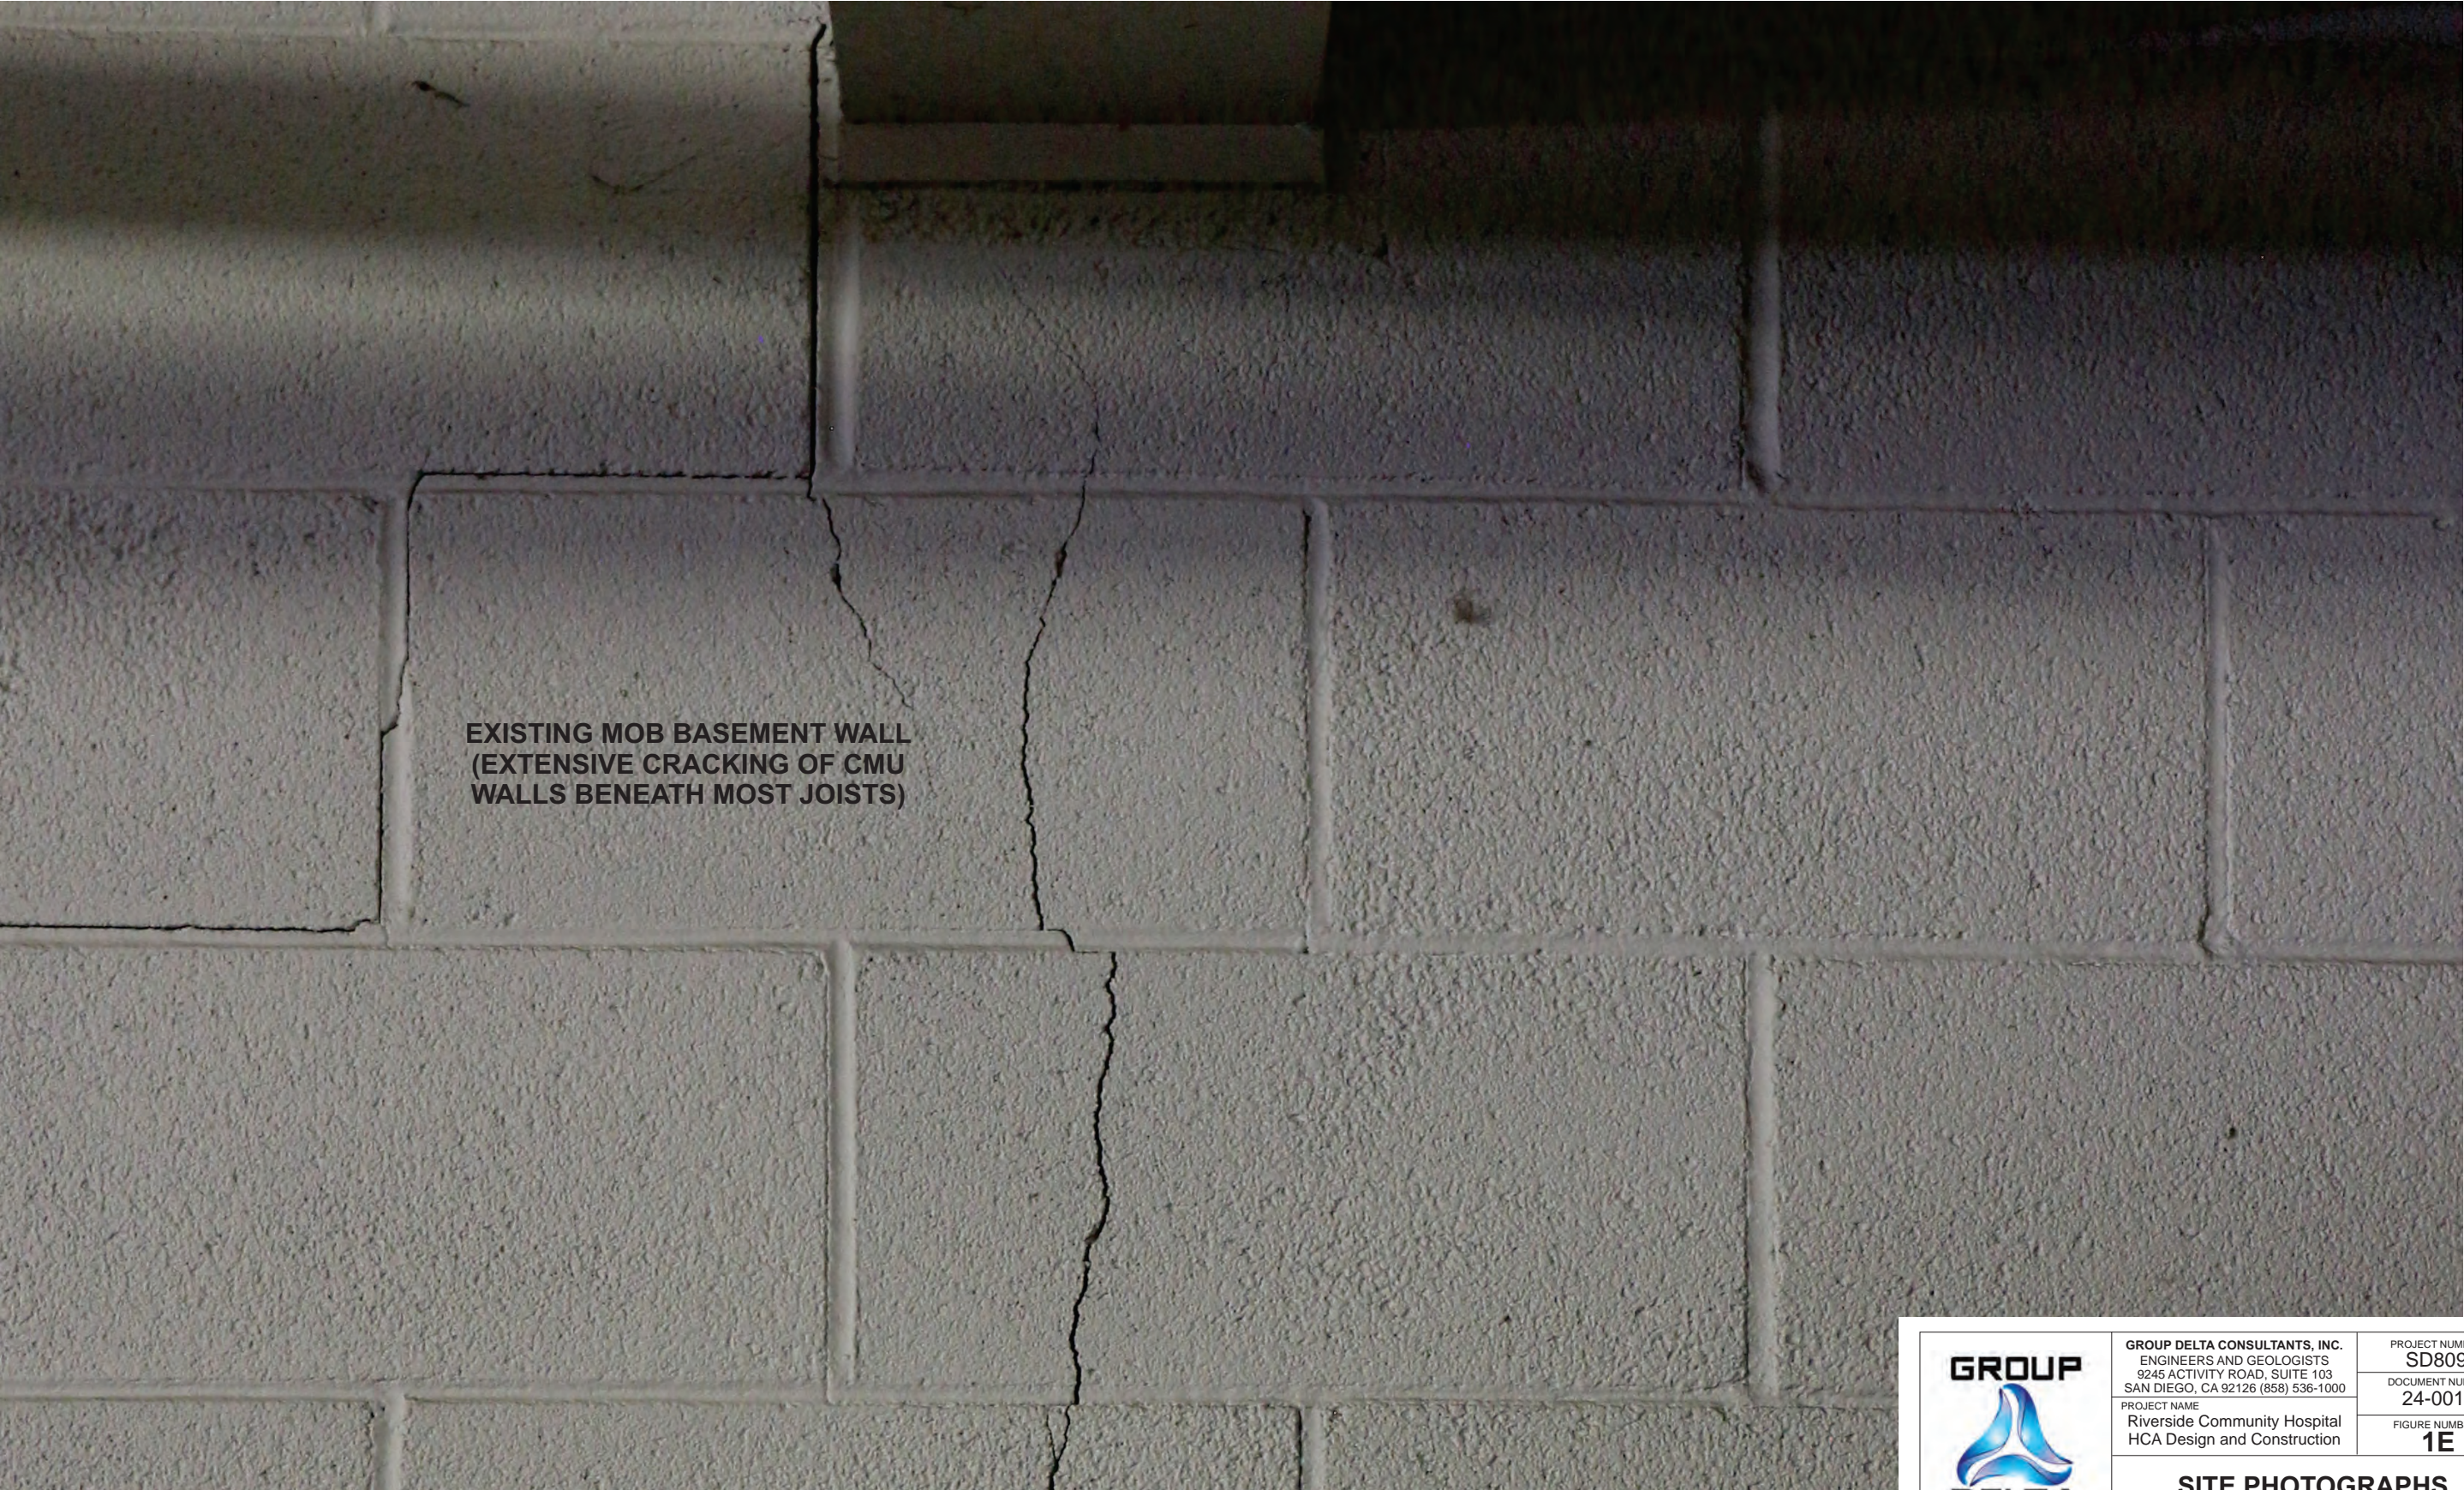
Extensive damage was observed within the basement garage of the Community Medical Center at the proposed Garage site. The basement extends roughly 10-feet below surrounding grades and was constructed using cement masonry units (CMU). It appears that this structure is founded on shallow spread footings. The CMU walls are badly cracked beneath nearly all of the joists that support the first floor of the building (see Figure 1E). Most of the cracking was hairline in width, although a few of the cracks were 1/8th of an inch or wider. These regular cracks extended from the bottom of the joists all the way down through the CMU wall to the slab-on-grade. The concrete slab-on-grade was also extensively cracked throughout the structure, and cracks were also observed in the slab around the column footings. The pattern of distress in the basement garage of the Community Medical Center is consistent with soil and foundation settlement.

EXISTING MOB BASEMENT WALL
(EXTENSIVE CRACKING OF CMU
WALLS BENEATH MOST JOISTS)
