STRUCTURAL DAMAGE EVALUATION REPORT – FIRE DAMAGE

RIVERSIDE OFFICE OF EDUCATION

4472 Orange Street, Riverside, California

Project Number: IF24105

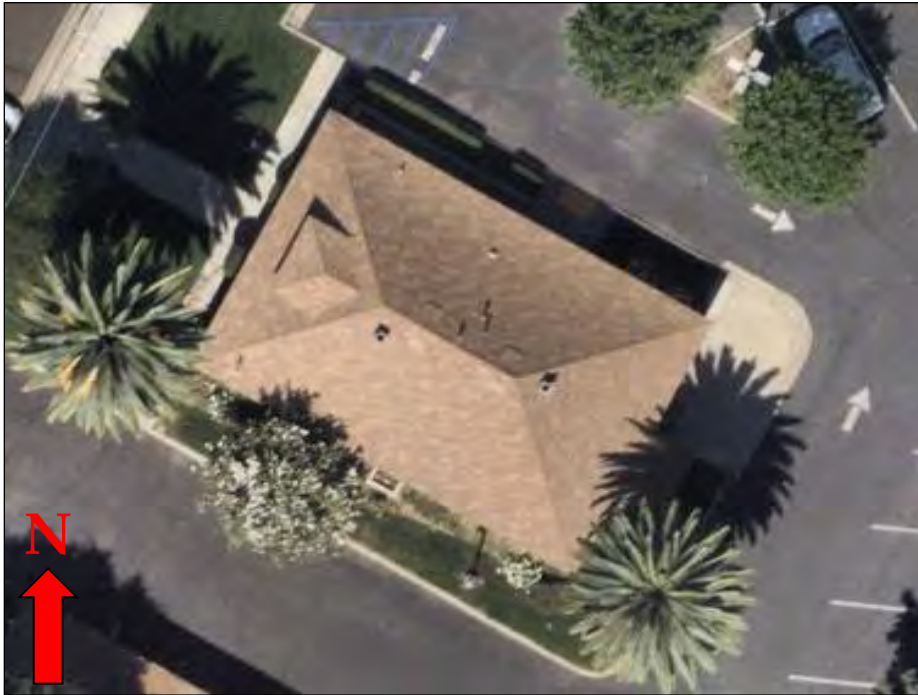
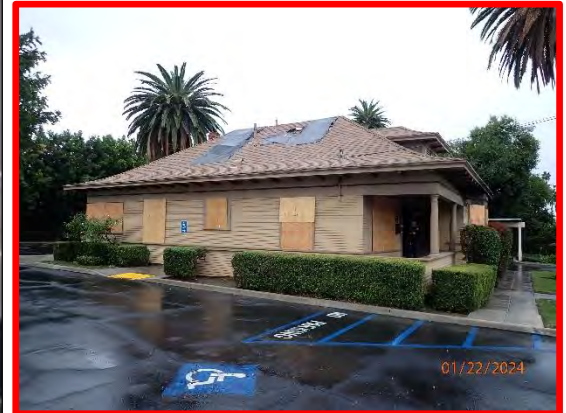
The subject building is a one-story historic structure built circa 1908 based on County records and is currently serving as an office/administrative building for the district of Riverside County Office of Education. The property is 0.15-acres, and the total area of the building is approximately 1,430-square feet. The structure consists of wood framed exterior and interior walls with wood siding panels on the exterior and painted/textured lath and plaster finishes on the interior. The pitched gable/hip roof structure consists of asphalt shingles atop roofing membrane/felt over 1x skip sheathing and oriented strand board (OSB) sheathing supported by roof rafters and the load-bearing walls of the structure. The ceiling is composed of "T-bar"/drop ceiling tiles, and the floor consists of carpet atop raised-floor system with straight lank sheathing supported by joints and beams, which in turns are supported by vertical components entailing posts and piers or stem walls within the crawlspace (*see Photographs 1 & 2*).

1. Close-up aerial view of the subject building; source: *nearmap.com*; view of the north elevation of the building from the parking lot.

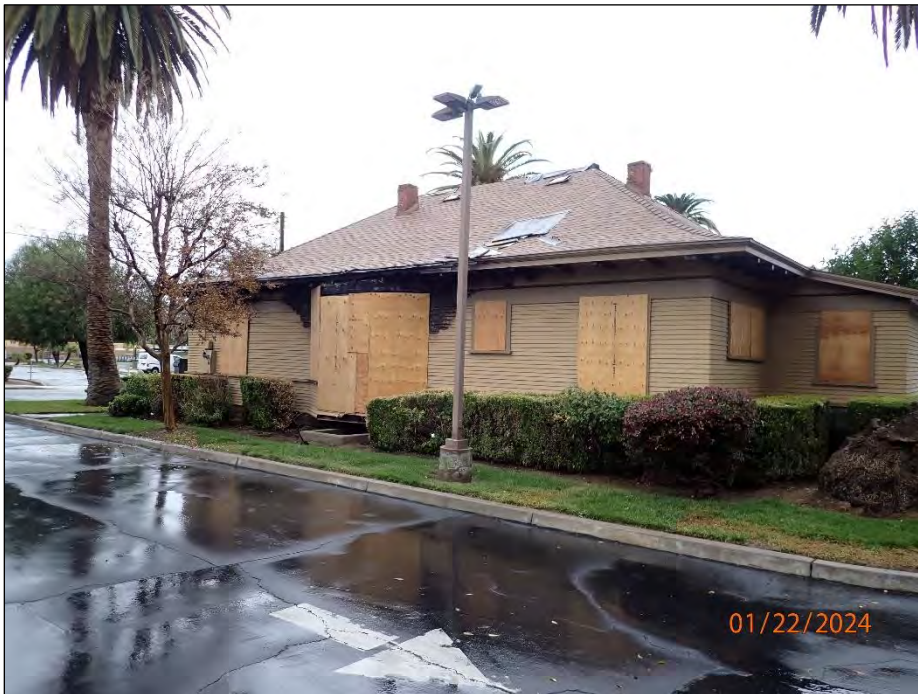
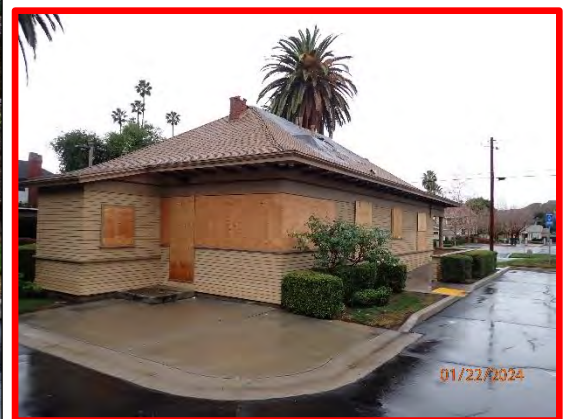
2. View of the east and south exteriors of the building from the parking lot. Wall/window openings had been boarded with plywood subsequent to the reported fire event.

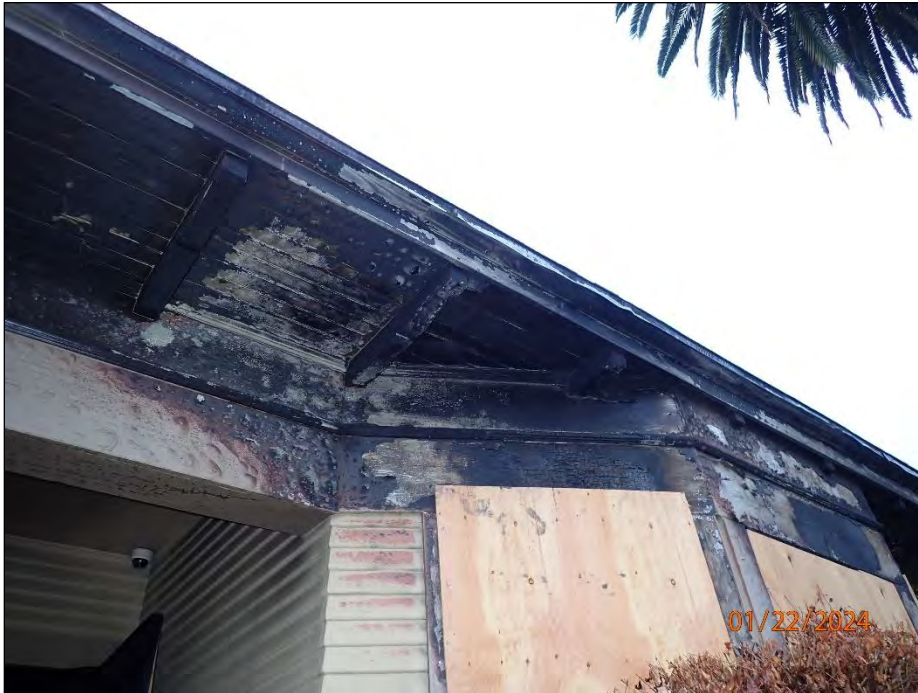
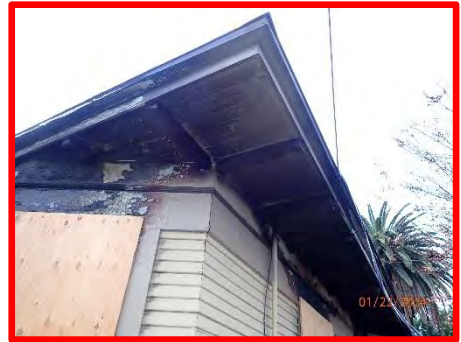
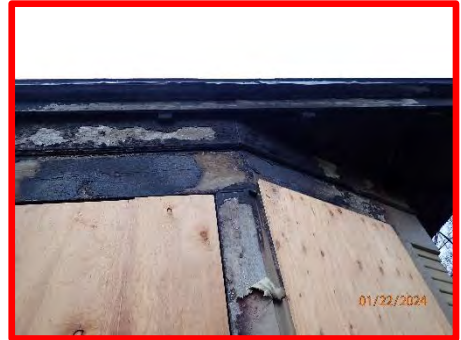
- There was evidence of surficial charring and carbon/soot deposits at the exterior finishes around/adjacent to wall/window openings, consistent with fire induced by oxygen or airflow from the exterior/outdoor environment (*see Photograph 3*).

3. There was evidence of surficial charring and carbon/soot deposits at the exterior finishes around/adjacent to wall/window openings, consistent with fire induced by oxygen or airflow from the exterior/outdoor environment.

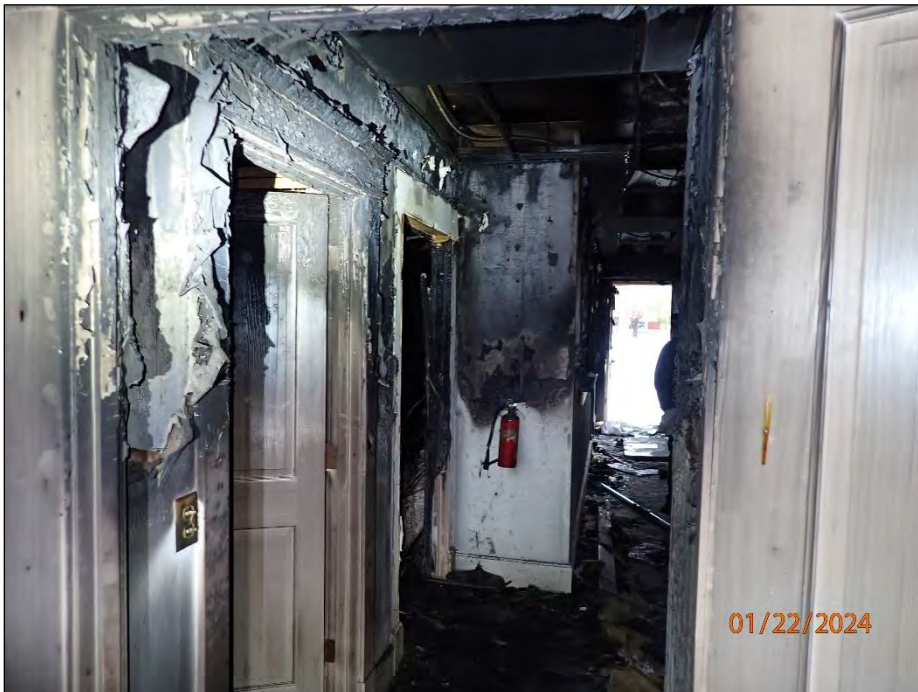
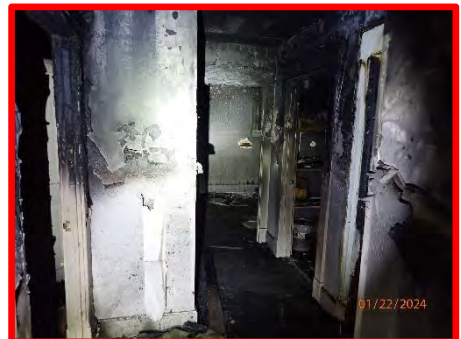
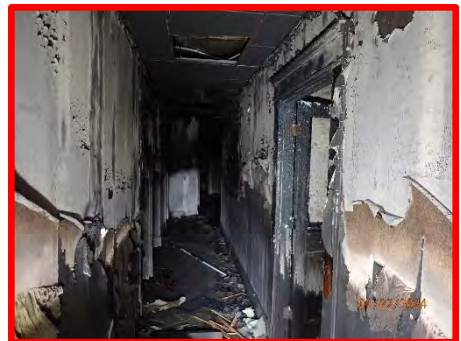
- Fire/heat-related damage to the interior finishes/components was noted throughout the building (*see Photograph 4*).
- Areas within the northern portion of the building had no discernible fire/heat-related damage to the structural framing of the structure; carbon/soot deposits were noted on the surface of the interior finishes (*see Photograph 5*).

4. Fire/heat-related damage to the interior finishes/components was noted throughout the building.

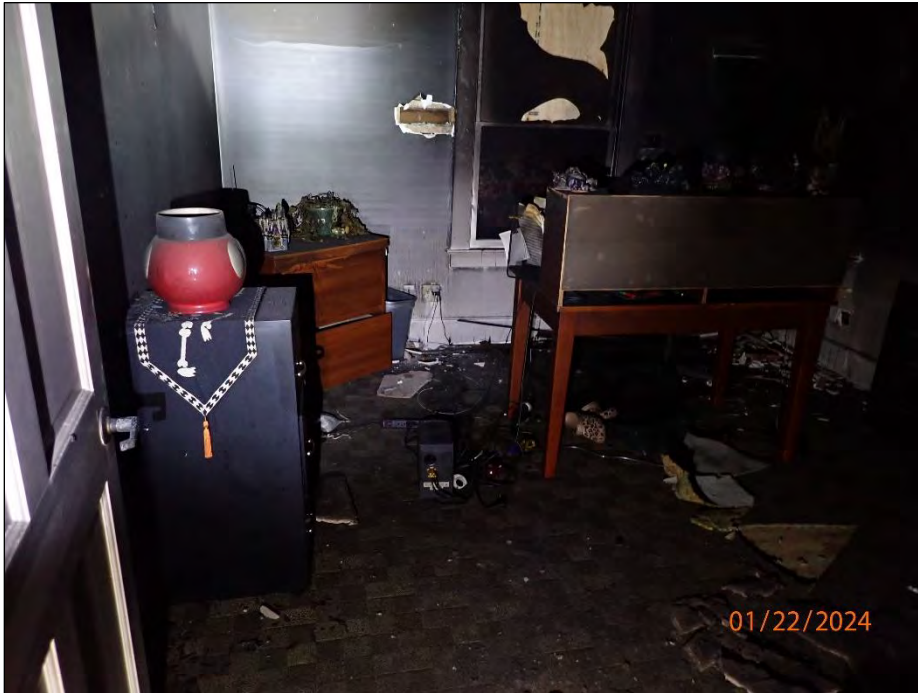
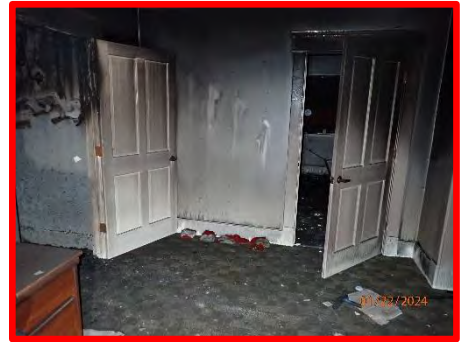
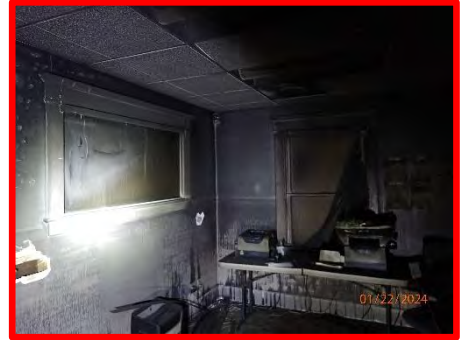
5. Areas within the northern portion of the building had no discernible fire/heat-related damage to the structural framing of the structure; carbon/soot deposits were noted on the surface of the interior finishes.

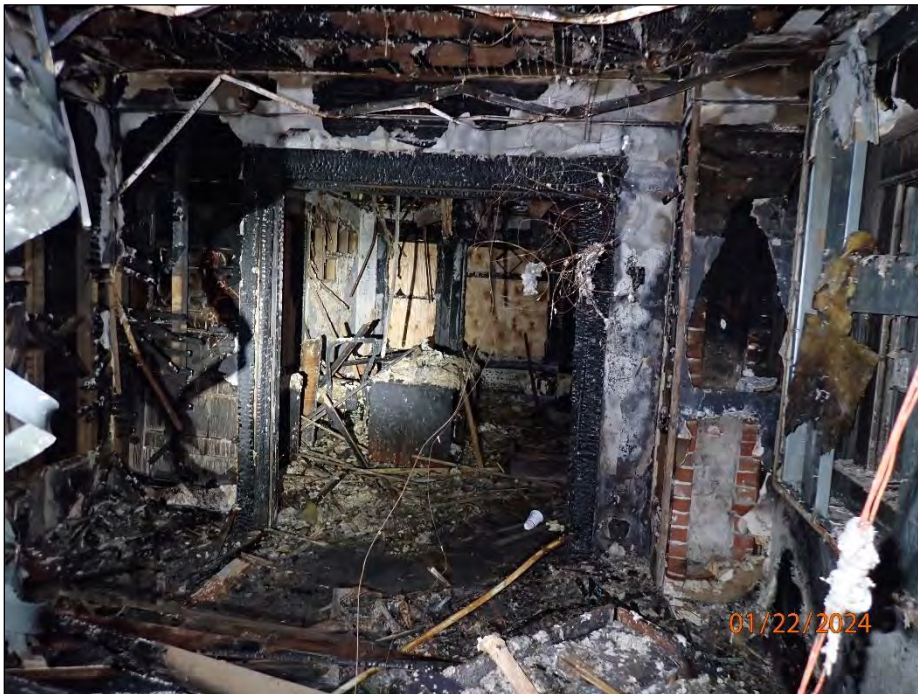
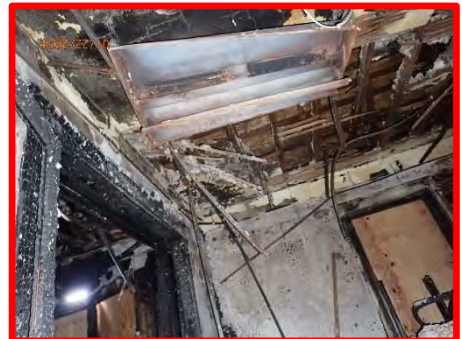
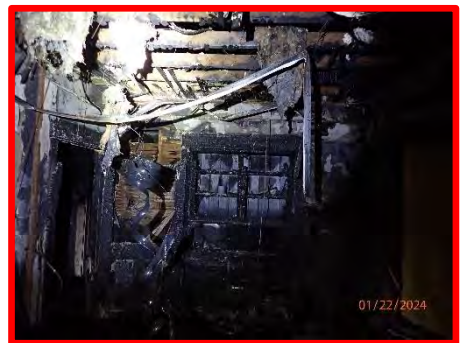
- Visible charring/burning and/or discoloration was prominent at areas of the structural framing members/components (i.e., subfloor, wood laths, straight/skip sheathing, joists, and rafters) within the southern portion of the building, which were partially or completely consumed by the fire. Bricks in the lower sections of the chimney had evidence of spalling. There were no visible indications of leaning or out-of-plumb conditions in the chimney structure; however, the structural element/stability of the chimney was compromised due to the spalling/detachment of bricks within the lower half of the stack construction (*see Photographs 6 & 7*).

6. Visible charring/burning and/or discoloration was prominent at areas of the structural framing members/components (i.e., subfloor, wood laths, straight/skip sheathing, joists, and rafters) within the southern portion of the building, which were partially or completely consumed by the fire.

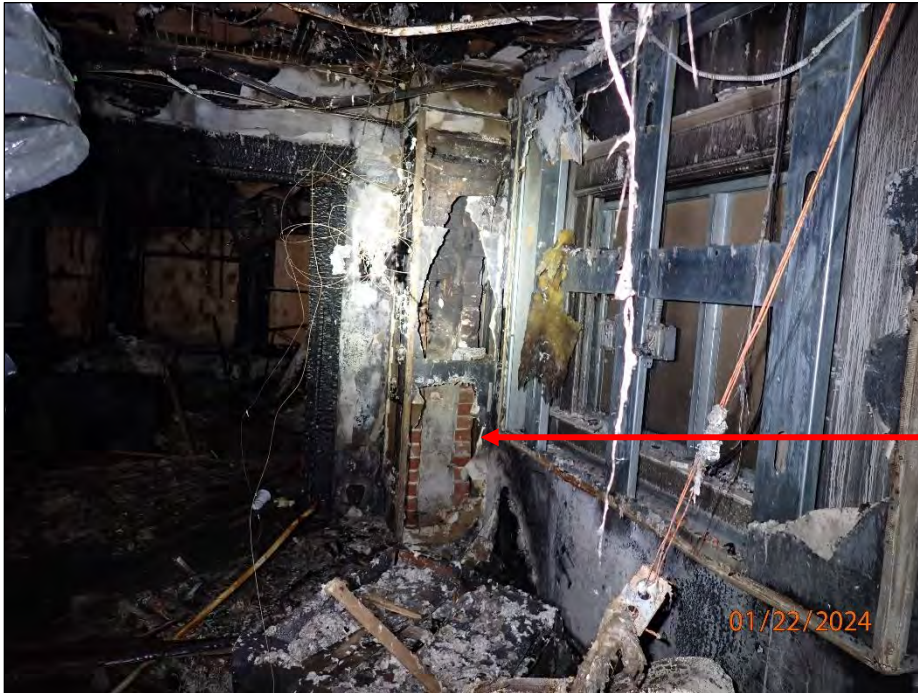
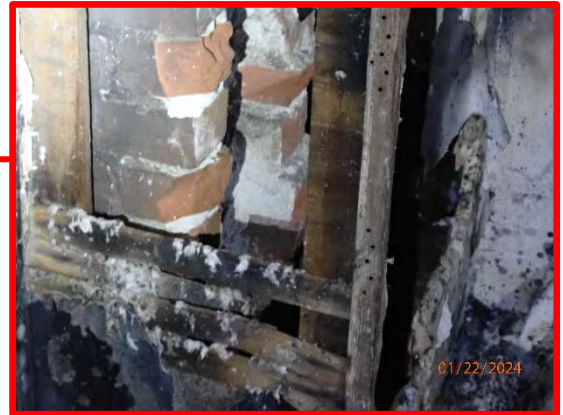
Bricks in the lower sections of the chimney had evidence of spalling; however, there were no visible indications of leaning or out-of-plumb to the chimney structure. Although Insight could not definitively associate the spalling with excessive fire/heat conditions during the reported event, the structural element/stability of the chimney was compromised due to the spalling/detachment of bricks within the lower half of the stack construction and will require repair/rebuild.

7. Bricks in the lower sections of the chimney had evidence of spalling. There were no visible indications of leaning or out-of-plumb conditions in the chimney structure; however, the structural element/stability of the chimney was compromised due to the spalling/detachment of bricks within the lower half of the stack construction.

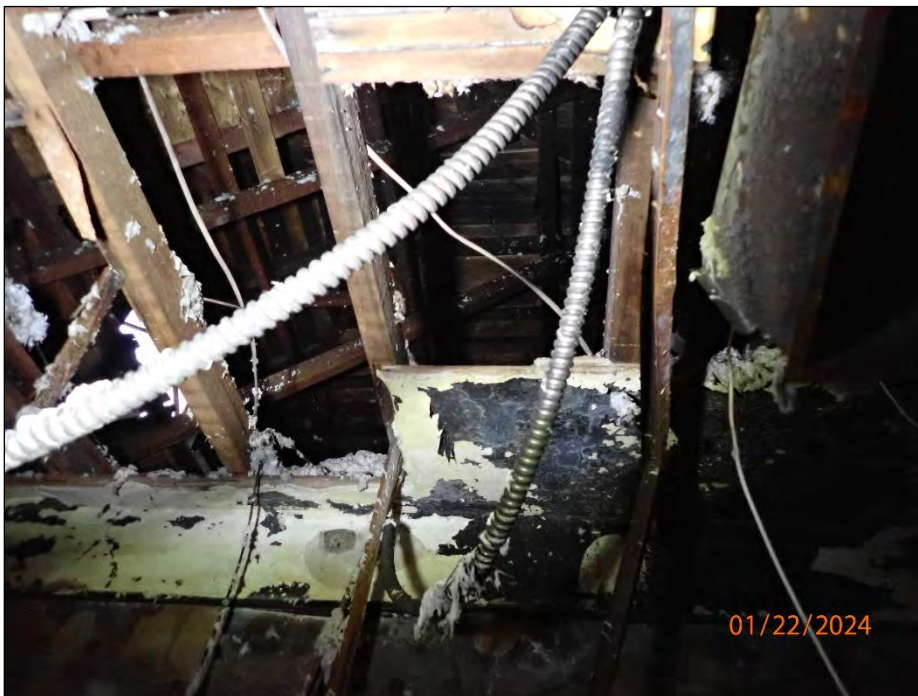
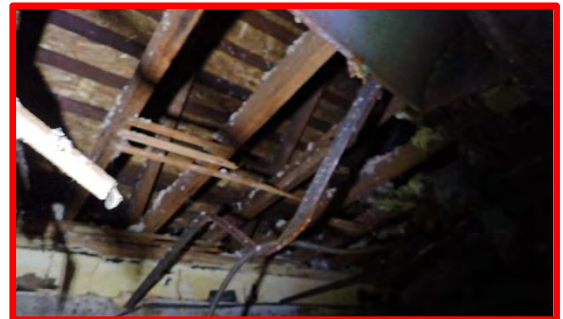
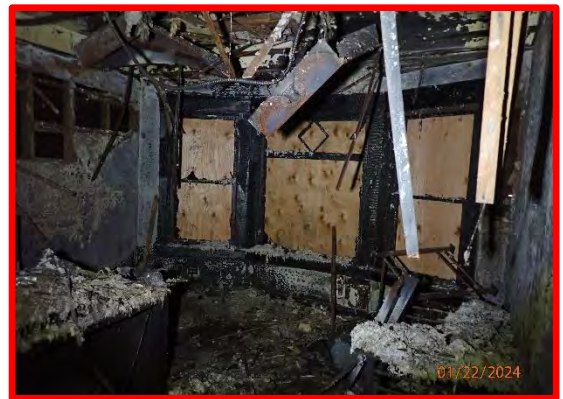
- The general disposition of the roof framing system within the southern portion of the building exhibited prominent signs of excessive amounts of charring. The noted fire/heat-related damage had compromised the integrity of the supporting members as well as the continuity of the load-carrying capacity. More than 60% of the roof system framing exhibited cross-sectional charring or excessive sapping/glazing appearance and were compromised (*see Photographs 8-through-11*).

8. The general disposition of the roof framing system within the southern portion of the building exhibited prominent signs of excessive amounts of charring. The noted fire/heat-related damage had compromised the integrity of the supporting members as well as the continuity of the load-carrying capacity. More than 60% of the roof system framing exhibited cross-sectional charring or excessive sapping/glazing appearance and were compromised.

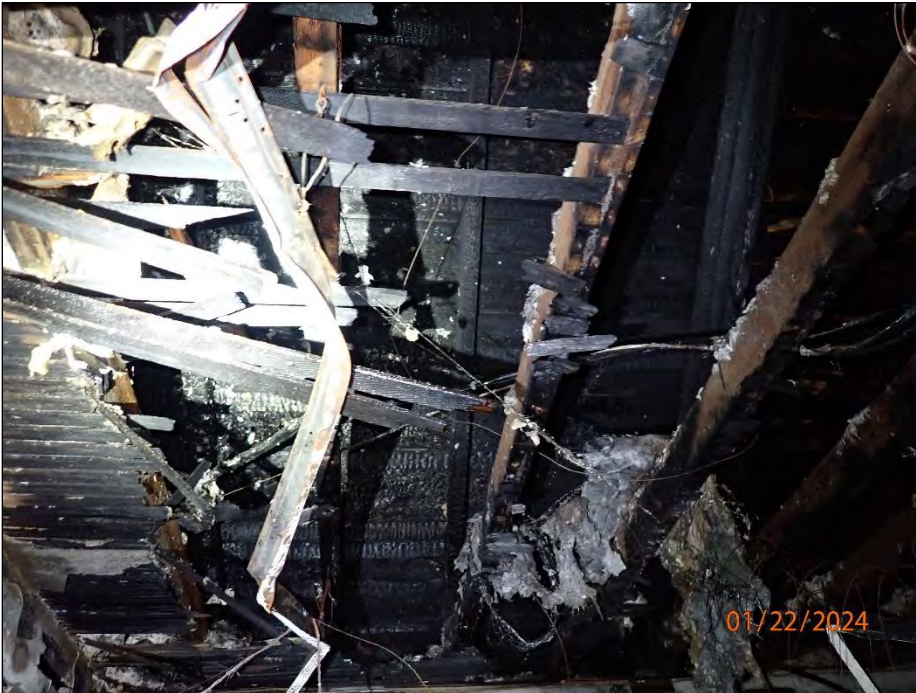
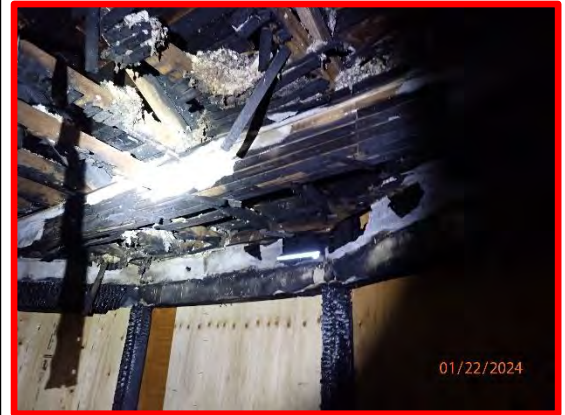
9. The general disposition of the roof framing system within the southern portion of the building exhibited prominent signs of excessive amounts of charring. The noted fire/heat-related damage had compromised the integrity of the supporting members as well as the continuity of the load-carrying capacity. More than 60% of the roof system framing exhibited cross-sectional charring or excessive sapping/glazing appearance and were compromised.

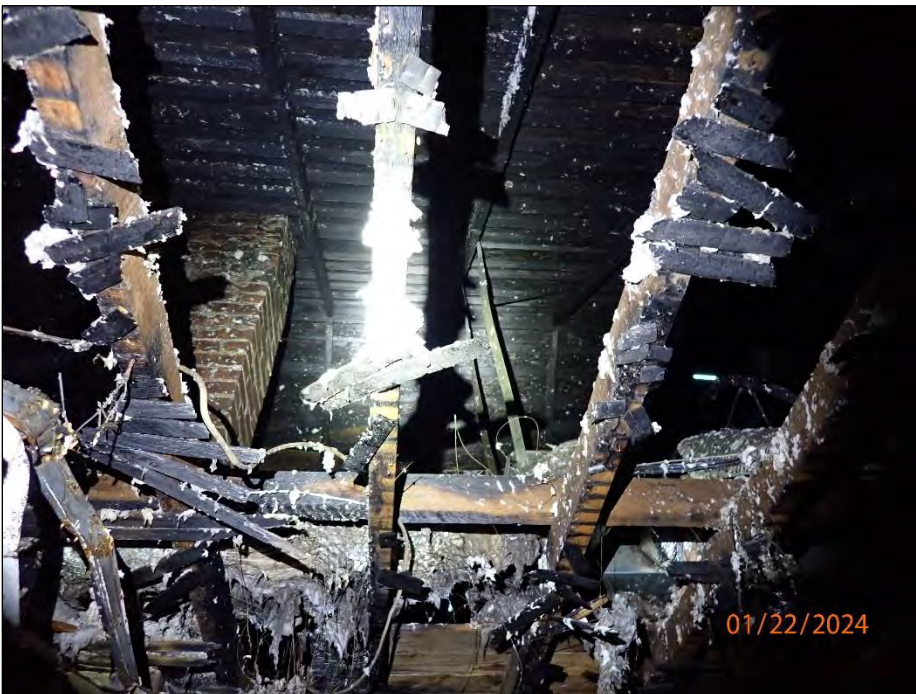
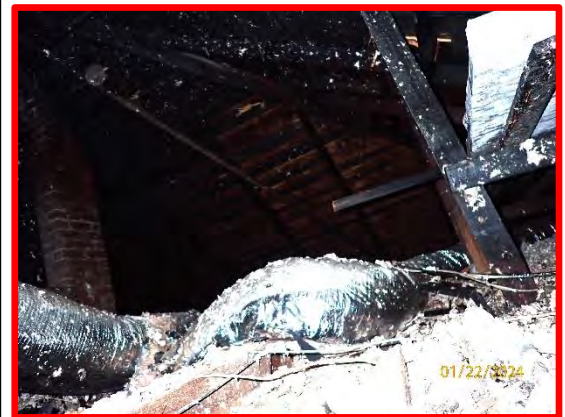
10. The general disposition of the roof framing system within the southern portion of the building exhibited prominent signs of excessive amounts of charring. The noted fire/heat-related damage had compromised the integrity of the supporting members as well as the continuity of the load-carrying capacity. More than 60% of the roof system framing exhibited cross-sectional charring or excessive sapping/glazing appearance and were compromised.

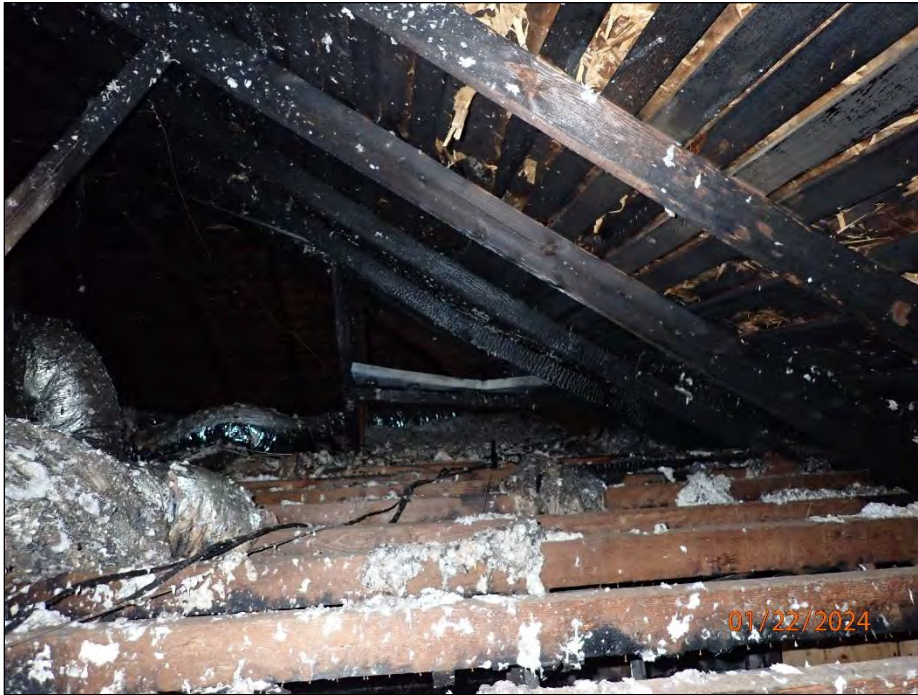
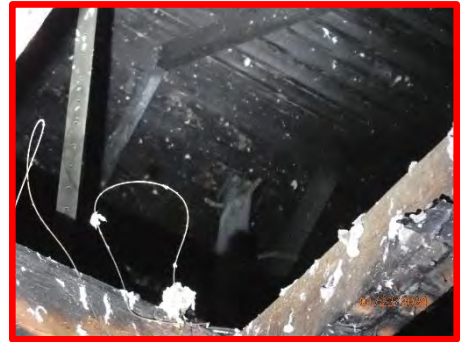
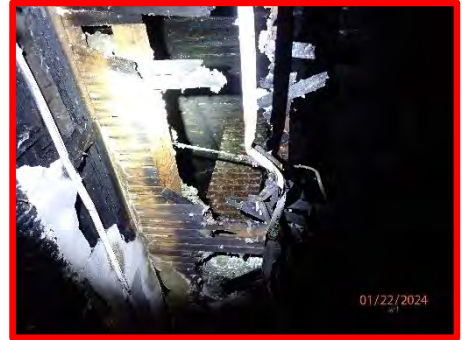
11. The general disposition of the roof framing system within the southern portion of the building exhibited prominent signs of excessive amounts of charring. The noted fire/heat-related damage had compromised the integrity of the supporting members as well as the continuity of the load-carrying capacity. More than 60% of the roof system framing exhibited cross-sectional charring or excessive sapping/glazing appearance and were compromised.

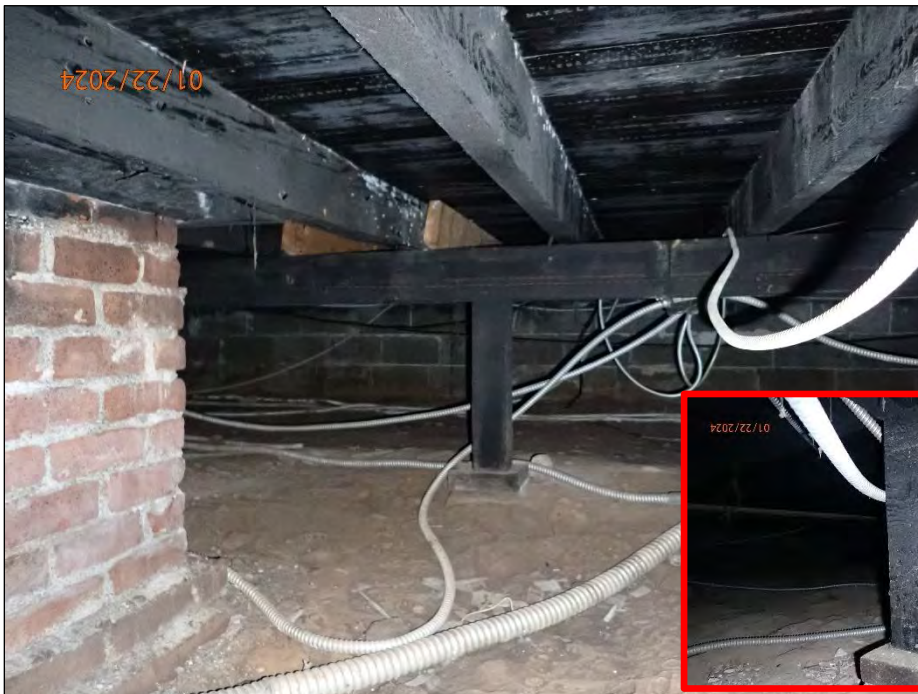
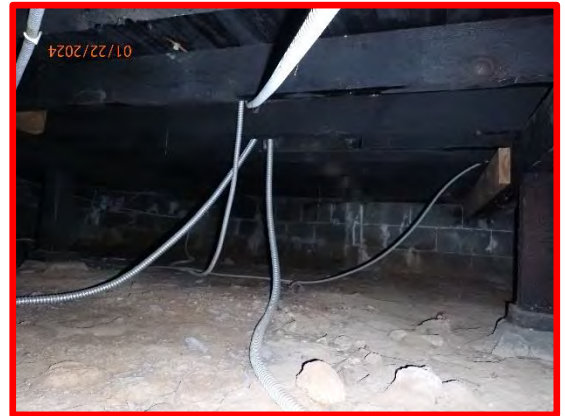
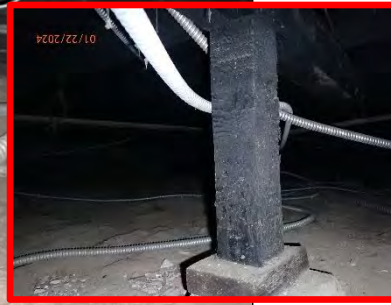
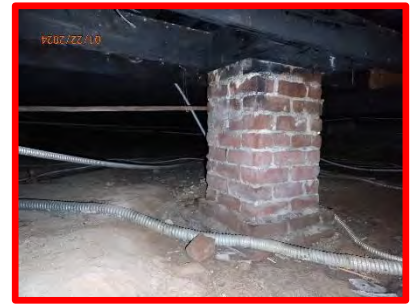
- There was visual evidence of fire/heat-related damage to the floor framing system/members, as evidenced by the visible degree of charring/burning or discoloration (*see Photograph 12*).

12. There was visual evidence of fire/heat-related damage to the floor framing system/members, as evidenced by the visible degree of charring/burning or discoloration. More than 50% of the floor system framing exhibited cross-sectional charring or excessive sapping/glazing appearance and were compromised by exposure to heat/fire.

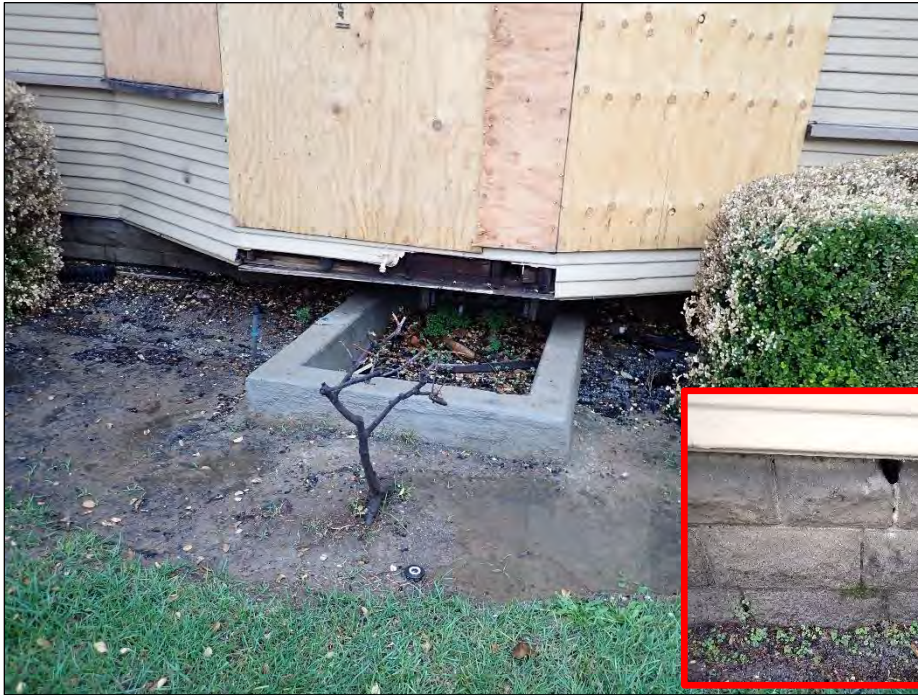
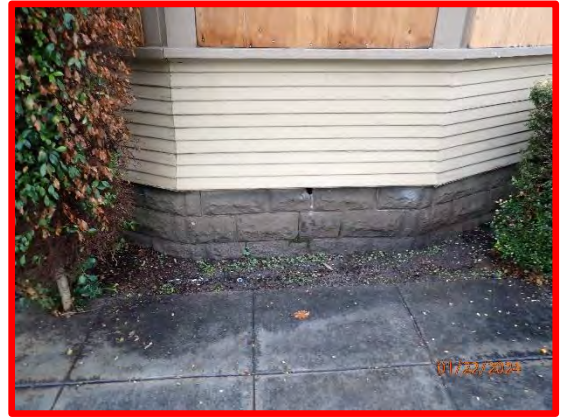
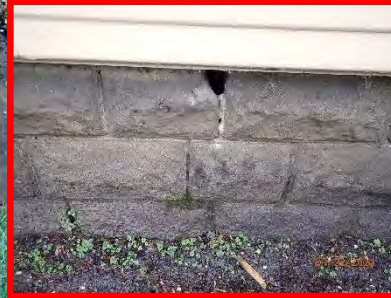
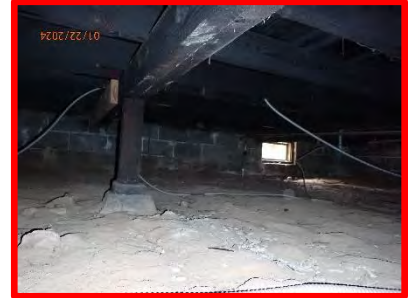
- The foundation of the structure had been retrofitted/replaced at some point during the life of the structure with CMU (concrete masonry unit) slump face block. There was limited damage to the accessible areas of the foundation. Heat/fire in the crawl space damaged limited sections of the block along the south wall (*see Photograph 13*).

13. The foundation of the structure had been retrofitted/replaced at some point during the life of the structure with CMU (concrete masonry unit) slump face block. There was limited damage to the accessible areas of the foundation. Heat/fire in the crawl space damaged limited sections of the block along the south wall.
