**REPORT OF GEOTECHNICAL INVESTIGATION  
RIVERSIDE COMMUNITY HOSPITAL  
RIVERSIDE, CALIFORNIA**

Project No. SD809  
December 6, 2024

**SUBJECT:      REPORT OF GEOTECHNICAL INVESTIGATION  
                  HCA Riverside Community Hospital  
                  Riverside, California**

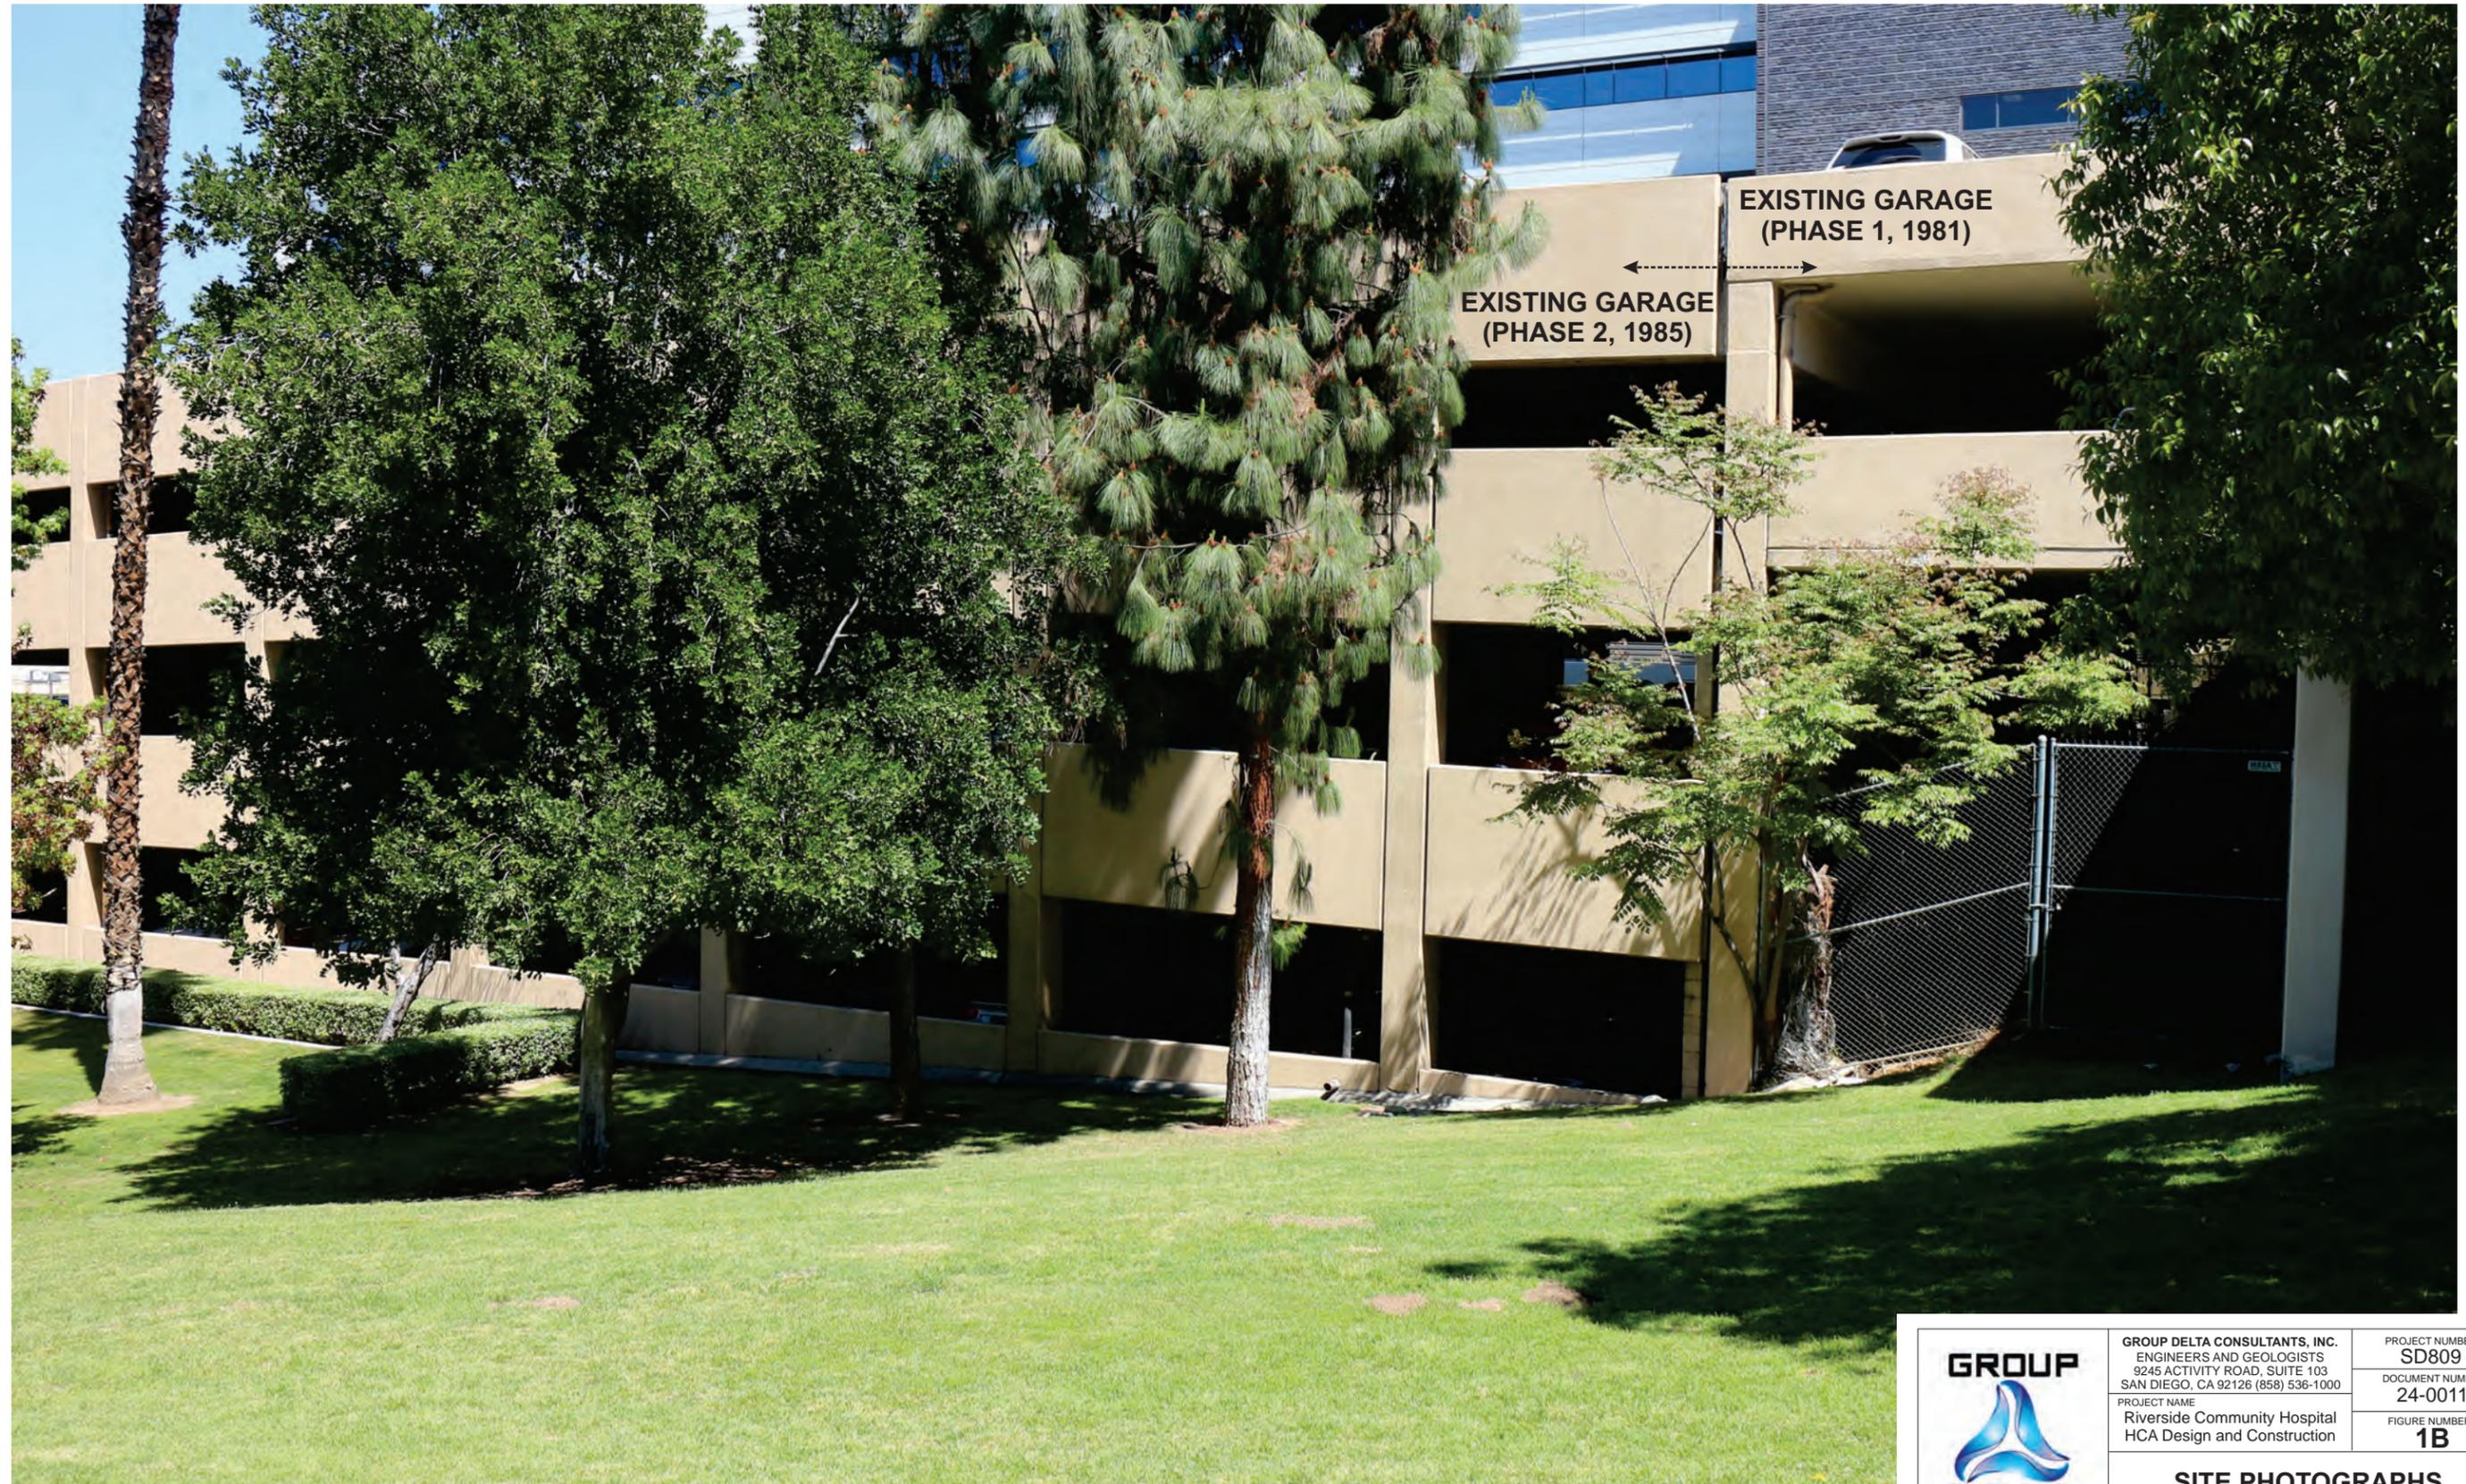
FIGURE NUMBER  
**1B**

Within the interior of the existing parking structure at the new Tower site, we observed relatively few cracks within the reinforced concrete columns and beams. The western portion of the slab-on-grade for the garage addition did have a few minor cracks (Crandall, 1985). Fairly extensive cracks were also observed around the perimeter of the structure. The concrete sidewalk along the eastern edge of the MOB immediately southwest of the Tower site was extensively cracked. The asphalt concrete pavements in this area also had extensive alligator cracking. Note that the western part of the Tower site is situated over compressible Young Alluvium. The patterns of cracking we observed in this area appear to be consistent with soil settlement.

The eastern portion of the existing garage at the Tower site is raised above grade and supported by concrete beams, columns and pile foundations (Crandall, 1981). This initial garage structure also appears to have performed fairly well to date, with only a few signs of cracking. However, the slope beneath this portion of the garage does show considerable signs of piping and soil erosion. One of the reinforced concrete beams in this area was longitudinally cracked with indications of seepage and corrosion of the steel reinforcement (i.e. rust stains). There are also indications of settlement of the asphalt concrete pavement located immediately east of the pile supported garage. Extensive cracks were also observed around the elevator tower in the northwest corner of the initial garage structure. Finally, the soldier pile shoring between the garage and Tower C is exposed along the staircase between these structures and appears to have been partially demolished.

EXISTING GARAGE  
(PHASE 1, 1981)

EXISTING GARAGE  
(PHASE 2, 1985)

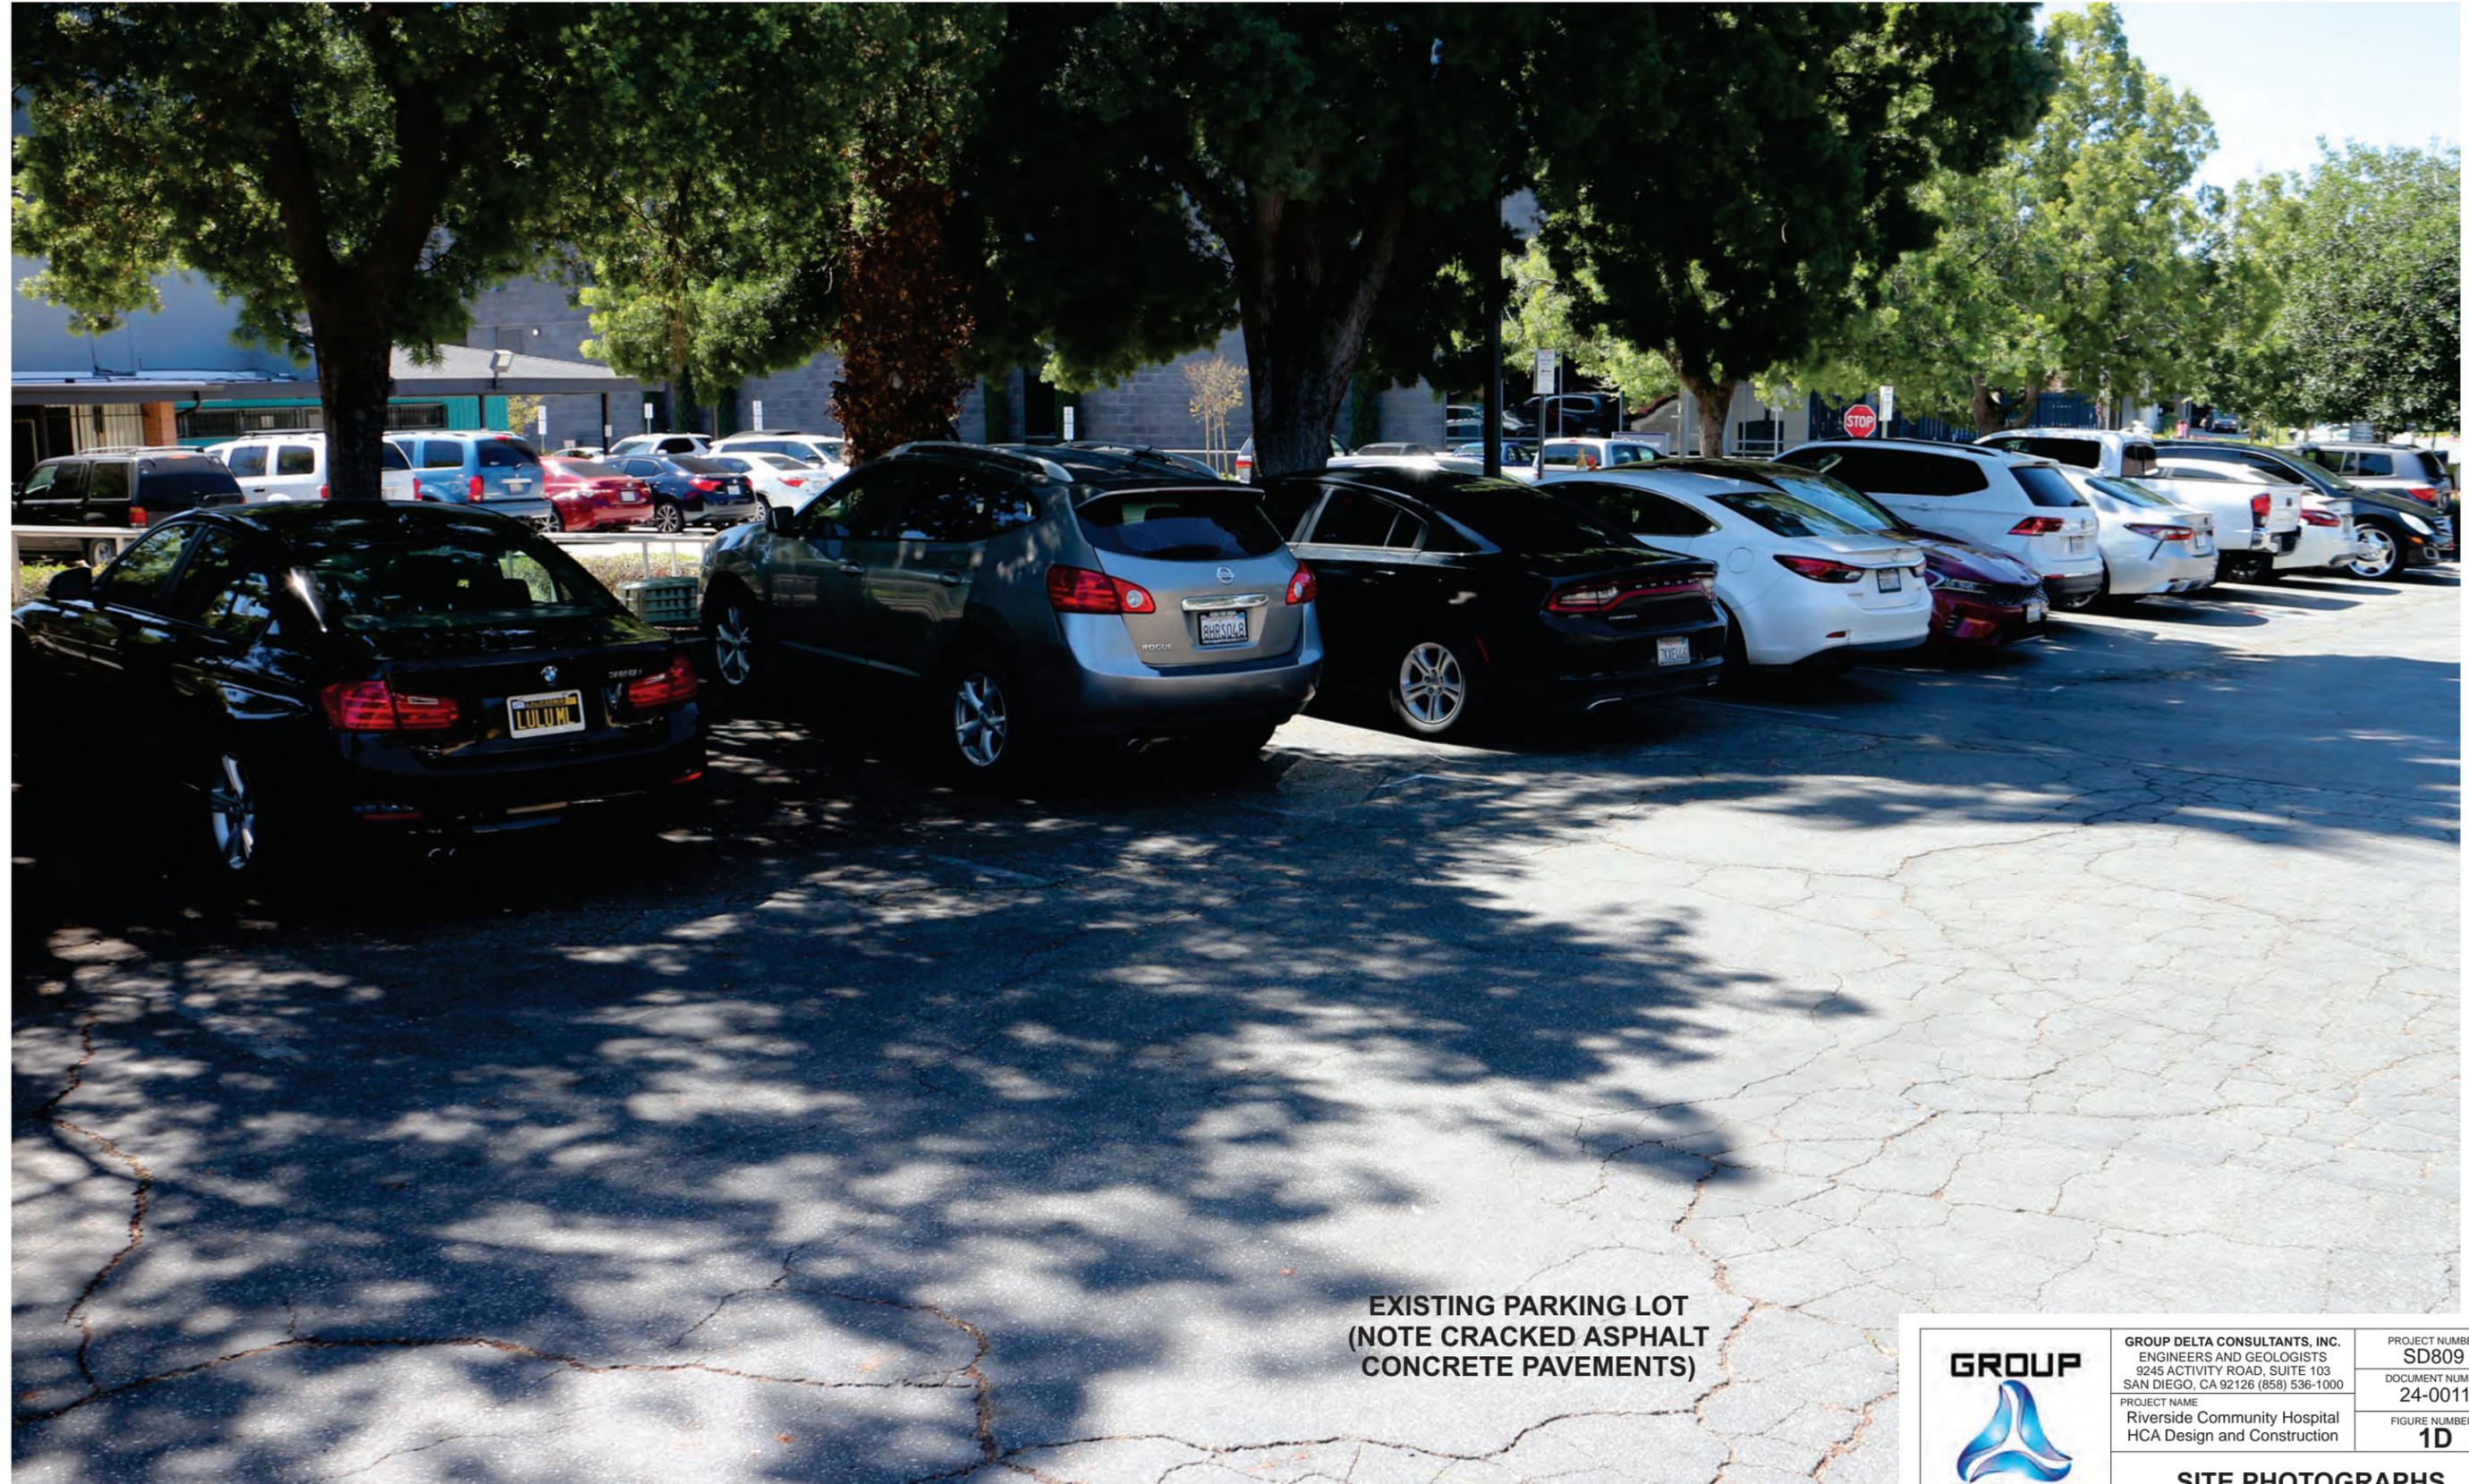
PROJECT NUMBER  
SD809  
DOCUMENT NUMBER  
24-0011  
FIGURE NUMBER  
1D

In comparison to the Tower site, the existing structures at the new Garage site show numerous signs of cracking and distress. The existing 4-inch-thick concrete pavements which surround the Brockton Auto Clinic are cracked on a relatively tight spacing. The 2-inch-thick asphalt concrete parking lot in the northern portion of the Garage site is also extensively cracked (see Figure 1D). The extensive cracking of these surface improvements may be related to an inadequate initial pavement section design. However, these cracks may also be related to soil settlement.

**EXISTING PARKING LOT  
(NOTE CRACKED ASPHALT  
CONCRETE PAVEMENTS)**

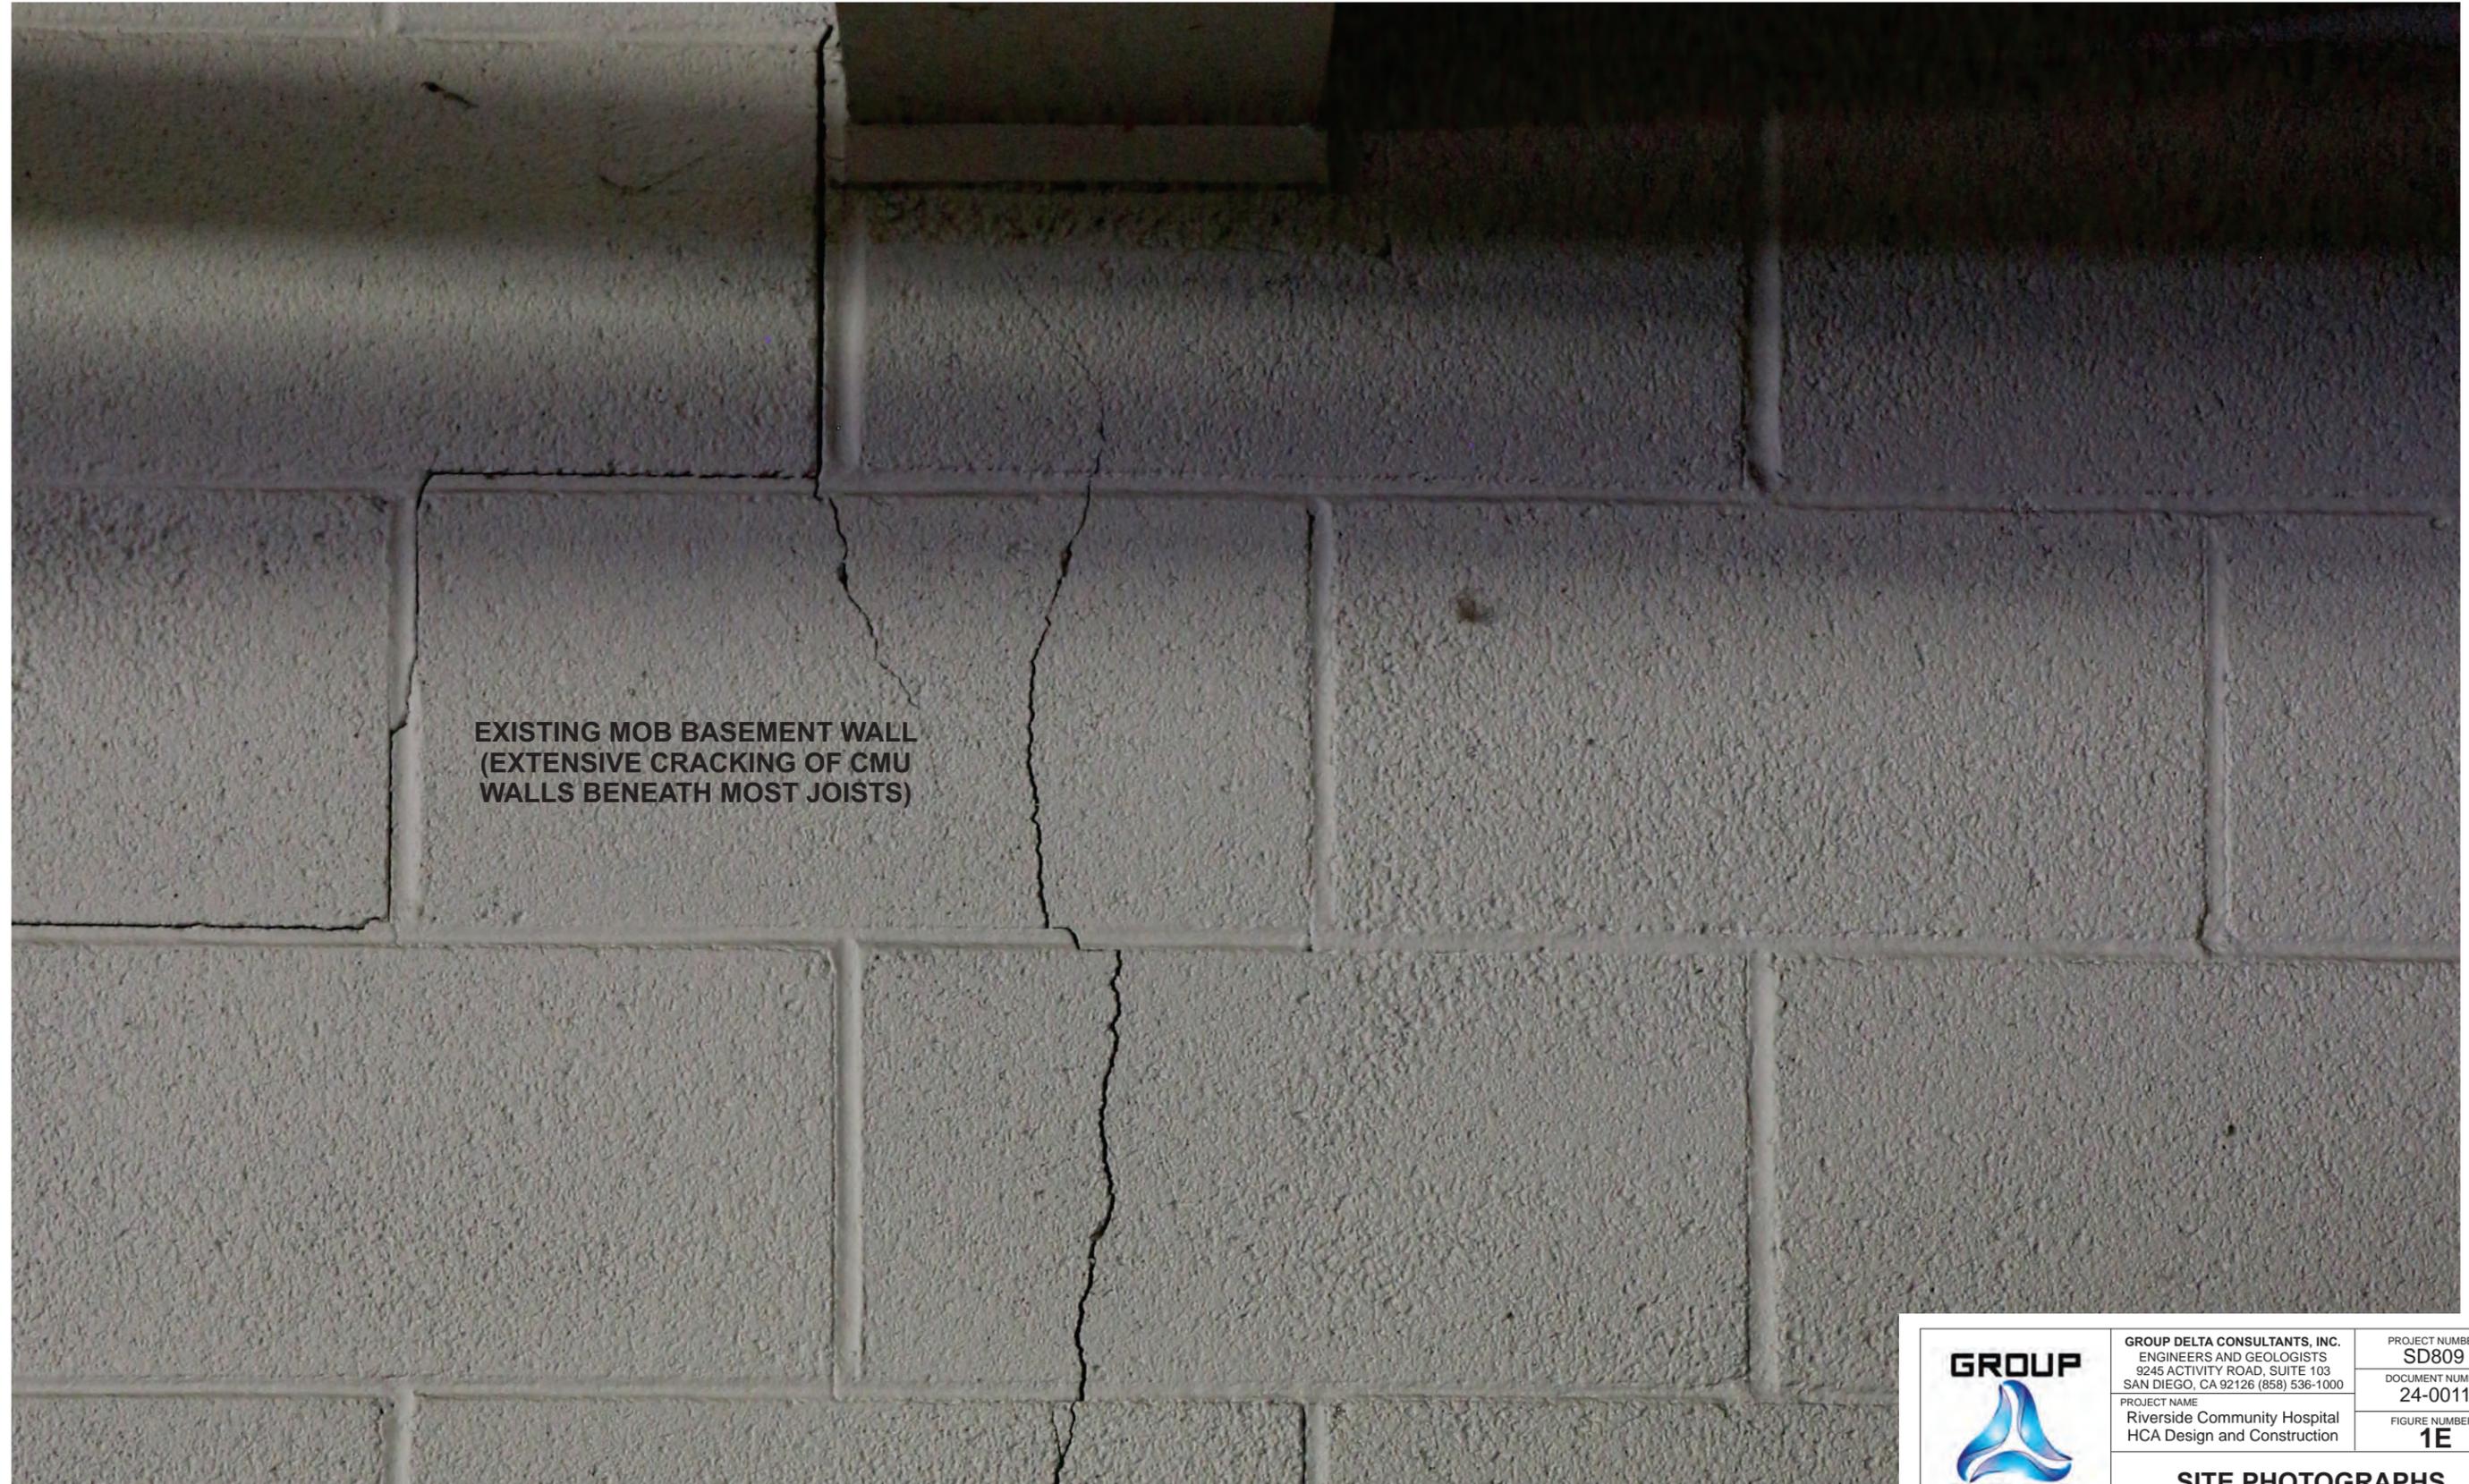
PROJECT NUMBER  
SD809  
DOCUMENT NUMBER  
24-0011  
FIGURE NUMBER  
1E

Extensive damage was observed within the basement garage of the Community Medical Center at the proposed Garage site. The basement extends roughly 10-feet below surrounding grades and was constructed using cement masonry units (CMU). It appears that this structure is founded on shallow spread footings. The CMU walls are badly cracked beneath nearly all of the joists that support the first floor of the building (see Figure 1E). Most of the cracking was hairline in width, although a few of the cracks were 1/8<sup>th</sup> of an inch or wider. These regular cracks extended from the bottom of the joists all the way down through the CMU wall to the slab-on-grade. The concrete slab-on-grade was also extensively cracked throughout the structure, and cracks were also observed in the slab around the column footings. The pattern of distress in the basement garage of the Community Medical Center is consistent with soil and foundation settlement.

EXISTING MOB BASEMENT WALL  
(EXTENSIVE CRACKING OF CMU  
WALLS BENEATH MOST JOISTS)
