Harada House Structural Engineering Assessment Work November 2017

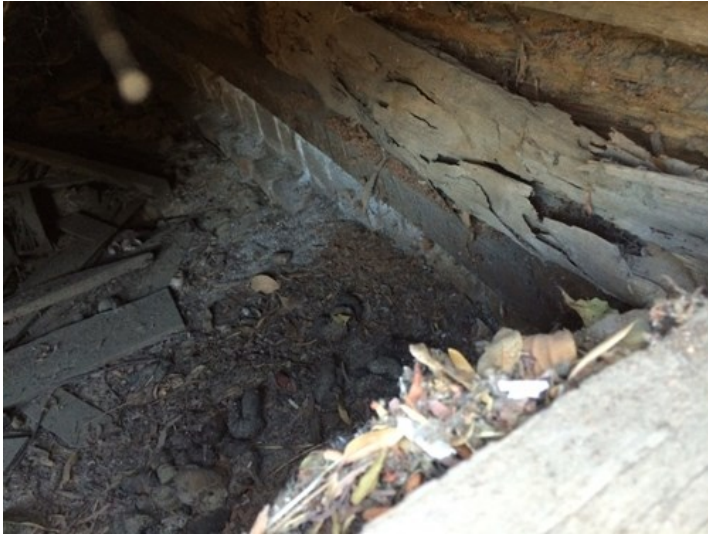
Termite and dry rot damaged floor beam
(supports front wall of Harada House)

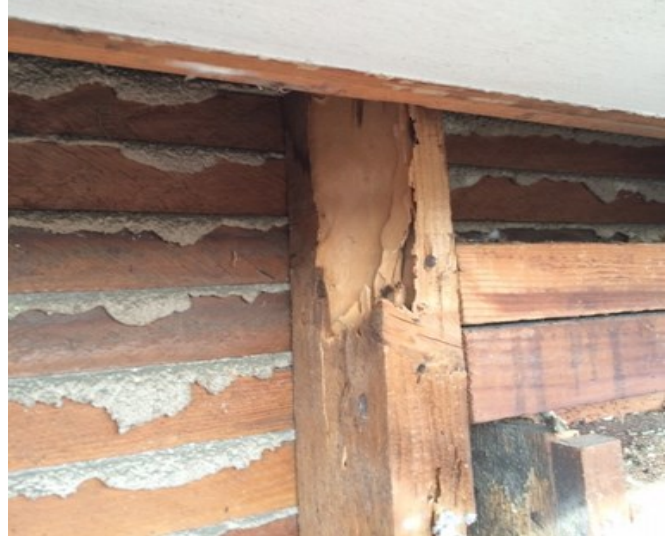
Termite damaged stud at window header,
East Elevation

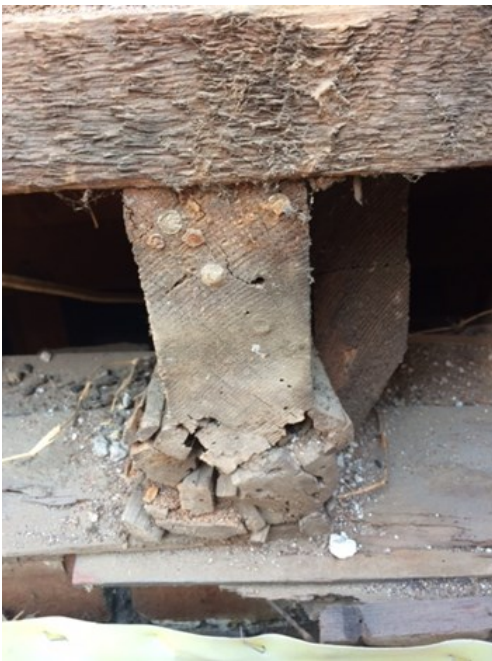
Dry rot damaged floor joist, South Elevation

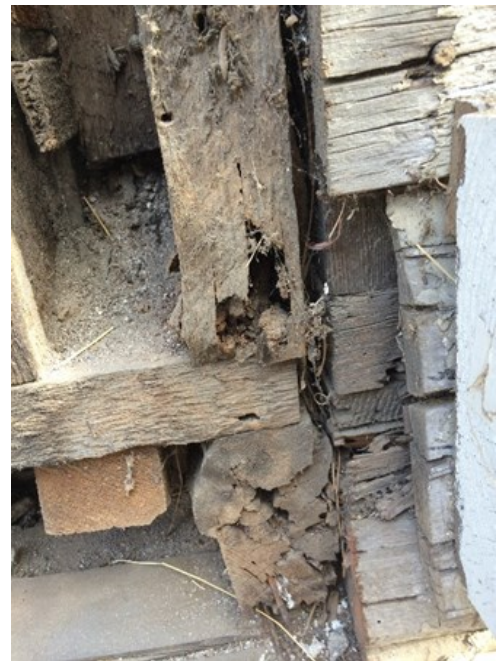
Dry rot damaged floor joist at South Elevation –
located at connection of dining room and kitchen

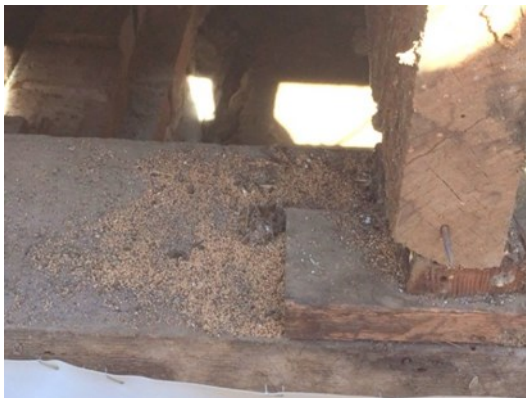
Evidence of termite activity
Floor joist at South Elevation
