## Project Field Memorandum: Imperial Hardware Lofts Façade Rehabilitation

**Project:** Imperial Hardware Lofts Adaptive Reuse Design Assessment, 3750 Main Street,  
Riverside CA 92501

Document issue 29 April 2015 **Transom window Addendum, 14 August 2018**

Historical Structure Evaluation / Assessment Report for the Record with Recommendations:

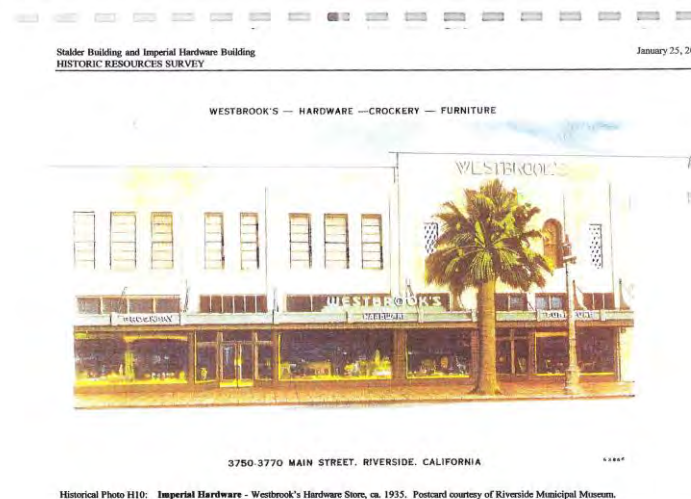
Colorized post card image, dated estimate of 1935. Used for reconstruction of the original storefront mullion pattern. Noted that the original ground level storefront was subsequently removed and was not extant.
