# HARADA HOUSE

**3356 Lemon Street  
Riverside, CA 92501**

April 30, 2018

## STRUCTURAL ENGINEERING ASSESSMENT REPORT

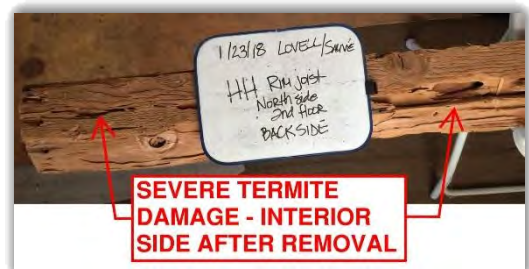
Figure 14 – Back side of Second Floor rim joist  
after being removed (January 23, 2018)

plate of the ground floor wall was replaced, and the ground floor joist tails were supplemented with a new 2x joist screwed to the side and then trimmed to facilitate the repair. At the Second Floor, the rim joist was replaced.

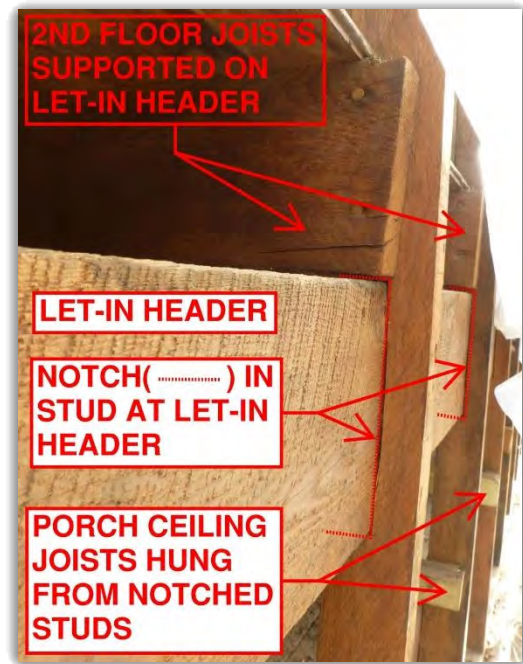
- i. The second-floor header on the west elevation contained a problematic framing condition. The header was originally built as a let-in 2x header creating a notch in the studs that the porch ceiling joists hang from. Figure 15 illustrates this condition.

*Figure 15 - Porch Ceiling Joists Hung from Notched Studs (January 16, 2018)*

This condition was mitigated by SSK-11 *Detail at (E) Let-In Header (West Elevation)* as an **Immediate Future** category repair. The detail adds new posts from the foundation of the west elevation to the roof, special detailing was required to pass around the existing let-in header at the second-floor.

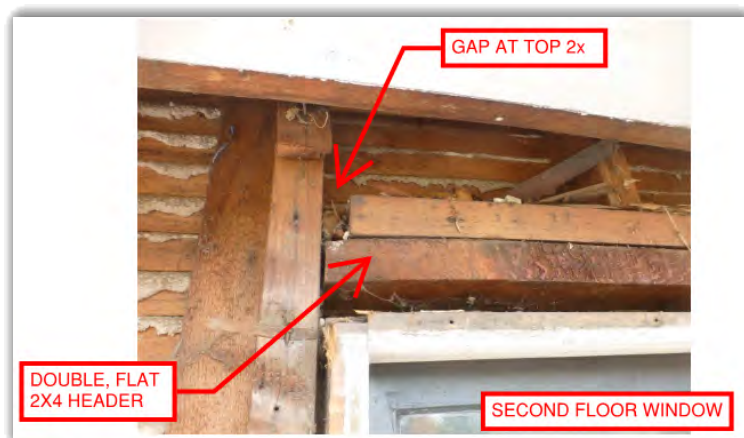
- a. Several poorly framed header conditions were found throughout the exterior walls. The headers often consist of a double, flat 2x4 that is end nailed to the closest adjacent stud. In some cases, the header is a single, flat 2x member. Figure 19 shows a typical header condition in the house.

Figure 19 - Harada House Typical Header Condition (November 6, 2017)

The **Permanent Solution category** repair for this condition is to remove the existing header and replace it with a properly designed and connected header. Modifications to the adjacent king studs as well as the addition of jack studs will also be required. Figure 20 shows a properly framed header condition using current construction practices.

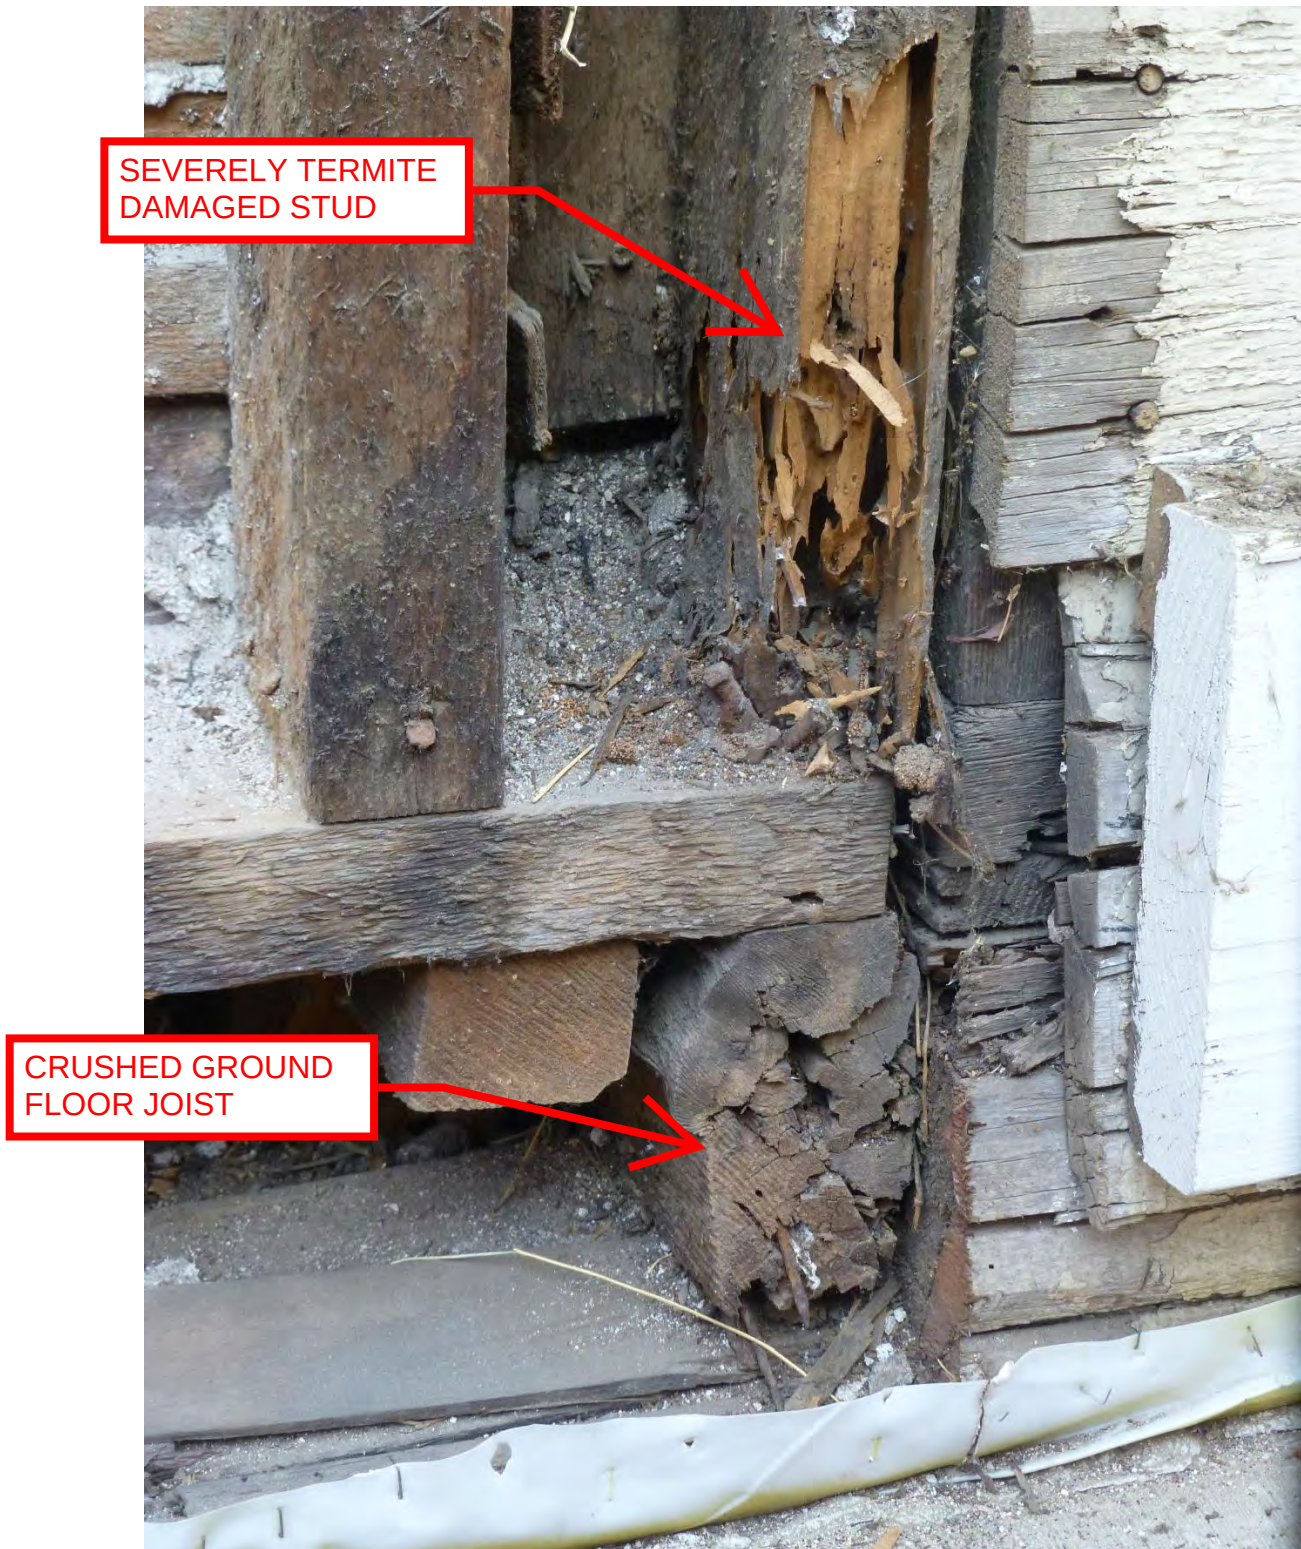
**PHOTO 1: SOUTH ELEVATION – GROUND FLOOR**

3. As noted in several of the Temporary Immediate Repairs listed above, severe termite damage was found in every exterior wall elevation when exposed. The ground floor framing and floor boards as observed from the partial cellar are also severely deteriorated from termite damage to the point that several holes through the floor were found. Additional photos of the most severe termite damage are provided in the photos at the end of this report. See Photos 1, 2, 4, 8, 10, and 11.

All structural elements that have been compromised by termite damage need to be replaced or supplemented with new wood members. This includes a large portion of the exterior wall framing that was observed during this structural assessment and is assumed to include the interior framing as mandated by the Director of the Riverside Metropolitan Museum since access was not provided to assess the interior wood framing. In addition, a robust termite inspection and treatment program by a qualified pest control professional shall be implemented and maintained immediately. The Termite Monitoring Program falls under the **Immediate Future** category.

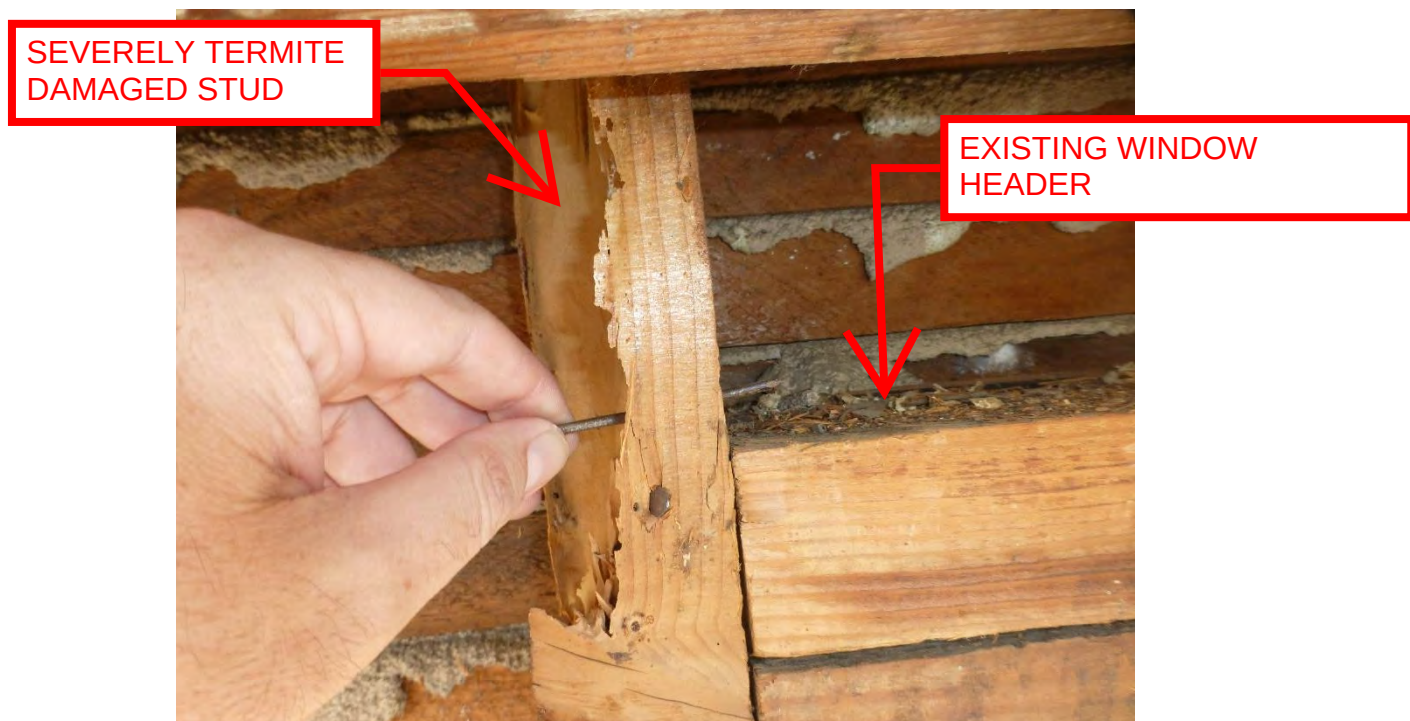
PHOTO 3: EAST ELEVATION – DAMAGED STUD

SEVERELY TERMITE  
DAMAGED RIM JOIST

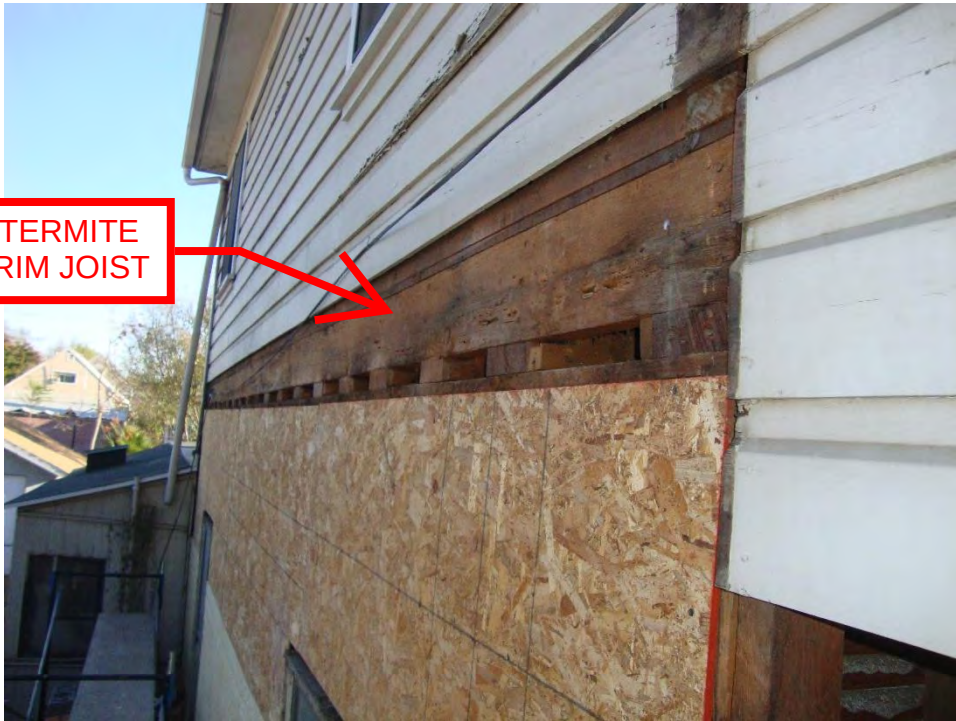
PHOTO 4: NORTH ELEVATION – 2ND FLOOR RIM JOIST

TERMITE DAMAGE

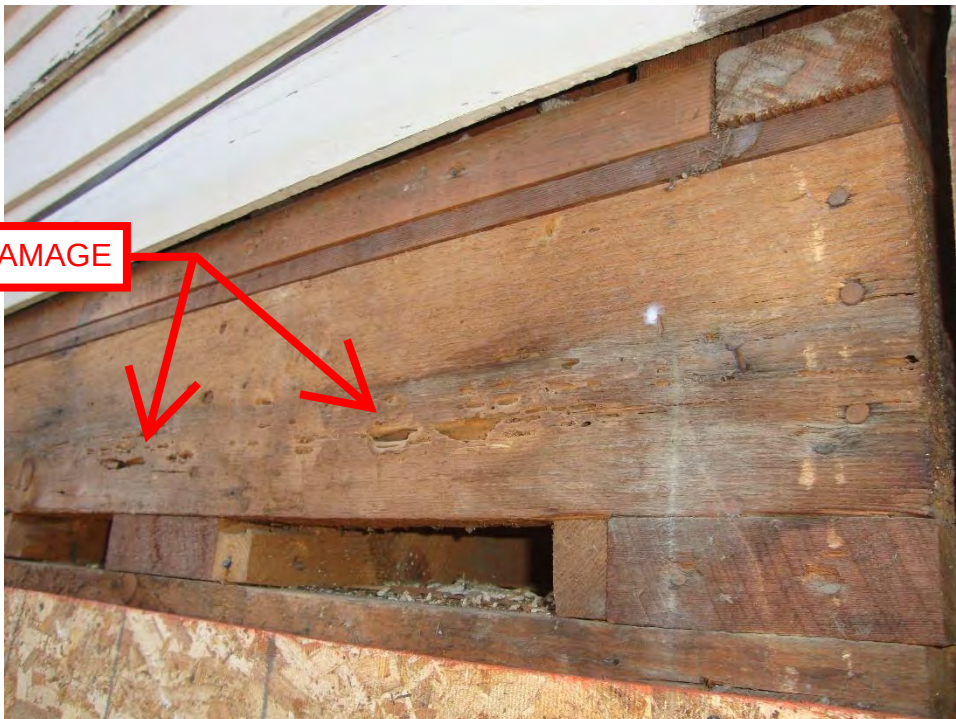
PHOTO 5: NORTH ELEVATION – DAMAGED RIM JOIST

SEVERELY TERMITE DAMAGED  
RIM JOIST - EXTERIOR SIDE  
AFTER REMOVAL

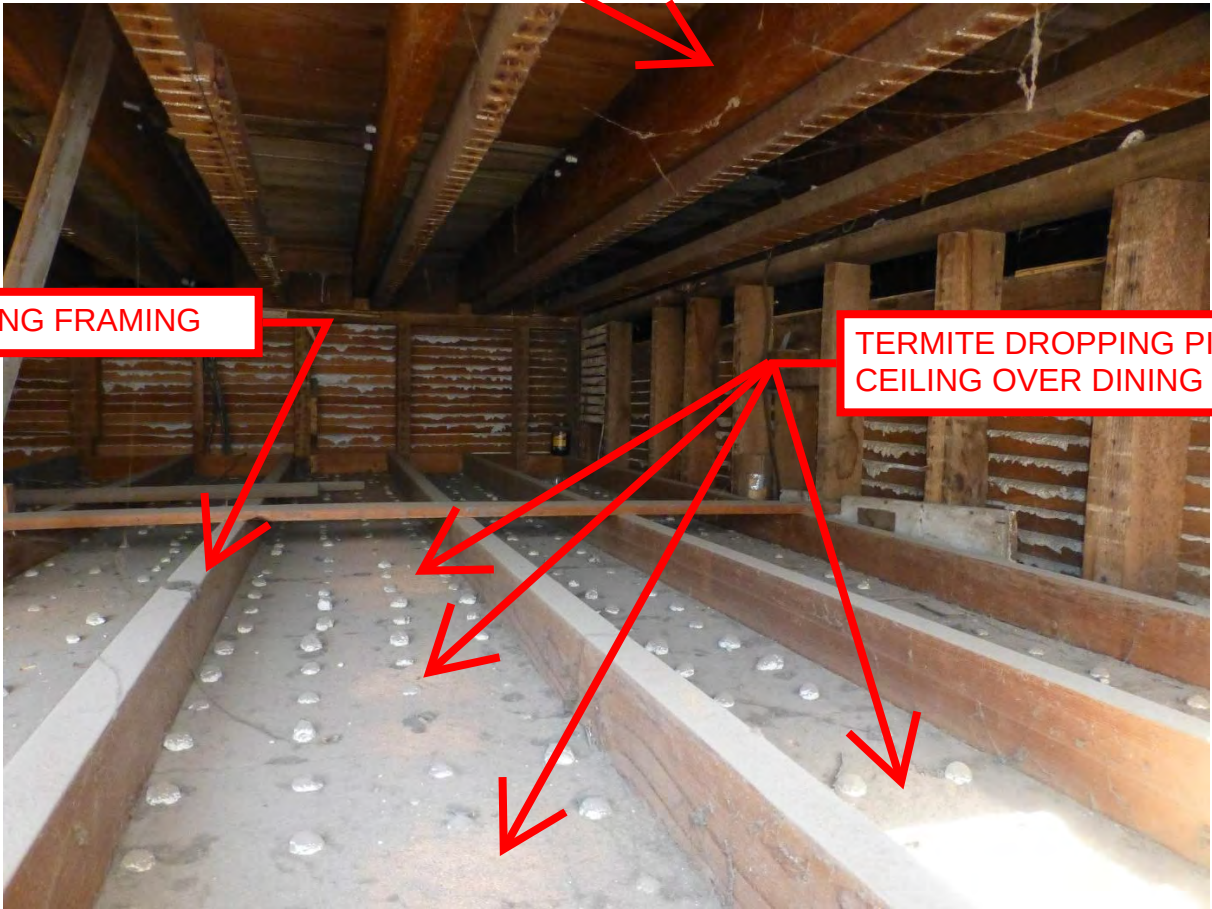
PHOTO 8: DROP CEILING OVER DINING ROOM  
(MIDDLE OF HOUSE ON SOUTH SIDE)

TERMITE DROPPING PILES ON  
CEILING OVER DINING ROOM
