**HISTORIC PRESERVATION FUND COMMITTEE MEETING DATE: JANUARY 14, 2019
AGENDA ITEM NO.: 3**

I. CASE NUMBER: P18-0951

HARADA HOUSE

**3356 Lemon Street
Riverside, CA 92501**

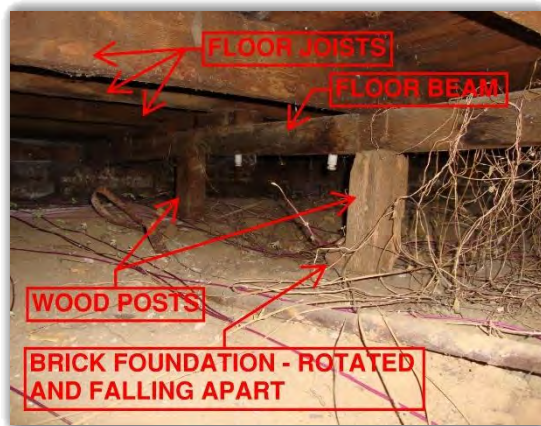
The Foundation System is the base of the structure and is the critical component for supporting all levels of a building. The Harada House is supported on wood posts on individual concrete and small brick pad foundations (spread footings) at the building interior in the crawl space (see Figure 4 below) and on straight line brick foundations (linear strip footings) around the perimeter of the building. A partial cellar was reportedly excavated in about 1915 and a new concrete foundation wall was constructed at that time. Figure 5 below shows the severely cracked concrete cellar wall located at the south-west corner of the house.

*Figure 4 - Crawl Space Framing
(June 20, 2017)*

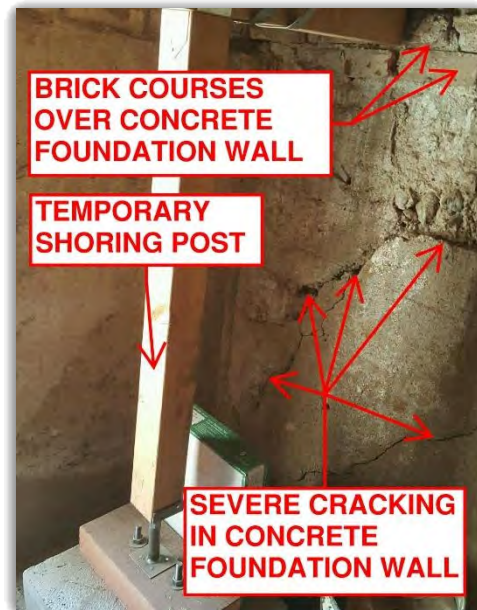
*Figure 5 - Cellar Foundation Wall
(July 27, 2016)*

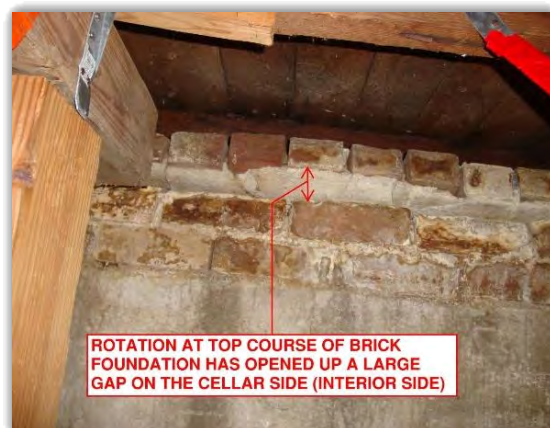
Although not verified with exploratory excavation, it appears that the perimeter wall foundations consist of double wide (two wythes) unreinforced brick. The depth of the brick foundation walls is unknown. The 2x wood sill plate typically bears on the top of the brick and the floor joists bear on the sill plate. The wall studs bear on the floor plate over the ends of the floor joists. There is typically no rim joist or blocking between the floor joists at the Ground Floor. There is no anchorage of the framing to the foundations. The condition of the brick foundation as observed from the interior side at the southwest corner cellar is very poor. The mortar joints are very soft and the bond between the bricks and mortar has released. The top course of brick on the south wall of the cellar have rotated and displaced due to rotation of the concrete retaining wall below. See Figure 6 for a photo of this condition.

*Figure 6 - Rotated Brick Foundation below South Wall
(June 20, 2017)*

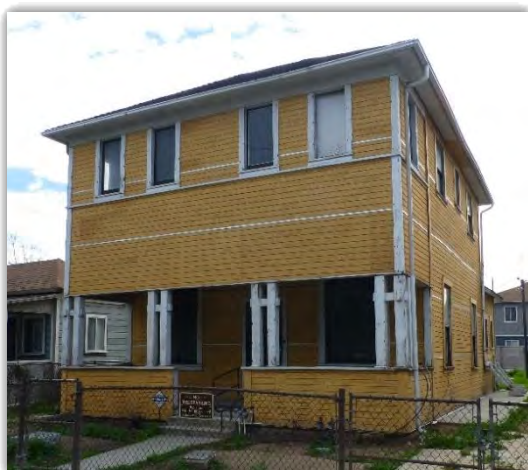
The original vertical lateral force resisting elements consist of the existing 2x4 wood stud walls. The interior walls are covered with wood lath and plaster on both faces, and the exterior perimeter walls have lath and plaster on the interior face and 1x horizontal clapboard siding on the exterior face. As part of this Structural Assessment project, the original siding was removed and replaced with plywood sheathing as shown in Figure 7 at the left. There is little

*Figure 7: Harada House with Plywood Sheathing
(March 20, 2018)*

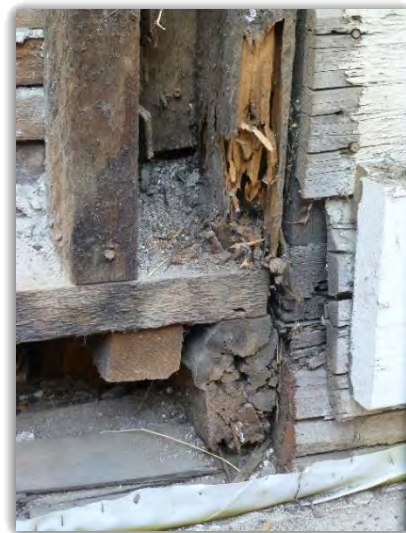
- a. Severe damage was found at the base of the wall on the south elevation in the middle portion of the house. The damage included deteriorated wood framing from termites, dry rot, and water damage (Figure 8 at right). In addition, the removal of the siding exposed a framing condition where load bearing studs were only supported by the bottom plate of the wall. This is not an adequate way to properly support wall studs

Figure 10 - South Wall Deteriorated Wood Framing (November 9, 2017)

The **Immediate Future category** repair for this condition was addressed with the implementation of sketch SSK-1 *Blocking at Base of Zone S1C*. The sketch can be found at the end of this report and provided new wood blocks at the base of the wall to provide direct support between load bearing exterior wall studs and the existing brick foundation. A permanent solution to this structural deficiency will be addressed with the construction of a new foundation for the building.

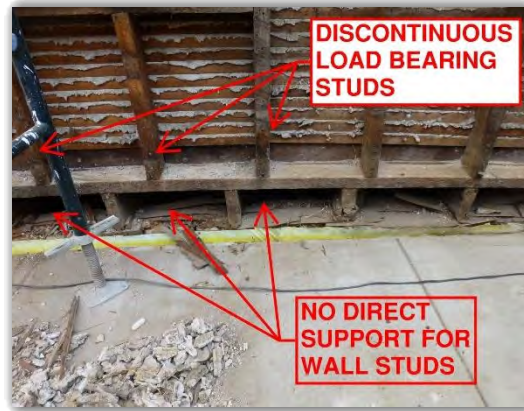
and is known as a discontinuous load bearing condition (Figure 9 at right).

Figure 11 - South Wall Discontinuous Load Bearing Condition (November 9, 2017)

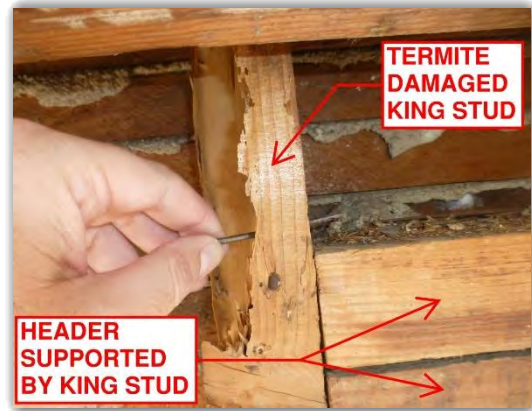
- d. Severe termite damage was found in two studs that support the south-east corner of the high roof. The most severely damaged stud was a header support stud (called a king stud) on the south side of the second-floor window. Approximately half of the stud width had been eaten away by termites, and the remaining portion of the stud was so compromised a nail could be pushed completely through with a bare hand. The photo at the right (Figure 12) shows this stud.

Figure 12 - Severely Compromised King Stud
(November 29, 2017)

The repair for this condition involved replacing the severely damaged stud with a new stud. **Immediate Future** category repair SSK-5 Stud Replacement at Zone E2A shows the most severely damaged wood stud on the south side of the Second Floor window was removed and replaced with a new stud. The next stud to the south was supplemented by screwing a new stud to the side of the damaged one.

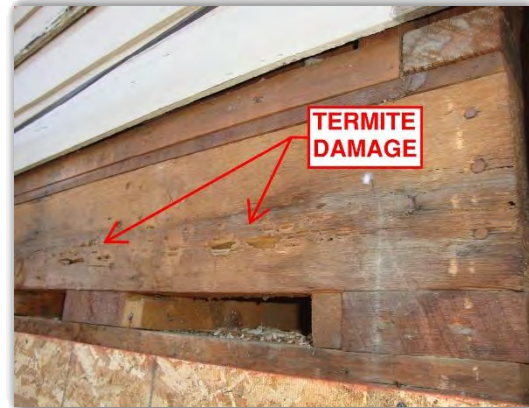
- e. The north elevation had two conditions that required immediate repair measures. The bottom plate of the ground floor wall was so badly damaged by termites that support for the north wall was compromised. In addition, the ground floor joist tails were irregularly framed and needed to be modified to facilitate the repair. At the second floor, the rim joist contained severe termite damage as well. Figure 12 and Figure 13 at the right show the extent of the damage.

Figure 13 - Second Floor Rim Joist with Termite Damage
(December 7, 2017)

Two **Immediate Future** category repair sketches were issued to address the inadequate framing on the north elevation: SSK-6 Temp Repair at North Wall Bottom Plate and SSK-7 North Wall 2nd Floor Rim Joist. The bottom

plate of the ground floor wall was replaced, and the ground floor joist tails were supplemented with a new 2x joist screwed to the side and then trimmed to facilitate the repair. At the Second Floor, the rim joist was replaced.

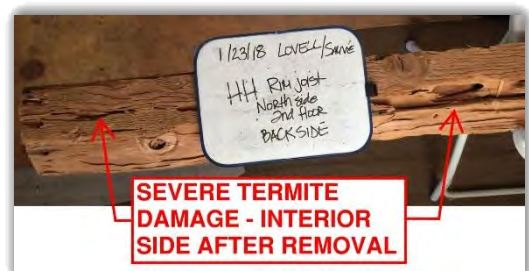
Figure 14 – Back side of Second Floor rim joist after being removed (January 23, 2018)

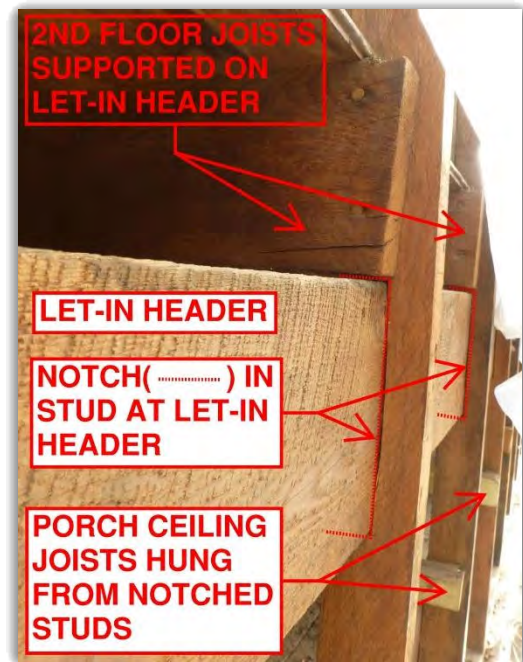
Figure 15 - Porch Ceiling Joists Hung from Notched Studs (January 16, 2018)

This condition was mitigated by SSK-11 *Detail at (E) Let-In Header (West Elevation)* as an **Immediate Future** category repair. The detail adds new posts from the foundation of the west elevation to the roof, special detailing was required to pass around the existing let-in header at the second-floor.

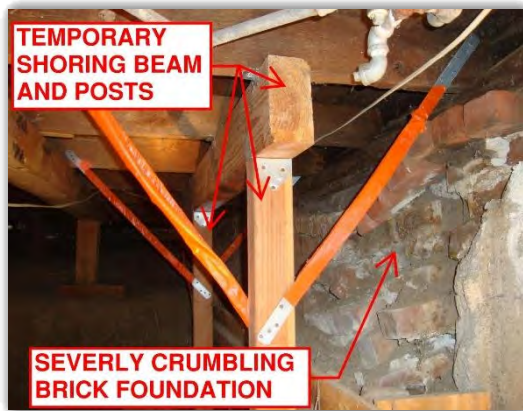
5. The original brick and concrete basement foundations are severely damaged and need to be replaced. In addition to the most visible damage at the south-east corner of the house in the partial cellar (see Figure 16 and Figure 17 below), there are loose bricks in several areas around the entire perimeter of the house.

Figure 16 – Crumbling Foundation below East Wall (June 20, 2017)

The Foundation System is the base of the structure and is the critical component for supporting all levels of a building. New code compliant foundations are needed to properly support the Harada House and anchor the wood framed building to the foundation. Structural Focus previously completed construction documents for new foundations to support the house, but the documents will need to be updated to include leveling the house. Replacing the foundation system will require a specialty contractor that can provide temporary support for the house and lift it to allow for construction of the new foundation system. The process will be a complex and risky undertaking that will likely involve major excavation work under the house. Figure 18 shows an example of a different historic house in Claremont, CA that was lifted and relocated on a new foundation. The photo is taken during construction when the holes for the new foundation were dug and steel reinforcing bars have been placed in the excavation in preparation for placement of new concrete foundations.

- Our recommendation for the Harada House is to construct the new foundation level and set the house on the foundation to restore the house back to a level condition. This will require removal of some of the temporary immediate repair work that was done in order to allow the house to properly sit on the new foundation. While time is of the essence when it comes to stabilizing the house on a proper foundation, this recommendation falls under the **Permanent Solution category**.

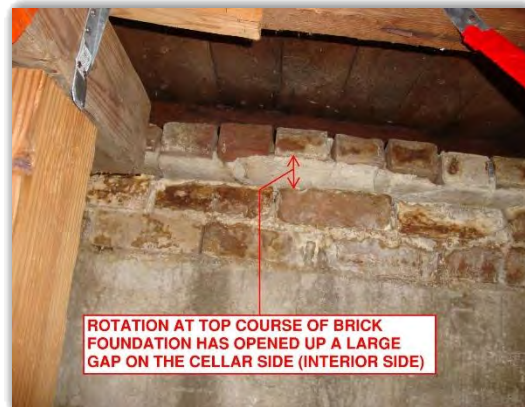
Figure 17 – Unstable Brick Foundation below South Wall (June 20, 2017)

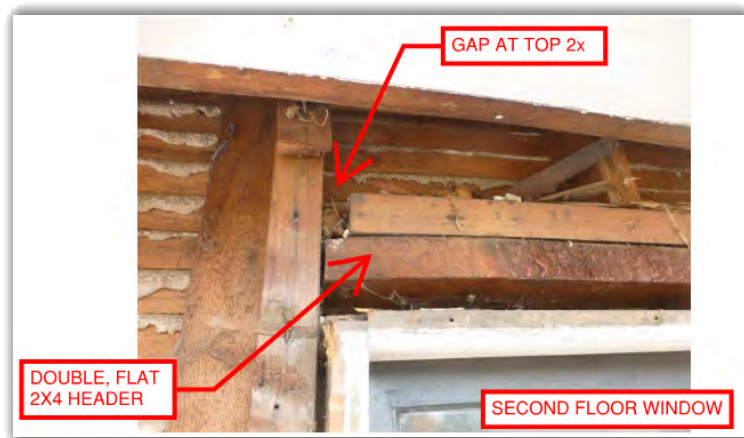
- a. Several poorly framed header conditions were found throughout the exterior walls. The headers often consist of a double, flat 2x4 that is end nailed to the closest adjacent stud. In some cases, the header is a single, flat 2x member. Figure 19 shows a typical header condition in the house.

Figure 19 - Harada House Typical Header Condition (November 6, 2017)

The **Permanent Solution category** repair for this condition is to remove the existing header and replace it with a properly designed and connected header. Modifications to the adjacent king studs as well as the addition of jack studs will also be required. Figure 20 shows a properly framed header condition using current construction practices.

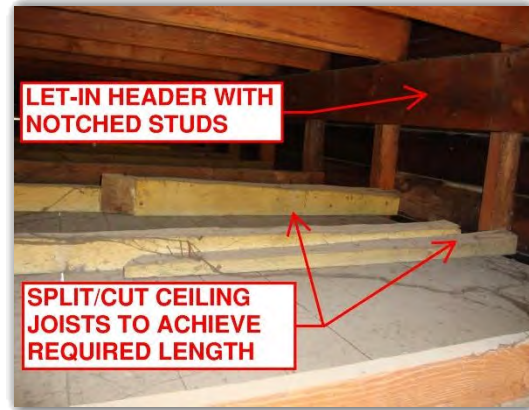
- b. The base of the stairs in the house are not properly supported. Standard construction practice would provide supplemental support framing at the base of the stair due to the critical nature of the stair as the sole exit option from the Second Floor. Providing supplemental framing at the ground floor is a **Permanent Solution category** repair to properly support the stairs.
- c. The framing for the front porch is severely deteriorated and poorly laid out. It does not properly support the second-floor sleeping porch. The porch ceiling appears to be framed with ceiling joists that were made from scrap wood on site at the time the ceiling was built. This is a dangerous condition. Several of the joists are short and have been split for splicing another member alongside to span the required length. This condition can be seen in Figure 21 at the right.

Figure 21 - Inadequate Porch Ceiling Framing
(December 7, 2017)

Rebuilding the front porch and the ceiling over the front porch is a necessary **Permanent Solution category** repair. Until this can be done, access to the space over the porch ceiling should be restricted.

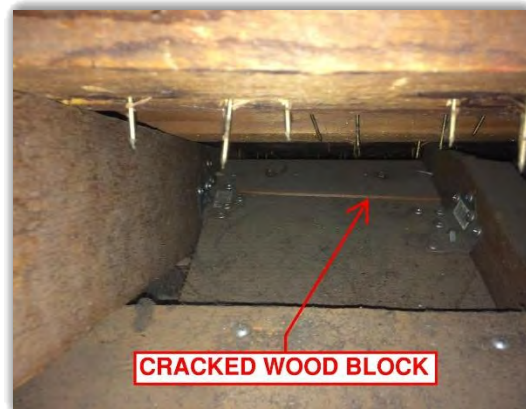
7. Cracked Wood Blocks in Attic – As part of the re-roofing project completed in 2006, horizontal wood blocks were added to properly connect the new plywood sheathing on the second-floor ceiling joists with the top plate of the perimeter walls. While assessing the condition of the house, it was observed that several of the blocks had cracked through the length of the block at the south-east corner of the house and along the north wall at the east end. Figure 22 shows this condition.

Figure 22 - Cracked Wood Blocking

once the base of the house is stabilized on a proper foundation and the house is brought to a level and plumb condition.

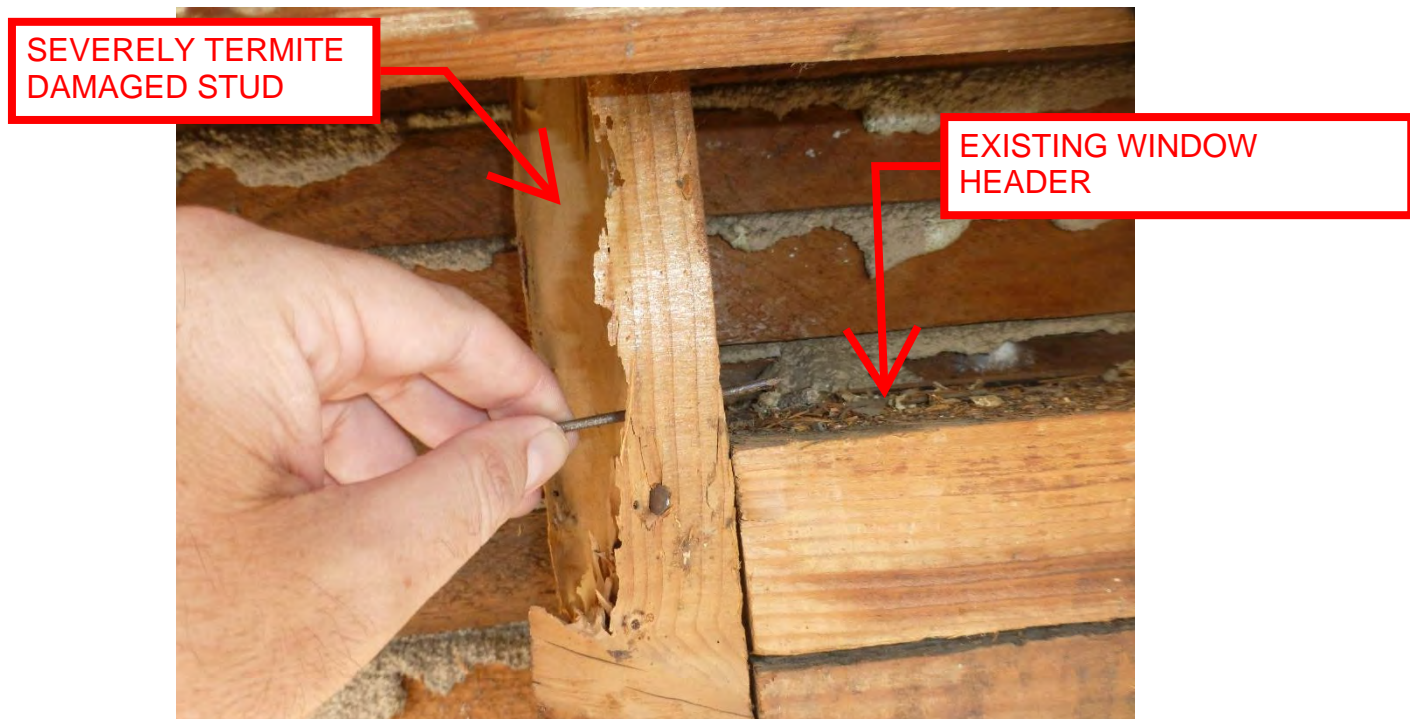
PHOTO 3: EAST ELEVATION – DAMAGED STUD

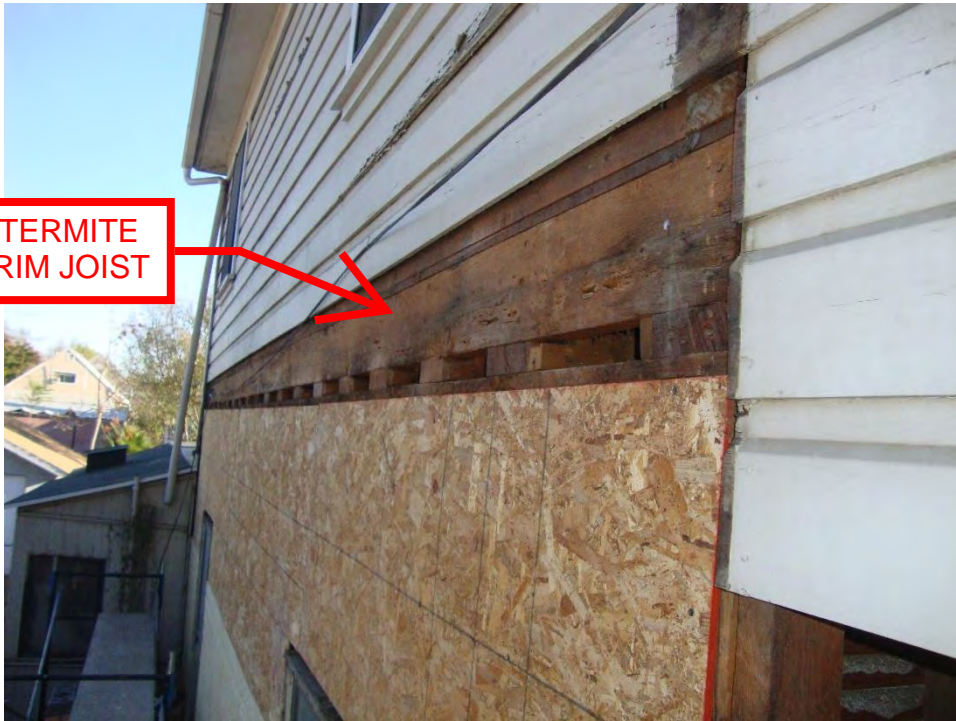
SEVERELY TERMITE
DAMAGED RIM JOIST

PHOTO 4: NORTH ELEVATION – 2ND FLOOR RIM JOIST

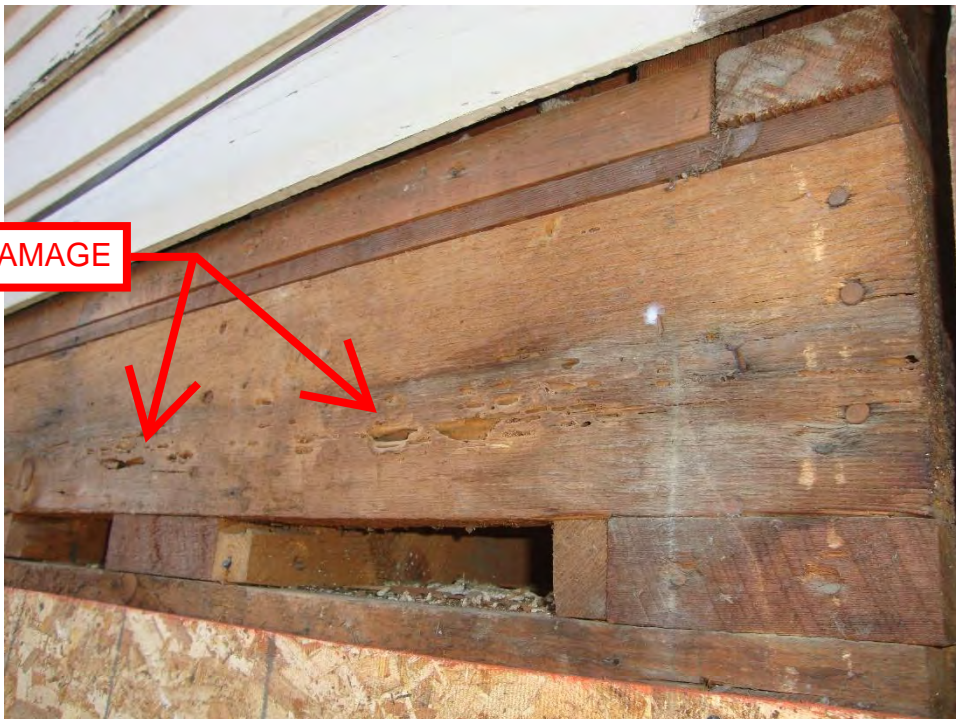
TERMITE DAMAGE

PHOTO 5: NORTH ELEVATION – DAMAGED RIM JOIST

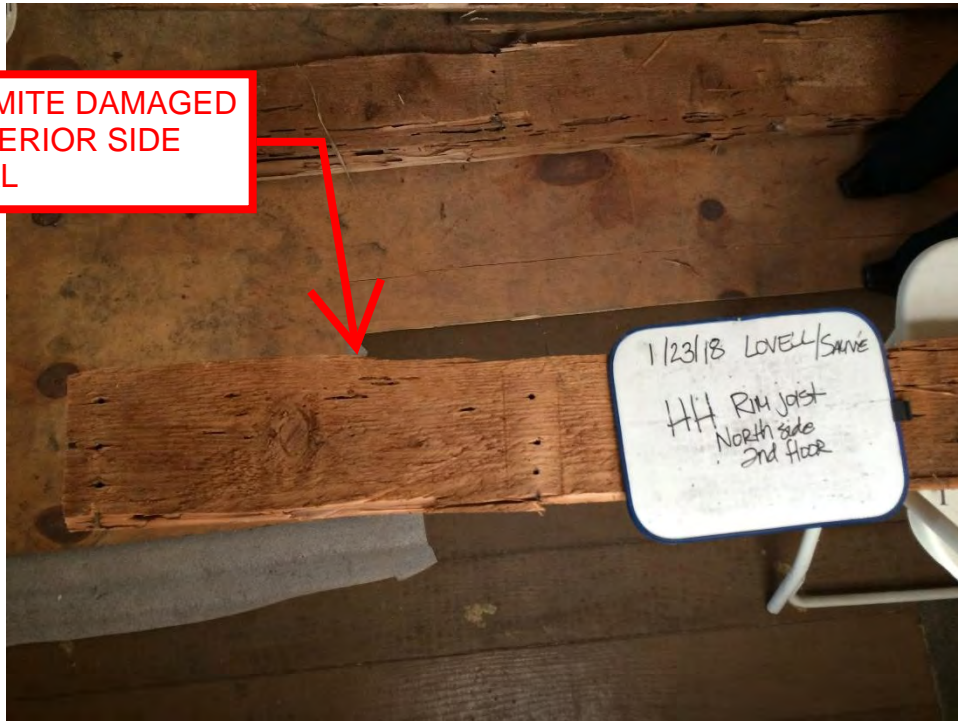
SEVERELY TERMITE DAMAGED
RIM JOIST - EXTERIOR SIDE
AFTER REMOVAL

PHOTO 6: NORTH ELEVATION – DAMAGED RIM JOIST

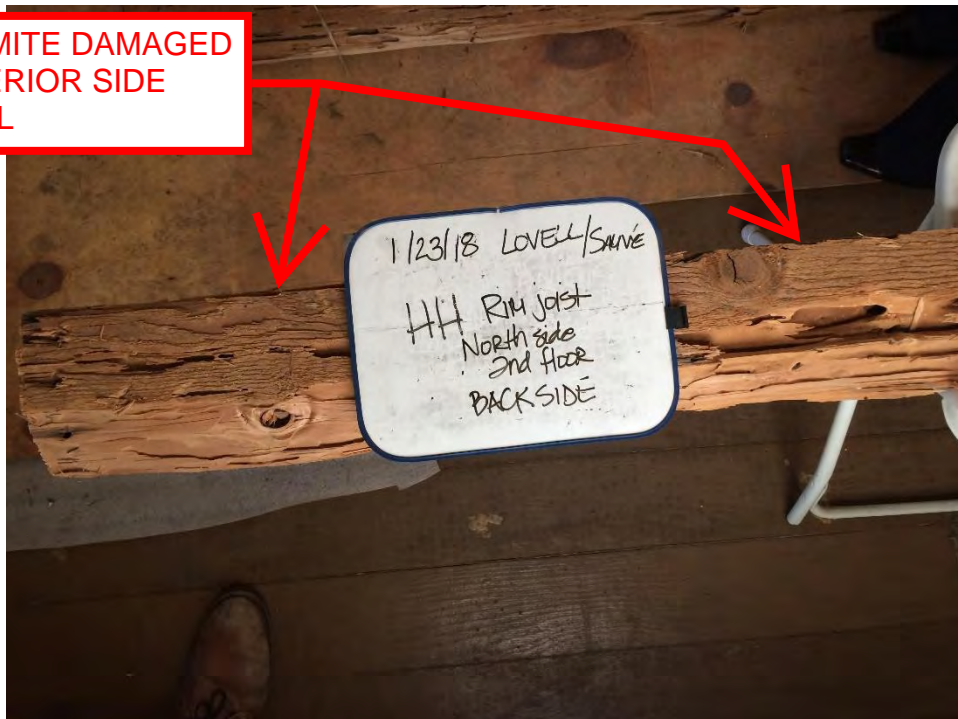
SEVERELY TERMITE DAMAGED
RIM JOIST - INTERIOR SIDE
AFTER REMOVAL

PHOTO 7: NORTH ELEVATION – DAMAGED RIM JOIST

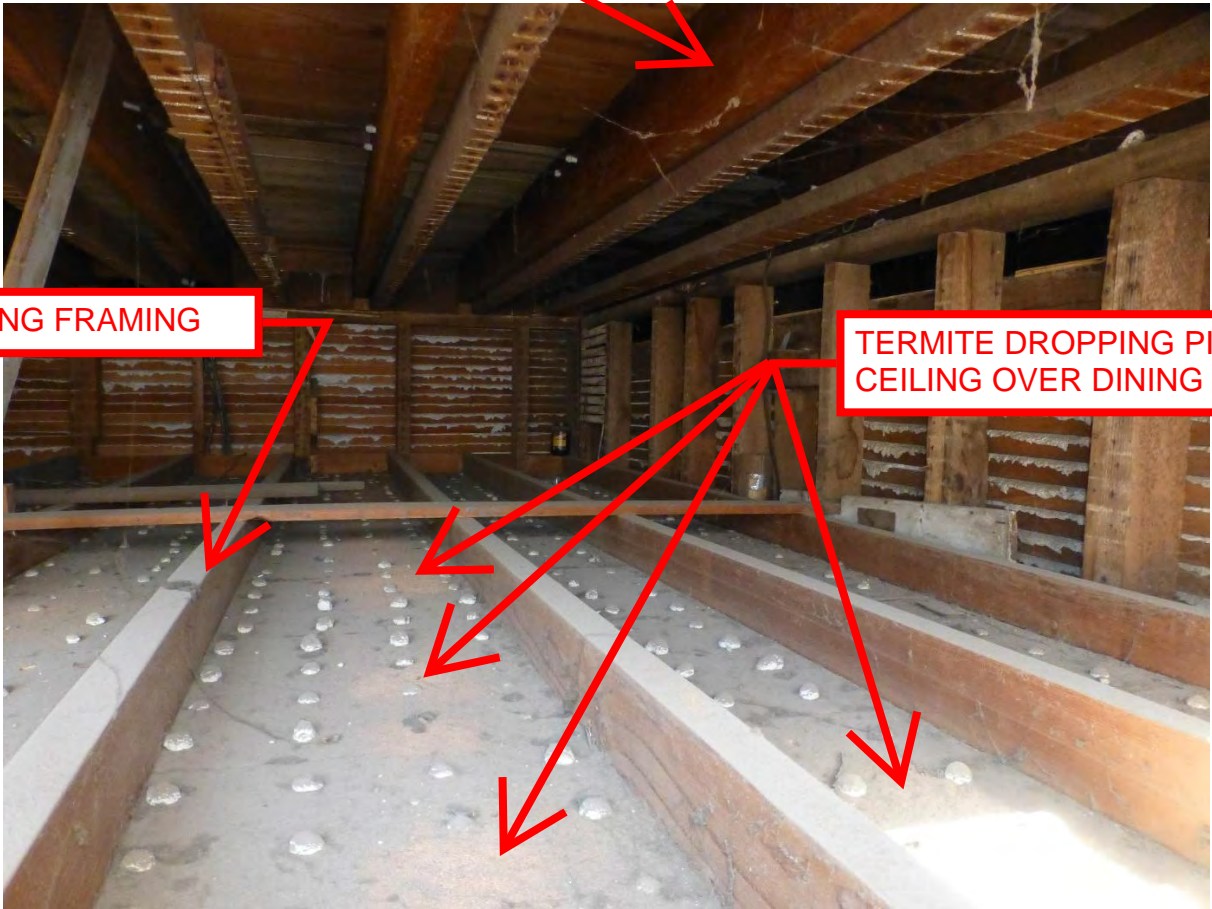
TERMITE DROPPING PILES ON
CEILING OVER DINING ROOM

PHOTO 8: DROP CEILING OVER DINING ROOM
(MIDDLE OF HOUSE ON SOUTH SIDE)

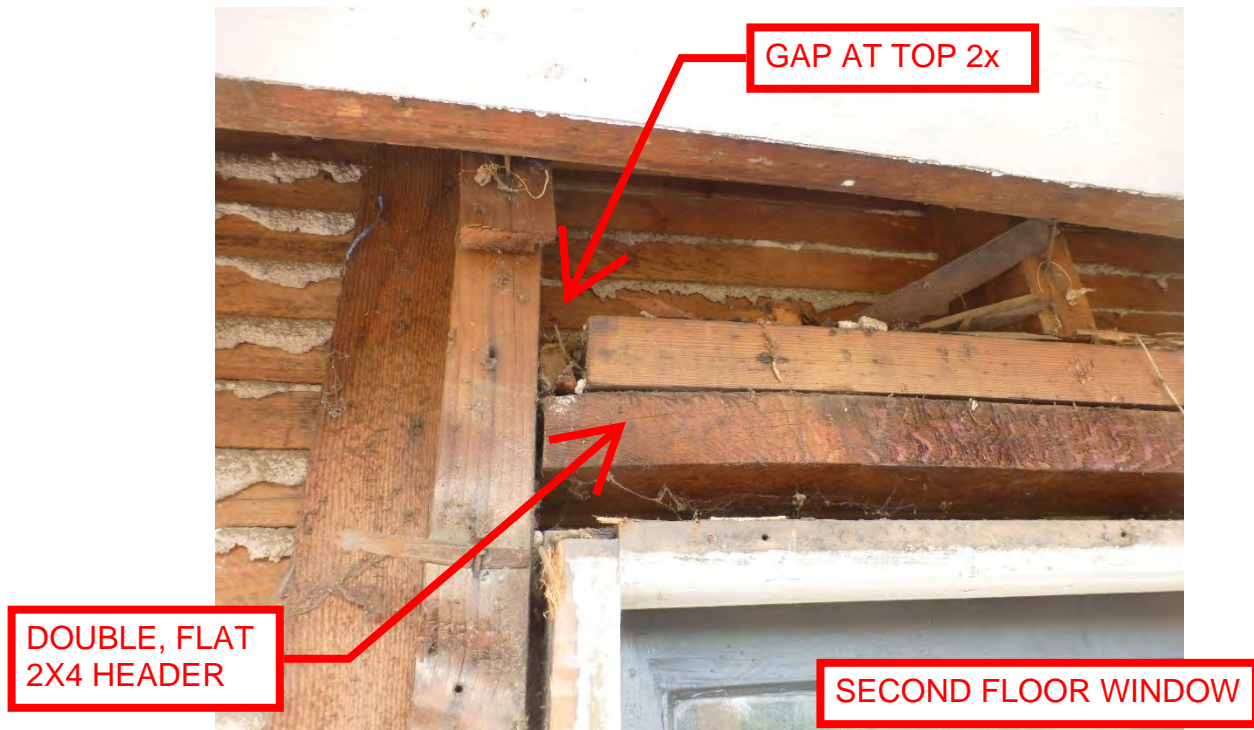
PHOTO 9: SOUTH ELEVATION – HEADER CONDITION

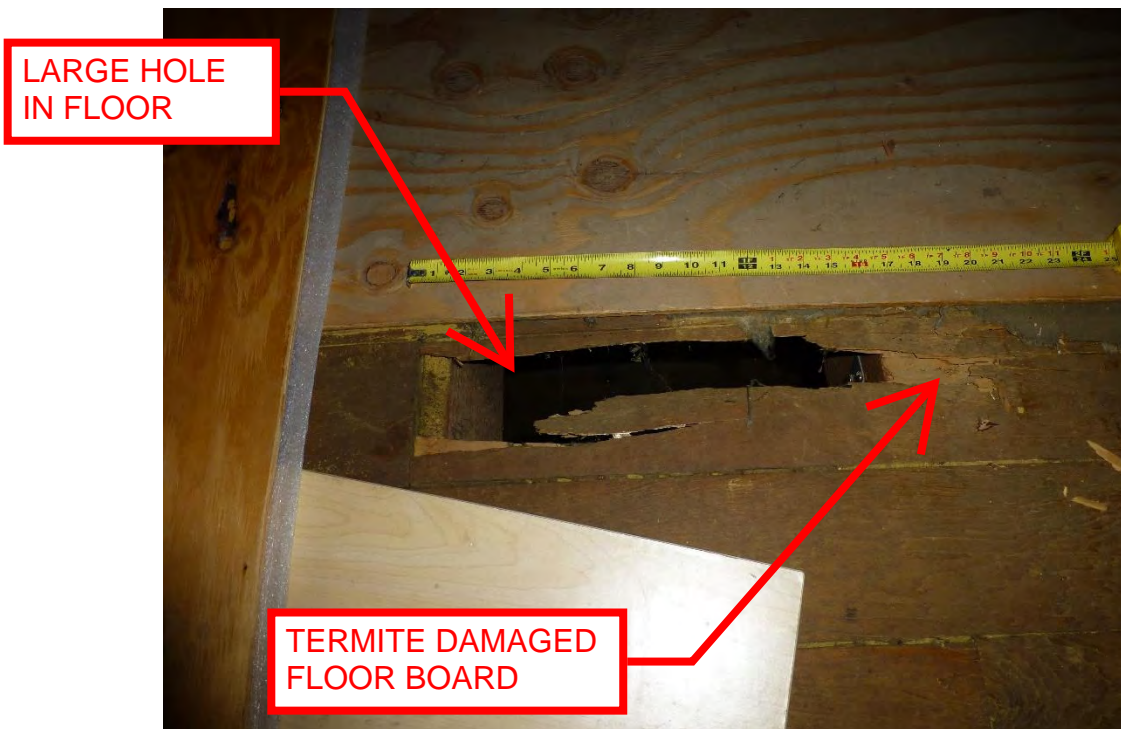
PHOTO 10: DINING ROOM – HOLE IN FLOOR BOARD

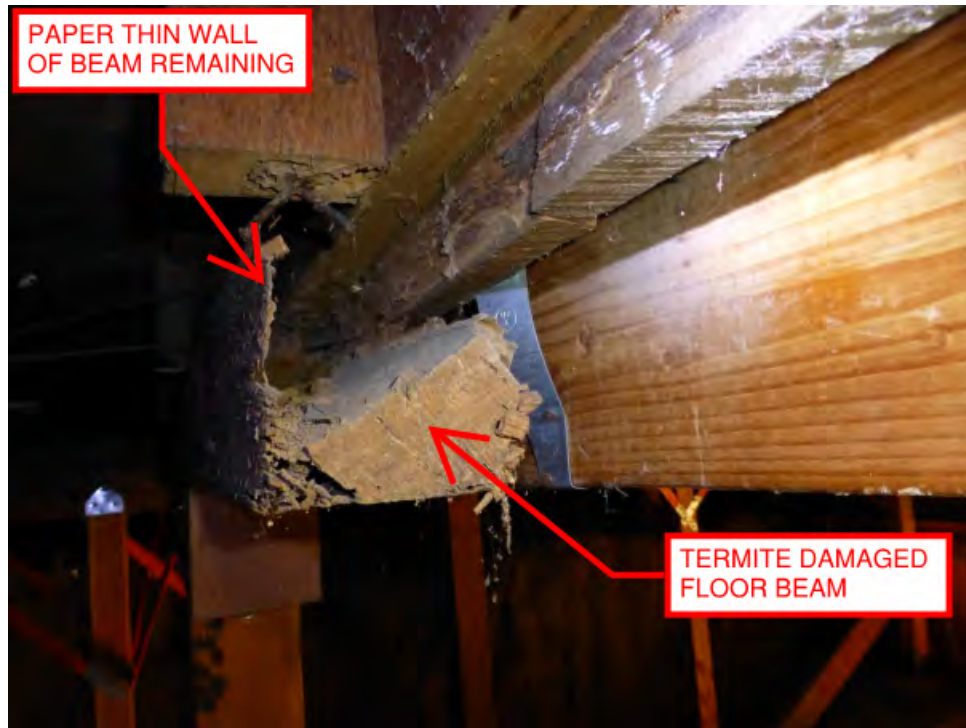
PHOTO 11: GROUND FLOOR –
TERMITE DAMAGED FLOOR BEAM

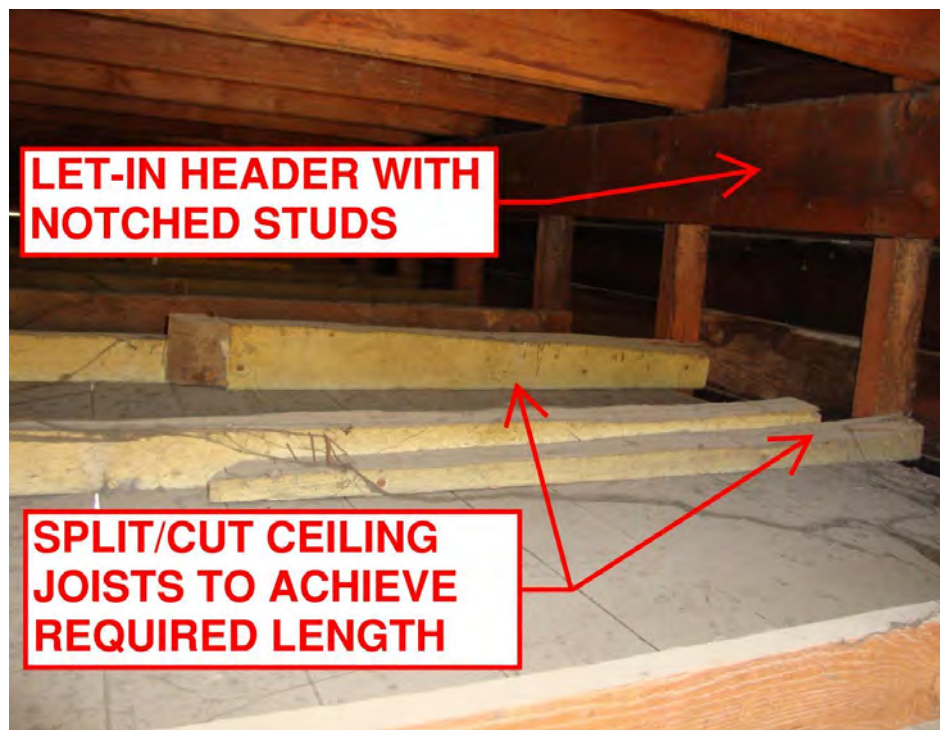
PHOTO 12: INADEQUATE PORCH CEILING FRAMING
