**LETTER REPORT
PROPOSED DELETION OF A EUCALYPTUS TREE AS A CONTRIBUTOR TO
THE HAWTHORNE RESIDENCE LANDMARK DESIGNATION**

April 25, 2025

EUCALYPTUS TREE RISK ASSESSMENT

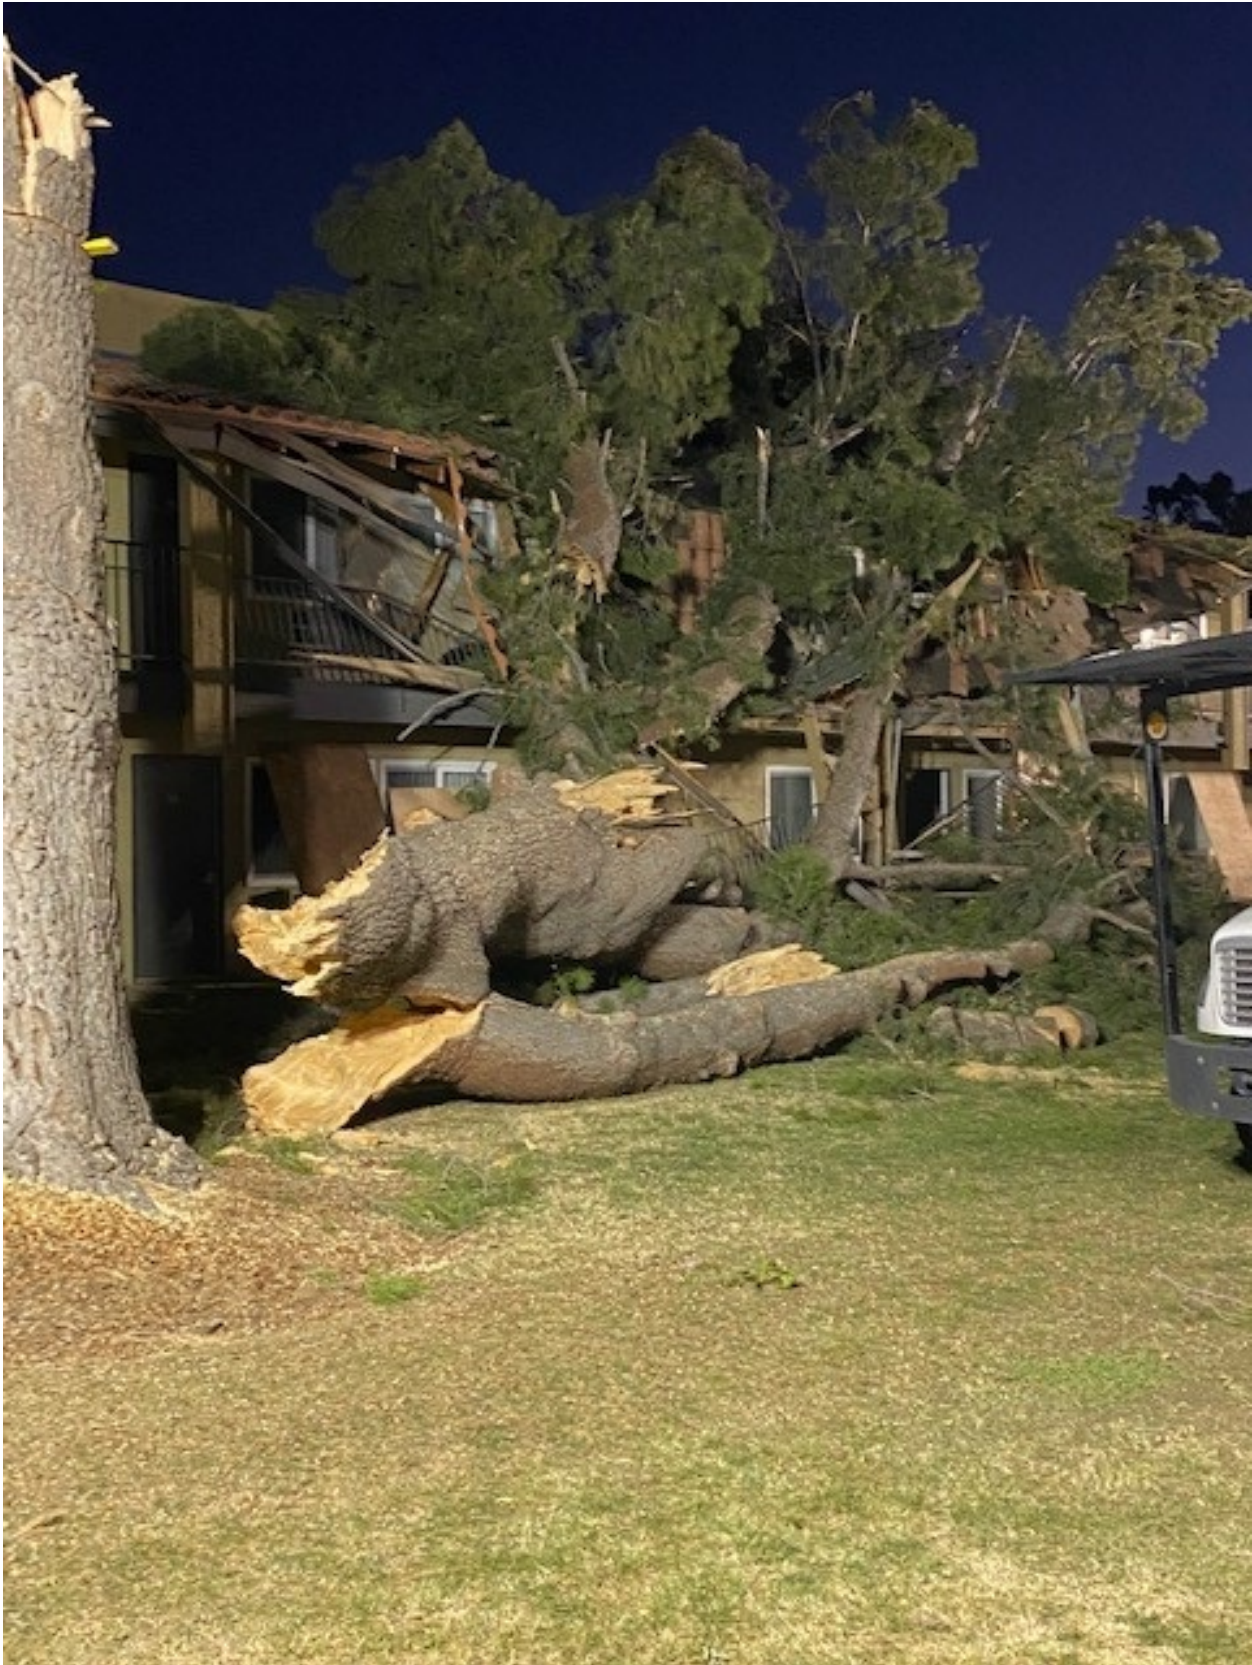
Recently, a large tree fell on a student housing building elsewhere on the campus, causing significant damage to the residential building (Figure 3). Fortunately, there were no students in the damaged units. If there had been students present, significant injury could have occurred. After this incident, the University's insurance broker, National Risk Control – GGB, recommended that CBU assess all of the trees on campus to determine if other hazards might exist. Page 3 of the broker's letter addressing their recommendations is included as Attachment A. In following up on the broker's recommendations, CBU became concerned about the potential hazard associated with the eucalyptus tree mentioned above.

Figure 3: The tree that Fell on Student Housing in 2024

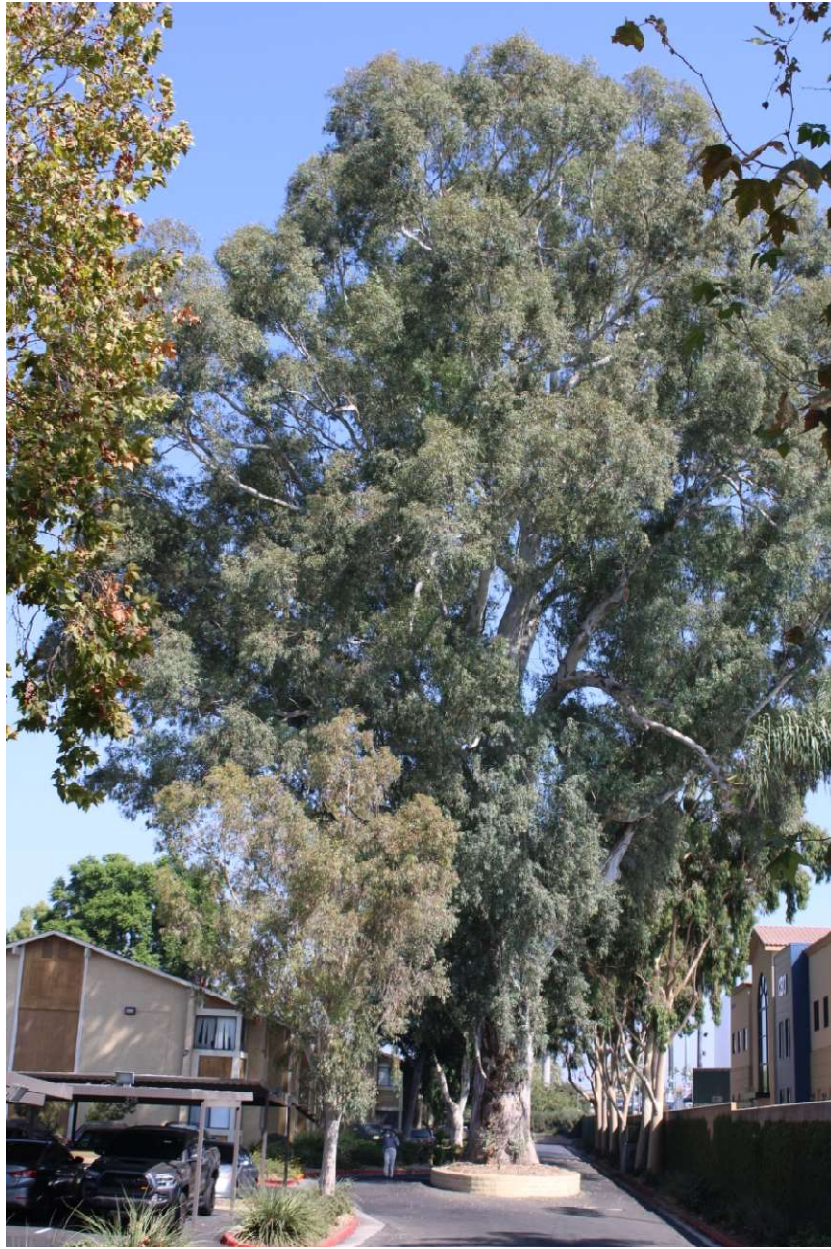
The eucalyptus tree in questions is massive in size and is located in an area of significant student and visitor activity, including pedestrian traffic, student housing, and athletic facilities. Figure 4 is a current photo of the tree and its associated plaque. To its north is the Colony student housing complex and to its south is an athletic field with grandstands and a restroom/utility building. Flanking the tree is a walkway/driveway serving the student housing complex (Figure 2). The detachment of a limb could cause significant damage and/or injury to students and/or visitors to the campus.

When the residence was designated a Landmark, the eucalyptus tree was determined to be a contributing feature of the residence. JMRC Mitigation measures called for the evaluation of the eucalyptus tree by a qualified arborist and the protection of the tree as recommended by the arborist (JMRC, 2012: 62). The tree is situated in a raised planter held in place by a low concrete block retaining wall. Some distance away, adjacent to Monroe Street, is a bronze plaque (Figure 4) that explains its association with the Hawthorne Residence.

Figure 4: Eucalyptus Tree and Plaque

5. **Recommendation:** For the reasons noted above, WHS recommends the eucalyptus tree be deleted as a contributor to the Hawthorne Residence Landmark designation. WHS recommends the plaque be returned to the City of Riverside.

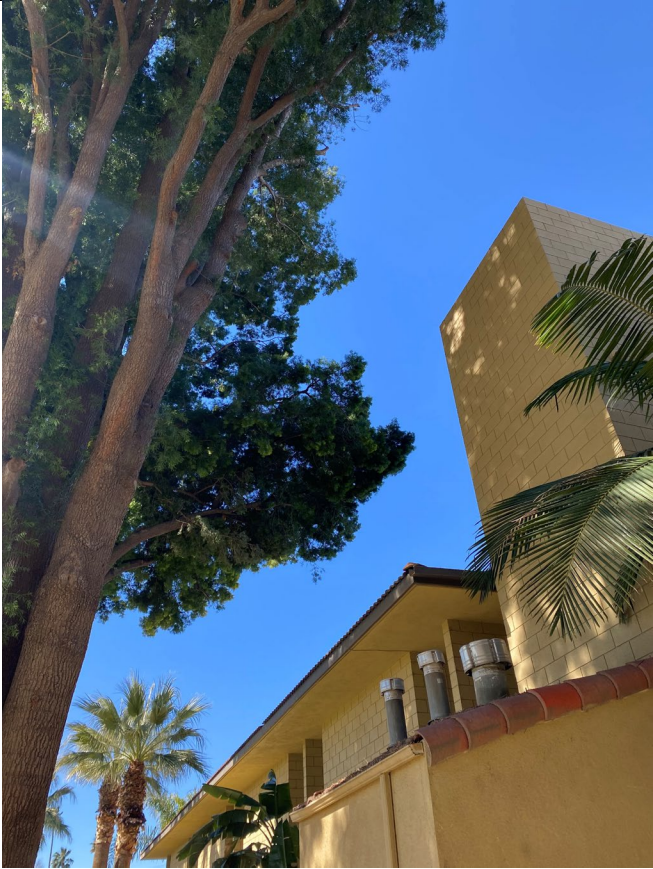
California Baptist University	
24-01	
Priority: Needs Attention	Type: Life Safety

<div> Observation: Large trees are continuing to grow in and around the campus of California Baptist University including student housing. </div> <div> Concern: Trees have become property and life safety hazards to the campus and students. When large tree branches or entire trees fall after storms or other weather events, they pose risk to the structures, students, and students' personal property. </div> <div> Recommendation: While complying with local codes and regulations. Gallagher National Risk Control recommends the removal of trees as needed when they pose threat to property or life safety. </div>

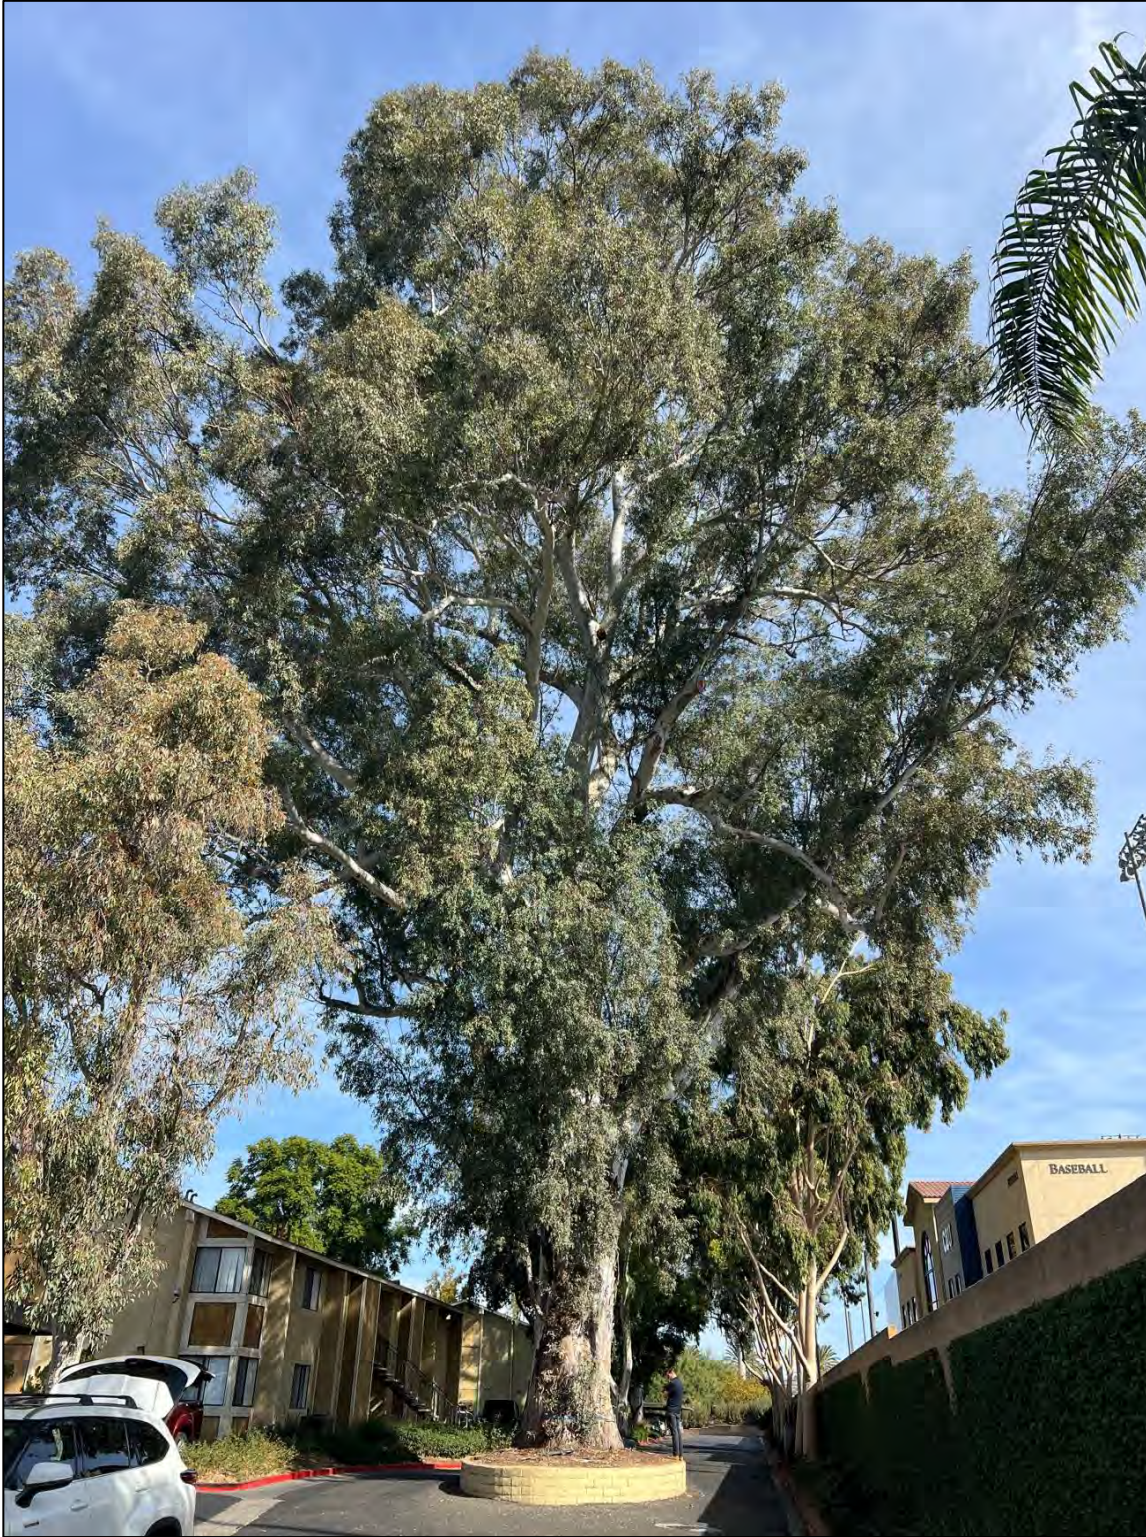
This tree is over 100 feet tall, and it has a trunk diameter of ninety-six (96) inches when measured at 4.5 feet above grade. It is in a raised planter, which appears to have been installed long after the tree was planted. There was a fungal conk present at the root collar, most likely of the *Laetiporus* genus, which is a wood decay organism. The tree's canopy was found to be in good health, and appears to be a heritage "wind row" Blue Gum Eucalyptus which were widely planted during the early- to mid-twentieth century along the edges of citrus and avocado groves in southern California. This tree is now surrounded by apartment homes and hardscapes, and it is almost certain that many of its roots have been pruned, or in some cases, removed, to facilitate the installation and / or repair of surrounding homes, parking lots, and sidewalks. Without excavating near the tree's trunk, we cannot be certain how many roots have been removed, but the likelihood of this having happened must be noted due to the presence of the retaining wall and the proximity of the tree to paved surfaces.

After conducting the decay assessment, the tree was found to already have advanced decay at, below, and just above natural grade. This does not mean that the tree is likely to fail in the *immediate* future, but it should be noted that such decay will only worsen over time. The presence of trunk decay is not necessarily indicated by canopy health, which is why the tree currently has a full crown. Essentially, the appearance of good canopy health cannot be considered an indicator of whole-tree health. As we just mentioned, the existing decay will only worsen, which will undoubtedly lead to declining health and a significantly increased risk of trunk or root failure.

When taking all the aforementioned factors into account, we consider it *possible* – not necessarily probable – that the tree could fail within a one-year timeframe, which renders it a Moderate risk. If we were to extend the assessment timeframe out to three- to five years, the tree would potentially be bumped up into the *probable* failure likelihood level, which is highly concerning and puts the tree in the High-Risk category.

Figure 2: The tree, as seen on November 19th.

Due to the risk factors discussed in this report, we recommend that the University consider removing this tree within the next year.

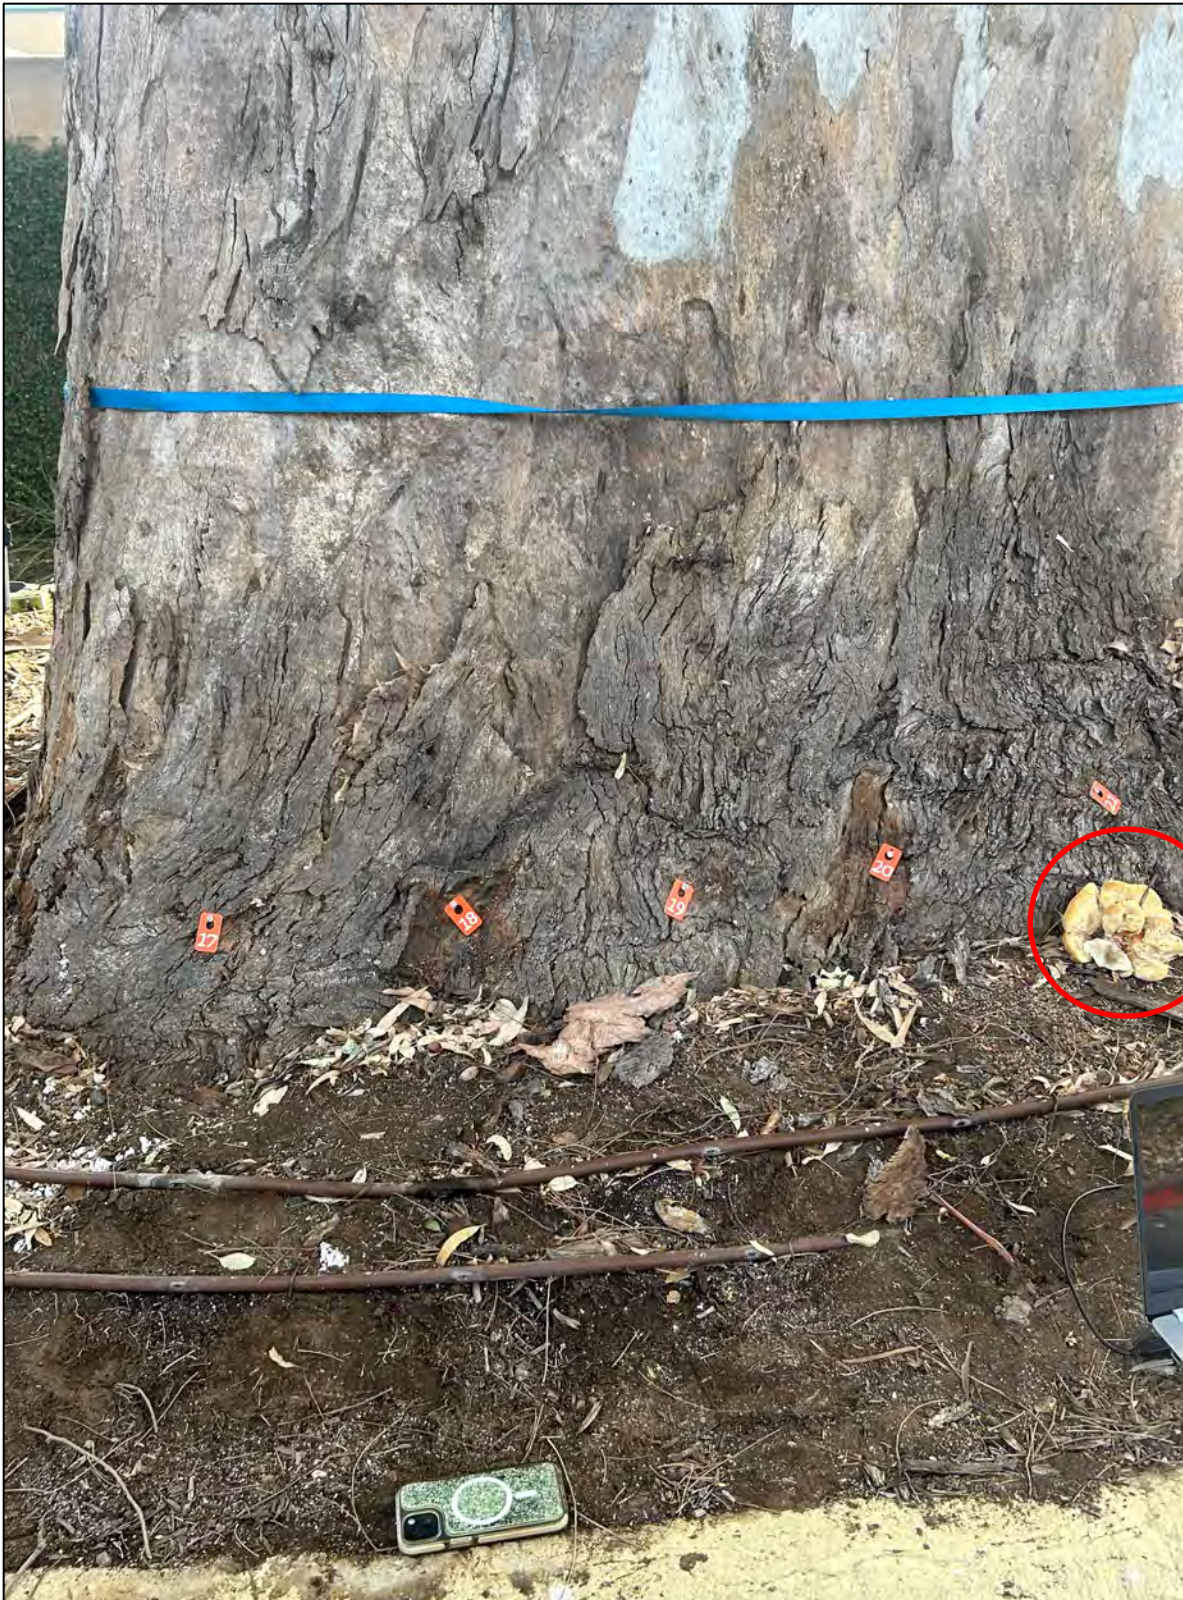
Figure 7: Drilling points 17 - 21 and a fungal conk.

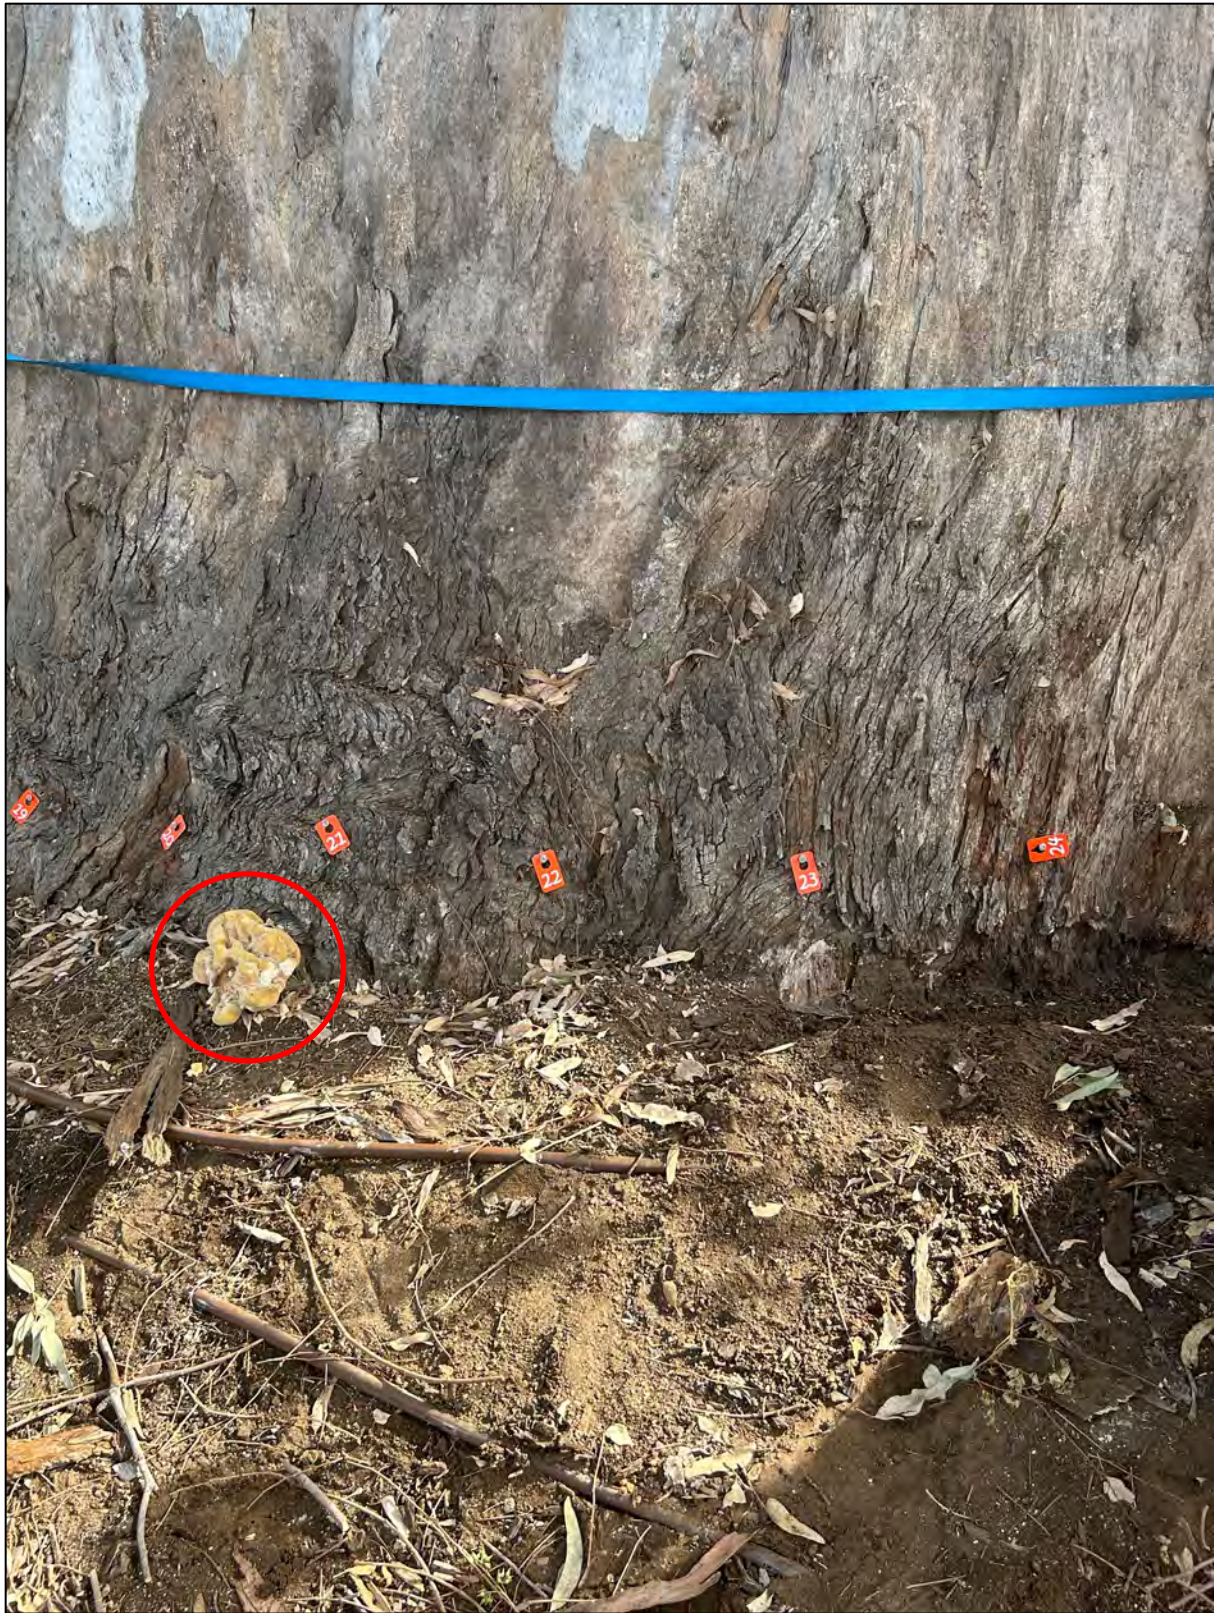
Figure 8: Drilling points 19 - 24 and a fungal conk.

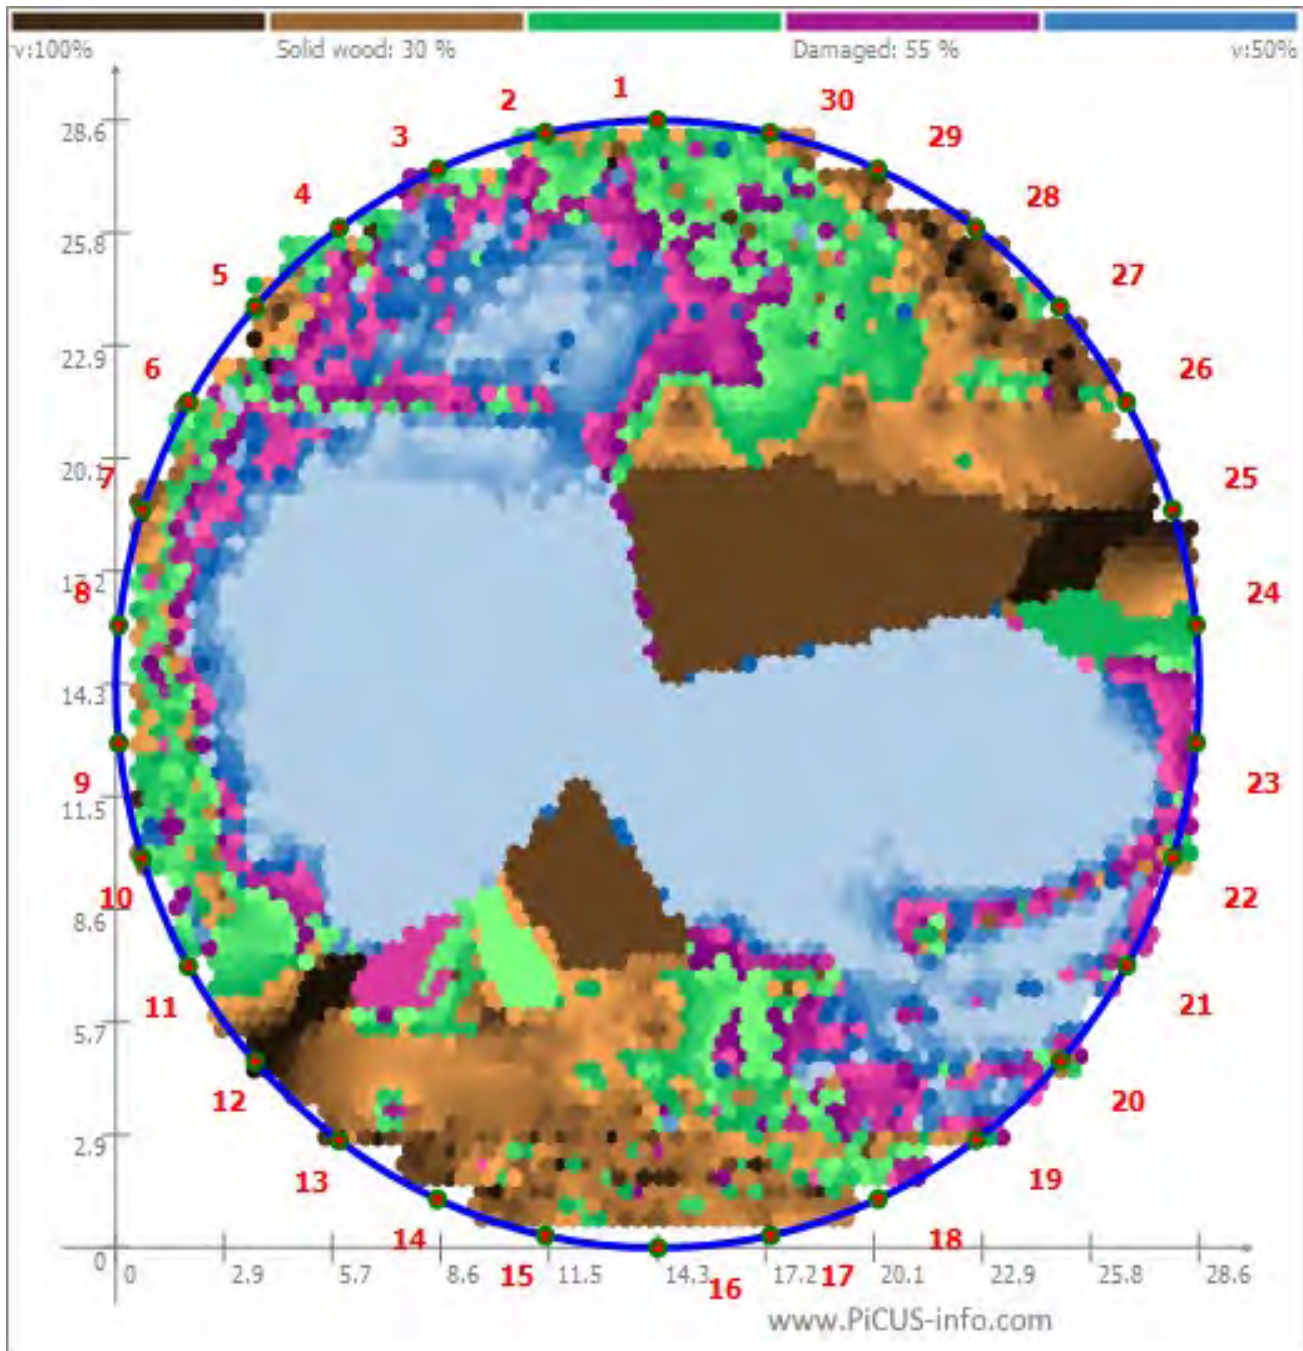
arranged uniformly between six to twelve inches above grade. When viewing the Tomograph reading, dark brown wood is considered sound, whereas blues and purples indicate decay and / or cavities, and greens are considered to be somewhat of a transition area.

Figure 11: Tomograph reading. Note the measured solid wood at 31% and damaged wood at 55%.
