## Site Photos

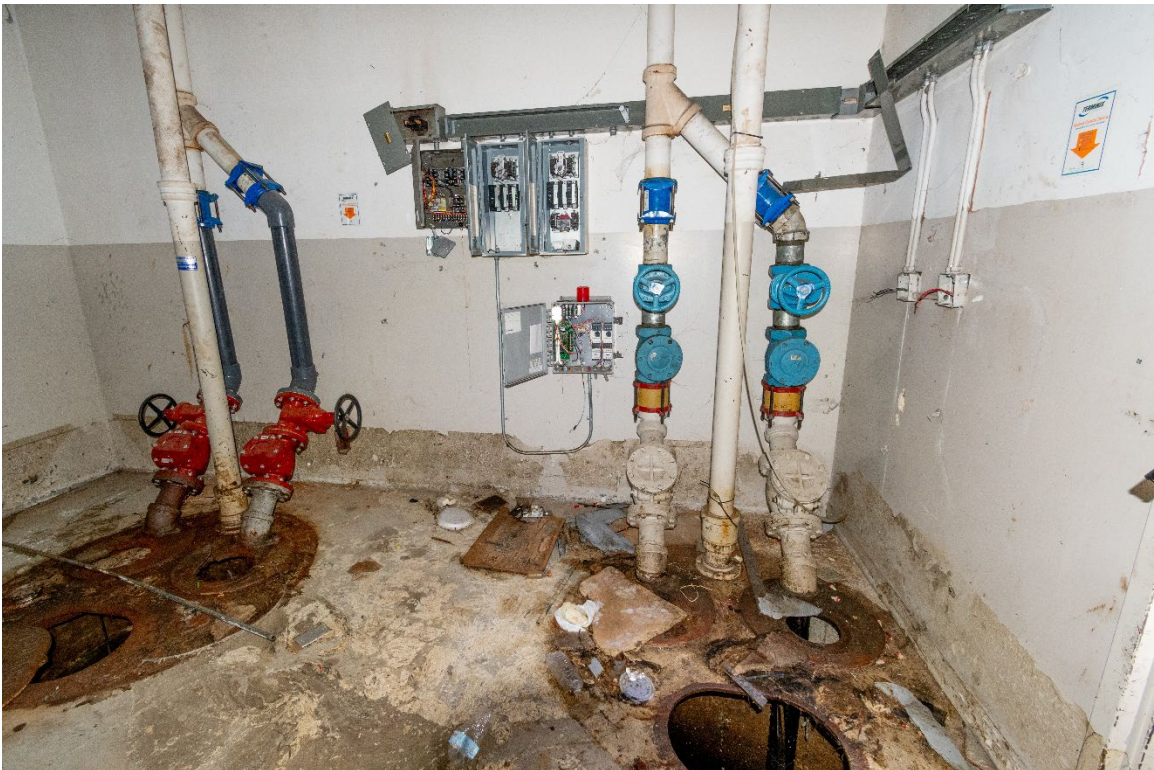
**Figure 26 - Plumbing system damage**

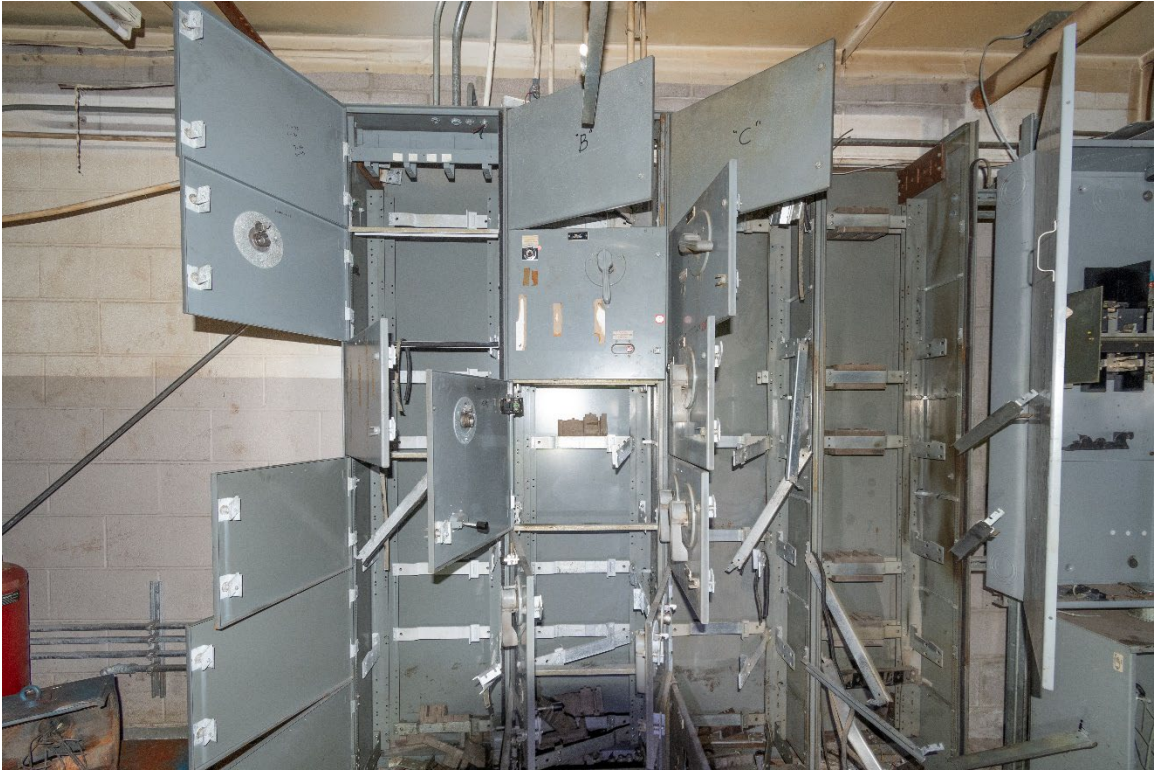
**Figure 27 - Electrical system damage**

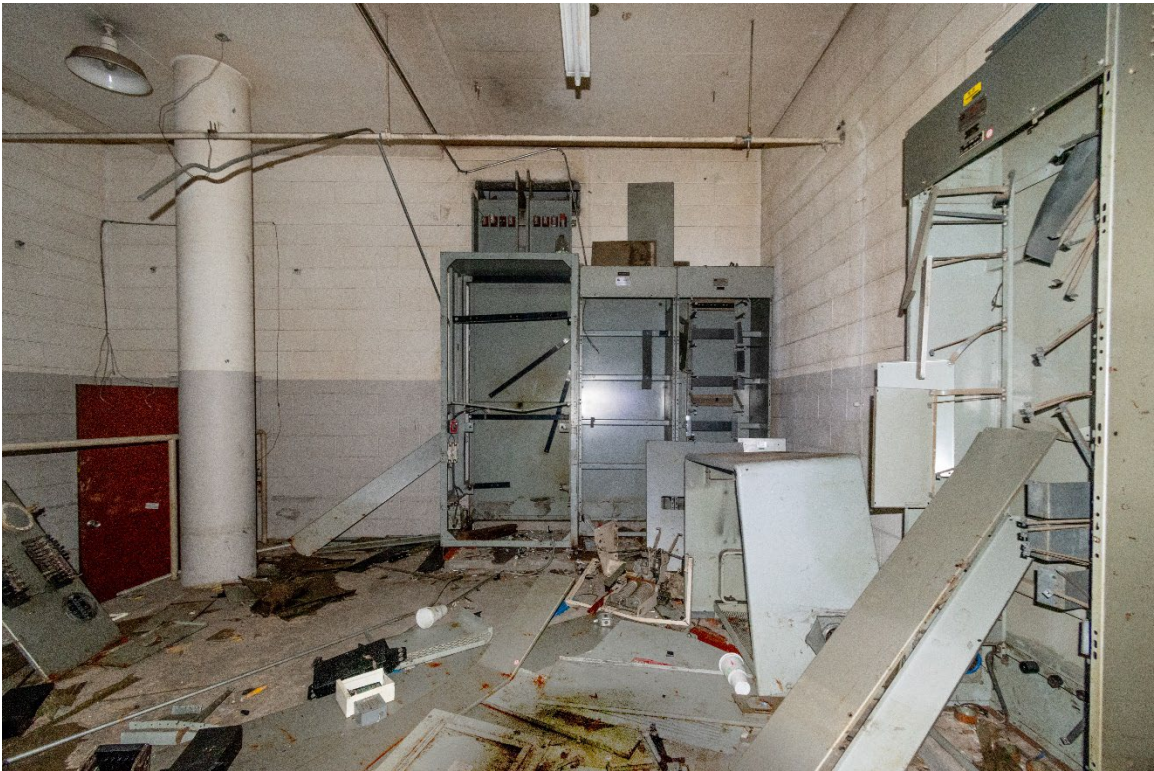
**Figure 28 - Electrical system damage**
