HARADA HOUSE

3356 Lemon Street Riverside, CA 92501

April 30, 2018

STRUCTURAL ENGINEERING ASSESSMENT REPORT

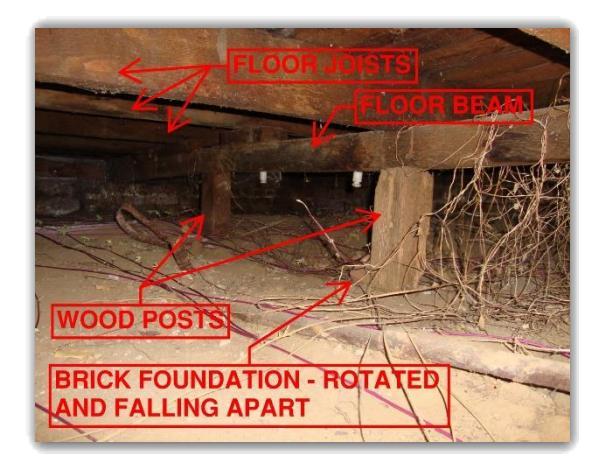
Figure 4 - Crawl Space Framing (June 20, 2017)

At the southeast corner, the crawlspace has been deepened to create a cellar and the south wall is a concrete retaining wall supporting the top three courses of brick. According to some records, the concrete wall was constructed in approximately 1915 to provide the space for the cellar and the bottom of the concrete foundation is approximately 6 inches below the floor of the cellar. However, the cellar floor elevation and therefore the bottom of the concrete wall is now unknown. In this location, the retaining wall is cracked in several locations and is leaning inward toward the building. In the remaining areas of the building there is a crawlspace roughly 24 inches tall (See Figure 4 above).

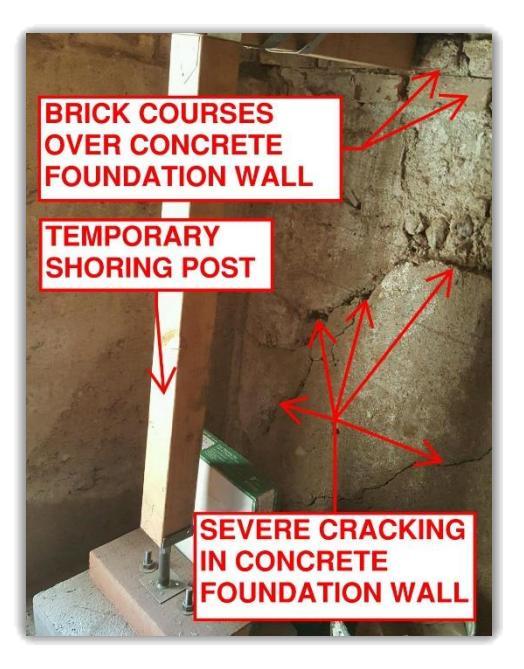
footings) around the perimeter of the building. A partial cellar was reportedly excavated in about 1915 and a new concrete foundation wall was constructed at that time. Figure 5 below shows the severely cracked concrete cellar wall located at the south-west corner of the house.

Figure 5 - Cellar Foundation Wall (July 27, 2016)

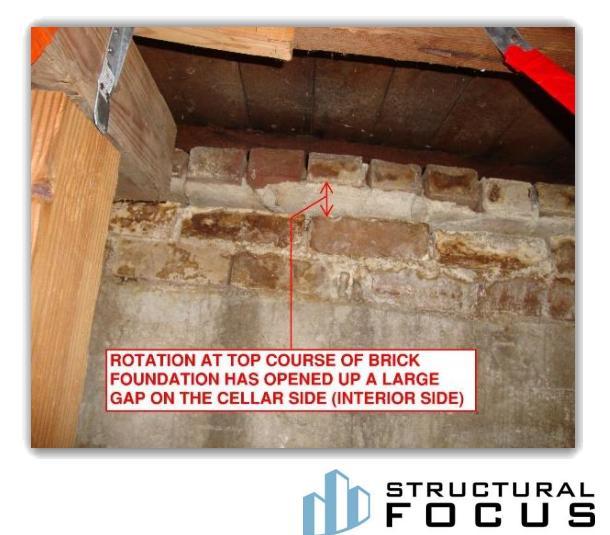
Ground Floor. There is no anchorage of the framing to the foundations. The condition of the brick foundation as observed from the interior side at the southwest corner cellar is very poor. The mortar joints are very soft and the bond between the bricks and mortar has released. The top course of brick on the south wall of the cellar have rotated and displaced due to rotation of the concrete retaining wall below. See Figure 6 for a photo of this condition.

Figure 6 - Rotated Brick Foundation below South Wall (June 20, 2017)

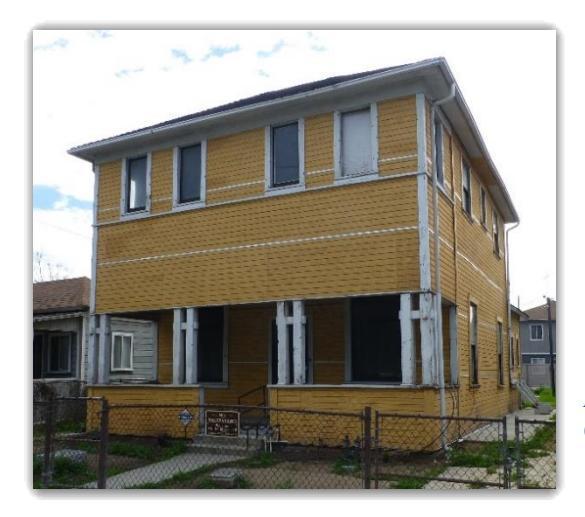
The original vertical lateral force resisting elements consist of the existing 2x4 wood stud walls. The interior walls are covered with wood lath and plaster on both faces, and the exterior perimeter walls have lath and plaster on the interior face and 1x horizontal clapboard siding on the exterior face. As part of this Structural Assessment project, the original siding was removed and replaced with plywood sheathing as shown in Figure 7 at the left. There is little

Figure 7: Harada House with Plywood Sheathing (March 20, 2018)

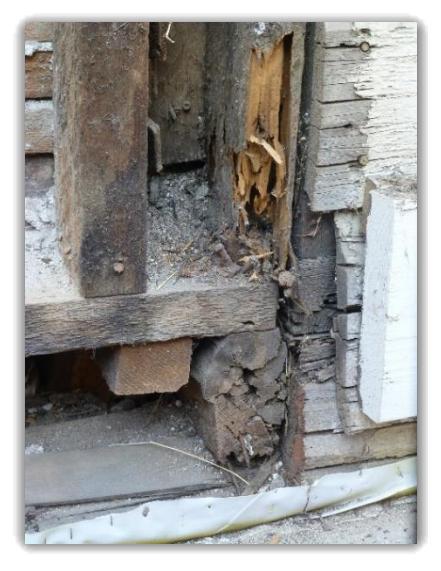
a. Severe damage was found at the base of the wall on the south elevation in the middle portion of the house. The damage included deteriorated wood framing from termites, dry rot, and water damage (Figure 8 at right). In addition, the removal of the siding exposed a framing condition where load bearing studs were only supported by the bottom plate of the wall. This is not an adequate way to properly support wall studs

Figure 10 - South Wall Deteriorated Wood Framing (November 9, 2017)

category repair for this condition was addressed with the implementation of sketch SSK-1 Blocking at Base of Zone S1C. The sketch can be found at the end of this report and provided new wood blocks at the base of the wall to provide direct support between

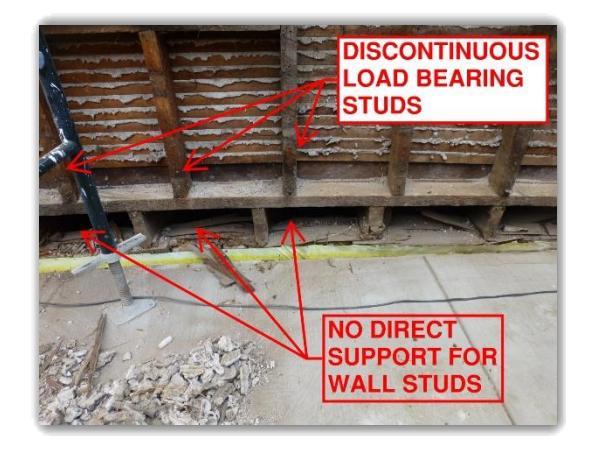
and is known as a discontinuous load bearing condition (Figure 9 at right).

Figure 11 - South Wall Discontinuous Load Bearing Condition (November 9, 2017)

existing brick foundation. A permanent solution to this structural deficiency will be addressed with the construction of a new foundation for the building.

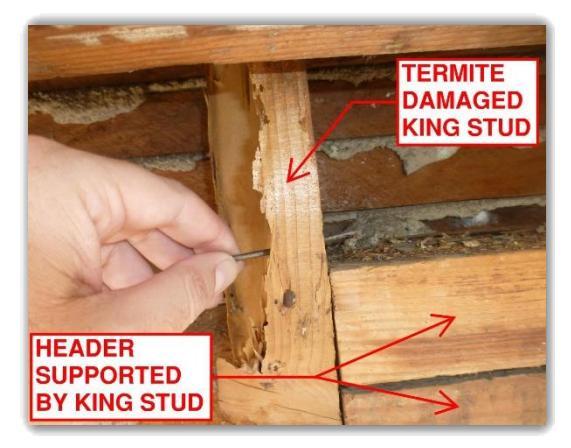
d. Severe termite damage was found in two studs that support the south-east corner of the high roof. The most severely damaged stud was a header support stud (called a king stud) on the south side of the second-floor window. Approximately half of the stud width had been eaten away by termites, and the remaining portion of the stud was so compromised a nail could be pushed completely through with a bare hand. The photo at the right (Figure 12) shows this stud.

Figure 12 - Severely Compromised King Stud (November 29, 2017)

The repair for this condition involved replacing the severely damaged stud with a new stud. **Immediate Future category** repair SSK-5 Stud Replacement at Zone E2A shows the most severely damaged wood stud on the south side of the Second Floor window was removed and replaced with a new stud. The next stud to the south was supplemented by screwing a new stud to the side of the damaged one.

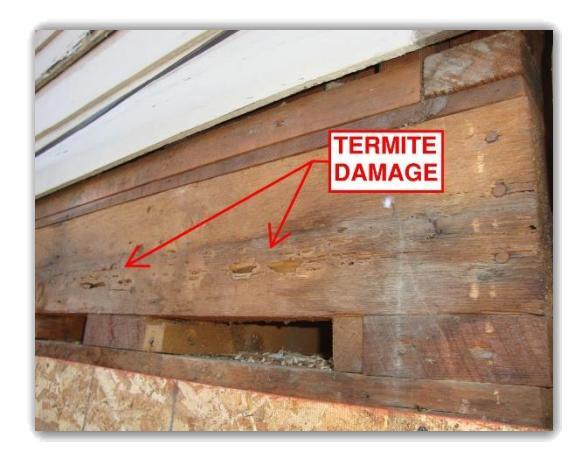
The north elevation had two e. conditions that required immediate repair measures. The bottom plate of the ground floor wall was so badly damaged by termites that support for the north wall was compromised. In addition, the ground floor joist tails were irregularly framed and needed to be modified to facilitate the repair. At the second floor, the rim joist contained severe termite damage as well. Figure 12 and Figure 13 at the right show the extent of the damage.

Figure 13 - Second Floor Rim Joist with Termite Damage (December 7, 2017)

category repair sketches were issued to address the inadequate framing on the north elevation: SSK-6 Temp Repair at North Wall Bottom Plate and SSK-7 North Wall 2nd Floor Rim Joist. The bottom

plate of the ground floor wall was replaced, and the ground floor joist tails were supplemented with a new 2x joist screwed to the side and then trimmed to facilitate the repair. At the Second Floor, the rim joist was replaced.

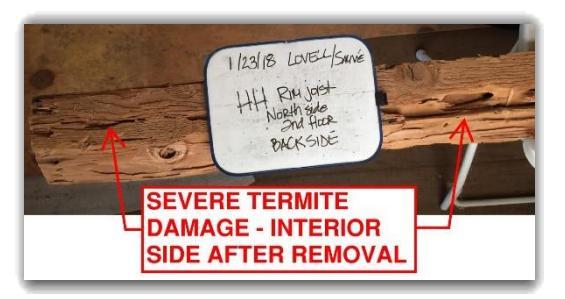
Figure 14 – Back side of Second Floor rim joist after being removed (January 23, 2018)

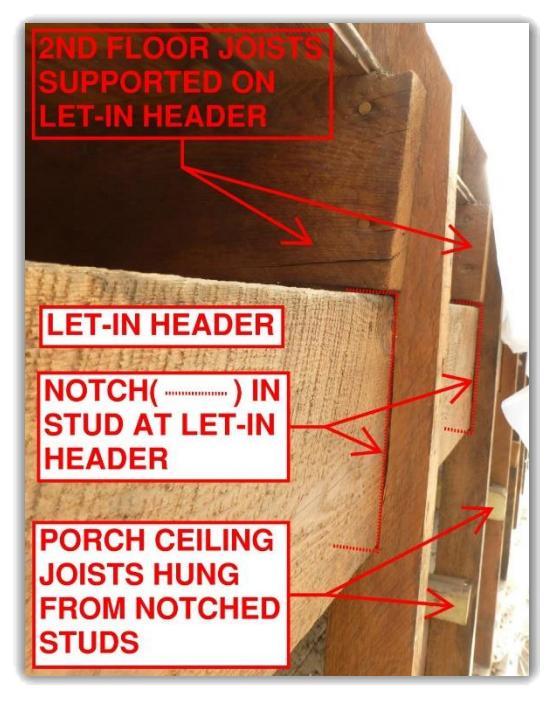
The second-floor header on the west elevation contained a problematic framing condition. The header was originally built as a let-in 2x header creating a notch in the studs that the porch ceiling joists hang from. Figure 15 illustrates this condition.

Figure 15 - Porch Ceiling Joists Hung from Notched Studs (January 16, 2018)

> This condition was mitigated by SSK-11 Detail at (E) Let-In Header (West Elevation) as an **Immediate Future category** repair. The detail adds new posts from the foundation of the west elevation to the roof, special detailing was required to pass around the existing let-in header at the second-floor.

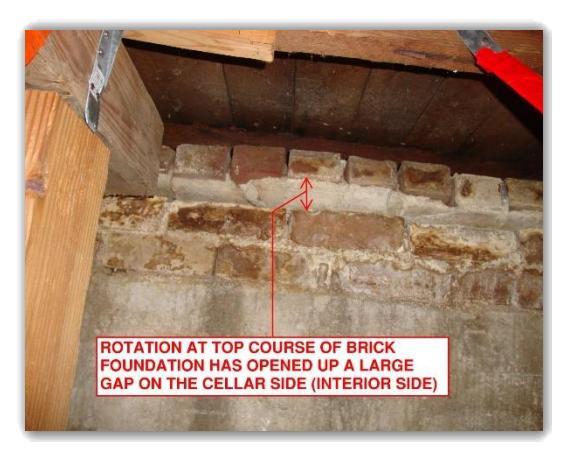
5. The original brick and concrete basement foundations are severely damaged and need to be replaced. In addition to the most visible damage at the south-east corner of the house in the partial cellar (see Figure 16 and Figure 17 below), there are loose bricks in several areas around the entire perimeter of the house.

Figure 17 – Unstable Brick Foundation below South Wall (June 20, 2017)

The Foundation System is the base of the structure and is the critical component for supporting all levels of a building. New code compliant foundations are needed to properly support the Harada House and anchor the wood framed building to the foundation. Structural Focus previously completed construction documents for new foundations to support the house, but the documents will need to be updated to include leveling the house. Replacing the foundation system will require a specialty contractor that can provide temporary support for the house and lift it to allow for

Our recommendation for the Harada House is to construct the new foundation level and set the house on the foundation to restore the house back to a level condition. This will require removal of some of the temporary immediate repair work that was done in order to allow the house to properly sit on the new foundation. While time is of the essence when it comes to stabilizing the house on a proper foundation, this recommendation falls under the **Permanent Solution category**.

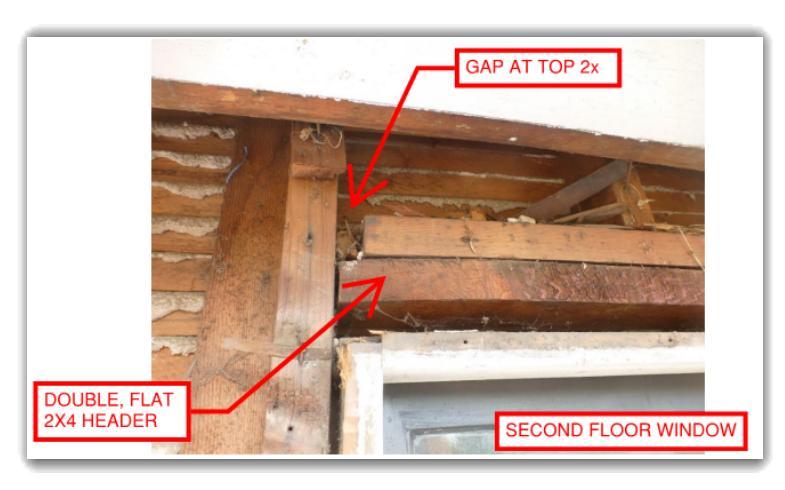
- 6. Several framing conditions were found during the assessment that need to be corrected. Correcting each poorly framed condition should be done as part of **Permanent Solution category** repairs <u>after</u> the house has been leveled on a new foundation system. This will allow for the corrective framing measures to be constructed properly in a level and plumb condition. A description of the condition and our recommendations for each item follows:
 - Several poorly framed header conditions were found throughout the exterior walls. The headers often consist of a double, flat 2x4 that is end nailed to the closest adjacent stud. In some cases, the header is a single, flat 2x member. Figure 19 shows a typical header condition in the house.

Figure 19 - Harada House Typical Header Condition (November 6, 2017)

category repair for this condition is to remove the existing header and replace it with a properly designed and connected header. Modifications to the adjacent king studs as well as the addition of jack studs will also be required. Figure 20 shows a properly framed header condition using current construction practices.

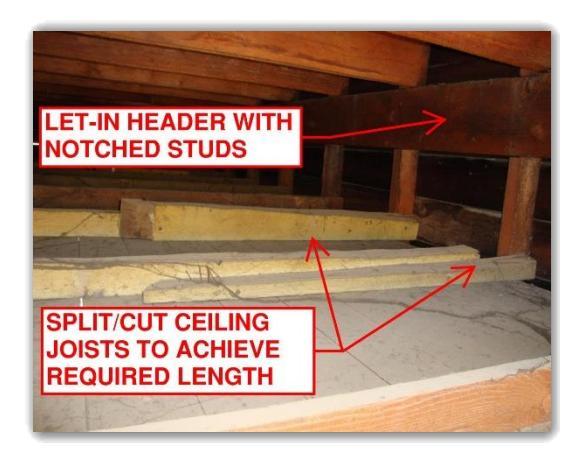
Figure 21 - Inadequate Porch Ceiling Framing (December 7, 2017)

Rebuilding the front porch and the ceiling over the front porch is a necessary **Permanent Solution category** repair. Until this can be done, access to the space over the porch ceiling should be restricted.

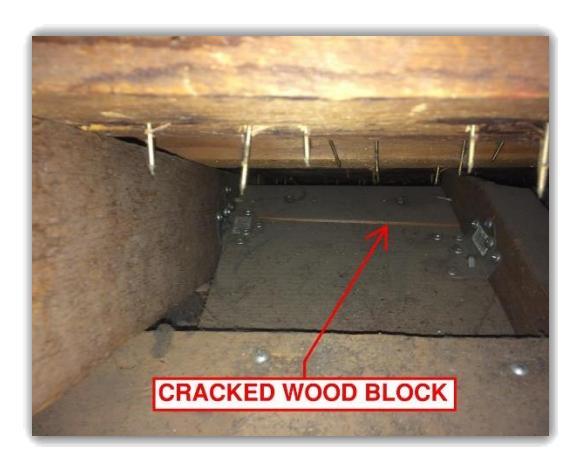
7. Cracked Wood Blocks in Attic – As part of the re-roofing project completed in 2006, horizontal wood blocks were added to properly connect the new plywood sheathing on the second-floor ceiling joists with the top plate of the perimeter walls. While assessing the condition of the house, it was observed that several of the blocks had cracked through the length of the block at the south-east corner of the house and along the north wall at the east end. Figure 22 shows this condition.

Figure 22 - Cracked Wood Blocking

Restoring the load path between the second-floor ceiling diaphragm and the exterior walls will need to be completed as part of the **Permanent Solution category** repairs. This can be done with standard wood framing details for residential construction
