**REPORT OF GEOTECHNICAL INVESTIGATION
RIVERSIDE COMMUNITY HOSPITAL
RIVERSIDE, CALIFORNIA**

GROUP DELTA CONSULTANTS, INC.
ENGINEERS AND GEOLOGISTS
9245 ACTIVITY ROAD, SUITE 103
SAN DIEGO, CA 92126 (858) 536-1000
PROJECT NAME
Riverside Community Hospital
HCA Design and Construction

PROJECT NUMBER
SD809
DOCUMENT NUMBER
24-0011
FIGURE NUMBER
1A

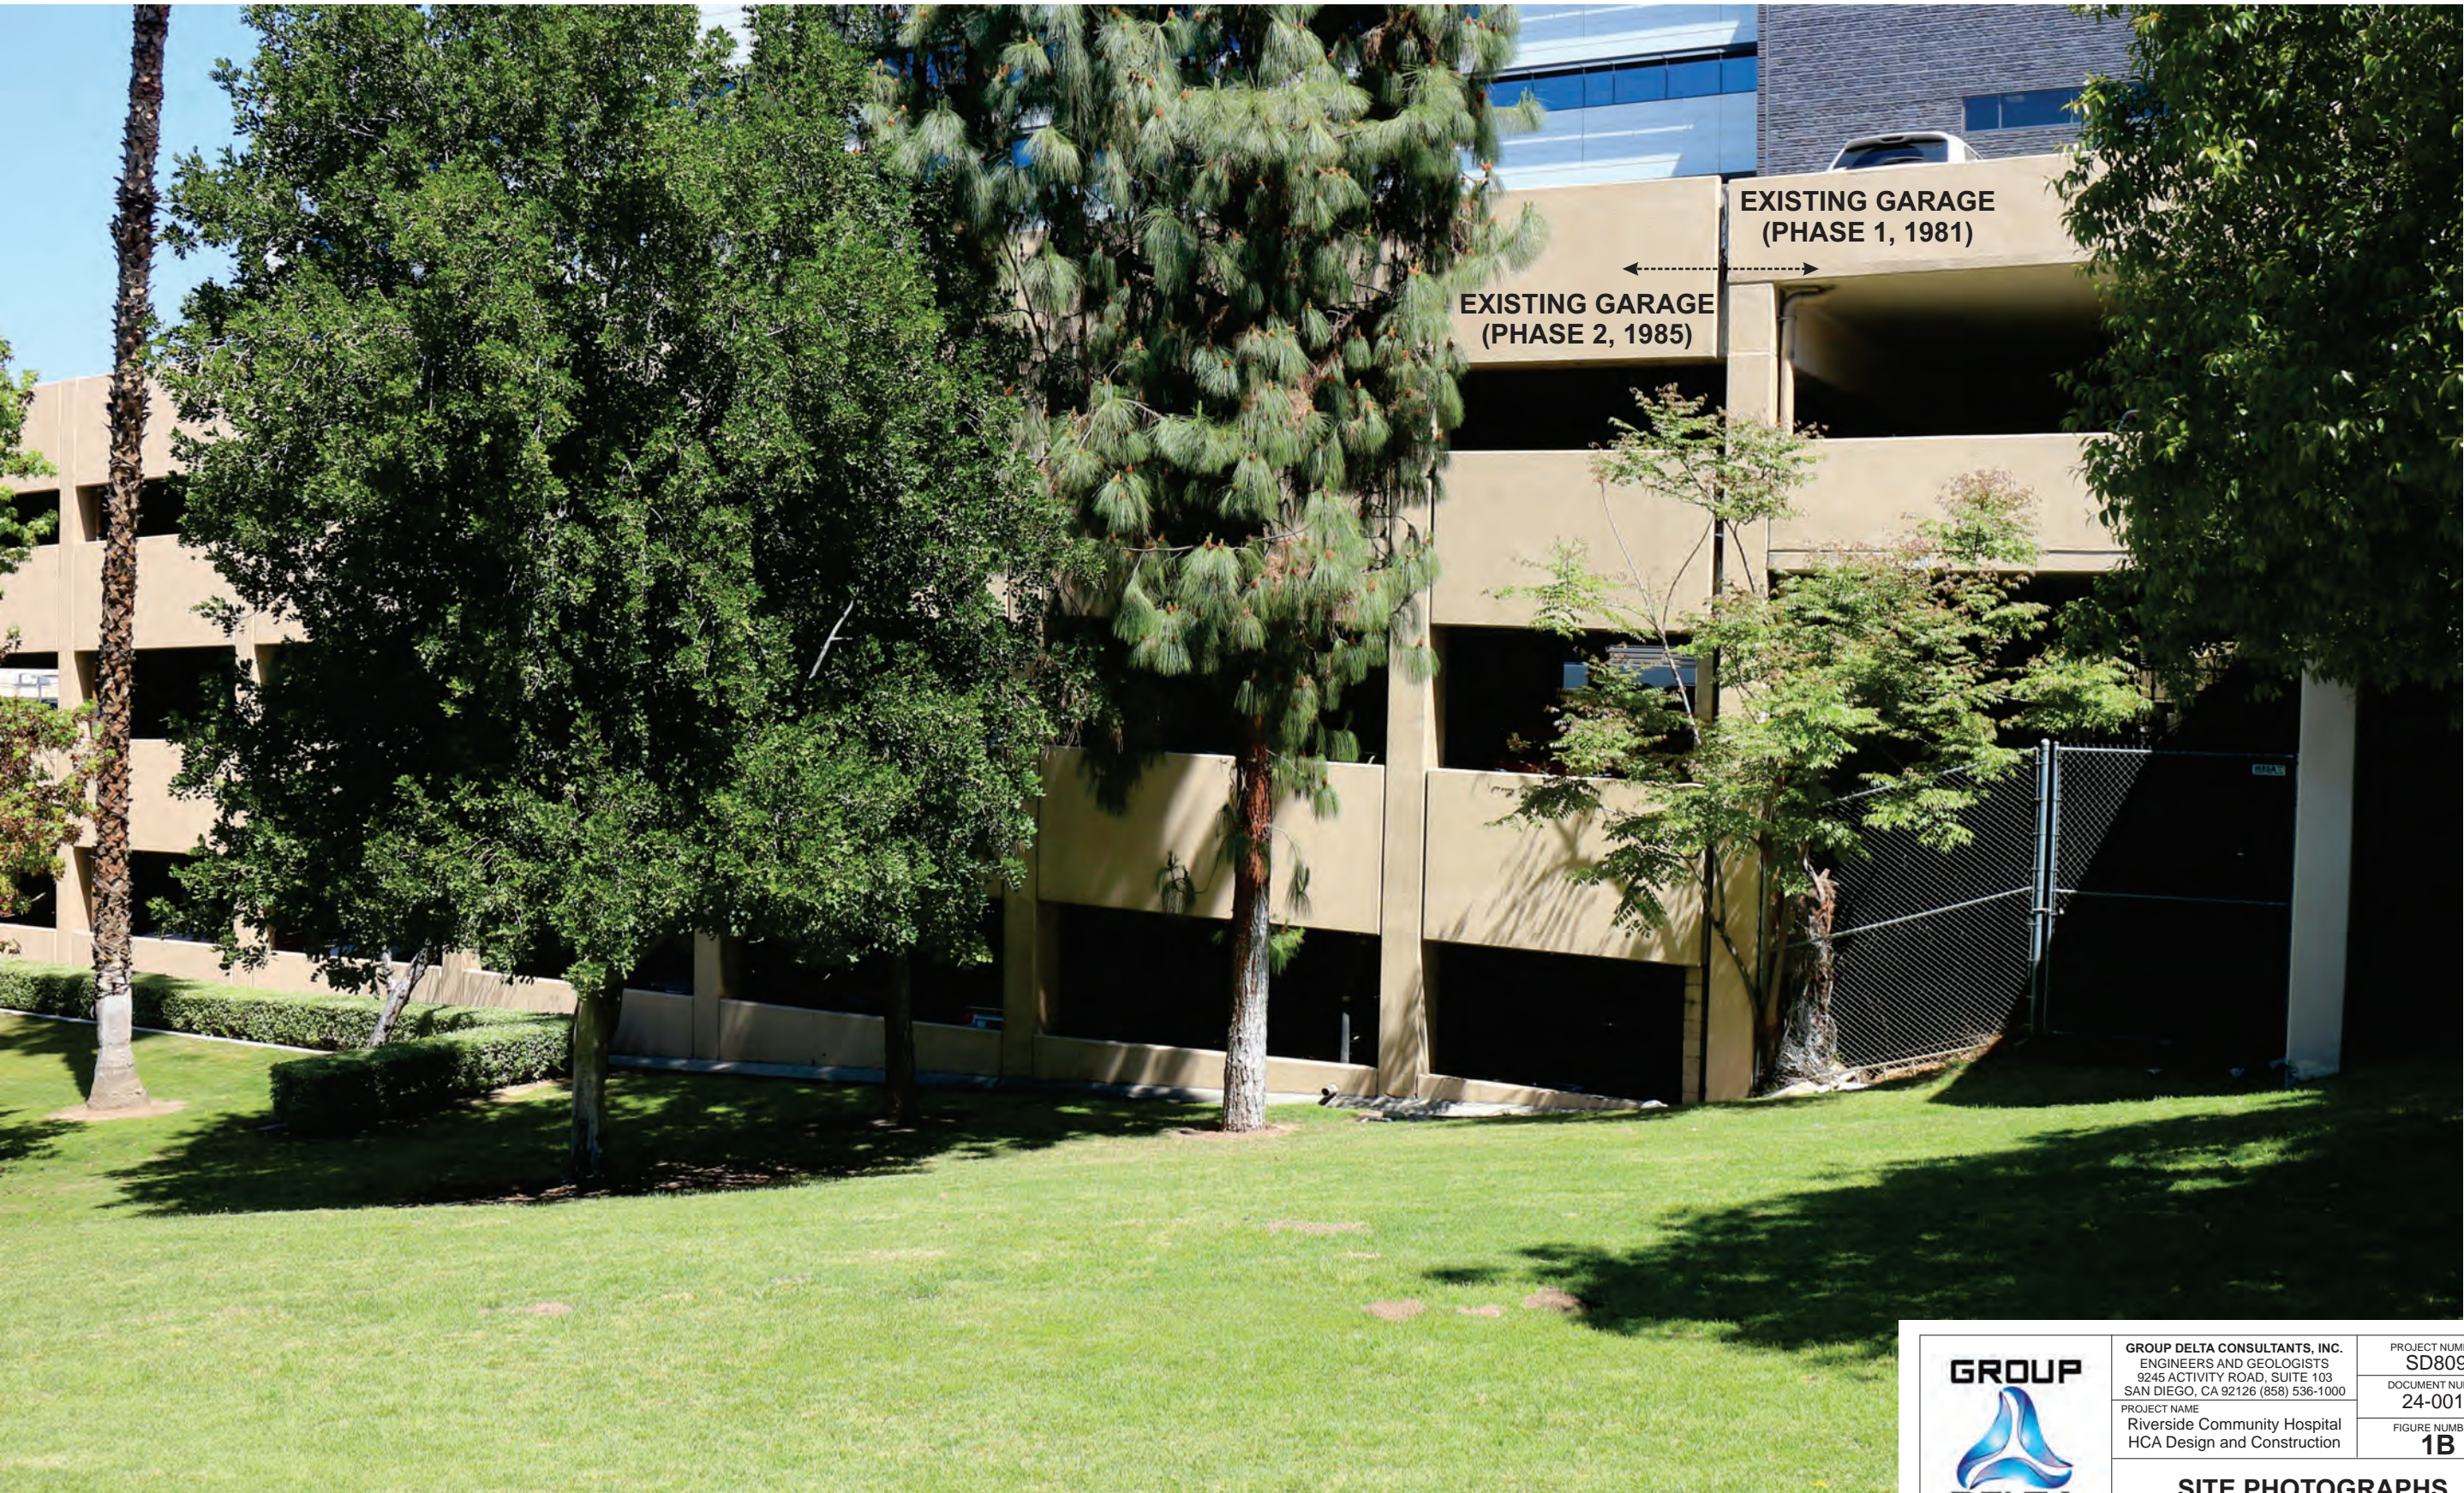
FIGURE NUMBER
1B

Within the interior of the existing parking structure at the new Tower site, we observed relatively few cracks within the reinforced concrete columns and beams. The western portion of the slab-on-grade for the garage addition did have a few minor cracks (Crandall, 1985). Fairly extensive cracks were also observed around the perimeter of the structure. The concrete sidewalk along the eastern edge of the MOB immediately southwest of the Tower site was extensively cracked. The asphalt concrete pavements in this area also had extensive alligator cracking. Note that the western part of the Tower site is situated over compressible Young Alluvium. The patterns of cracking we observed in this area appear to be consistent with soil settlement.

The eastern portion of the existing garage at the Tower site is raised above grade and supported by concrete beams, columns and pile foundations (Crandall, 1981). This initial garage structure also appears to have performed fairly well to date, with only a few signs of cracking. However, the slope beneath this portion of the garage does show considerable signs of piping and soil erosion. One of the reinforced concrete beams in this area was longitudinally cracked with indications of seepage and corrosion of the steel reinforcement (i.e. rust stains). There are also indications of settlement of the asphalt concrete pavement located immediately east of the pile supported garage. Extensive cracks were also observed around the elevator tower in the northwest corner of the initial garage structure. Finally, the soldier pile shoring between the garage and Tower C is exposed along the staircase between these structures and appears to have been partially demolished.
