**REPORT OF GEOPHYSICAL INVESTIGATION  
PROPOSED 950,000 SQUARE FOOT DISTRIBUTION CENTER  
SYCAMORE V PROJECT  
RIVERSIDE, CALIFORNIA  
PREPARED FOR  
HILLWOOD INVESTMENT PROPERTIES  
JOB NO. 14285-8**

May 14, 2014

Job No. 14285-8

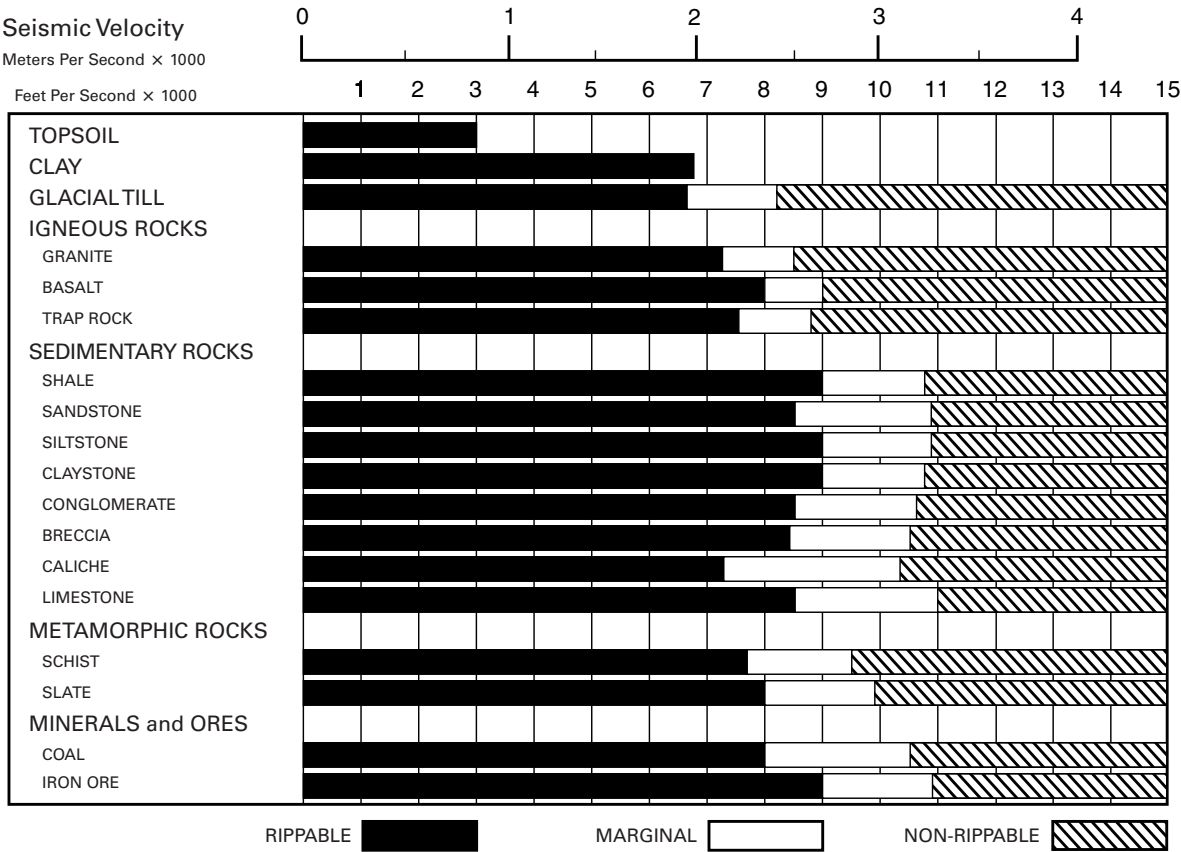
- Multi- or Single Shank No. 10 Ripper
- Estimated by Seismic Wave Velocities

The seismic velocity can be utilized to estimate the rippability of subsurface materials. Charts included in the Caterpillar Performance Handbook (2013), included as Appendix "E", correlate seismic velocity of different rock types to rippability by Cat D9R/D9T and D10T bulldozers utilizing a single or multi-shank ripper. The Caterpillar charts do not include tonalite as a rock type, but granite is included. For the purposes of this report, granite is considered to be the approximate equivalent of tonalite. The chart for the D10T indicates granite rock with a seismic velocity up to 7,200 fps as rippable. Granite with a seismic velocity of between 7,200 to 8,500 fps is considered to be marginally rippable, and velocities of greater than 8,500 fps are considered to be non-rippable. Based on our

The following table is a line-by-line summary of anticipated rippability conditions using a D10T ripper. It is based on the anticipated grades shown on the Cut/Fill Plan. We have not incorporated possible overexcavation depths for the proposed structure in our rippability analysis. Such overexcavation could be 5 feet or more in cut areas for the footings and could be deeper (at least 10 feet) for some deep footing elements such as "K" braces. These depths should be recommended during a future geotechnical investigation.
