CULTURAL HERITAGE BOARD MEETING DATE: OCTOBER 17, 2018
AGENDA ITEM NO.: 5

LANDMARK DESIGNATION

I. CASE NUMBER(S): P18-0578

- 1) **Proposal:** Proposed historic designation of E.T. Wall Packing House as a City Landmark
- 2) **Location:** 3280 Vine Street
- 3) **Ward:** 1
- 4) **Applicant:** Rick Scott of Corman Leigh Companies
- 5) **Case Planner:** Scott Watson, Associate Planner

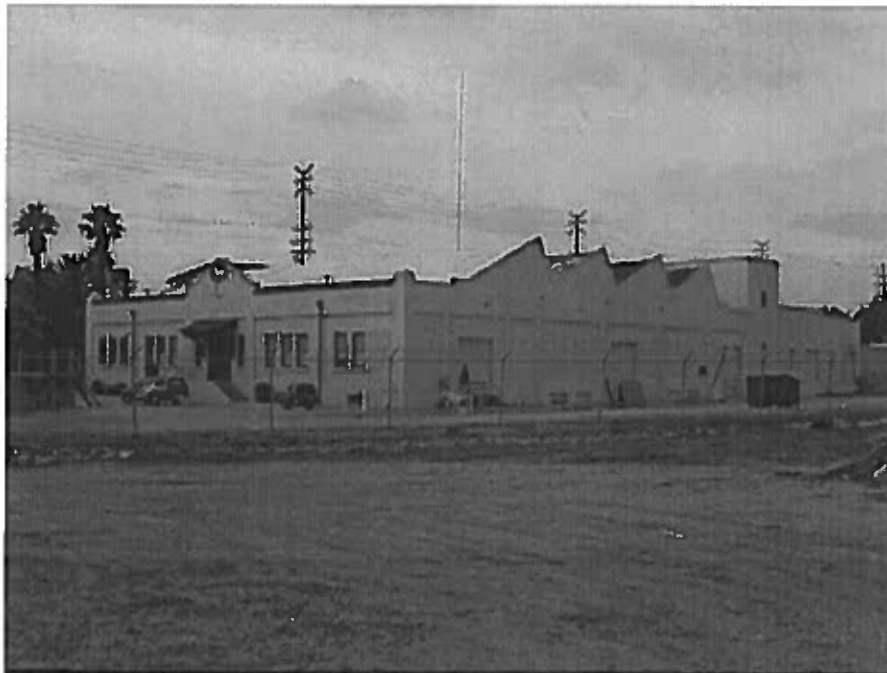
View of 3230 Vine, south (front) and east side elevations. (View toward northwest). Photo No: 1-2 2/25/2000

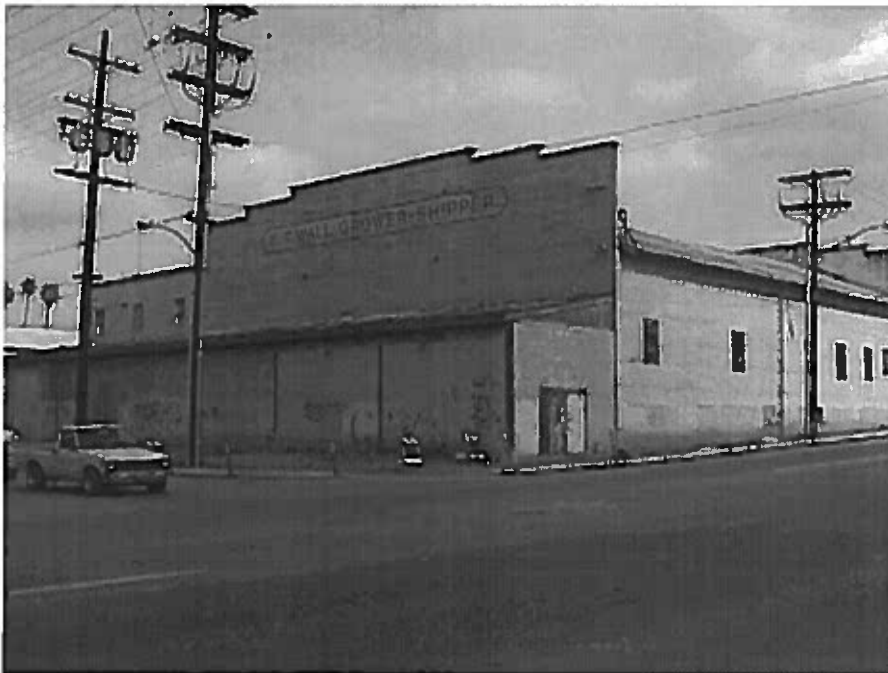
P5b. Description of Photo: (View, date, accession #)
 West elevation (View toward east). Photo No: 11-11, 2/23/2000

This combination one- and two-story building with elevated basement is designed in the Industrial Western False Front style and sits on a concrete foundation. The warehouse portion of the building is one-story in height and is of board-formed concrete construction. The office/administration portion is of frame and stucco construction and is two-stories. A concrete storage add-on situated at the corner of Third and Vine Streets is one-story in height. Typical of the style, the building displays few architectural details. Stepped parapets placed at the east and west ends of the structure conceal a sawtooth roof with clerestory windows. The extant fenestration consists primarily of one over one double hung sash, wood framed windows without lintels or sills. A former building entry facing Third Street (south) was been removed leaving an impression in the concrete wall where a tile shed roof once penetrated it. A large space between the loading docks and roofline was once used to display the company name. Three elevated receiving bays, closed off by large doors, are located along the east elevation. This elevation was originally adjacent to a long railroad spur that once connected the packing house facility to the Union Pacific Railroad system. Later additions and alterations include a wooden cull bin built in 1945, the canopy enclosure, and a partial second story added in 1966. A window opening located toward the rear of the structure has been infilled with brick. The building occupies most of the paved parcel.

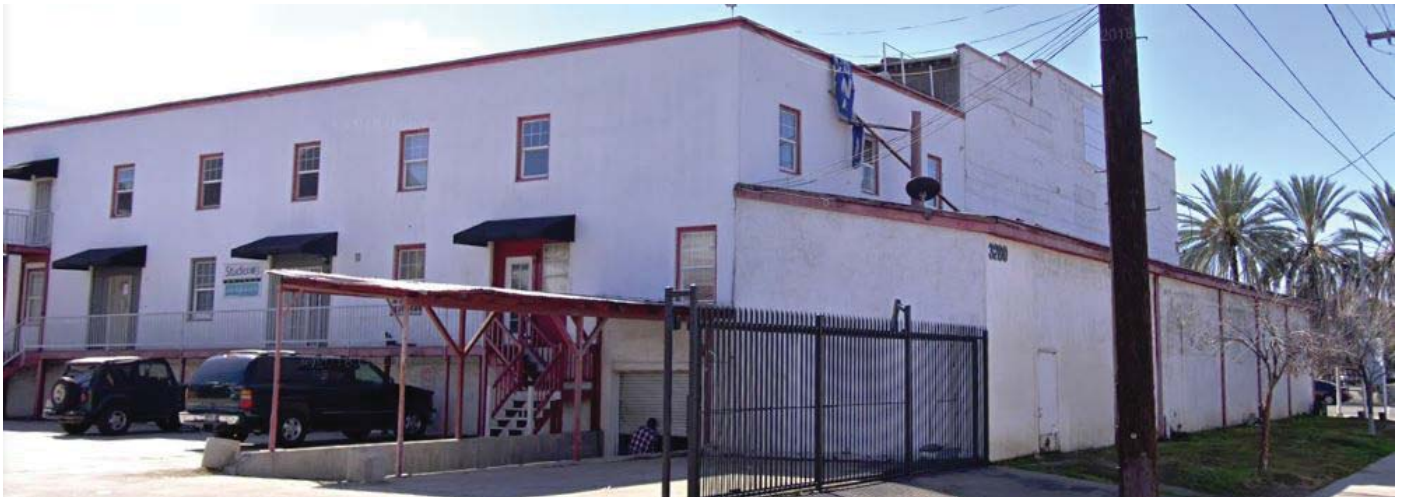
North and west elevations, view looking southeast

This large, one- and two-story industrial building with an elevated basement covers most of the paved lot on the northeast corner of Vine and Third Street. The unpainted, stacked concrete one-story packing house portion, and later warehouse, on the south is topped by a saw-toothed roof with clerestory and anchored by two Western False Front style stepped parapet walls with coping on the east and west elevations.

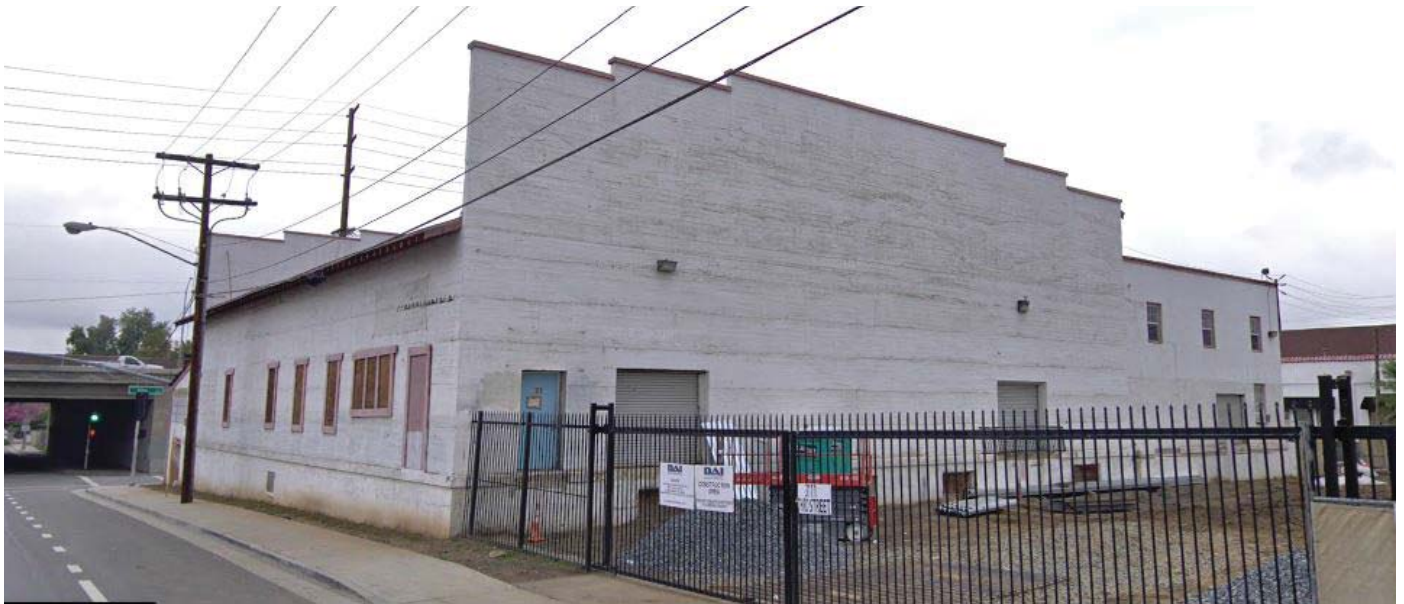
South and east elevations, view looking northwest

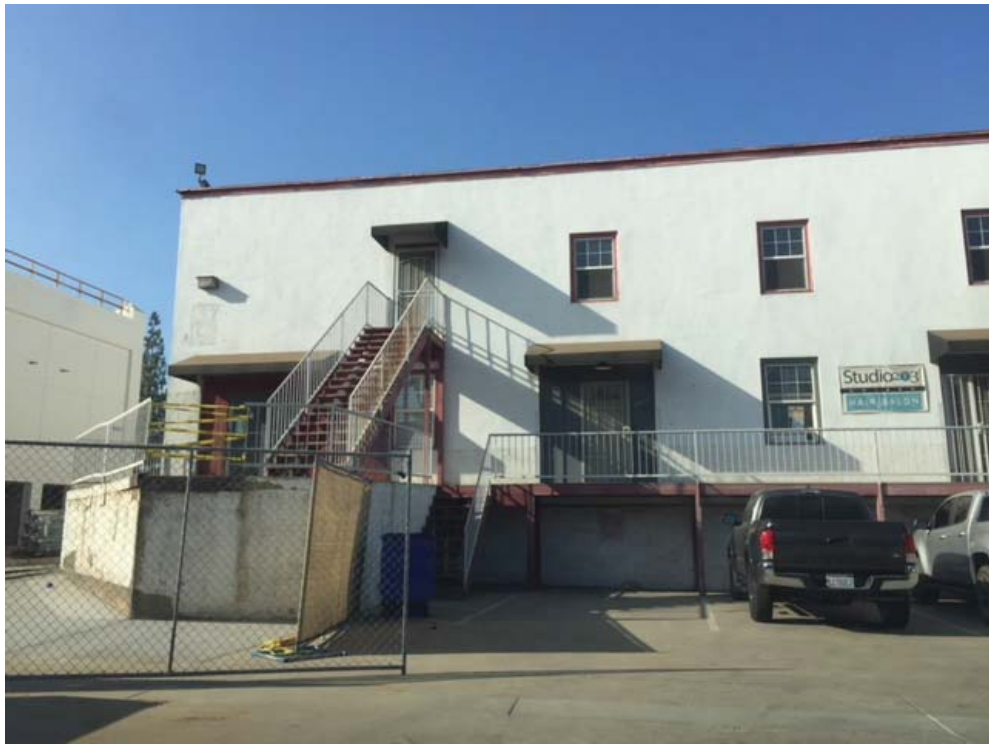
Two-story administration addition, view looking south

Building permits and previous surveys document a 1945-46 cull bin, and in 1966 the enclosure of the west canopy and a partial second story addition at the canopy enclosure. Although the west canopy was enclosed after 1952, the cull bin has since been removed and partial second story addition does not appear to be extant. It is possible that the second story addition was not completed. The E.T. Wall Citrus Warehouse Packing House is in good condition and retains sufficient integrity for Landmark Designation.

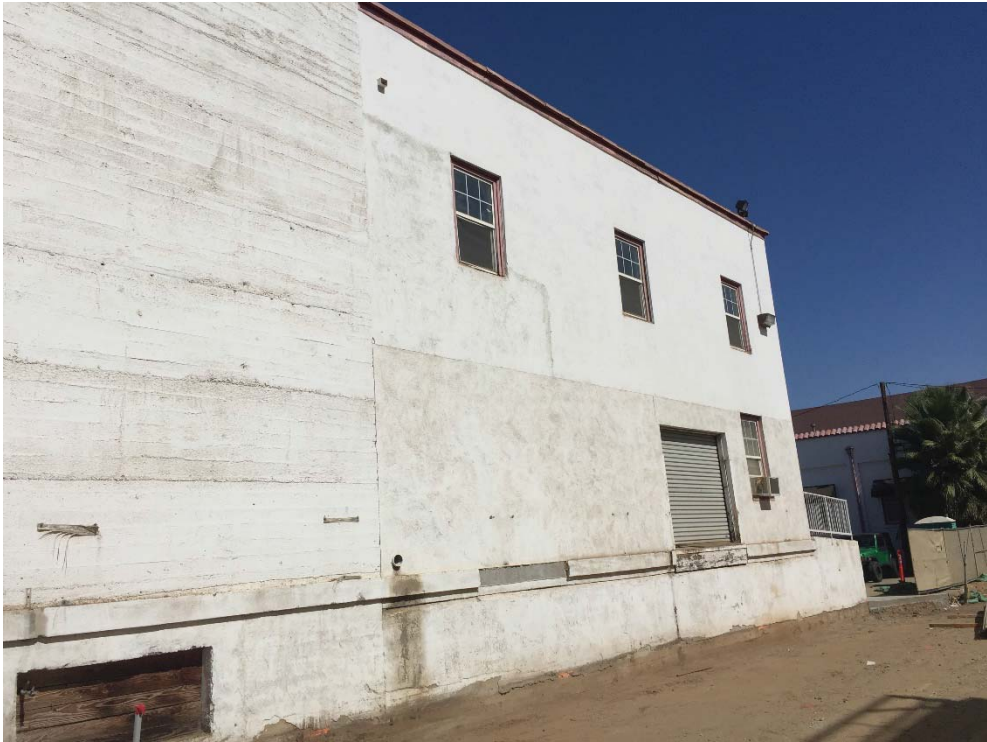
East elevation loading bay, view looking northwest

Fenestration consists of boarded double-hung, one-over-one sash without lintels or sills. Three loading bays with roll-up metal doors and a pedestrian door are found on the rear (east) elevation, which once faced the railroad tracks, and a red tiled hood has been removed over a side pedestrian-door entrance. The two-story, wood-framed stucco office/administration portion on the north is topped by a flat roof. This addition appears to be an early addition, circa 1930s, but the windows have been replaced with vinyl-framed double-hung windows within the original openings.

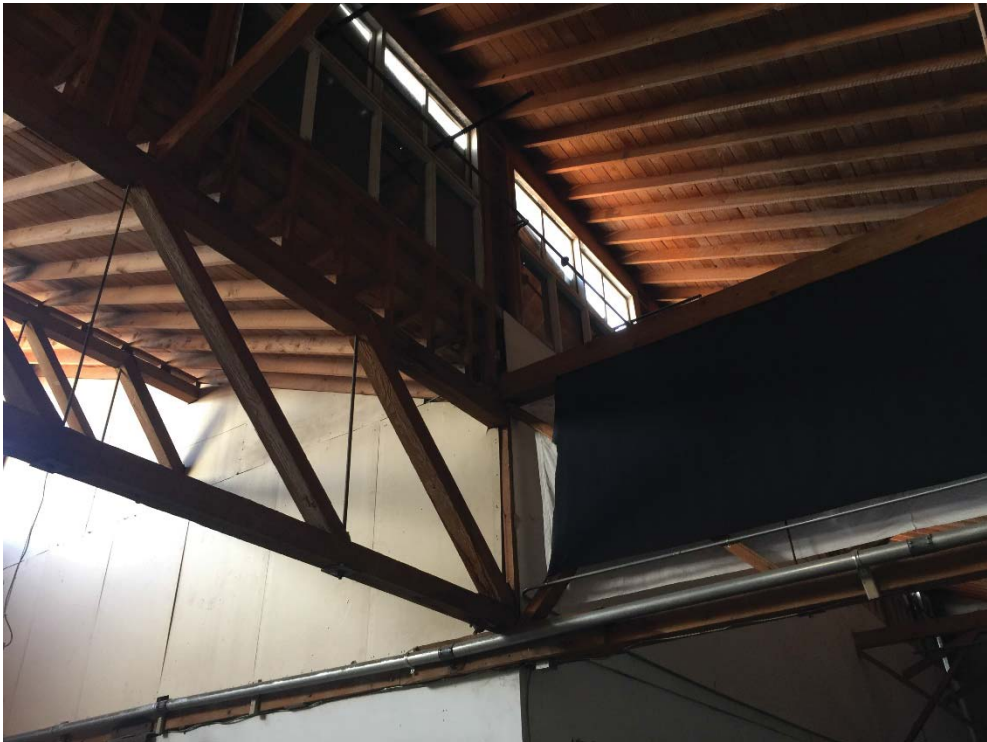
Saw-toothed roof

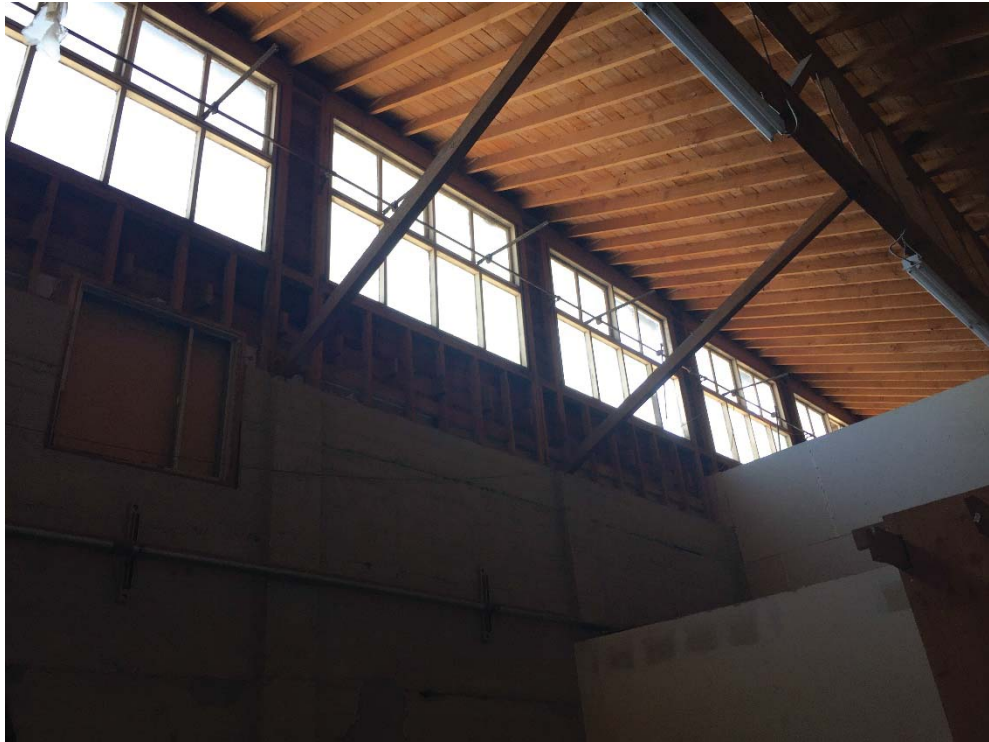
Clerestory windows

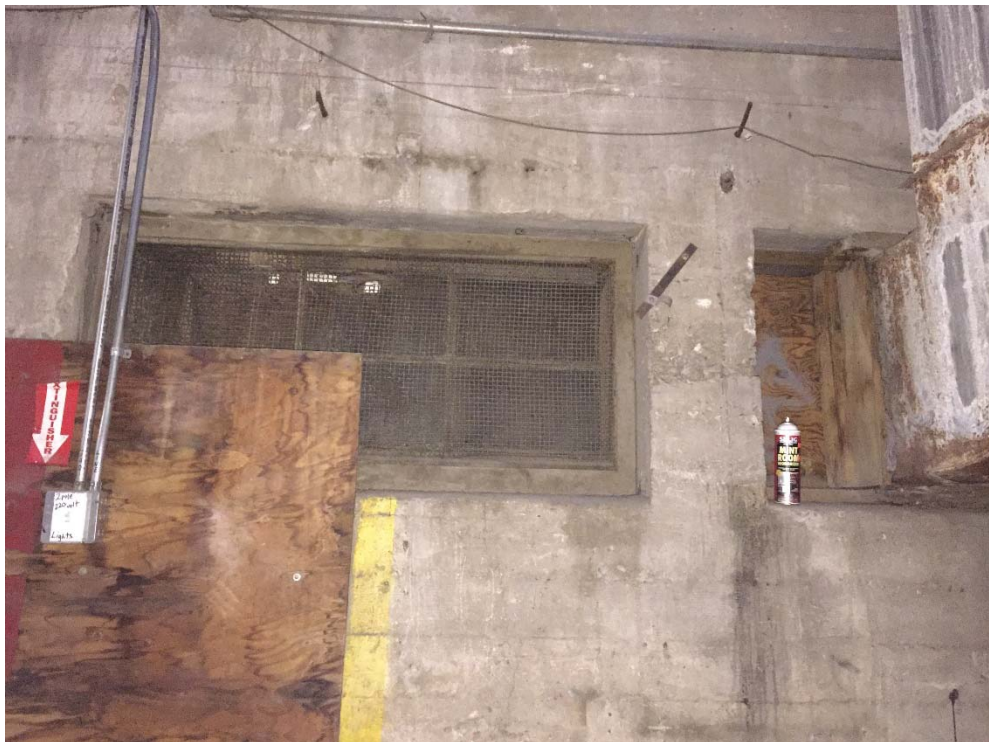
"Coloring" basement ventilation windows

One feature of the building, which demonstrates its connection to the industry is the basement. The basement of the packing house was often used as a "coloring" room. This is where green oranges would "color" before being shipped to eastern markets. The temperature and humidity levels of the basement made this a prime location for "coloring." The ventilation windows throughout the basement demonstrate this use.
