# BIOLOGICAL RESOURCES ASSESSMENT, JURISDICTIONAL DELINEATION, AND MSHCP CONSISTENCY ANALYSIS FOR PARCEL 237-130-023 CITY OF RIVERSIDE, RIVERSIDE COUNTY, CALIFORNIA

# September 2020

Revised July 2021, June 2022, and May 2025

# PONYHAYVIN RANCH SITE ASSESSEMENT JUNE 2019

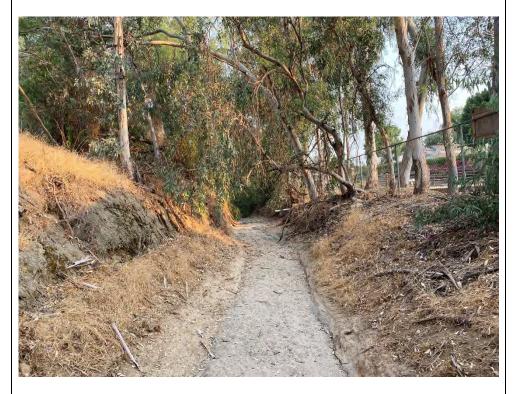
Photo 1 – Eastern edge of parcel showing drainage feature A, downstream.

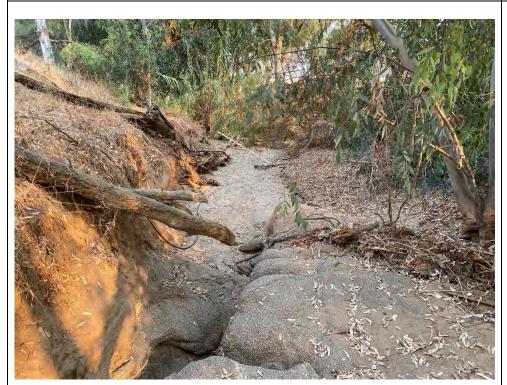
Photo 2 – Central portion of drainage feature A and extent of Arroyo, showing lack of veg and high rock layer.

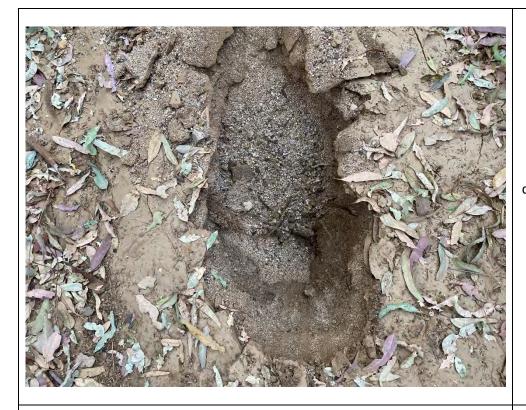
Photo 3 – Soil pit dug near center of drainage A. Now hydric soils or hydrology.

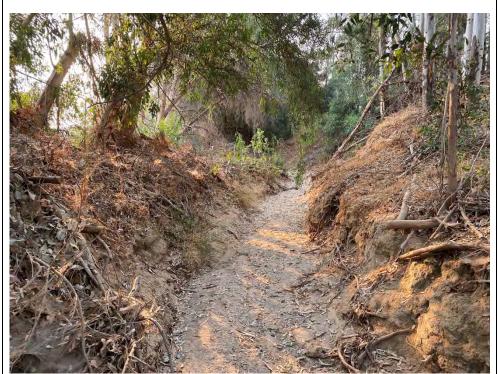
Photo 4 – Western edge of drainage feature A and extent of Arroyo. Facing upstream.

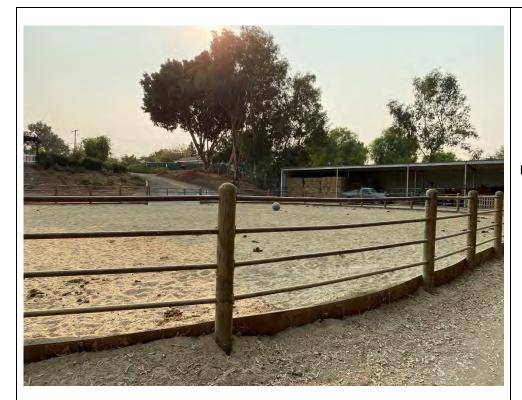
Photo 5 – Showing barn and horse pens near southern portion of property.

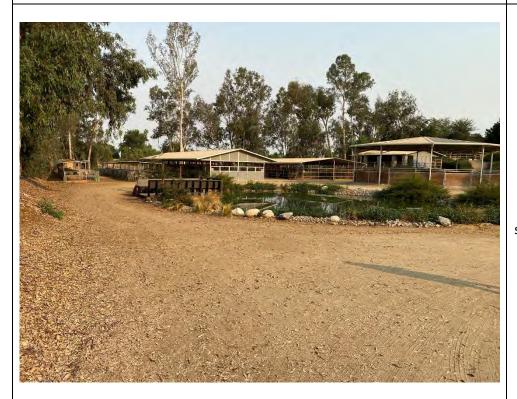
Photo 6 – Southwestern portion of the parcel showing stables, corals, and pond.

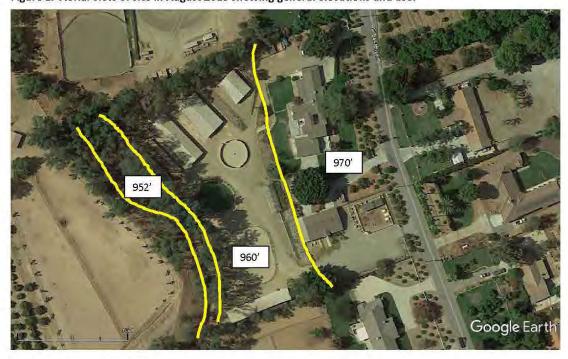
Figure 1: Aerial view of site in August 2018 showing general elevations and use.

The site is situated on approximately 5 acres of upland, agricultural, residential and a small portion of streambed, along the Woodcrest Arroyo in the City of Riverside, (Fig. 1). The residence is situated along St. Lawrence Ave. at approximately 970' elevation. The corrals and arena are at a 960' elevation and the Woodcrest Arroyo is at a 950-952' elevation, starting at the upper end of property, downstream for approximately 490', with a cross-section depth averaging 8'. (Fig. 2).

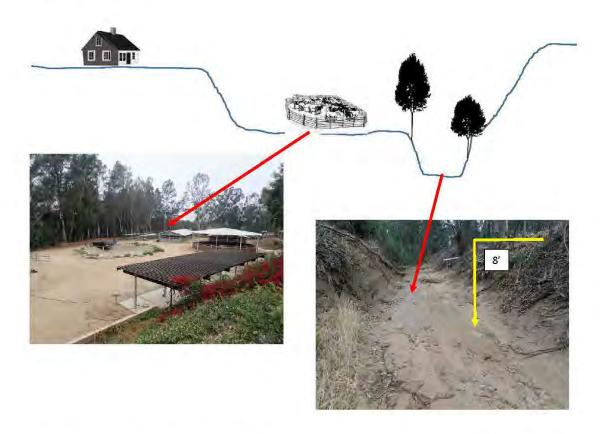
Fig 2: Site Cross-section View

In order to determine flood--prone width of the channel at this location for conservation purposes, take the standard depth of the channel flow, x 2 and measure the width at that height to determine if the channel is incised. Under current conditions the natural channel is considered constrained from both above and below the property.  $(2.5') \times 2 = 5'$ . The current channel depth is over 8', which does not allow water, even at peak flood stage, (5') to overtop the bank and inundate the arena and corral areas of the property. While older USGS quad maps show elevations at 10 and 20 intervals, this site has undergone grade changes over the decades from upstream property owners and past owners that have decreased the floodplain width to its current location and depth.

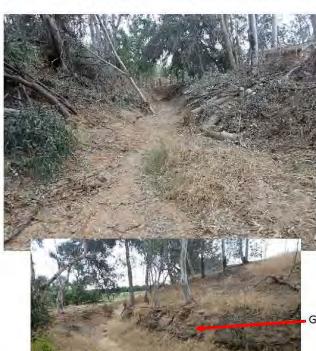
Photo looking downstream toward adjacent property and wider channel bottom with exotic grasses and non-native plants such as castor bean, tree tobacco and a small patch of arundo donax (giant reed). Many channel bottom areas in the upper reach of the arroyo consist of gray, decomposing granite, which makes erosion in these areas impossible. While the rock is considered weathered, decomposition is extremely slow. Nonnative plants can be removed and controlled and a plant pallet developed based on local natives to help increase habitat value while protecting streambanks and property uses.
