Billing Information:	Project Information:
City of Riverside Public Utilities 2911 Adams St. Riverside, CA 92504 (951) 351-6368	6389 CityRiv-Sirokman Sewer Back Up 6168 Bluffwood Drive, Riverside Sewer Back Up with Flooding in house Architect: NO ARCHITECT Vendor #0003307

Description: Sewer Flood Remediation and Repair

6168 Bluffwood Drive
Sewer Back Up Damages

Sewer Back-up Repairs Letter of Understanding

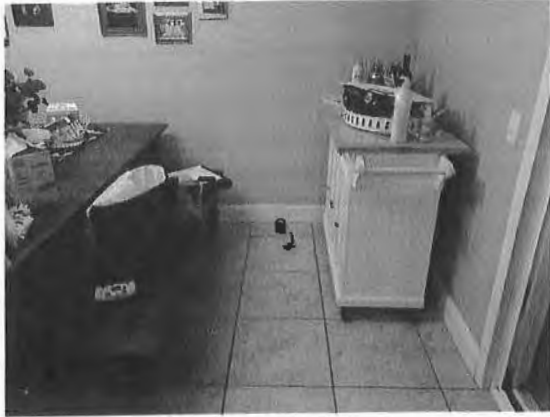
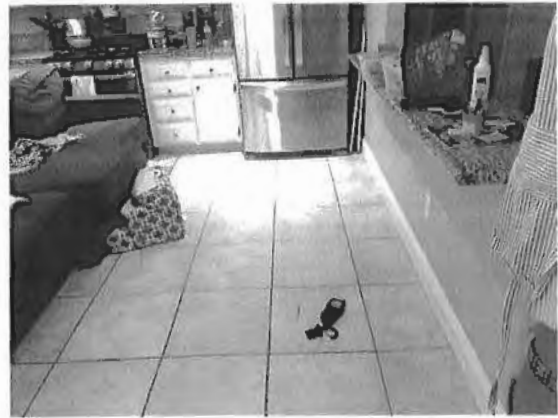
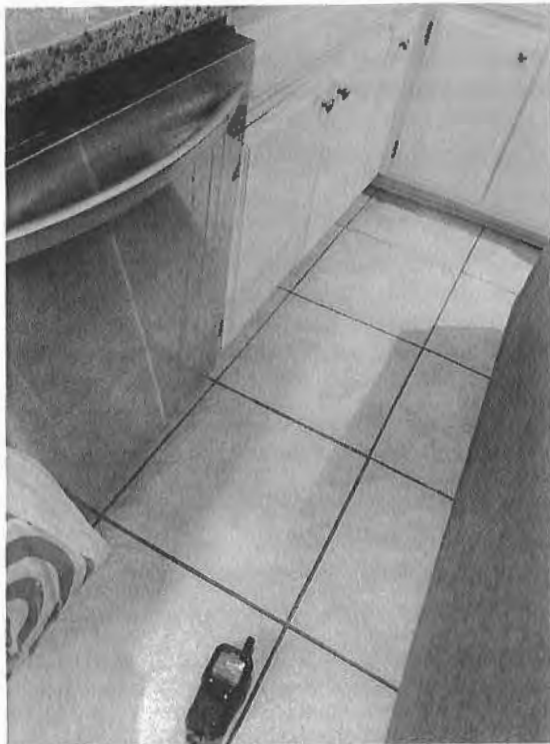
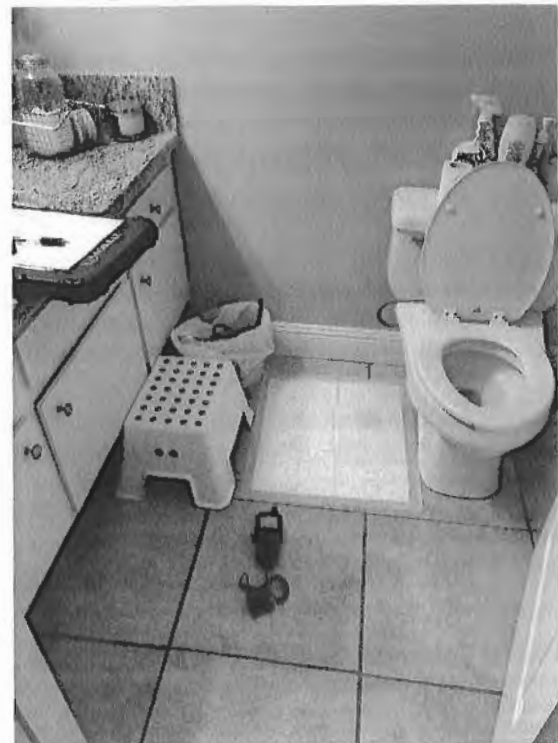
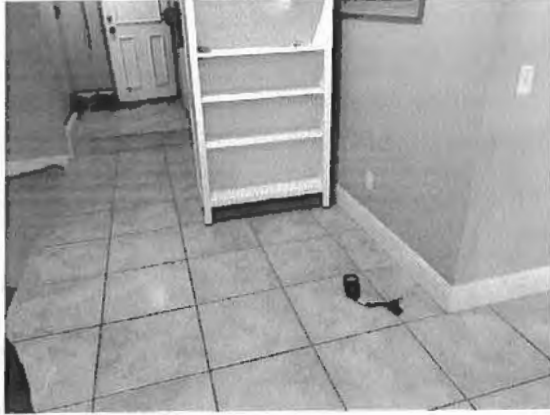
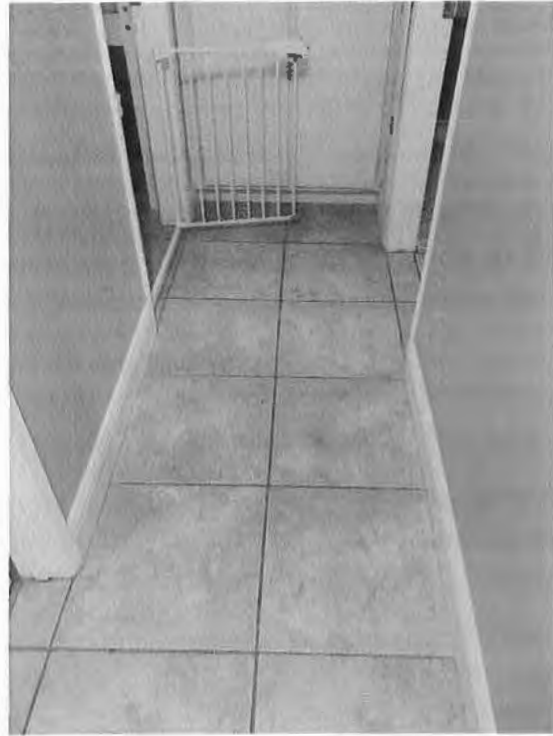
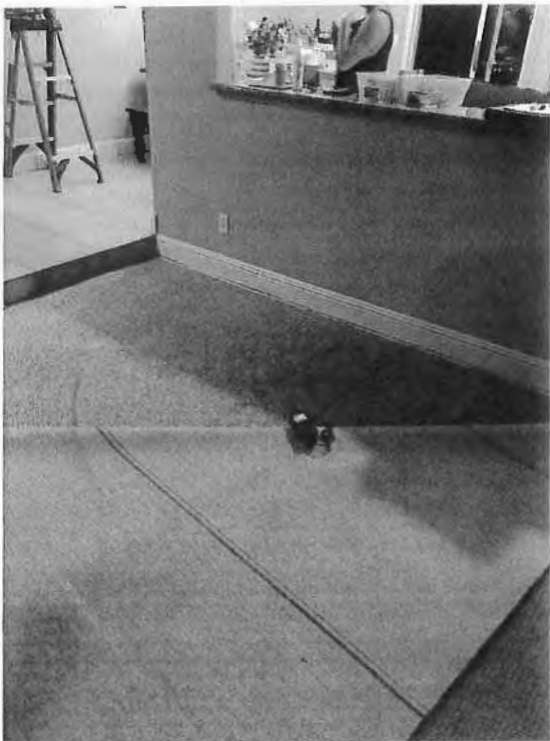
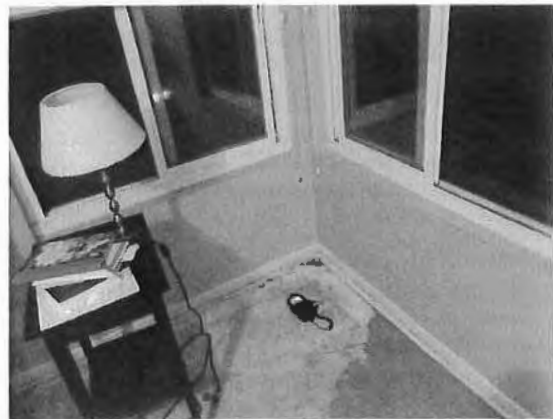
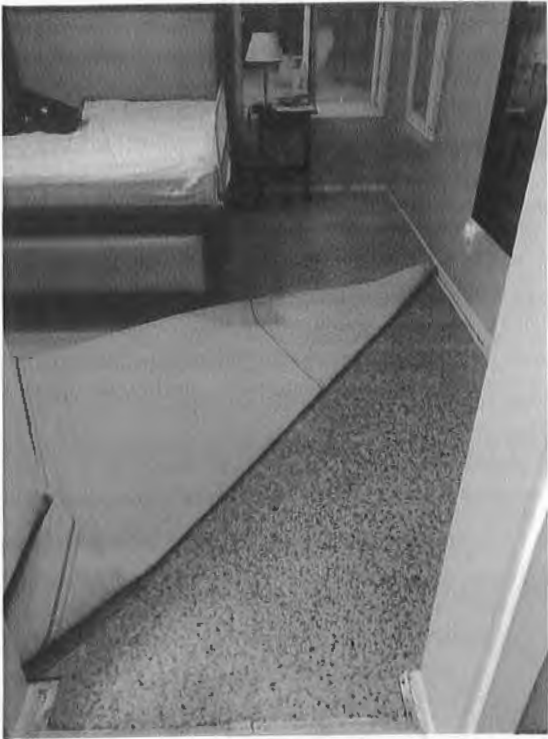
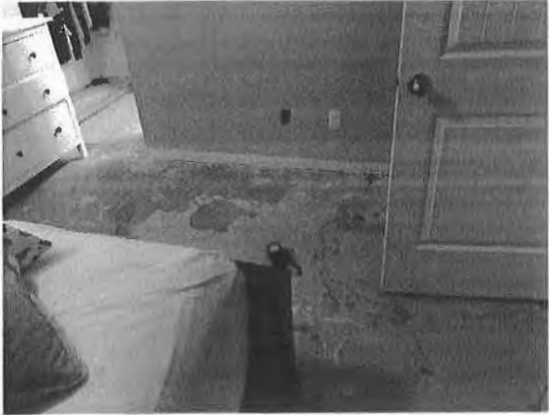
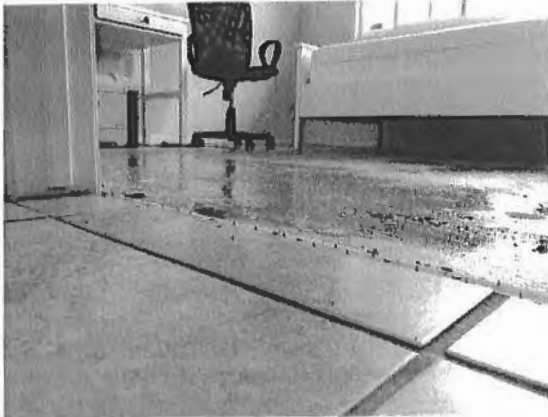
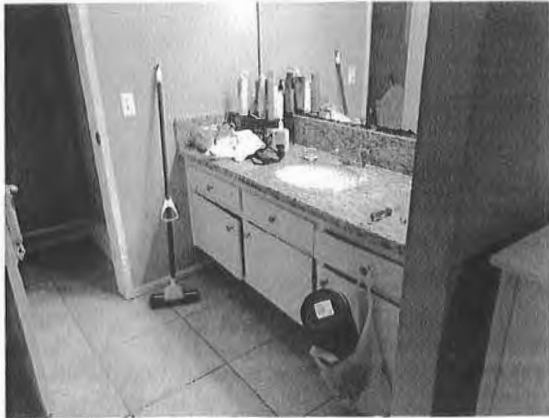
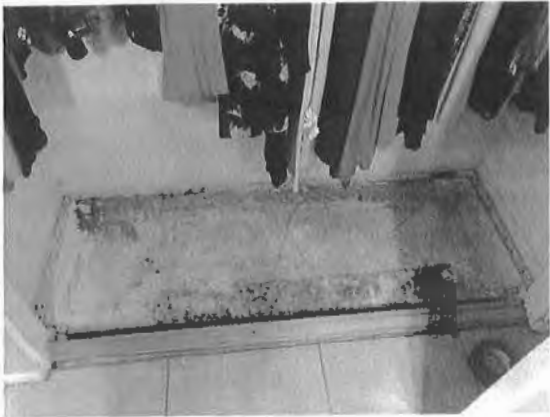
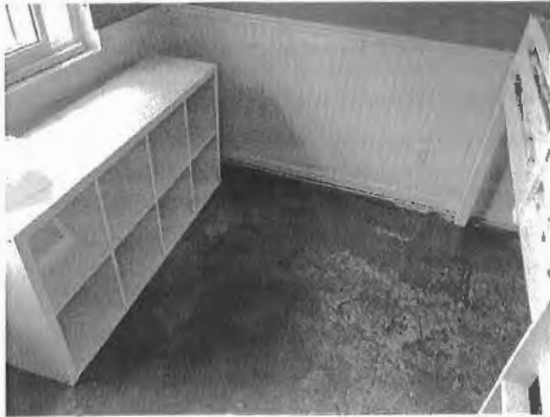
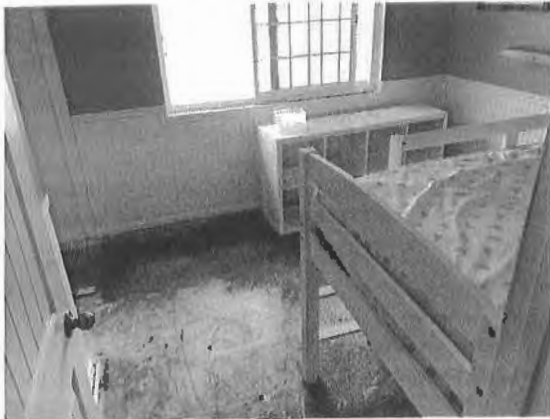
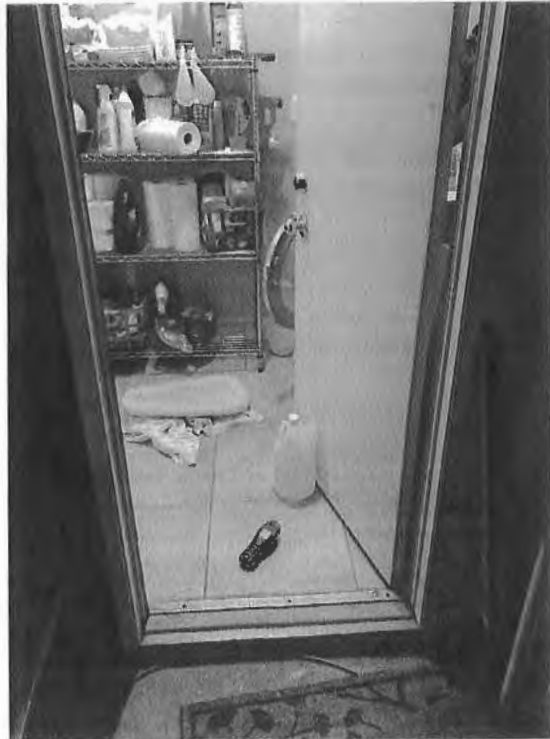
Our technician arrived at approximately 6:30 pm and upon initial inspection, there was no clean out installed at the residence. We installed a clean out to inspect the sewer lateral, hydro jetted and videoed the lateral, and found there were no visible signs of tree roots or offsets. We also investigated the inside of the residence as the backup had spilled into the residence. We found the sewage spill had occurred in both bathrooms and went out into the hallway, 2 bedrooms, the kitchen, front room and laundry room. We pulled up the carpet in the front room and bedrooms and are in the process of drying out the floors. We removed the drywall 2' up from the floor in the bathrooms, bedrooms, kitchen, front room and laundry room to dry out and disinfect the framing. We removed tile from the bathroom, kitchen, hallways and laundry room as well to dry out the floors. We moved all furniture and appliances off-site in order to begin the restoration process.

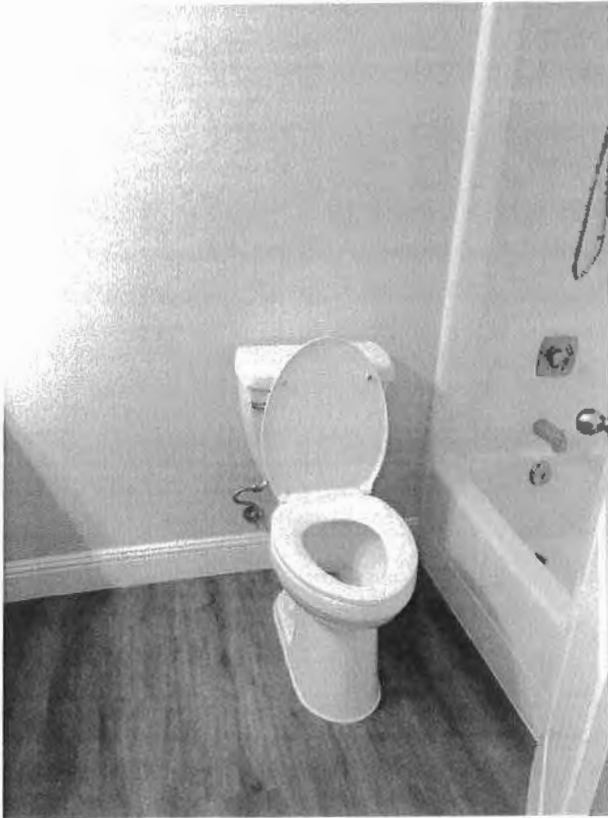
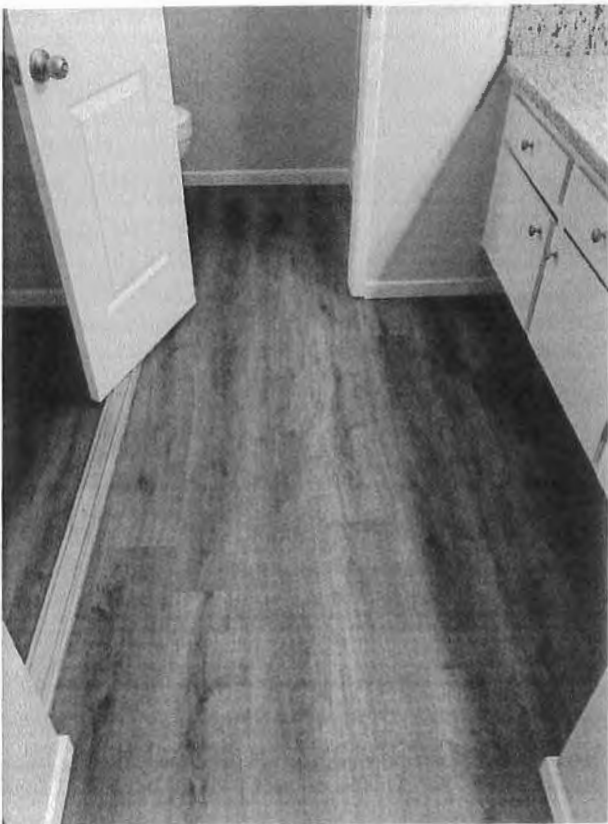
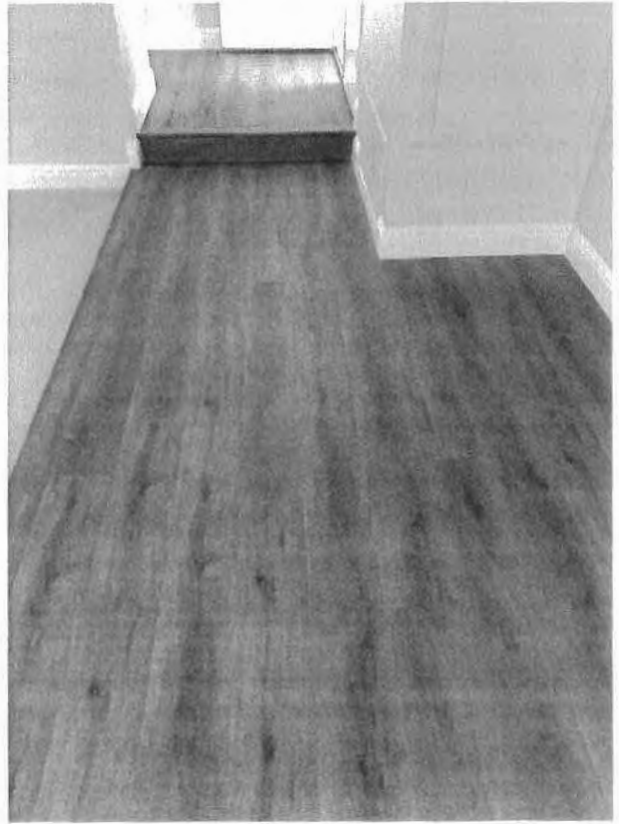
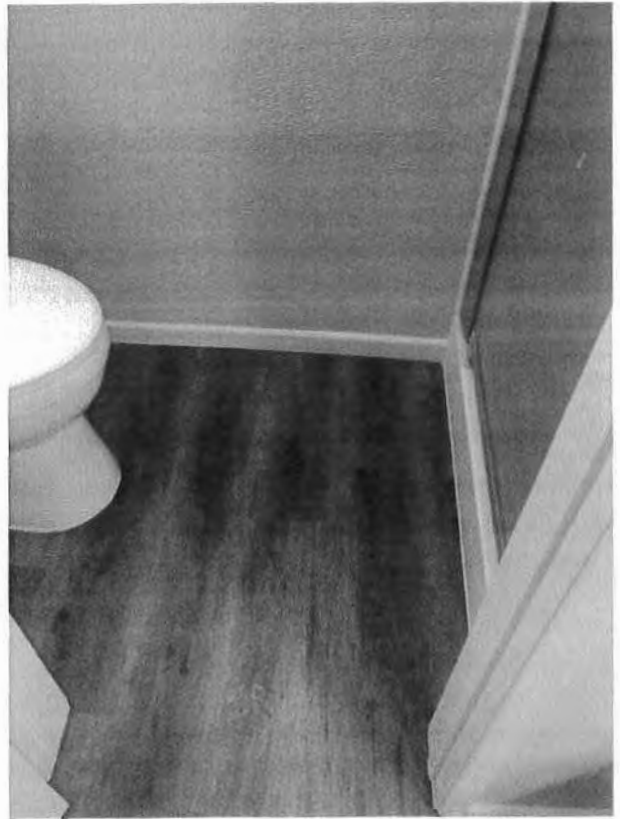
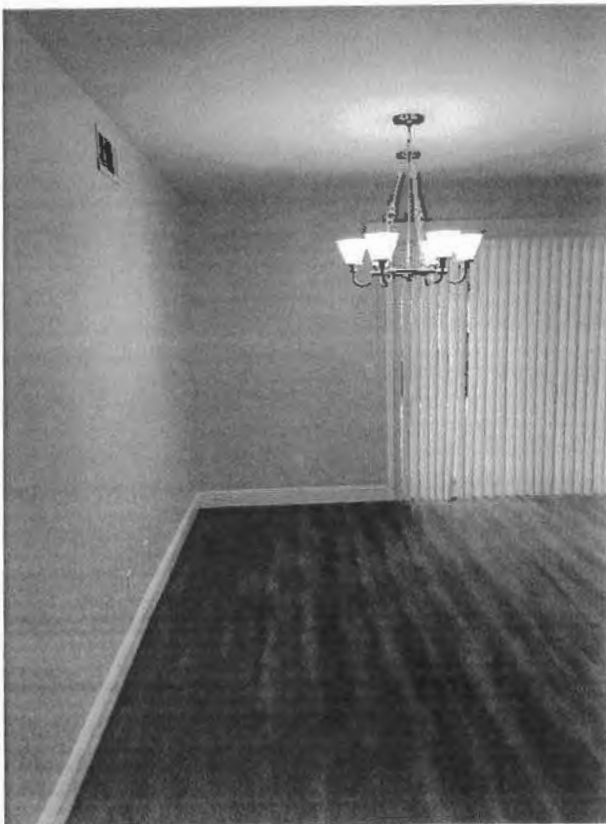
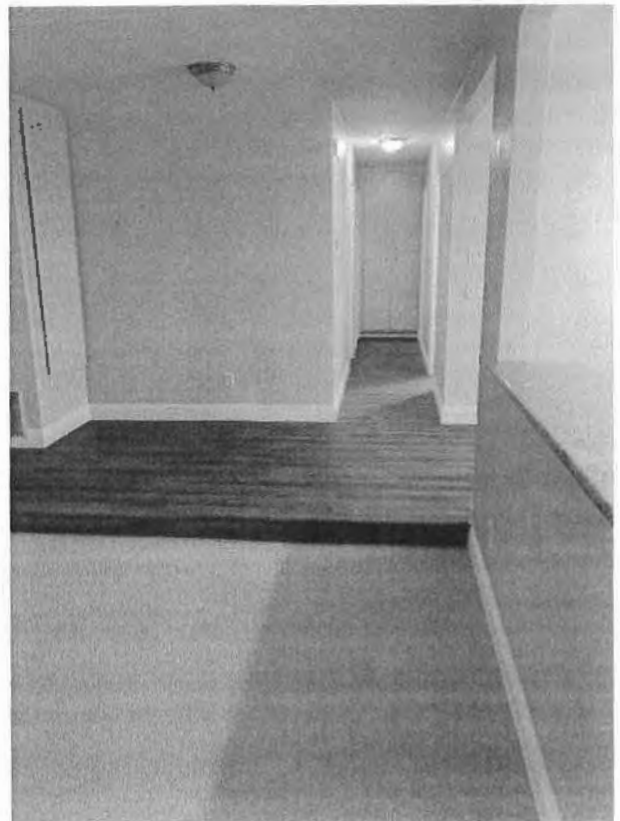
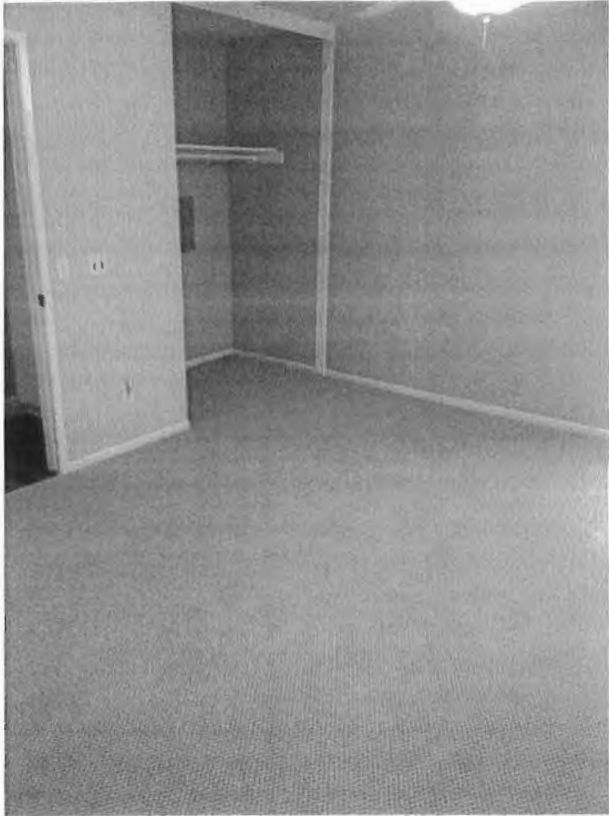
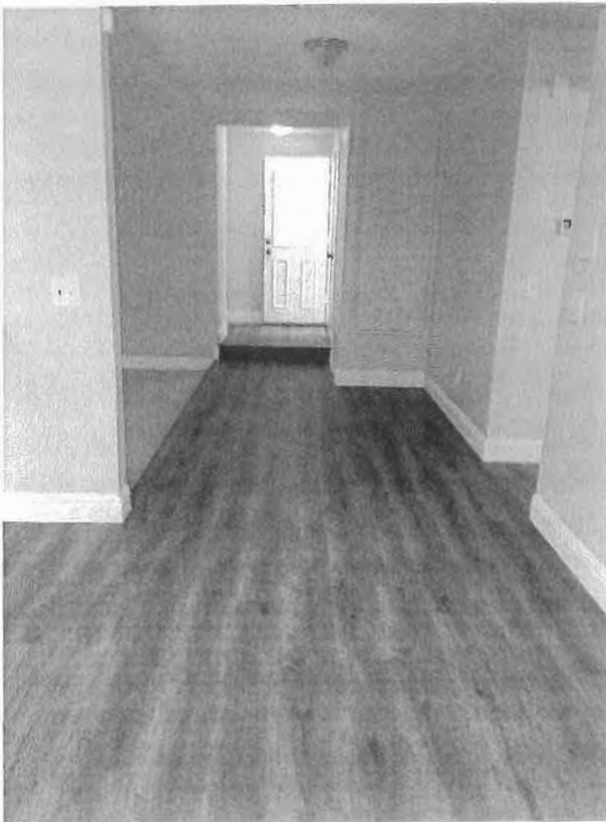
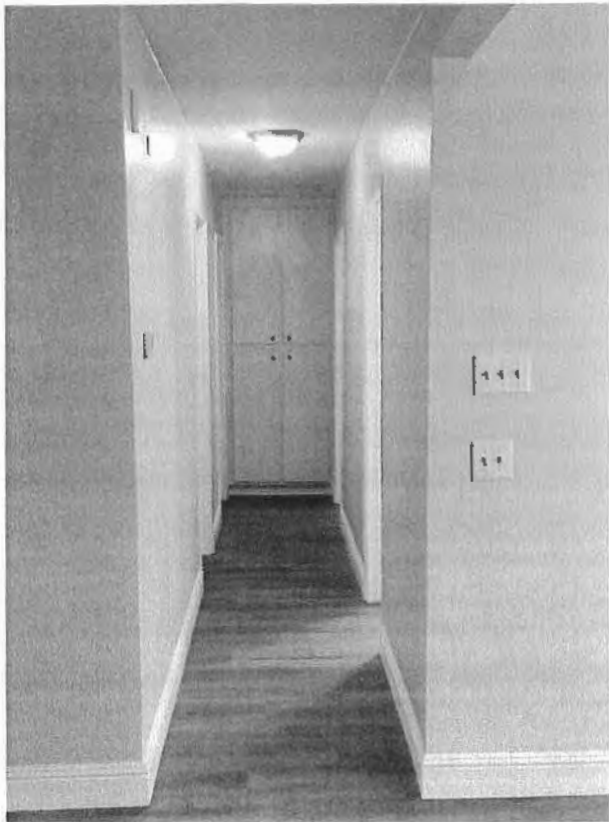
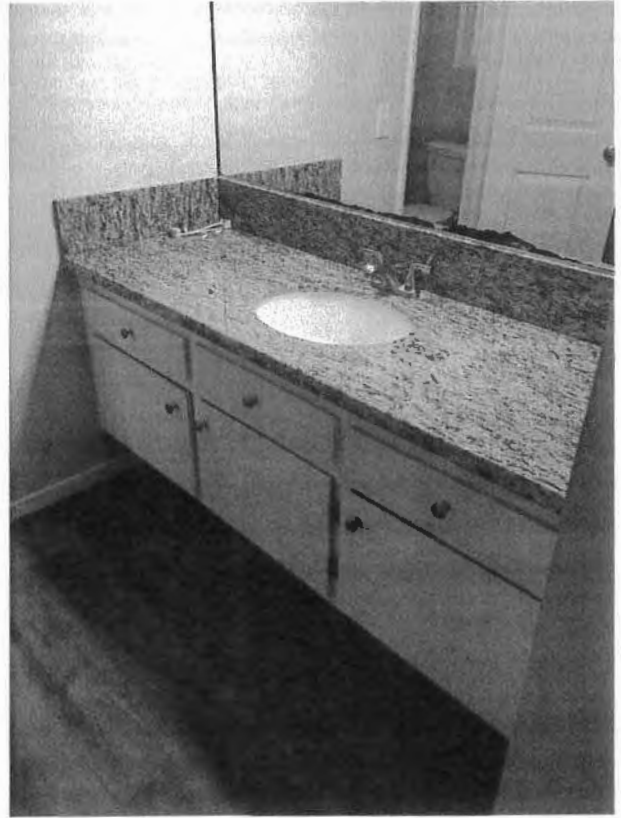
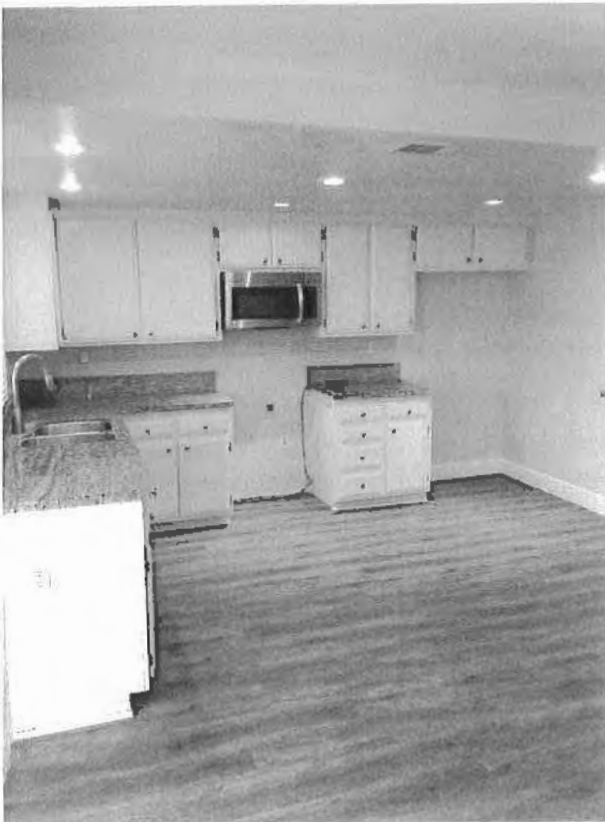
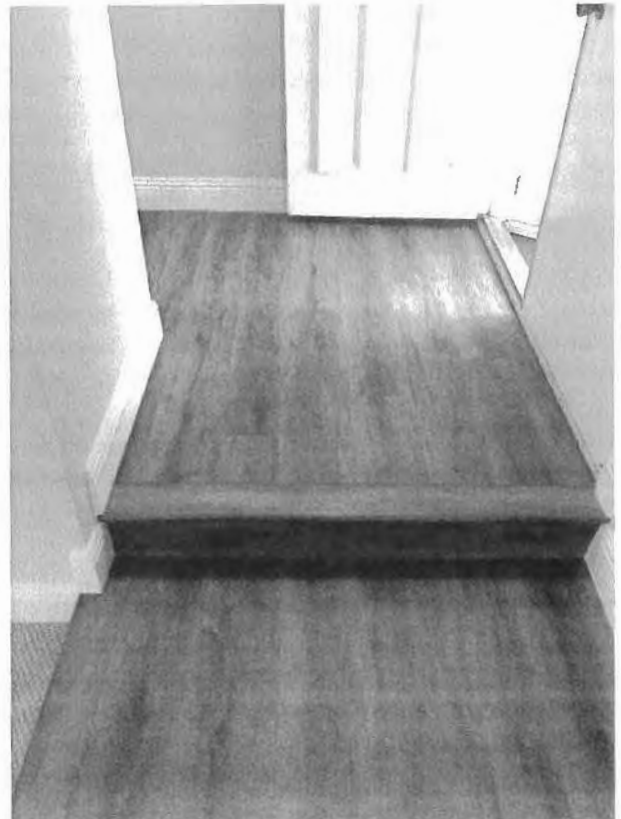
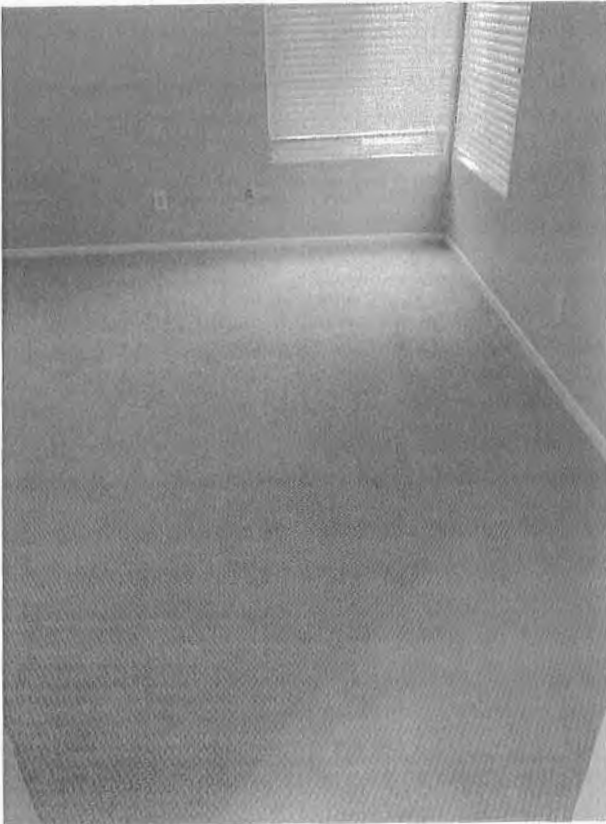
**6168 Bluffwood Drive
Sewer Back-up Final Photo's**

Visual Assessment – No visible signs of mold growth were observed inside the containment. No elevated moisture was detected.

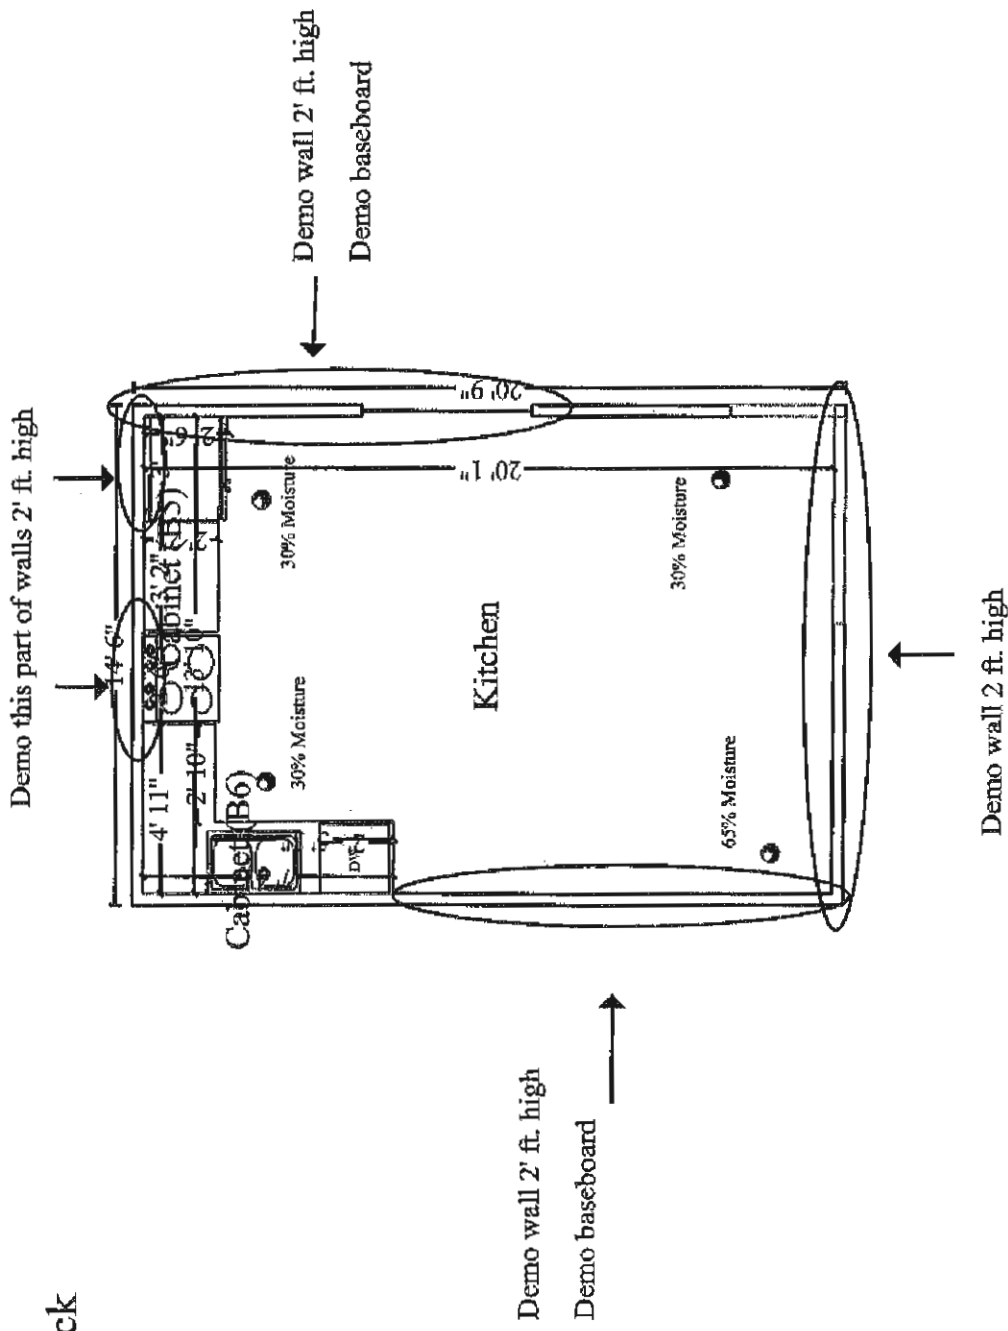
Removed tile floor

Removed cabinet toe kick
