CASA BLANCA SUBSTATION TRANSFORMER No. 1

TRANSFORMER OUT-OF-SERVICE UPDATE AND PLANS FOR RESTORATION

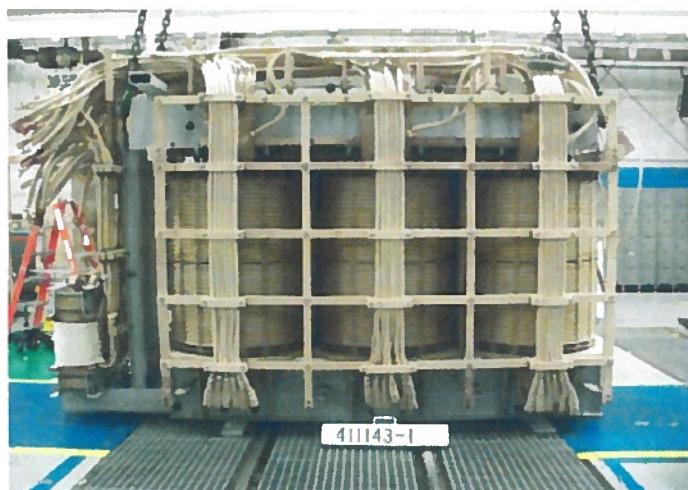
FABRICATION

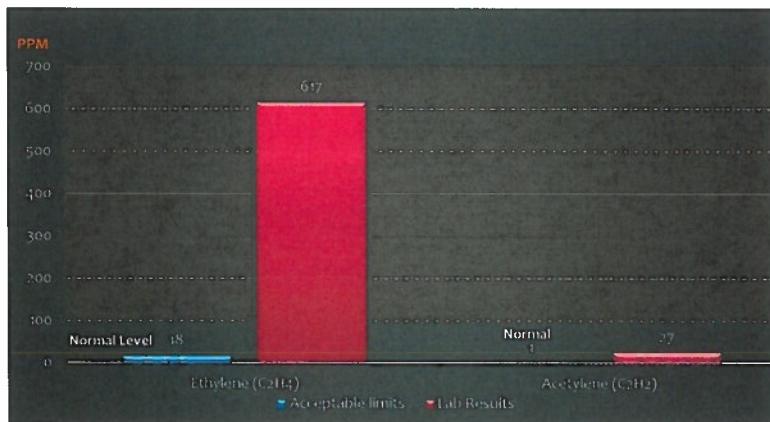
ABNORMAL DGA RESULTS

Gas ratios indicate internal arcing over
700°C / 1,300° F
