## **Appendix C-1**

Cultural Resources Assessment Report: Barley Mills Building,  
3596 Commerce Street & 3051 Mission Inn Avenue; Riverside CA  
Site of Riverside Soda Works, 2993 Mission Inn Avenue; Riverside CA

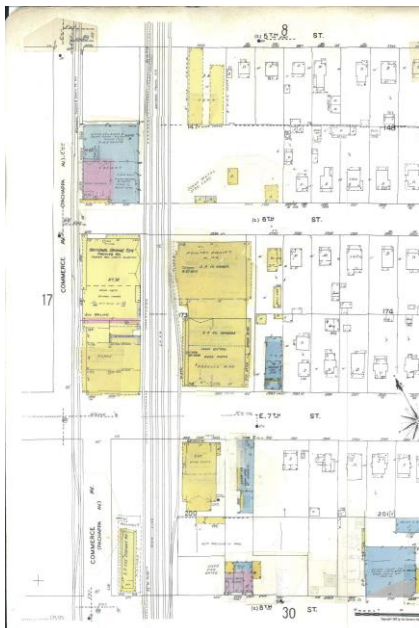
**Figure # 15: Sanborn Map, Detail; dated January 1952.** North is up. Noted that the salmon/reddish color graphic at the upper left corner of Sixth and Commerce streets represents the 1891 Barley Mills Building. Green color represents the 1930 additions. A note stating the entire structure including the 1930 additions was "VACANT." Scrap Metal yard noted to the east.

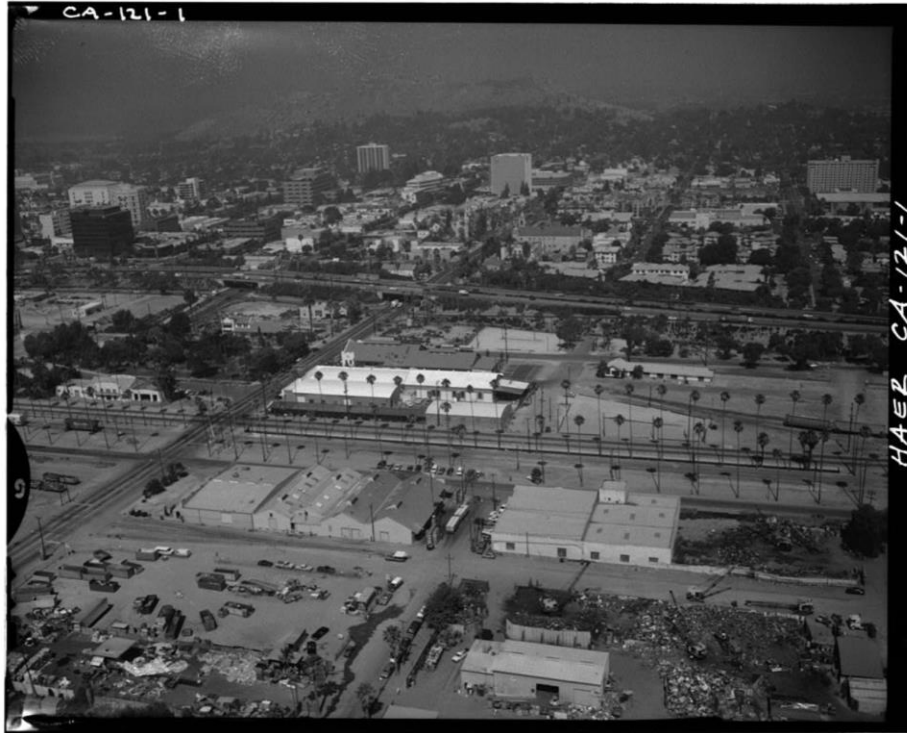
**Figure # 16: HAER aerial photo documentation;** Source Library of Congress; file HAER CA-121-1; 6/24. View is towards the west; main line railroad tracks bisects the image left to right. The Sunkist Packing House complex is in the left side foreground ; the Barley Mills Building is to the right of the Sunkist Packing House in the right side foreground. Scrap metal yard is in the foreground.

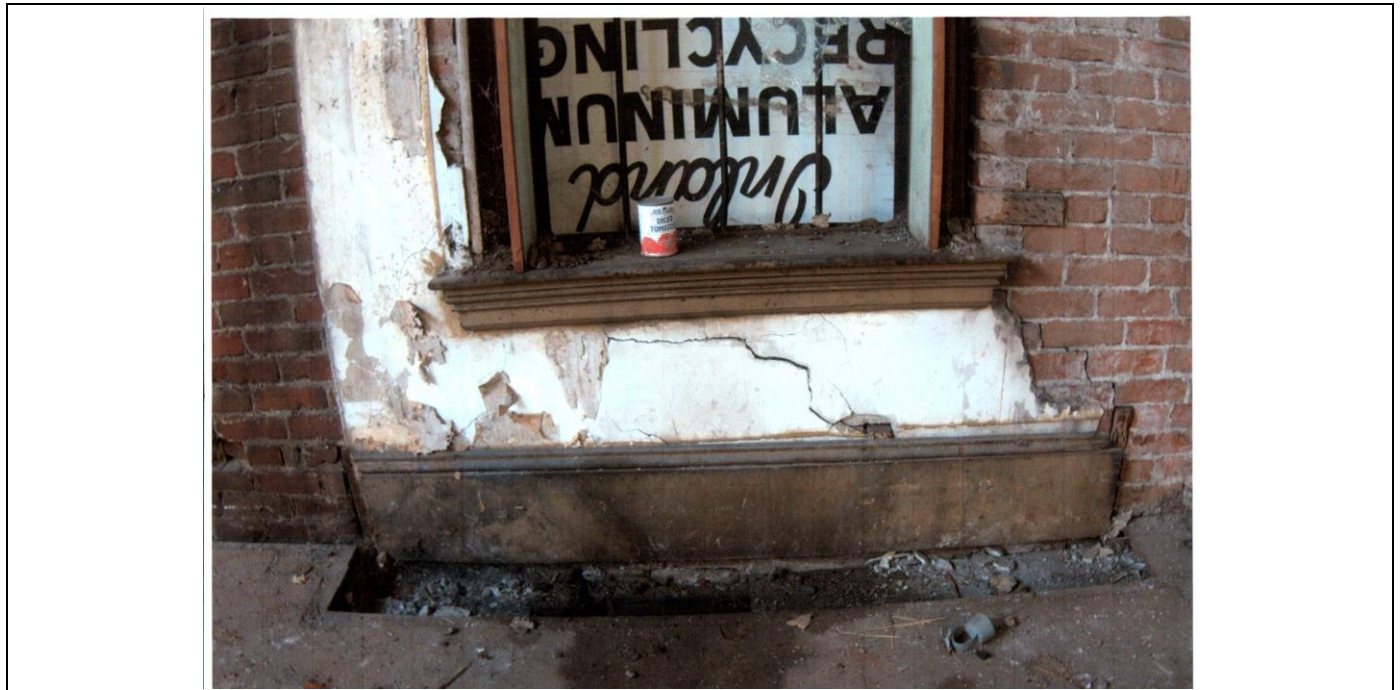
**Figure # 20: The remaining original south façade interior wood window trim details at the named "office" area of the Barley Mills Structure:** wall base and trim cap; window apron, window sill, window jamb trim/sash window weight box. See Appendix D.

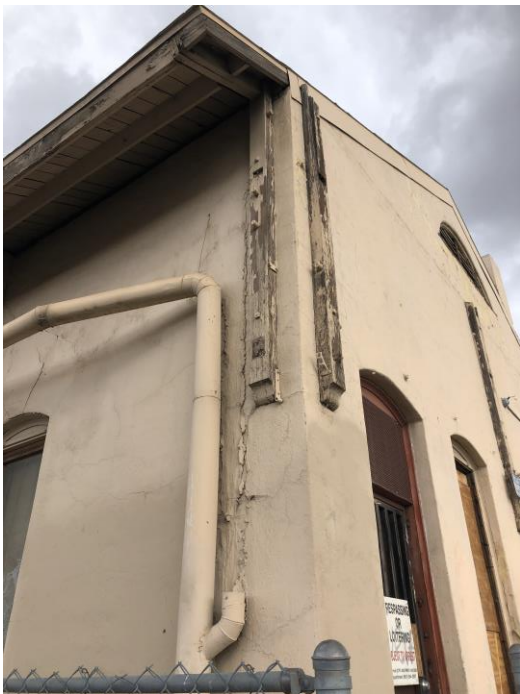
Barley Mills Building: Source G T Loudon AIA Photography, February 2022 ;  
Existing Conditions at corner, including wood brackets for attachment of non-extant canopies south  
façade door and window rough openings; Figure # D-10

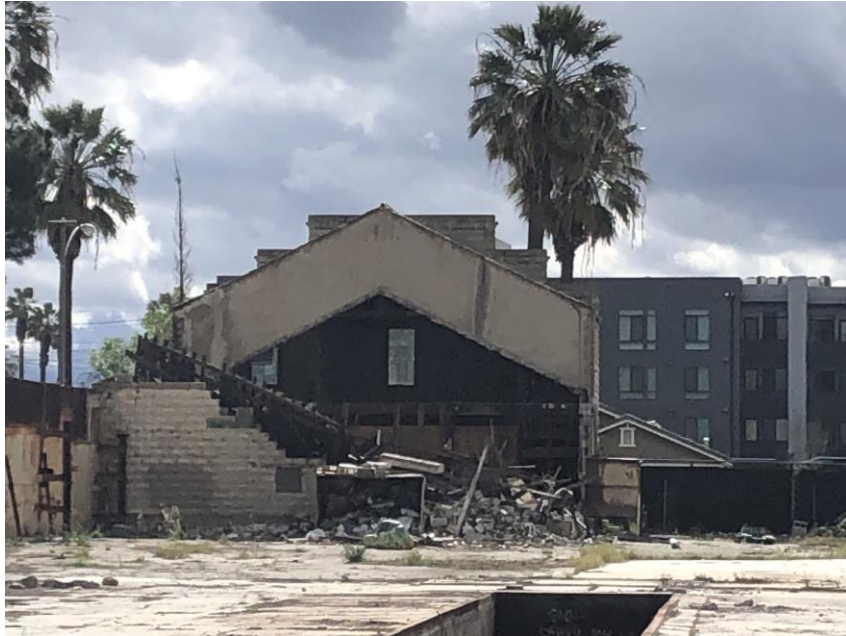
Soda Works Building: Source G T Loudon AIA Photography, February 2022 ; Figure # D-13  
View south of partially remaining north façade and roof collapse from previous fire damage.

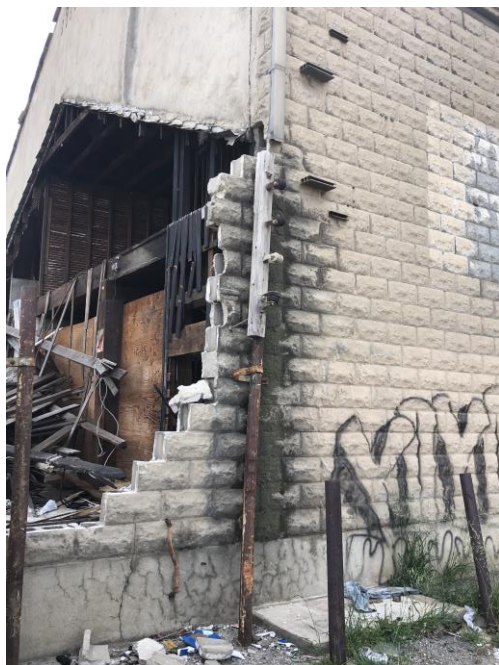
Soda Works Building: Source G T Loudon AIA Photography, February 2022 ; Figure # D-14  
View east of partially remaining west façade and exposed interior showing prior damage by fire.

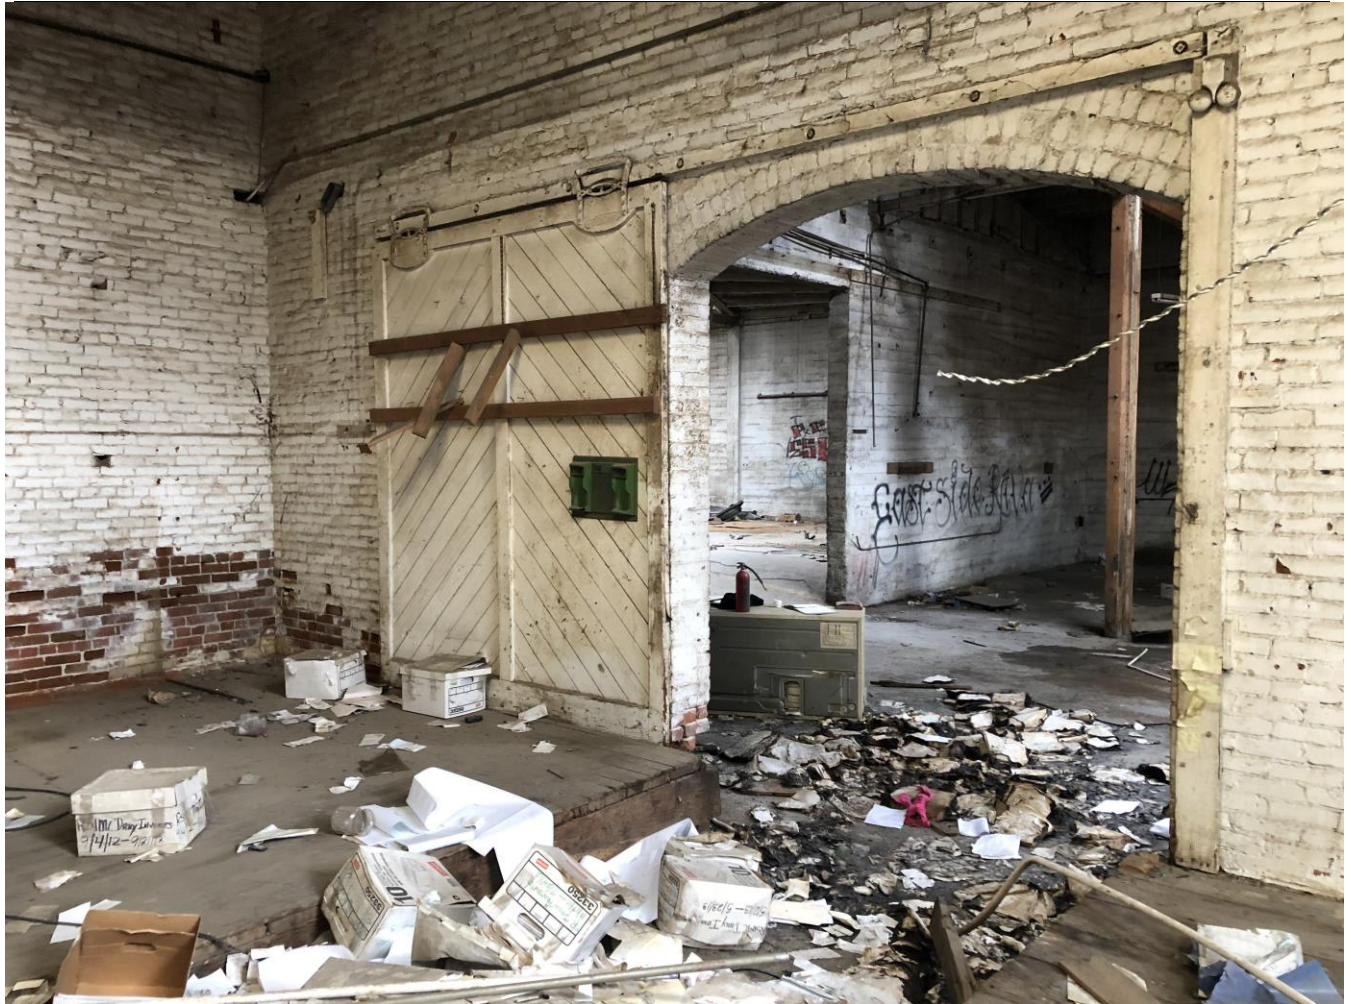
Barley Mills Building Interior: Source G T Louden AIA Photography, February 2022; Figure # D-15  
View to east of original triple wythe segmented brick arch opening in original east exterior façade. View through opening is of the concrete walls structure of the later 1930 additions.

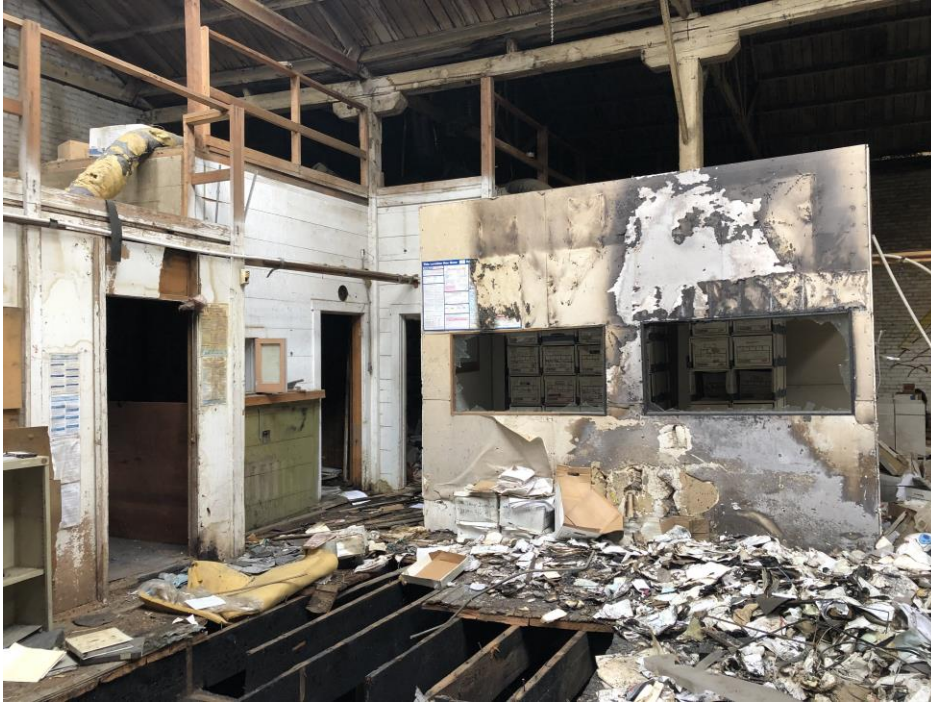
Barley Mills Building Interior: Source G T Louden AIA Photography, February 2022;  
View to southwest corner of original 1891 structure; note the fire damaged wood floor and joists in near foreground; added mezzanine and interior wood framed enclosed space; Figure # D-16

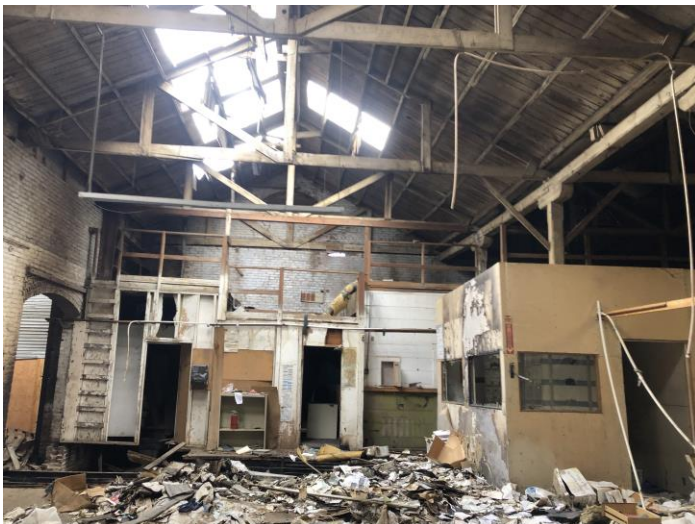
Barley Mills Building Interior: Source G T Louden AIA Photography, February 2022;  
View to south façade of original 1891 structure; note the fire damaged wood floor and joists in near foreground; added mezzanine and interior wood framed enclosed space; note wood roof trusses viewed at location at centerline of the two gables; Figure # D-17

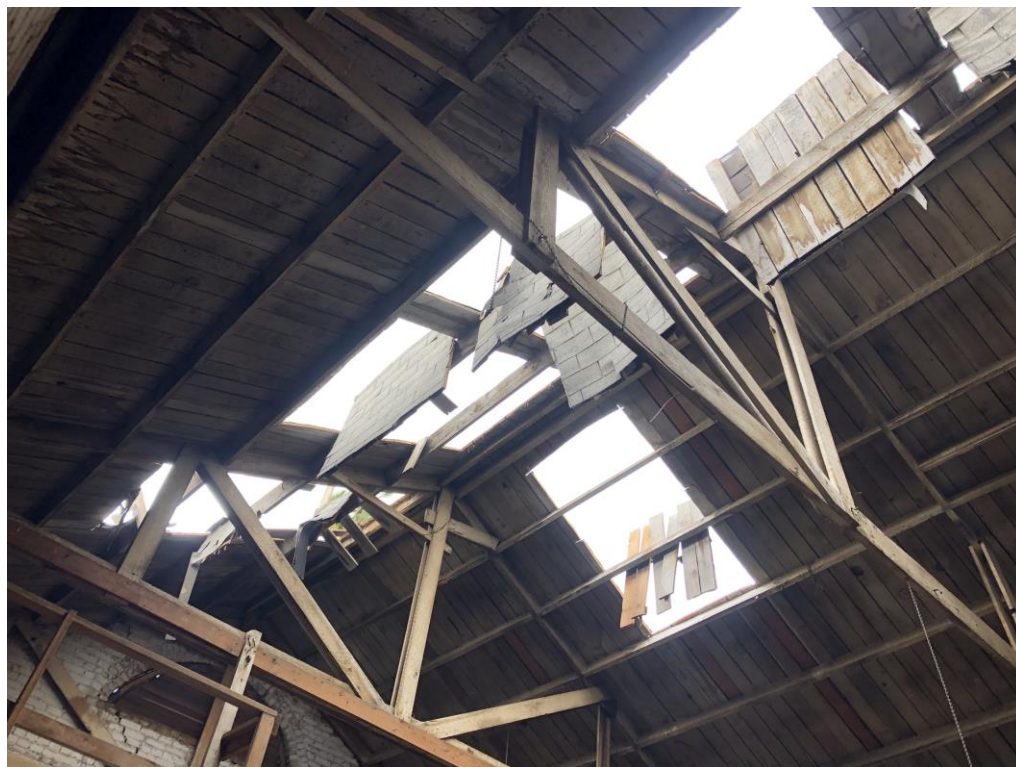
Barley Mills Building Interior: Source G T Loudon AIA Photography, February 2022;  
View of wood roof framing, board finish at the joists; the south wall brick façade and the half circular  
vent; the roof openings for skylights are not original and are not proposed to be restored. **Figure # D-18**

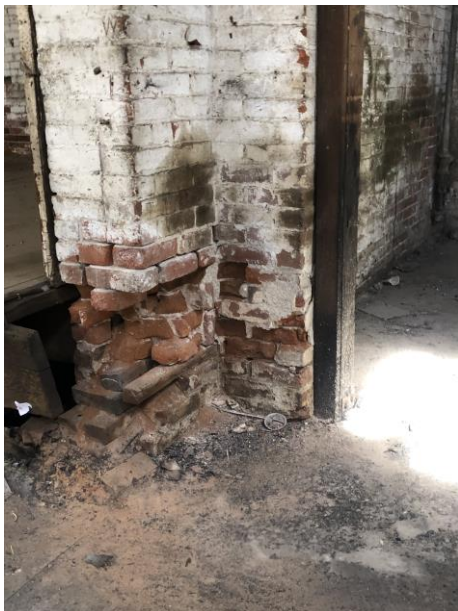
Barley Mills Building Interior: Source G T Loudon AIA Photography, March 2022;  
Interior view of south east façade, near the corner; note the brick masonry foundations have failed at the original west façade opening at the former exterior doorway jamb; **Figure # D-21.**

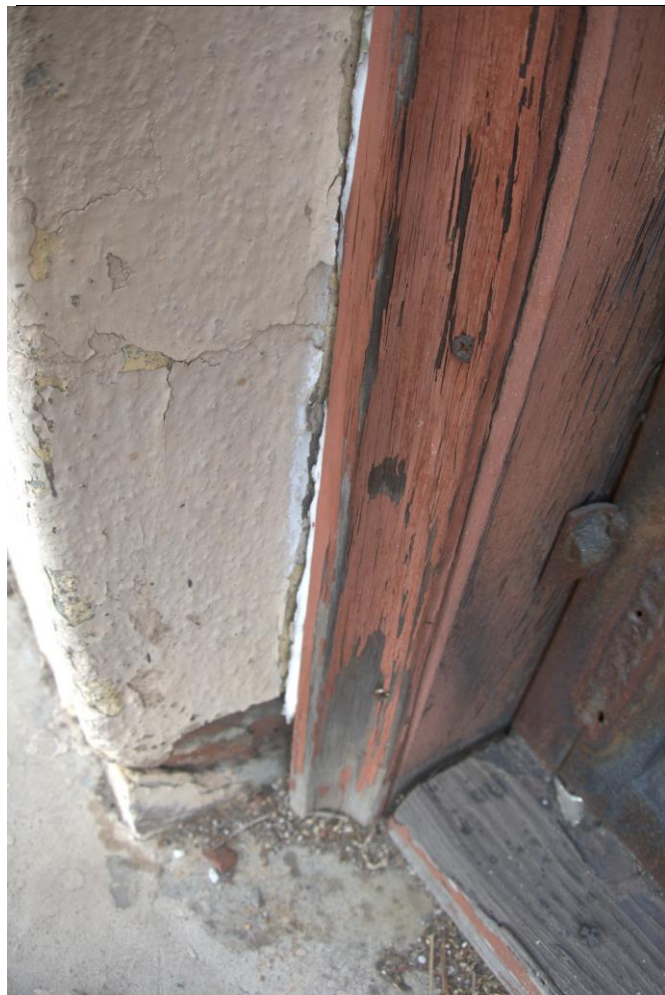
Barley Mills Building Exterior Window wood trim: Source G T Loudon AIA Photography, November 2103; Detail of window jamb, plaster veneered brick recess and sill. Figure # D-22
