## **Sycamore Hills Distribution Center Project**

### **Draft Environmental Impact Report (DEIR)**

**Biological Resources and Western Riverside County Multiple Species  
Habitat Conservation Plan Consistency Report**

**Sycamore Hills Distribution Center Project  
Riverside County, California**

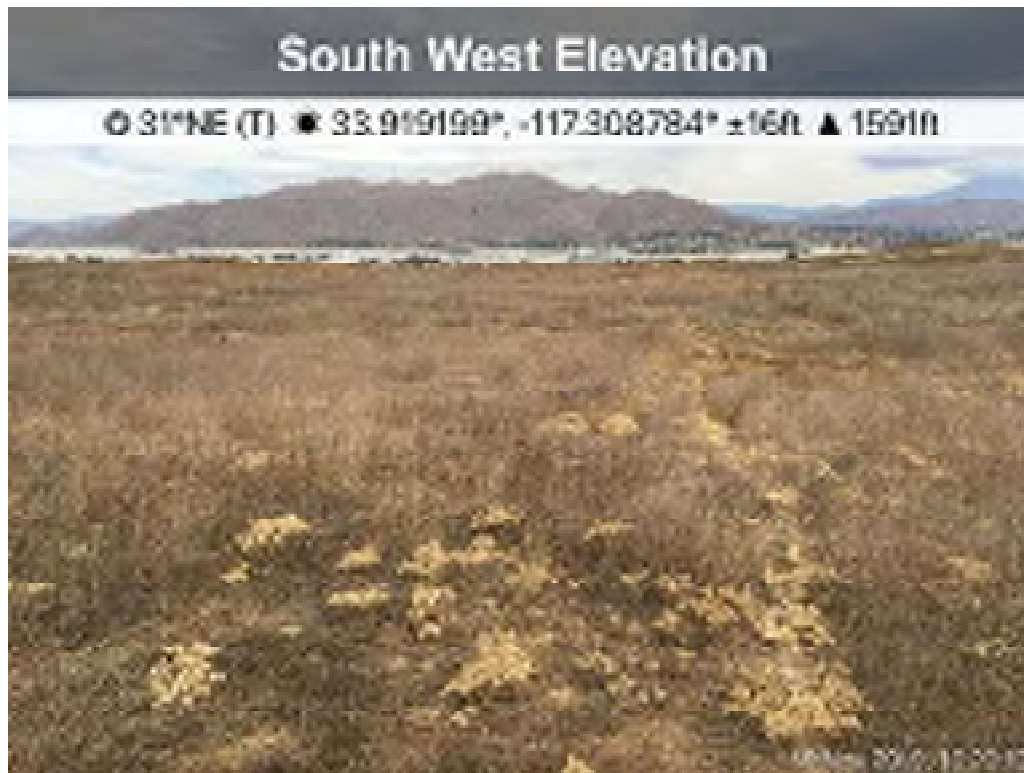
Photo 1. Non-native grassland from center of eastern site. Burrowing owl habitat.

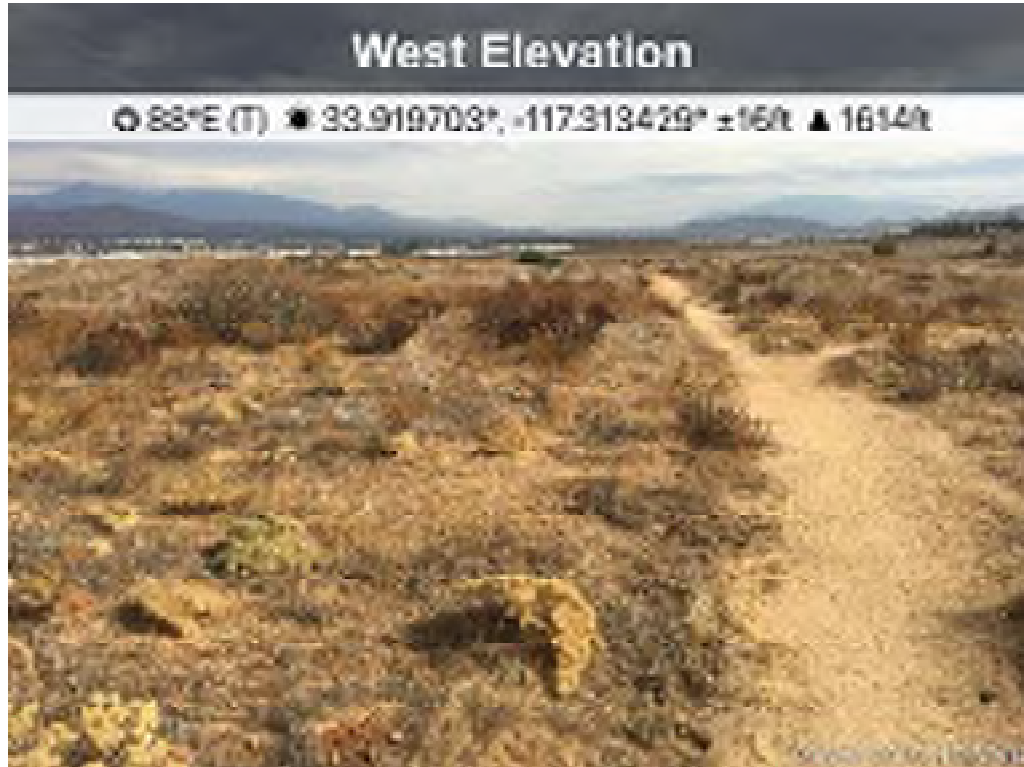
Photo 2. Sparse Riversidean sage scrub from northwestern corner of western site.

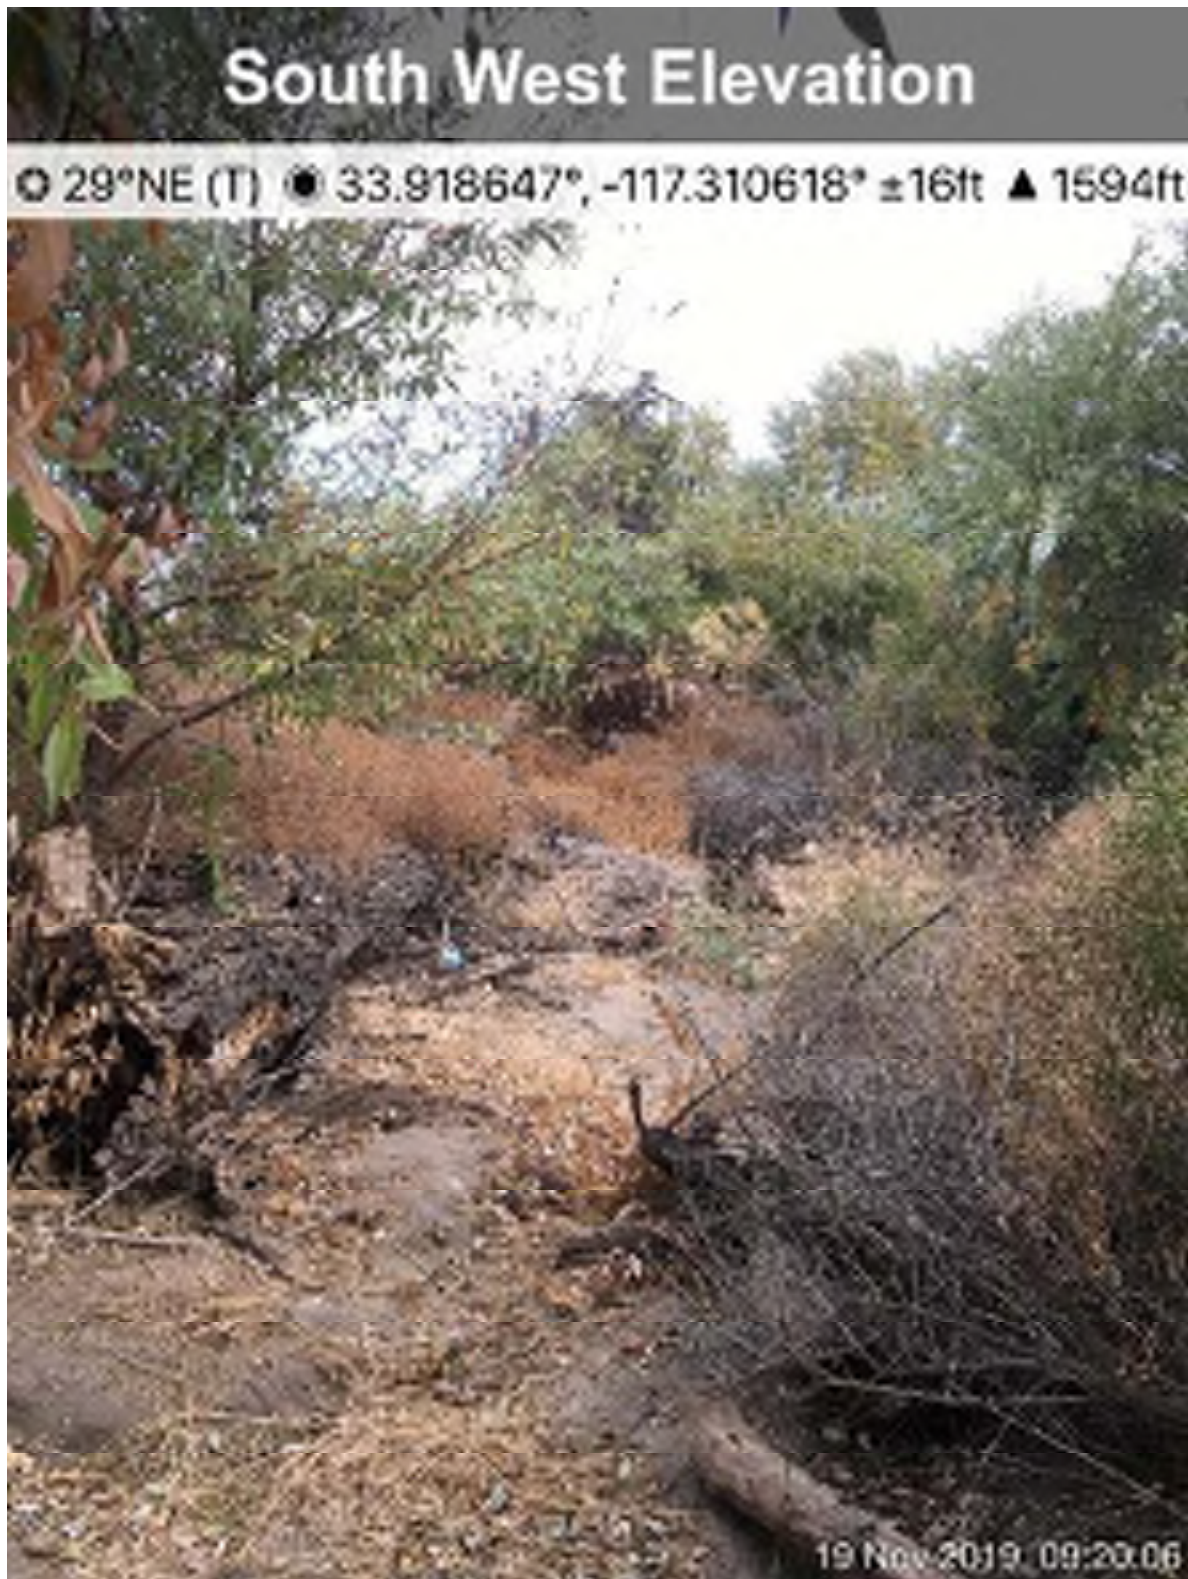
Photo 3. Riparian (state & federally jurisdictional waters, MSHCP riverine/riparian, and potential least Bell's vireo & southwestern willow flycatcher habitat. This area is project designated as restricted property to be preserved.

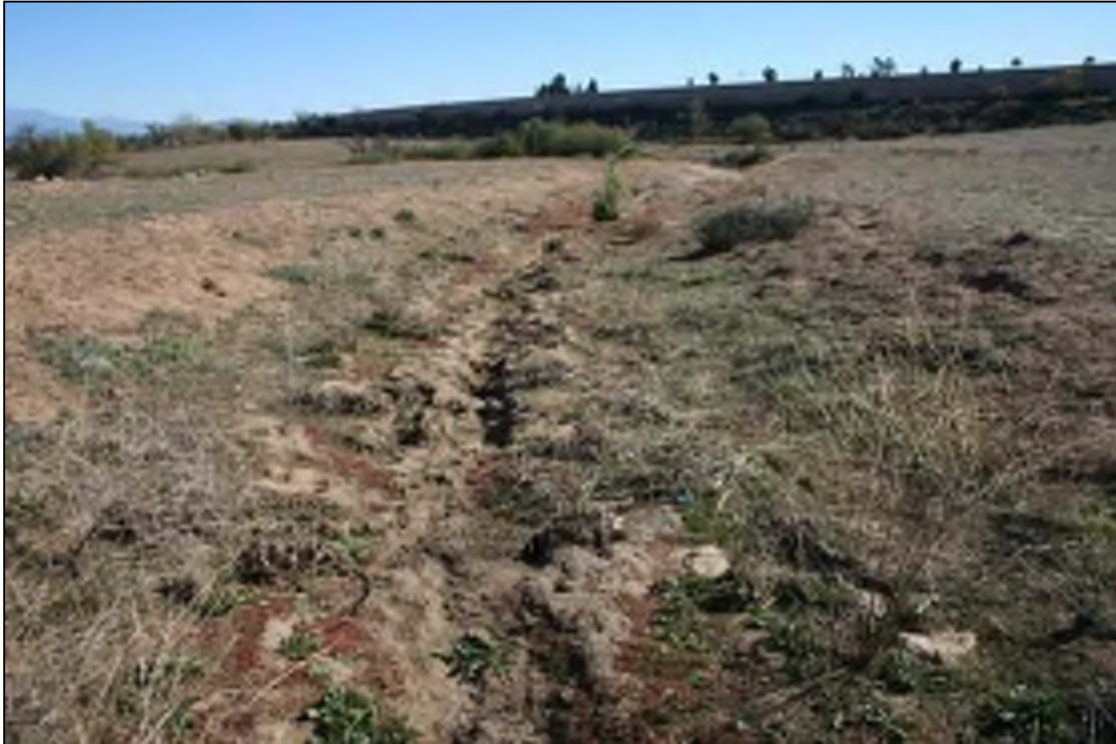
Photo 1 – View of Drainage A facing downstream near where it enters the site through a 4-foot concrete pipe.

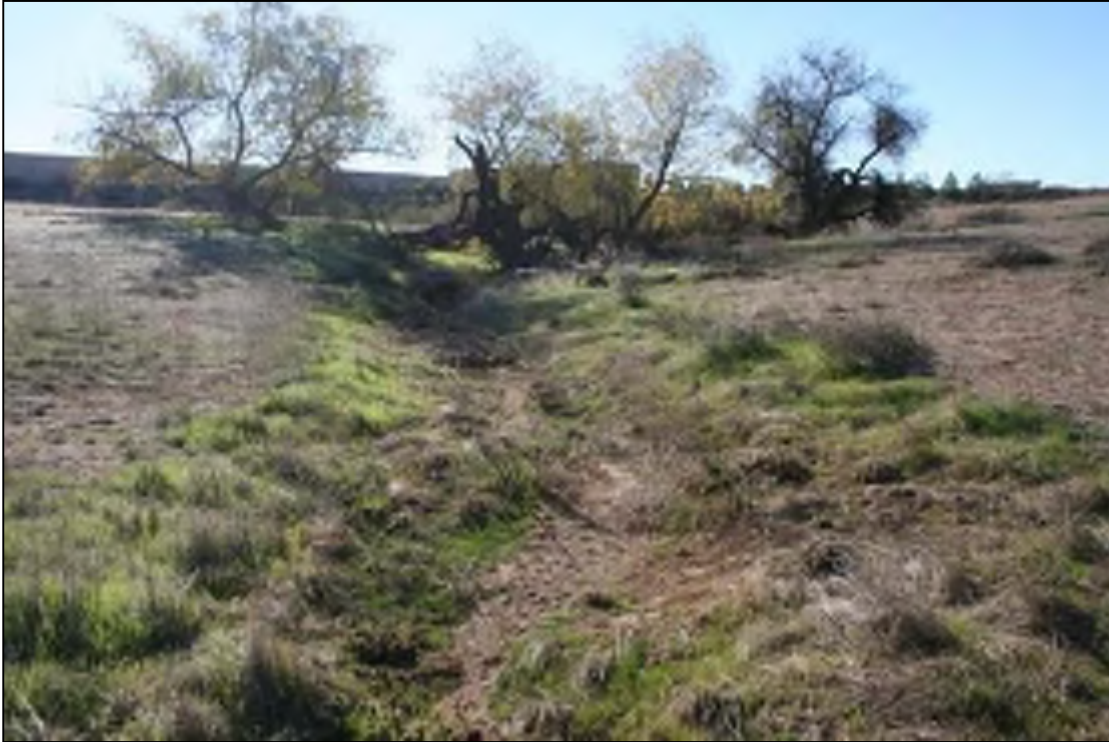
Photo 2 - View of Drainage A facing upstream near the middle of the on-site extent.  
The Ordinary High-Water Mark width is approximately 3 feet.

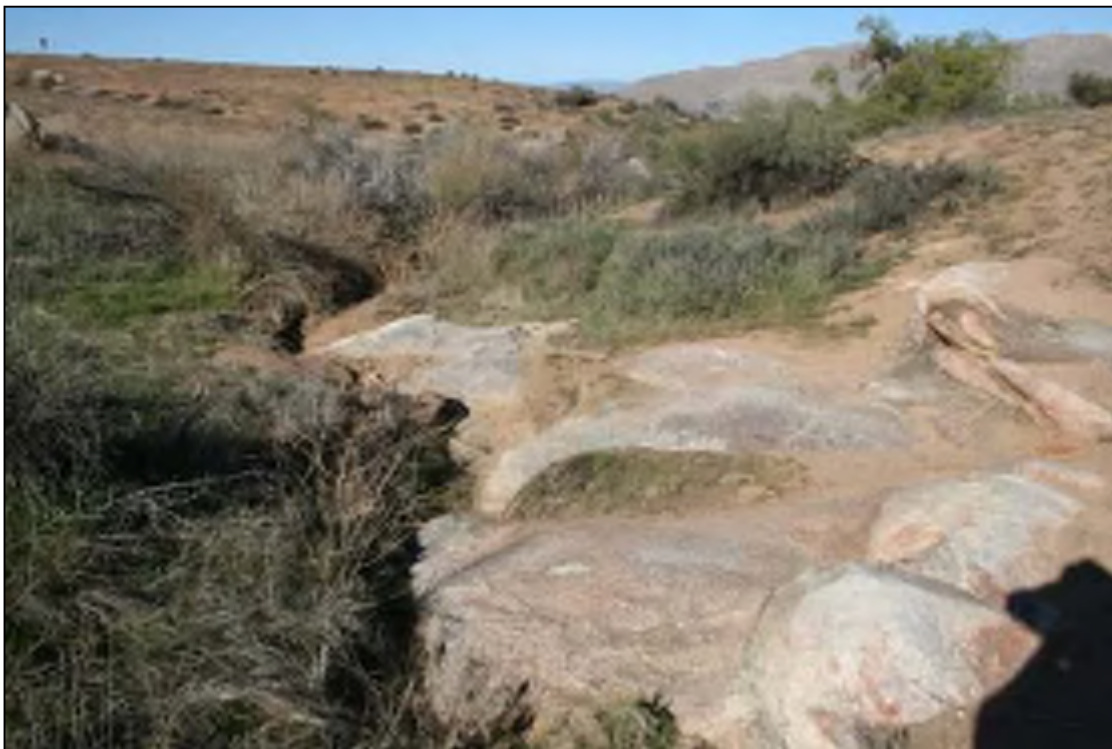
Photo 3 – Downstream-facing perspective of Drainage A near the downstream end.

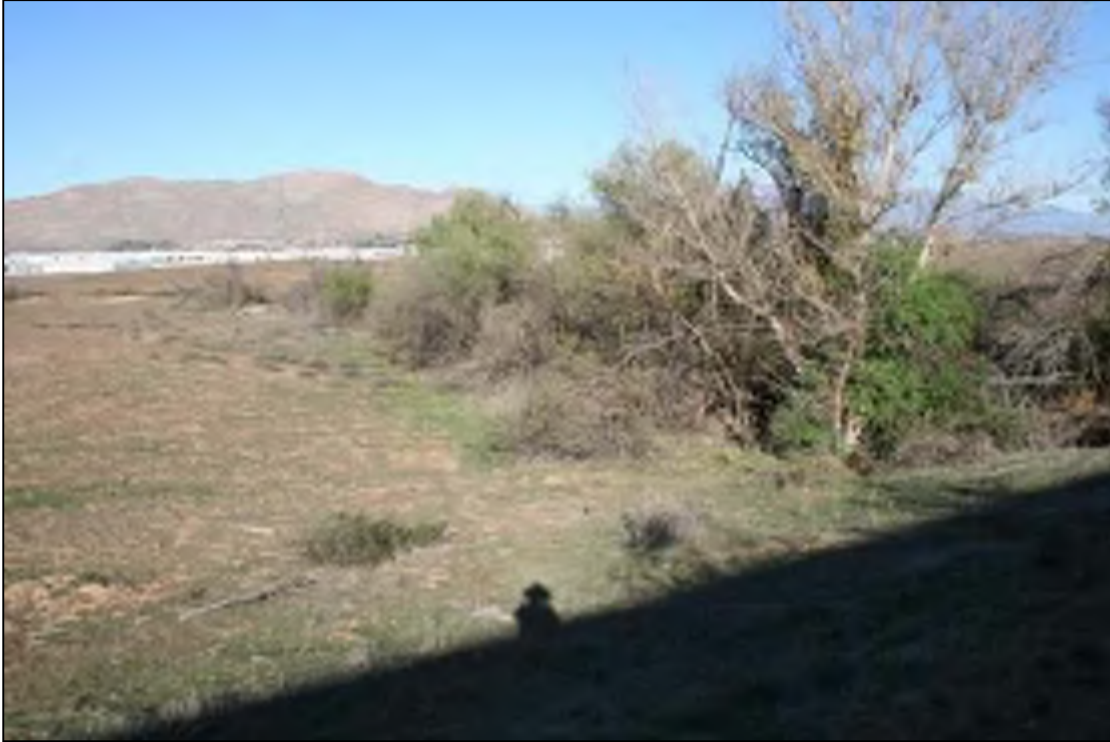
Photo 4 - View Drainage B facing downstream at the upstream end.

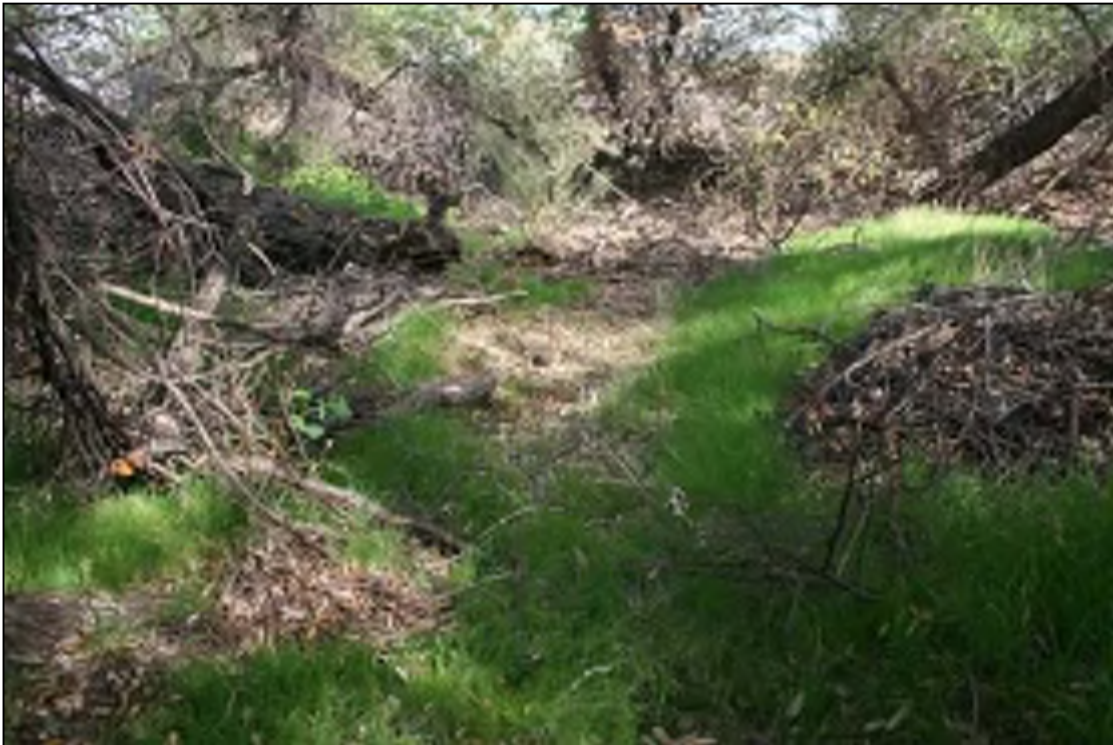
Photo 5 - View of the channel beneath the riparian canopy of Drainage B where the Ordinary High-Water Mark is approximately 5 feet wide.

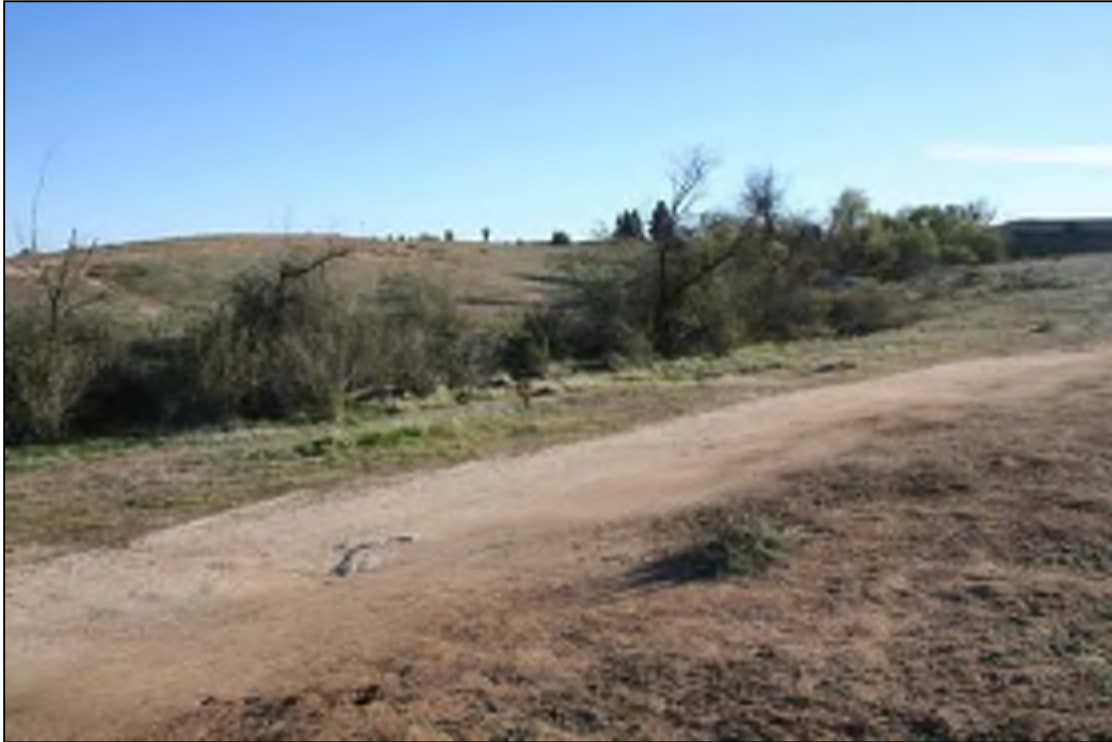
Photo 6 – Upstream-facing perspective of Drainage B.

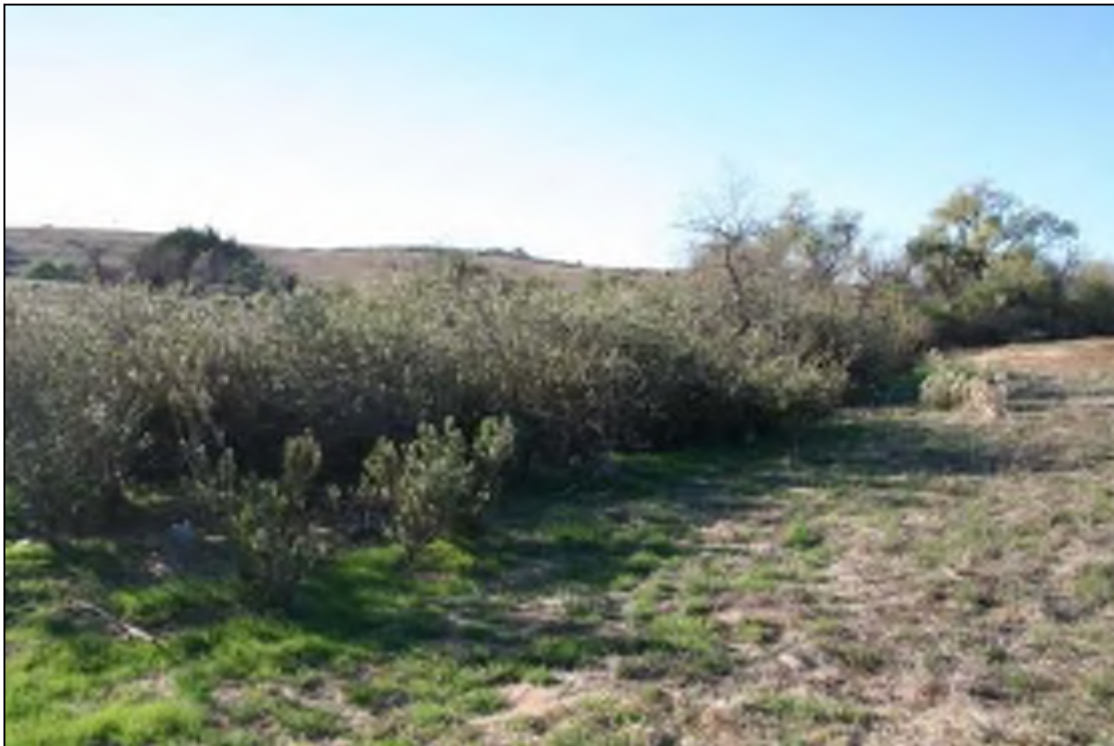
Photo 7 - View of Drainage B facing downstream at the downstream end.

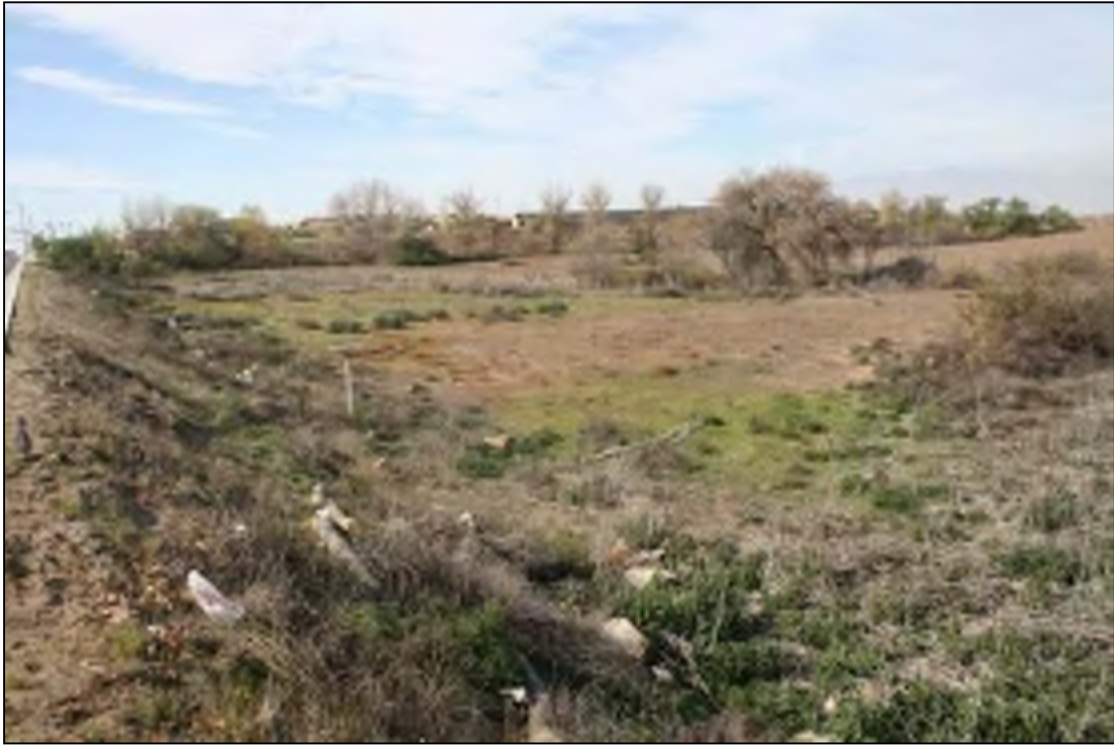
Photo 8 - View of riparian Area C that did not exhibit an Ordinary High Water Mark.

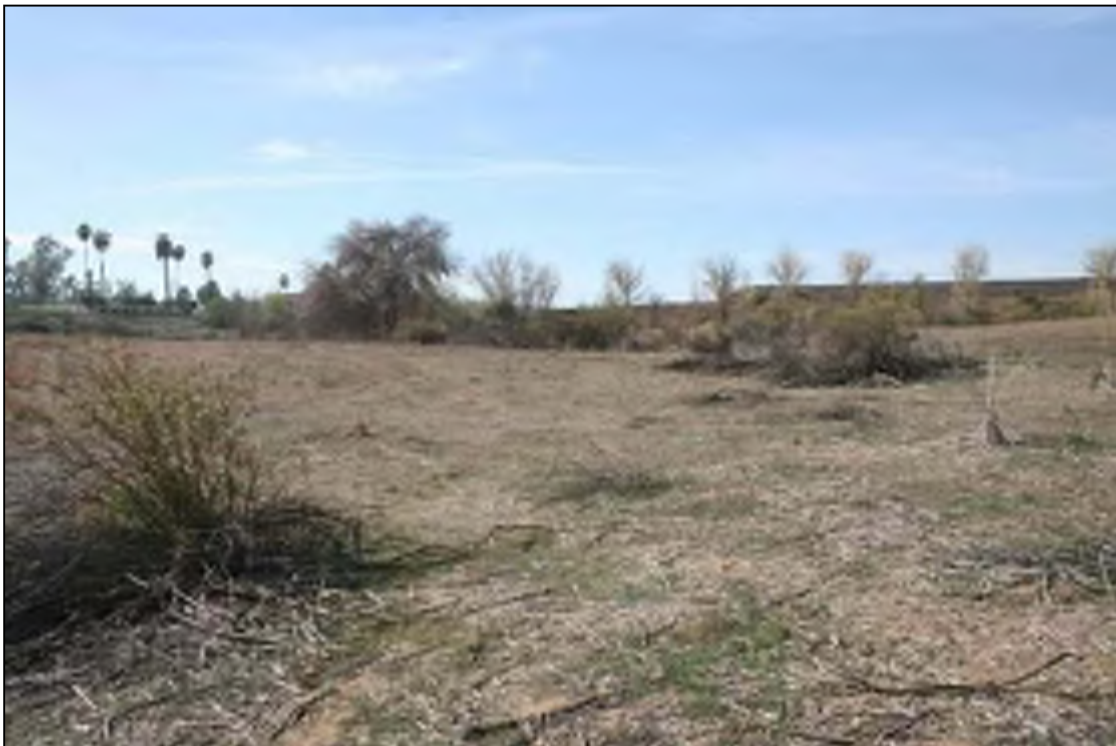
Photo 9 - View of isolated riparian habitat near where a permanent access road will be constructed.

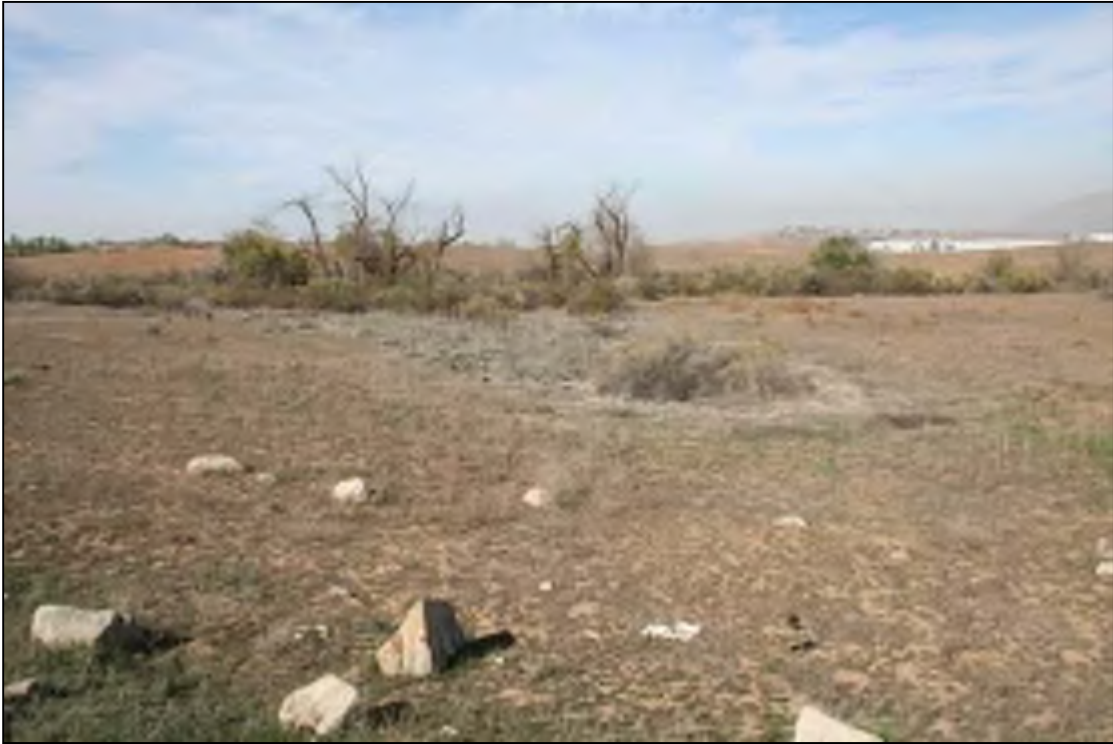
Photo 10 - View of riparian habitat within Area C that did not exhibit an Ordinary High Water Mark.
