Re: Historic Building Evaluation
Jenkins Building, 9502-9506 Magnolia Avenue/3790 Van Buren Boulevard
City of Riverside, Riverside County, California
Planning Case PR-2021-001079; CRM TECH Project No. 3748

Documentation Review

Field Inspection

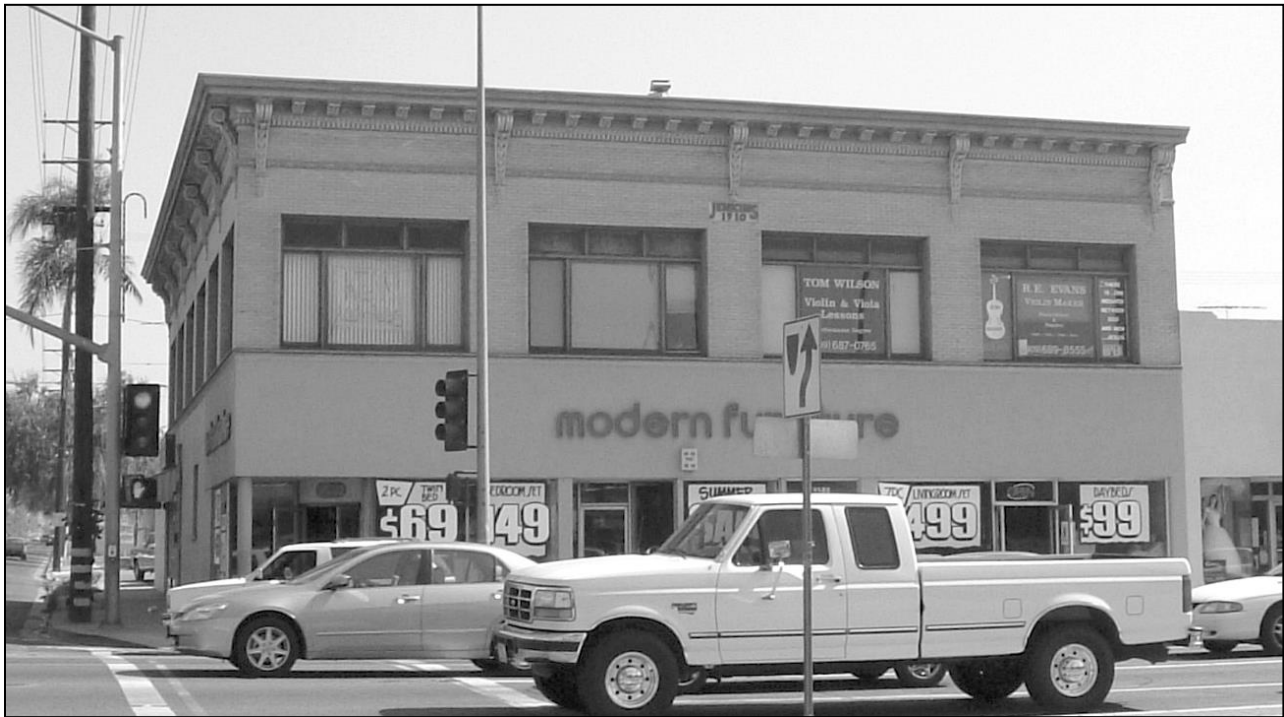
Figure 1. The Jenkins building as it appeared in 2003.

As a part of the 2003 survey, the Jenkins Building was formally recorded on the State of California's standard record forms that have since been on file at the City of Riverside (Tibbet and Tang 2003; see App. 1). The description of the building notes that the façades facing Magnolia Avenue and Van Buren Boulevard were "more elegant and detailed than others in the vicinity," with the most notable features being the "widely overhanging cornice along the edges of the flat roof, richly adorned with modillions of two different sizes at regular intervals" (Tibbet and Tang 2003:1; see App. 1).

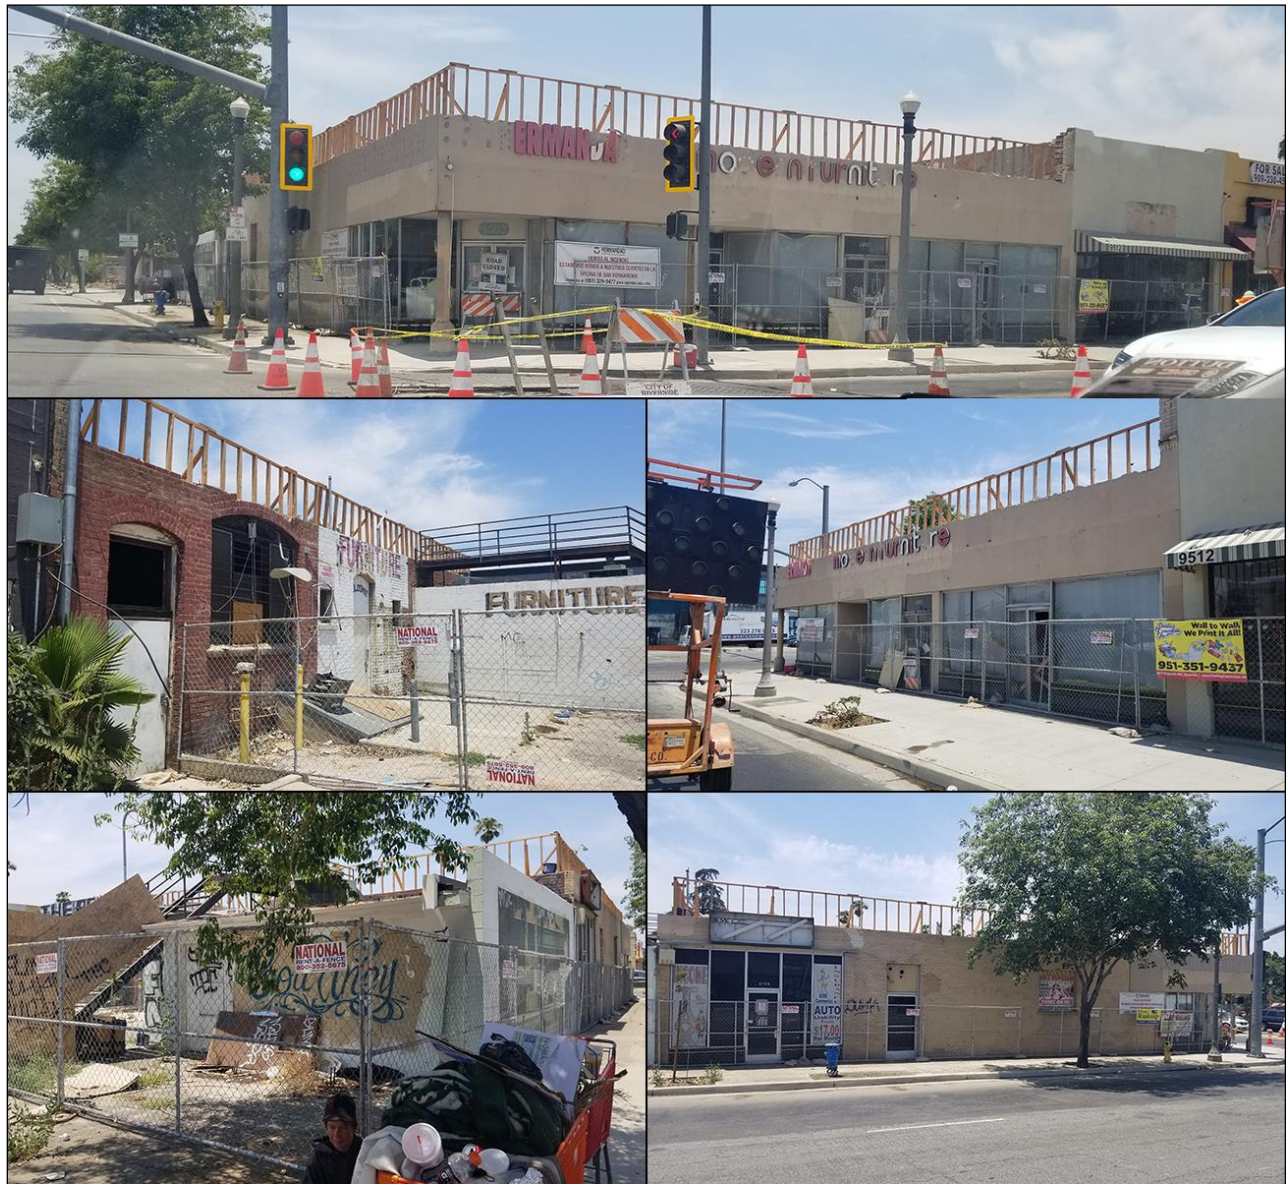
The field inspection of the Jenkins Building was carried out by Terri Jacquemain on June 15, 2021. Field observations confirmed that repairs to the building were underway, and the second story had by then been entirely removed while an approximately three-foot-tall, unfinished wood frame had been erected along the perimeter at the top of the ground floor (Fig. 2). The surviving ground-floor façades remained similar to what was observed during the 2003 survey, when past alterations to the exterior were already evident in bricks painted yellow-tan or covered by stucco, with the upper portion covered by wooden sign panels over an assemblage of plate-glass storefront windows and steel-framed glass doors below. The original brick exterior at the rear of the building was crumbling

Figure 2. Post-fire condition of the Jensen Building. *Clockwise from top*: overview of both street-facing facades, to the southwest; Magnolia Avenue façade, view to the southeast; Van Buren Boulevard façade, view to the west; rear addition to the building, view to the north; rear façade, view to the northeast. (Photographs taken on June 15, 2021)

in spots, but two arched entryways, a large arched window opening, and two smaller square ones are still intact, as is the one-story concrete block addition at the southeastern corner of the building.

Unfortunately, after the fire in 2020, the City of Riverside Building Official determined the heavily damaged second story to be a major and immediate threat to public safety, which provided an overriding consideration for potential environmental concerns, including those related to cultural resources, under CEQA provisions. In the subsequent repair effort to eliminate such threat, the upper level of the building was removed in its entirety, and none of the original features identified above as the embodiment of the building's historic character remain extant today, leaving only the lower level with its extensively altered street-facing façades and relatively plain, utilitarian secondary façades (Fig. 2).

In its current condition, the Jenkins Building no longer retains sufficient historic integrity to relate to the early 20th century development of the town of Arlington or to G. Stanley Wilson's original architectural design. Consequently, it no longer appears eligible for designation as a City of Riverside "landmark" pursuant to the criteria outlined in RMC §20.50.010(U), nor does it appear to meet the criteria for designation in a secondary category, "structure or resource of merit," as outlined in RMC §20.50.010(FF). In particular, Criteria 4 and 6 provide that a potential "landmark" that does not exhibit a high level of integrity but retains sufficient integrity to convey significance would be eligible for the status of a "structure or resource of merit" (RMC §20.50.010(FF)). In this case, however, the nearly total loss of its character-defining architectural features has left the Jenkins Building with little integrity to meet these criteria.

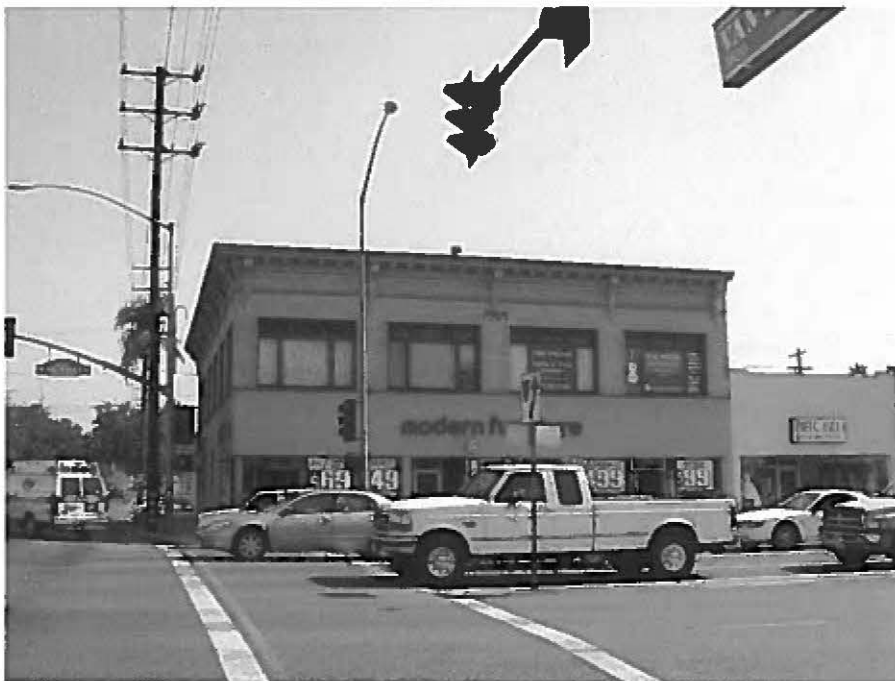
P5b. Description of Photo:
(View, date, accession #)

This two-story commercial building is situated on the southerly corner of the intersection of Magnolia Avenue and Van Buren Boulevard, in the heart of Arlington's once thriving commercial district. It is a box-shaped brick masonry structure that presents two strikingly different appearances. The two façades facing Magnolia Avenue and Van Buren Boulevard are much more elegant and elaborate in decorative details than the other two elevations, and indeed than any other commercial buildings in the vicinity. The most notable feature in these two façades is the widely overhanging cornice along the edges of the flat roof, richly adorned with modillions of two different sizes at regular intervals. The upper floor is fenestrated with a continuous row of wood-framed, fixed windows, each with a large pane surrounded by five smaller panes. The lower level, which is covered with stucco in the two principal façades, features aluminum-framed windows and doors of much more recent vintages. The two elevations facing away from the street are evidently more original in appearance, characterized by unclad and unpainted brick walls punctuated by gently arched window openings filled with rectangular, wood-framed double-hungs with plain, single-pane sashes.
