CULTURAL RESOURCES ASSESSMENT

CHOW ALLEY - 4049-4053 MAIN STREET

CITY OF RIVERSIDE RIVERSIDE COUNTY, CALIFORNIA

April 2016

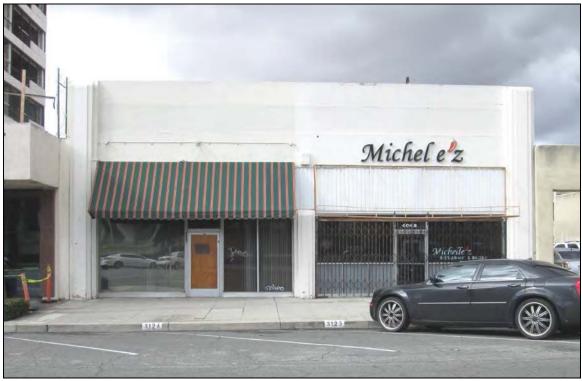
Figure 4 – Façade, view to the west (1/7/2016)

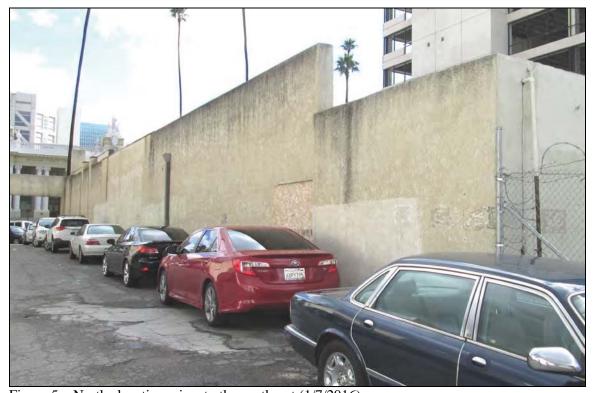
The south side elevation is attached to an adjacent building, and because the north side elevation was also attached to a building (demolished ca. 1980), it retains no decorative detail or fenestration, but does include a plywood patch (Figure 5). The rear elevation includes a large concrete block addition and a smaller addition that appears to be constructed of concrete covered by plaster (Figure 6). The concrete block addition has two doors. The rear of the original building has an aluminum-framed glass storefront-type rear entrance for 4049 Main Street and the original brick construction can be seen where damage to the building has occurred. The smaller addition includes an aluminum-framed glass door and sidelight sheltered by a flat canopy and a slightly recessed window with a narrow metal frame (Figure 7). Chicken wire is embedded in the window glass, which is broken.

Figure 5 – North elevation, view to the southeast (1/7/2016)

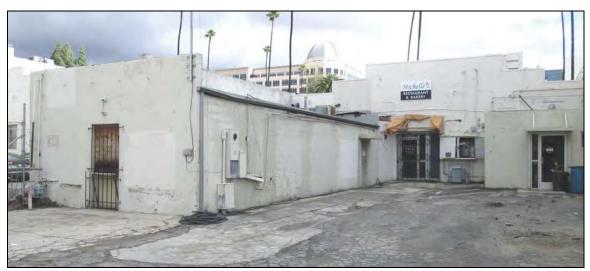
Figure 6 – West (rear) elevation, view to the east (1/7/2016).

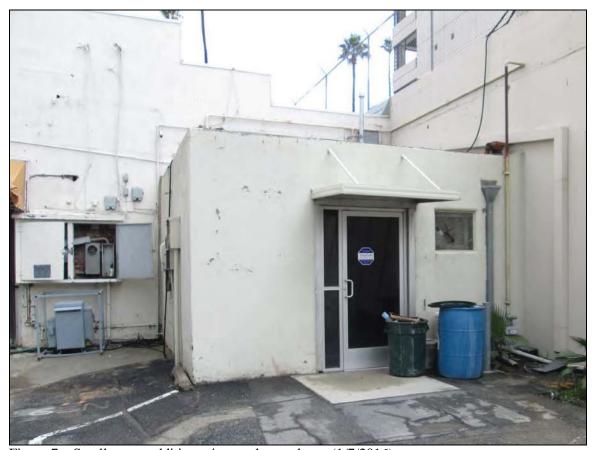
Figure 7 – Smaller rear addition, view to the southeast (1/7/2016).

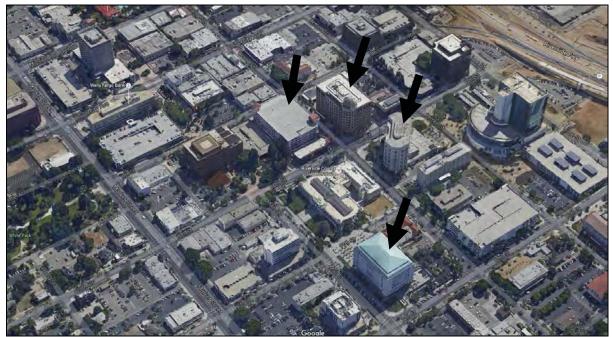
Since 1985, considerable development has occurred within and adjacent to the southern boundaries of the District (Figure 11). There are four multi-story buildings in the immediate vicinity that are all visible from Main Street and the Courthouse: a parking garage at the southwest corner of 10th and Orange Streets, an office building on Orange Street between 9th and 10th streets, the Robert Presley Detention Center on Orange Street behind the Courthouse, and a court building between Main and Orange Streets south of the Courthouse. In addition, there are large modern buildings on the west side of Main Street between 9th Street and Mission Inn Avenue. All of this development has weakened the original boundaries and cohesion of the District.

Figure 11 – Aerial image showing the project vicinity and the four multi-story buildings near the Courthouse. (Source: Google 2016)

To reduce the number of modern intrusions and strengthen the cohesiveness of the District, the boundaries should be shifted to the northeast side of 9th Street, with the exception of the building at 3506-3544 10th Street across from the Post Office parking lot (Figure 12). This would remove eight contributing buildings from the District (Table C). These buildings would retain their current designations as Structures of Merit or Landmarks and would remain historical resources for the purposes of CEQA.

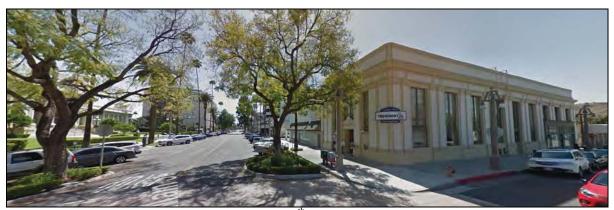
Figure 13 – View southeast from the intersection of 10th and Main streets showing 4001 Main Street on the right side of the photograph and the Courthouse partially visible on the left side. (Source: Google April 2015).

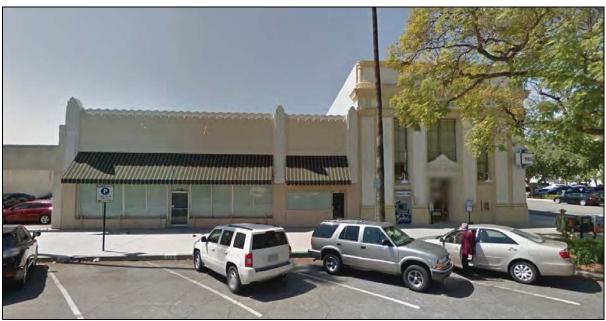
Figure 14 – 4015-4023 and 4001 Main Street. View to the northwest. (Source: Google April 2015)

4015-4023 Main Street. As discussed above (Standard 2), the demolition of the building at 4049-4053 Main Street will include the removal of a horizontal beam with three vertical supports. This has the potential to damage the exterior wall of the building at 4015-4023 Main Street. The mitigation measure recommended above should adequately address this concern.

Recommended Mitigation Measure: All reasonable care shall be taken to preserve and protect the exterior of the building at 4015-4023 Main Street during removal of the adjacent structure. Any damage to the exterior of the building at 4015-4023 Main Street shall be repaired in a historically appropriate manner that matches the original wall in texture, materials, and colors.

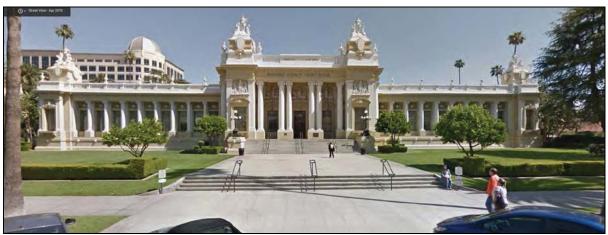
Figure 15 – County Courthouse, 4050 Main Street. View to the southeast. (Source: Google April 2015).

Recommended Mitigation Measure: Existing historic-period streetlights, street trees, curbs, and sidewalks within the existing right-of-way shall be protected and preserved in place. The existing curb, parkway, and sidewalk configuration adjacent to the courthouse (4050 Main Street) will be preserved and protected in place.
