**FINAL  
QUAIL RUN RESTORATION PLAN**

**Prepared for:  
SDH & Associates, Inc.  
5225 Canyon Crest Drive #71439  
Riverside California 92507**

**Submitted by:  
Amec Foster Wheeler Environment & Infrastructure, Inc.  
San Diego, California**

**Amec Foster Wheeler Project No. 1555500022**

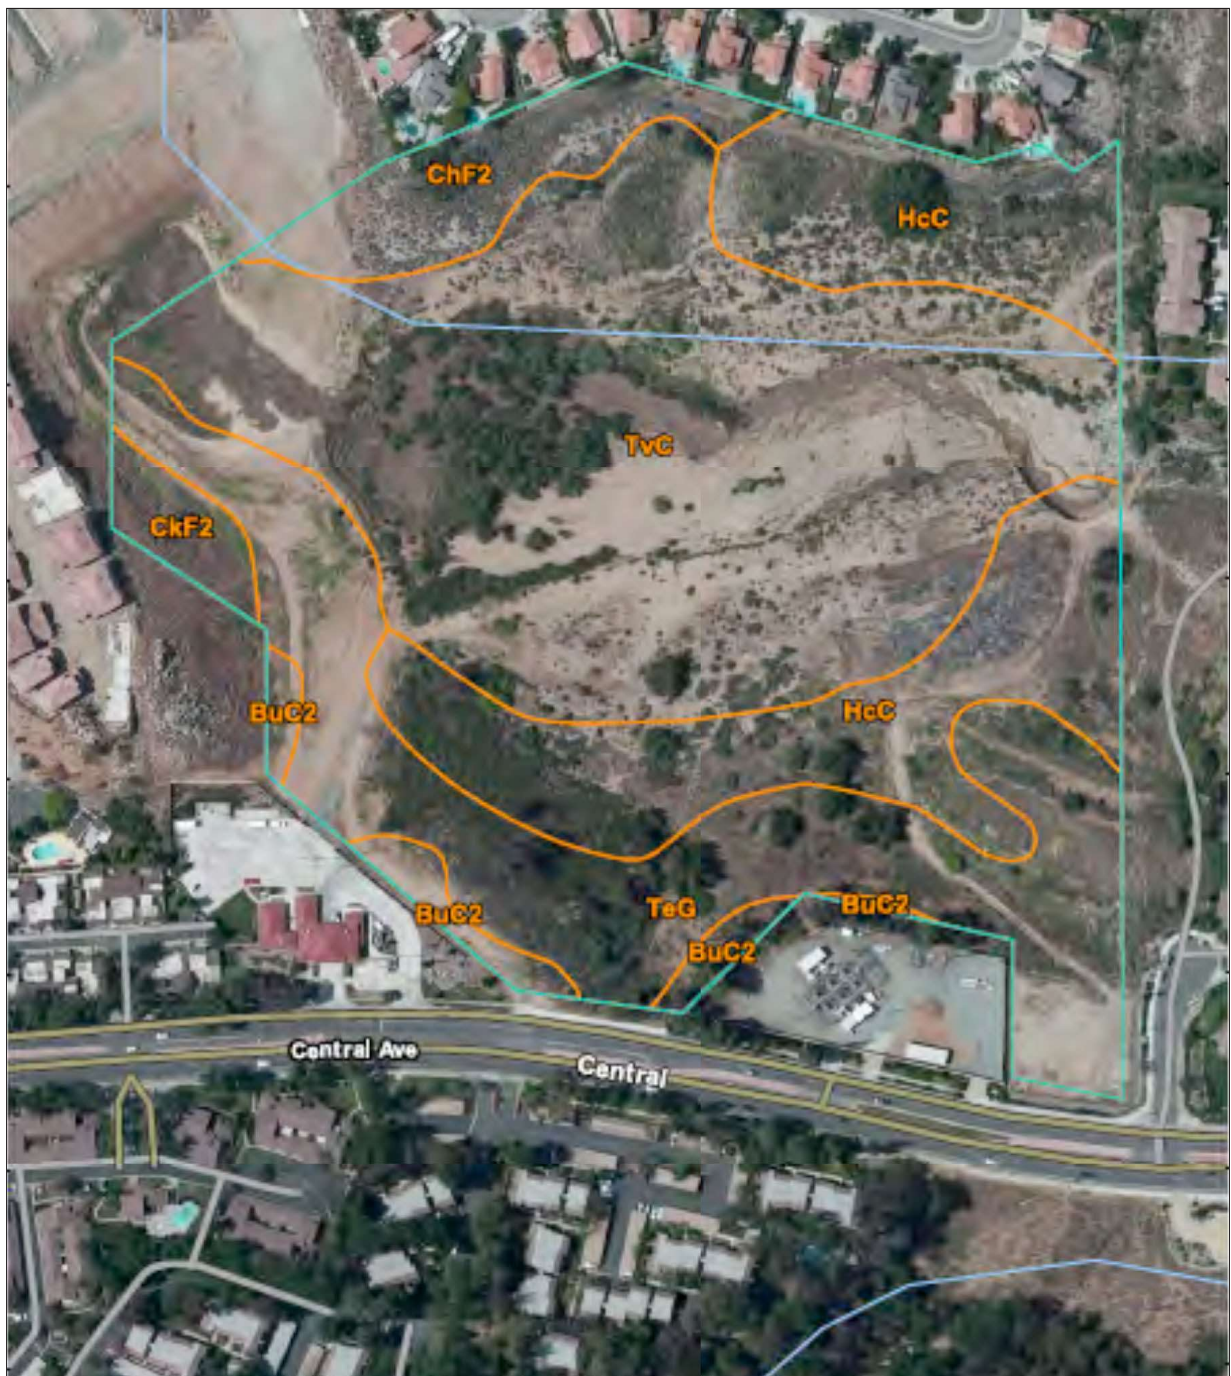
L:\1 --Projects--\Quail Run Restoration\Quail Run Restoration Plan\Figures\Fig4\_SoilsMap

There are six soils that occur on the property (Figure 4, NRCS 2014). They are Buren fine sandy loam, eroded, Cieneba sandy loam, eroded, Cieneba rocky loam, eroded, Hanford coarse sandy loam, Terrace escarpments, and Tujunga loamy sand, channeled. Cieneba sandy and rocky loams are residuum soils weathered from igneous rock, and are restricted to the hillside in the north-central area of the property. Burren fine sandy loam, Hanford coarse sandy loam, Terrace escarpments, and Tujunga loamy sand are all alluvial soils that are found in the lower slopes along the southern boundary and on the upper and lower flat areas to the north and south of the Box Springs Canyon channel. The Hanford and Tujunga soils are the ones where the restoration sites are located. Boring conducted during the geotechnical investigations for the project implementation (Geomat 2014) indicated that such alluvial soils continue at least to the level of the bottom of the borrow areas, and therefore are expected to be the substrates on which restoration will be implemented. Infiltration rates conducted at selected locations at the depth that would be surface soils at the final grading indicated infiltration rates of 10-16 inches per hour.

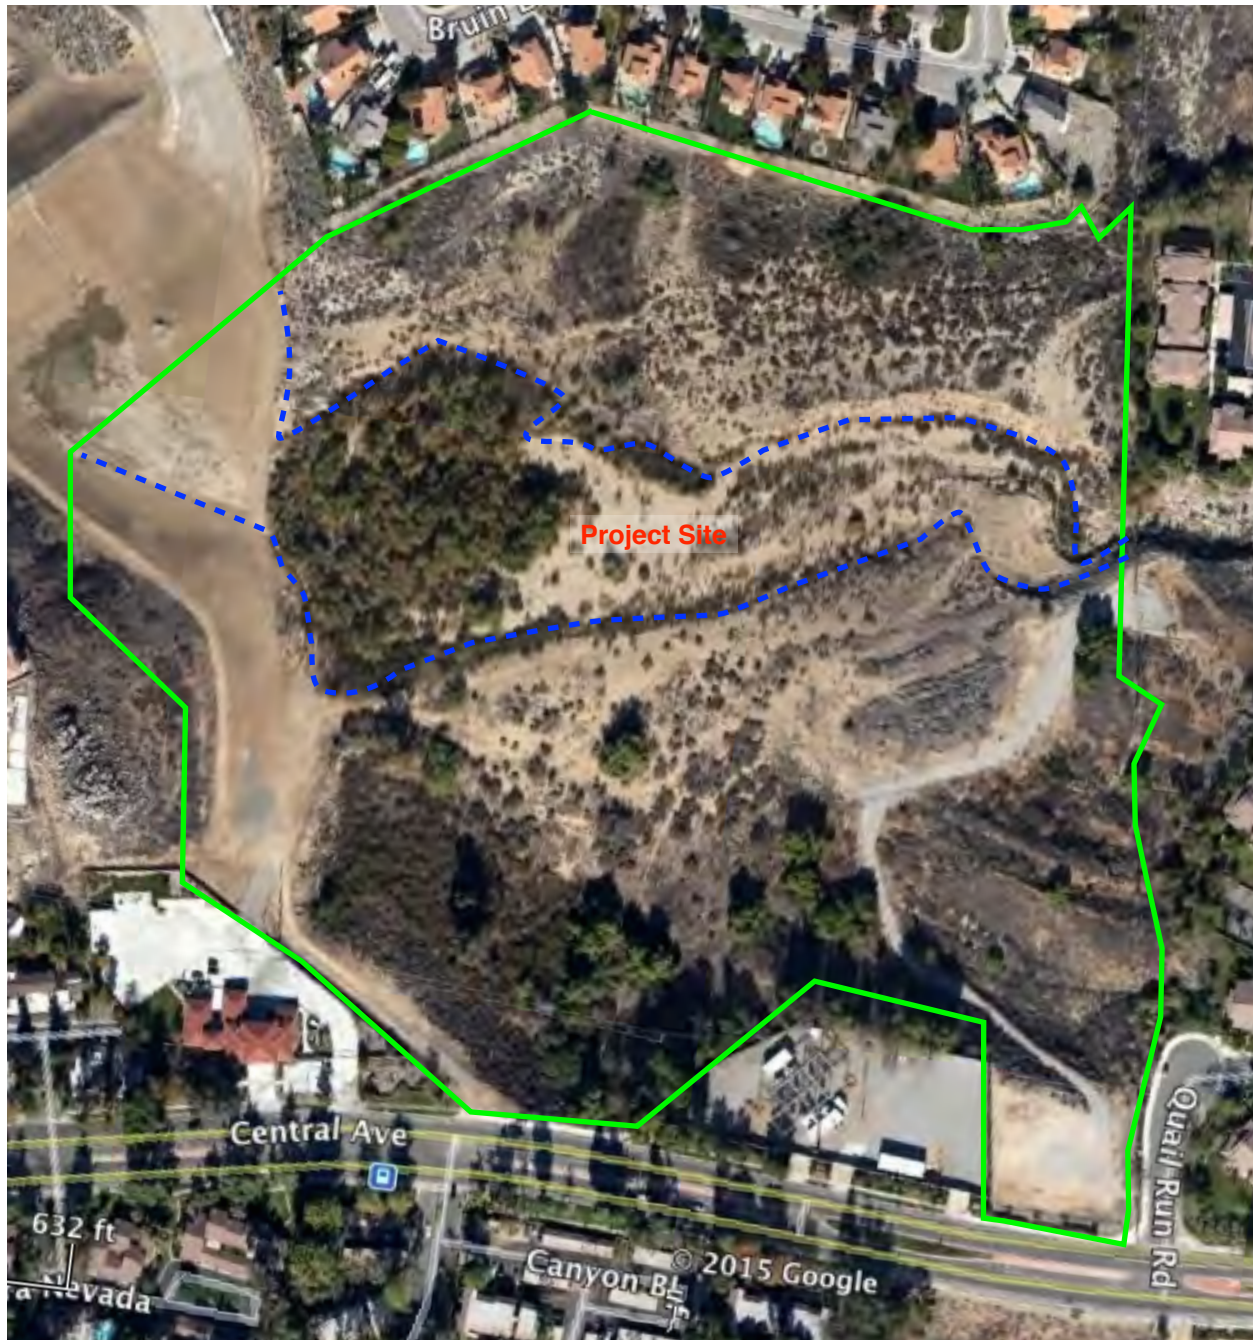
Figure 2. Project Aerial

Quail Run Development  
APNs 253-240-020, 253-240-028 and 253-060-020  
Riverside, California

Map Base: Google Earth 2015

The project area consists of 30.09 acres located northwest of the corner of Quail Run Road and Central Avenue in Riverside, California (Figures 1 and 2). It is in Section 1, Township 3 south, Range 5 west, San Bernardino base and meridian (Figure 2).

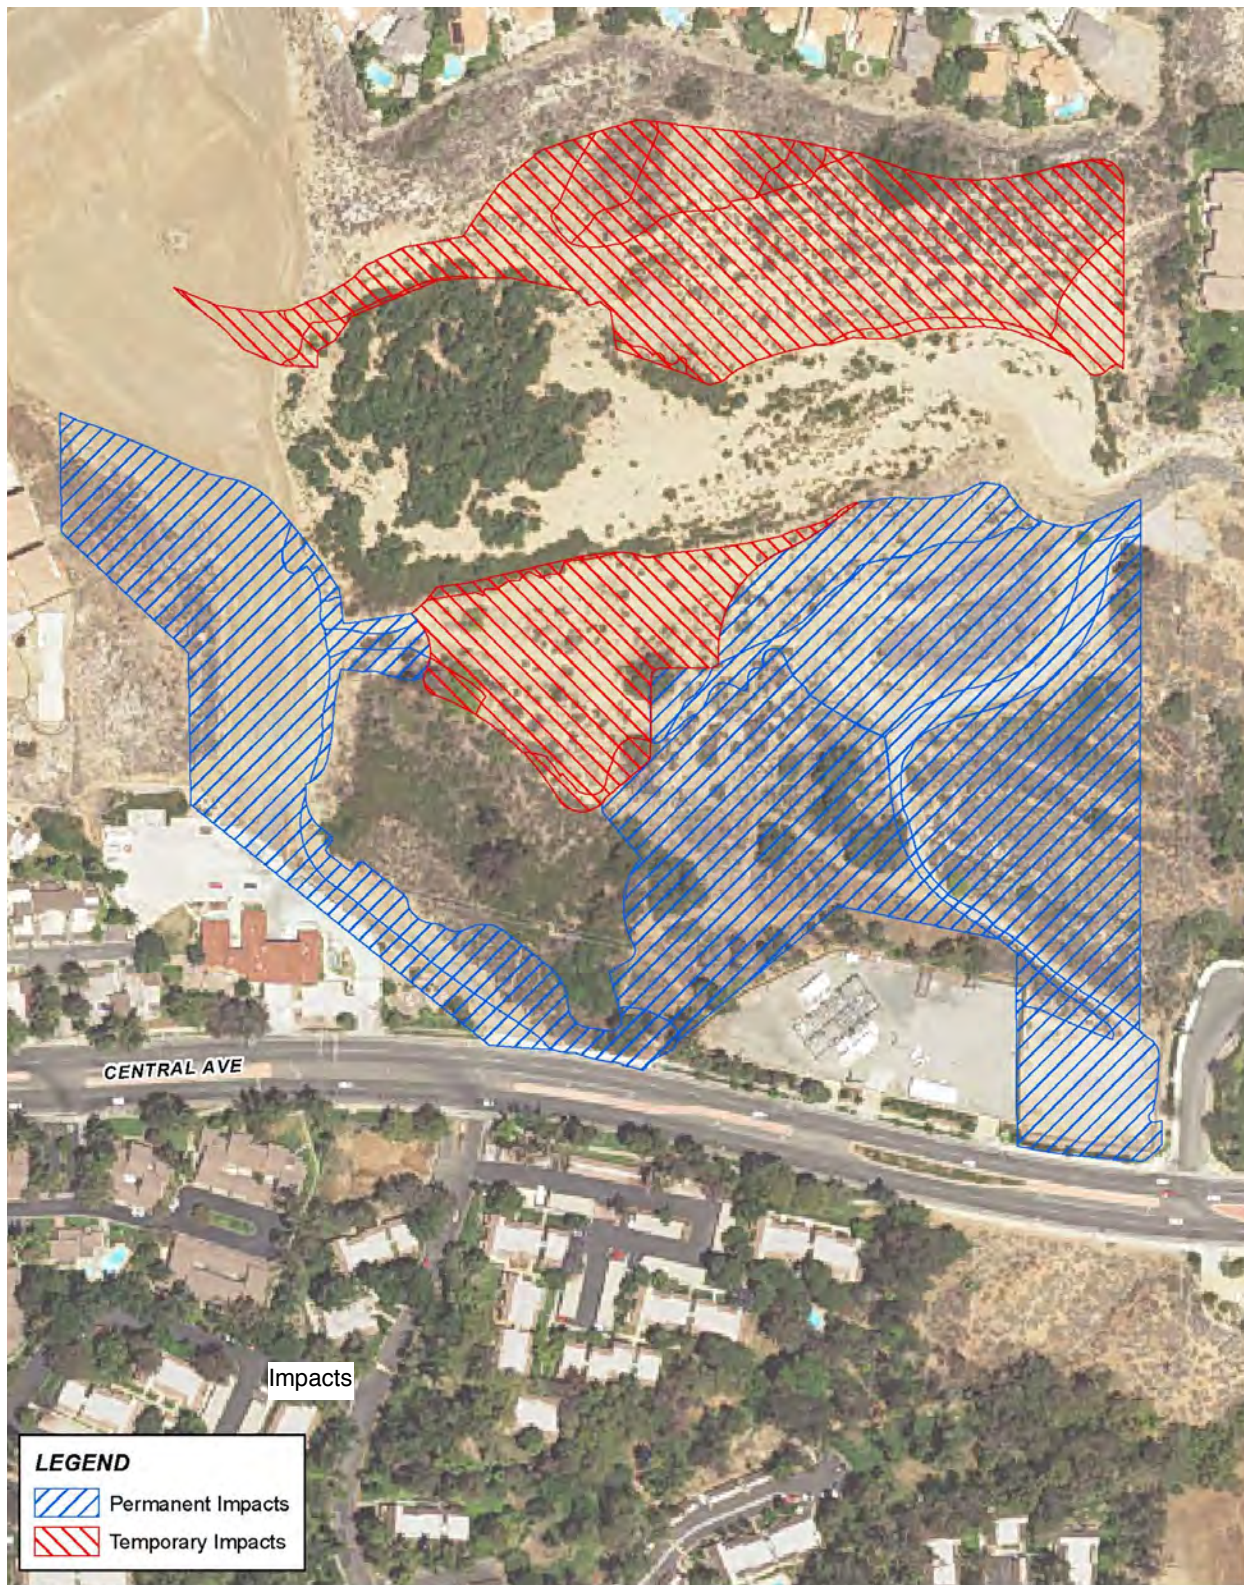
Figure 4. Development and Borrow Site Areas

Sources: SDH Inc, April 2015;  
JSDA NAIP, 2014.
