HISTORICAL ASSESSMENT REPORT

**Project: Stalder Building Adaptive Reuse Design Assessment, Riverside CA,
Mission Inn Boulevard, Riverside CA 92501**

Final Document issue 26 January 2017

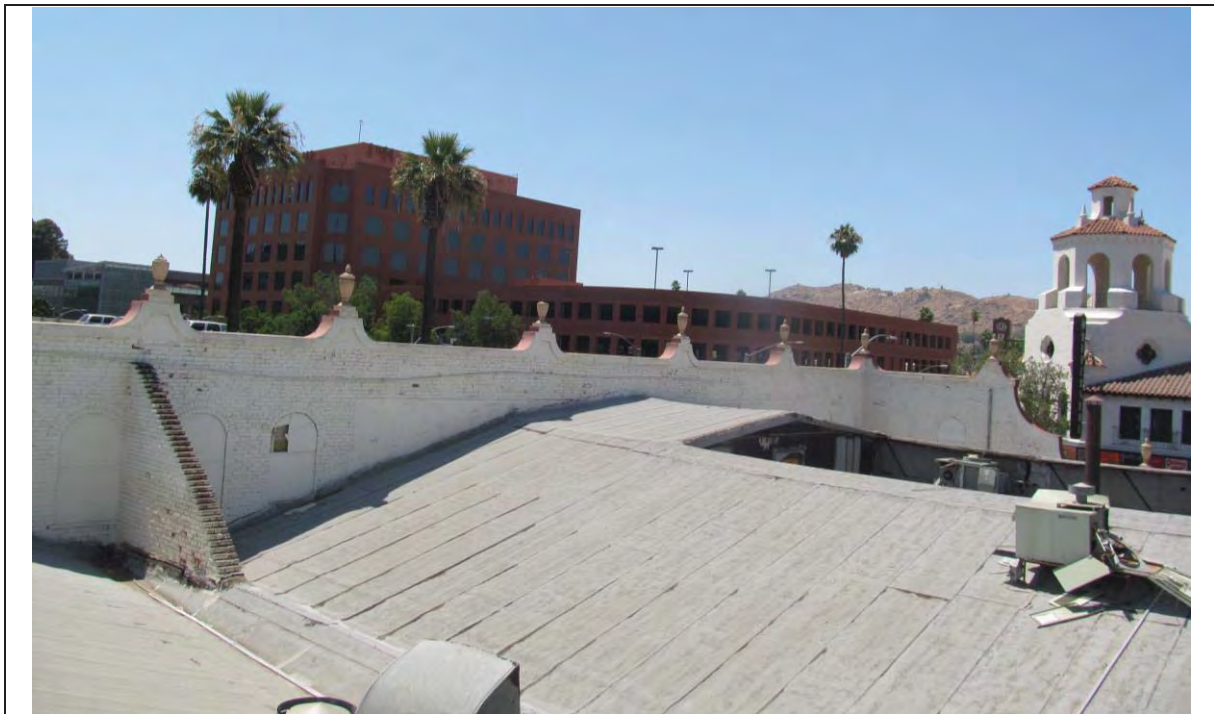
GTL | MHA, August 2016 site recordation photograph;
Detail view of south-western façade from the interior of the roof showing exposed “false” second floor windows. Station point is approximately at parapet top; view southwest towards the corner; Fox Theater tower at far right.

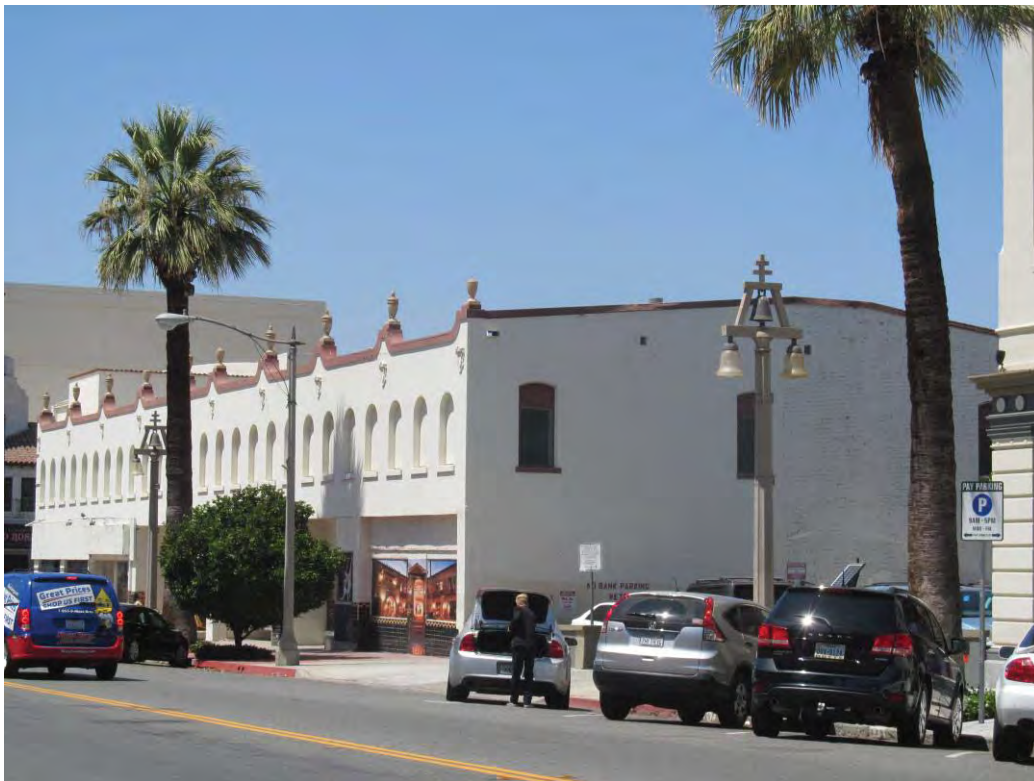
Detail view of Character-defining parapet mounted urns above cast cartouches along the south façade at Mission Inn Avenue.

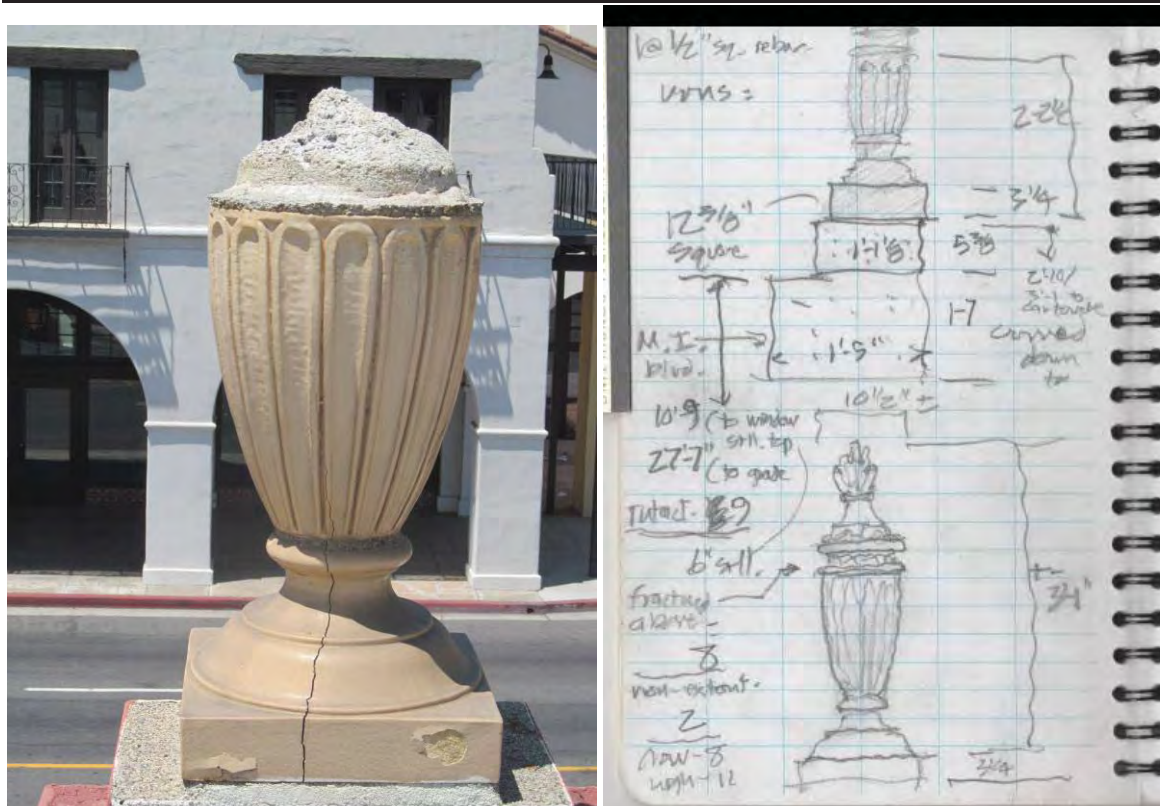
GTL | MHA, August 2016 site recordation photograph; Field notes for dimensions and condition.

Detail view of Character-defining parapet urns, with field notes

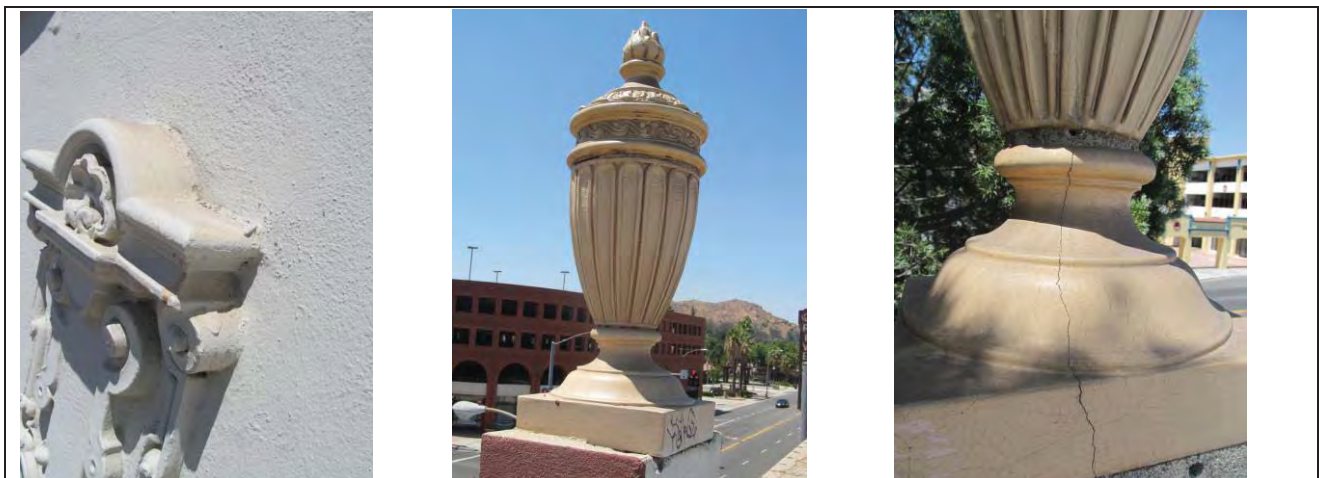
GTL | MHA, August 2016 photodocumentations, Stalder Building roof level, second floor decorative details field reconnaissance
Exterior south façade.

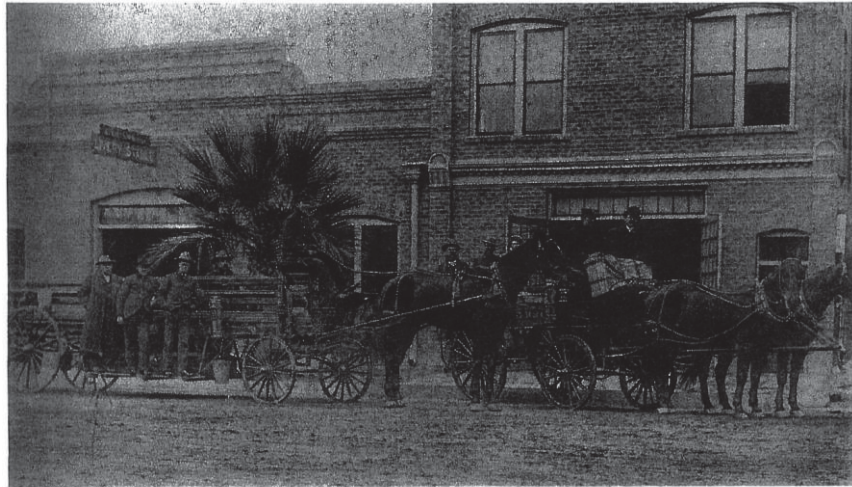
Historic Photo H1: Stalder Building - East end with the original exposed brick and straight parapet, ca. 1900. Photo courtesy of the Riverside Fire Department, "A Century of Service."

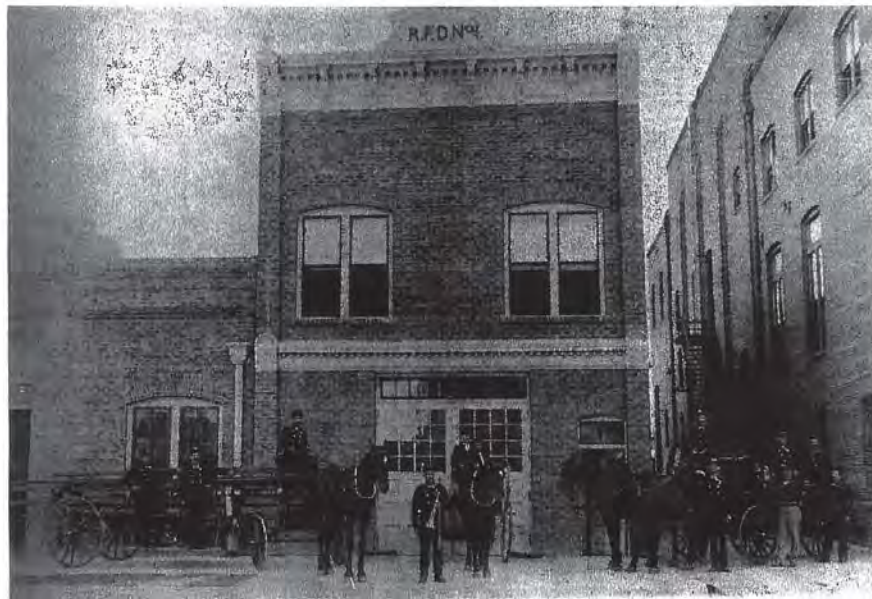
Historic Photo H2: Stalder Building - Fire Department, showing parapet sign and finials, ca. 1898. Photo courtesy of the Riverside Fire Department, "A Century of Service."

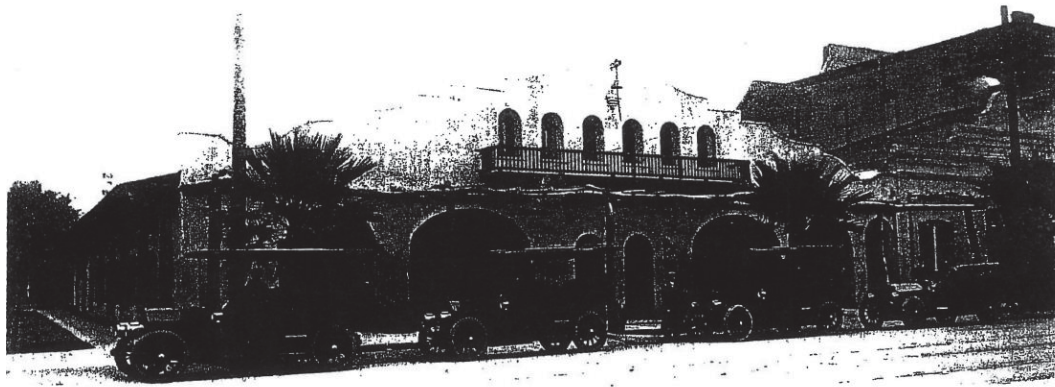
Historic Photo H4: Stalder Building - Garage, looking northeast, ca. 1910.

GTL | MHA, August 2016 photodocumentations research;
Stalder Building images from Milford Wayne Donaldson's 25 January 2001 Historic Resources Survey:
South Garage façade at corner, c.1910. No element of this façade is extant.

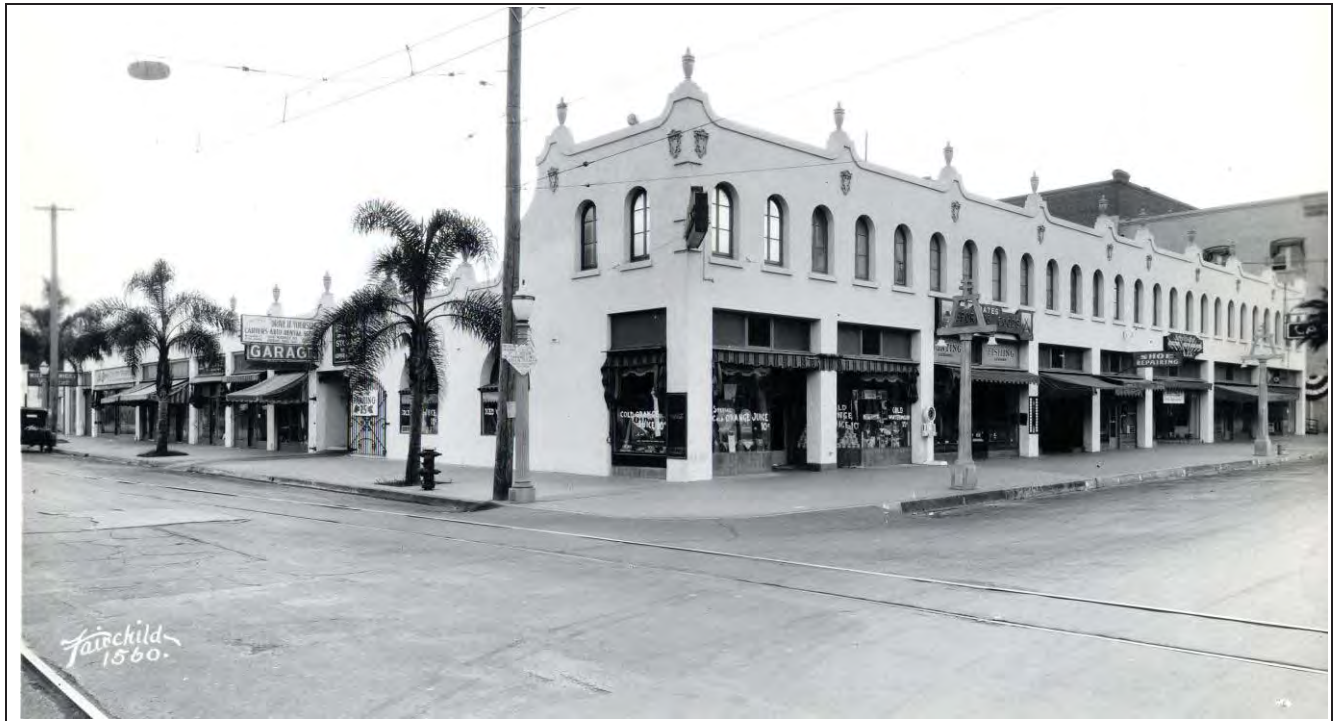
GTL | MHA, August 2016 photodocumentations research;
Stalder Building images: City of Riverside: Wilson's south façade, c 1935.

It is recommended to consider the date of 1926 as the date of the period of significance. This represents the condition at the time of completion of the G. Stanley Wilson designed façade, unifying the three different structures behind it. These buildings were previously modified construction that continued to be modified from the date of their initial construction and beyond the 1926 significant year. This represents a conservative approach, recommended here as it allows for the simplest definition of what possesses sufficient integrity for interpretation. Modifications made at a date later than 1926 do not enhance the significance, and are not recommended to have achieved significance on their own merits. Exemplifying this distinction is the later ceramic tile façade wainscot. The c.1935 photograph from the southwest shows no tile wainscot; the c.1955 image shows the tile in place. This modification is not recommended to be considered a part of the Wilson design.

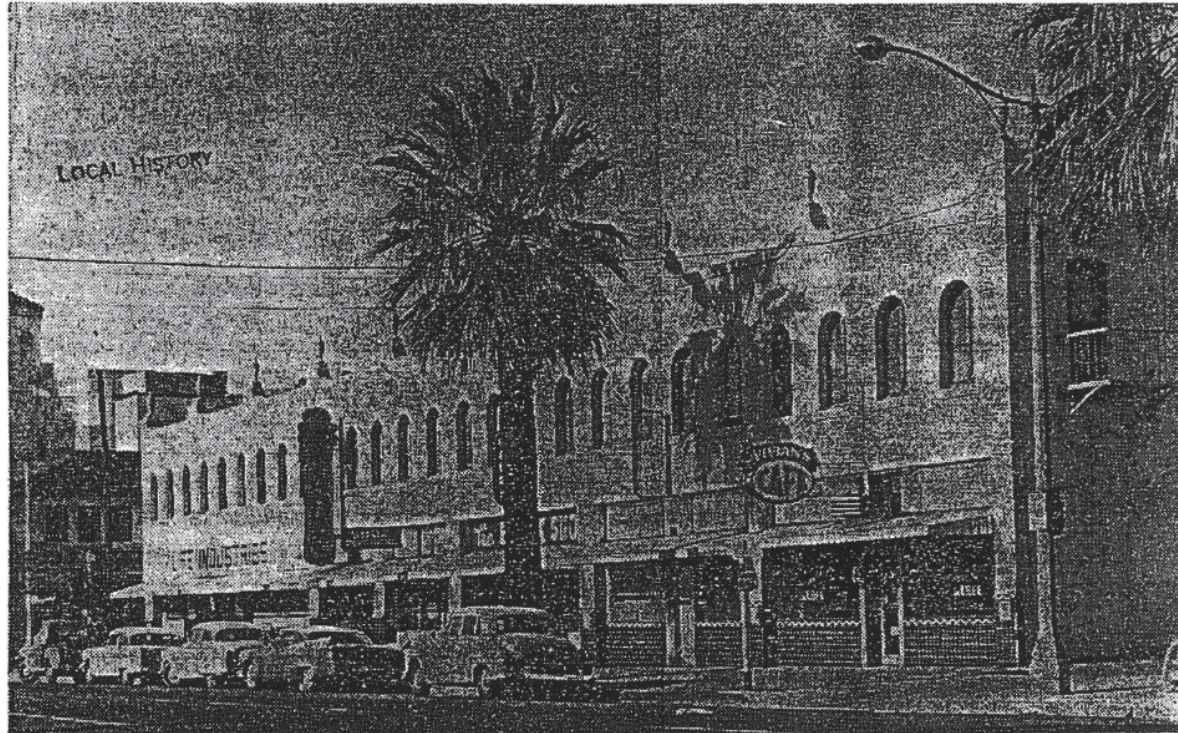
A NEW FACADE—But the entire group of buildings was joined with a new mission-style front 1926, and so they appear today.

Historic Photo H7: Stalder Building - Looking northwest, ca. 1955. Vivian's Cafe occupies the former fire station. Photo courtesy of the Riverside Public Library.

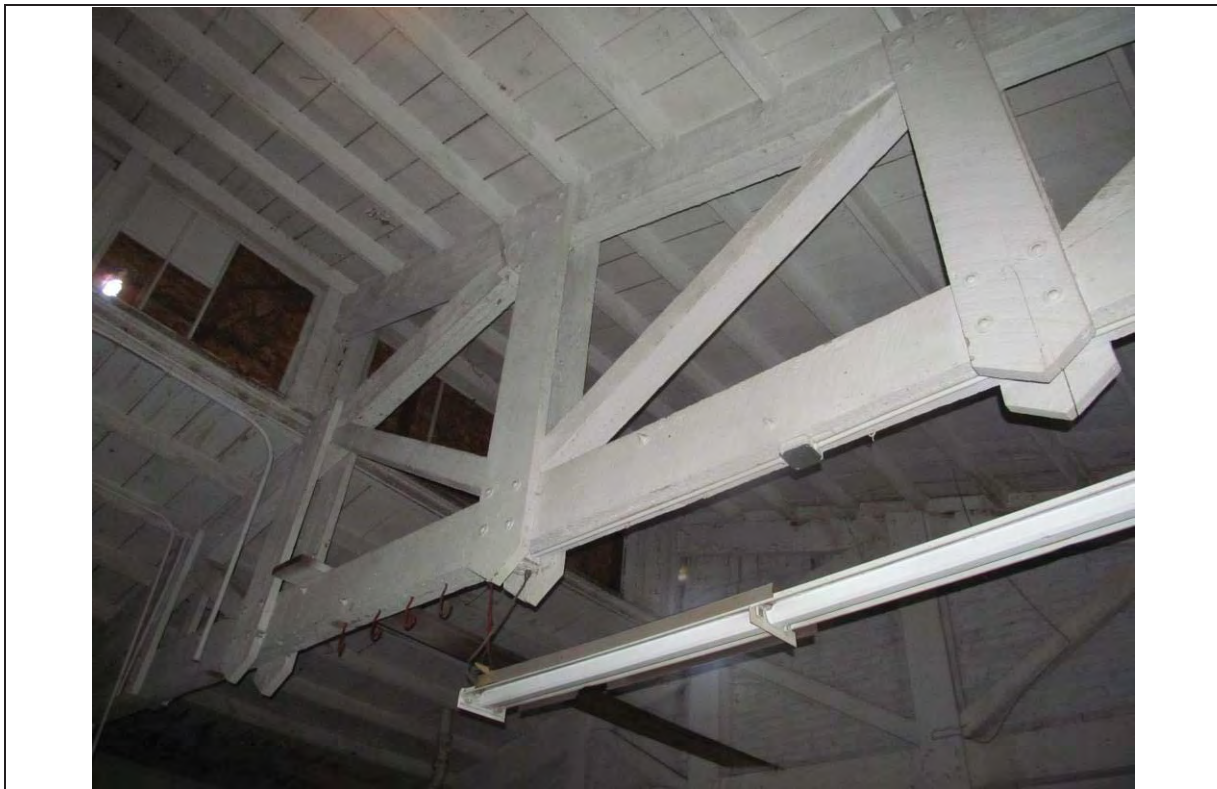
GTL | MHA, August 2016 photodocumentations,
Stalder Building ground level interior photographic field reconnaissance: Roof trusses.

Trusses, for possible documentation prior to removal for reuse off-site.

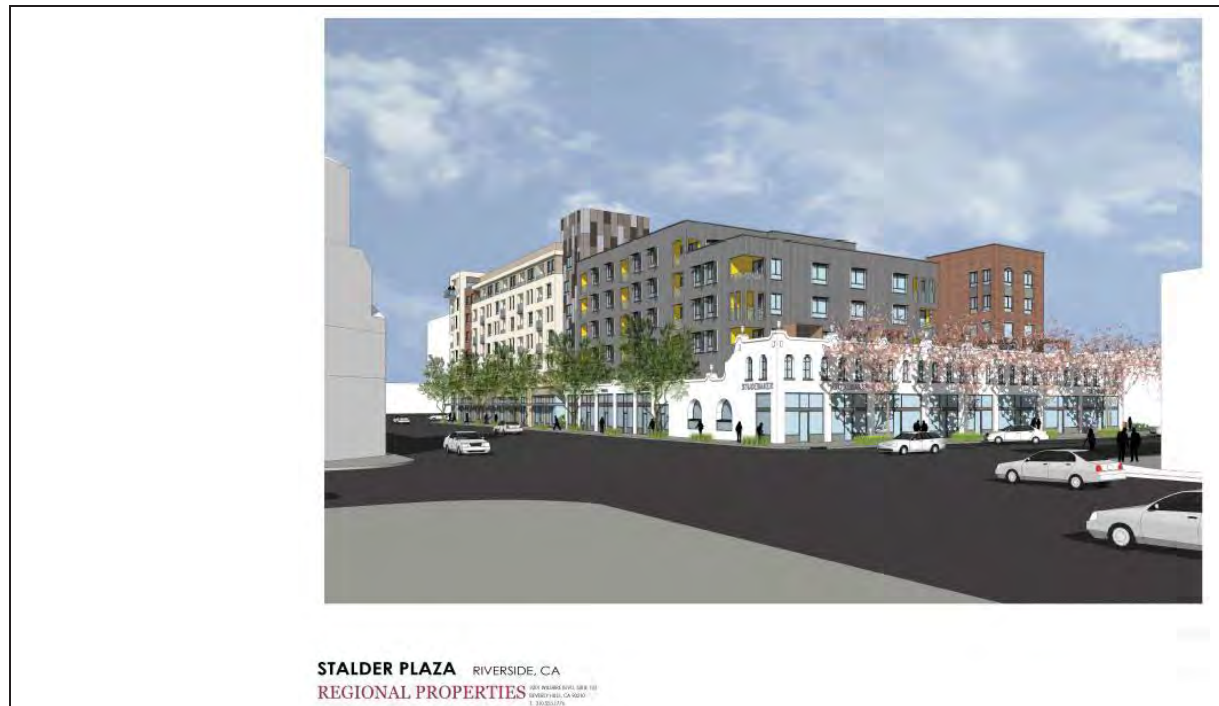
Architects Orange, January 2017 design presentation; Exterior perspective, southwest façade study. Stalder is rendered white.

It is recommended that an interpretive derivation of Wilson's style be employed in the facade design of the structure located above and behind the Stalder Building. The proposed design at the adjoining parking lot to the north is not recommended to directly interpret Wilson's style, but to form a design cohesiveness on its own site. It is recommended to have these two halves incorporate a "hyphen" type of revealed connection, to distinguish the two properties adequately. The proposed design as analyzed in this Adaptive Reuse Design Assessment does employ these features.

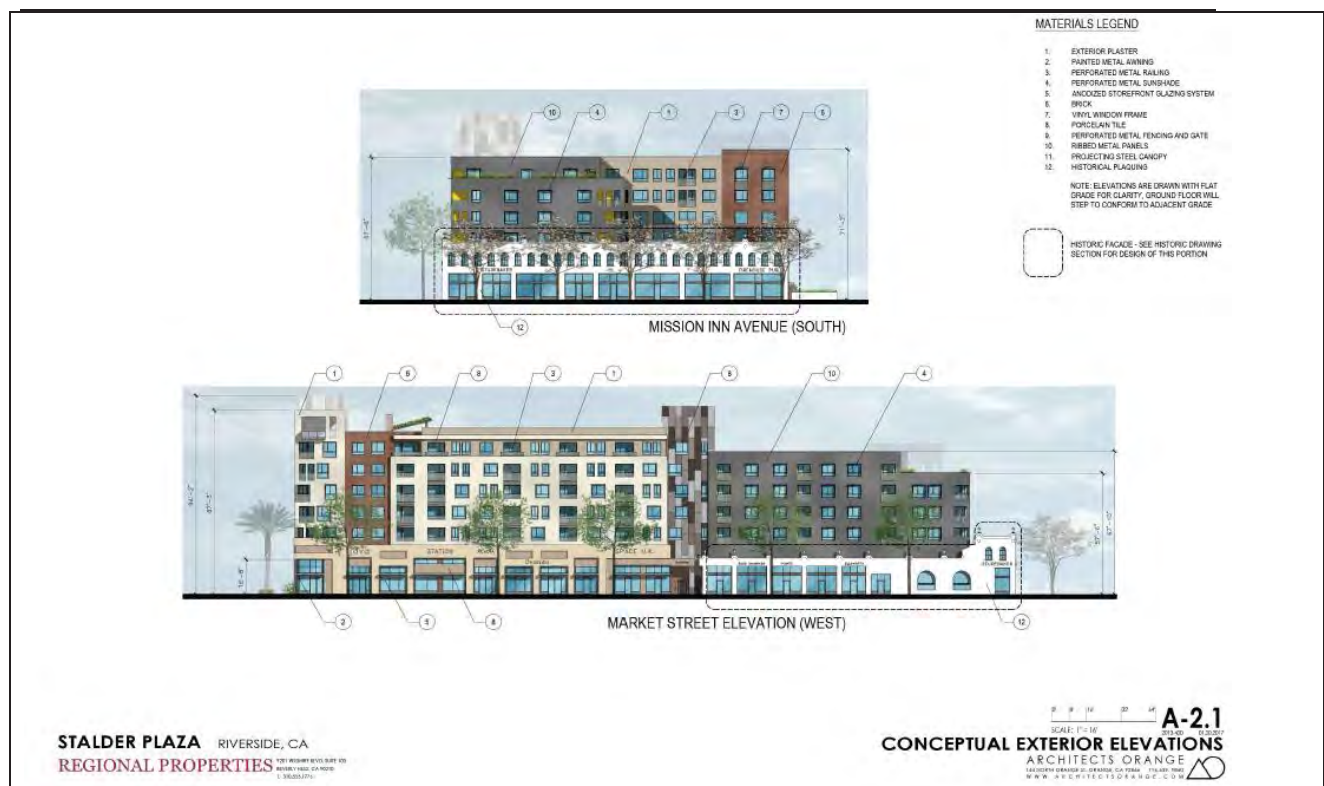
Architects Orange, January 2017 design presentation; Exterior south and west façade study.

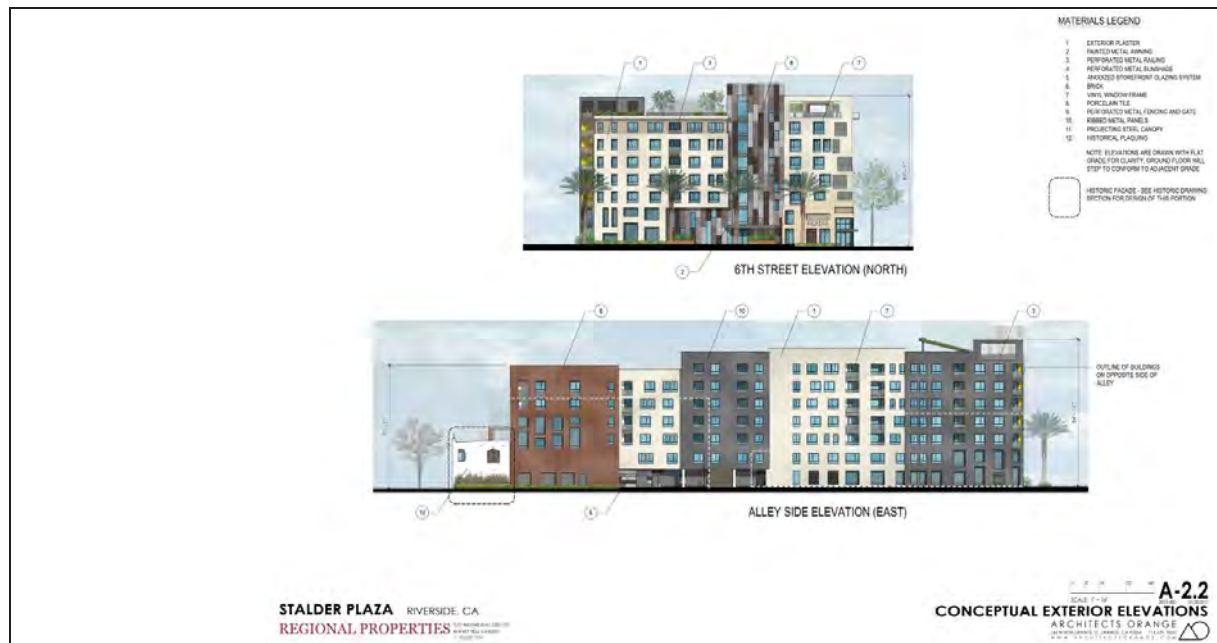
Architects Orange, January 2017 design presentation; Exterior north and east façade study.

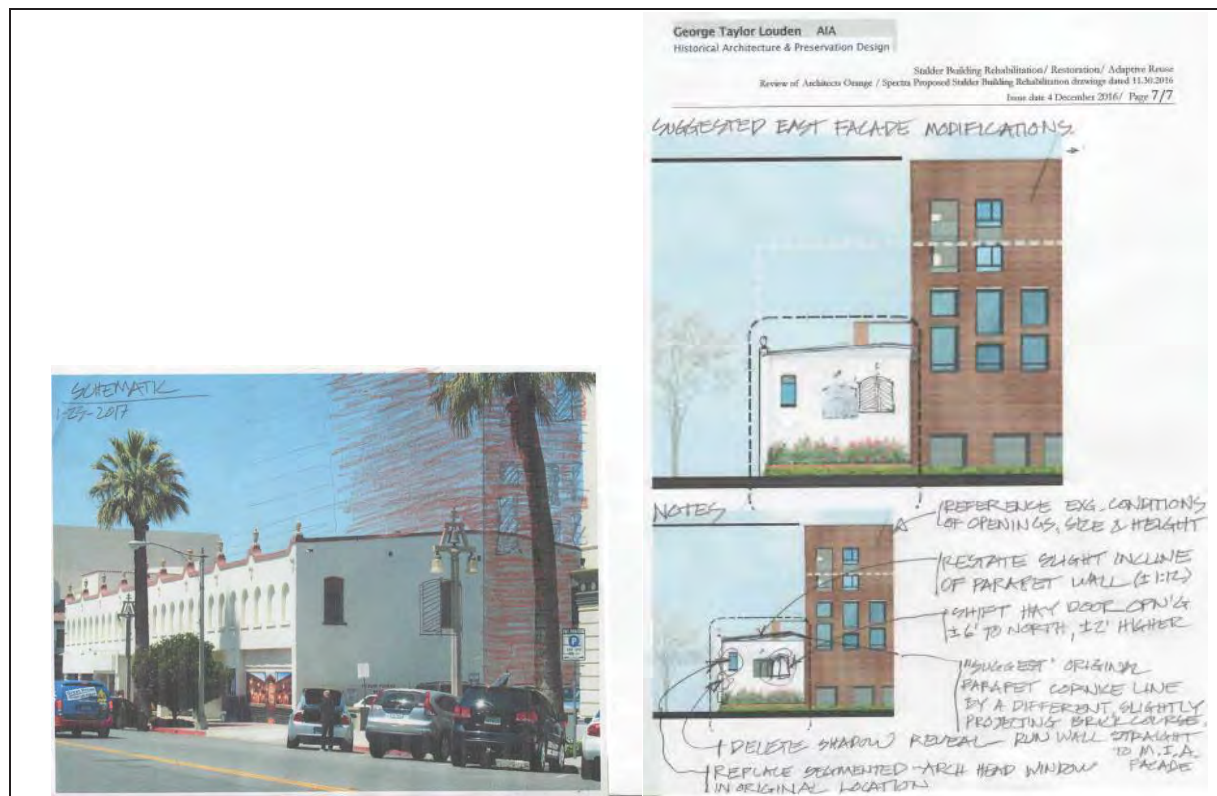
GTL | MHA, December 2016 / January 2017 design recommendation; Exterior east façade details studies.

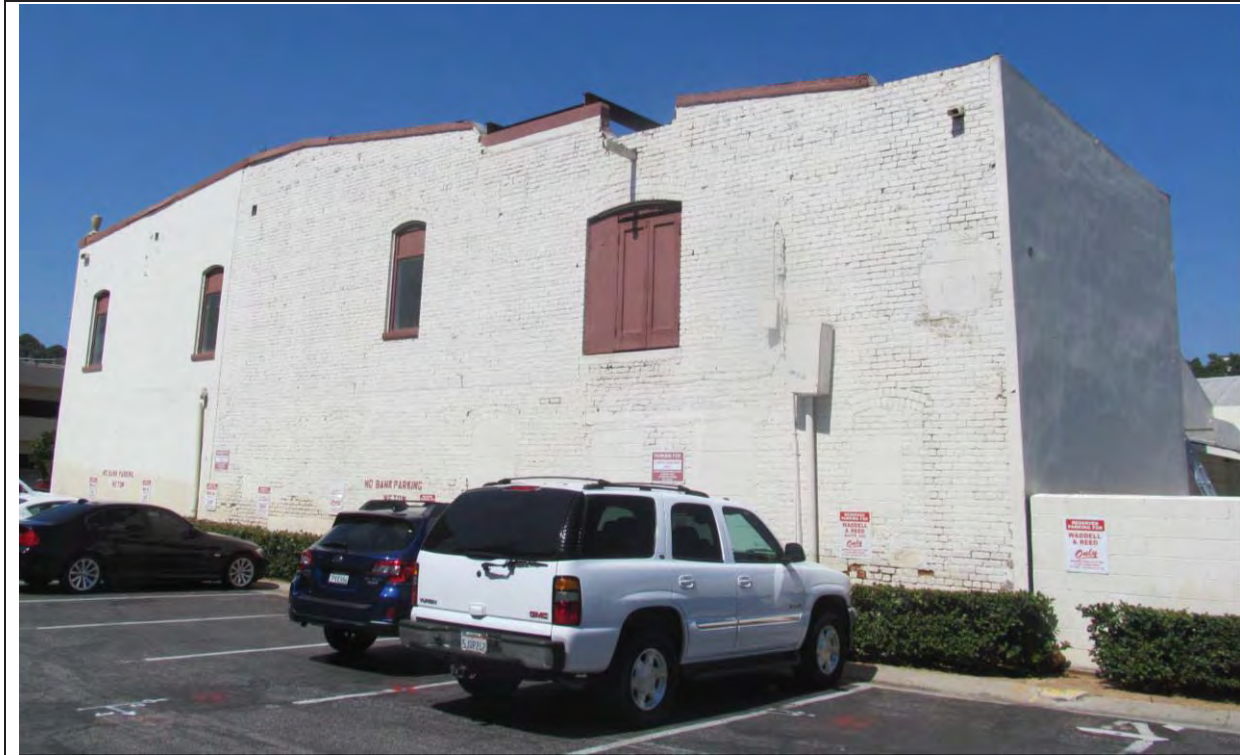
GTL | MHA, August 2016 site recordation photograph; Detail view of east façade remaining of Fire House Number 1. Plastered façade return at left side of image is representative of the extent of the G. Stanley Wilson's façade design modification.

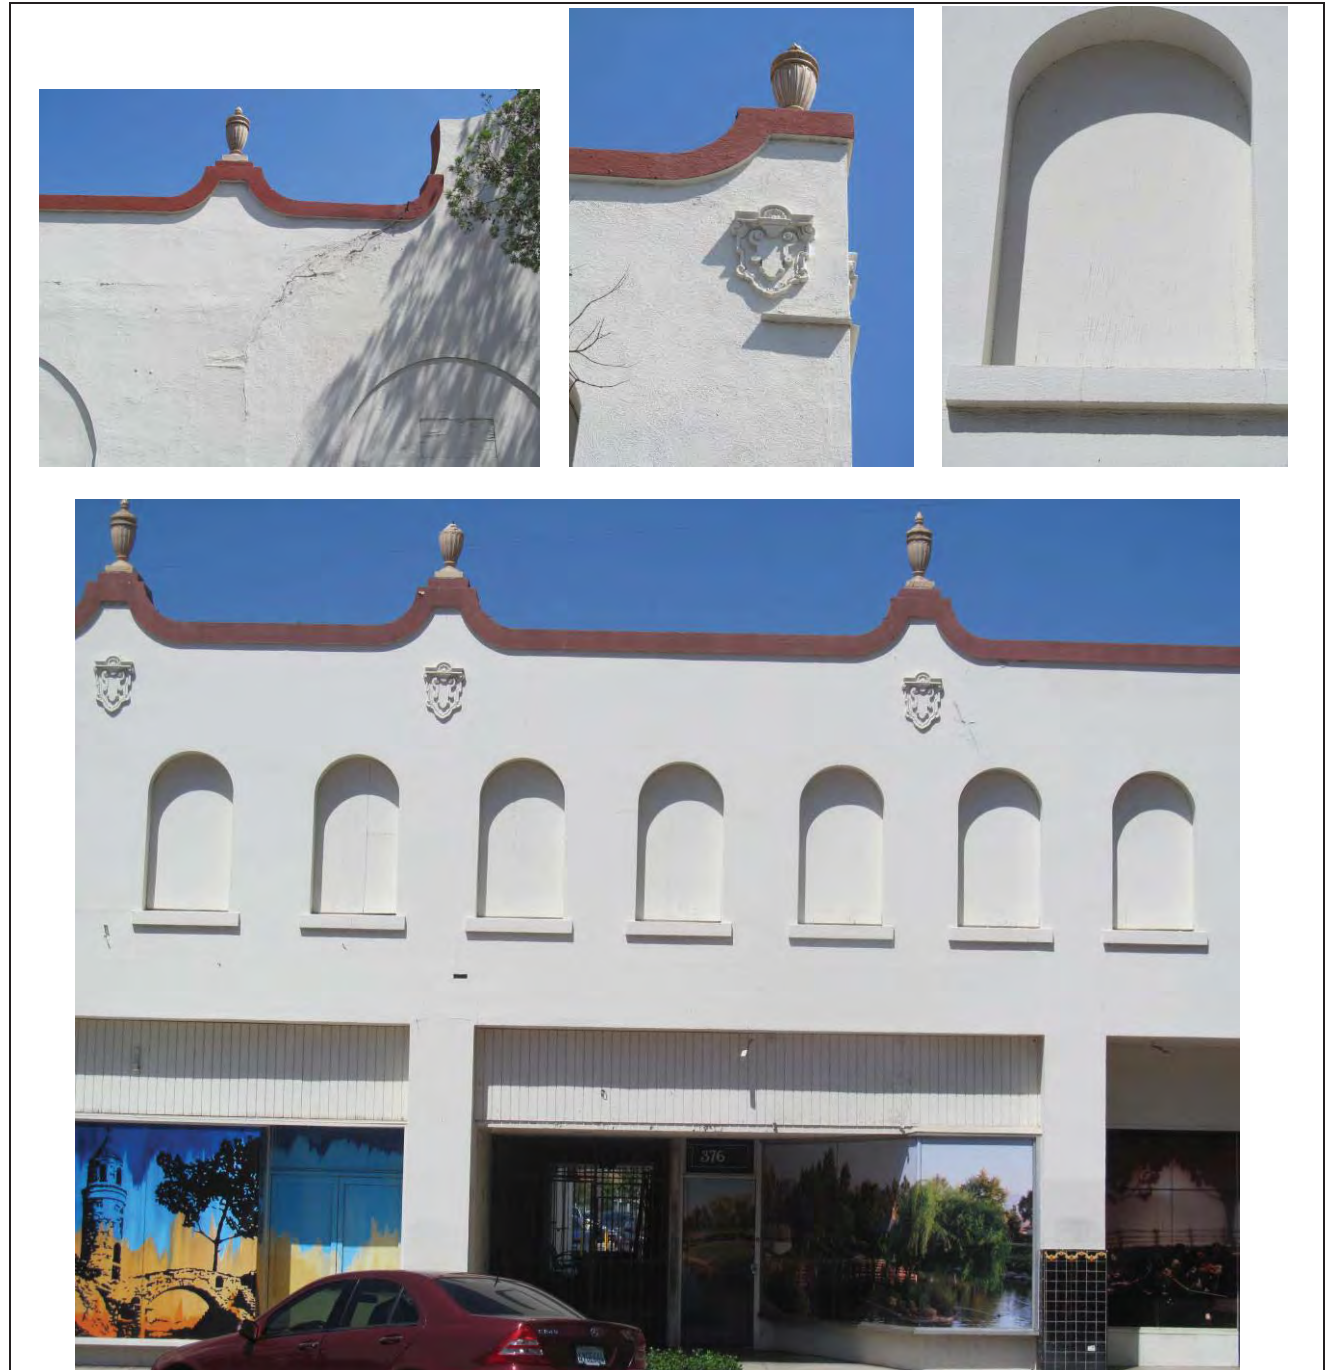
GTL | MHA, August 2016 site recordation photograph; Detail views of various terra cotta urn, parapet and cartouche conditions, south and west façade. Station point is from street.

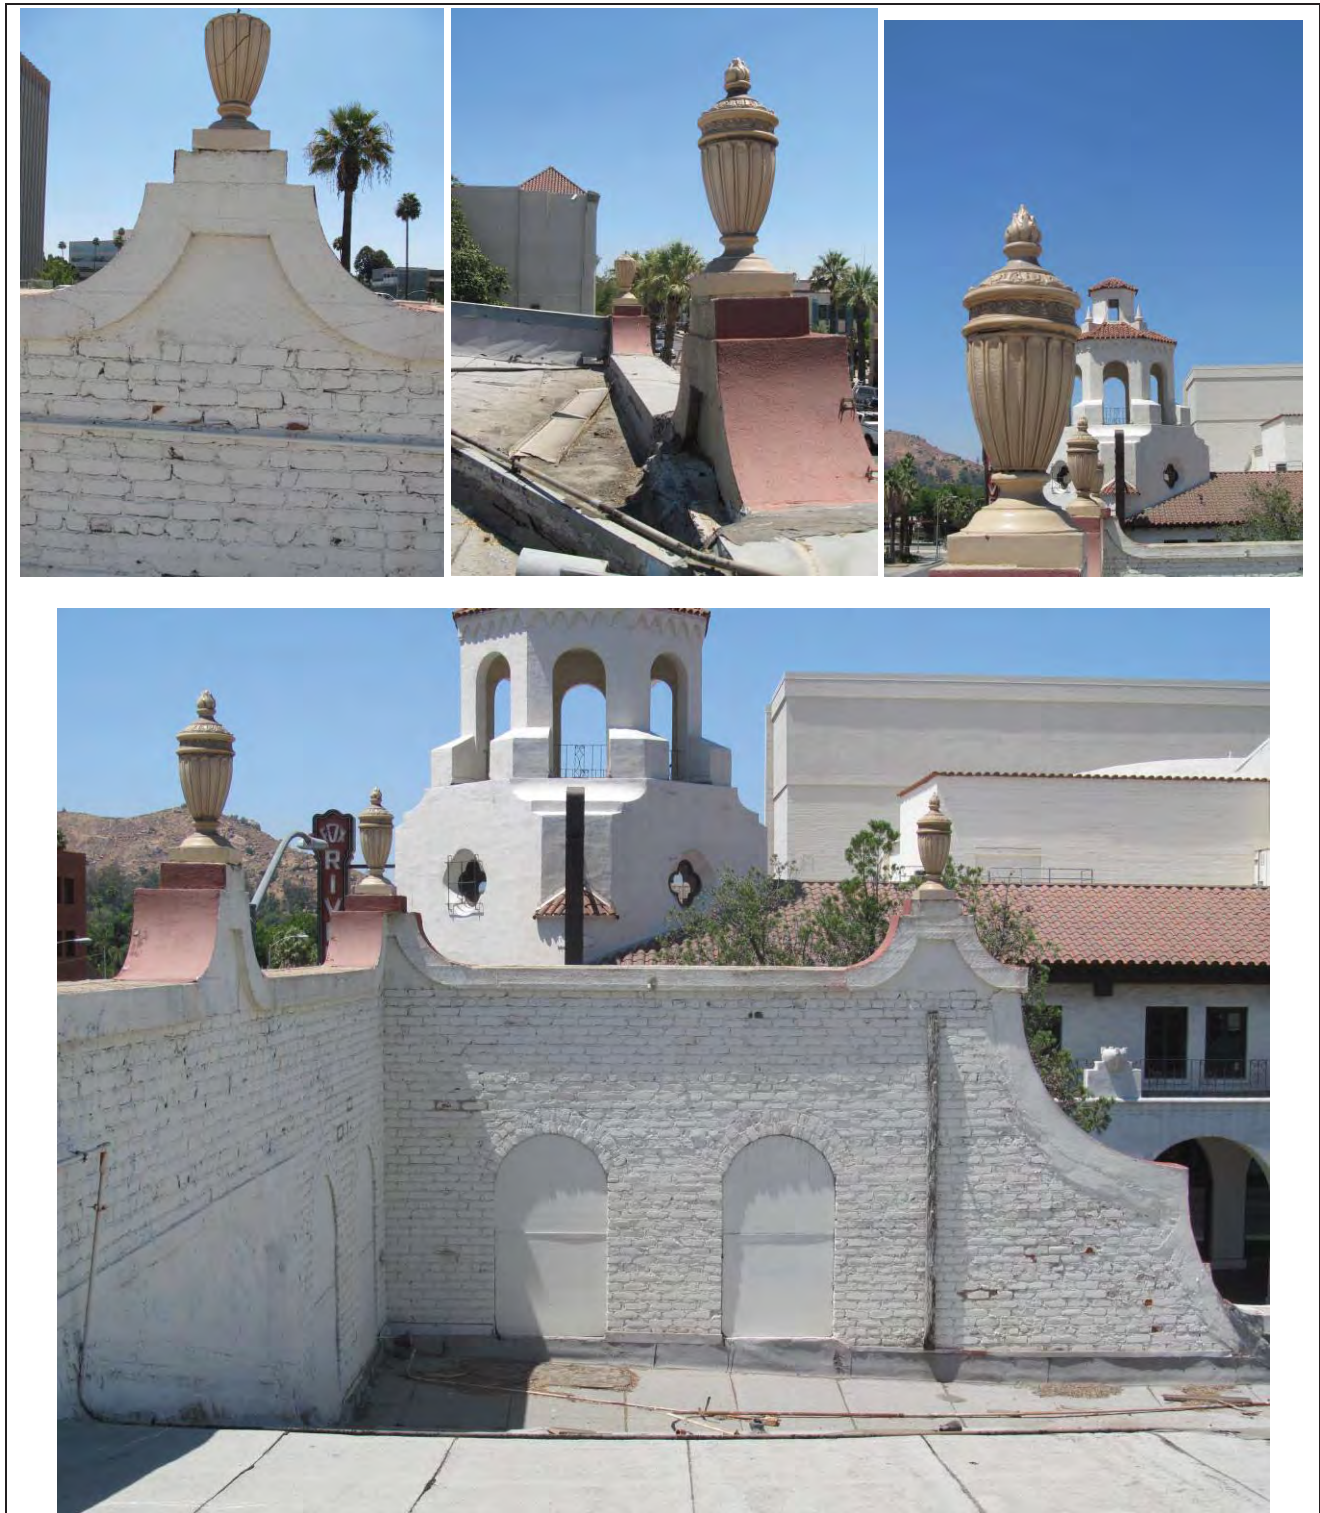
GTL | MHA, August 2016 site recordation photograph; Detail views of various terra cotta urn & parapet condition Station point is from roof, view west. Note covered window openings and drop in façade. Tower beyond is Fox Theater.

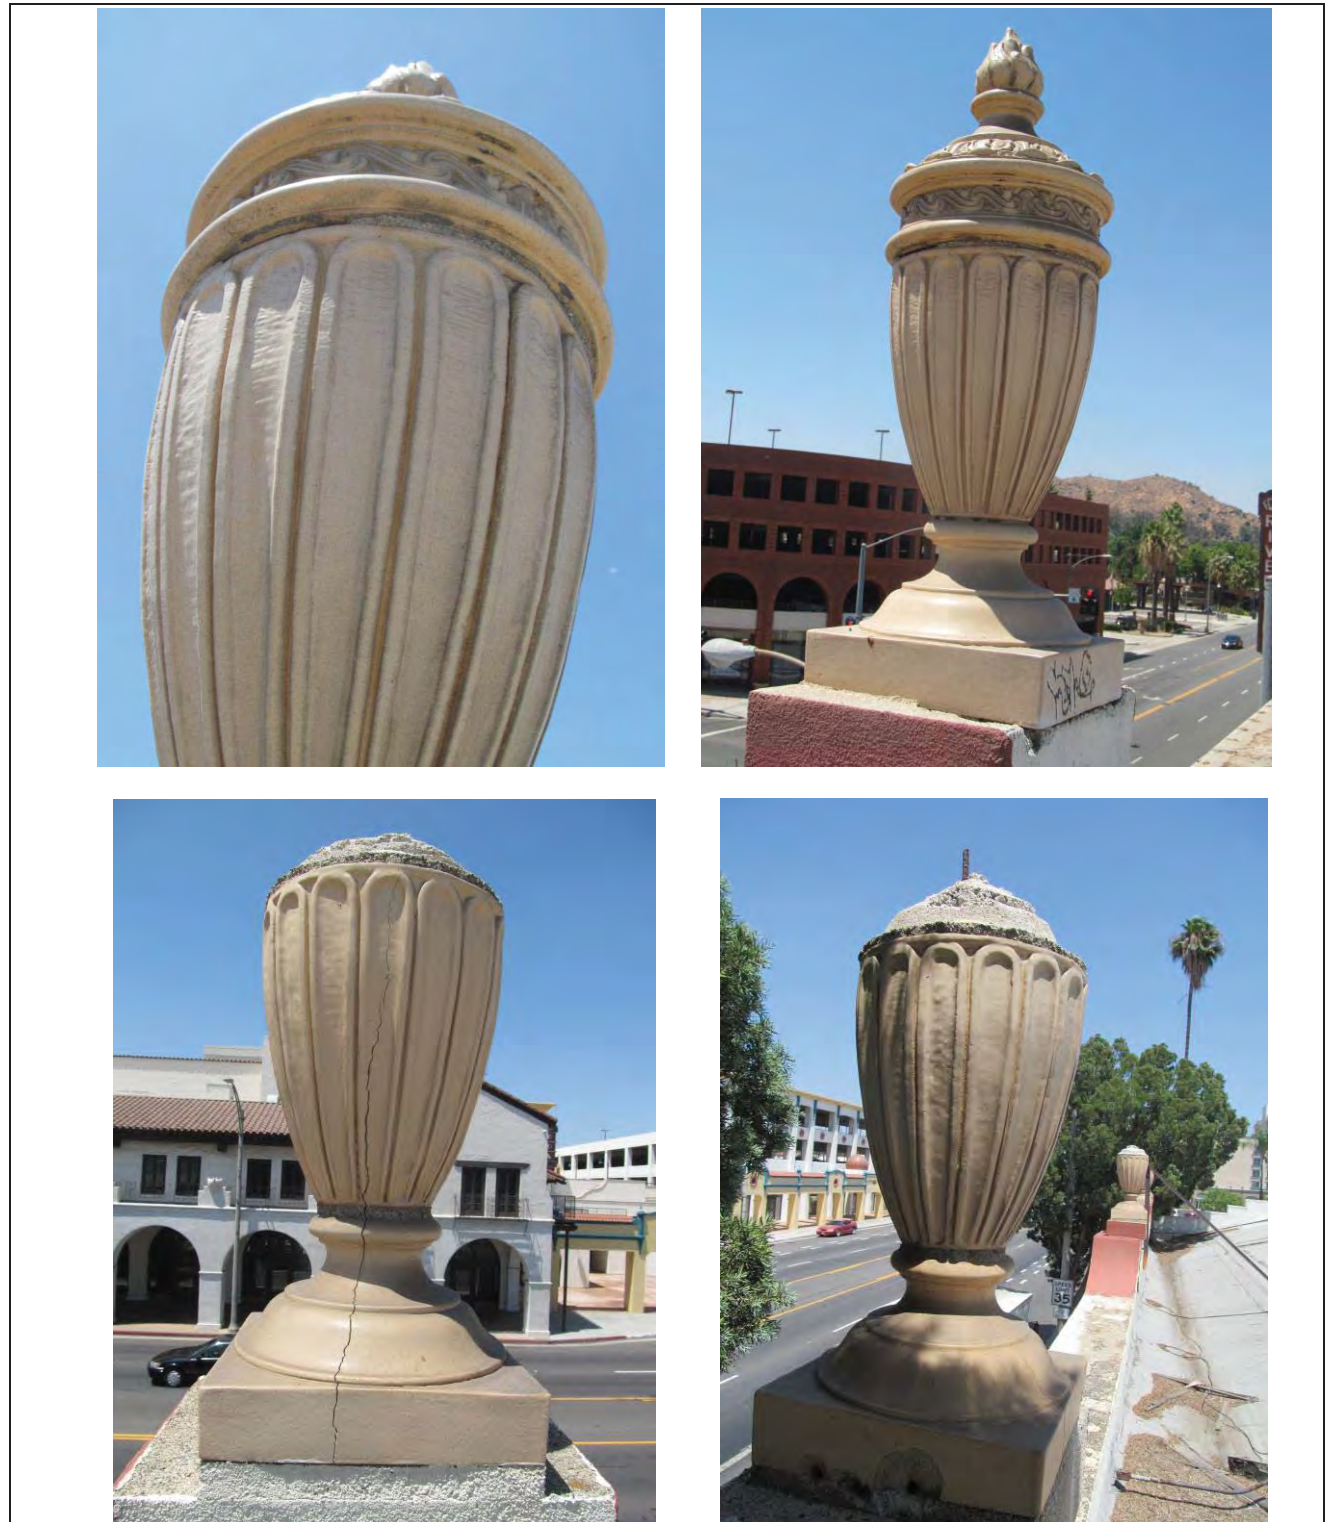
GTL | MHA, *August 2016 site recordation photograph; Detail views of various terra cotta urns. Station point is from roof.*
Note color, finish and texture at fronds; construction in three-piece casts, cemented together around a single .5" square reinforcing steel rod, and consequent longitudinal cracking.

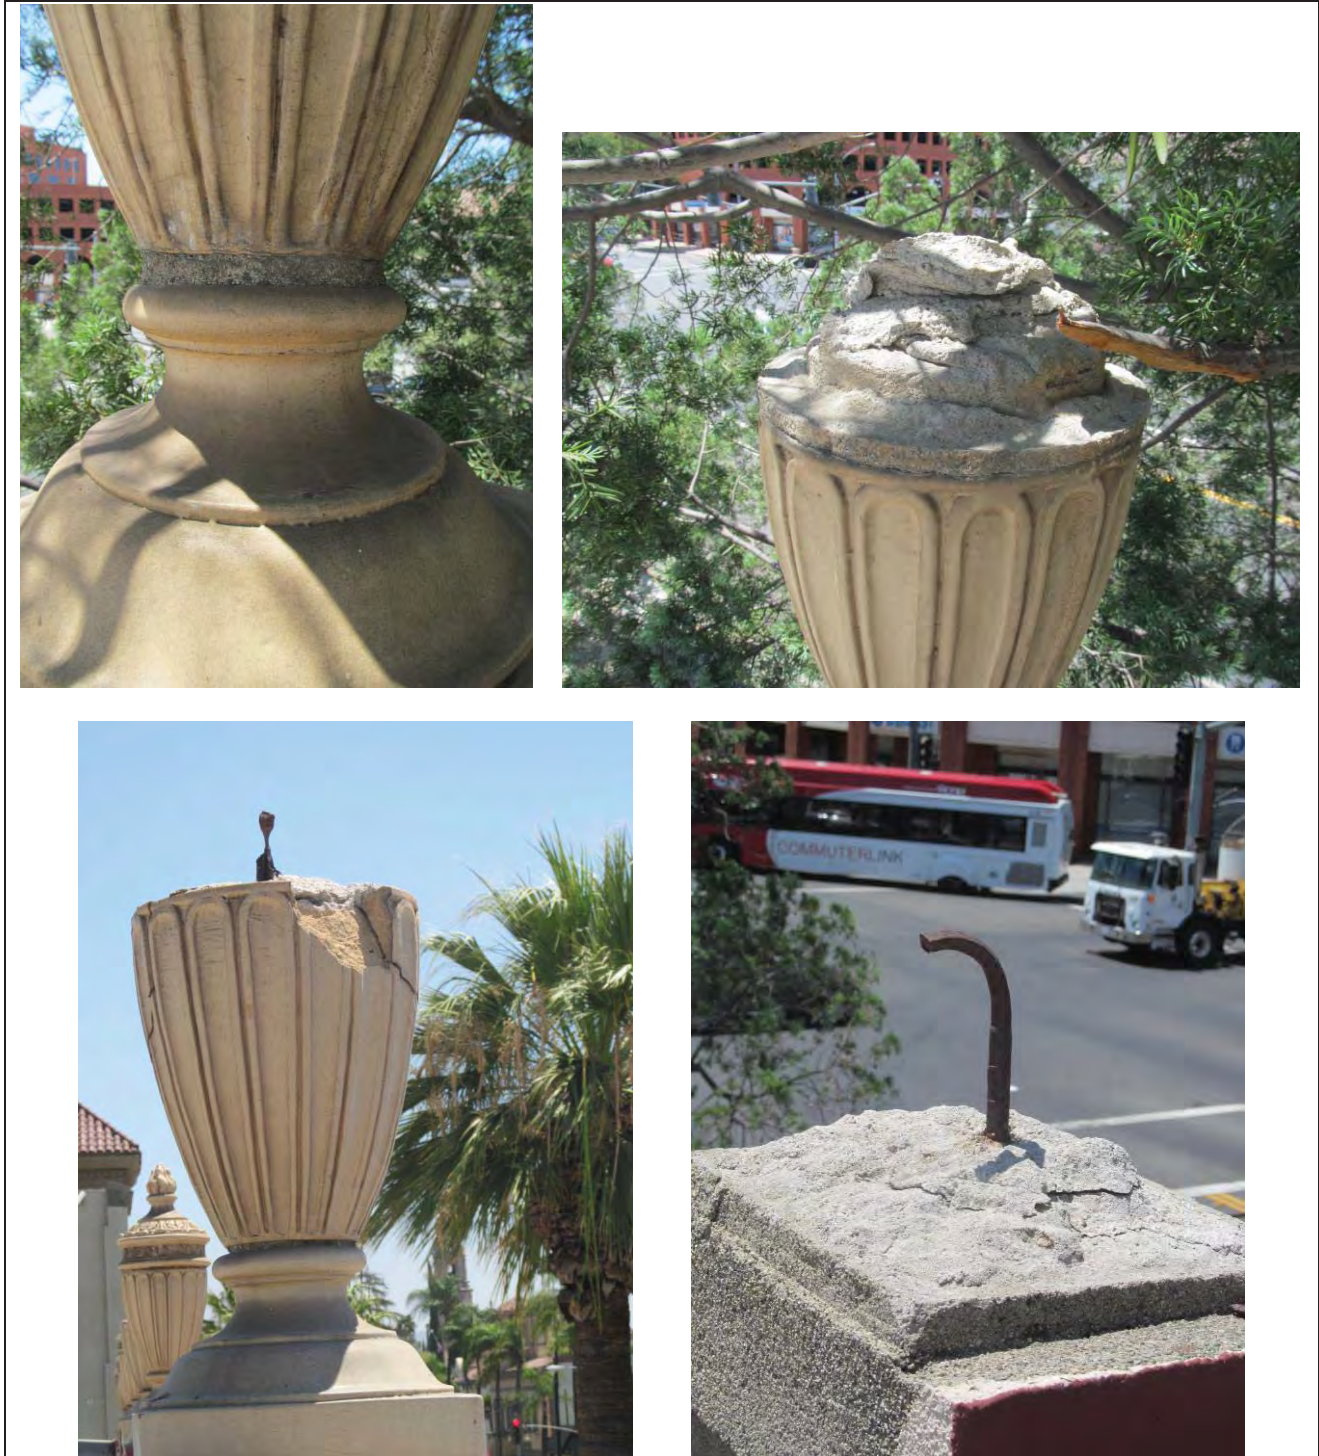
GTL | MHA, *August 2016 site recordation photograph; Detail views of various terra cotta urns. Station point is from roof.*
Note color, finish and texture at fronds and base; construction in three-piece casts, cemented together around a single .5" square reinforcing steel rod, and setting base.

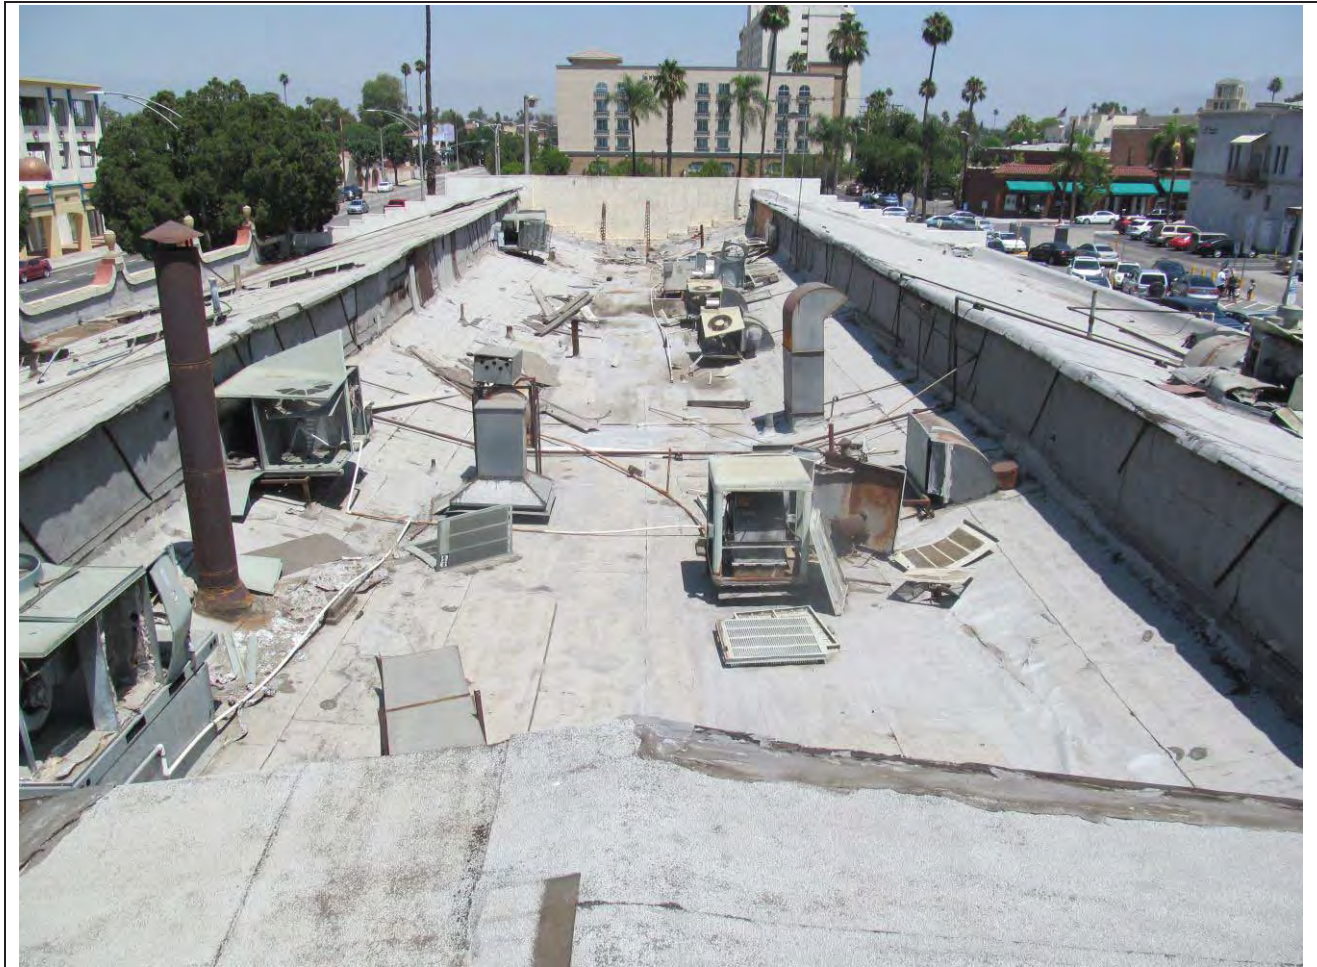
GTL | MHA, August 2016 site recordation photograph; Context view of garage roof to north. Note covered clerestory roof feature.

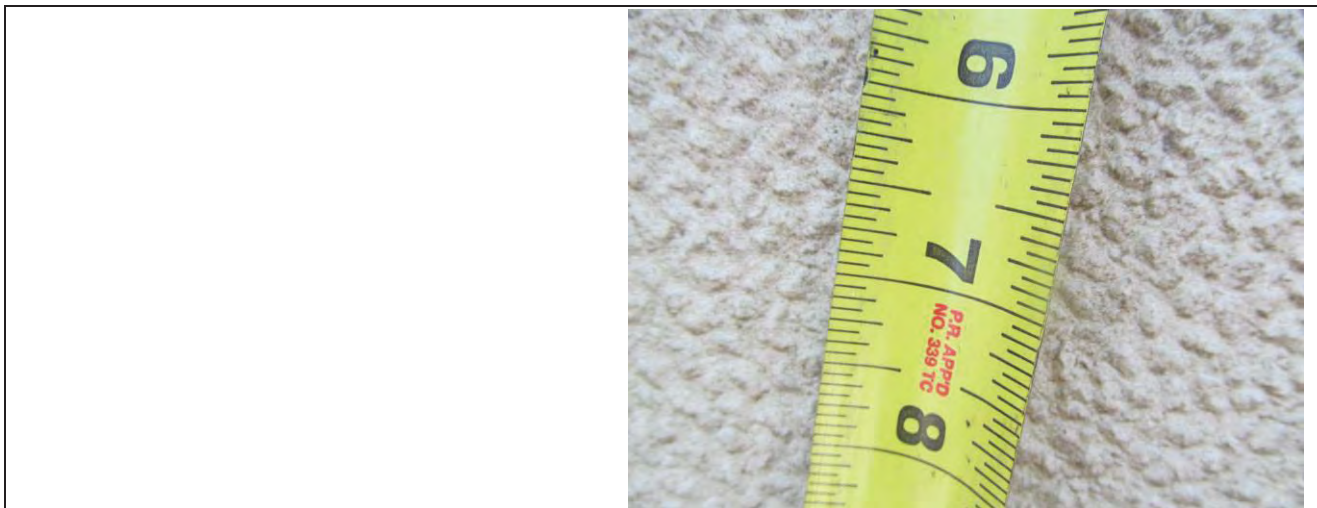
GTL | MHA, August 2016 site recordation photograph; Detail view of second floor glazing: "pebbled" translucent finish.
