HISTORICAL ASSESSMENT REPORT

**Project: Stalder Building Adaptive Reuse Design Assessment, Riverside CA,
Mission Inn Boulevard, Riverside CA 92501**

Final Document issue 26 January 2017

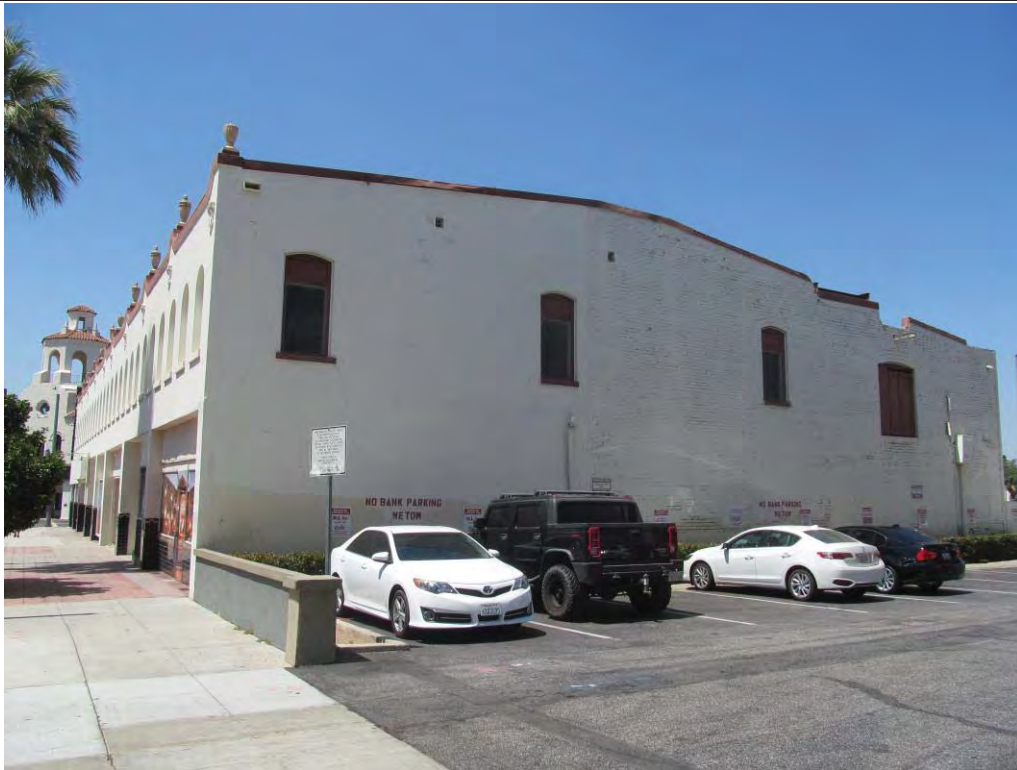
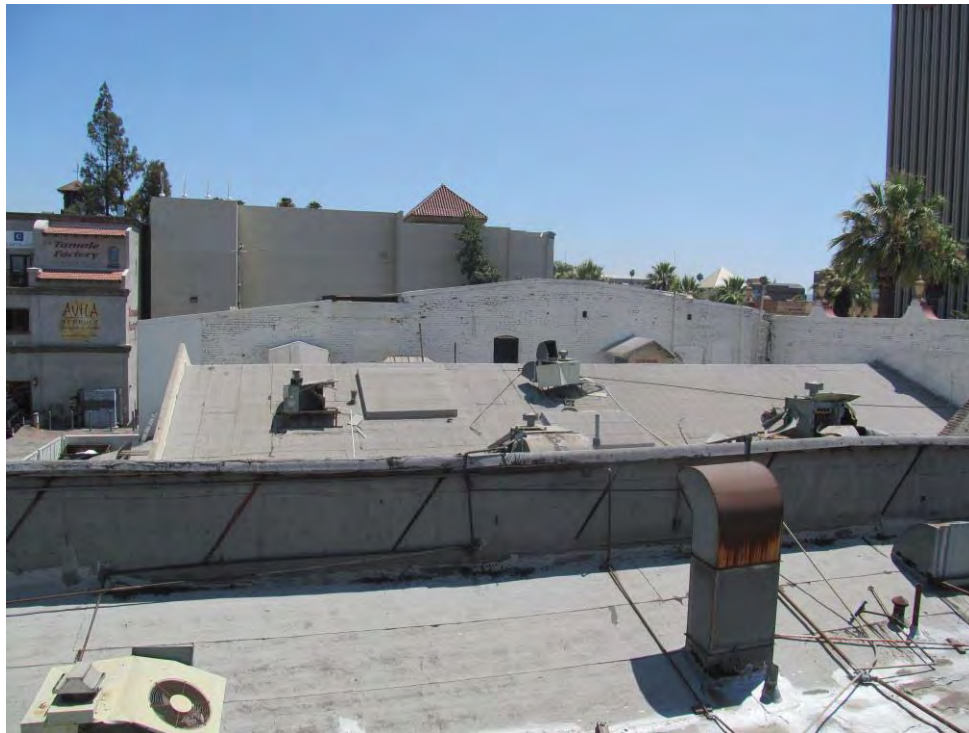
GTL | MHA, August 2016 site recordation photograph; View of east façade, from exterior alley and view to east from the roof

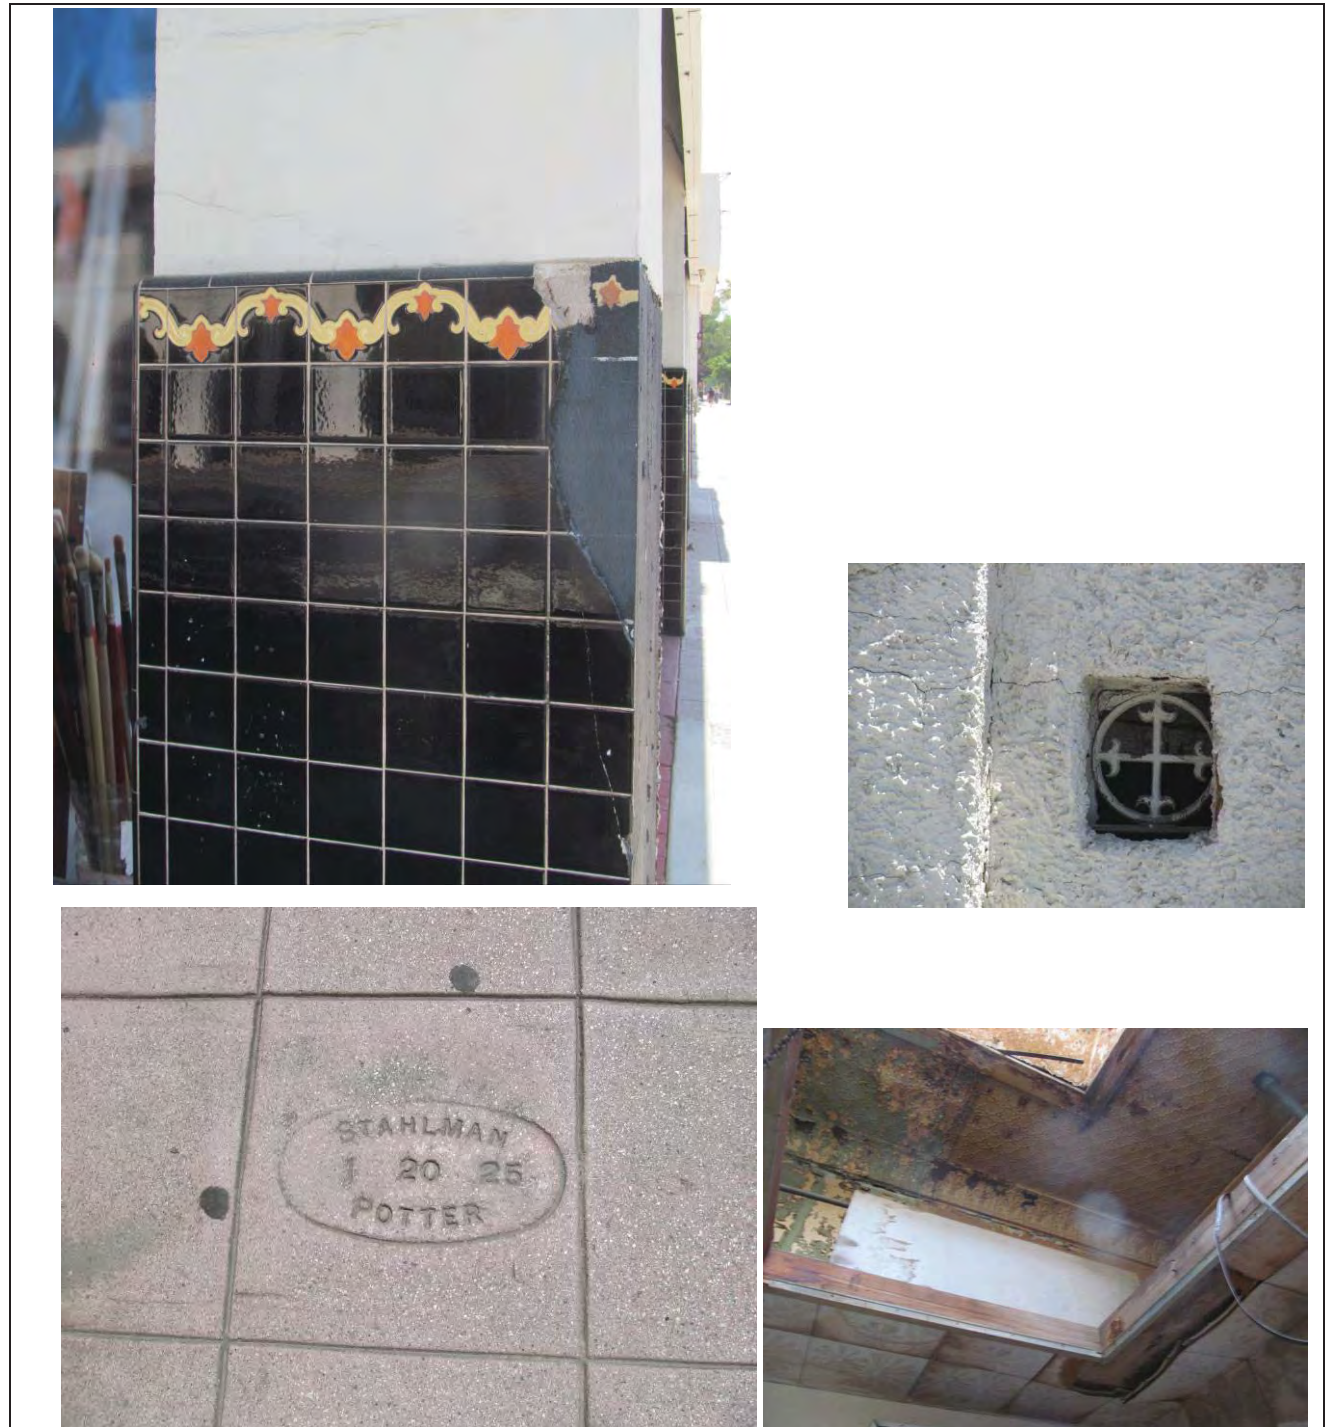
GTL | MHA, August 2016 site recordation images: Detail view of sidewalk paving stamp. Tile wainscot not considered significant. Cast attic vent at east façade to be relocated in new construction. Tin ceilings have potential reuse.

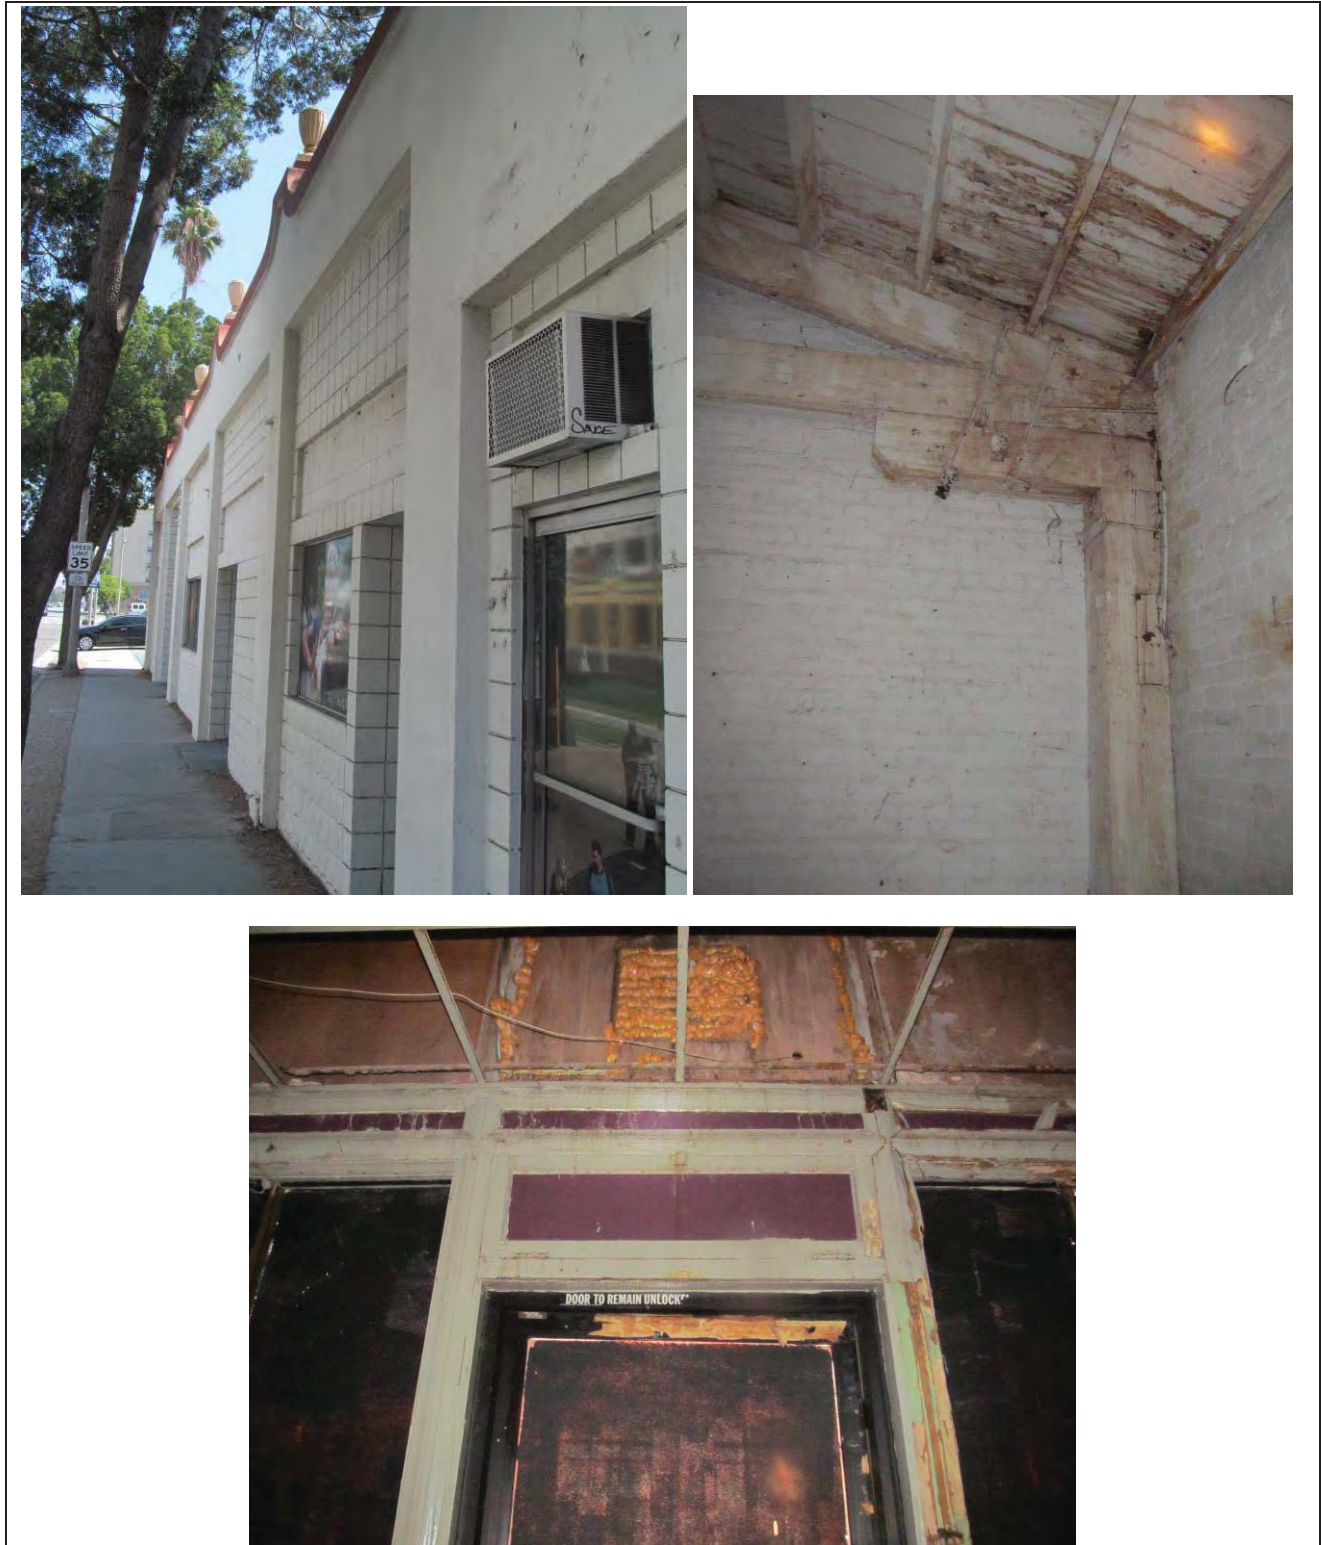
GTL | MHA, August 2016 site recordation photograph; Detail view of west façade existing storefront not dated from significant era, and presumed original G. Stanley Wilson storefront, exposed interior view & detail. Wood truss at north interior wall.
