# RIVERSIDE PUBLIC UTILITIES

## Board Memorandum

**SUBJECT:** WORK ORDER NO. 2016734 IN THE AMOUNT OF \$750,000 FOR THE FY2019/2020 WATER SERVICE LATERAL REPLACEMENT PROGRAM

# WATER SERVICE LATERAL REPLACEMENT PROGRAM

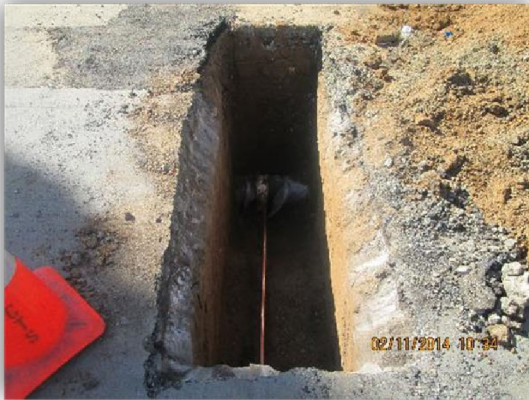
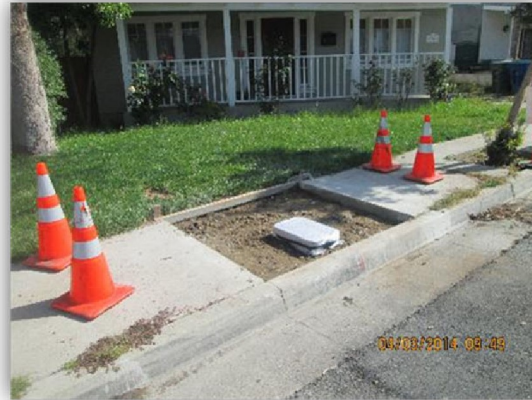
3

1. Service laterals fail due to age, quality of material, and corrosion
2. Life expectancy is approximately 30-40 years
3. The same service lateral may fail at multiple locations and at different times.
