Phase I Environmental Site Assessment

Riverside Tennis Center

5695 Glenhaven Avenue

June 11, 2015

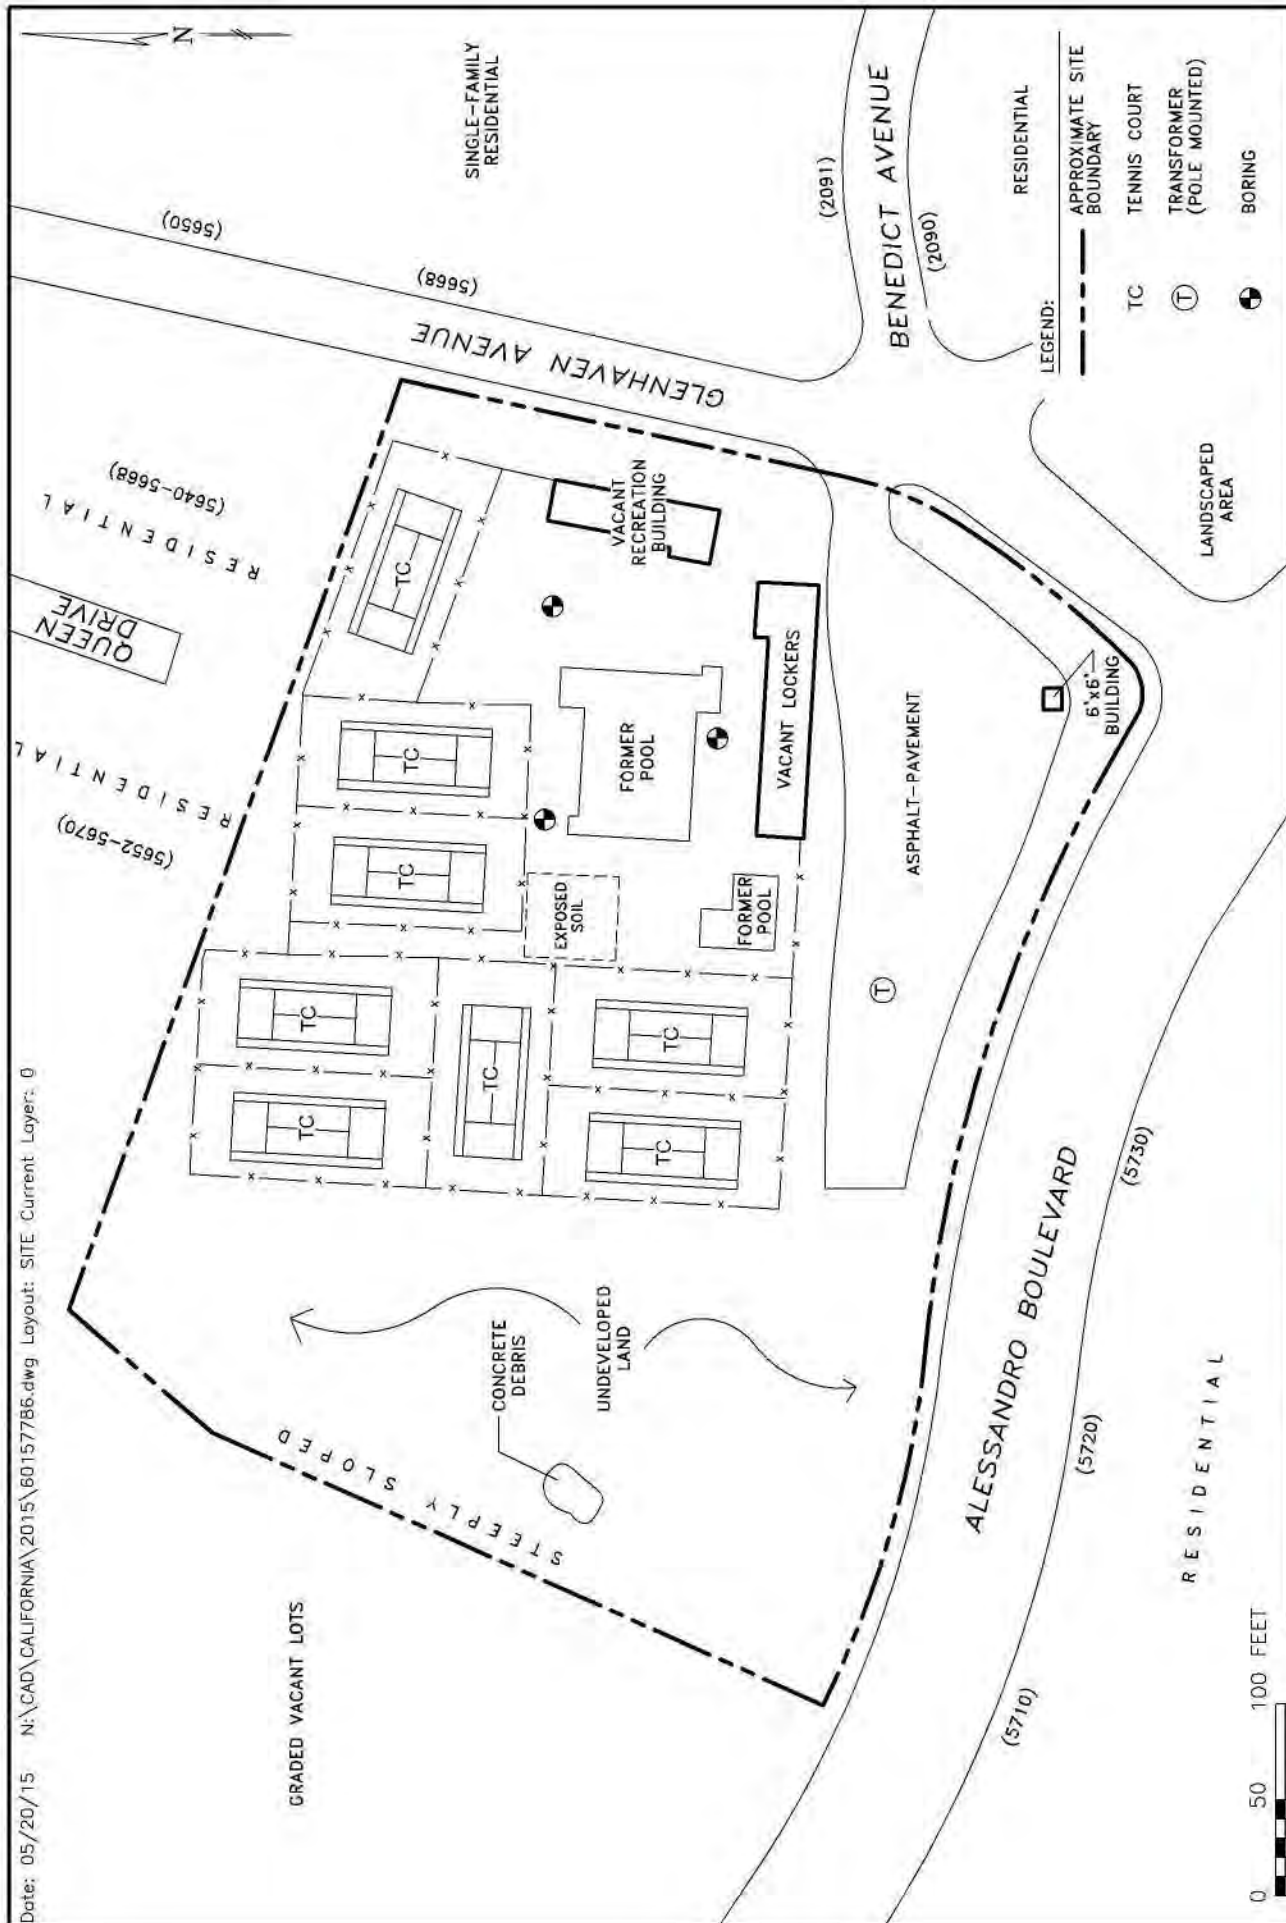
EXHIBIT <div style="font-size: 2em; float: right;">2</div>	
SITE DIAGRAM RIVERSIDE TENNIS CENTER 5695 GLENHAVEN AVENUE RIVERSIDE, RIVERSIDE COUNTY, CALIFORNIA	
<div style="text-align: right;"> </div> Consulting Engineers and Scientists 2817 MCGAW AVENUE IRVINE, CALIFORNIA 92614 PH: (949) 261-0051 FAX: (949) 261-0110	
Project No: 60157786 Scale: AS SHOWN Date: 05/08/2015	Project Mgr: JSV Drawn By: DLC Checked By: JSV Approved By: JSV
THIS DRAWING SHOULD NOT BE USED SEPARATELY FROM ORIGINAL REPORT.

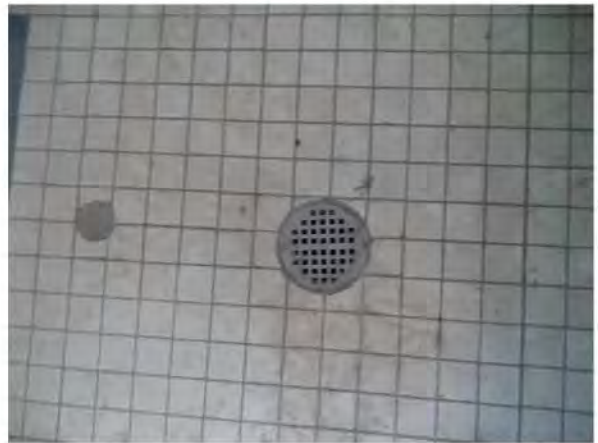
Interior floor drains were observed at the following site locations: showers and restrooms. According to Mr. Wuo, the floor drains discharge to the city sanitary sewer. Staining and/or releases to the floor drains was not observed during the site reconnaissance. Potentially hazardous materials did not appear to be stored in the vicinity of the floor drains. Based on site observations, the interior floor drains do not constitute a REC.

Photo #10 View of the floor drain located in the shower area.

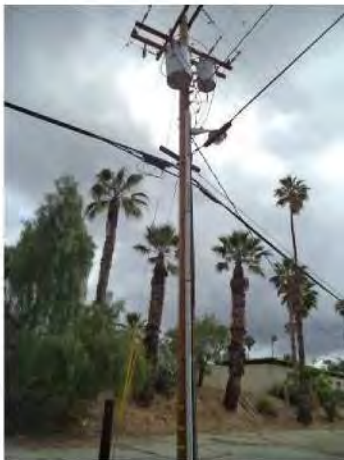
Photo #11 View of the pole-mounted transformer located on the south portion of the site.

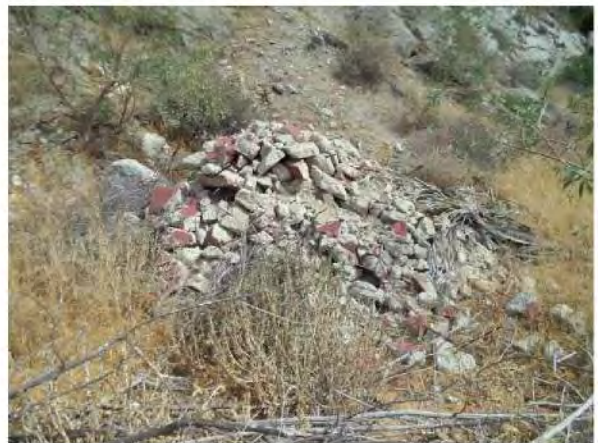
During the site reconnaissance, interior floor drains, one pole-mounted transformer, approximately two cubic yards of debris (concrete rubble, PVC piping, wood, and gardening pots), two filled pools, and three six inch circular patches were observed. Indications of RECs were not observed.

Photo #12 View of the concrete rubble located on the west portion of the site.

Based on the identified undocumented fill and construction-related debris, Terracon recommends if soil or groundwater at the site is to be disturbed during future excavations, proper procedures should be followed with respect to worker health and safety, and any affected soil or groundwater encountered should be properly managed and disposed in accordance with local and state regulations. In addition, Terracon recommends that a qualified environmental professional oversee excavation activities of the undocumented backfill reported on the western and southwestern portions of the site to identify the need for alternative soil management or sampling and analysis.

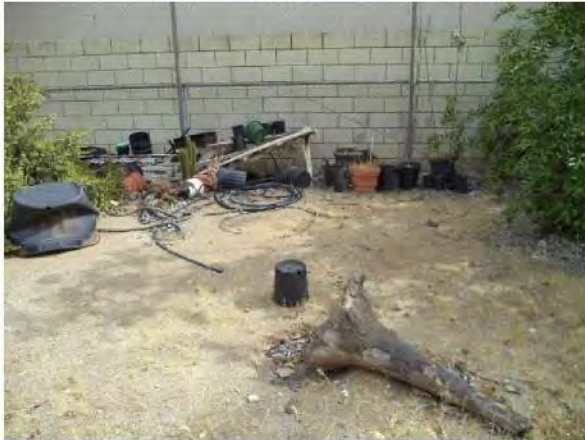
Photo #13 View of gardening pots located on the northern portion of the site.

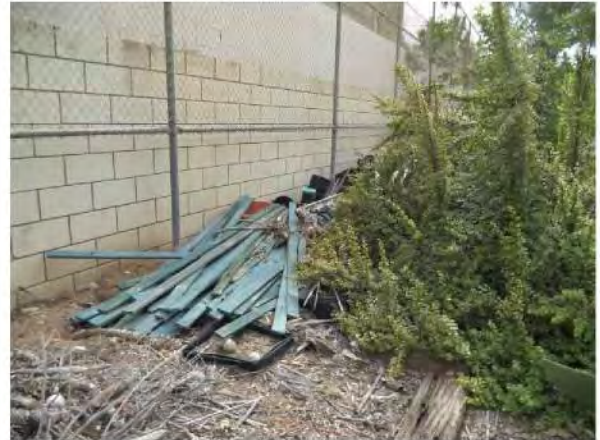
Photo #14 View of wood debris located on the northern portion of the site.

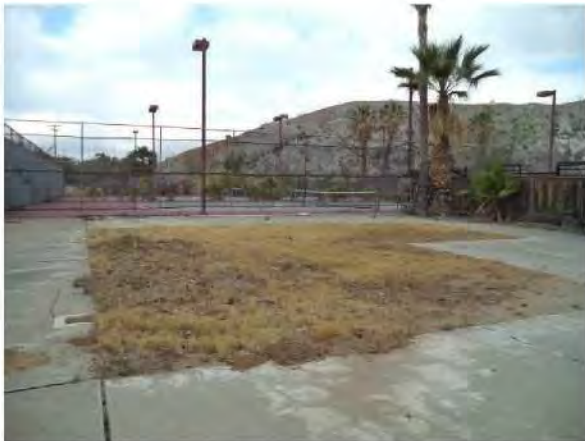
Photo #15 View of a former pool located on the central-south portion of the site.

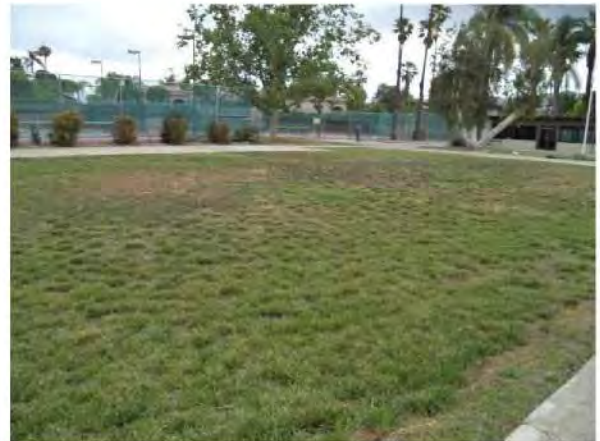
Photo #16 View of the former pool located on the central-east portion of the site.

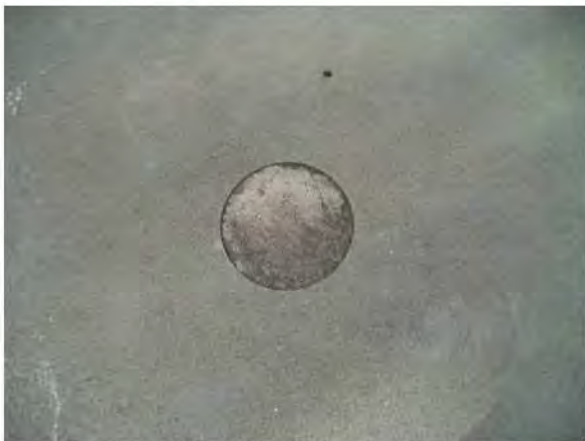
- At the time of the site reconnaissance, the 6'x6' building on the southern portion of the site was locked and inaccessible.
- Based on observations made during the site reconnaissance, three 6-inches soil borings were observed. The purpose of these borings was not identified based on interviews conducted with the current owner.

Photo #17 View of a circular concrete patch located in the vicinity of the former pool area.

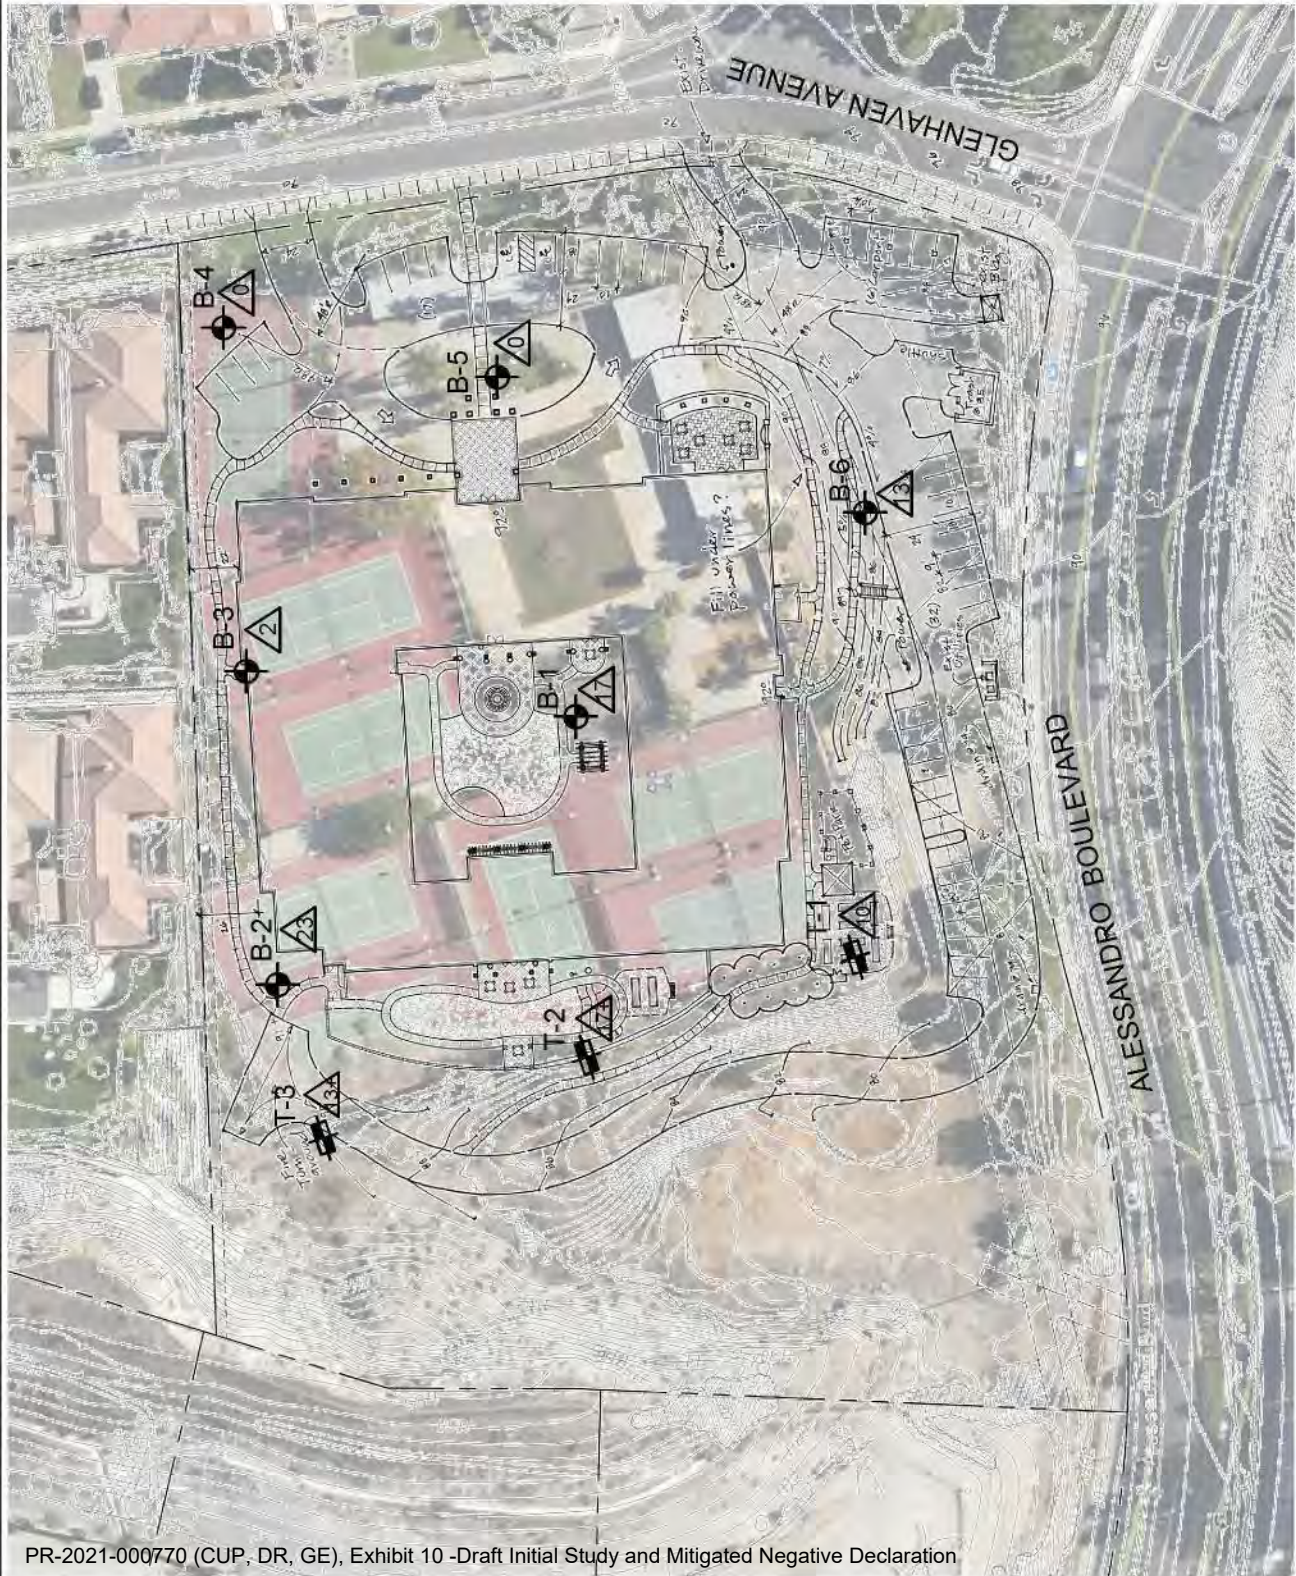
BORING AND TRENCH LOCATION PLAN	
PROPOSED SENIOR HOUSING	
RIVERSIDE, CALIFORNIA	
SCALE 1" = 50'	 
DRAWN: DRK	
CHECK: GRM	
SOG PROJECT 155150-1	
PLATE 2

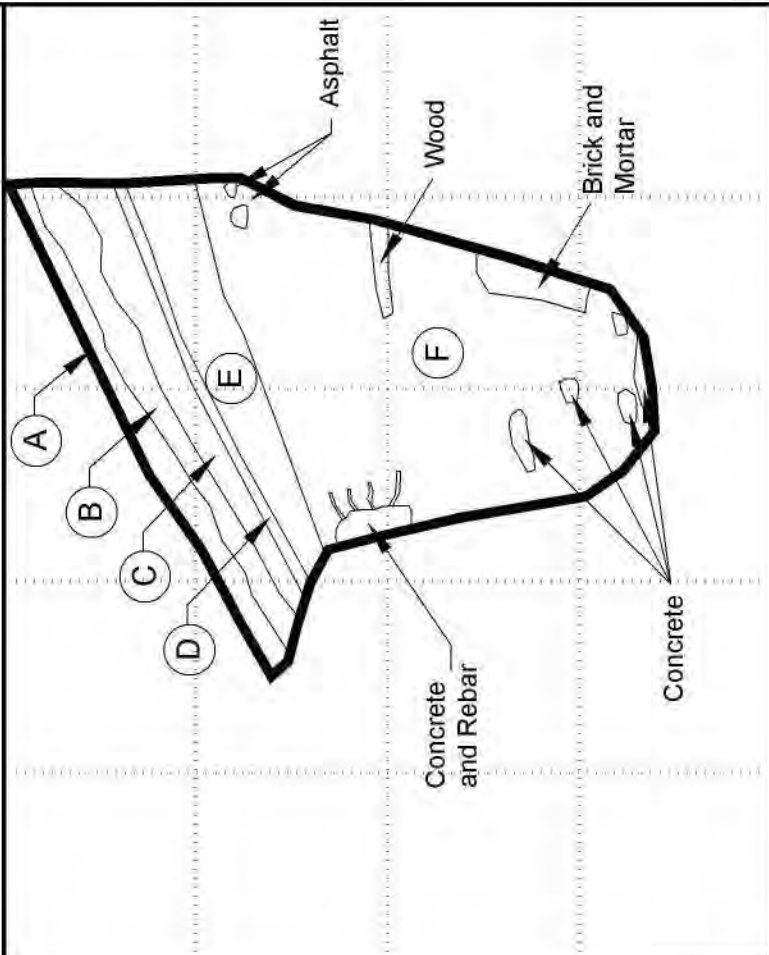
PLATE B-8

JOB NO.: 15G150-1	EQUIPMENT USED: Backhoe	WATER DEPTH: Dry
PROJECT: Proposed Senior Housing	LOGGED BY: Daryl Kas	SEEPAGE DEPTH: Dry
LOCATION: Riverside, CA	ORIENTATION: N 90 E	READINGS TAKEN: At Completion
DATE: 05-12-2015	ELEVATION: 1090 feet msl

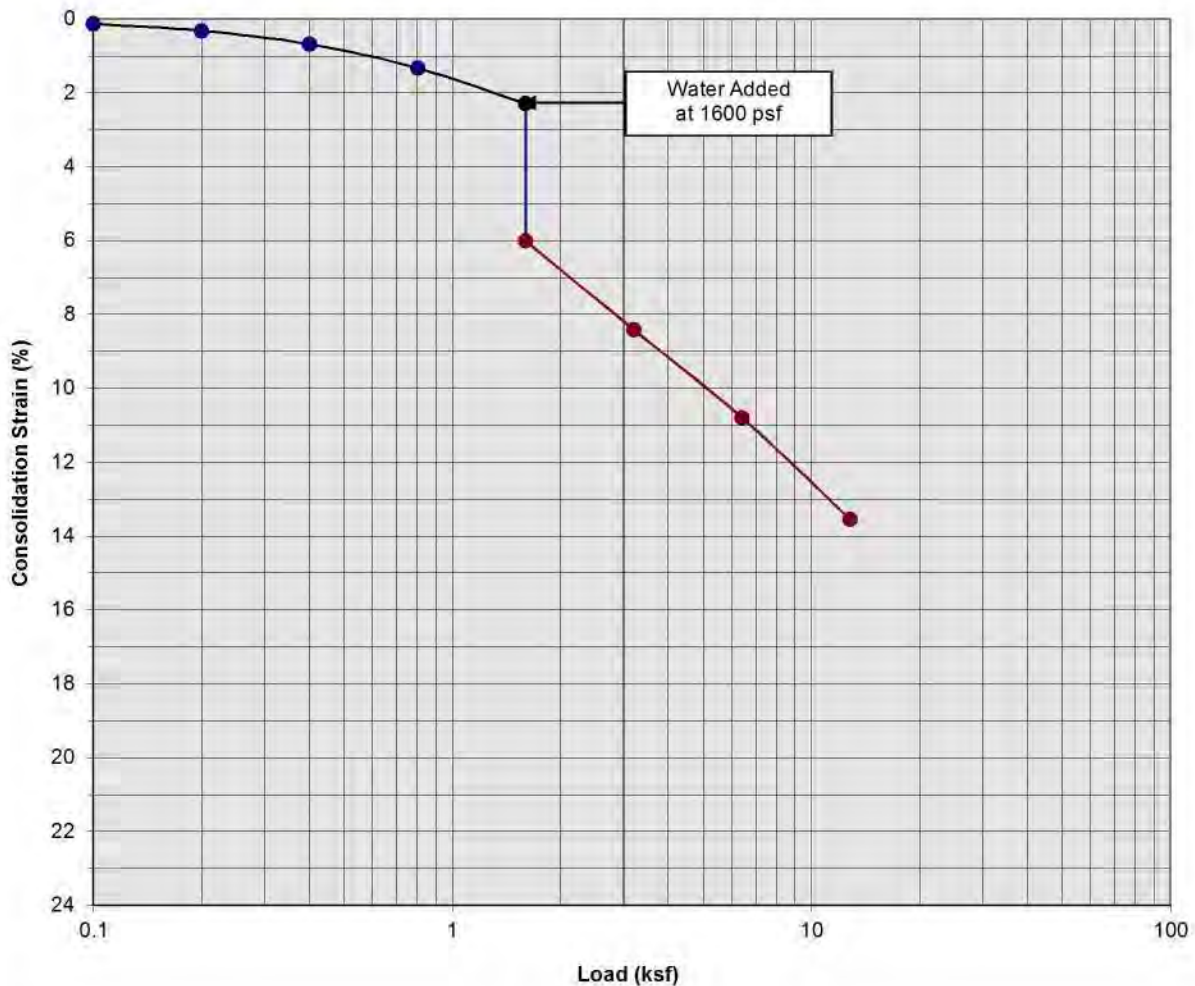
Classification: FILL: Gray Brown fine to medium Sand, trace coarse Sand

Boring Number:	B-2	Initial Moisture Content (%)	8
Sample Number:	---	Final Moisture Content (%)	15
Depth (ft)	1 to 2	Initial Dry Density (pcf)	109.2
Specimen Diameter (in)	2.4	Final Dry Density (pcf)	125.9
Specimen Thickness (in)	1.0	Percent Collapse (%)	3.72

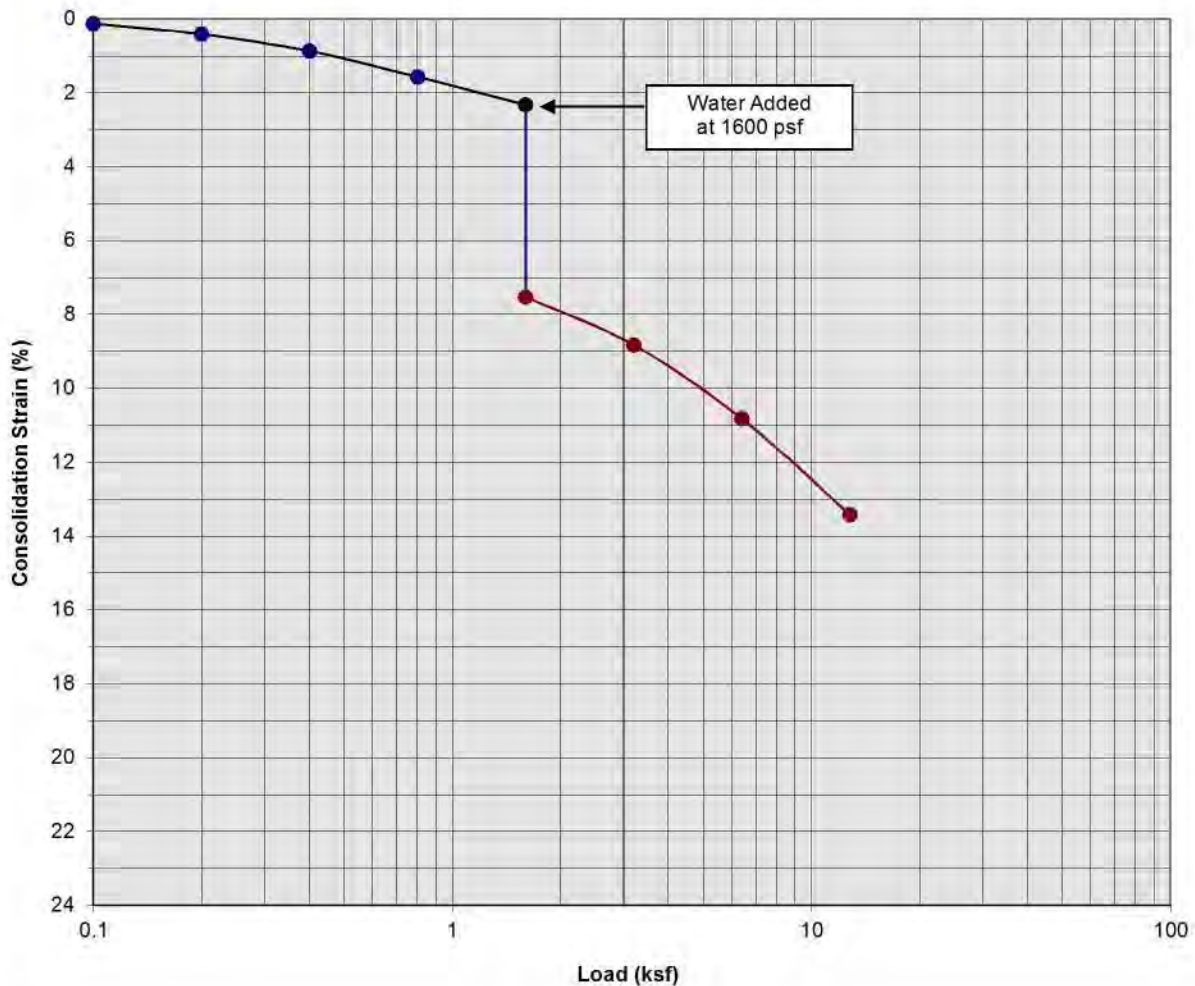
Classification: FILL: Dark Brown Silty fine Sand, trace medium Sand

Boring Number:	B-2	Initial Moisture Content (%)	8
Sample Number:	---	Final Moisture Content (%)	18
Depth (ft)	5 to 6	Initial Dry Density (pcf)	101.8
Specimen Diameter (in)	2.4	Final Dry Density (pcf)	116.2
Specimen Thickness (in)	1.0	Percent Collapse (%)	5.20

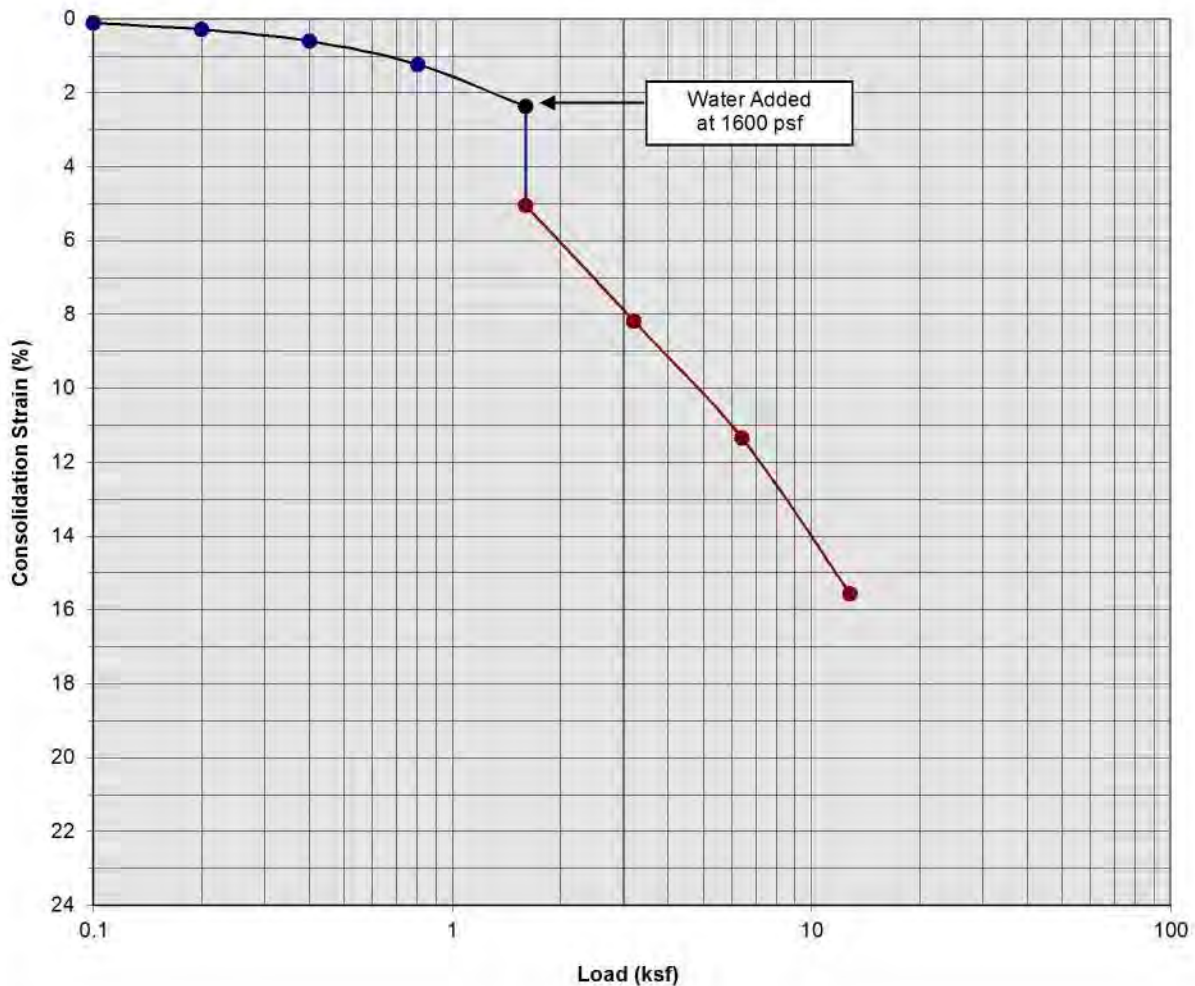
Classification: FILL: Dark Brown Silty fine Sand, trace medium Sand

Boring Number:	B-2	Initial Moisture Content (%)	10
Sample Number:	---	Final Moisture Content (%)	25
Depth (ft)	7 to 8	Initial Dry Density (pcf)	86.5
Specimen Diameter (in)	2.4	Final Dry Density (pcf)	102.4
Specimen Thickness (in)	1.0	Percent Collapse (%)	2.68

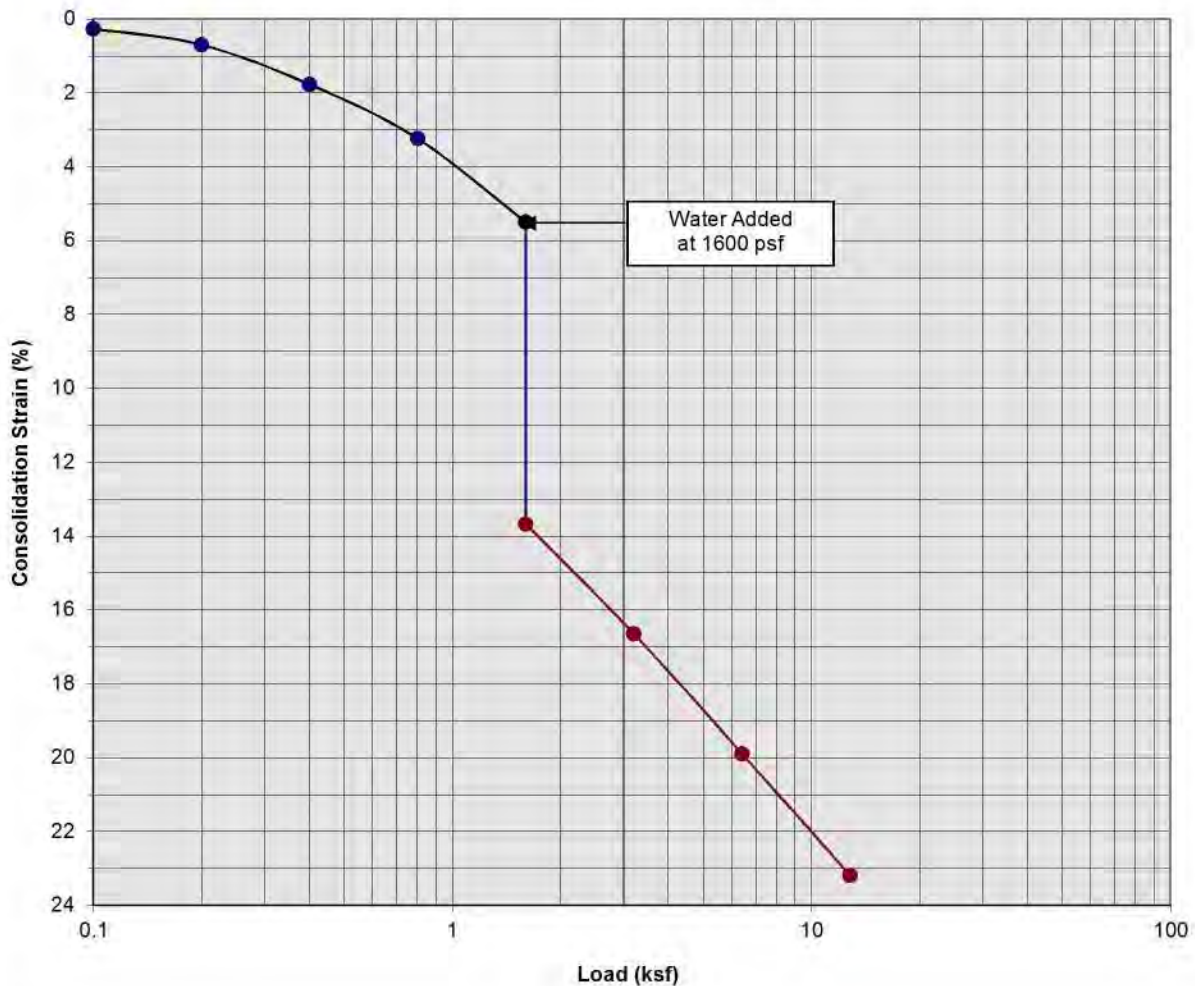
Classification: FILL: Dark Brown Silty fine Sand, trace medium Sand

Boring Number:	B-2	Initial Moisture Content (%)	27
Sample Number:	---	Final Moisture Content (%)	17
Depth (ft)	9 to 10	Initial Dry Density (pcf)	81.4
Specimen Diameter (in)	2.4	Final Dry Density (pcf)	106.1
Specimen Thickness (in)	1.0	Percent Collapse (%)	8.18

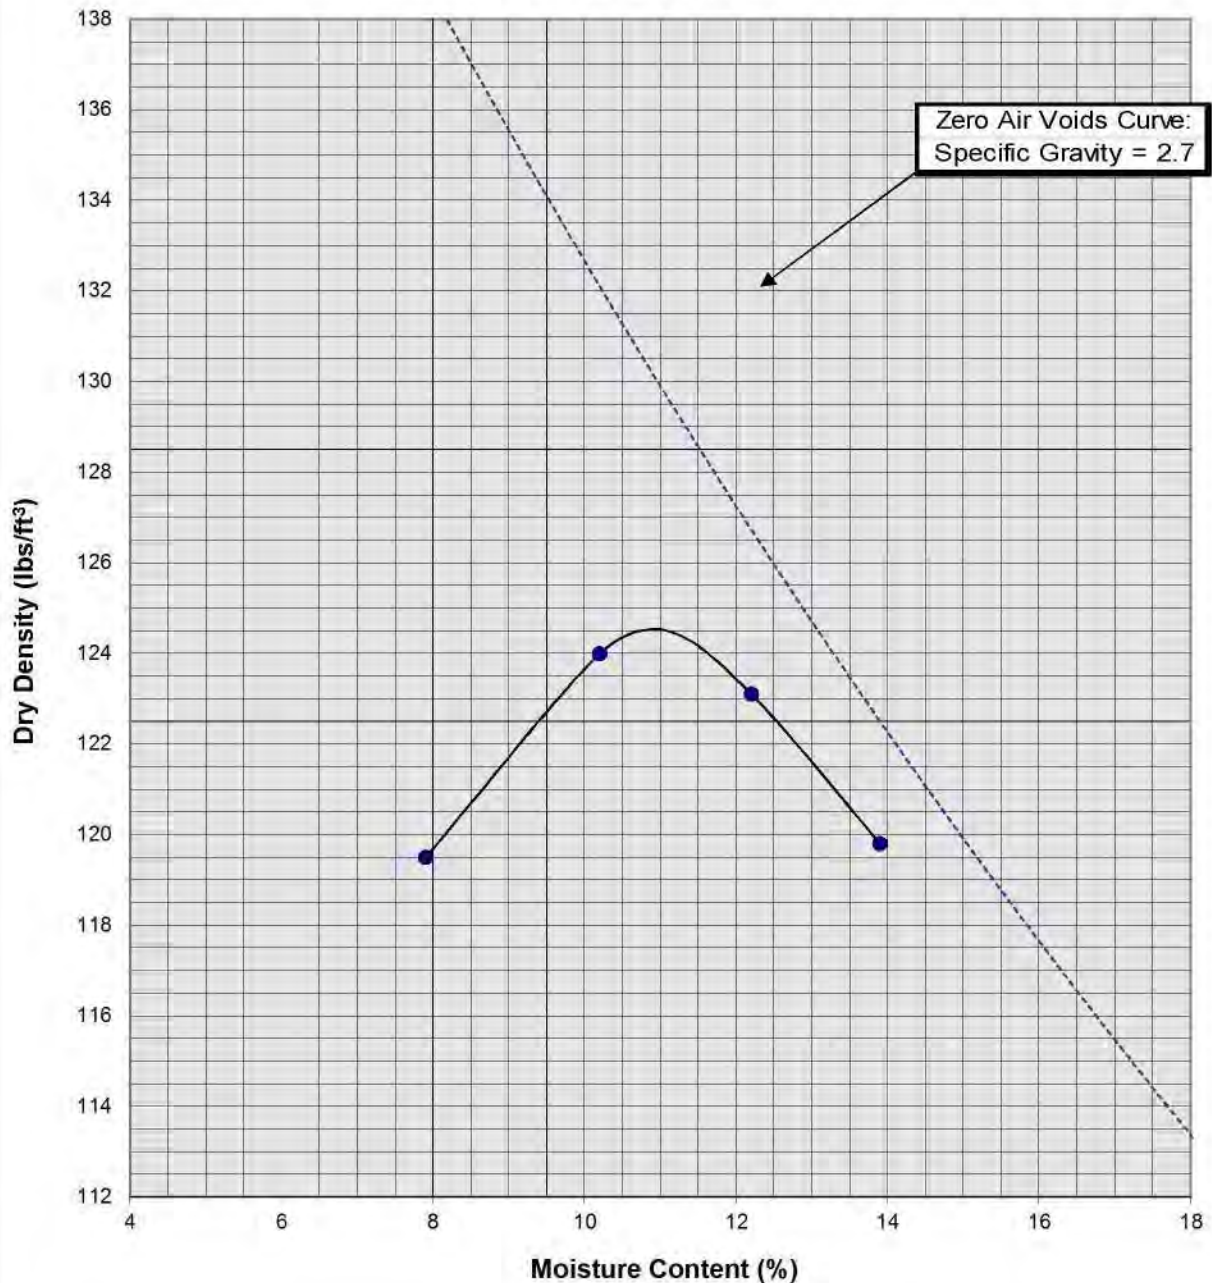
Oakmont Senior Housing
Riverside, California
Project No. 15G150
PLATE C-5

Soil ID Number	B-2 @ 0 to 5'
Optimum Moisture (%)	11
Maximum Dry Density (pcf)	124
Soil Classification	Gray Brown to Dark Brown Silty fine Sand, trace fine Gravel

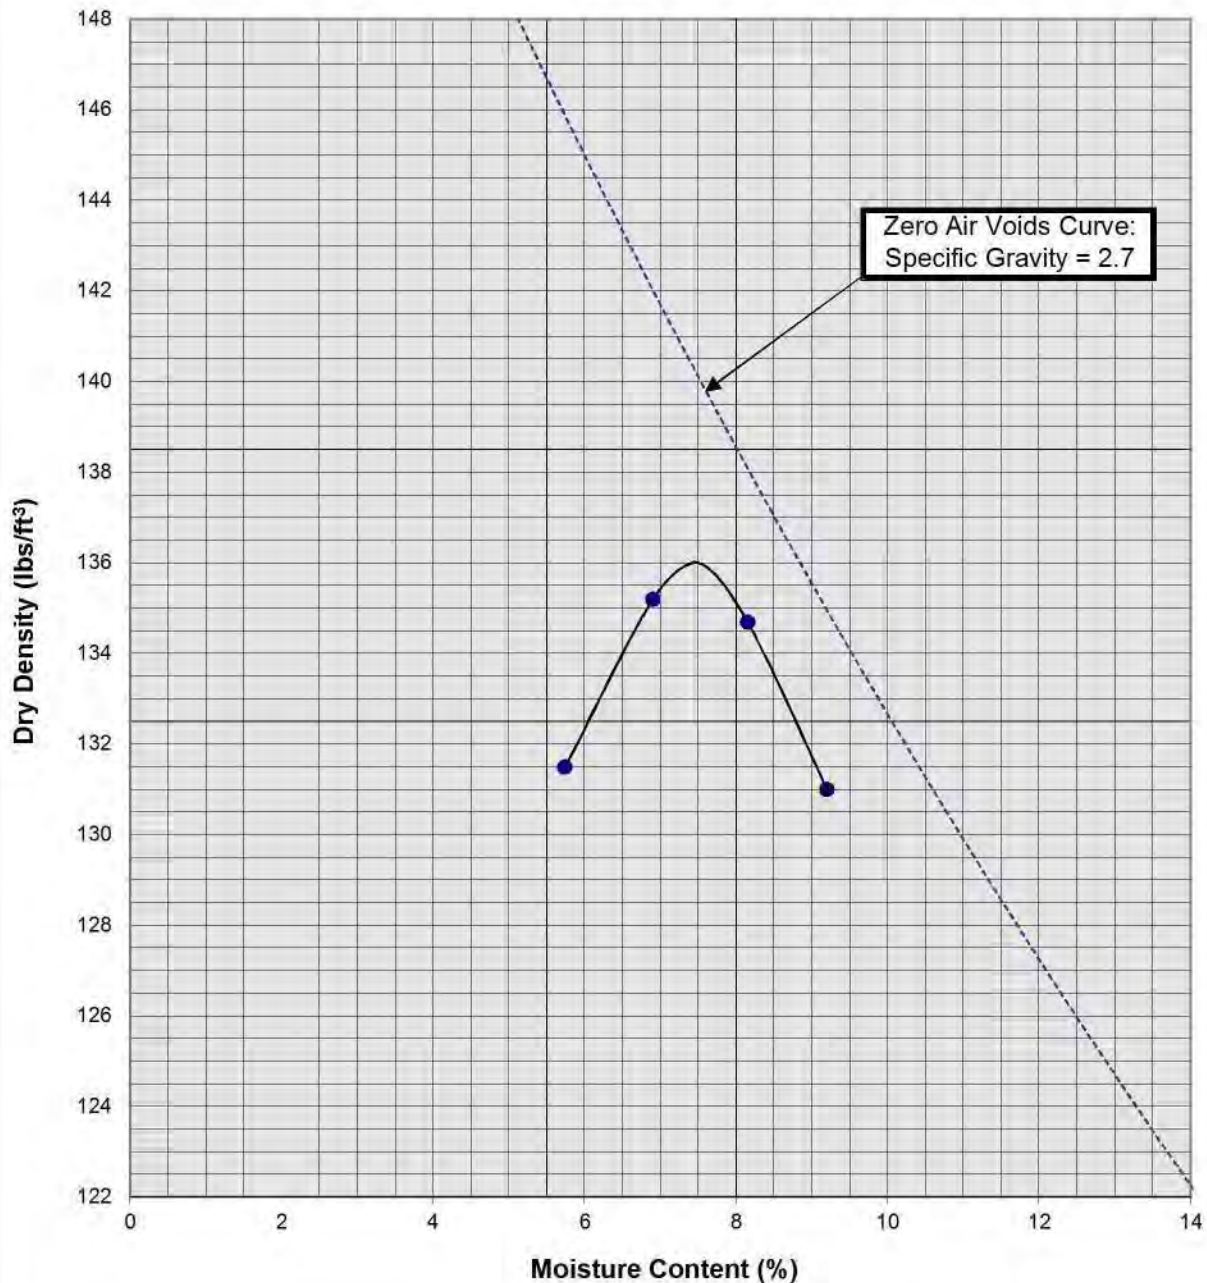
Oakmont Senior Housing
Riverside, California
Project No. 15G150
PLATE C-6

Soil ID Number	B-6 @ 0 to 5'
Optimum Moisture (%)	7.5
Maximum Dry Density (pcf)	136
Soil Classification	Brown Silty fine Sand, trace Gravel

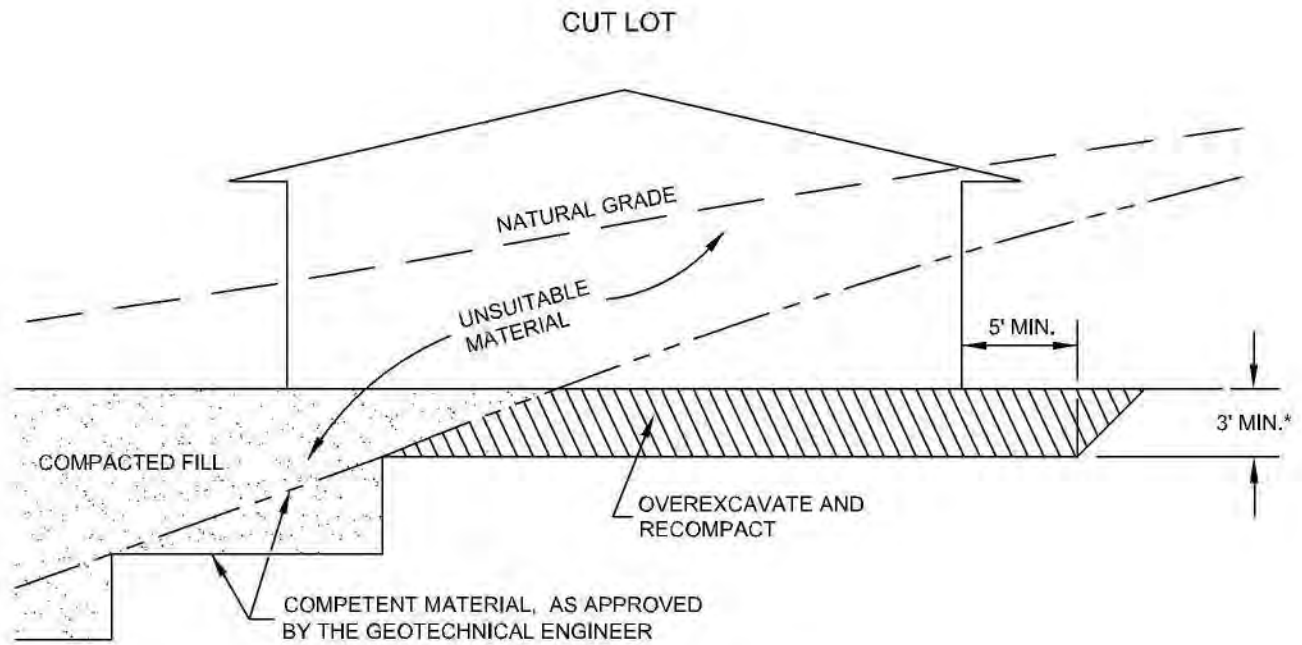
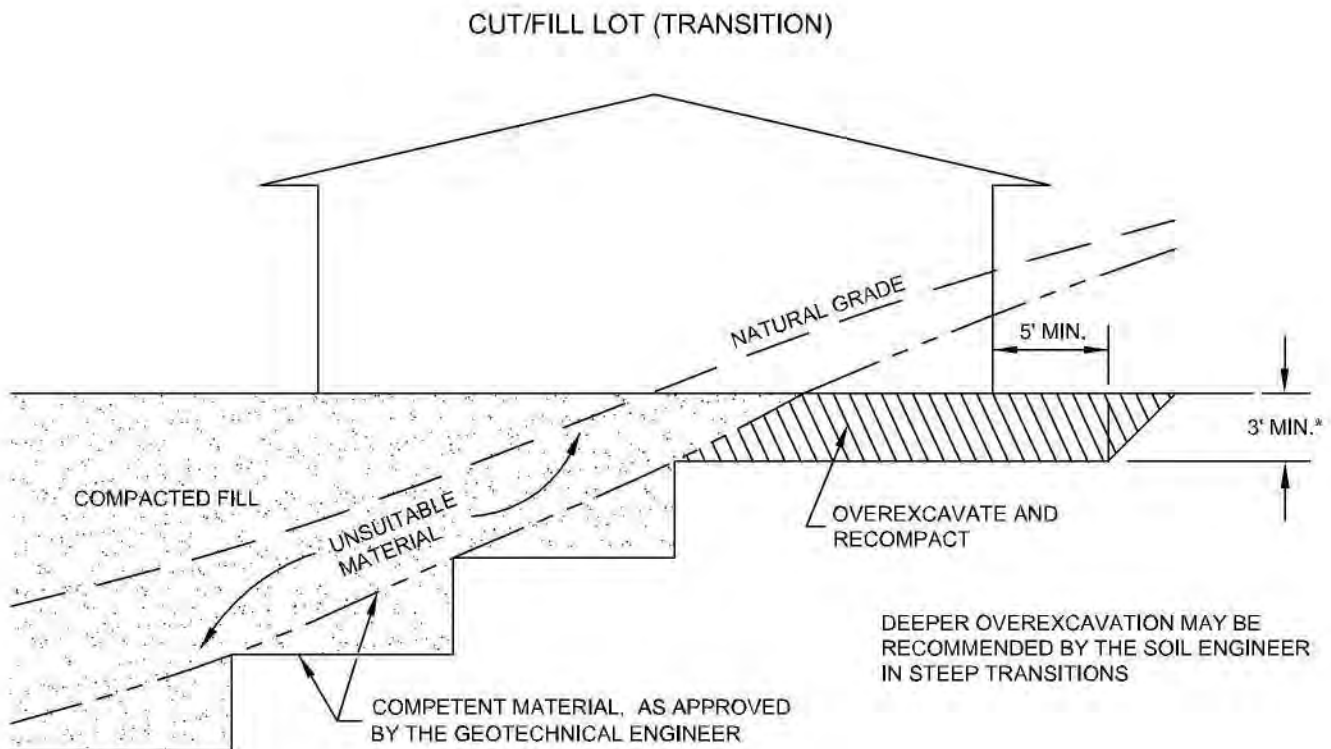
*SEE TEXT OF REPORT FOR SPECIFIC RECOMMENDATION.
ACTUAL DEPTH OF OVEREXCAVATION MAY BE GREATER.

TRANSITION LOT DETAIL	
GRADING GUIDE SPECIFICATIONS	
NOT TO SCALE	  SOUTHERN CALIFORNIA GEOTECHNICAL
DRAWN: JAS	
CHKD: GKM	
PLATE D-1

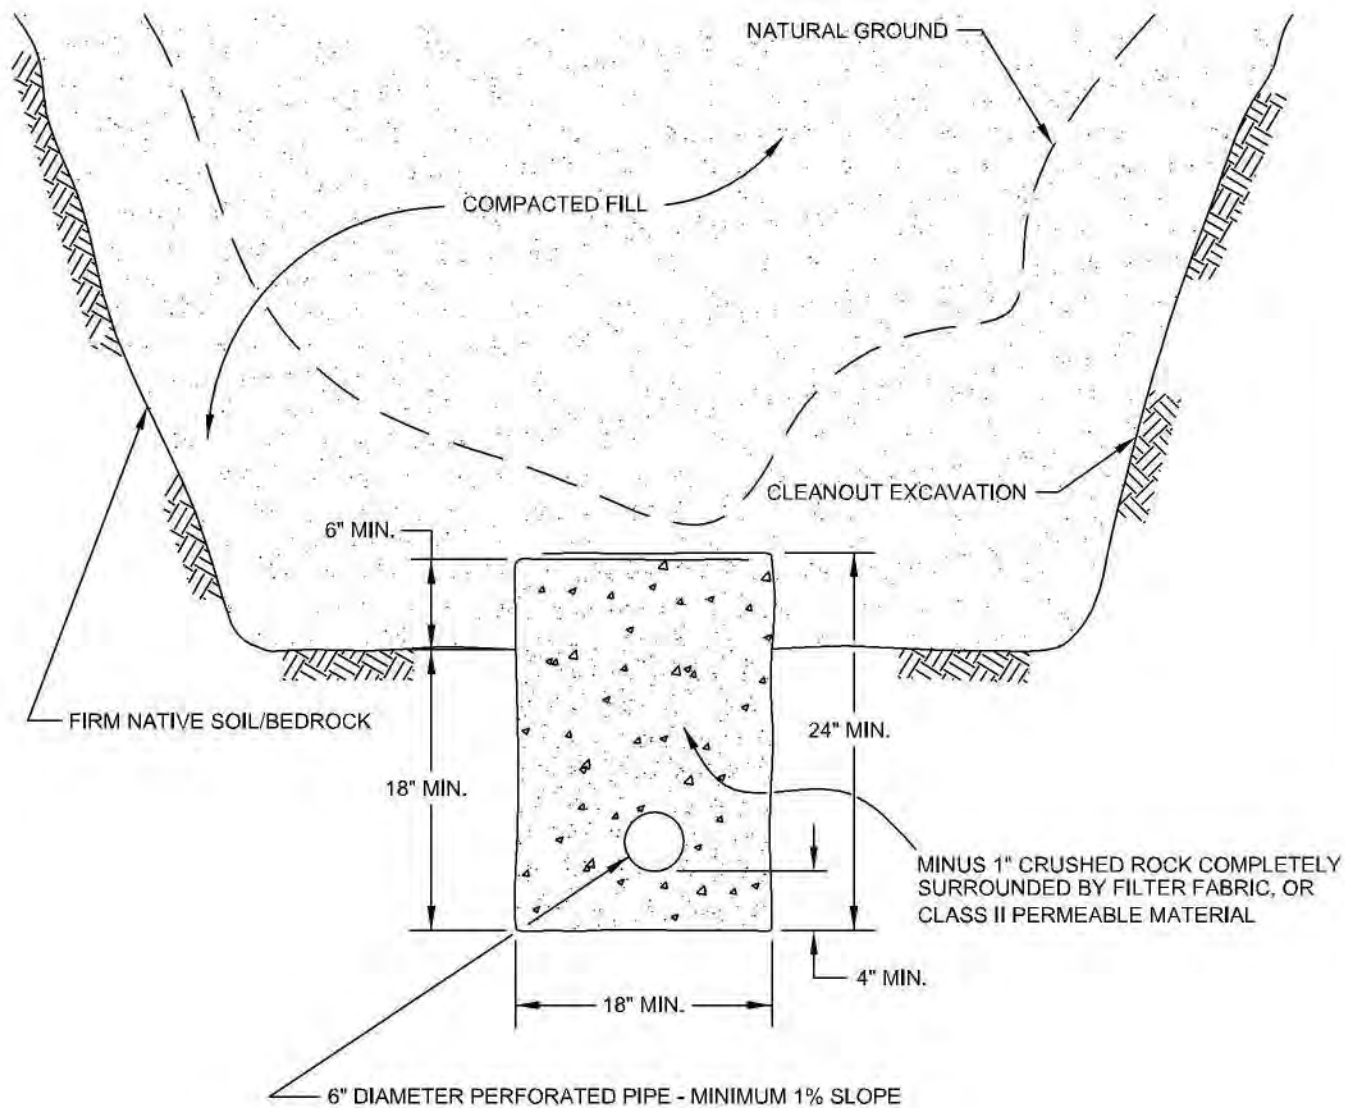
PIPE MATERIAL	DEPTH OF FILL OVER SUBDRAIN
ADS (CORRUGATED POLETHYLENE)	8
TRANSITE UNDERDRAIN	20
PVC OR ABS: SDR 35	35
SDR 21	100

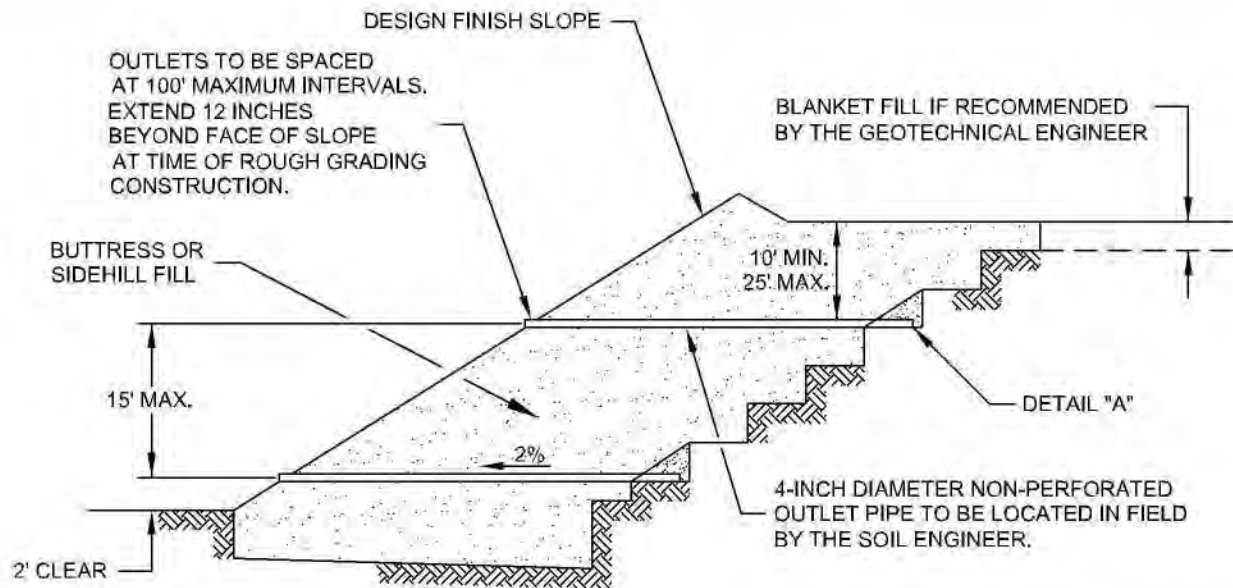
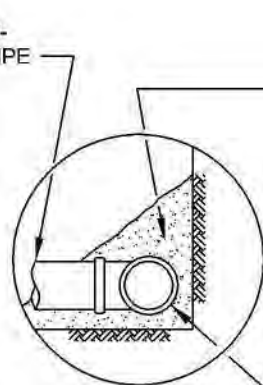
DETAIL "A"

"FILTER MATERIAL" TO MEET FOLLOWING SPECIFICATION OR APPROVED EQUIVALENT: (CONFORMS TO EMA STD. PLAN 323)

OUTLET PIPE TO BE CONNECTED TO SUBDRAIN PIPE WITH TEE OR ELBOW

FILTER MATERIAL - MINIMUM OF FIVE CUBIC FEET PER FOOT OF PIPE. SEE ABOVE FOR FILTER MATERIAL SPECIFICATION.
