Subject: Orangecrest Community Church Air Quality and Greenhouse Gas Emissions

**GEOTECHNICAL INVESTIGATION  
PROPOSED ORANGECREST COMMUNITY  
CHURCH CAMPUS**

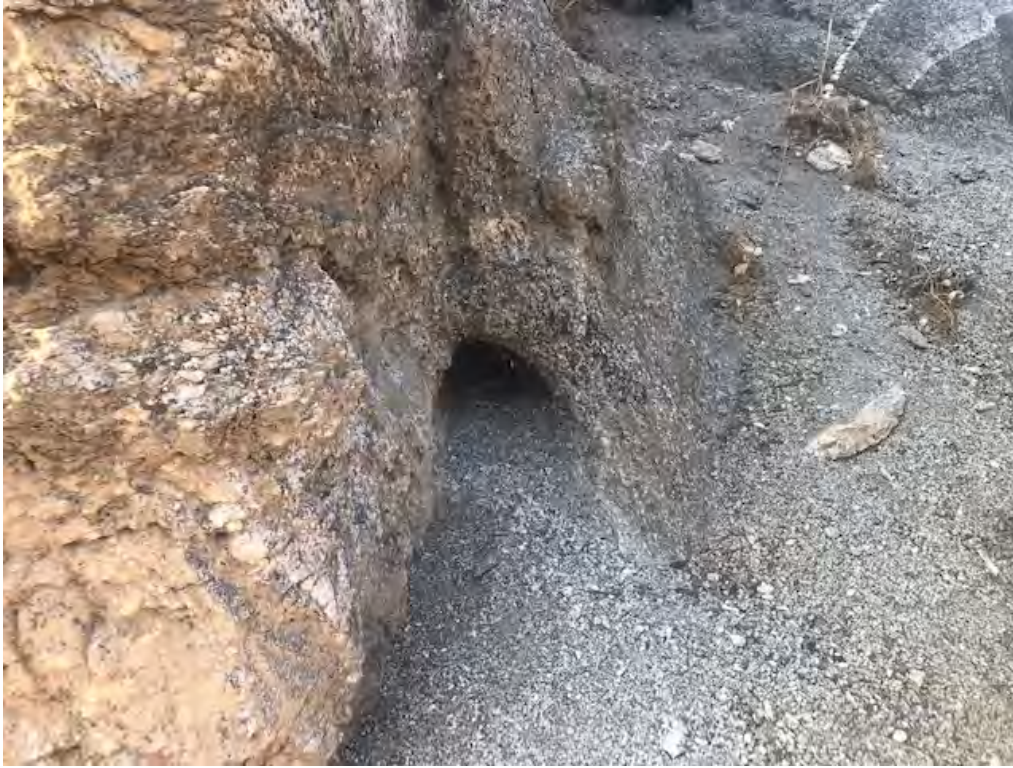
**Photo 1.** Ground squirrel burrow along the cliff face.

Wildlife species observed on site include house finch (*Carpodacus mexicanus*), common raven (*Corvus corax*), Anna's hummingbird (*Calypete anna*), and lesser goldfinch (*Spinus psaltria*). California ground squirrel (*Otospermophilus beecheyi*) burrows were found at the southern base of the cliff on site.

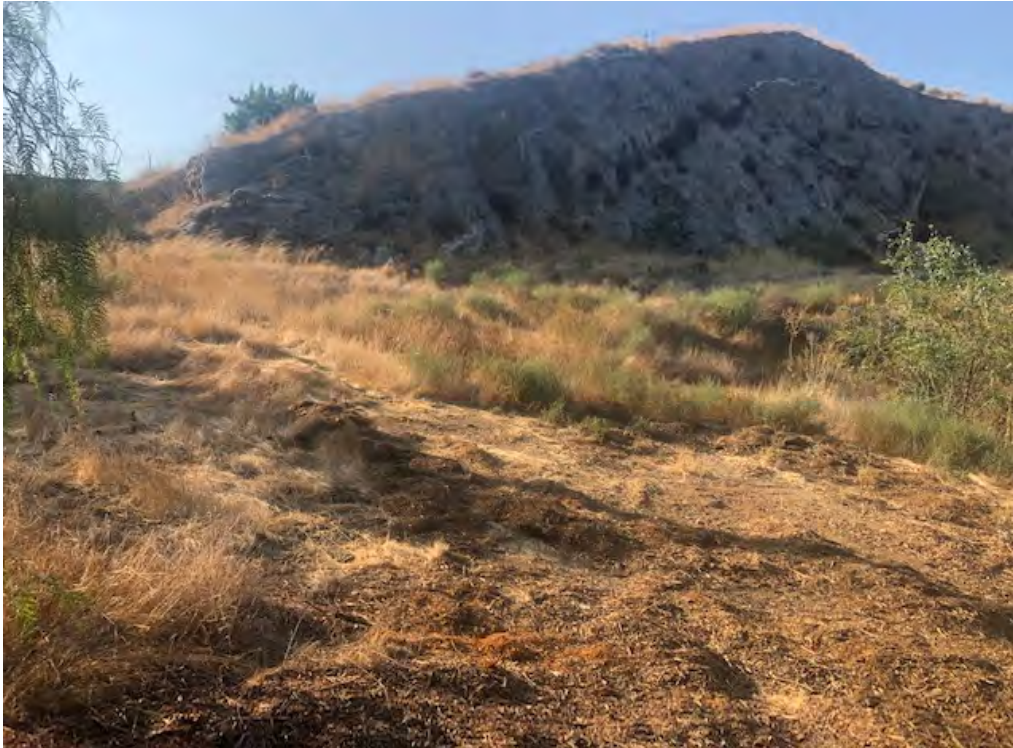
**Photo 2.** West-facing shot of the cliff face on site in the undeveloped portion of the parcel

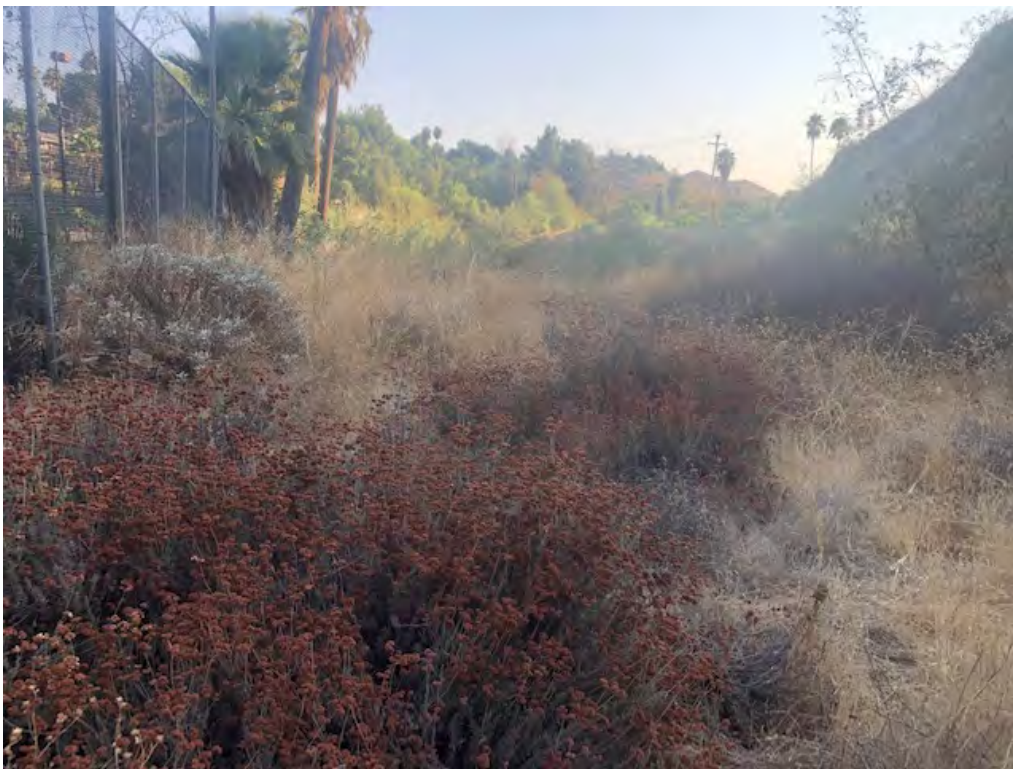
**Photo 4.** Coastal scrub species in the north portion of the undeveloped area.
