IMPACTS ASSESSMENT FOR THE DEVELOPMENT OF AC/MARRIOTT RESIDENCE INN DUAL BRANDED HOTEL, RIVERSIDE, CALIFORNIA

August 2021

ICF. 2021. *Impacts Assessment for the Development of AC/Marriott Residence Inn Dual Branded Hotel, Riverside, California*. August. (ICF 352.21.) Los Angeles, CA. Prepared for Greens INV 10.

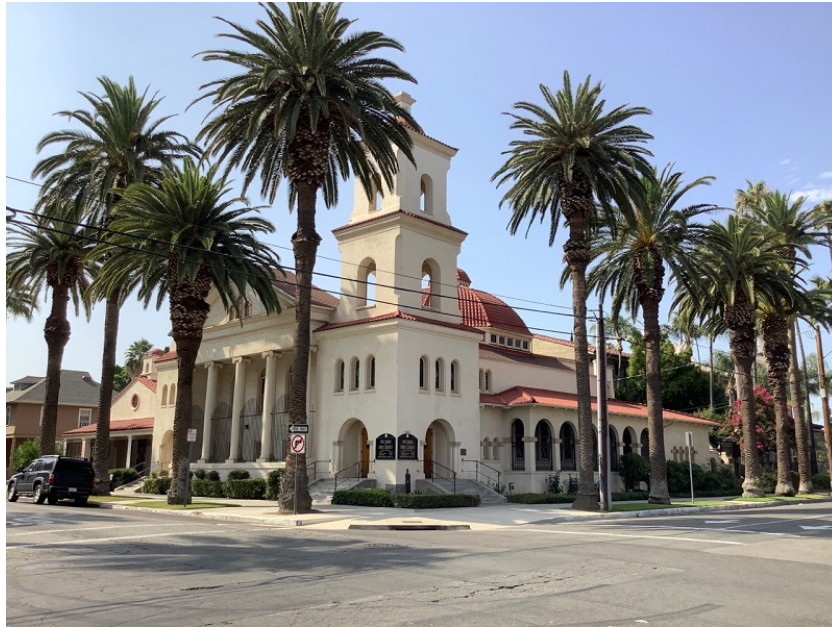
The First Church of Christ, Scientist is a rectangular, stucco-clad Classical and Mission Revival-style church that dates to 1900 and displays some elements of classical architecture (Figure 4). The primary (northwest) elevation facing Lemon Street features an arched loggia flanked by a set of three and four arched stained glass windows. Ionic capital embellishments accompany both the loggia and the windows. A red tile-clad dome rises from the church's roof, with square stained glass windows at its base. A cupola caps the church's dome. A tower completes the elevation to the north. It includes a recessed pedestrian entrances at the ground level with arched windows and arched openings in the upper stories. A small, red tile-clad dome caps the tower, which is also articulated on the side (northeast) elevation.

The side (northeast) elevation consists of an Ionic columned portico supporting a pediment with three arched stained glass windows and addresses Sixth Street. Composite shingles cap the pediment. Set within the portico, three windows punctuate the church's wall. Mission styles towers flank the classical portico. The eastern tower rises three stories while the western tower

rises four. Both contain recessed pedestrian entrances at the ground level with arched windows and arched openings in the upper stories. A small, red tile-clad dome caps each tower.

Figure 4. First Church of Christ, Riverside, view south. ICF, 2021.

Historically significant for its Classic and Mission Revival style, the proposed project will not impact the church's character-defining features which all convey its architectural style. The proposed project will not physically alter, damage, or destroy the First Church of Christ, Scientist in part or in its entirety. Given the type of construction proposed at the project site and the approximate 325 foot distance between the two locations, it is not anticipated that the historical resource will be damaged due to vibration from construction.

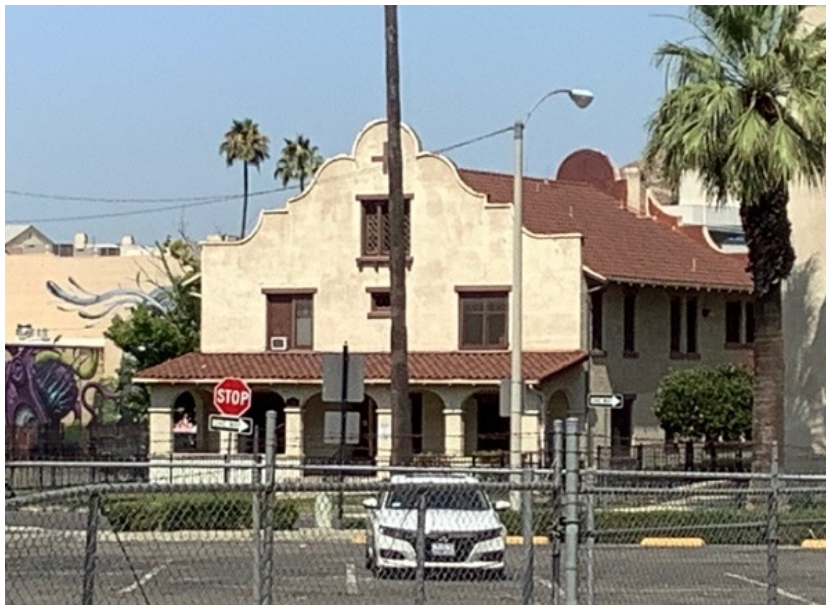
First Congregational Church of Riverside Parsonage is a rectangular, stucco clad Mission Revival building that dates to 1905 (Figure 5). Associated with the First Congregational Church of Riverside, the owners moved the Parsonage from Mission Inn Avenue to its present location in 1912 when they expanded the church. The primary (southeast), symmetrical elevation faces southeast onto Lemon Street. Its Mission style parapet dominates the primary elevation. At the ground level, a centered staircase leads to a centrally located pedestrian door within an arched, full-width portico. A shallow-pitched shed roof shades the portico. Raised side lights flank the pedestrian entrance and a wide wood sash window punctuates the walls to either side of the entry configuration. Two widely spaced windows and one small, raised wood sash window separate define the second story. The third story consists of three arched sashes set within a square wood molding supported by decorative corbels. The top of the parapet is punctuated by an embedded Greek wood cross. The side (northeast and southwest) elevations contain wood sash windows in the first and second stories of the building. Window location and sizes vary. A stucco clad chimney rises from the roof. A red clay tile roof caps the building.

Figure 5. First Congregational Church of Riverside Parsonage, view west. ICF, 2021.

Historically significant for its Mission Revival style architecture, the proposed project will not impact the parsonage's character-defining features which all convey its architectural style. The proposed project will not physically alter, damage, or destroy the First Congregational Church of Riverside Parsonage in part or in its entirety. Given the type of construction methods proposed at the project site, the approximately 85-foot distance between the two locations, and the First Congregational Church of Riverside Parsonage's wood-frame construction, which will absorb some of the vibrations, it is not anticipated that the historical resource will be damaged due to vibration.¹³

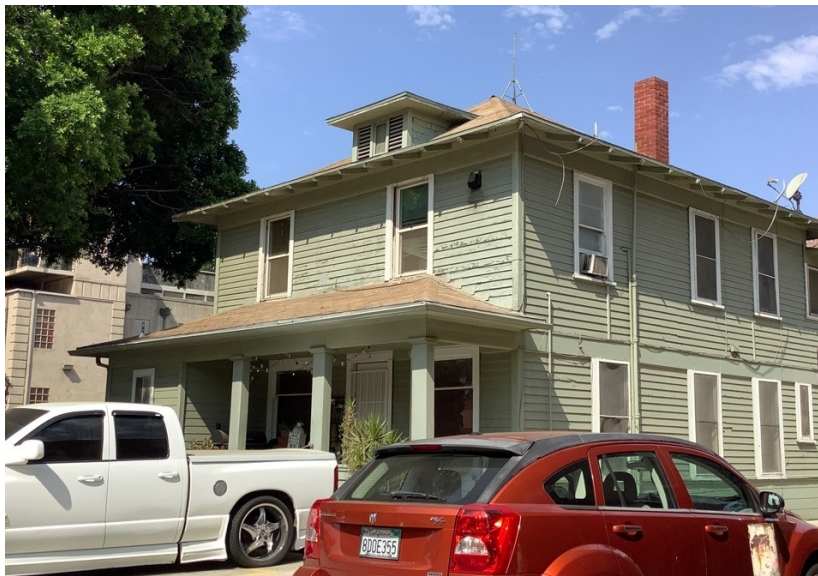
Constructed circa 1906, the American Foursquare residence at 3637 Lime Street is clad in wood shiplap siding and has a rectangular plan (Figure 6). A two-story single-family residence, the primary (southeast) elevation features a two-thirds width porch. Low walls form the porch's balustrade and square columns support the porch's full-width hipped hood. The southeast corner of the porch displays a non-original enclosure. Two windows flank a door opening covered by a non-original metal security door. The second floor contains two windows. A rectangular dormer with a single glass panel flanked by louvered vents adorns the medium-pitched, hipped roof. Composition tiles cover the roof. Stacked windows characterize the side (northeast and southwest) elevations. A brick chimney rises from the roof.

Figure 6. 3637 Lime Street, view southwest. ICF, 2021.

Historically significant for its architecture, the proposed project will not impact the residence's character-defining features. The proposed project will not physically alter, damage, or destroy the building at 3637 Lime Street in part or in its entirety. Given the type of construction proposed at the project site and the approximate 315-foot distance between the two locations, it is not anticipated that it would be damaged by vibration during construction.

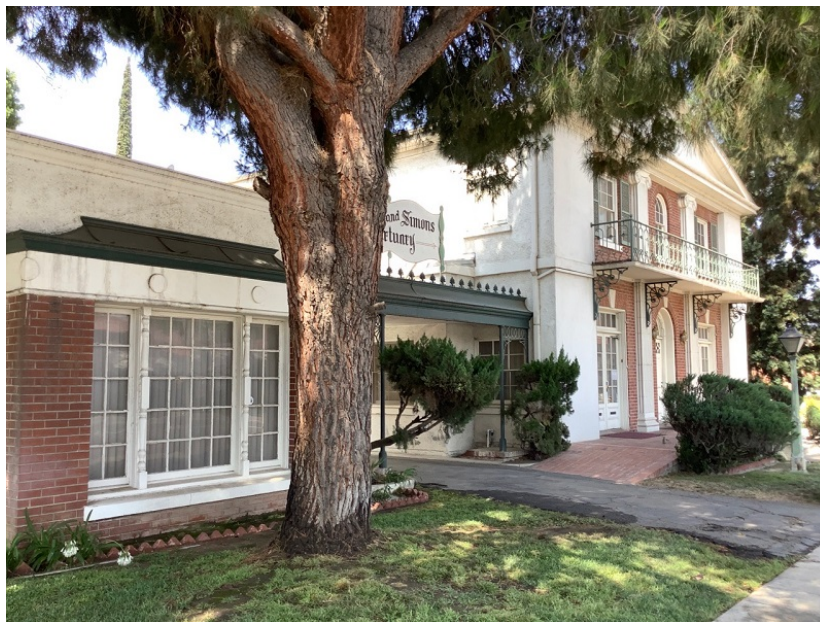
The Mission Business Building, also known as the Preston-Simmons Mortuary, is sited directly adjacent to SR-91 (Figure 7). The building dates to 1912, with an addition and alterations completed in 1950. The primary (northeast) elevation features two buildings connected by a porte-cochere. One building features Colonial Revival design with a rectangular plan and front gable. Stucco and brick clad the building. An arched transom caps a wood and glass panel door. Two wood and glass multi-paneled double doors surmounted by a multi-light transom flank the door. The second floor features an arched wood sash window flanked by six over six wood sash windows. Fluted engaged columns with Ionic capitals adorn the façade. In addition, a metal balconette with metal corbels, decorative brick patterns around fenestration, and louvered shutters further embellish the elevation. An ovular window punctuates the gable end. The second building features Regency influences. Rectangular in plan, the one-story building features a cornice at the roofline. Its large three-window configuration is emphasized through brickwork and a projecting hood above.

Figure 7. the Mission Business Building/Preston-Simmons Mortuary, view west. ICF, 2021.

Historically significant for its architecture, the proposed project will not impact the mortuary's character-defining features. The proposed project will not alter, damage, or destroy the Mission Business Building/Preston-Simmons Mortuary in part or in its entirety. Given the type of construction proposed at the project site and the approximately 325-foot distance between the two locations, it is not anticipated that the historical resource will be damaged due to vibration.

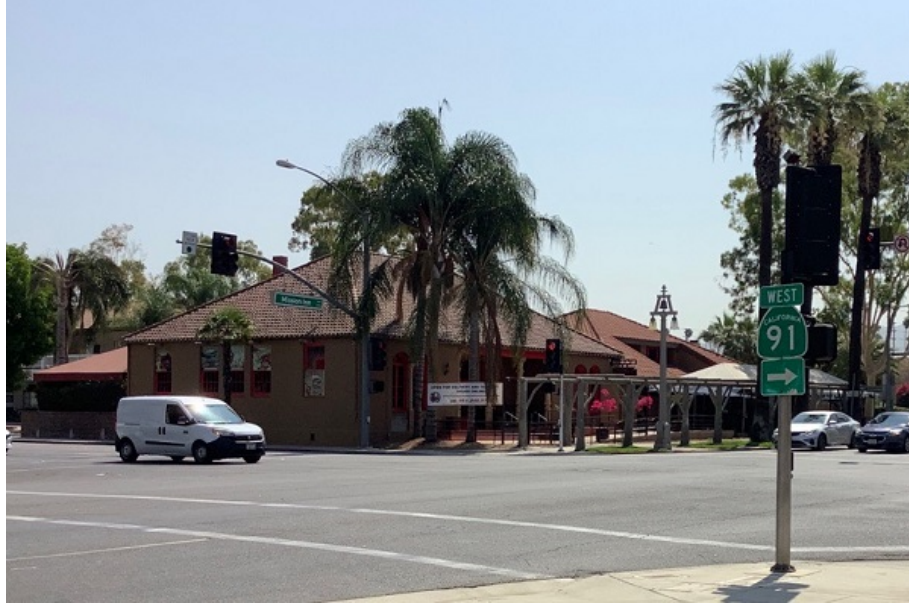
The Riverside-Arlington Heights Fruit Exchange is a one-story Mediterranean Revival commercial building that dates to 1923 with a 1980 addition to the southeast (Figure 8). The 1923 building is rectangular in plan and has a symmetrical primary (southwest) elevation. A centered entry portico includes a recessed entrance. Spiral columns with Corinthian capitals support the entry portico. Miniature portico columns separate paired multi-light, arched windows, which flank the entry. Multi-light rectangular windows punctuate the northwest elevation. A medium pitched red clay tile clad hipped roof with shallow overhanging eaves caps the building. After 1980, the Riverside-Arlington Heights Fruit Exchange's owners completed alterations, including construction of a rear (northeast) patio and a hyphenated side addition to the southeast. The brick patio includes a low brick wall and a fabric canopy. The addition is a 1980s interpretation of the 1923 building with a symmetrical primary elevation, recessed entry, with flanking paired arched windows, and a red tile clad medium-pitched gabled roof with shallow overhand. It also includes two tri-partite windows in the roof. It lacks the ornamentation found on the 1923 building.

Figure 8. Riverside-Arlington Heights Fruit Exchange, view north. ICF, 2021.

Historically significant for its architecture and associations with the citrus industry, the proposed project will not impact the building's character-defining features. The proposed project will not alter, damage, or destroy Riverside-Arlington Heights Fruit Exchange in part or in its entirety. Given the type of construction proposed at the project site and the approximately 225-foot distance between the two locations, it is not anticipated that the historical resource will be damaged due to vibration.

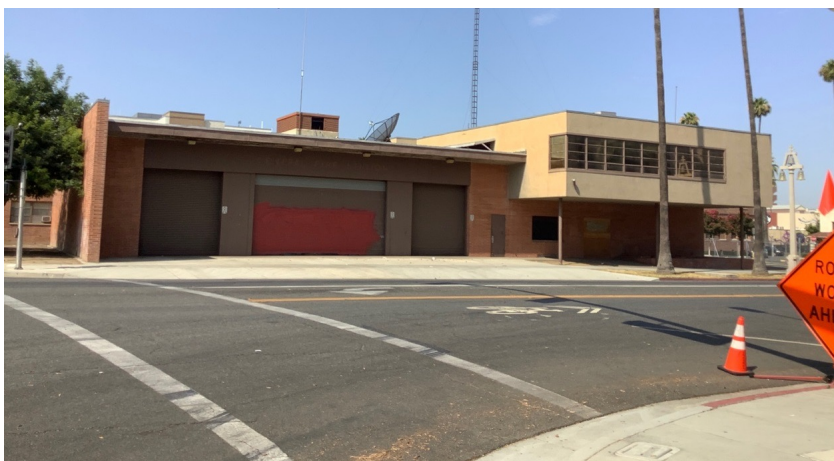
The side (southeast) elevation, visible along Lime Street primarily features a solid brick wall. Towards the rear of the building, a narrow mass protrudes and functioned as a repair garage. The side (northwest) elevation faces onto a parking lot. Several windows punctuate the brick and stucco cladding and thick, boxy brise soleil screens shade the windows. The rear (southwest) elevation is also balanced, but asymmetrical. The front elevation's fire truck doors are replicated here to provide through access. Adjacent, a concrete and metal louvered tower rises above the building forms the Central Fire Station's hose drying compartment.

Figure 9. Central Fire Station, view southwest. ICF, 2021.

The building is directly adjacent to the project site and faces northeast onto Mission Inn Avenue. Given the type of construction proposed at the project site and the Central Fire Station's reinforced concrete construction with metal piloti and I-beams, it is not anticipated that the historical resource will be damaged due to vibration despite its close proximity to construction.²²

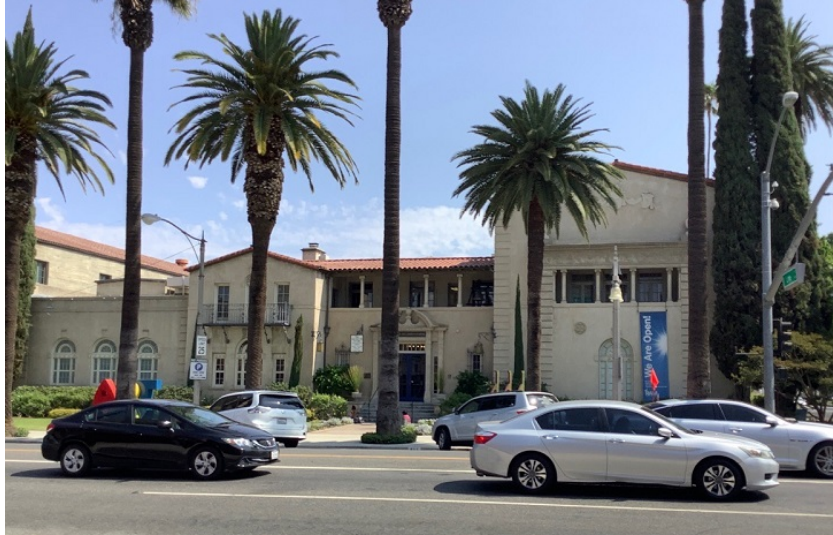
The secondary (southeast) elevation, visible along Lime Street contains a series of arched and rectangular windows in the first-floor and rectangular windows and a metal balconette accompanies in the second floor.

Figure 10. Former YWCA/Riverside Museum, view north. ICF, 2021.

Historically significant for its architecture, the proposed project will not impact the building's character-defining features. The proposed project will not alter, damage, or destroy the former YWCA/Riverside Museum in part or in its entirety. Given the type of construction planned for construction at the project site, the approximate 115-foot distance between the two sites, and the

YWCA/Riverside Museum's one- and two-story reinforced concrete construction, it is not anticipated that the historical resource will be damaged due to vibration impacts.²⁵

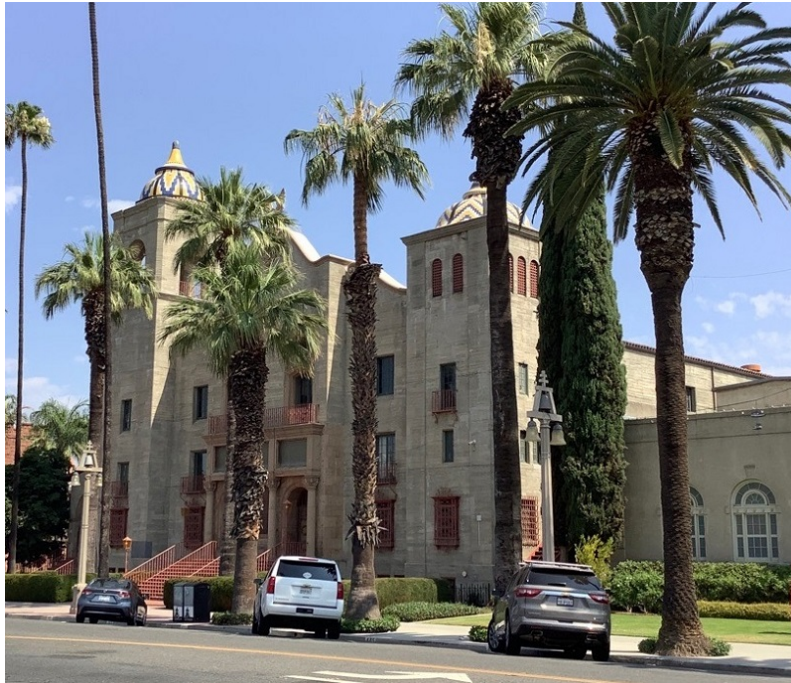
The side (northwest) elevation rises two stories above a raised basement. A portion of the basement level and first floor feature an arched loggia. Red clay tiles clad the low-pitched shed roof of the first floor loggia. Multi-light double doors with transoms penetrate the wall at the rear of the loggia. Multi-light windows punctuate the second story.

Figure 11. Municipal Auditorium, view north. ICF, 2021.

Historically significant for its architecture, the proposed project will not impact the building's character-defining features. The proposed project will not alter, damage, or destroy the Municipal Auditorium in part or in its entirety. Given the type of construction proposed at the project site, the approximate 115-foot distance between the two sites, and the Municipal Auditorium's reinforced board-formed concrete and steel frame construction, it is not anticipated that the historical resource will be damaged due to vibration impacts.²⁷

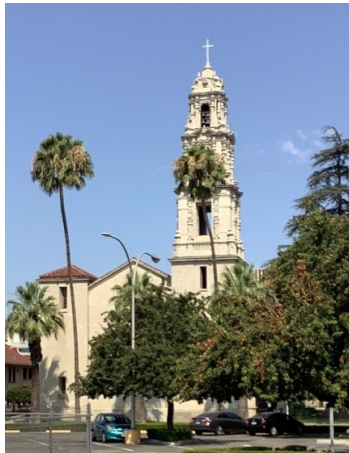
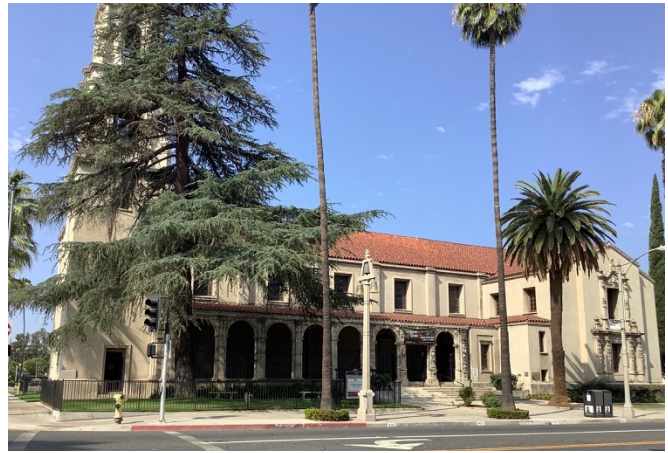
The First Congregational Church of Riverside is a cross-shaped, concrete constructed Spanish Colonial Revival church that dates to 1914 (Figures 12 and 13). Located on the southwest corner of Mission Inn Avenue and Lemon Street, the church's primary (northeast) elevation faces onto Mission Inn Avenue. A 125-foot tall Churrigueresque designed tower rises near the intersection's corner. At the church's level the tower is simple and features minimal deeply set, rectangular windows. In the upper levels, above the church, the tower features a myriad of Spanish and classical geometric themed embellishment. Arched openings hold the church's bells. A cross projects above a small dome. A Churrigueresque designed loggia capped by a low-pitched red clay tiled shed roof provides the primary elevation's main embellishment. Rectangular clerestory windows, which are separated by pilasters, penetrate the church's thick walls above the loggia. Additional Churrigueresque decoration embellishes the transept's stacked fenestration. A small balconette fronts the upper window. The remaining elevations lack Churrigueresque embellishment.

Figure 12. First Congregational Church of Riverside, view west. ICF, 2021

Figure 13. First Congregational Church of Riverside, view south. ICF, 2021

Historically significant for its architecture, the proposed project will not impact the church's character-defining features. The proposed project will not alter, damage, or destroy First Congregational Church of Riverside in part or in its entirety. Given the type of construction proposed at the project site and First Congregational Church of Riverside's reinforced concrete foundation and double brick walled construction, it is unlikely that the historical resource will be damaged due to vibration.²⁹

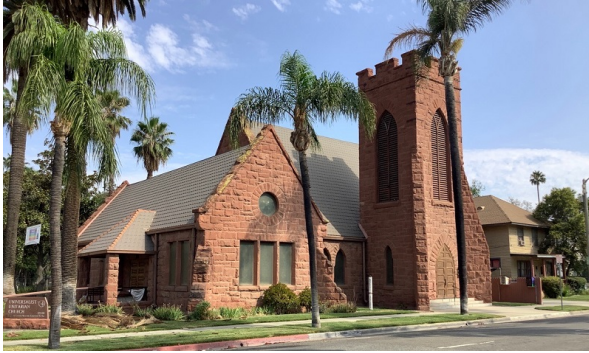
The Universalist-Unitarian Church, with its parsonage, includes a T-plan, rough-cut red sandstone Richardsonian Romanesque church that dates to 1891 and an American Foursquare parsonage that dates circa 1910 (Figures 14 and 15). A steeply pitched front and side gabled, non-original shingle roof caps the church. Buttresses support the church's corners. The church's primary (southwest) elevation is asymmetrical and features a porch. Thick square columns support a steeply pitched, hipped porch hood. Multi-paneled wood doors secure the entrance. Three sets of paired, rectangular windows accompany the entrance. The secondary (southeast) elevation, visible along Lemon Street, has a variegated plan to account for the T-shape and an attached tower. A side-gabled portion projects towards the Lemon Street. A set of three rectangular windows with a circular window in the gable fenestrate the southwesternmost part of the building's side elevation. Along the front gabled portion to the northeast, paired lancet windows penetrate the wall and flank a rectangular tower. The tower rises above the church building. At the tower's base, a multi-panel wood double door mimics the window's lancet form and faces toward the street. Side elevations contain a single lancet window. Above, a tall lancet shaped louvered vent punctuates the tower wall. Crenellations cap the tower.

Figure 14. The Universalist-Unitarian Church, view north. ICF, 2021

Historically significant for its associations with the early history in Riverside and its architecture, the proposed project will not impact neither the church's character-defining features nor the parsonage's character-defining features. The proposed project will not alter, damage, or destroy Universalist-Unitarian Church or its parsonage in part or in its entirety. Given the type of construction proposed at the project site, the approximately 140-foot distance between the project site and the church, the Universalist-Unitarian Church's buttressed corners which provide additional support for the building, it is not anticipated that the church will be damaged due to vibration.³¹ In addition, given the approximately 250-foot distance between the project site and the parsonage and the type of construction proposed, it is not anticipated that the parsonage will be damaged due to vibration.

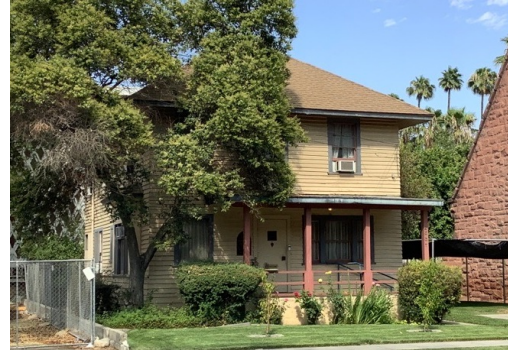
The parsonage is two-story American Foursquare residence located northeast from the church. Rectangular in plan, it addresses Lemon A hipped roof with medium overhanging eaves caps the wood-clad building. A partial width porch with a shed roof provides access to the centered front door in the first story of the primary (southeast) elevation. A low concrete block wall fronts the poured concrete porch. A simple wood post-and-balustrade rests atop the concrete block wall. . The front door is a non-original slab door punctuated by a square light. A three window configuration and a single window flank the door. The three-part window includes a one over one wood sash window flanked on either side by a narrow one over one wood sash window. Three symmetrically placed windows punctuate the second story of the primary elevation. All windows are one over one double hung sashes. Foliage obscures views of the side (northeast and southwest) elevations. Both elevations contain groupings of one, two, or three windows. The northeast elevation includes a shallow bay window that projects from the wall and contains a three-window configuration surmounted by a transom.

Figure 15. The Universalist-Unitarian Parsonage, view west. ICF, 2021

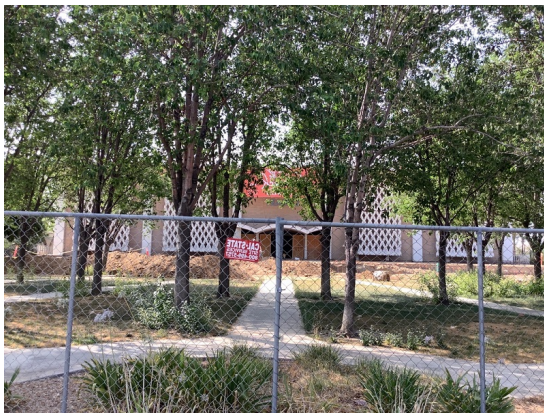
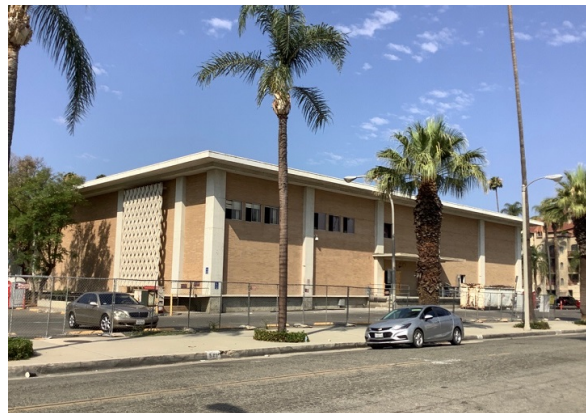
The Main Branch Library is a brick and concrete, rectangular plan building that dates to 1965 and displays some elements of Neo-formalism and Mid-century Modern styles (Figures 16 and 17). The building is set on a raised podium and the primary (southwest) elevation is symmetrical. Flat concrete columns separate the elevation into five bays. It features a centered entrance accessed by a concrete staircase. A wave-shaped cantilevered porch hood surmounts the entrance. Each of the bays that flank the entrance include a diamond lattice patterned concrete screen. The flat roof features deep eaves and a wide fascia. Side (northwest and southeast) elevations are similarly designed but lack emphasized entrances. The rear (northwest) elevation includes one pedestrian door. A loading dock and glazed double doors rest beneath a cantilevered porch hood on the asymmetrical rear elevation. The second floor contains aluminum slider windows above and southeast of the first-floor double door.

Figure 16. Main Branch Library, view northeast. ICF, 2021

Figure 17. Main Branch Library, view south. ICF, 2021

Historically significant for its architecture, the proposed project will not impact the library's character-defining features. The proposed project will not alter, damage, or destroy Main Branch Library in part or in its entirety. Given the type of construction proposed at the project site and the approximately 315-foot distance between the two locations, it is not anticipated that the historical resource will be damaged due to vibration.

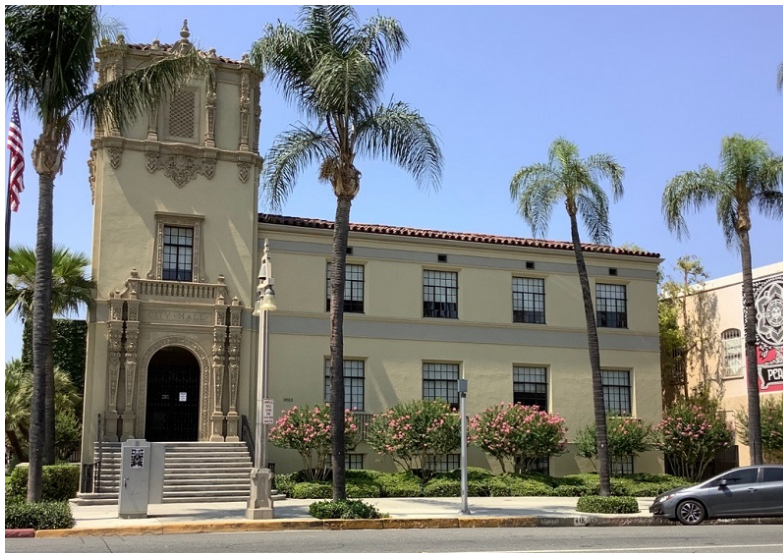
Riverside City Hall is a stucco-clad building with a rectangular plan that dates to 1924 and displays modest Spanish Colonial Revival with churrigueresque embellishment (Figure 18). It is two stories above a raised basement. Red clay tiles adorn its roof along its street-facing elevations. The primary (northeast) elevation faces onto Mission Inn Avenue. A square tower rises above the building and is located at the northeast corner of the building. Accessed by a concrete staircase, an ornate metal grille set within an arch secures a deeply recessed entrance alcove. Ornately decorated columns rise in pairs on either side of the arch, which is also decorated with an ornate frame. A rectangular window punctuates the tower above. Churrigueresque embellishment adorns the tower. Above the columns, an engaged balustrade rests below the window and evokes a balconette. Ornately decorated columns and other floral-patterned items complete the tower near its roofline. Stacked, multi-light casement windows punctuate the building walls west of the tower. A string course horizontally divides the first floor from the basement and level and the first-and second floors. Flat metal balustrades below first floor windows evoke balconettes.

The side (southwest) elevation is similar to the primary elevation. However, it lacks an entrance in the tower. Instead, it features a multi-light double door with transom configuration adjacent to the tower.

Figure 18. Riverside City Hall, View southwest. ICF, 2021.

Historically significant for its architecture, the proposed project will not impact the building's character-defining features. The proposed project will not alter, damage, or destroy Riverside City Hall in part or in its entirety. Given the type of construction proposed at the project site and the approximately 450-foot distance between the two locations, it is not anticipated that the historical resource will be damaged due to vibration.

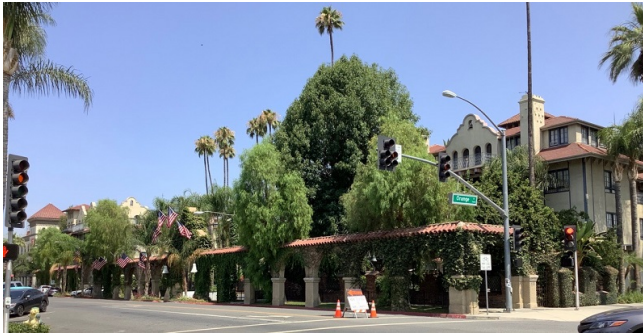
Originally known as the Glenwood Inn, the Mission Inn features a U-shaped plan and stucco-cladding (Figures 19 and 20). Occupying an entire city block and now expressing the Mission Revival style, the building originally dates to 1871. Owner Frank Miller first hired architects to alter the original building in 1902 to include Mission style elements.³⁷ It reflects numerous additional alterations through the 1940s, with the most significant dating to circa 1930.

Figure 19. Mission Inn, primary elevation, view north. ICF, 2021

Historically significant for its architecture, the proposed project will not impact the building's character-defining features. The proposed project will not alter, damage, or destroy Mission Inn in part or in its entirety. Given the type of construction proposed at the project site and the approximately 475-foot distance between the two locations, it is not anticipated that the historical resource will be damaged due to vibration.

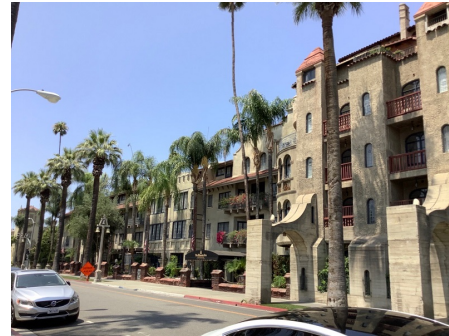
The side (southeast) elevation along Orange Street is variegated with different setbacks from the sidewalk and recessed or extending balconies. At the sidewalk, a crenelated brick wall with metal panels and chains extends across the southern part of the building. Plants occupy the space between the wall and the buildings. Near the center of the elevation, a canopied entrance provides access the building's interior. Stacked windows and balcony doors punctuate the elevation. South of the entrance, fenestration is primarily rectangular, while to the north, it is arched. A Mission parapet rises at the fourth floor above the entrance. A pent roof separates the third story from the fourth south of the entrance. A semi-circular tower rises north of the entrance, with arches supported by Ionic columns. Diamond-patterned multi-light windows are present with the arched openings. North of this tower, the elevation alternates between recessed balconies and projecting walls. Also along this northern portion of the elevation, board-formed concrete flying buttresses arch over the sidewalk. The northeasternmost corner features a tower capped by a dome.

Figure 20. Mission Inn, side elevation, view west. ICF, 2021

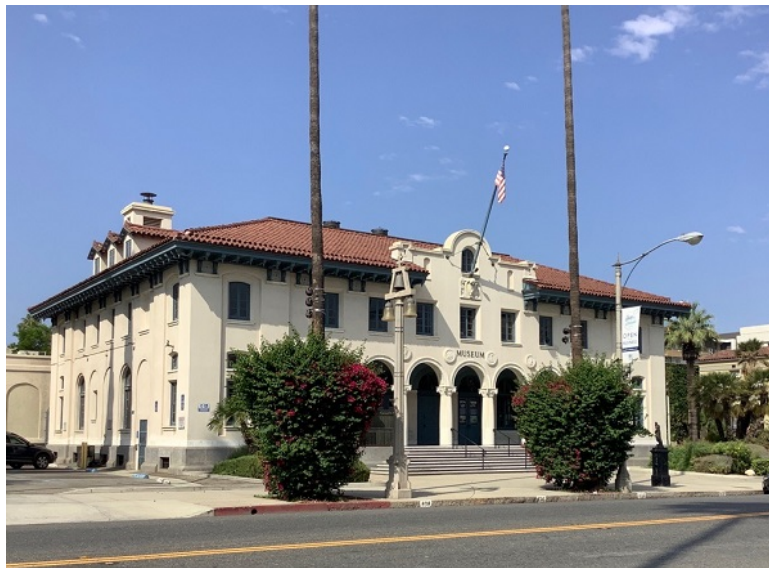
The Post Office, which is now used as a Municipal Museum, is a stucco-clad Mission and Spanish Revival building that dates to 1911 (Figure 21). It has a rectangular plan. The primary (northeast), symmetrical elevation along Mission Inn Avenue features a portico with recessed entrances accessed by a staircase. Fluted columns with modest Corinthian inspired capitals

support arches and form the portico. Three double doors access the interior. The central door is a multi-panel door. Multi-panel and multi-light glazed doors flank the center door. Multi-light arched transoms surmount each door and multi-light windows. Rectangular and segmental arched windows flank the portico. The second floor contains multi-light windows stacked above the first-floor fenestration. The outermost windows feature a segmented arched window, while the other windows are rectangular. A Mission style parapet rises above a red clay tile pent roof. Numerous brackets support deep overhanging eaves. Medallions between the first and second story and an eagle themed relief panel adorn the elevation.

The side (northwest and southeast) elevations have stacked windows that replicate the primary elevation's fenestration. Rectangular dormers, set in groups of three, capped with front gabled, red clay tile roofs punctuate the side elevations' pent roofs. A stucco clad louvered vent chimney rises above the roof.

Figure 21. Post Office/Municipal Museum, view southwest. ICF, 2021.

Historically significant for its architecture, the proposed project will not impact the building's residence's character-defining features. The proposed project will not alter, damage, or destroy Post Office/Municipal Museum in part or in its entirety. Given the type of construction proposed at the project site and the approximately 270-foot distance between the two locations, it is not anticipated that the historical resource will be damaged due to vibration.

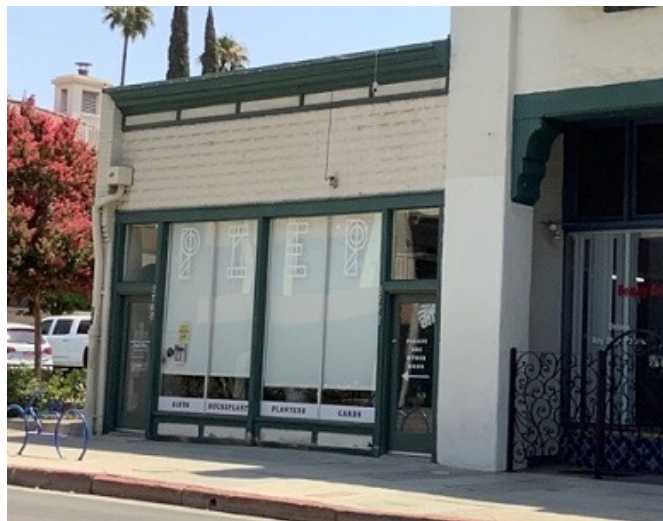
Toddy's Cake and Candy Supply is painted masonry block and wood vernacular commercial building with a rectangular plan that dates to 1940 (Figure 22). The one-story building's primary (southwest) elevation has a large storefront glazing program, with wood mullion framing two tall window and two doors with transoms above. Within the wood mullions, enframed metal windows form the storefront. Beveled masonry blocks with a projecting wood cornice at the roofline complete the building.

Figure 22. Toddy's Cake and Candy Supply , view east. ICF, 2021.

Historically significant for its commercial architecture, the proposed project will not impact the building's character-defining features. The proposed project will not alter, damage, or destroy Toddye's Cake and Candy Supply in part or in its entirety. Given the type of construction proposed at the project site and the approximately 375-foot distance between the two locations, it is not anticipated that the historical resource will be damaged due to vibration.

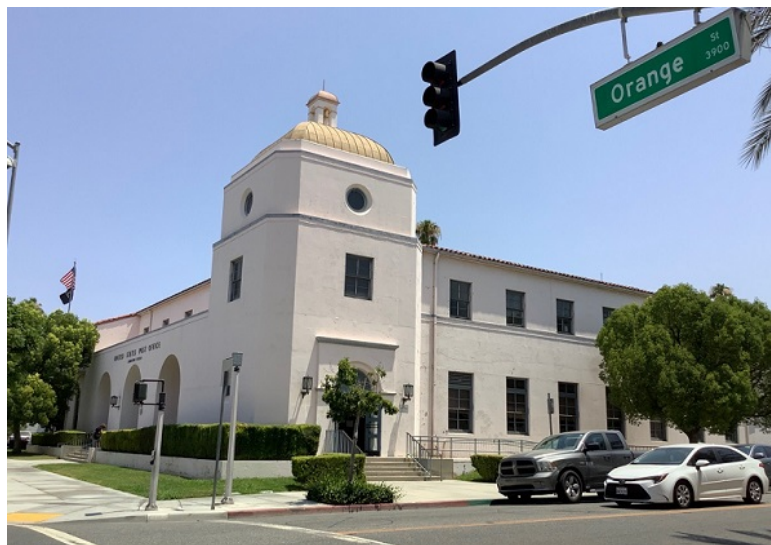
3890 Orange Street, a Post Office constructed circa 1935, is a stucco-clad Spanish and Mediterranean Revival building that has a low-pitched hipped roof along the street and a flat roof to the rear (Figure 23). It has a rectangular plan. Red clay tile covers the hipped roof. It features a shallow overhang. The primary (northwest) elevation has a deep set arched entrance flanked by deep set arched windows. A tower rises at the southwest corner. Three stacked windows penetrate the tower wall, with a circular window just below the tower's dome. A square cupola accompanies a quadrantal dome. To the northeast, stacked windows penetrate the wall, with the second-floor windows including a metal balustraded balconette. Other windows in the second story are two over two wood sash single hung windows. The secondary (southwest) elevation includes a multi-light wood sash door at the base of the tower. Two over two wood sash, stacked windows complete this elevation. The rear (southeast) elevation includes a covered loading dock with slab doors and two over two wood sash windows.

Figure 23. 3890 Orange Street, view northeast. ICF, 2021.

Historically significant for its architecture, the proposed project will not impact the building's character-defining features. The proposed project will not alter, damage, or destroy the post office in part or in its entirety. Given the type of construction proposed at the project site and the approximately 525-foot distance between the two locations, it is not anticipated that the historical resource will be damaged due to vibration.

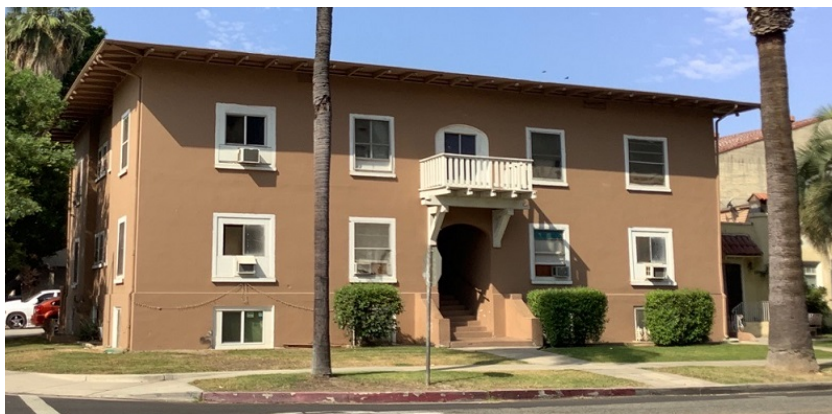
The Olympic Apartment building is a circa 1916 stucco-clad vernacular building with slight Mediterranean Revival-inspired features (Figure 24). The two-story building has a rectangular plan. It rests on a raised basement level emphasized by a watertable. The primary (northeast) elevation is symmetrical. Concrete steps provide access to an arched entry way containing doors recessed within that archway. Stacked windows, primarily aluminum and vinyl replacements, adorn the elevation. Above the arched entryway, a wooden balconette with brackets emphasizes arched fenestration. Owners installed smaller windows in original window openings. A low-pitched hipped roof with medium overhanging eaves and exposed rafters caps the building. Side (northwest and southeast) elevations are also symmetrical and include stucco cladding with stacked replacement window sashes.

Figure 24. Olympic Apartment Building, view southwest. ICF, 2021.

Historically significant for its architecture, the proposed project will not impact the building's character-defining features. The proposed project will not alter, damage, or destroy the Olympic Apartment building in part or in its entirety. Given the type of construction proposed at the project site and the approximately 320-foot distance between the two locations, it is not anticipated that the historical resource will be damaged due to vibration.

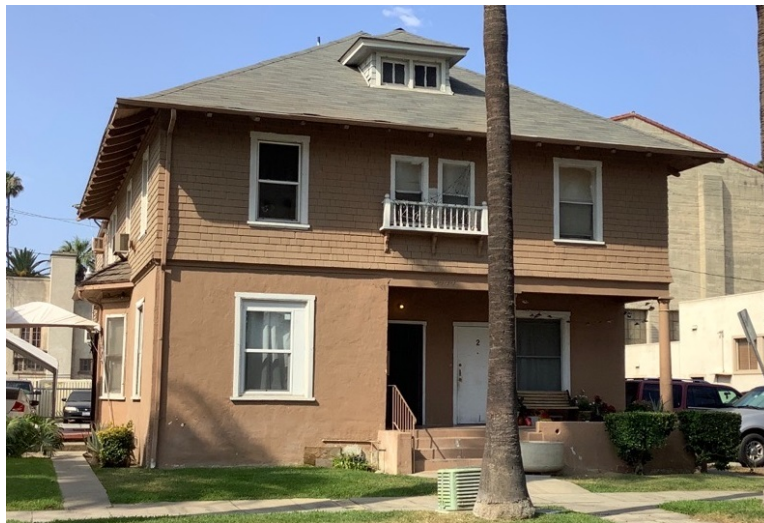
The residence at 3444 Sixth Street is a circa 1903 wood shingle and stucco-clad American Foursquare with a rectangular plan (Figure 25). The two-story, converted multiple-family residence features a two-thirds width porch on the first floor of the primary (northeast) elevation. The non-original concrete porch lacks a balustrade. Two round wood columns support the second level. Two doors accompanied by a window punctuate the first-floor within the porch area. One door is secured by a metal security gate while the other is a solid slab replacement. The window appears to be an original wood-sash window. A second window punctuates the first-floor to the east. The second floor includes two centered windows set side by side flanked by one window on either side. A small balustrade supported by brackets accompanies the two center windows. A rectangular dormer with two windows centered on the medium-pitched, hipped roof. Composition tiles cover the roof. Side (northwest and southeast) elevations include stacked windows.

Figure 25. Residence at 3444 Sixth Street, view southwest. ICF, 2021.

Historically significant for its architecture, the proposed project will not impact the residence's character-defining features. The proposed project will not alter, damage, or destroy it in part or in its entirety. Given the type of construction proposed at the project site and the approximately 290-foot distance between the two locations, it is not anticipated that the historical resource will be damaged due to vibration.

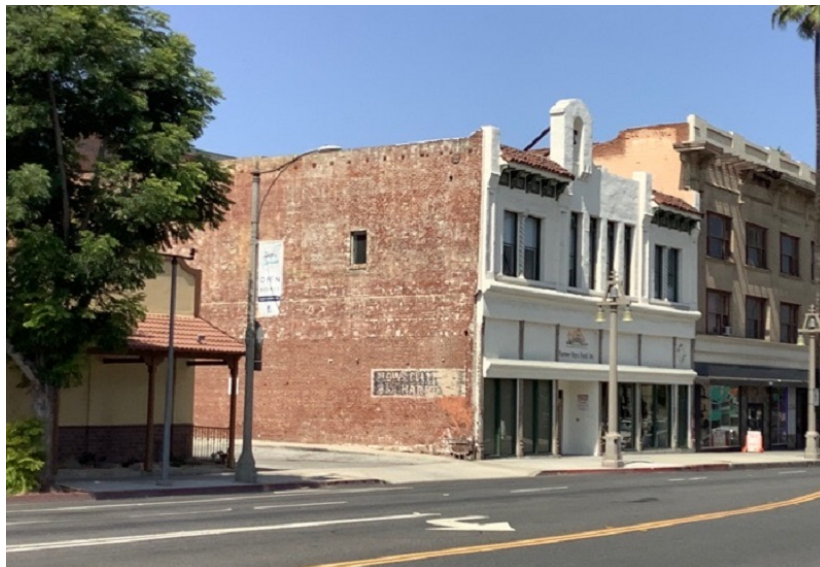
The Button Building is a 1918 two-story, stucco-clad Mission and Mediterranean Revival commercial building with a rectangular plan (Figure 26). The asymmetrical primary (northeast) elevation features a recessed, glazed double door entry flanked by four full-height storefront windows set in pairs, with a single panel door at the northwest corner. Each pair of windows is set within wood mullions. Pilasters attached to the stucco walls separate the pair windows and double or single doors. A projecting entablature surmounts the first-floor fenestration. Above, the columns extend above the entablature and frame recessed stucco clad panels. These panels appear to be an alteration that infilled transom windows. A second entablature separates the first-floor from the second. Second floor fenestration is symmetrically arranged. Four, one over one wood sash windows punctuate the center of the wall. Decorative panels are set above these windows. Rectangular pilasters flank the four centered windows and rise above the roofline. Paired rectangular windows separated by a spiraled column flank the center configuration. the southeastern column rises above its counterpart and arches into a small, Mission style bell tower. The roofline to either side of the centered raised parapet, which includes the bell tower, includes a red clay tile pent roof supported by brackets. Decorative panels accompany the roofline.

Figure 26. Button Building, view southwest. ICF, 2021.

Historically significant for its architecture, the proposed project will not impact the building's character-defining features. The proposed project will not alter, damage, or destroy the Button Building in part or in its entirety. Given the type of construction proposed at the project site and the approximately 390-foot distance between the two locations, it is not likely that the historical resource will be damaged due to vibration.

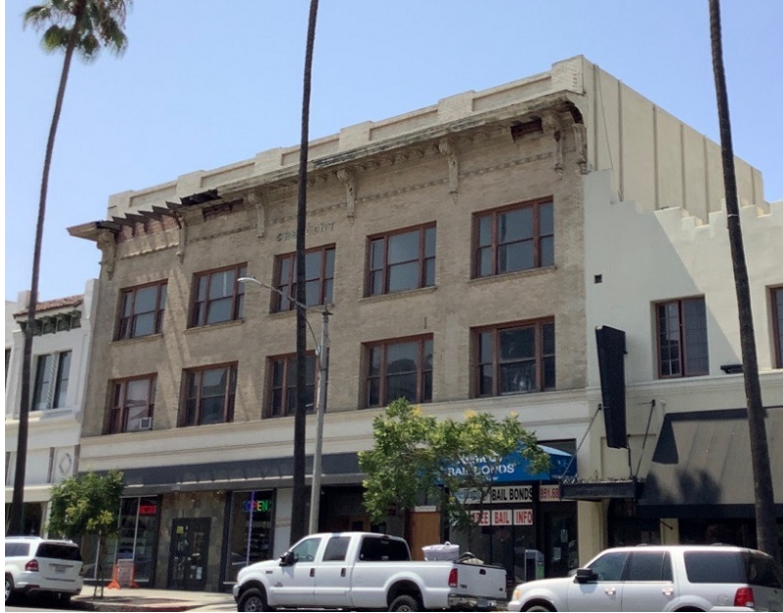
The Crescent Hotel is a rectangular plan, blonde brick Classical Revival building that dates to circa 1909 and rises three stories (Figure 27). Plaster decoration and wood moldings framing door and window openings accompany the blond brick walls. The primary (northeast) elevation's first-floor features several non-original storefronts. A classically inspired entablature separates the storefronts from the second floor above. It includes flat surfaces with egg-and-dart dentil molding. The second the third floors have stacked fenestration. Wood mullions sperate a wide wood sash window from two narrower windows. A brick sill with dentils stretches the width of each three-part window configuration. Deep overhanging eaves with both large and small brackets forms the cornice. Acanthas leaves adorn the brackets. In addition, egg-and-dart, dentil, and garland detailing accompanies the design. Part of the cornice and its brackets are missing. A raised parapet completes the building. "Crescent" lettering is located between the third-floor windows and the roofline.

Figure 27. Crescent Hotel, view south. ICF, 2021.

Historically significant for its architecture, the proposed project will not impact the building's character-defining features. The proposed project will not alter, damage, or destroy the

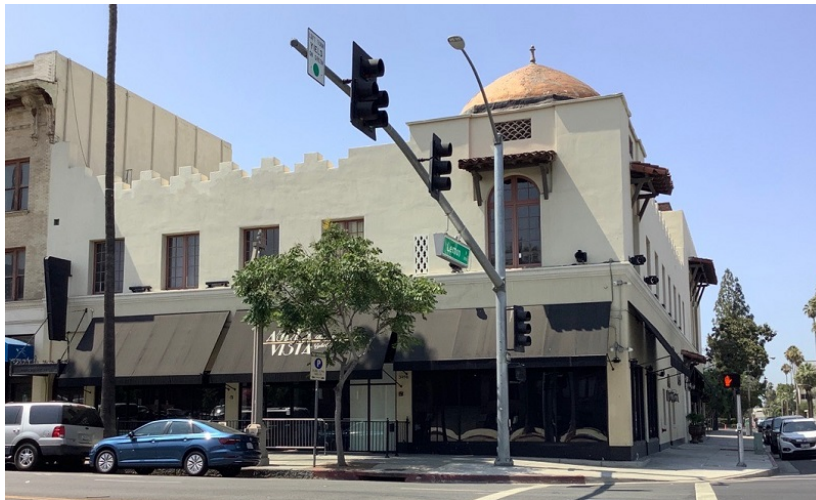
The Aurea Vista Hotel is a rectangular plan, stucco-clad building that dates to 1928. The Spanish Revival style building displays some elements of Moorish architecture (Figure 28). The primary (northeast) elevation addresses University Avenue. The first-floor along University Avenue features non-original storefronts shaded by non-original fabric awnings. The first-floor along University Avenue also includes a multi-light double door entrance at the southeast corner. A multi-light transom and metal porch hood surmount the entrance. A tower at the corner along

University Avenue and Lemon Street rises slightly above the roof's crenelated parapet. A dome caps the tower. Rectangular, multi-light casement windows penetrate the second story walls. Within the tower, an arched transom surmounts the window. A red clay tile pent roof shelters the window. A red clay tile vent pierces the tower wall above the pent roof.

The secondary (northwest) elevation along Lemon Street also has non-original storefronts at both corners. A centered entrance comprised of a multi-light arched door and transom configuration includes a red clay tile pent roof and colored tilework. A secondary entrance is located to the northeast. Two shuttered windows flank it. The second story of the side elevation matches the second story of the primary elevation, except at its southwest corner. At the southwest corner, the second story rises the height of two stories and includes a recessed portico. An arched colonnade with Corinthian capitals, tile work, and a red clay tile clad pent roof form the portico. Multi-light door and window configurations punctuate the recessed portico wall. Decorative screens flank the portico.

Figure 28. Aurea Vista Hotel, view southwest. ICF, 2021.

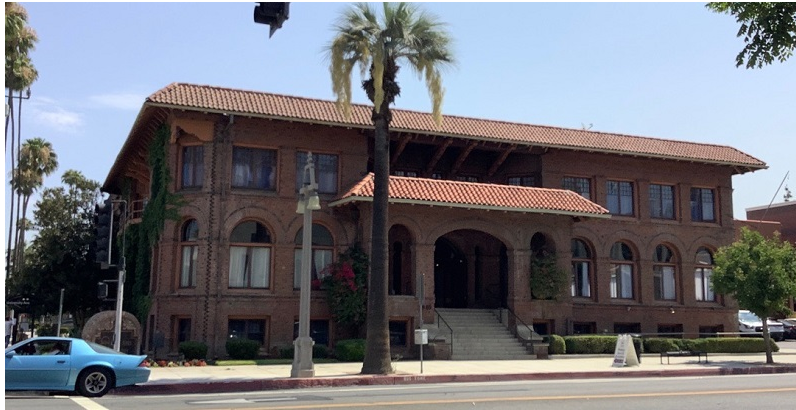
The Riverside YMCA is a T-shaped, brick Renaissance Revival building that dates to 1909 (Figure 29). The exterior features patterned red and clinker bricks. With two stories above a raised basement, the building has a flat roof with a pent roof parapet. Red clay tiles clad the building's and its portico's pent roofs, which has deep overhanging eaves with exposed rafters. The asymmetrical primary (southwest) elevation includes an off-center entrance that projects towards the street. Accessed by a concrete staircase, an arched portico fronts arched fenestration. The elevation features stacked windows, with paired rectangular one over one windows in the basement, one by one casement windows with an arched transom at the first story and, eighteen over two casement windows in the second story. Above the entrance, a deep set balcony is present.

The stacked fenestration pattern present on the primary elevation continues on the secondary (northwest) and side elevations (southeast). The canted westernmost corner of the building rests below a carved wood hood. The elevation is not flat across its length. Two alcoves along Lemon Street elevation distinguish the elevation. While plants obscure one indentation, the other, towards University Avenue includes canted walls, a balcony with a metal balustrade, and two open arches that access a third floor outdoor rooftop patio. The other side elevation includes a non-original metal and concrete porch with a hipped hood and a Moderne addition towards the rear.

Figure 29. Riverside YMCA, view southeast. ICF, 2021.

concrete foundation and unreinforced masonry , it is not anticipated that the historical resource will be damaged due to vibration.⁵⁵

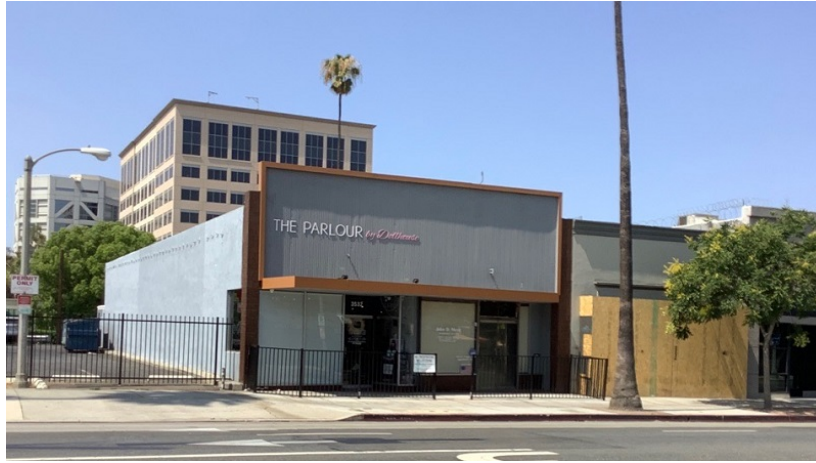
The commercial building at 3532-3538 University Avenue is a rectangular plan, stucco-clad Mid-Century, Contemporary commercial building that dates to 1938 with circa 1950s alterations (Figure 30). The one-story building has a flat roof with a parapet. Two enframed storefronts with metal mullions form the glazing program on the primary (northwest) elevation. A transom surmounts a glass door, and is adjacent to its associated storefront. The glass curtain wall formed by this configuration angles inward from the corner of the building;

however, at the edge of the first storefront, it runs parallel to the side walls several feet, then the second storefront angles inward. This pattern forms small triangular porches for each storefront. The cantilevered porch hood is also triangular shaped. Vertical incised lines texture the wall above storefront, which extends to form the parapet.

Figure 30. 3532-3538 University Avenue, view southwest. ICF, 2021.

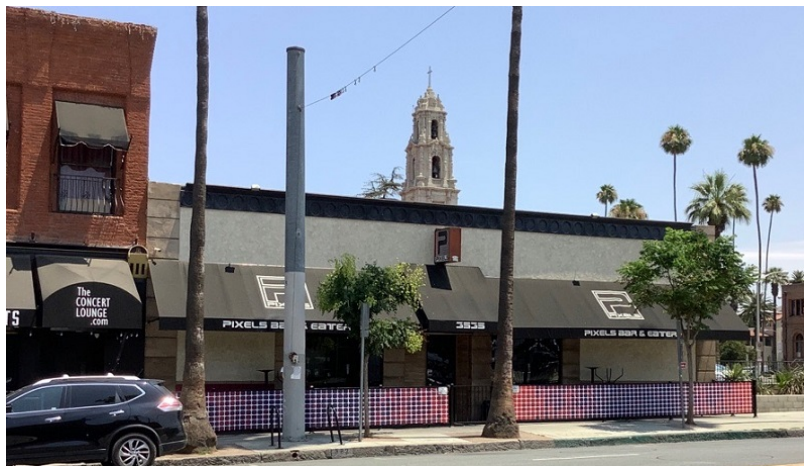
The building at 3535 University Avenue is a stucco-clad commercial building that dates to 1910, with alterations completed in 1934 (Figure 31). It has a rectangular plan. Rough stucco cladding is non-original. The primary (southwest) elevation contains the entrance, which is slightly off-center and appears to be non-original. Fabric awnings shade the entrance. Pilasters separate a single glazed door and two large picture windows. Incised stucco gives the appearance of masonry blocks. This design forms the pilasters, which also frame the one-story building along the primary elevation. A watertable runs across the base of the elevation. In addition, a geometric patterned cornice runs along the building's roofline. A small sign extends above the entrance.

Figure 31. 3535 University Avenue, view northeast. ICF, 2021.

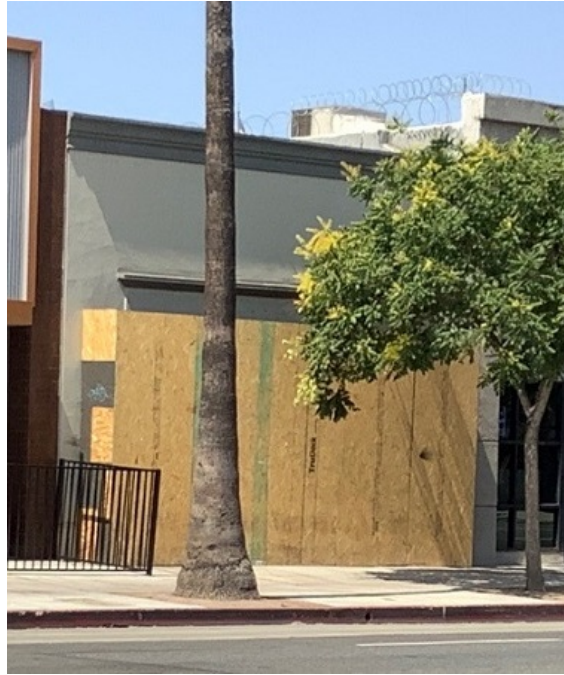
Dick's Harness Shop is a stucco-clad Moderne building that dates to 1922 (Figure 32). It has a rectangular plan. The primary (northeast) elevation addresses University Avenue. Because the building's owner has boarded up the store front, the following description is taken from the City of Riverside's Cultural Resource Inventory spreadsheet: "The roofline has a simple entablature and the exterior material is stucco. The front façade features a recessed entry. The entrance is on the right

side of the façade and a brick planter topped by two windows separated by a mullion is on the left side.”⁶⁰

Figure 32. Dick's Harness Shop, view southwest. ICF, 2021.
