IMPACTS ASSESSMENT FOR THE DEVELOPMENT OF AC/MARRIOTT RESIDENCE INN DUAL BRANDED HOTEL, RIVERSIDE, CALIFORNIA

August 2021

ICF. 2021. *Impacts Assessment for the Development of AC/Marriott Residence Inn Dual Branded Hotel, Riverside, California*. August. (ICF 352.21.) Los Angeles, CA. Prepared for Greens INV 10.

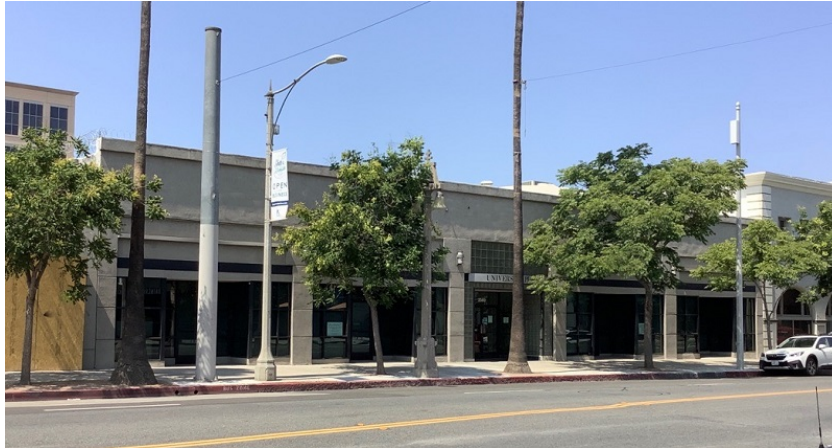
3550-3560 University Avenue is an L-shaped, stucco-clad Moderne commercial building that dates circa 1930 (Figure 33). Owners combined two buildings to form the subject property, with one unified façade. Five store fronts comprise the symmetrical primary (northeast) elevation. The center storefront is narrow and features a deep-set entrance. A glazed double door with side lights and a transom form the storefront. Glass blocks line the sides of the deep set entrance. Above, glass blocks embedded in the wall and a curved metal sign, "University Place" provides distinction for this storefront. two store fronts on either side complete the elevation. Each of these four store fronts includes windows along the street with centered, deep-set entrance. Side lights and a transom accompany a single pedestrian door. The entire

program is glazed in thick black metal mullions, and is a replacement for original storefronts. An indentation in the stucco walls is located above each store front, denoting an area used for signage. Above, the stucco wall rises to form a parapet. Horizontal incised lines in the stucco walls in between storefronts create simulated masonry columns that rise the height of the storefronts. Non original light fixtures are located above the columns.

Figure 33. 3550-3560 University Avenue, view southwest. ICF, 2021.

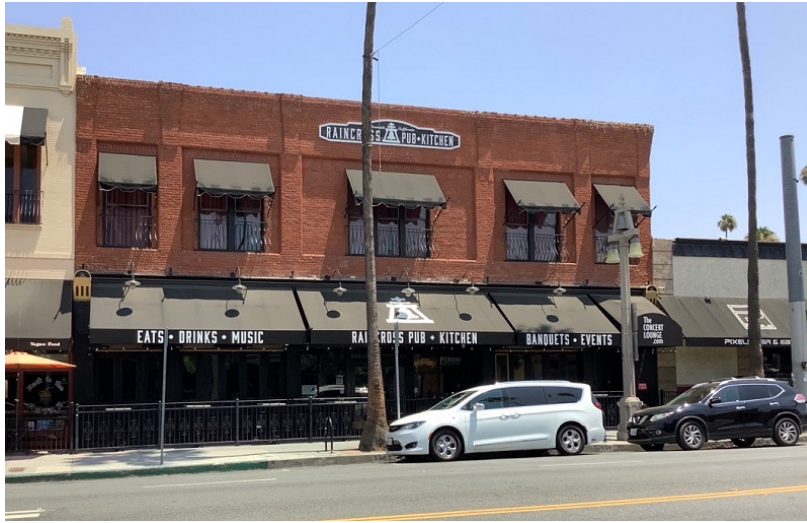
3557 University Avenue is a wood and brick commercial building that dates to 1926, with alterations in 1947 (Figure 34). It has a rectangular plan. The building rises two stories and has a flat roof with a parapet. The primary (southwest) elevation features a store front, operating as a restaurant, in the first-floor. Set beneath a cloth canopy, a pair of glazed doors accompanied by side lights and a transom form the main entrance. Two windows punctuate the wall to the left and one punctuates the wall to the right. Owners recently replaced original four-light, fixed sash windows with multi-paneled accordion windows. A single door at the southeast corner of the elevation provides secondary access to the building's interior. Wood framing forms the storefront area, although it is not easily discernable beneath the canopy. The second story elevation is symmetrical. A group of three windows separated by mullions pierces the center of the wall. A painted window, also separated by a wood mullion flank the center configuration, and a single window bookends the configuration. metal balconettes and cloth canopies are

recent additions. Surrounding windows, the brickwork projects slightly. Brickwork also embellished the cornice and parapet.

Figure 34. 3557 University Avenue, view northeast. ICF, 2021.

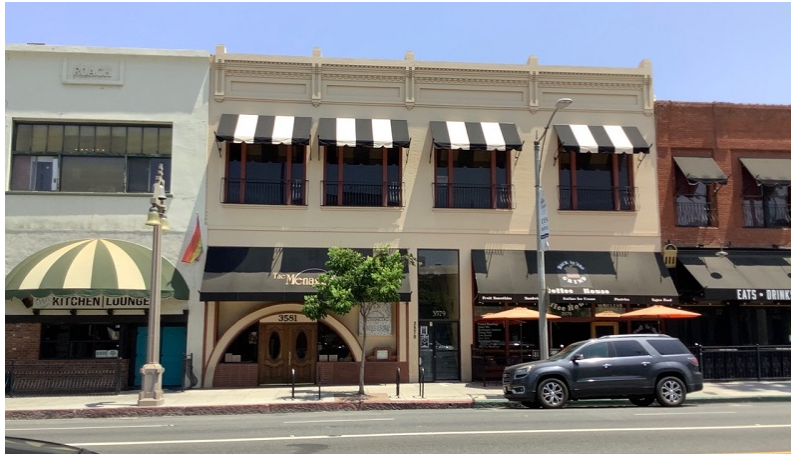
3573-3581 University Avenue a painted brick commercial building that dates to 1920 (Figure 35). It has a rectangular plan. The primary (southwest) elevation addresses University Avenue. The two-story building includes a centered, first-floor entrance that leads to the second floor flanked by a storefront on either side. Owners altered first-floor entrance and storefronts. A glazed pedestrian door, with one side light and a tall transom form the entrance. The right storefront features a rectilinear, glazed and mullioned storefront set beneath a non-original fabric canopy. The left storefront is a Moderne Spanish/Mission Revival design, with a low stack-bond brick wall and a wide arch. A fabric canopy replaced a tile clad pent roof. Tri-partite windows separated by wood mullions, with transoms above penetrate the second story wall. Metal balconettes and fabric canopies are not original. The cornice features brickwork design,

with inset panels framed by bracket-like columns. Bricks arranged in dentil and other patterns stretch across the top of the cornice.

Figure 35. 3573-3581 University Avenue, view northeast. ICF, 2021.

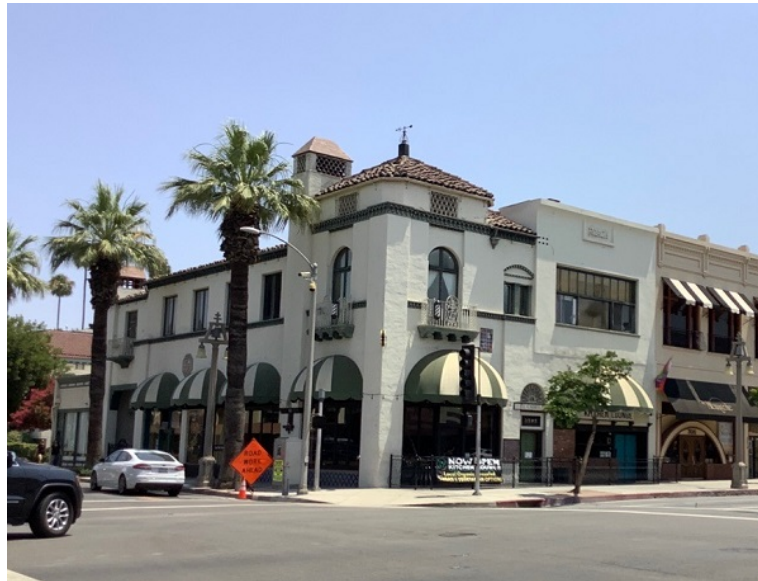
The El Cabrillo/Roach Building is a stucco-clad Spanish Colonial Revival building that dates circa 1890 (Figure 36). It has a rectangular plan. Both of the building's street facing elevations are asymmetrical. A tower rises at the corner, and is clearly articulated along the Orange Street elevation.

a wood and nail double door to the southeast. Brick cladding accompanies the window. A non-original semi-circular canopy shades the storefront. The second story includes a large window that punctuates the wall above the southeastern storefront. A multi-light transom surmounts a tri-partite window with wood mullions. The parapet includes lettering that states, "ROACH." Above, but off-set from the first-floor entrance, a pair of windows pierces the wall. Pilasters with modest Corinthian capitals separate and flank these windows. Brickwork forms an arched dentil pattern above. An arched window with a beaded mullion accessed a small balconette. Layered dentil molding stretched above these two windows, with a low pitched tile clad roof above.

The Orange Street (northwest) elevation features multiple arched storefronts in the first-floor that are similar to the one on the University Avenue elevation. Tile clads several of the storefront's low walls. In addition, one store front is recessed and framed within a rectangular opening. The second story contains fenestration above each storefront. Except for one, these are rectangular with beaded mullions. One door, located in the tower at the southwest corner of the elevation, is arched with beaded mullions. A balconette accompanies the door. A second balconette completes the building to the northeast. This elevation also includes two chimneys with decorative caps.

Figure 36. El Cabrillo/Roach Building, view northeast. ICF, 2021.

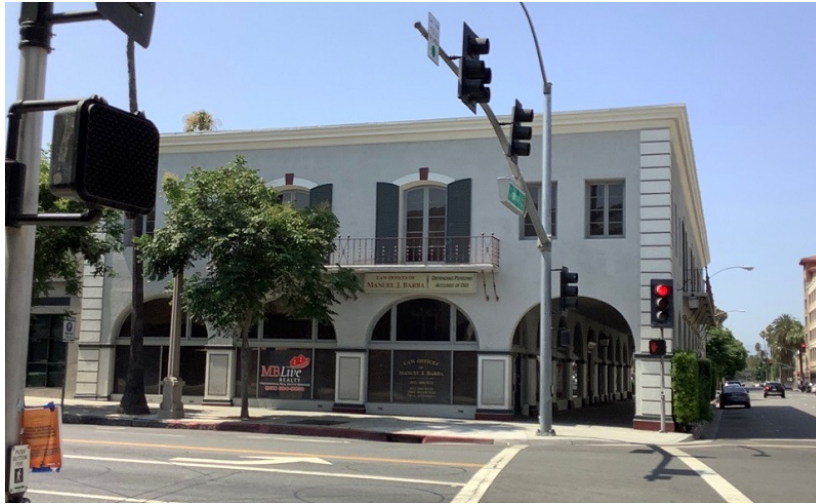
The E.M. Bonnett Building is a stucco-clad Spanish Colonial Revival building that dates to 1908 (Figure 37). It has a rectangular plan. A flat roof with a parapet and projecting cornice caps the two-story building. The building faces onto Orange Street, where an arched arcade runs the length of the building along the first-floor. Replicating the arcade along the building, arched fenestration punctuates the primary (northeast) elevation's wall. The location of entrances versus windows does not form a pattern. Centered, a main entrance formed by multi-light double door penetrates the wall. Colonial inspired decoration, including a broken pediment-shaped lintel, accompanies the entrance. A glazed door framed by side lights set onto a low wall, and an arched transom form other entrances along the elevation. Multi-light arched windows set above a low wall complete fenestration on the primary elevation's first-floor. The second floor is symmetrical. Centered and above a metal balconette, paired multi-light casement windows separate three multi-light arched doors. Shutters and a keystone accompany the doors. Four rectangular multi-light casement windows flank the centered configuration. Metal light fixtures on either side of the balconette, between the ground and second stories, hang over the street. At its corners, stacked quoins rise the height of the building.

The side (southeast) elevation along University Avenue is similar. However, it lacks an arcade. In addition, the second floor features two doors accompanied by a balconette, with flanking paired windows.

Figure 37. E.M. Bonnett Building, view southeast. ICF, 2021.

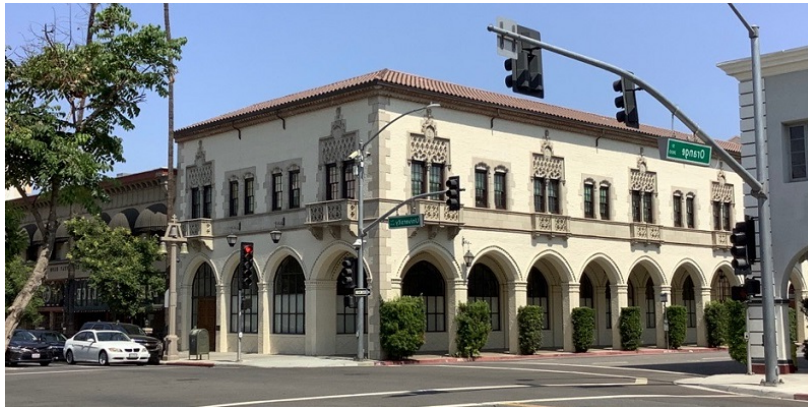
Figure 38. Security Title Insurance Co., view southwest. ICF, 2021.

The Security Title Insurance Co. building is a stucco-clad Spanish Colonial Revival building with Moorish influences that dates to 1928 (Figure 38). It has a rectangular plan. A flat roof with a red clay tile pent roof caps the two-story building. A pointed arched arcade along Orange Street is a notable feature; however, the building faces onto University Avenue.

The side (southeast) elevation along Orange Street is similar to the primary elevation. However, a pointed arched arcade fronts the building walls. The southernmost corner of the elevation includes an entrance, while pointed arched windows surmount a low pattered wall across the elevation to the north. In the second story, paired windows with a balconette alternate with windows that do not include one. Balconettes in the center are shallower than the Balconettes at each end of the elevation.

Historically significant for its architecture, the proposed project will not impact the building's character-defining features. The proposed project will not alter, damage, or destroy Security Title Insurance Co. building in part or in its entirety. Given the type of construction proposed at the project site and the approximately 440-foot distance between the two locations, it is not anticipated that the historical resource will be damaged due to vibration.

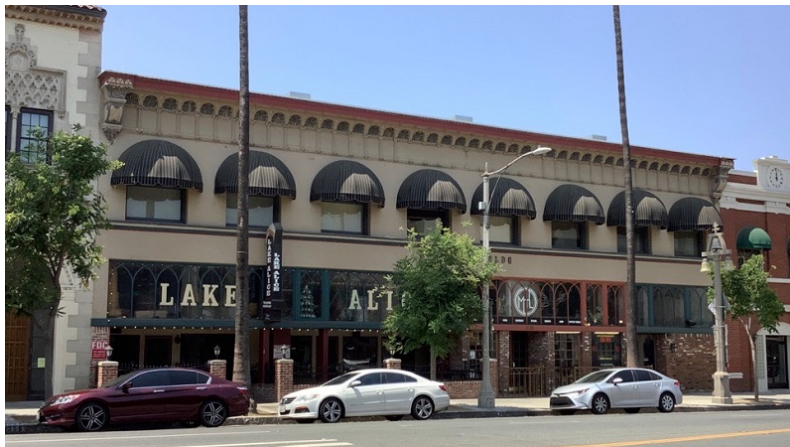
Figure 39. Roosevelt Building, view southwest. ICF, 2021.

The Roosevelt Building is modest Italianate commercial building that dates to 1904, with 1930 alterations (Figure 39). It has a rectangular plan. The two-story building has a long profile along University Avenue. The primary (northeast) elevation's first-floor contains four storefronts, with recessed glazed storefronts set beneath a glazed mezzanine level above. The overlapping arched muntins form the mezzanine level's glazing program. One over one wood sash windows punctuate the second level's painted brick wall. They are shaded by semi-circular fabric awnings. A bracketed cornice at the roofline embellishes the building's design. It features ornate brackets with multiple designs including acanthus leaves at each edge of the building. In between the two brackets, delicate arched panels separated by miniature columns further embellish the building. Signage between the mezzanine and second floor spells, "Roosevelt Building." A non-original brick porch fronts the building.

Historically significant for its architecture, the proposed project will not impact the building's character-defining features. The proposed project will not alter, damage, or destroy the Roosevelt Building in part or in its entirety. Given the type of construction proposed at the project site and the approximately 625-foot distance between the two locations, it is not anticipated that the historical resource will be damaged due to vibration.

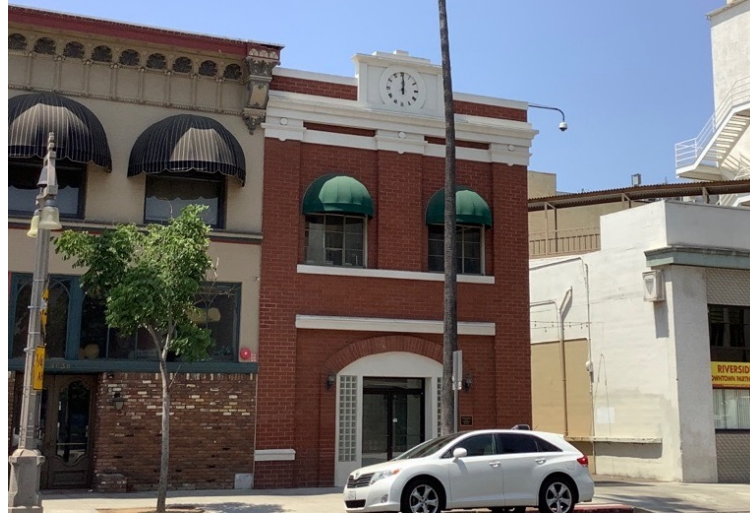
Figure 40. 3642 University Avenue, view southwest. ICF, 2021.

3642 University Avenue is a narrow, two-story brick clad building that dates to 1920 (Figure 40). It has a rectangular plan. The Colonial Revival building's primary (northeast) elevation features recessed door set within a wide arch formed by variations in the brickwork.

The second floor includes two multi-light windows shaded by semi-circular fabric awnings. A simple entablature is located just below the roofline. A clock framed on a rectangular white background rises slightly above the roofline. Brickwork at the edge of the elevation evokes columns. A flat roof with a straight parapet caps the building.

Historically significant for its architecture, the proposed project will not impact the building's character-defining features. The proposed project will not alter, damage, or destroy 3642 University Avenue in part or in its entirety. Given the type of construction proposed at the project site and the approximately 650-foot distance between the two locations, it is not anticipated that the historical resource will be damaged due to vibration.

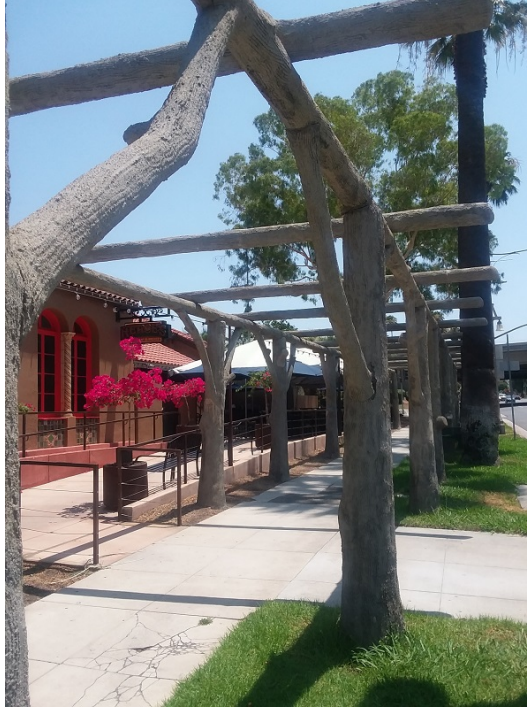
Figure 41. Citrus Tree Pergola, view northeast. ICF, 2021.

The Citrus Tree Pergola within the study area is located along the northeast side of Mission Inn, between Lime Street and SR91 (Figure 41). It frames the sidewalk. Constructed of concrete in the 1980s, it replicates an original wooden pergola at the site dating to 1929. The pergola has trunk and branch-like posts that rise on either side of the sidewalk at regular intervals. Branch-like members stretch across and connect the posts together. In addition, branch-like members rest perpendicular to the sidewalk, above. The City maintains three additional pergolae, none of which are in the study area.

Historically significant for its association with the citrus industry and rebuilt of concrete in the 1980s, the proposed project will not impact the Citrus Tree Pergola's character-defining features. The proposed project will not alter, damage, or destroy the Citrus Tree Pergola in part or in its entirety. Given the type of construction proposed at the project site and the Citrus Tree Pergola's simple post-and-beam concrete construction dating circa 1985, it is not anticipated that the historical resource will be damaged due to vibration.

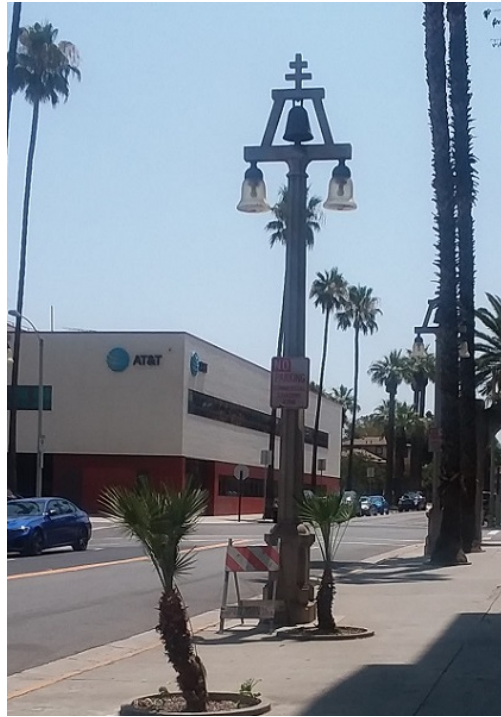
Figure 42. Example streetlight, view southeast. ICF, 2021.

The Navaho Raincross Streetlights proliferate the study area and extend beyond it (Figure 42). There are over 140 Navaho Raincross Streetlights located in Riverside, with at least 105 dating to 1928.⁷⁰ Formed of concrete, the column rises to the light fixture and Navaho Raincross symbol. A T-bar rests atop the column, with two lights pointing downward. Each light has a glass light cover. Angled bars with a double cross above frame a bell. They primarily align Mission Inn Avenue, University Avenue, Ninth Street, Orange Street, but other examples occasionally dot nearby streets.

favor of firetruck access. The Navaho Raincross Streetlights within the study area date to 1928 or are replicated replacements that date to the 1980s and 1990s.

Replacement streetlights from the 1980s and 1990s are non-contributing elements of the district, including streetlights along the northside of Mission Inn Avenue. It is unclear from the documentation if all streetlights along the northside of Mission Inn Avenue from Buena Vista Bridge near Mt. Rubidoux Drive to the west to the former Santa Fe Railway tracks near Commerce Street to the east are replacements or if only some are replacements. Others may have been replaced, but visual inspection did not identify which examples are original and which examples are replacements.

The proposed project will relocate one streetlight. The one streetlight will be relocated to another location in the vicinity, along the southside of Mission Inn Avenue between Lemon and Lime Streets. Greens INV 10 will coordinate with the City Department of Public Works to determine the appropriate location based on the City's streetlighting requirements. It is anticipated that the streetlight will likely be relocated approximately 15 feet to the south, but it may be moved northwest or southeast along the block.⁷² The streetlight will not be altered, damaged, or destroyed. In addition, its character-defining features will remain intact. It will remain along the same block, within the vicinity of its current location.

Two streetlights are approximately ten-feet from the project site, one of which will be relocated as described above. Others in the vicinity are approximately 20-feet, 80-feet, and over 125-feet from the project site. Given the type of construction planned for at the project site and the streetlights' concrete construction, it is not anticipated that the historical resource will be damaged due to vibration.

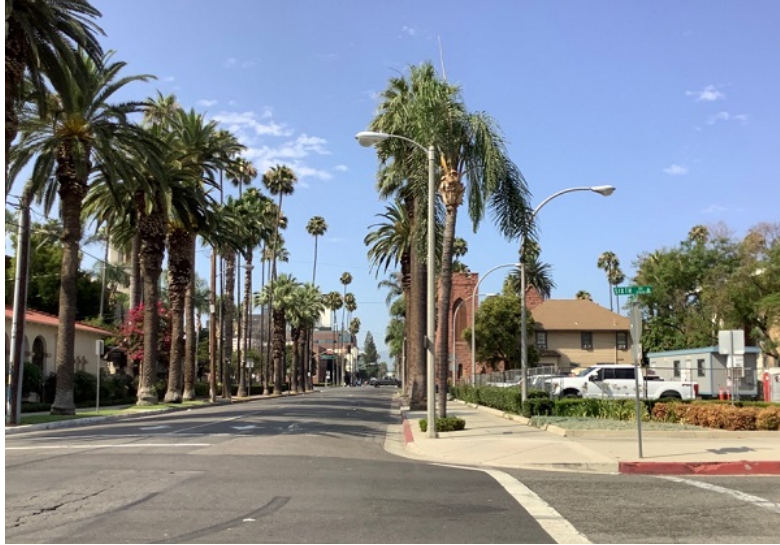
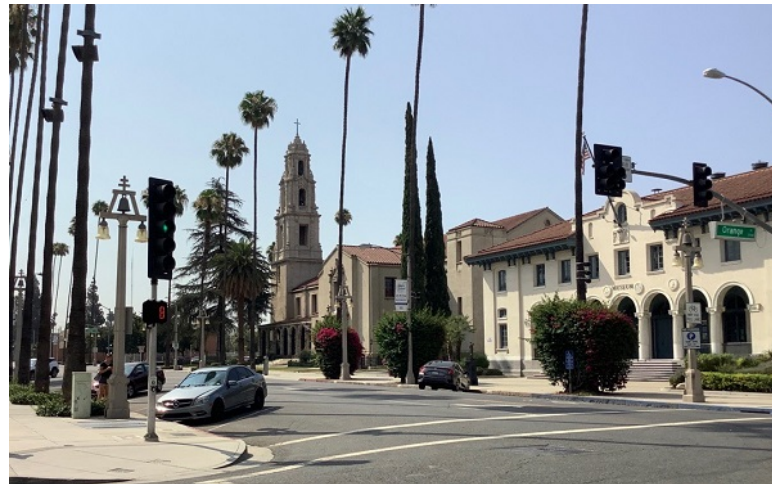
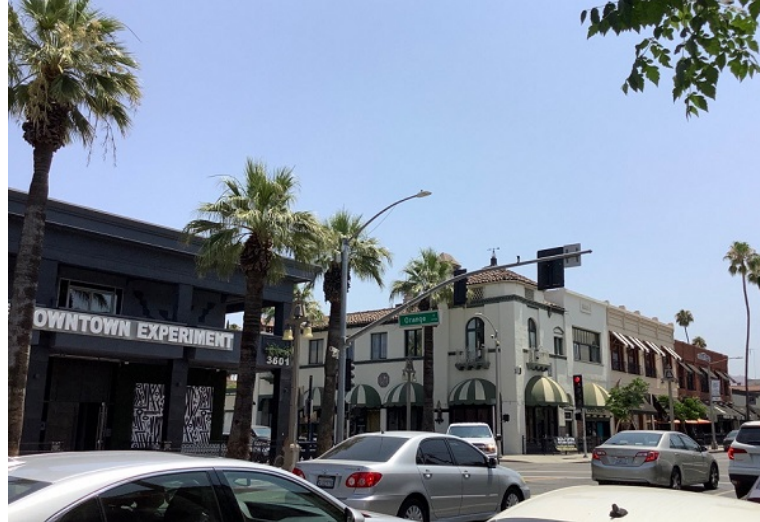
The Mission Inn Historic District is roughly bound by SR 91 to the east, sixth Street to the north, Market Street to the west, and Eleventh Street to the south. The district boundary encompasses the city's historic commercial and civic center (Figures 43 to 45). It includes numerous contributing buildings that date from 1880s through the 1940s, many of which are also individually listed or determined eligible for the NRHP, listed in the CRHR, or locally designated. Streets are laid on a grid that is skewed from a north-south axis. As such, streets extend northeast to southwest and northwest to southeast. In addition to buildings, the district includes the Navaho Raincross Streetlights, other streetlighting, the Citrus Tree Pergola, parkways, sidewalk planters, street trees, and street furniture.⁷⁴

Figure 43. Mission Inn Historic District, along Lemon Street at the intersection of Lemon Street and Sixth Street, view southwest. ICF, 2021.

Figure 44. Mission Inn Historic District, along Mission Inn Avenue at the intersection of Mission Inn Avenue and Orange Street, view southeast. ICF, 2021.

Figure 45. Mission Inn Historic District, along University Avenue near the intersection of University Avenue and Orange Street, view east. ICF, 2021.

The proposed project will not have a significant impact the district nor will it impact district contributors. No contributing buildings will be demolished for construction because the proposed project site currently consists of a surface parking lot. (Owners demolished buildings on the site over 50-years ago.⁷⁶) Neither non-parcel contributing features such as Citrus Tree Pergola and Navaho Raincross Streetlights, nor contributing buildings will be physically altered, damaged, or destroyed. In addition, the street grid and street furniture will not be physically altered, damaged, or destroyed. The district's physical integrity, therefore, will not be impacted by construction of the new building.

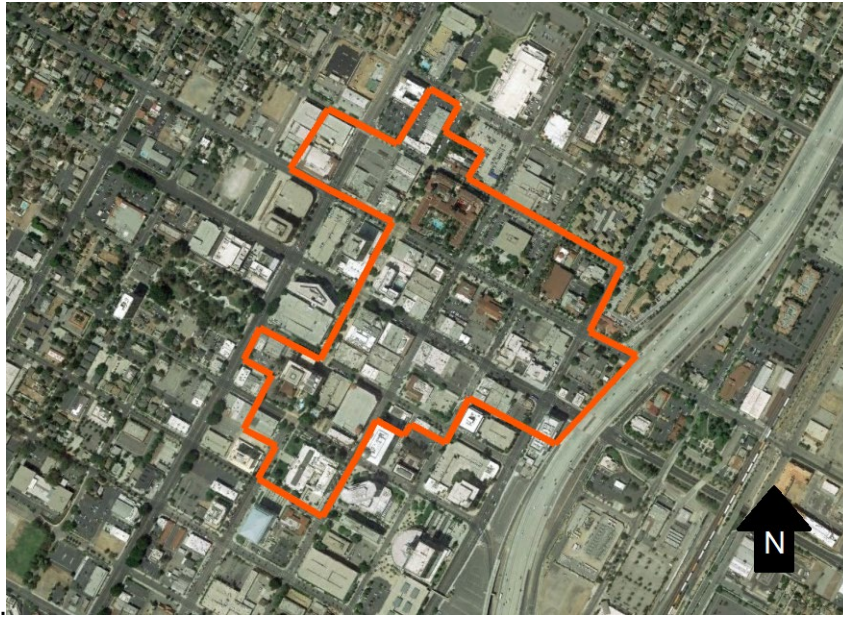
Figure 46. Mission Inn Historic District Boundary with North Arrow.

The historic district boundary is irregular but roughly bounded by Sixth Street, Eleventh Street, Market Street and SR-91 (Figure 46).

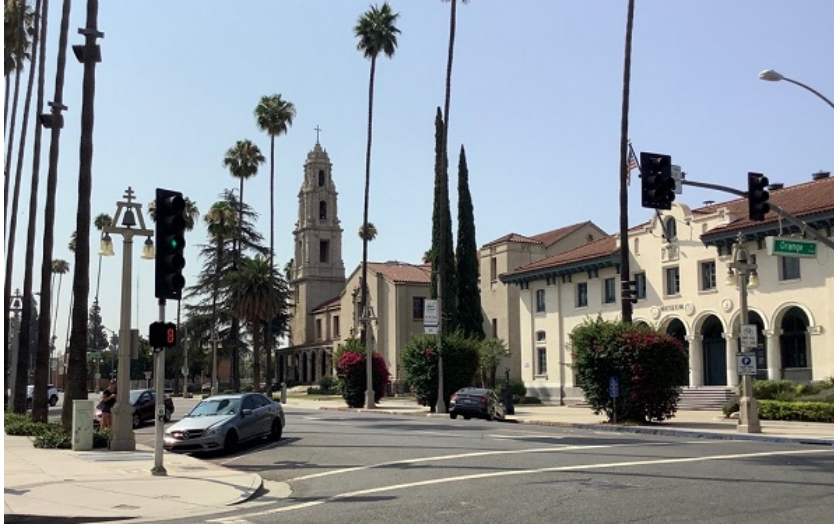
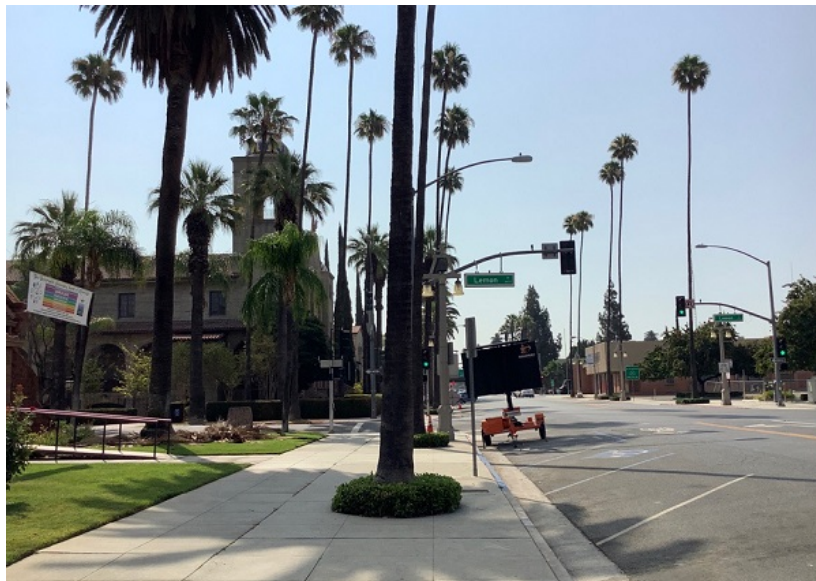
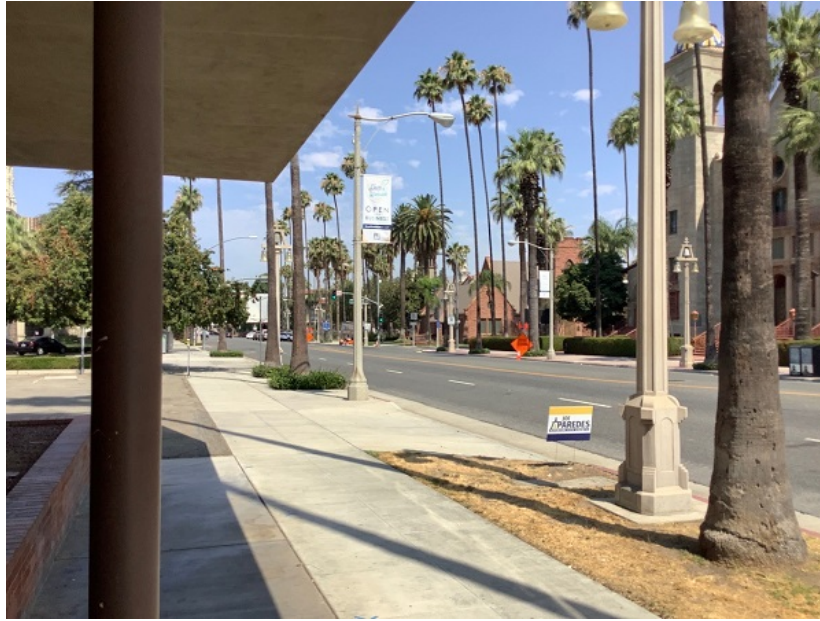
The Seventh Street Historic District in downtown Riverside extends along Mission Inn Avenue's northwest to southeast alignment from the Buena Vista Bridge near Mt. Rubidoux Drive to the former Santa Fe Railway tracks near Commerce Street. Significant for its associations with the initial settlement at and founding of Riverside, it is also significant for its architecture (Figures 47 to 49).⁸² It includes a high number of contributing buildings that date from the late nineteenth century to just after World War II. In addition to contributing to the district, many of these buildings are also individually listed or have been formally determined eligible for the NRHP, are listed in the CRHR, or are locally designated. In addition to buildings, the district includes the Navaho Raincross Streetlights and the Citrus Tree Pergolae as contributing features.⁸³

Figure 47. Seventh Street Historic District, along Mission Inn Avenue at the intersection of Mission Inn Avenue and Orange Street, view southeast. ICF, 2021.

Figure 48. Seventh Street Historic District, along Mission Inn Avenue north of the intersection of Mission Inn Avenue and Orange Street, view southeast. ICF, 2021.

Figure 49. Seventh Street Historic District, along Mission Inn Avenue in front of the Central Fire Station, view northwest. ICF, 2021.

The proposed project will neither significantly impact the district nor impact its contributors. The site proposed for new construction includes a surface parking lot. Owners demolished buildings on the site over 50-years ago.⁸⁴ No contributing buildings, therefore, will be demolished for construction. As discussed above, neither non-parcel district contributors, specifically the Citrus Tree Pergola and Navaho Raincross Streetlights, nor building contributors will be physically altered, damaged, or destroyed.

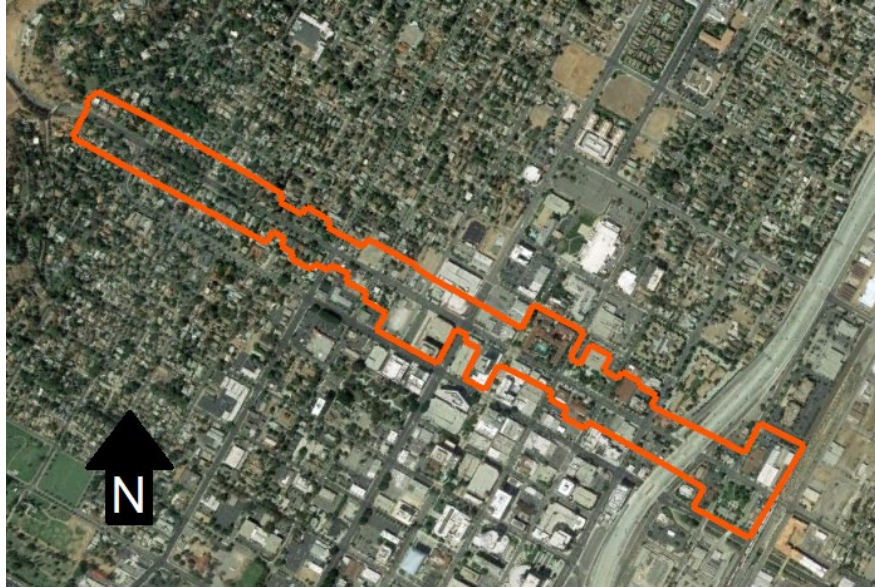
Figure 50. Seventh Street Historic District Boundary with North Arrow.

The historic district boundary extends along Mission Inn Avenue from the Buena Vista Bridge near Mt. Rubidoux Drive to the former Santa Fe Railway tracks near Commerce Street. (Figure 50). It includes parcels on both sides of the street.

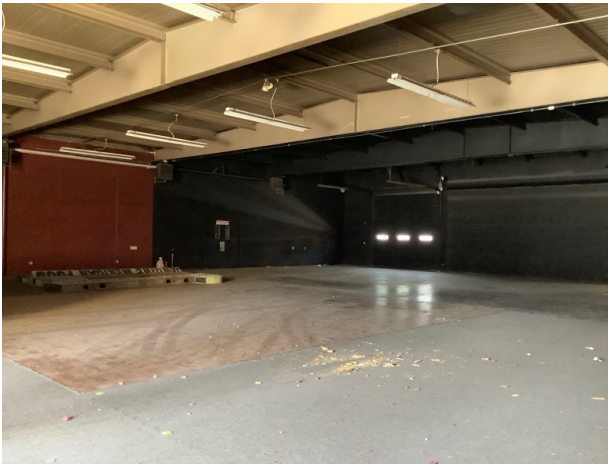
Figure 51. Fire truck Garage. ICF, 2021

- Delineation of fire truck space, office and living space, and the hose drying space.
- Garage lacking interior partitions, with three garage bays along the northeast and southwest elevations (Figure 51).
- Two story, stacked office and living space with rooms on either side of an L-shaped hall on both floors (Figures 52 and 53).
- Hose drying tower, without interior partitions, and with bare concrete walls and louvered vents. Associated apparatus contributes to significance (Figure 54).
- Two fire pole openings between the first and second floors (Figure 55).
- Skylights (some appear to be hidden by interior drop ceilings).
- Two staircases between first and second floors, with circular metal balustrades.
- Slab wood doors with metal doorknobs (Figure 56).

Although plans are not developed for interior work, it is anticipated that the proposed project will be designed to meet the Standards for Rehabilitation and, as such, no direct impacts are anticipated to occur to the Central Fire Station.

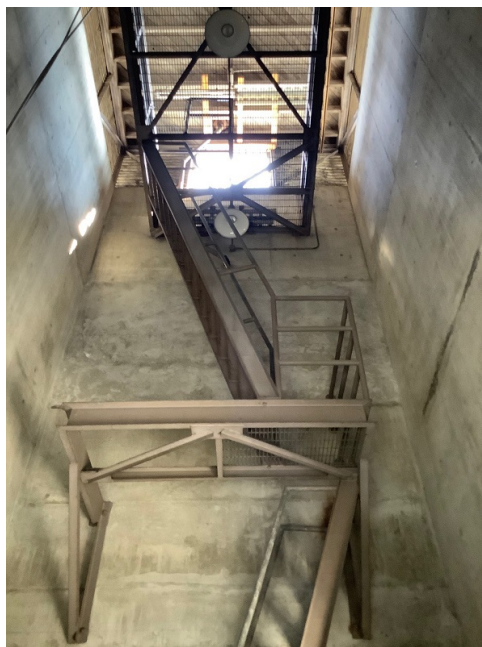
Figure 54: Hose drying tower. ICF, 2021
