Order Number: 22052601279

**LIMITED PHASE II
ENVIRONMENTAL SITE ASSESSMENT**

PROPERTY ASSESSED:
4468 Brockton Avenue
Riverside, Riverside County, California 98501

**RSB Project No. 2203037
Report Date: March 31, 2022**

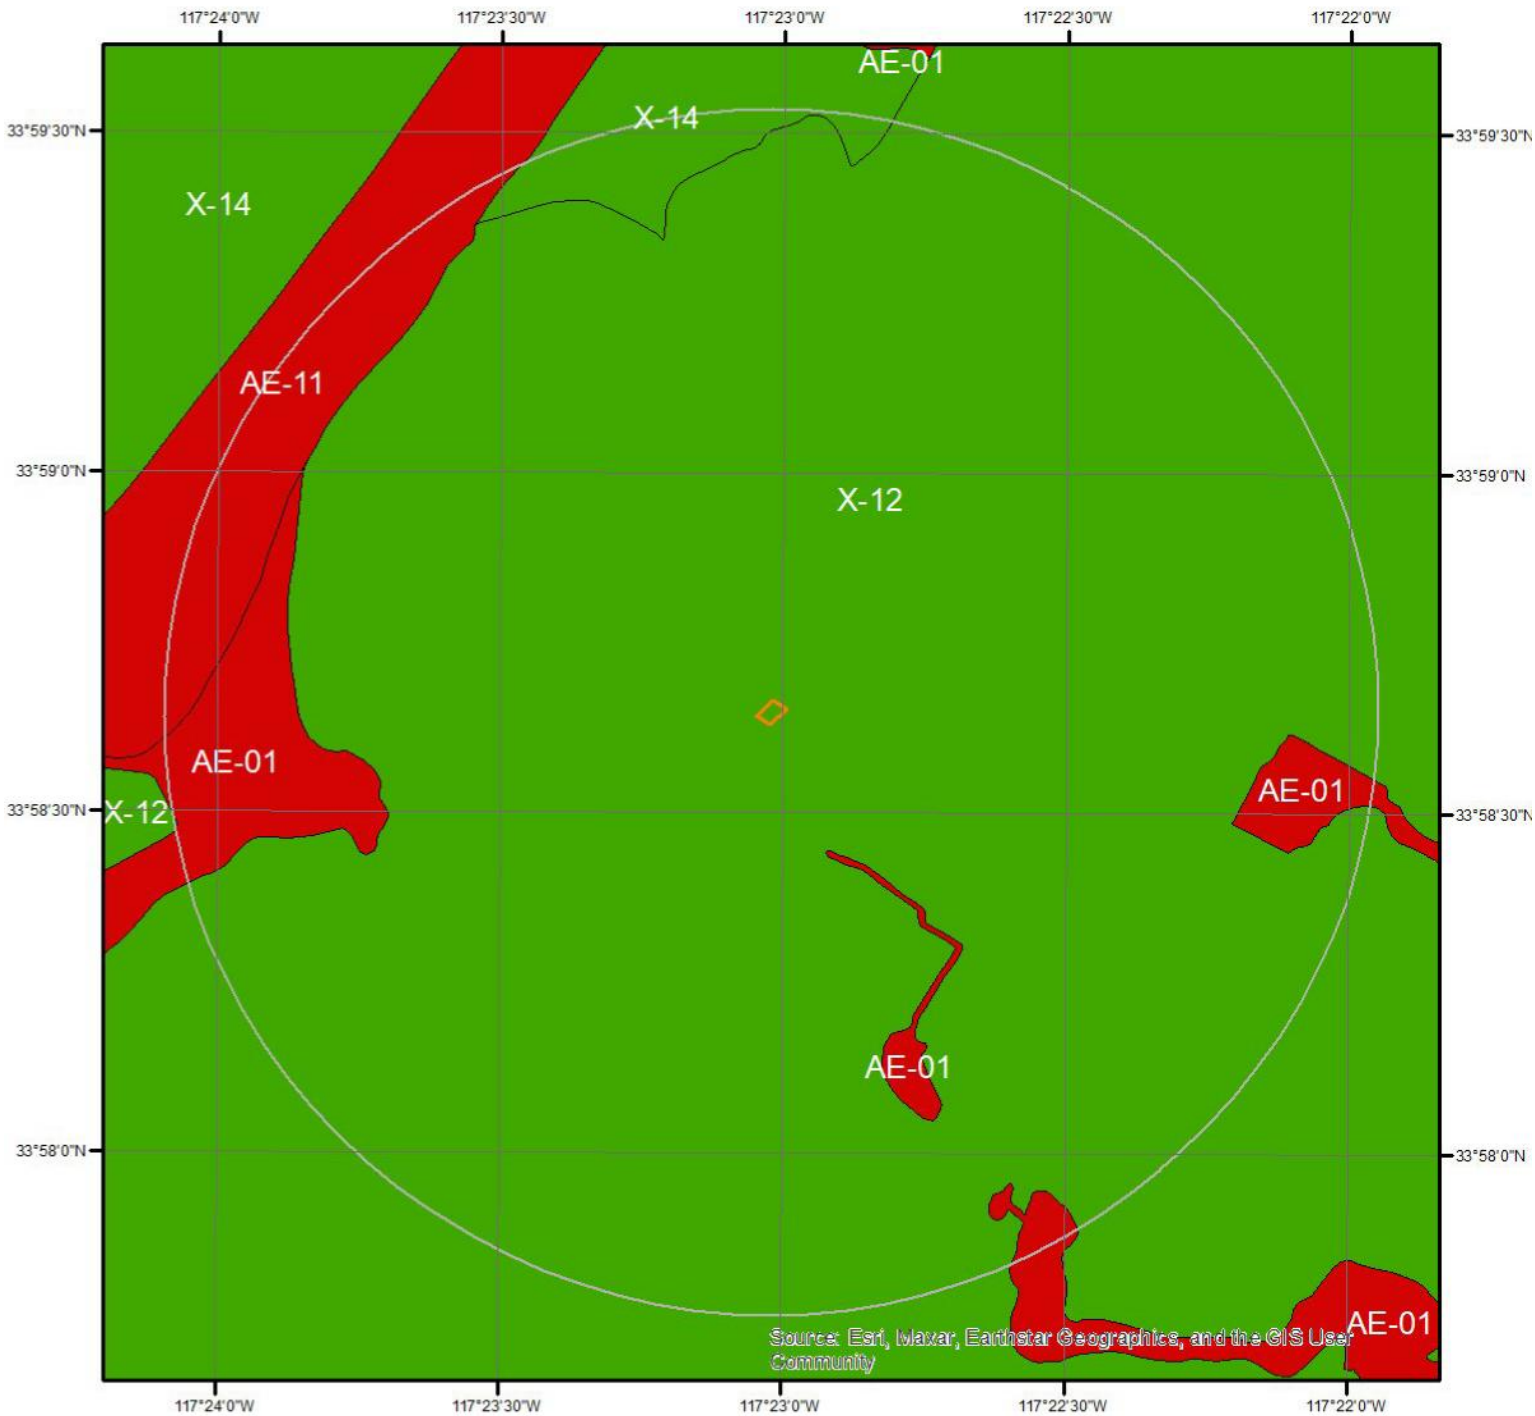
Flood Hazard Zones

Zone: X
Zone subtype: AREA WITH REDUCED FLOOD RISK DUE TO LEVEE

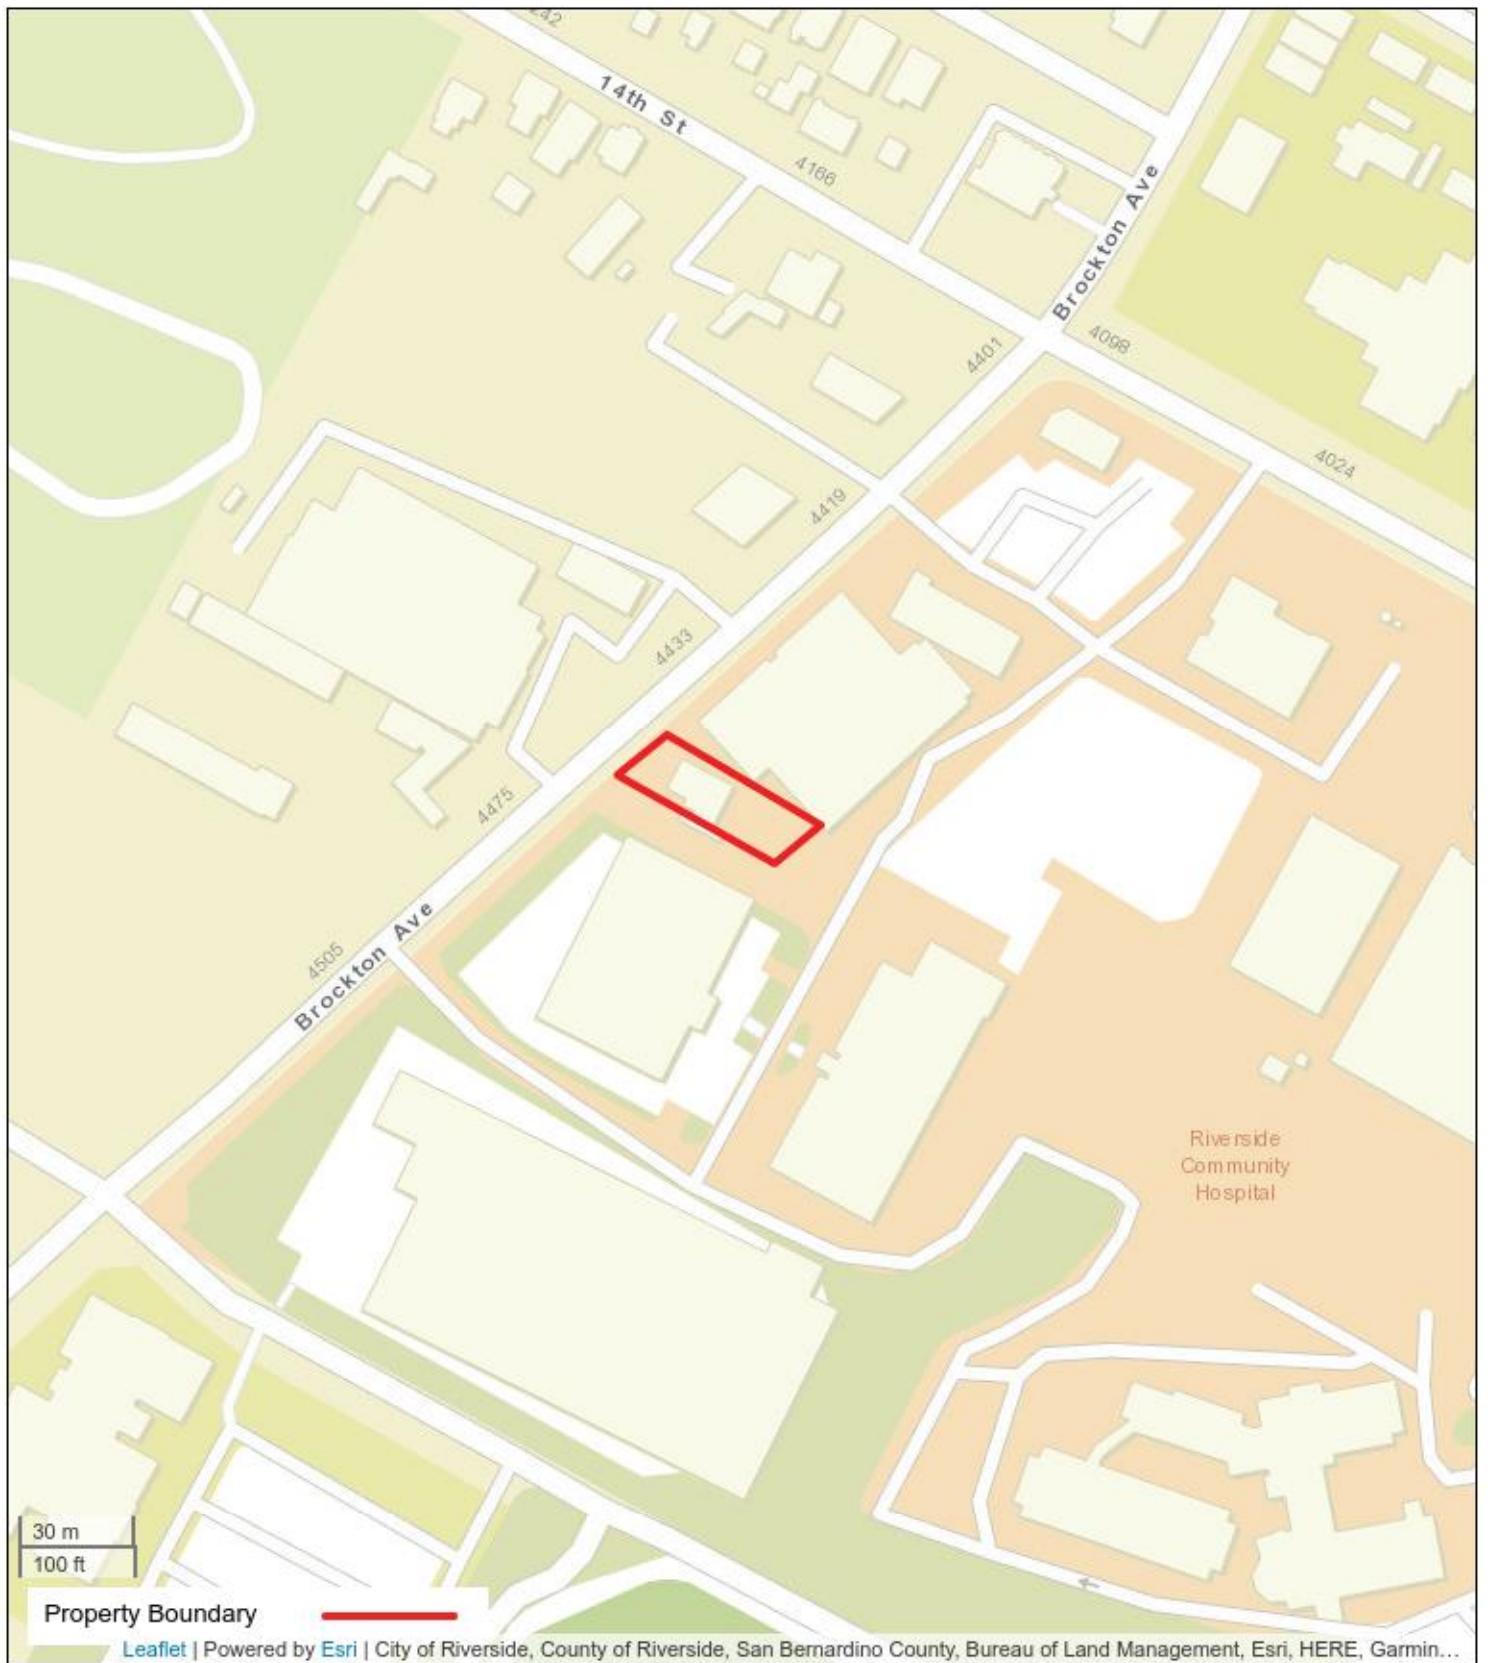
Figure 1: Site Map

4468 Brockton Avenue, Riverside, California 98501
