## **Appendix C-1**

Cultural Resources Assessment Report: Barley Mills Building,  
3596 Commerce Street & 3051 Mission Inn Avenue; Riverside CA  
Site of Riverside Soda Works, 2993 Mission Inn Avenue; Riverside CA

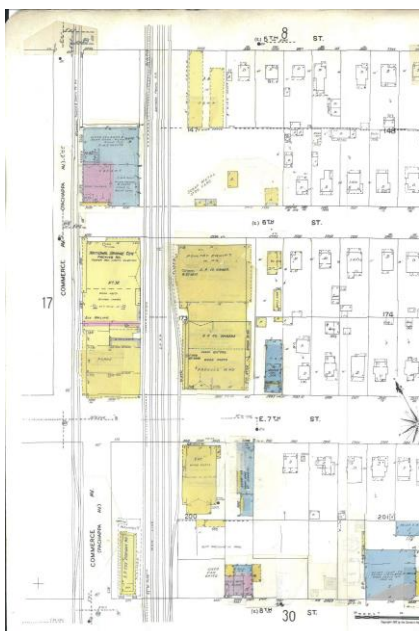
**Figure # 15: Sanborn Map, Detail; dated January 1952.** North is up. Noted that the salmon/reddish color graphic at the upper left corner of Sixth and Commerce streets represents the 1891 Barley Mills Building. Green color represents the 1930 additions. A note stating the entire structure including the 1930 additions was "VACANT." Scrap Metal yard noted to the east.

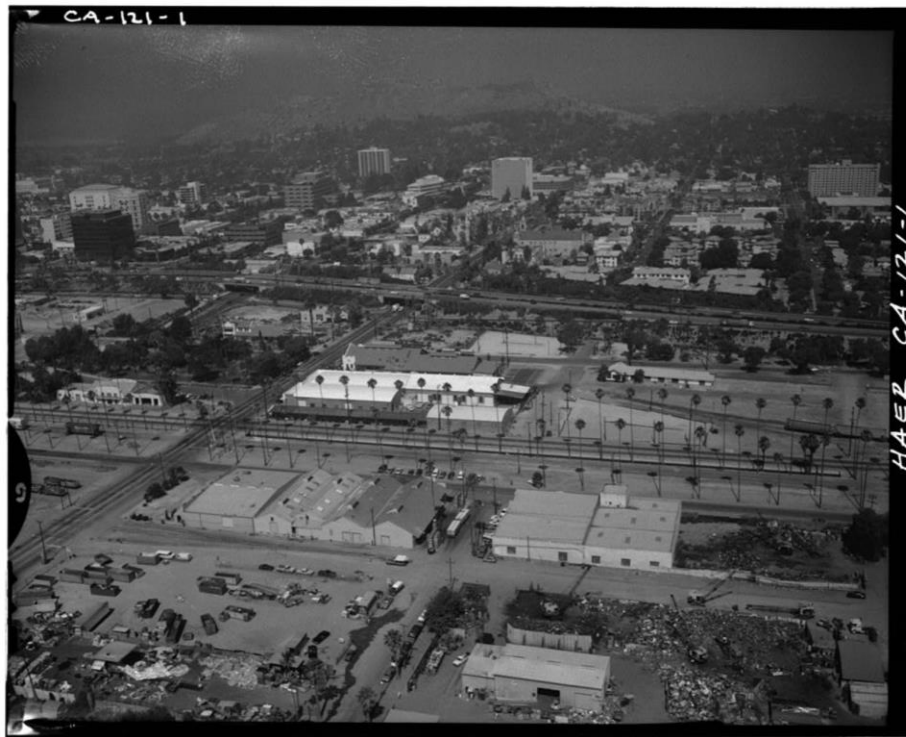
**Figure # 16: HAER aerial photo documentation;** Source Library of Congress; file HAER CA-121-1; 6/24. View is towards the west; main line railroad tracks bisects the image left to right. The Sunkist Packing House complex is in the left side foreground ; the Barley Mills Building is to the right of the Sunkist Packing House in the right side foreground. Scrap metal yard is in the foreground.

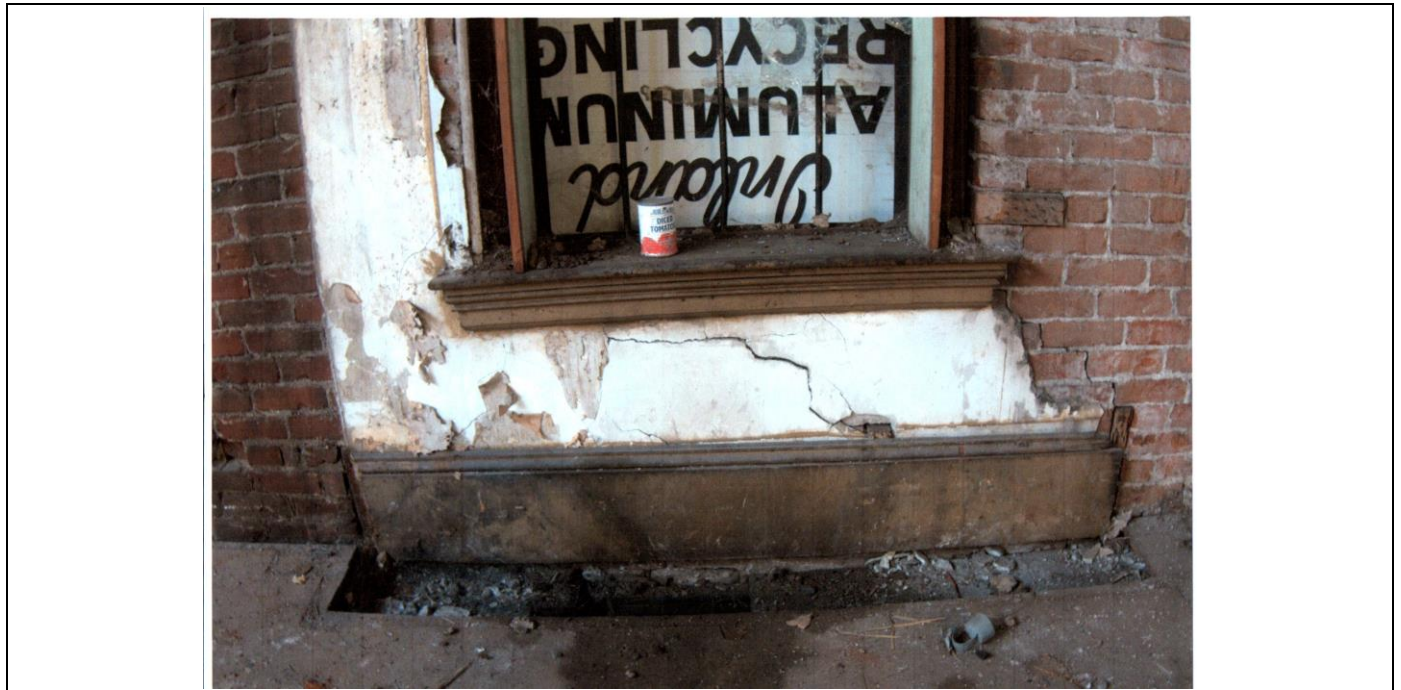
Figure # 20: The remaining original south façade interior wood window trim details at the named "office" area of the Barley Mills Structure: wall base and trim cap; window apron, window sill, window jamb trim/sash window weight box. See Appendix D.
