## **Appendix C-1**

Cultural Resources Assessment Report: Barley Mills Building,  
3596 Commerce Street & 3051 Mission Inn Avenue; Riverside CA  
Site of Riverside Soda Works, 2993 Mission Inn Avenue; Riverside CA

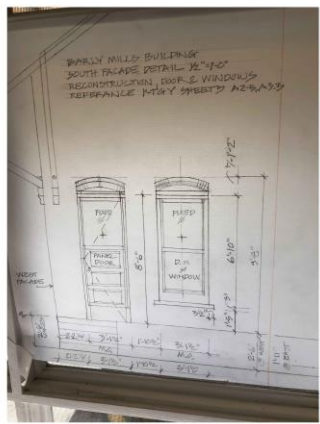
Figure # 9 Barley Mills Building: Reconstruction of c 1891 era doors and windows with dimensions of existing conditions and interpretive canopy roof framing. Proposed section and elevation. Source of field survey, GT Loudon Historical Architect; ktgy Architecture + Planning, sheet number A2-8.

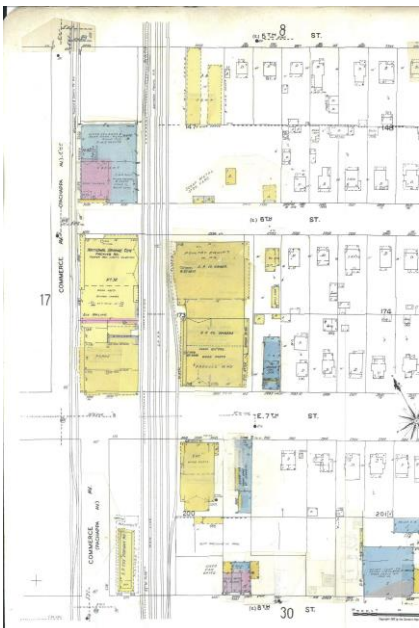
**Figure # 15: Sanborn Map, Detail; dated January 1952.** North is up. Noted that the salmon/reddish color graphic at the upper left corner of Sixth and Commerce streets represents the 1891 Barley Mills Building. Green color represents the 1930 additions. A note stating the entire structure including the 1930 additions was "VACANT." Scrap Metal yard noted to the east.

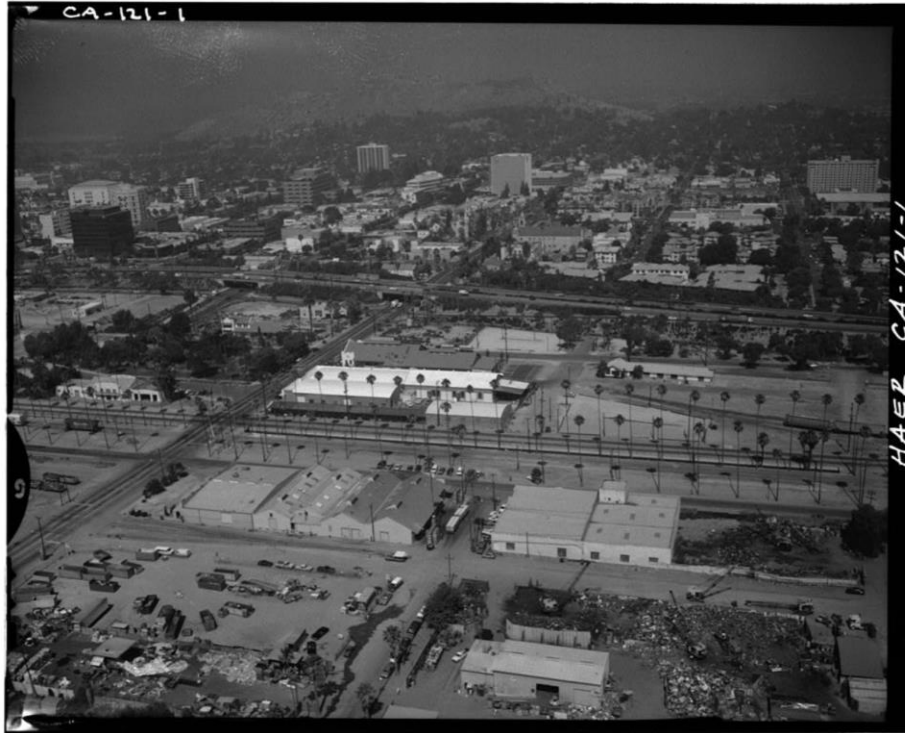
**Figure # 16: HAER aerial photo documentation;** Source Library of Congress; file HAER CA-121-1; 6/24. View is towards the west; main line railroad tracks bisects the image left to right. The Sunkist Packing House complex is in the left side foreground ; the Barley Mills Building is to the right of the Sunkist Packing House in the right side foreground. Scrap metal yard is in the foreground.

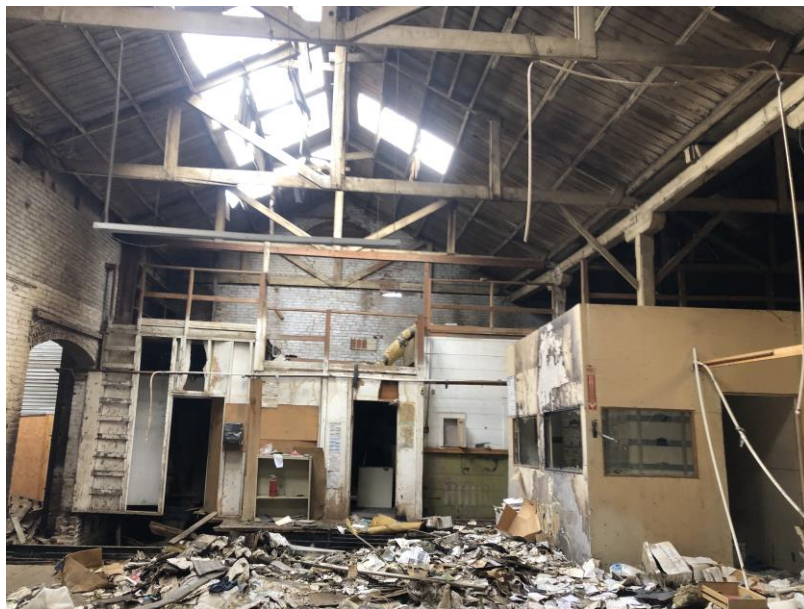
**Figure # 19: Interior photographs, 2022** showing non-contributing interior build-out construction prior to their removal. The remains are clear expressions of the spatial volume with trusses, exposed brick walls, and triple- segmented arched masonry doorway openings. Raised wood flooring visible in the foreground is severely damaged by fire at the southeast corner.

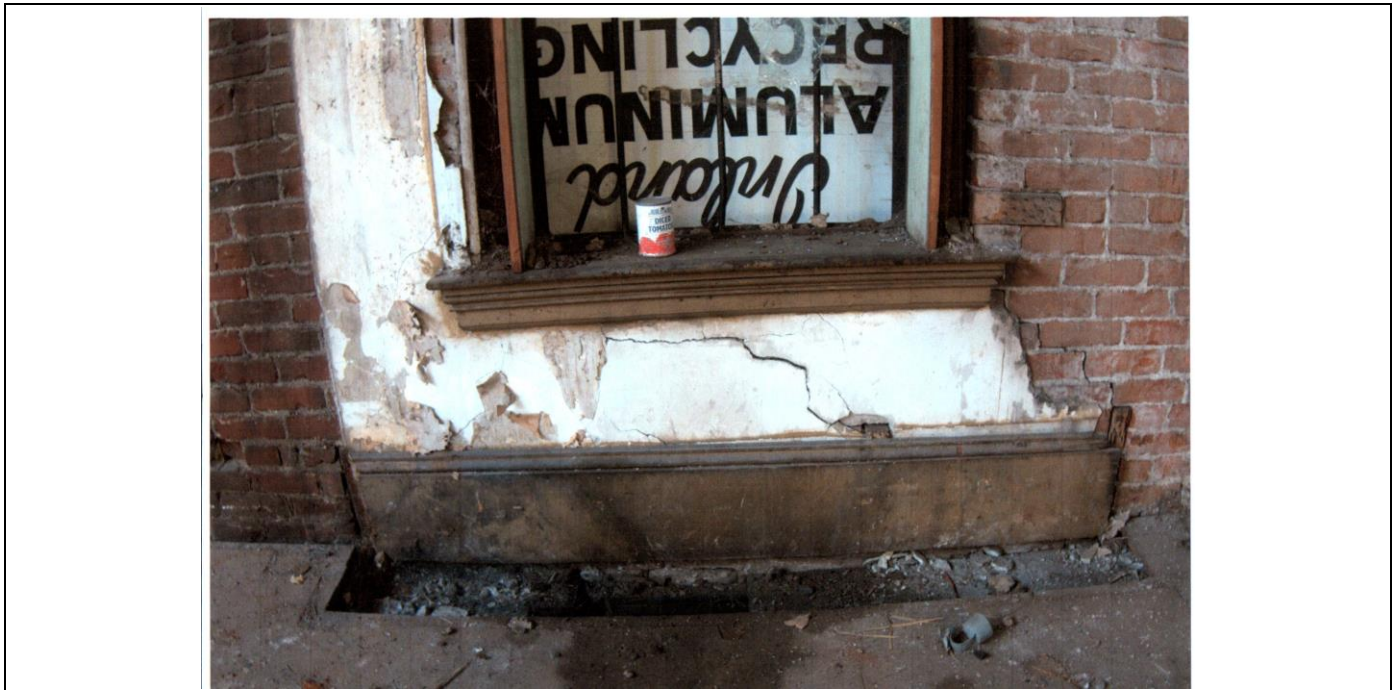
Figure # 20: The remaining original south façade interior wood window trim details at the named "office" area of the Barley Mills Structure: wall base and trim cap; window apron, window sill, window jamb trim/sash window weight box. See Appendix D.

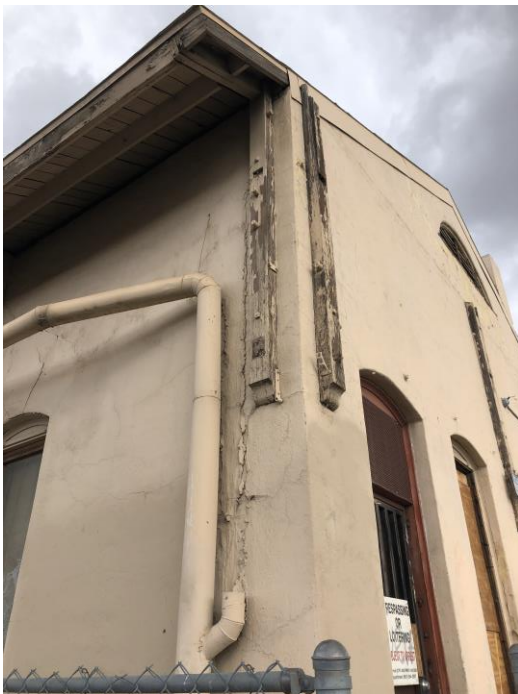
Barley Mills Building: Source G T Loudon AIA Photography, February 2022 ; Existing Conditions at corner, including wood brackets for attachment of non-extant canopies south façade door and window rough openings; **Figure # D-10**

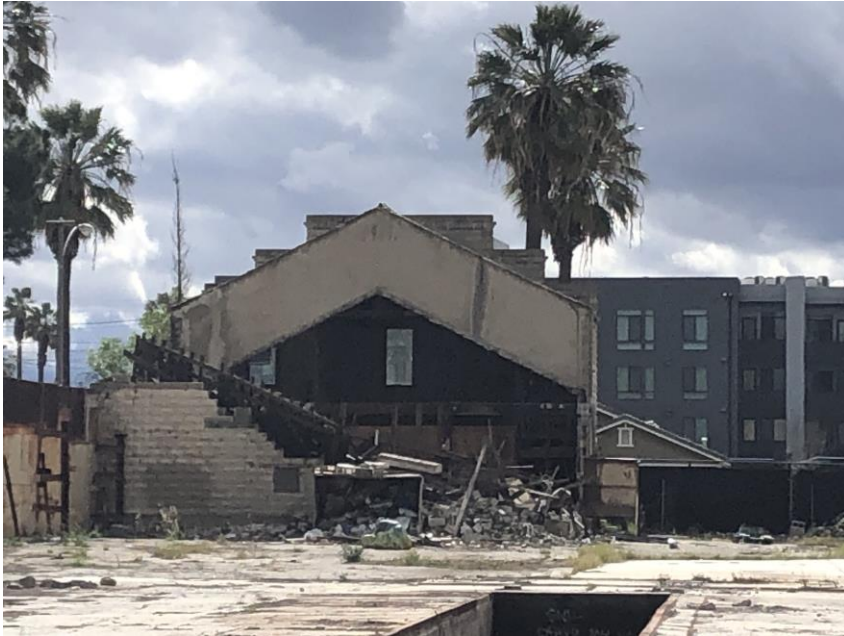
Soda Works Building: Source G T Loudon AIA Photography, February 2022 ; **Figure # D-13**  
View south of partially remaining north façade and roof collapse from previous fire damage.

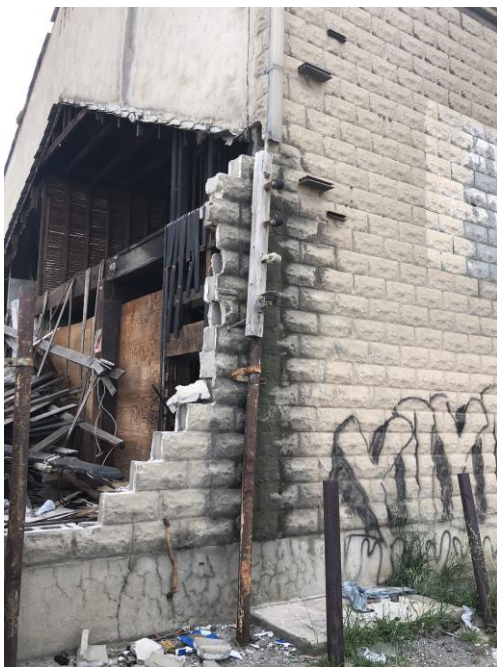
Soda Works Building: Source G T Loudon AIA Photography, February 2022 ; **Figure # D-14**  
View east of partially remaining west façade and exposed interior showing prior damage by fire.

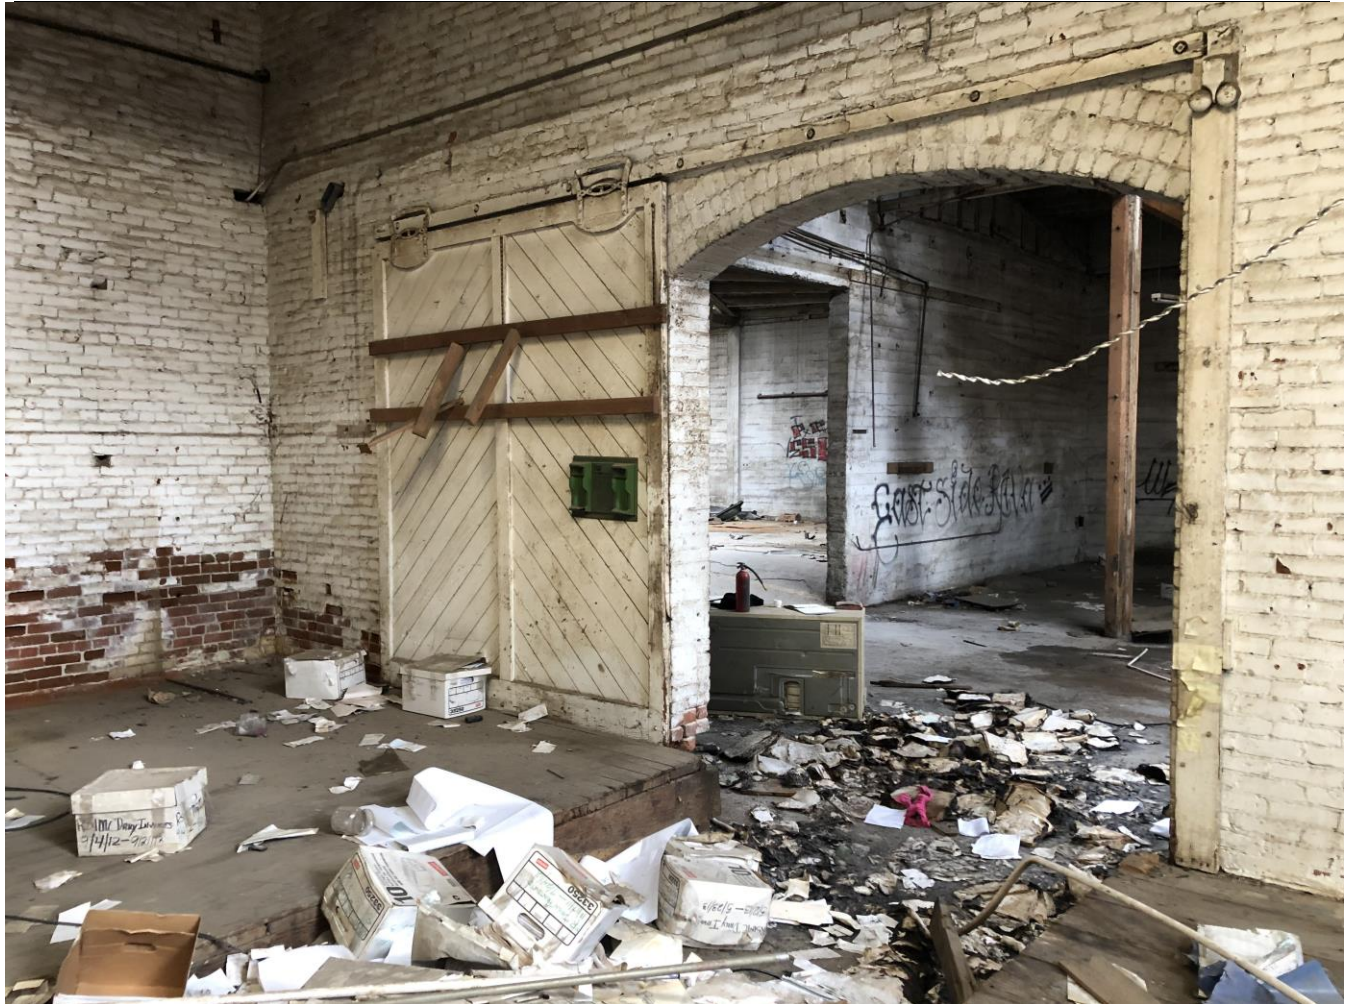
Barley Mills Building Interior: Source G T Loudon AIA Photography, February 2022; Figure # D-15  
View to east of original triple wythe segmented brick arch opening in original east exterior façade. View through opening is of the concrete walls structure of the later 1930 additions.

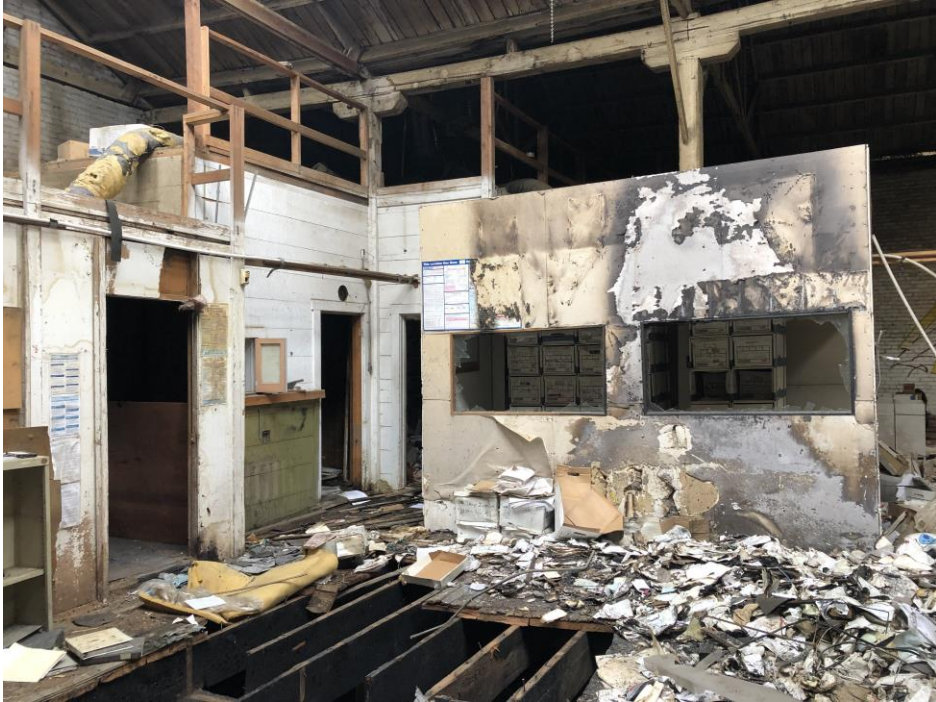
Barley Mills Building Interior: Source G T Loudon AIA Photography, February 2022;  
View to southwest corner of original 1891 structure; note the fire damaged wood floor and joists in near foreground; added mezzanine and interior wood framed enclosed space; Figure # D-16

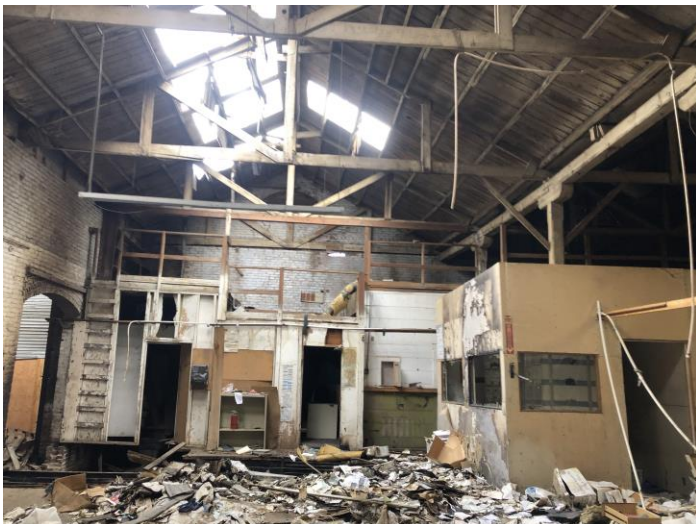
Barley Mills Building Interior: Source G T Loudon AIA Photography, February 2022;  
View to south façade of original 1891 structure; note the fire damaged wood floor and joists in near foreground; added mezzanine and interior wood framed enclosed space; note wood roof trusses viewed at location at centerline of the two gables; Figure # D-17

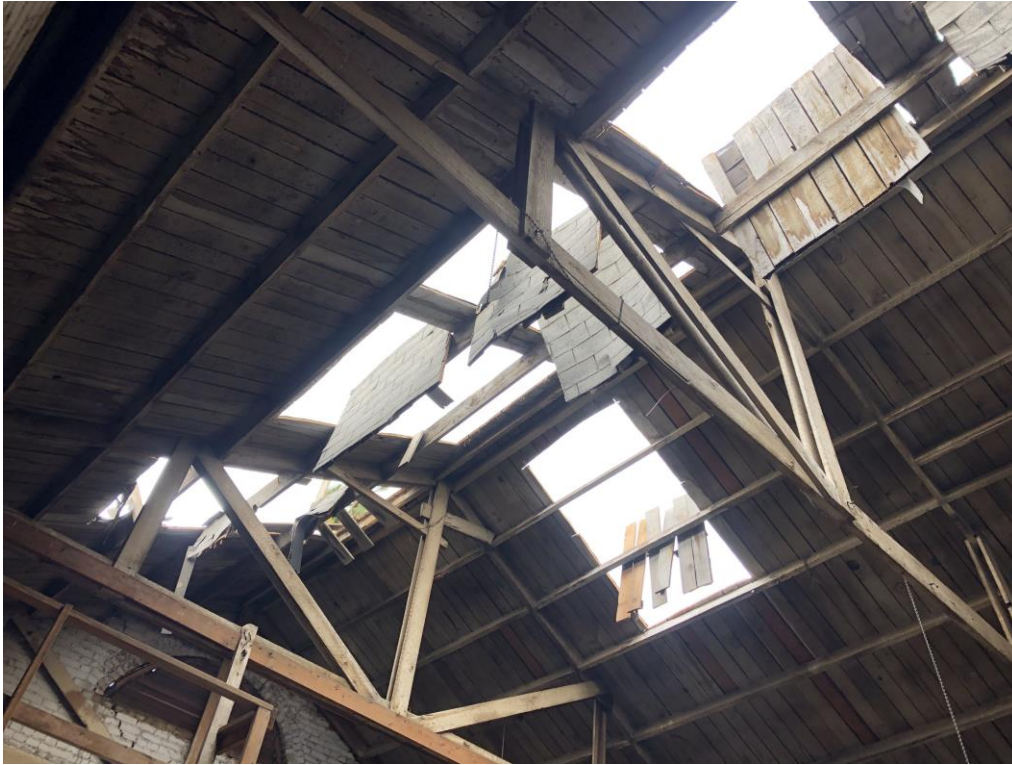
Barley Mills Building Interior: Source G T Loudon AIA Photography, February 2022;  
View of wood roof framing, board finish at the joists; the south wall brick façade and the half circular  
vent; the roof openings for skylights are not original and are not proposed to be restored. **Figure # D-18**

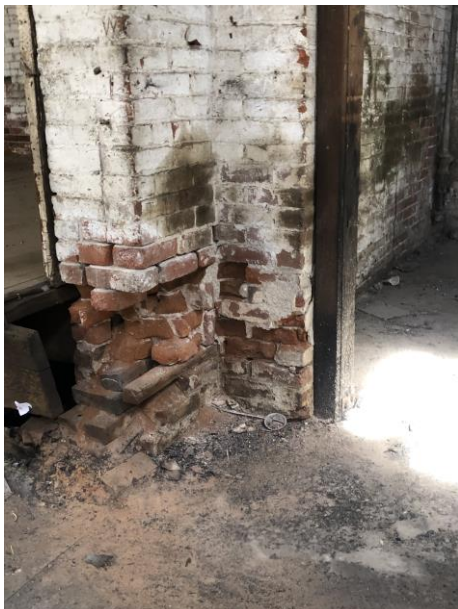
Barley Mills Building Interior: Source G T Loudon AIA Photography, March 2022; Interior view of south east façade, near the corner; note the brick masonry foundations have failed at the original west façade opening at the former exterior doorway jamb; Figure # D-21.

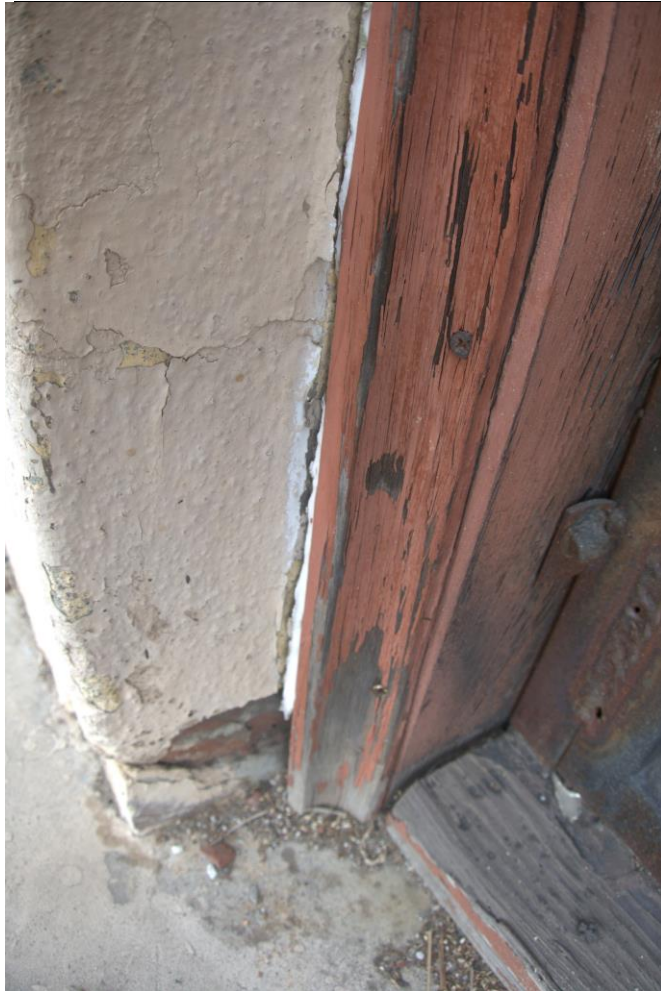
Barley Mills Building Exterior Window wood trim: Source G T Loudon AIA Photography, November 2103; Detail of window jamb, plaster veneered brick recess and sill. Figure # D-22

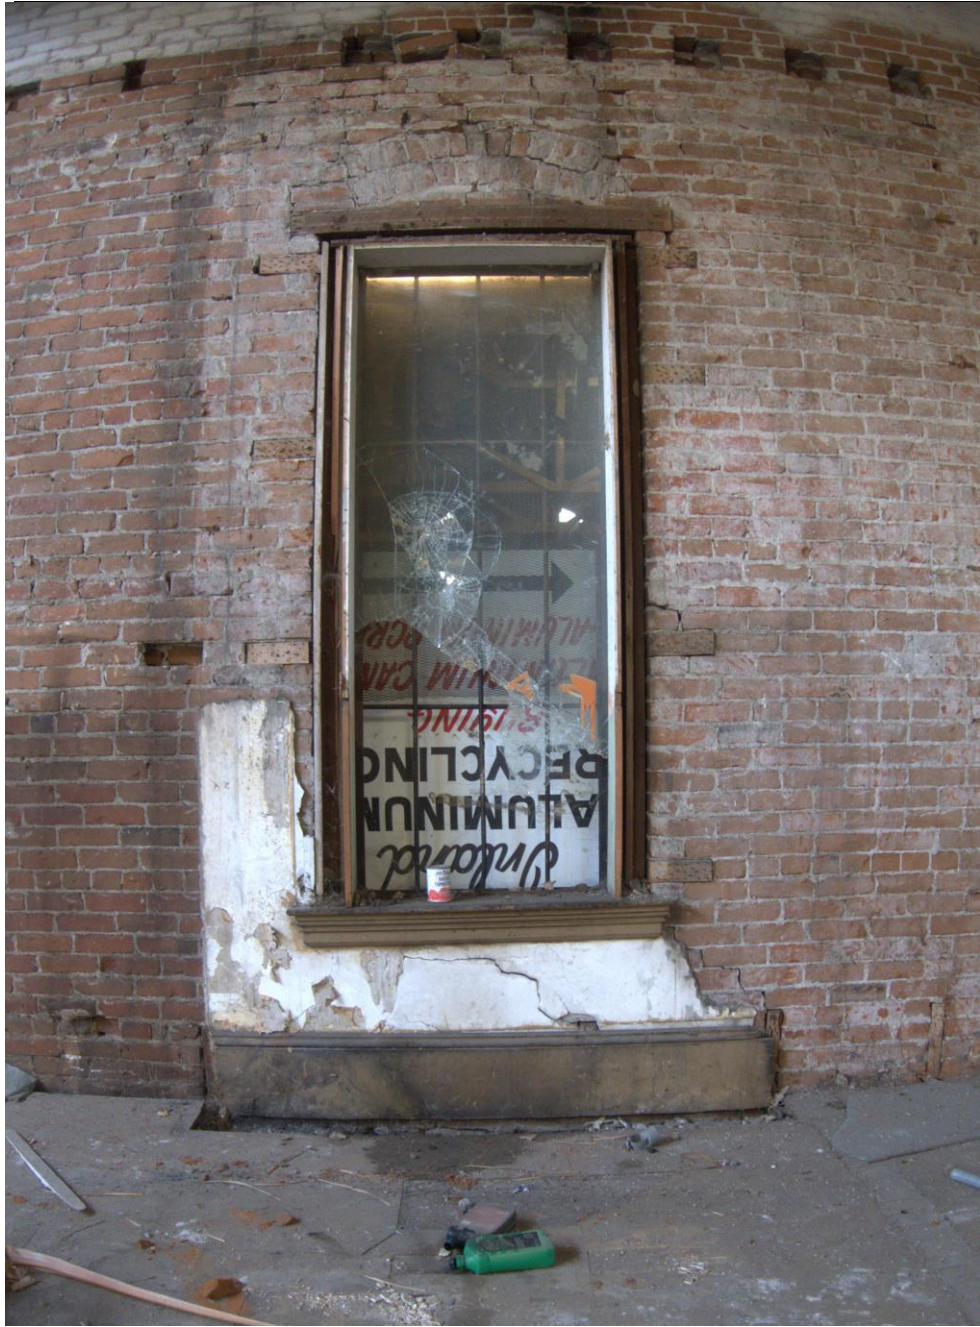
Barley Mills Building Interior : Source G T Loudon AIA Photography, November 2103; Detail of window jamb, sill, apron trim weight box and plaster veneered brick recess at base trim. Figure # D-23
