# Cultural Heritage Board

**CULTURAL HERITAGE BOARD MEETING DATE: JUNE 18, 2025**

<b>Case Numbers</b>	<b>DP-2025-00269</b> (Certificate of Appropriateness)	
<b>Request</b>	To consider a Certificate of Appropriateness to demolish an existing fire damaged residential office structure.	
<b>Applicant</b>	Belen Bobadilla on behalf the Riverside County Office of Education

# *STRUCTURAL DAMAGE EVALUATION REPORT – FIRE DAMAGE*

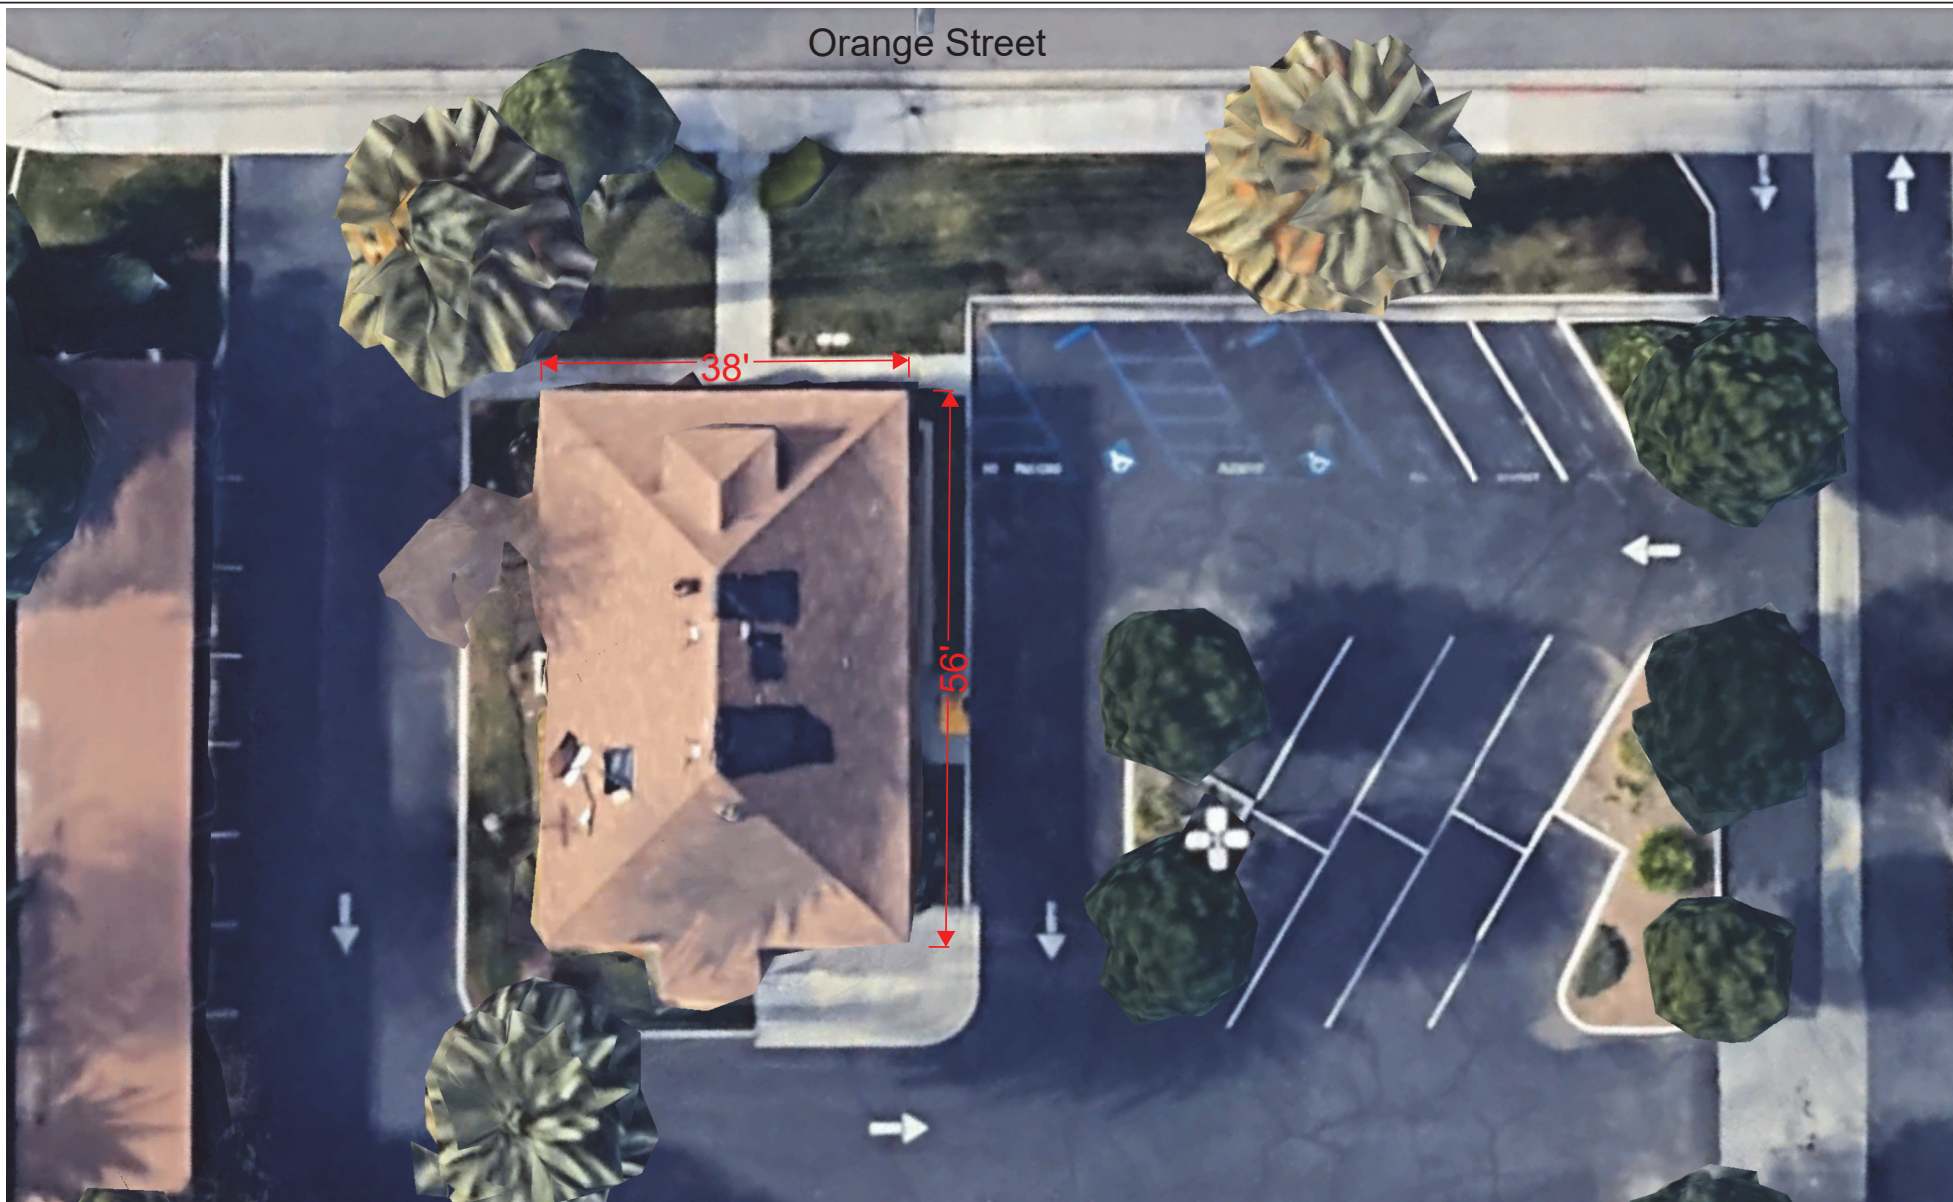
Project:	4472 Orange St.
Author:	
Date:	2/20/25
Sheet Name:	Site Plan

**Structure Dimensions**  
**4472 Orange St, Riverside, CA 92501**

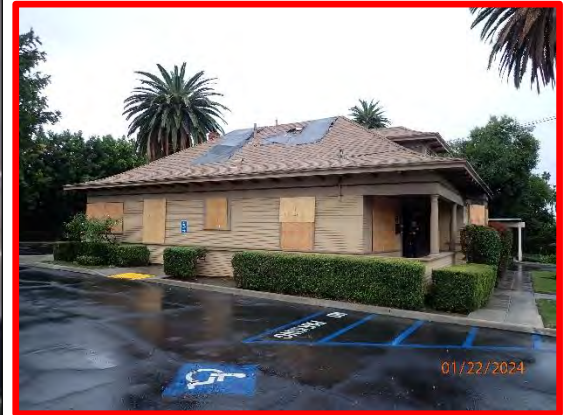
1. Close-up aerial view of the subject building; source: *nearmap.com*; view of the north elevation of the building from the parking lot.

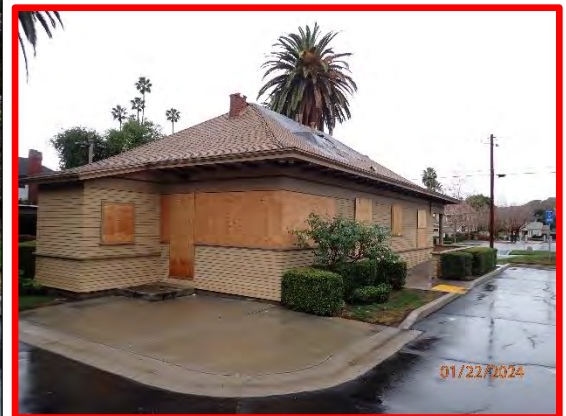
2. View of the east and south exteriors of the building from the parking lot. Wall/window openings had been boarded with plywood subsequent to the reported fire event.

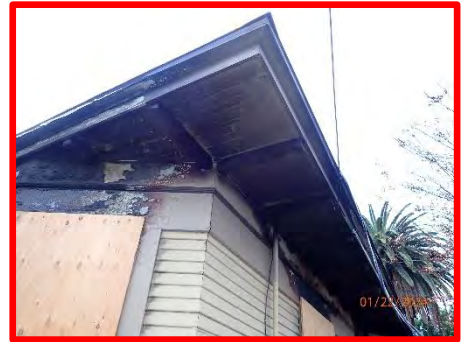
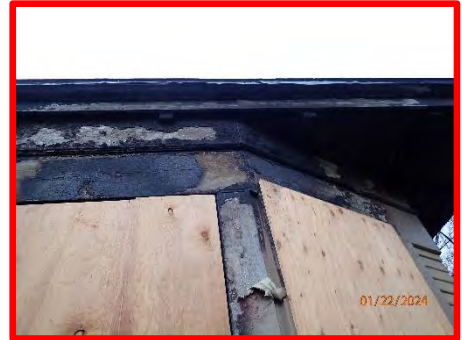
3. There was evidence of surficial charring and carbon/soot deposits at the exterior finishes around/adjacent to wall/window openings, consistent with fire induced by oxygen or airflow from the exterior/outdoor environment.

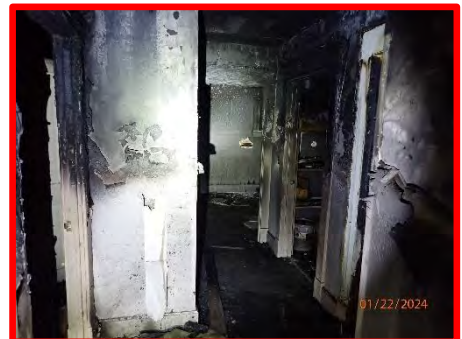
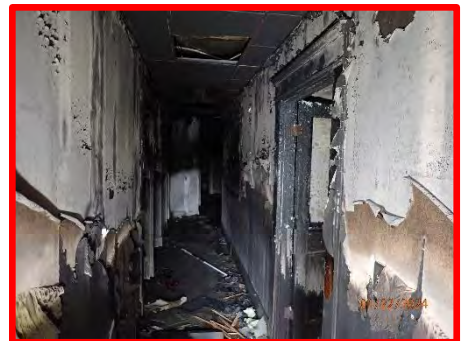
- Fire/heat-related damage to the interior finishes/components was noted throughout the building (*see Photograph 4*).
- Areas within the northern portion of the building had no discernible fire/heat-related damage to the structural framing of the structure; carbon/soot deposits were noted on the surface of the interior finishes (*see Photograph 5*).

4. Fire/heat-related damage to the interior finishes/components was noted throughout the building.

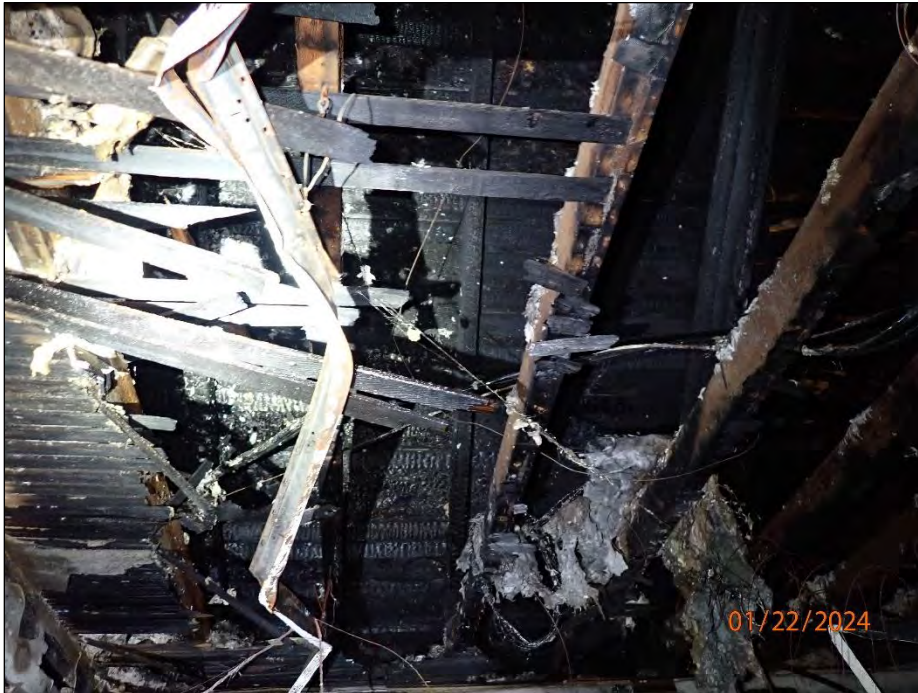
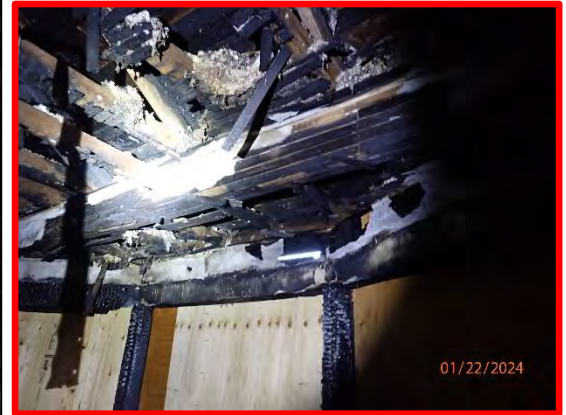
- The general disposition of the roof framing system within the southern portion of the building exhibited prominent signs of excessive amounts of charring. The noted fire/heat-related damage had compromised the integrity of the supporting members as well as the continuity of the load-carrying capacity. More than 60% of the roof system framing exhibited cross-sectional charring or excessive sapping/glazing appearance and were compromised (*see Photographs 8-through-11*).

9. The general disposition of the roof framing system within the southern portion of the building exhibited prominent signs of excessive amounts of charring. The noted fire/heat-related damage had compromised the integrity of the supporting members as well as the continuity of the load-carrying capacity. More than 60% of the roof system framing exhibited cross-sectional charring or excessive sapping/glazing appearance and were compromised.

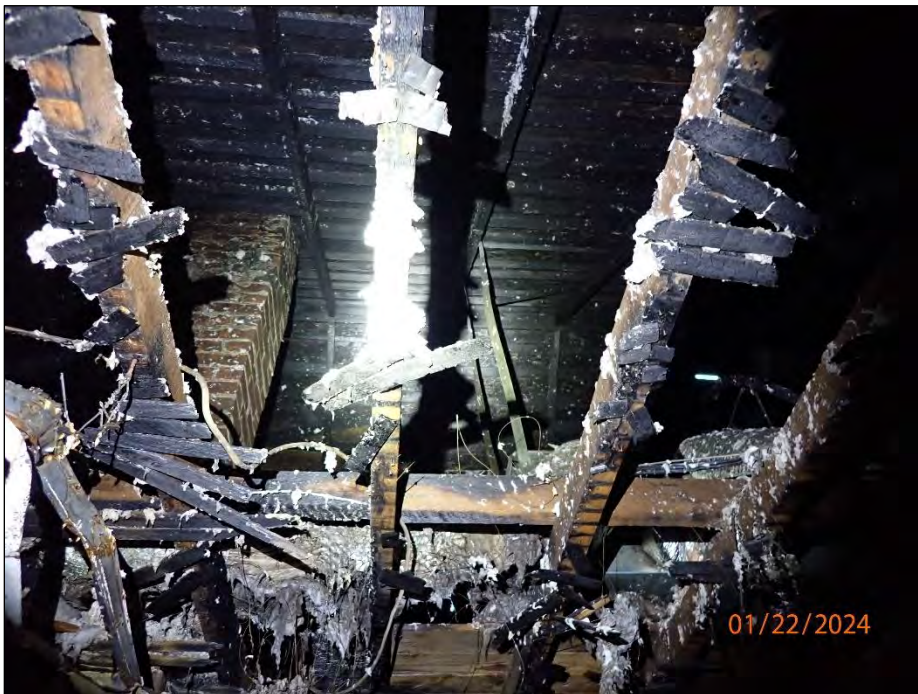
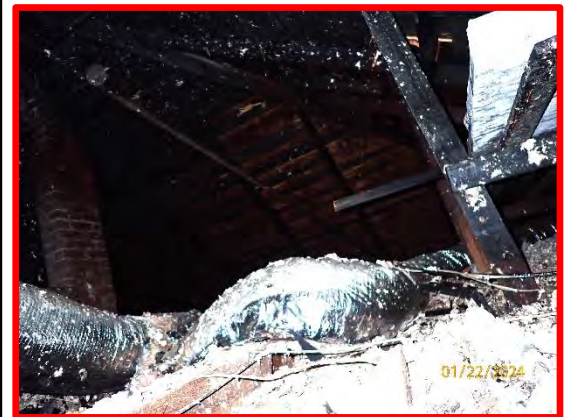
10. The general disposition of the roof framing system within the southern portion of the building exhibited prominent signs of excessive amounts of charring. The noted fire/heat-related damage had compromised the integrity of the supporting members as well as the continuity of the load-carrying capacity. More than 60% of the roof system framing exhibited cross-sectional charring or excessive sapping/glazing appearance and were compromised.

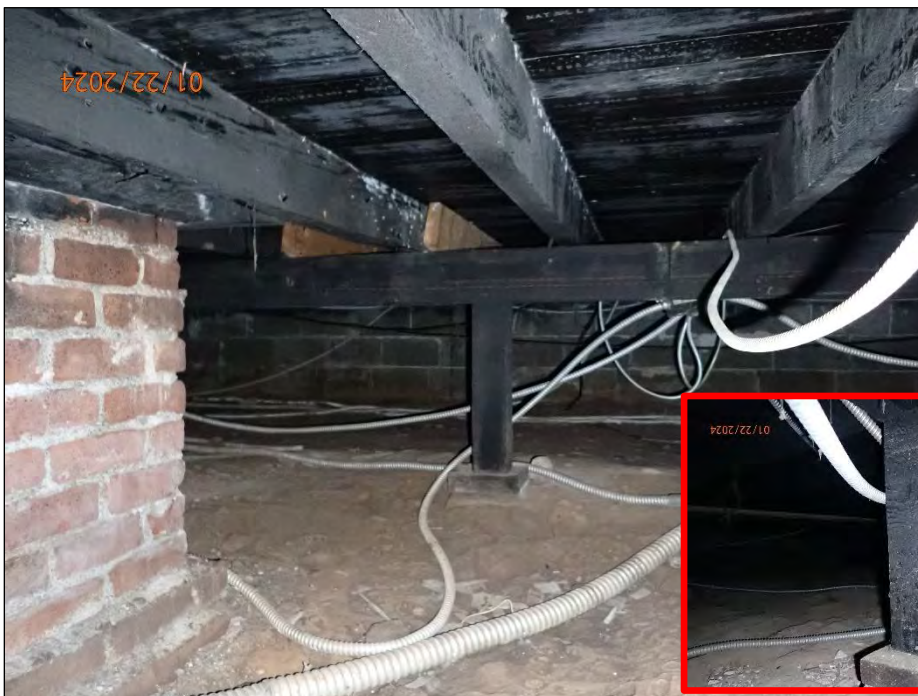
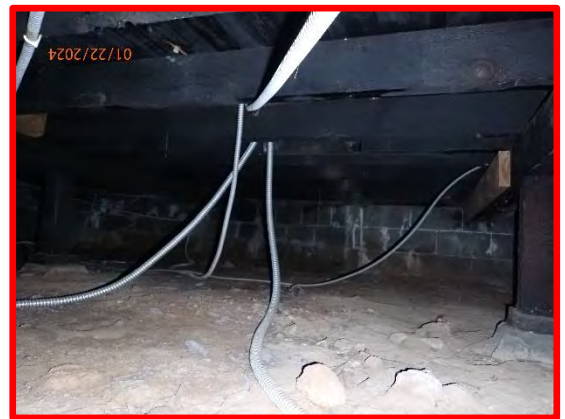
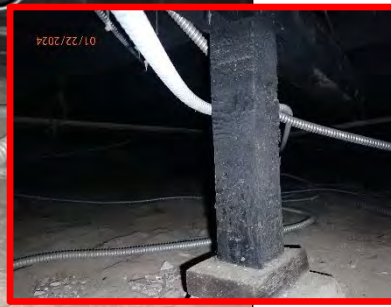
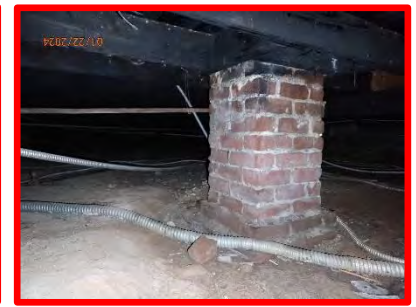
- There was visual evidence of fire/heat-related damage to the floor framing system/members, as evidenced by the visible degree of charring/burning or discoloration (*see Photograph 12*).

12. There was visual evidence of fire/heat-related damage to the floor framing system/members, as evidenced by the visible degree of charring/burning or discoloration. More than 50% of the floor system framing exhibited cross-sectional charring or excessive sapping/glazing appearance and were compromised by exposure to heat/fire.

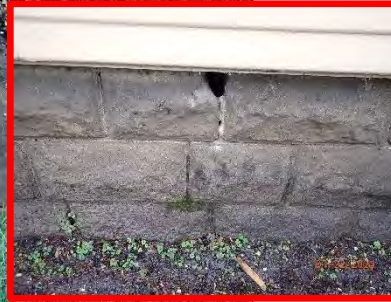
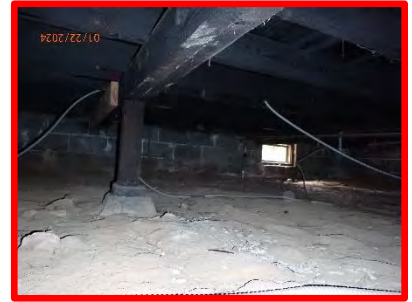
- The foundation of the structure had been retrofitted/replaced at some point during the life of the structure with CMU (concrete masonry unit) slump face block. There was limited damage to the accessible areas of the foundation. Heat/fire in the crawl space damaged limited sections of the block along the south wall (*see Photograph 13*).

13. The foundation of the structure had been retrofitted/replaced at some point during the life of the structure with CMU (concrete masonry unit) slump face block. There was limited damage to the accessible areas of the foundation. Heat/fire in the crawl space damaged limited sections of the block along the south wall.
