Draft Report

Pavement Utility Cut Impact Fee Study

City of Riverside, CA

2300 E Katella Avenue, Suite 125
Anaheim, CA 92806
NCE Project No. 879.02.30

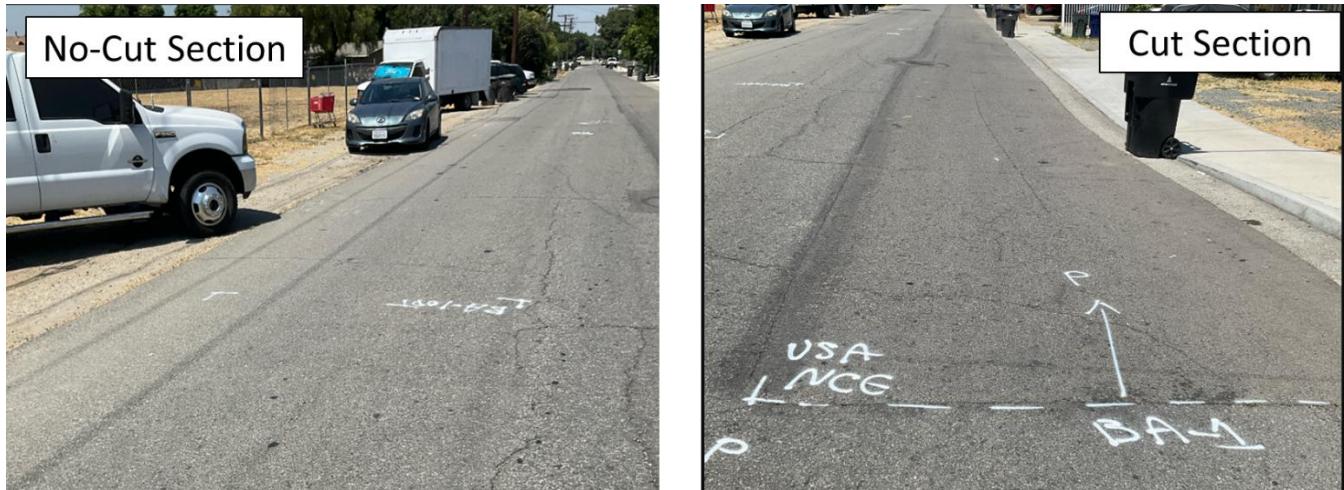
Figure 3. Example Test Site

- To evaluate functional deterioration (more details provided in Section 3.1), NCE:
 - Surveyed pavement distresses for the Cut and No-Cut Sections per ASTM D6433 standards.
 - Compared the PCIs of the Cut and No-Cut Sections by functional class.
 - Calculated the percent reduction in pavement service life associated with utility cuts and compared the impacts across functional classes and PCI groups from the pavement deterioration curves.
- To evaluate structural deterioration (more details provided in Section 3.2), NCE:
 - Tested deflection at each site per California Test Method (356).
 - Extracted cores from each of the No-Cut Sections to measure pavement thickness.
 - Calculated average pavement deflections and required overlay thicknesses on the cut, the T-arm of the cut, 2 feet away from the cut, and in the No-Cut Section.

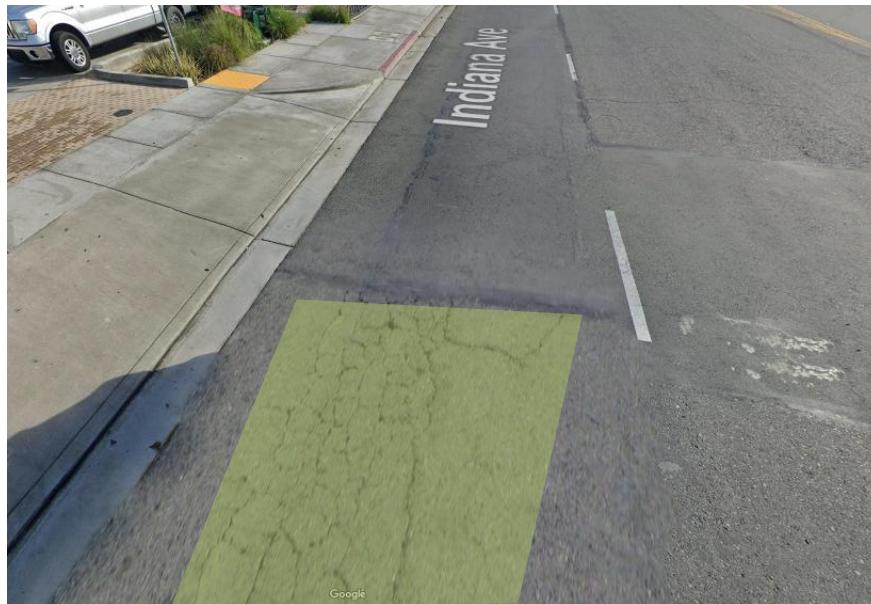
Figure 5. Propagating Cracks (Highlighted) Near Patch on Indiana Avenue

On average, the PCI of No-Cut Sections was 59, and 41 for Cut Sections, indicating a drop in condition category from Fair to Marginal (Table 1). This average decrease of 18 PCI points is primarily due to the cut itself, but additional longitudinal/transverse/fatigue cracking near cuts also impacts PCI. Figure 5 shows propagating longitudinal/transverse/fatigue cracking near a patch on Indiana Avenue.
