HARADA HOUSE

3356 Lemon Street Riverside, CA 92501

April 30, 2018

STRUCTURAL ENGINEERING ASSESSMENT REPORT

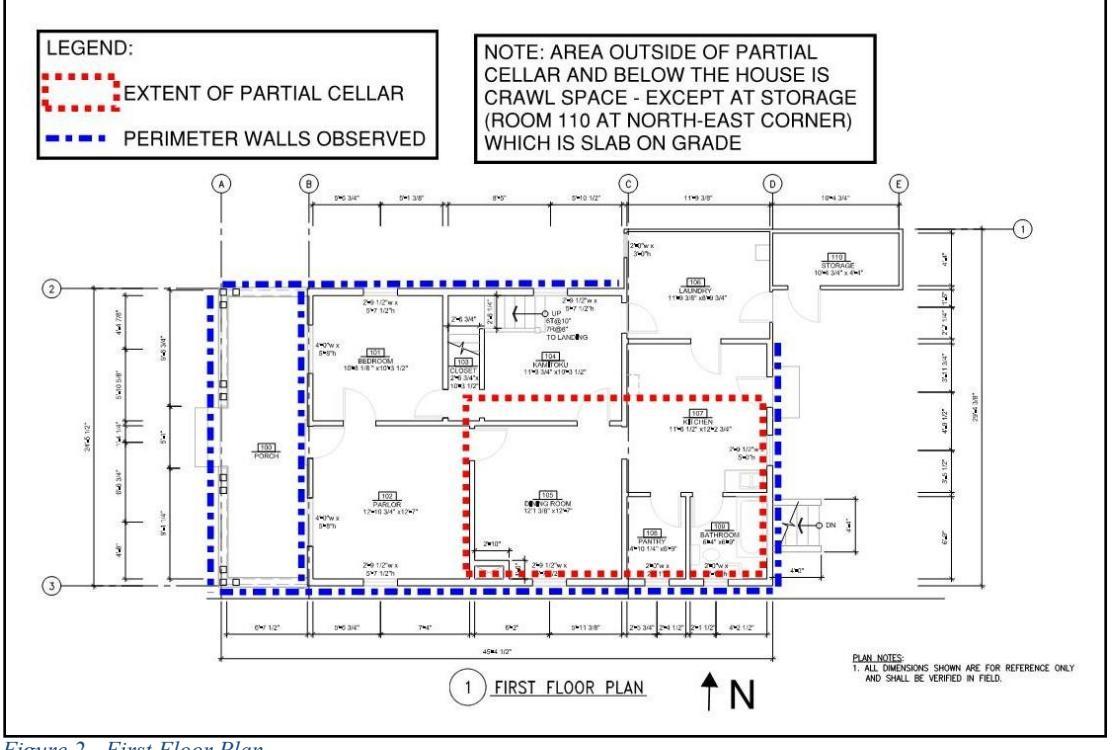
Figure 2 - First Floor Plan

While at the site, Structural Focus observed the condition of the existing structure, where visible, from the subterranean partial cellar, the crawl space below the house, around the perimeter from the exterior of the house during the siding removal process, and from the attic space through an access hatch in the second-floor hallway adjacent to the bathroom. The floor plans on the following page (Figure 2 and Figure 3) identify the location of these areas.

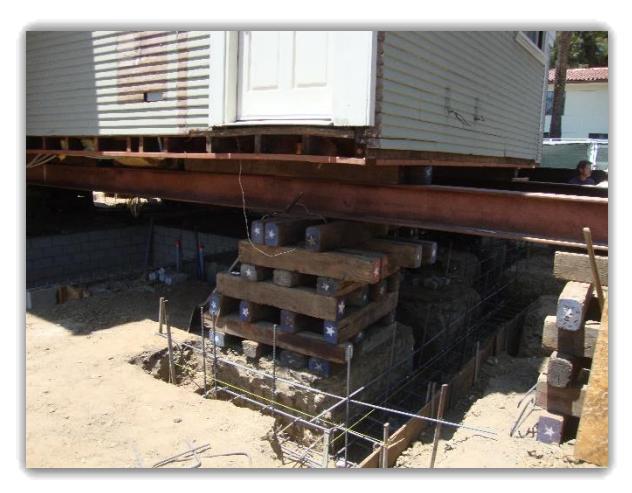
Figure 18 - Lifting of an Existing House for Construction of a new Foundation under the House (July 2017)

The Foundation System is the base of the structure and is the critical component for supporting all levels of a building. New code compliant foundations are needed to properly support the Harada House and anchor the wood framed building to the foundation. Structural Focus previously completed construction documents for new foundations to support the house, but the documents will need to be updated to include leveling the house. Replacing the foundation system will require a specialty contractor that can provide temporary support for the house and lift it to allow for

construction of the new foundation system. The process will be a complex and risky undertaking that will likely involve major excavation work under the house. Figure 18 shows an example of a different historic house in Claremont, CA that was lifted and relocated on a new foundation. The photo is taken during construction when the holes for the new foundation were dug and steel reinforcing bars have been placed in the excavation in preparation for placement of new concrete foundations.

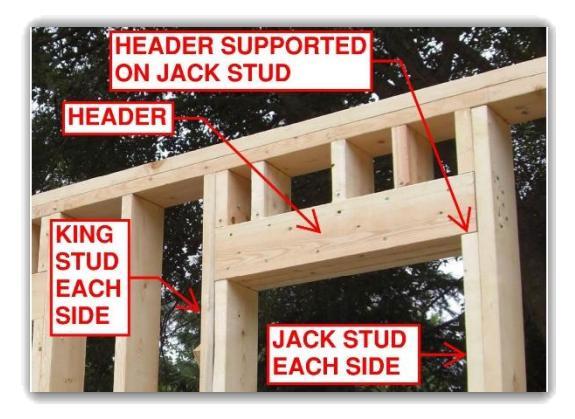
Figure 20 - Standard Header Framing

category repair for this condition is to remove the existing header and replace it with a properly designed and connected header. Modifications to the adjacent king studs as well as the addition of jack studs will also be required. Figure 20 shows a properly framed header condition using current construction practices.
