# HARADA HOUSE

**3356 Lemon Street  
Riverside, CA 92501**

April 30, 2018

## STRUCTURAL ENGINEERING ASSESSMENT REPORT

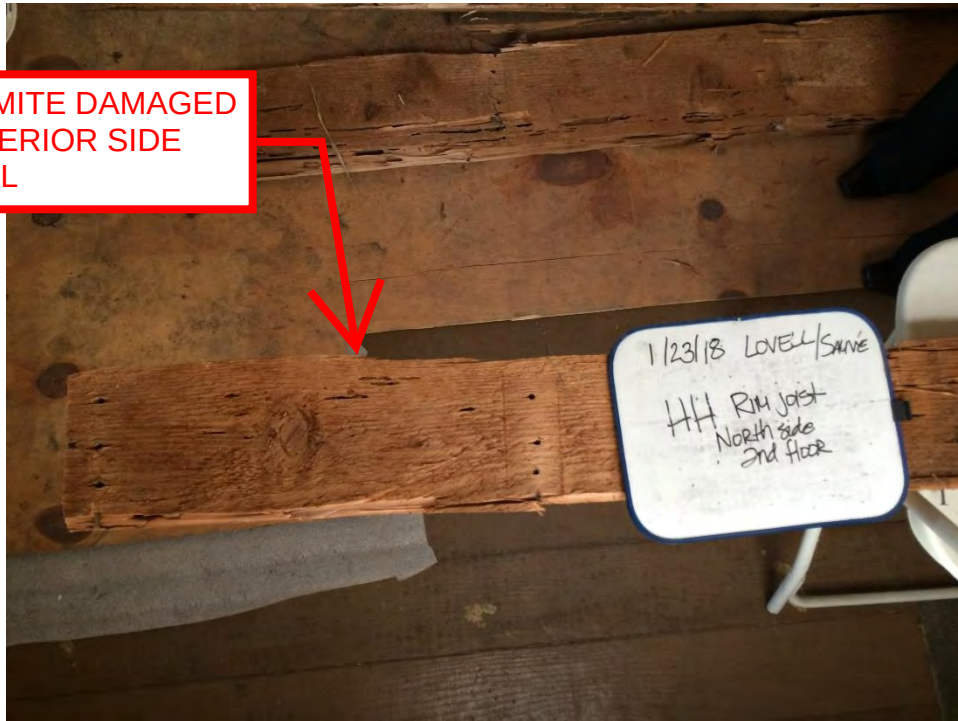
PHOTO 6: NORTH ELEVATION – DAMAGED RIM JOIST

SEVERELY TERMITE DAMAGED  
RIM JOIST - INTERIOR SIDE  
AFTER REMOVAL

- ① INSTALL (N) 2x12 SHORING BEAM WITH (2) - #7 WOOD SCREWS TO EACH STUD
- ② REPLACE (E) SEVERELY DETERIORATED RIM JOIST W/ (N) 3x RIM JOIST CUT TO FIT; REPLACE IN 8'-0" SECTIONS MAX AND 4'-0" SECTIONS MIN; SHIM FOR FULL BEARING; PROVIDE M5TA36 STRAP AT (N) RIM JOIST BUTT JOINTS

- ③ INSTALL (N) T1-11 PLYWOOD SHEATHING PER CONSTRUCTION DOCUMENTS
- ④ PROVIDE (3) - #7 WOOD SCREWS BETWEEN (N) RIM JOIST AND (E) FLOOR JOIST TO REPLACE (E) NAILS TO BE REMOVED; (2) OF THE (N) WOOD SCREWS SHALL PENETRATE THRU THE (N) PLYWOOD SHEATHING; 2" MIN PENETRATION INTO (E) FLOOR JOIST
