**HISTORIC PRESERVATION FUND COMMITTEE MEETING DATE: JANUARY 14, 2019
AGENDA ITEM NO.: 3**

I. CASE NUMBER: P18-0951

HARADA HOUSE

**3356 Lemon Street
Riverside, CA 92501**

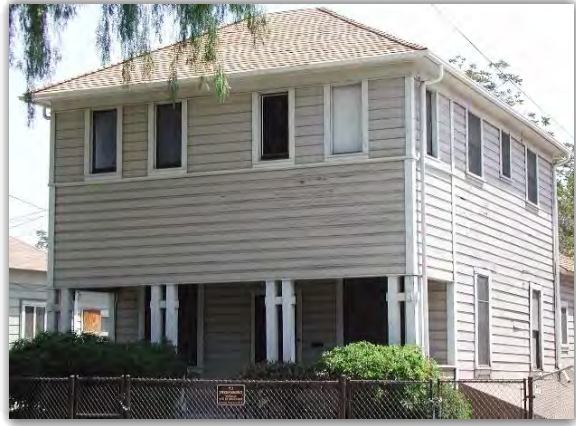
*Figure 1: Harada House
Photo from 2015*

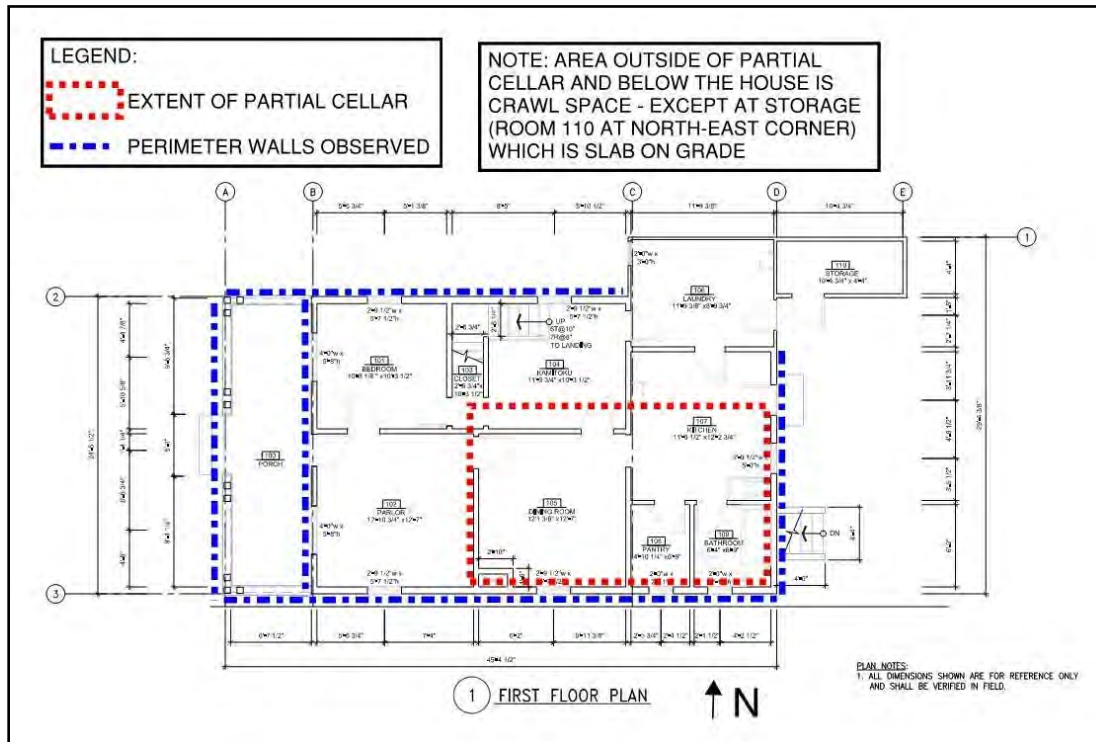
Figure 2 - First Floor Plan

While at the site, Structural Focus observed the condition of the existing structure, where visible, from the subterranean partial cellar, the crawl space below the house, around the perimeter from the exterior of the house during the siding removal process, and from the attic space through an access hatch in the second-floor hallway adjacent to the bathroom. The floor plans on the following page (Figure 2 and Figure 3) identify the location of these areas.

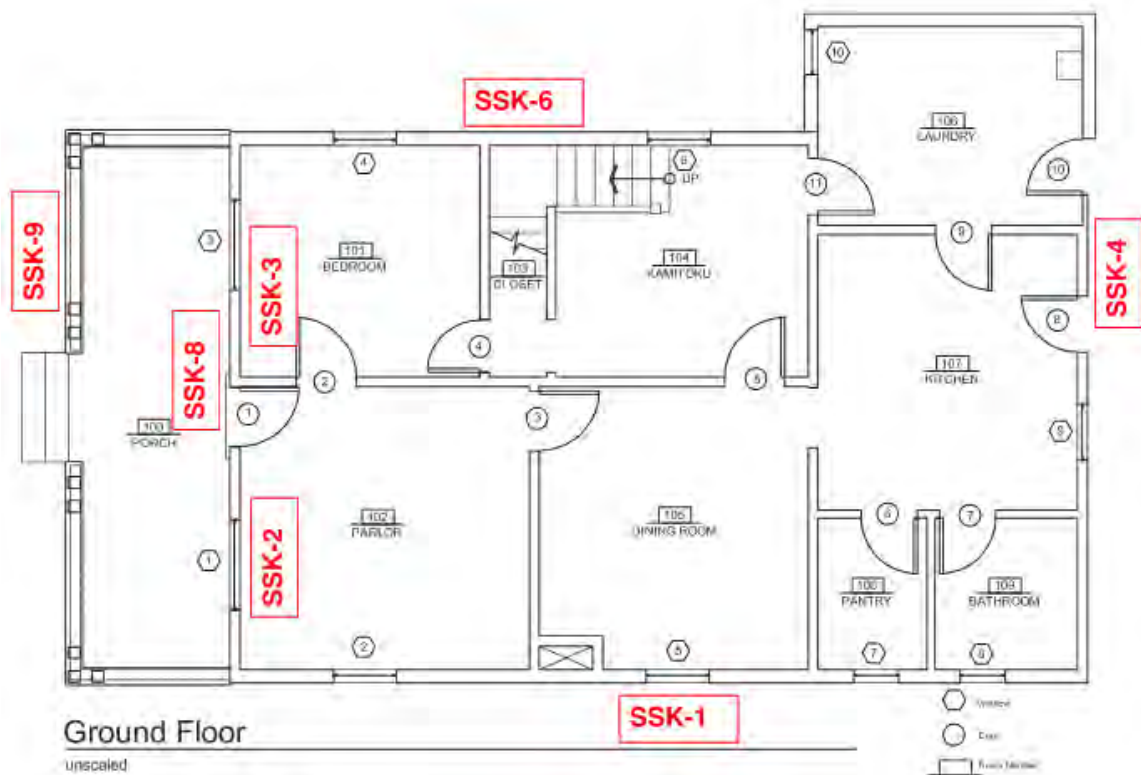
Figure 8 - Ground Floor Temporary Immediate Repair Sketch Locations

- a. Severe damage was found at the base of the wall on the south elevation in the middle portion of the house. The damage included deteriorated wood framing from termites, dry rot, and water damage (Figure 8 at right). In addition, the removal of the siding exposed a framing condition where load bearing studs were only supported by the bottom plate of the wall. This is not an adequate way to properly support wall studs

2. Temporary Immediate Repairs - During the assessment discovery process, several conditions were found that required immediate measures to stabilize the Harada House. These items fall under the **Immediate Future category**, and the stabilization details provided to the contractor are documented in sketches at the end of this report. Figures 8 and 9 below illustrate where each of the repair sketches were implemented.

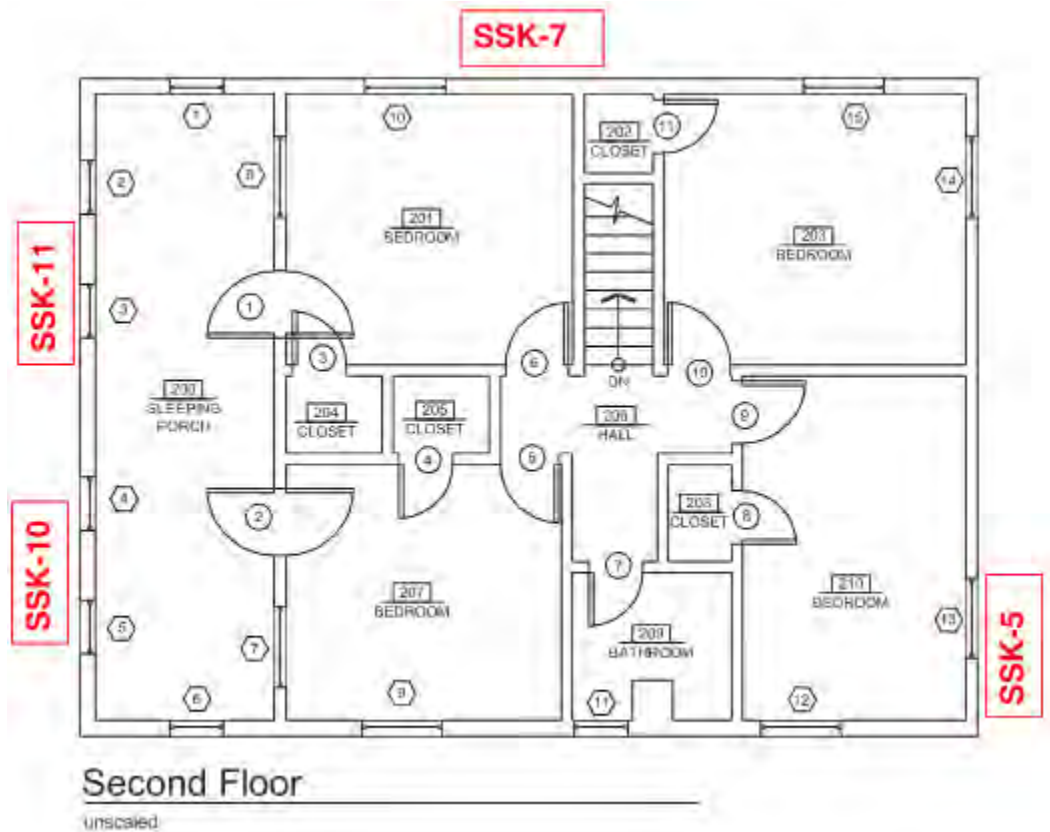
Figure 9 - Second Floor Temporary Immediate Repair Sketch Locations

and is known as a discontinuous load bearing condition (Figure 9 at right).

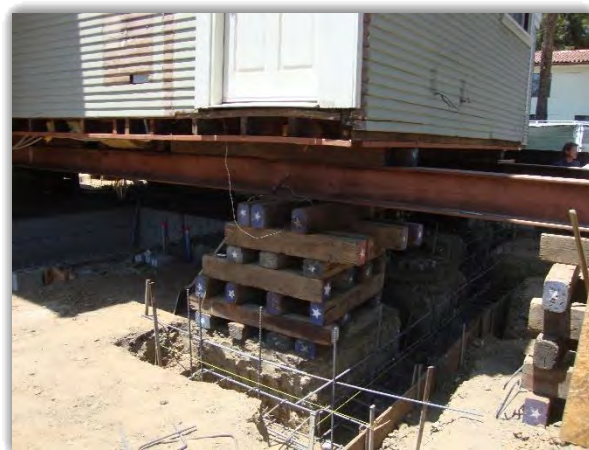
Figure 18 - Lifting of an Existing House for Construction of a new Foundation under the House (July 2017)

- Our recommendation for the Harada House is to construct the new foundation level and set the house on the foundation to restore the house back to a level condition. This will require removal of some of the temporary immediate repair work that was done in order to allow the house to properly sit on the new foundation. While time is of the essence when it comes to stabilizing the house on a proper foundation, this recommendation falls under the **Permanent Solution category**.

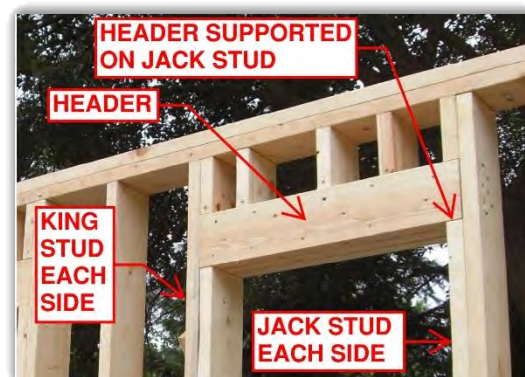
Figure 20 - Standard Header Framing

The **Permanent Solution category** repair for this condition is to remove the existing header and replace it with a properly designed and connected header. Modifications to the adjacent king studs as well as the addition of jack studs will also be required. Figure 20 shows a properly framed header condition using current construction practices.

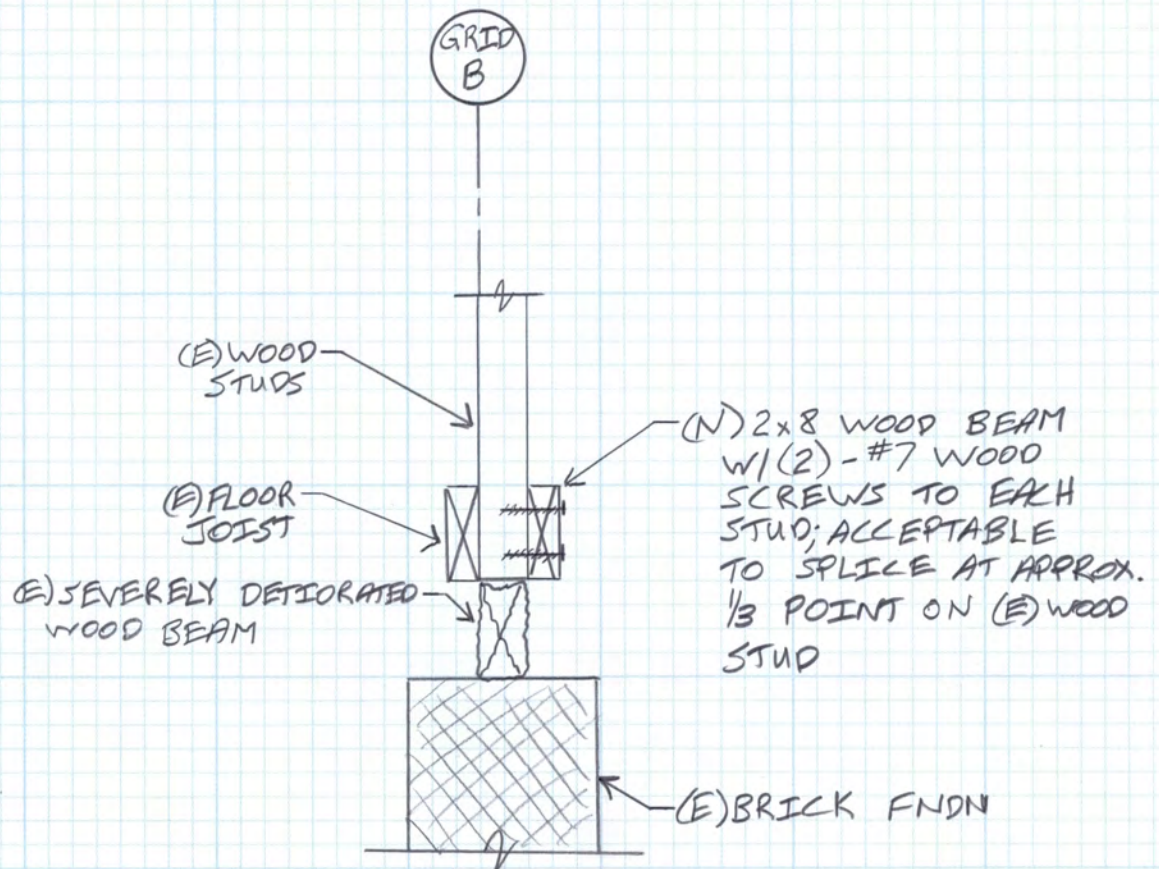
SSK
3

SECTION AT GRID B

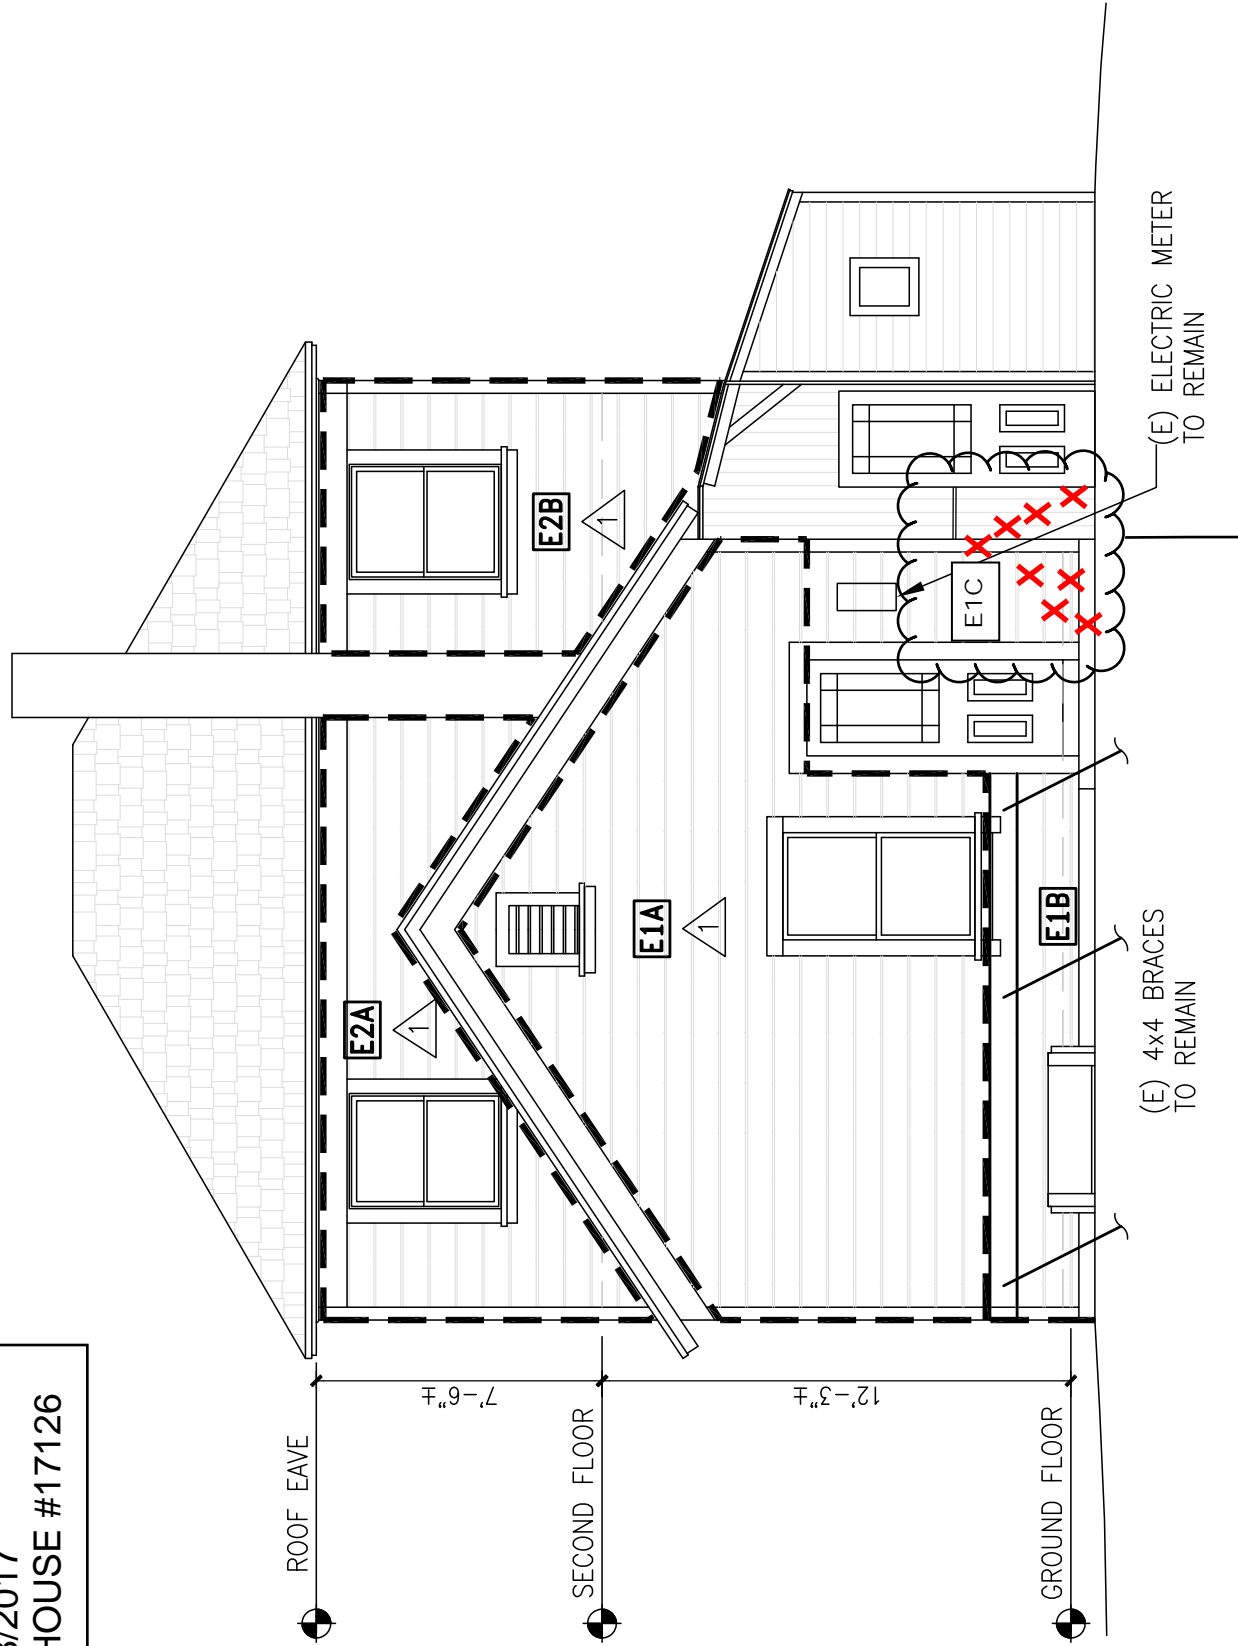
AREA OF NEW ZONE E1C:
- REMOVE SIDING/TRIM BOARDS
MARKED WITH AN 'X'
- LEAVE OPEN FOR OBSERVATION
BY STRUCTURAL FOCUS

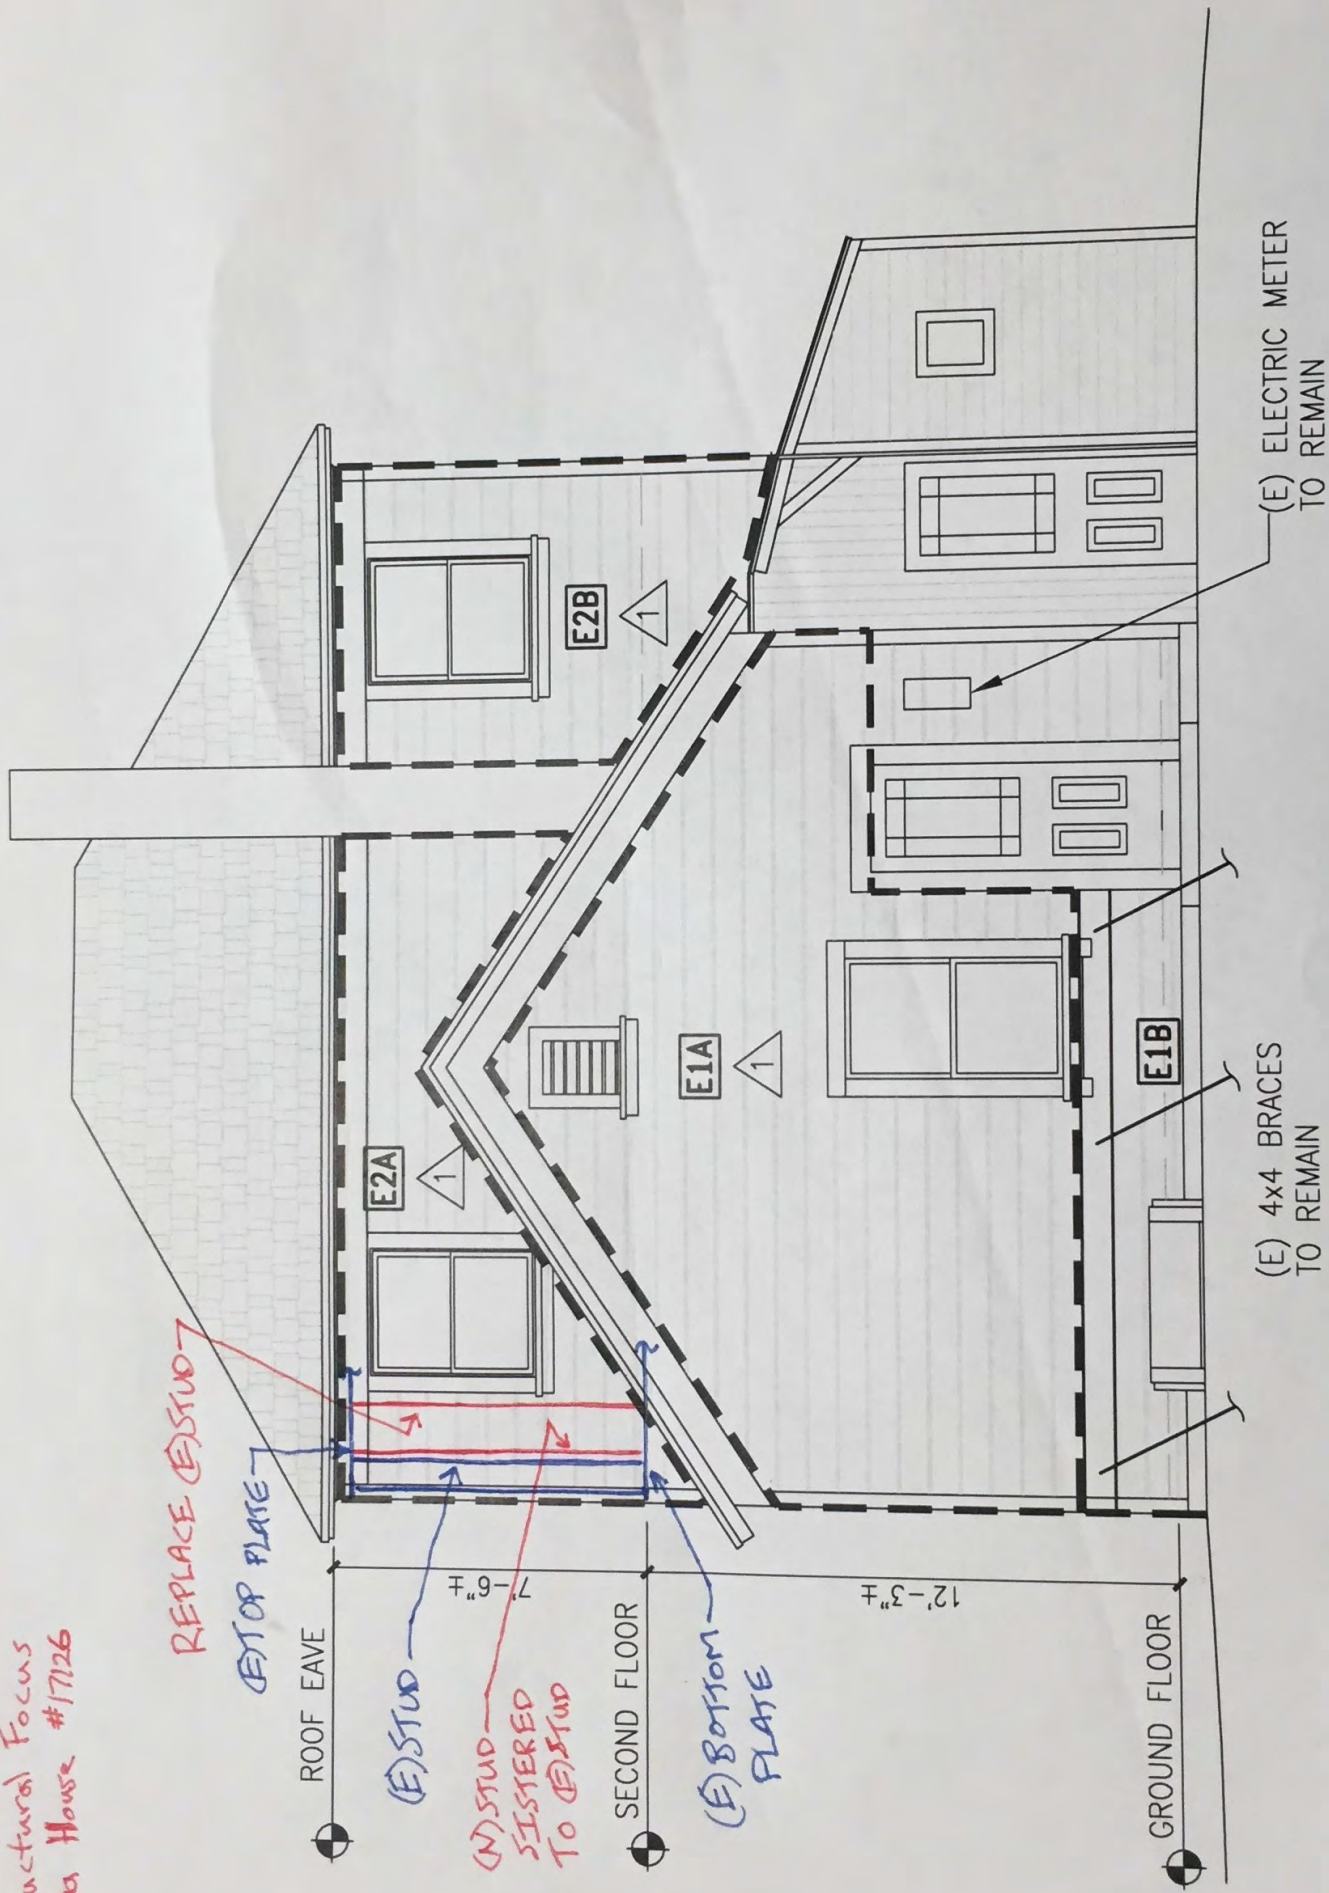
SSK STUD REPLACEMENT AT ZONE E2A

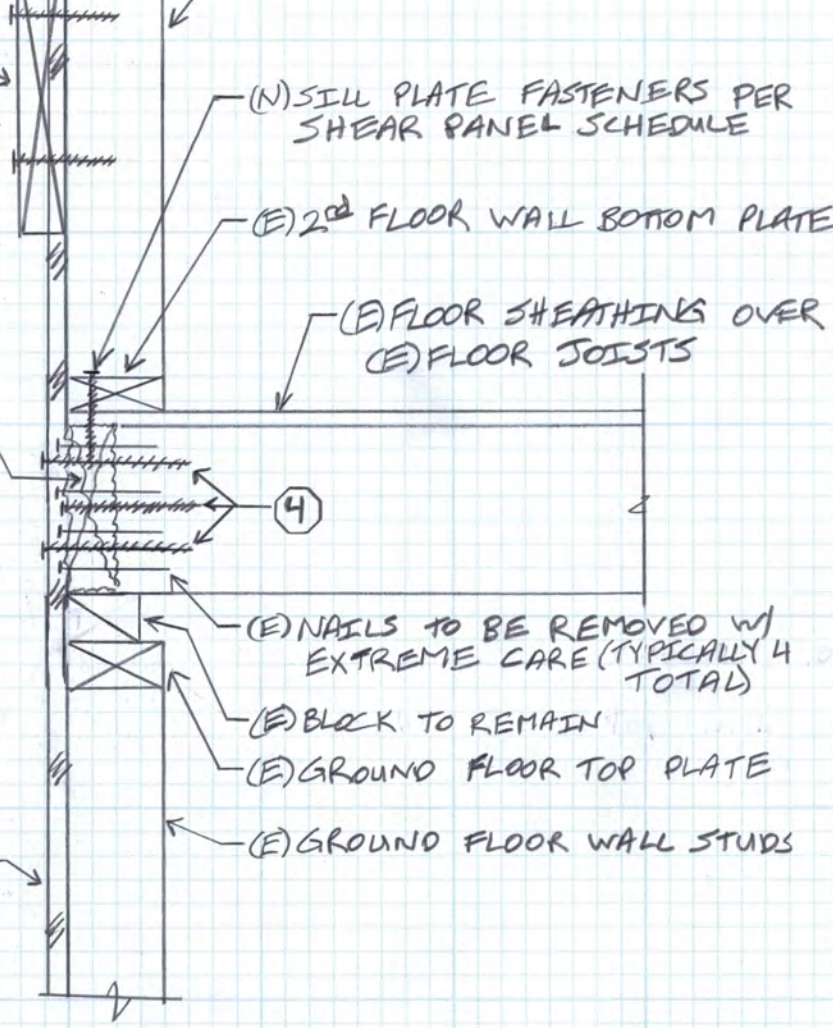
SSK
7

NORTH WALL 2nd FLOOR RIM JOIST
N.T.S.

- ① INSTALL (N) 2x12 SHORING BEAM WITH (2) - #7 WOOD SCREWS TO EACH STUD
- ② REPLACE (E) SEVERELY DETERIORATED RIM JOIST W/ (N) 3x RIM JOIST CUT TO FIT; REPLACE IN 8'-0" SECTIONS MAX AND 4'-0" SECTIONS MIN; SHIM FOR FULL BEARING; PROVIDE M5TA36 STRAP AT (N) RIM JOIST BUTT JOINTS
- ③ INSTALL (N) T1-11 PLYWOOD SHEATHING PER CONSTRUCTION DOCUMENTS
- ④ PROVIDE (3) - #7 WOOD SCREWS BETWEEN (N) RIM JOIST AND (E) FLOOR JOIST TO REPLACE (E) NAILS TO BE REMOVED; (2) OF THE (N) WOOD SCREWS SHALL PENETRATE THRU THE (N) PLYWOOD SHEATHING; 2" MIN PENETRATION INTO (E) FLOOR JOIST
- (E) 2nd FLOOR WALL STUDS
- (N) SILL PLATE FASTENERS PER SHEAR PANEL SCHEDULE
- (E) 2nd FLOOR WALL BOTTOM PLATE
- (E) FLOOR SHEATHING OVER (E) FLOOR JOISTS
- (E) NAILS TO BE REMOVED W/ EXTREME CARE (TYPICALLY 4 TOTAL)
- (E) BLOCK TO REMAIN
- (E) GROUND FLOOR TOP PLATE
- (E) GROUND FLOOR WALL STUDS

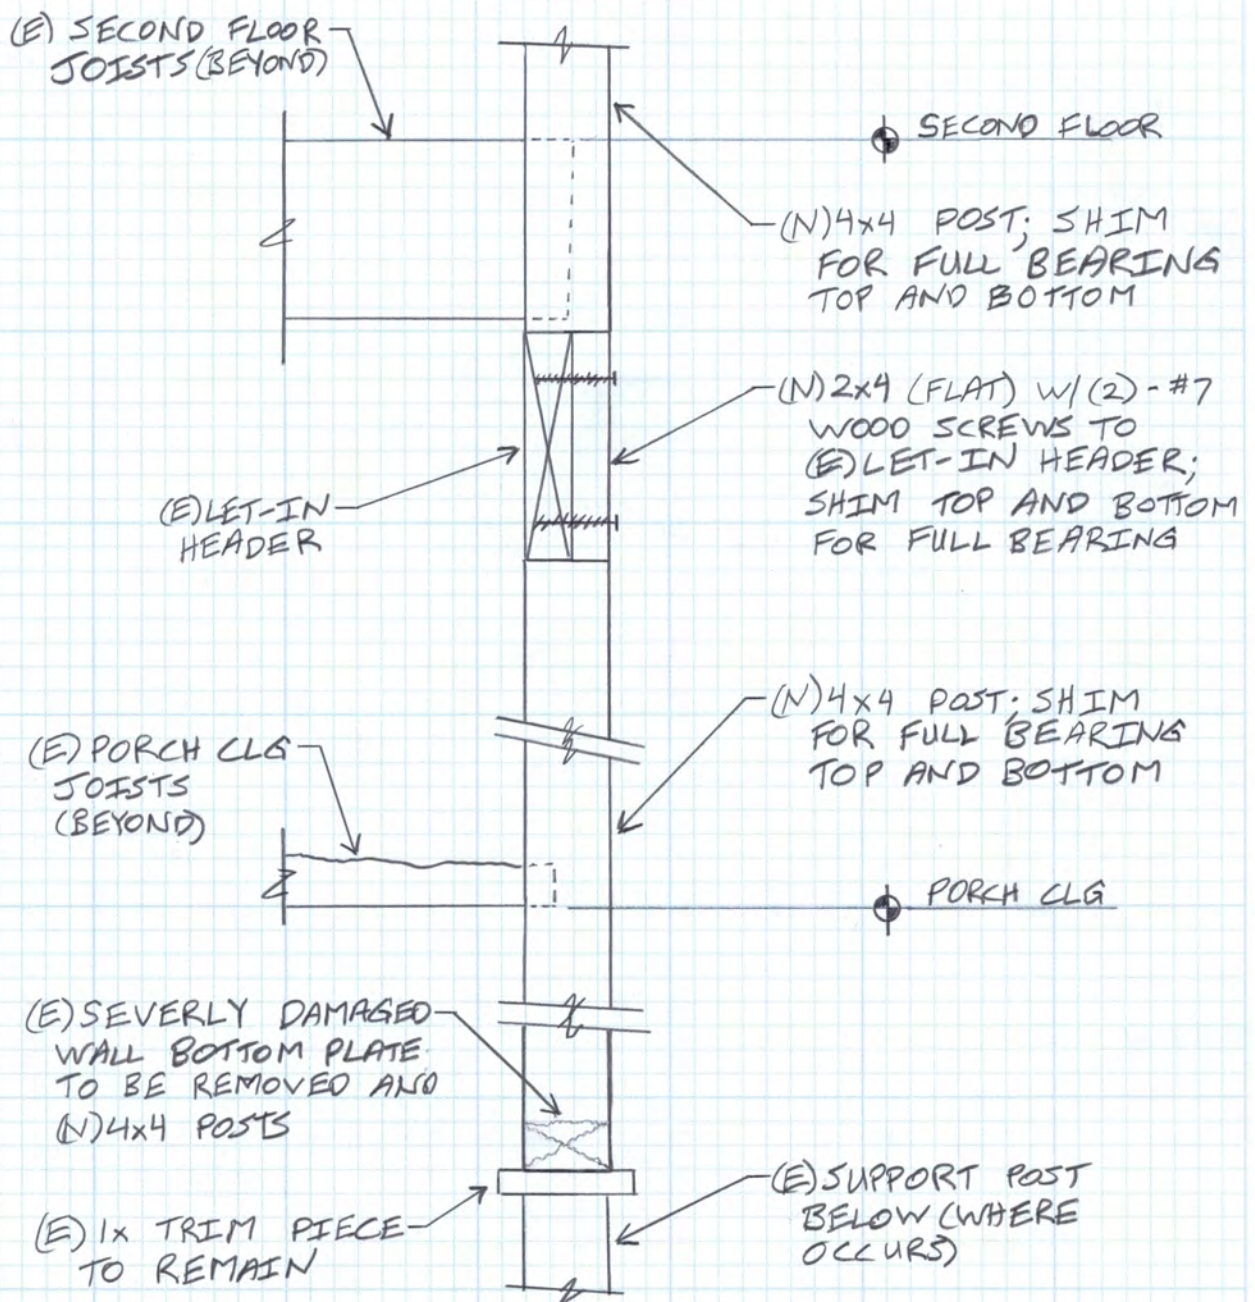
SSK
11

DETAIL AT (E) LET-IN HEADER (WEST ELEVATION)
