November 6, 2024
Project No: 23-15446

**Subject: Historical Design Review Letter Report
César E. Chávez Community Center Renovation Project
2060 University Avenue, Riverside, California 92507**

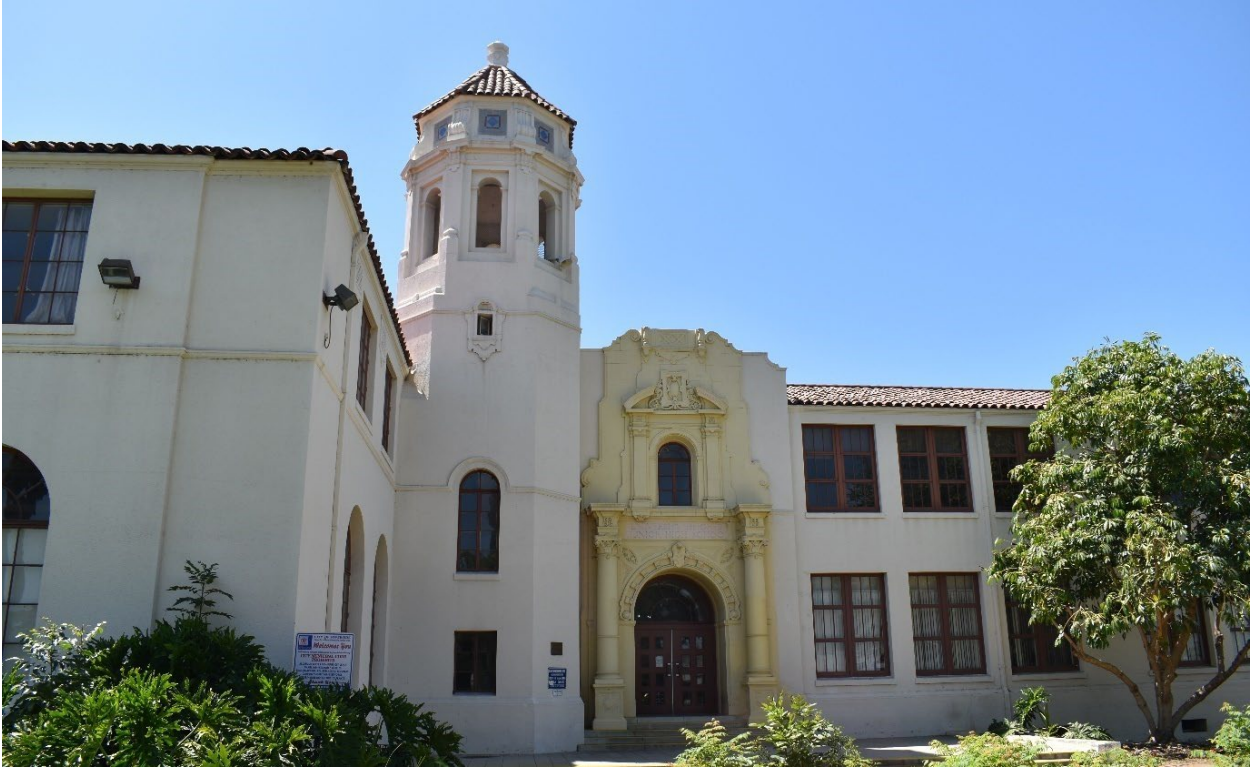
Photograph 2. Main Entrance and Tower Feature, North Elevation, Facing South

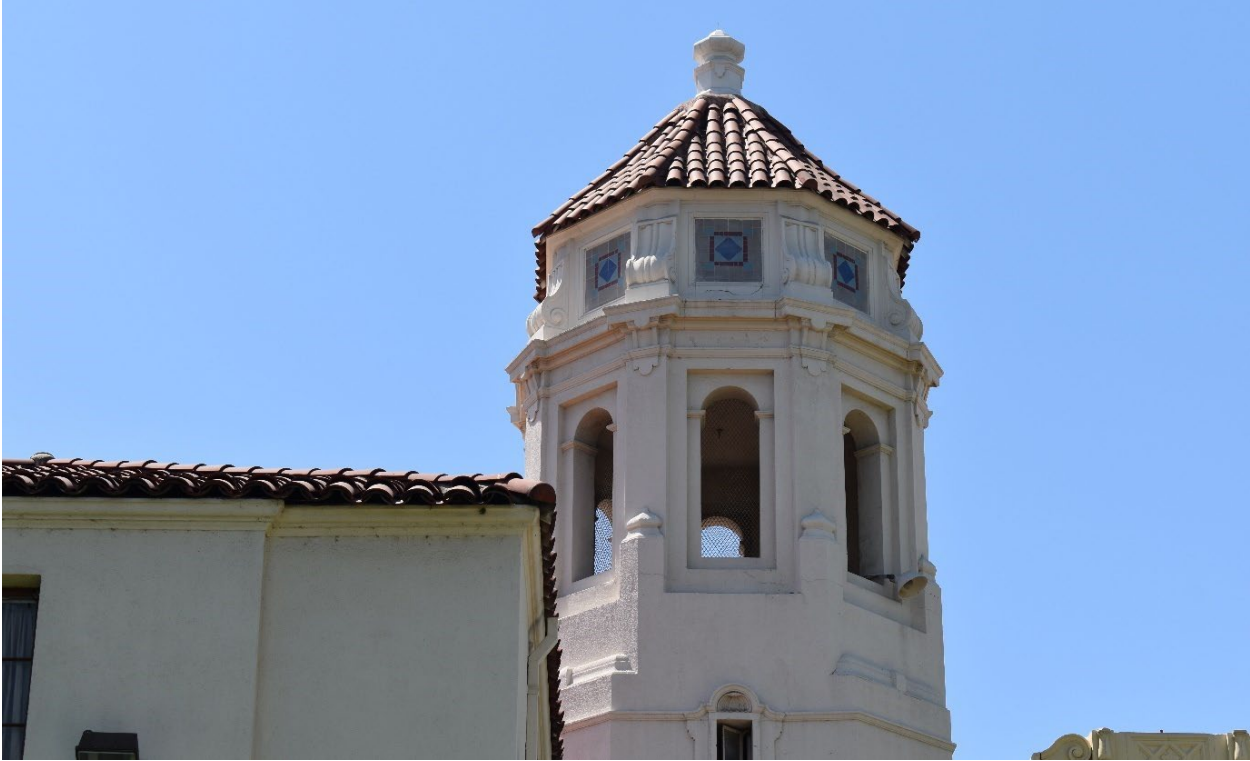
Photograph 3. Upper End of Tower Feature, Facing South

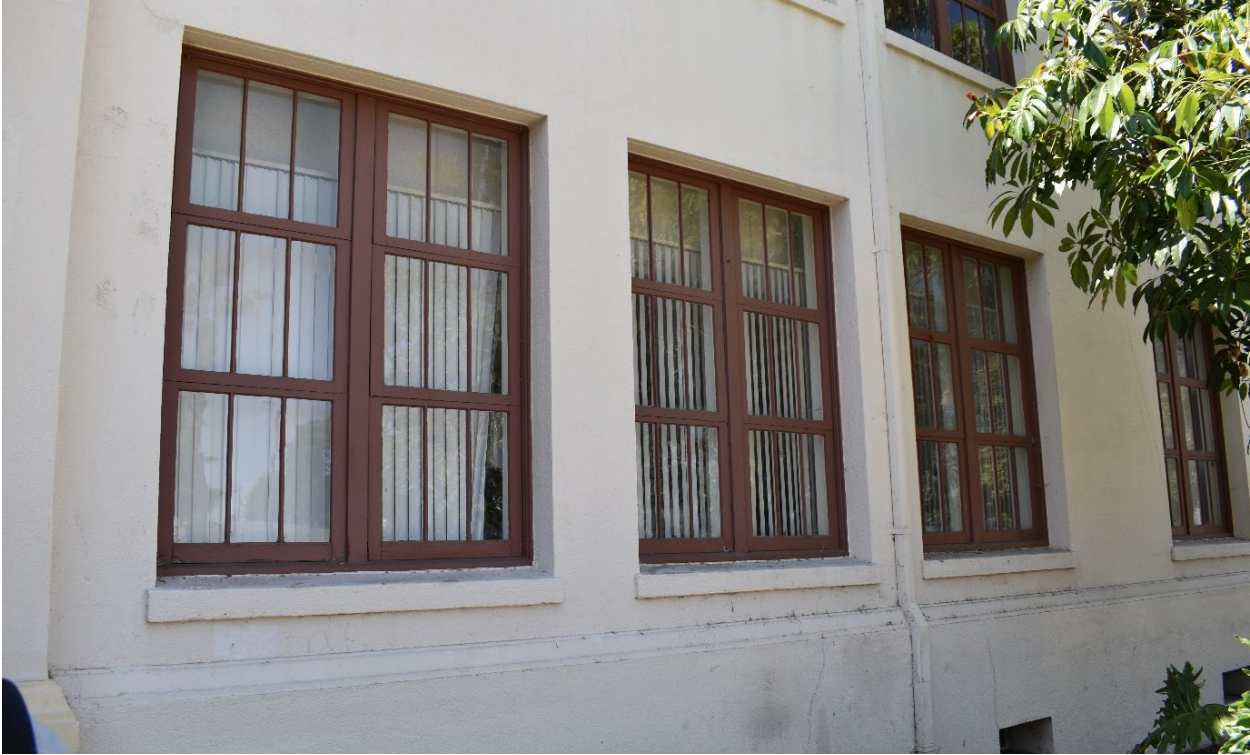
Photograph 4. Typical Wood-Sash Awning Window on North Elevation

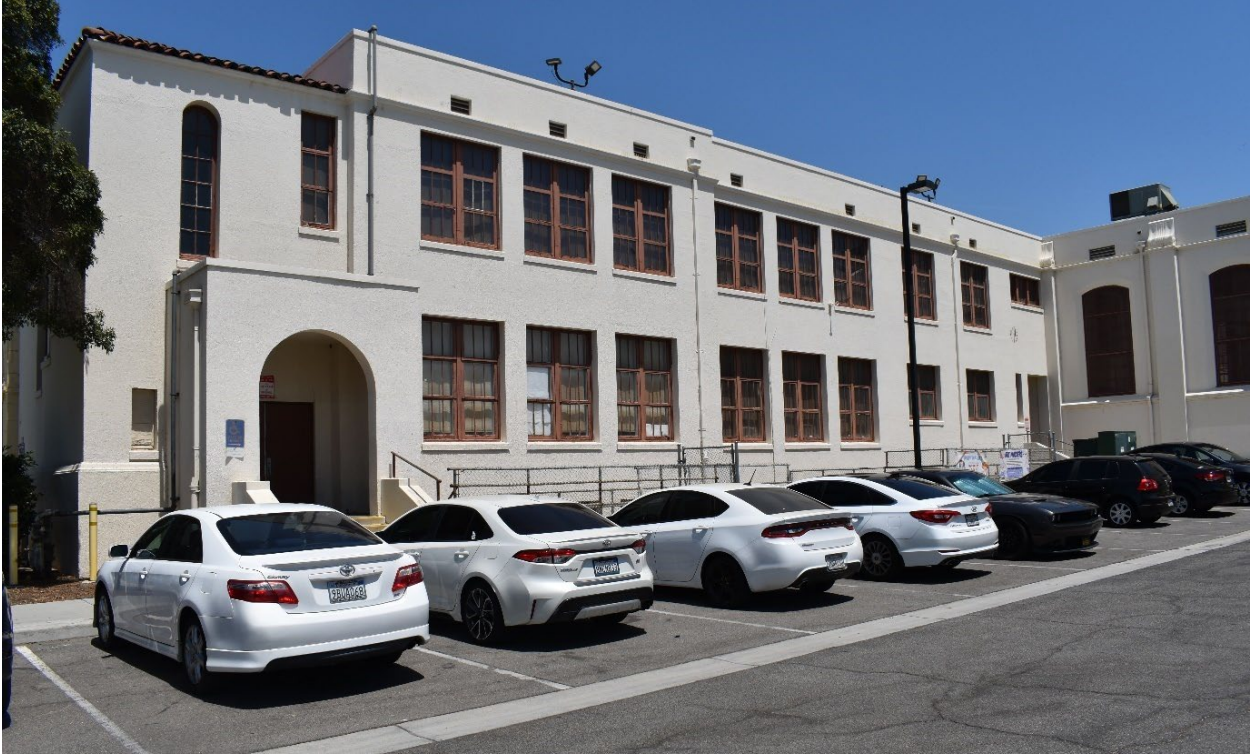
Photograph 5. South Elevation, Featuring Typical Fenestration, Facing Northeast

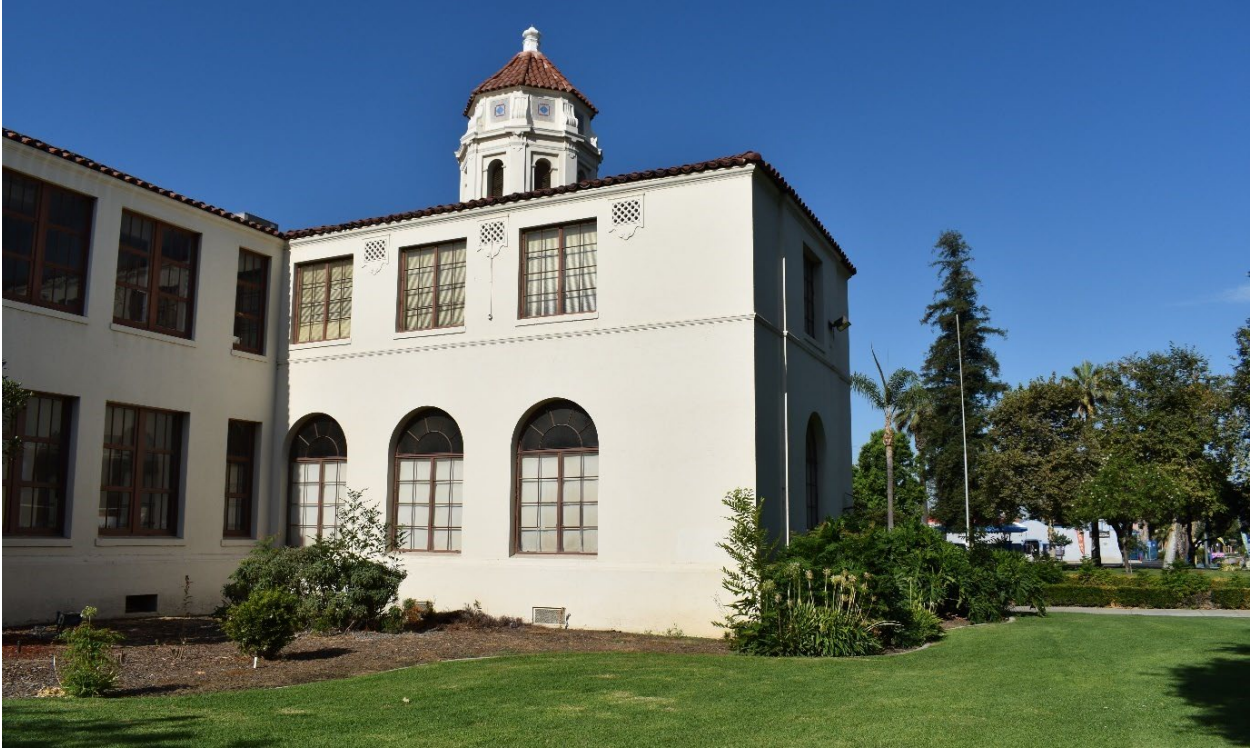
Photograph 6. North Ell, Displaying Typical Fenestration, Facing Southwest

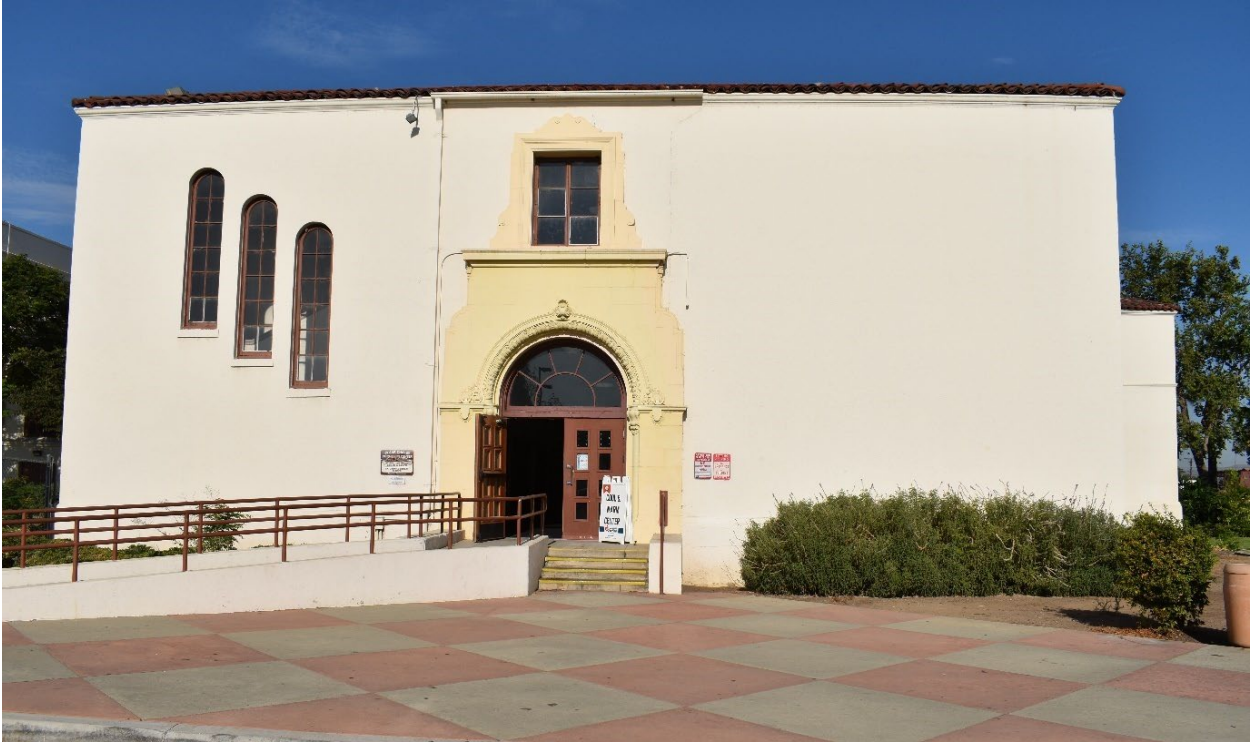
Photograph 7. East Elevation (Partial), Featuring Formal Entrance and Stepped Stairwell Lights, Facing West

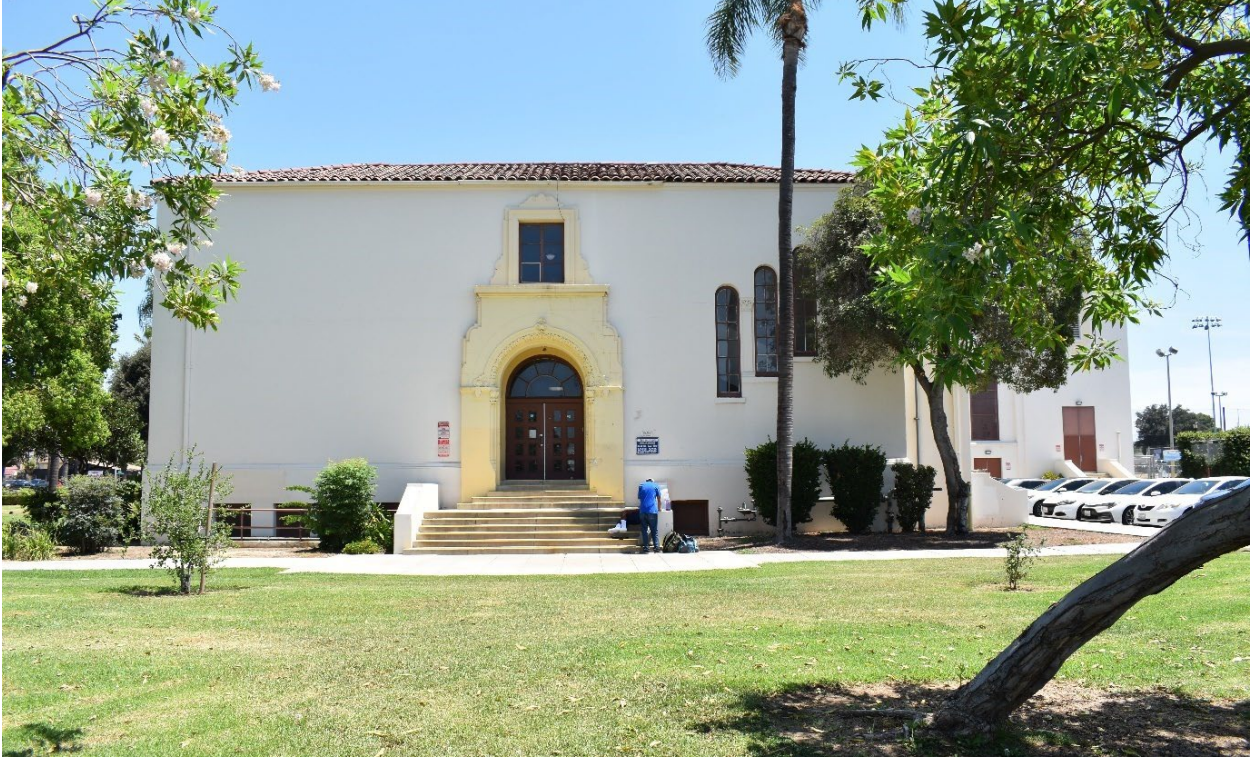
Photograph 8. West Elevation, Including Formal Entrance, Facing East

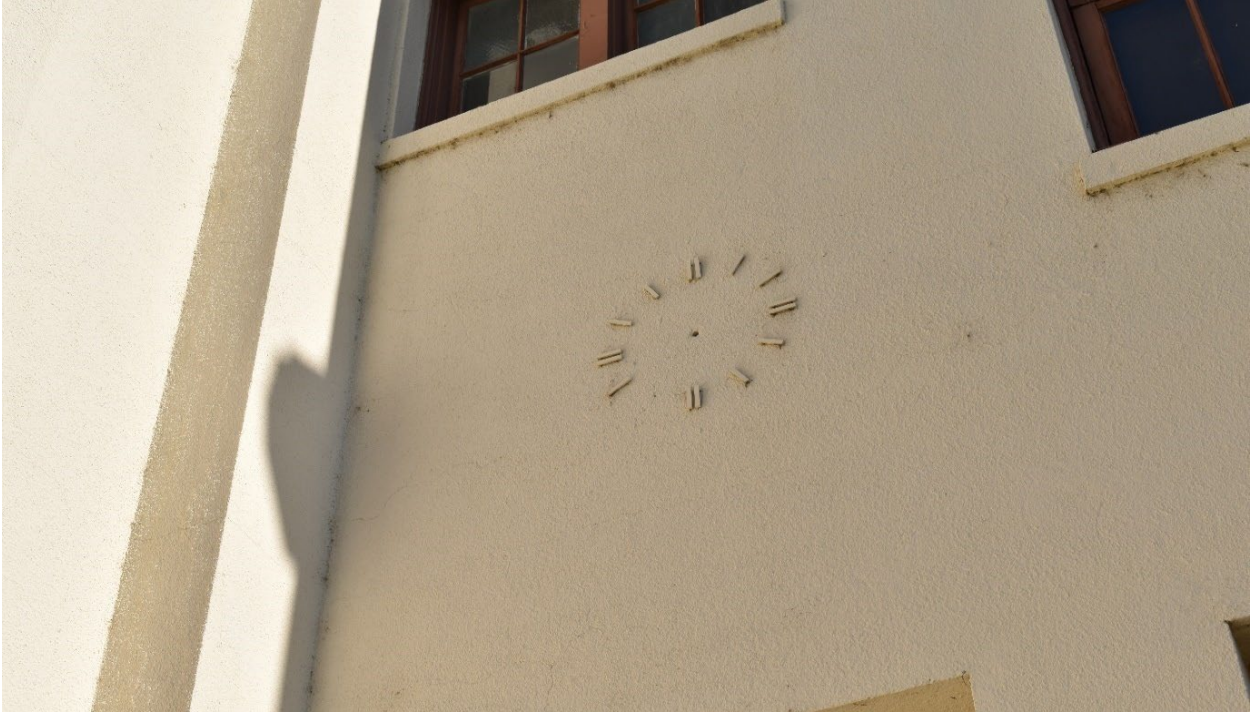
Photograph 9. Integrated Clock Above South Elevation Entrance

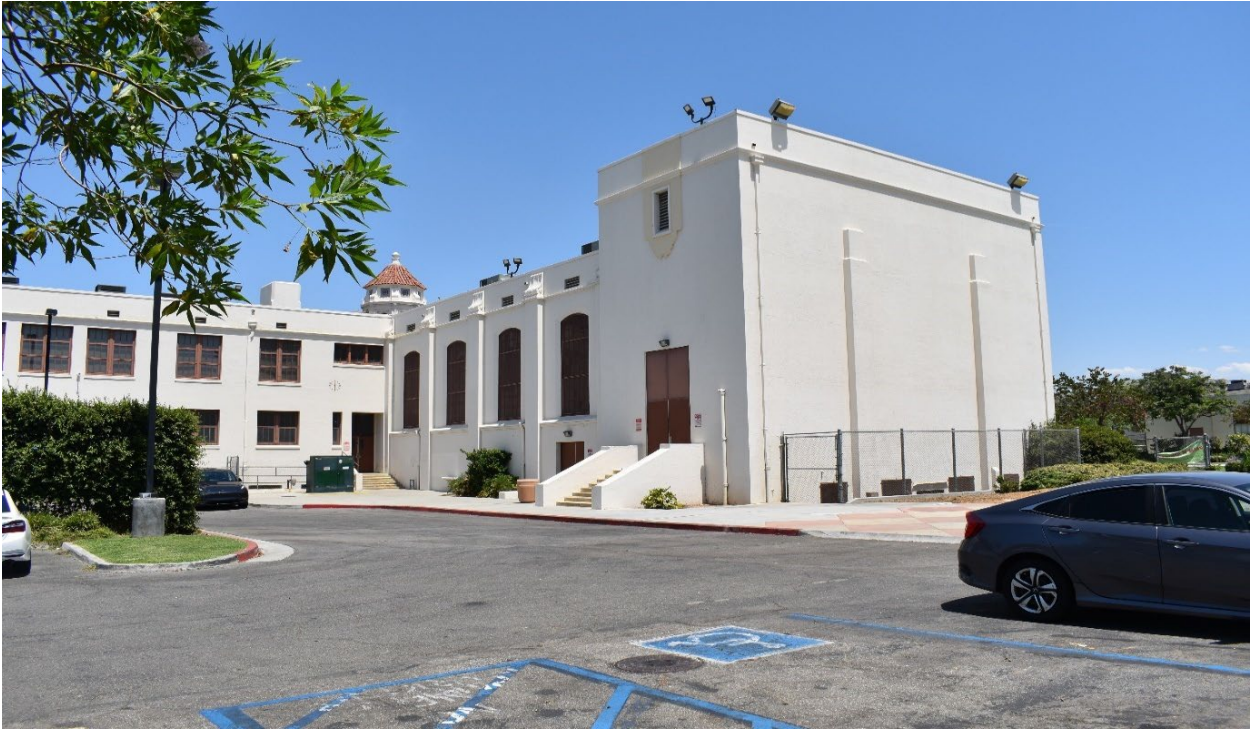
Photograph 10. Exterior of Auditorium, South and West Elevations, Facing Northeast

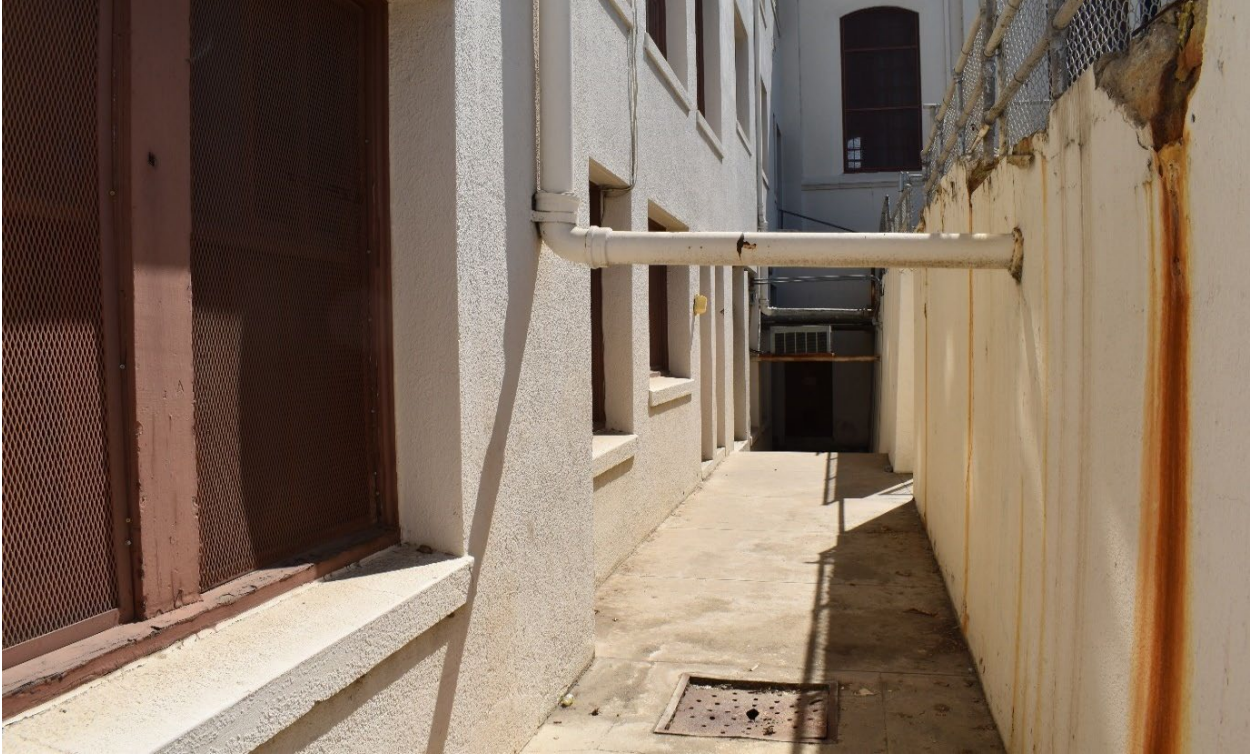
Photograph 11. Representative View of Sub-Grade Access Area, Facing East

At certain locations on the north and south elevations, the subgrade exterior is exposed to provide access to basement facilities (Attachment 1, Photograph 11). These areas are generally more utilitarian in character and appearance, for example, as embodied in the sparing use of industrial-type steel-sash windows.

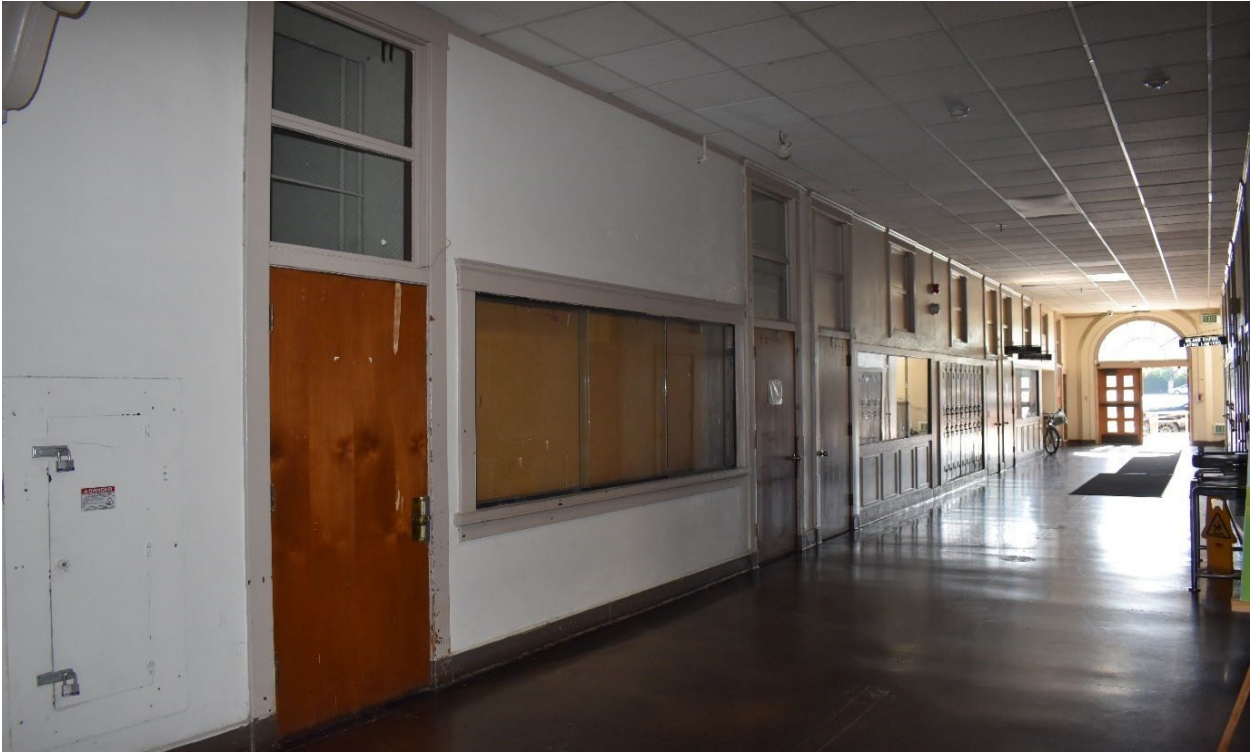
Photograph 12. Representative View of First Floor Corridor

The interior of University Heights Junior High School is organized around long corridors that follow the east-west primary axis of the building (Attachment 1, Photograph 12 and Photograph 13). On both the first and second stories, classrooms, the auditorium, offices, and other support facilities flank, and are accessed directly from, the main corridor. At either end of the corridor are stairwells for circulation between the two floors. Finishings in the corridor include painted concrete floors, plastered or painted concrete walls, non-original suspended ceilings, banks of built-in sheet-metal student lockers (Attachment 1, Photograph 14), iron radiators, and non-historic suspended ceilings.

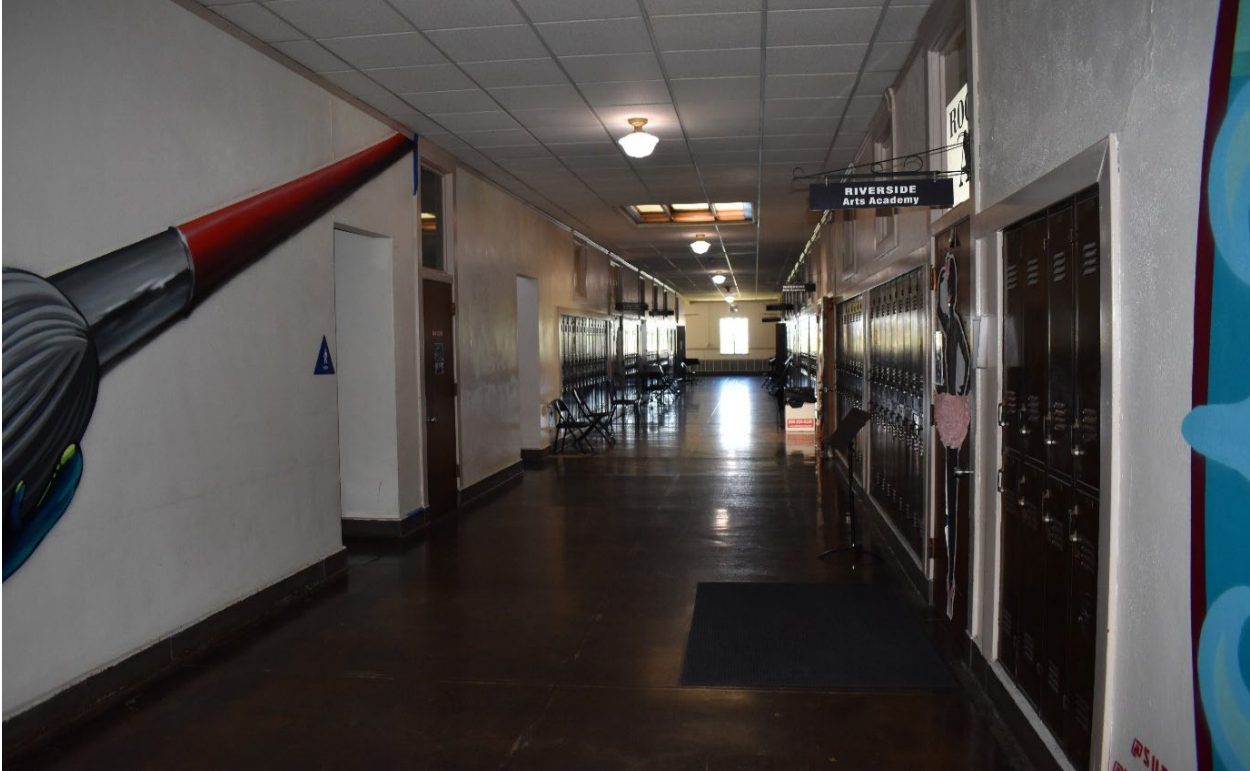
Photograph 13. Representative View of Second Floor Corridor

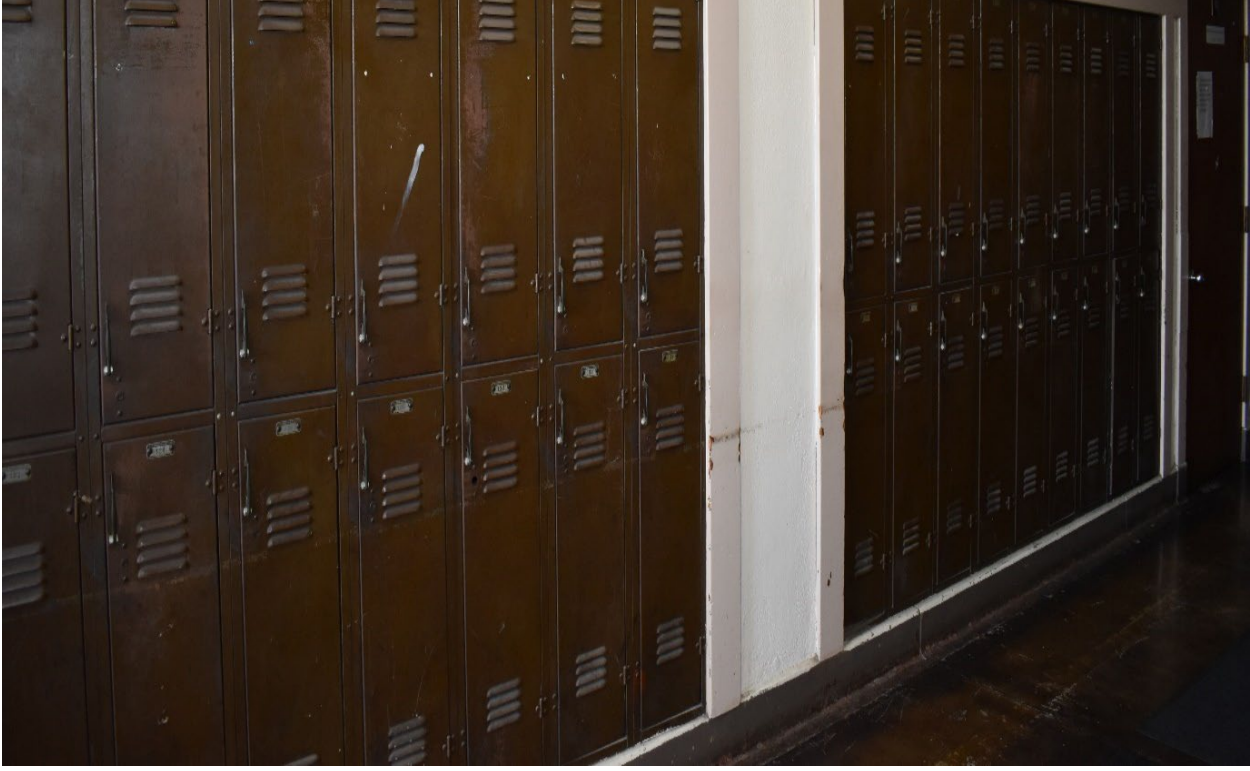
Photograph 14. Representative View of Lockers

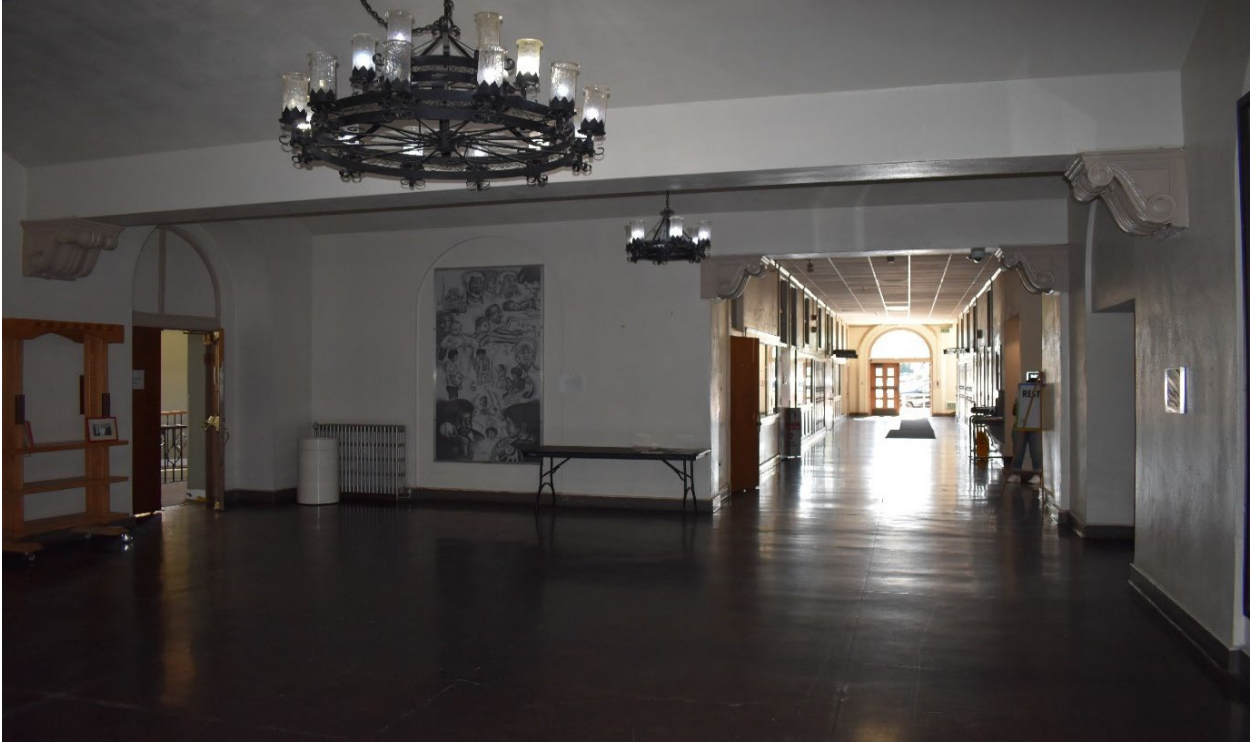
Photograph 15. Overview of Lobby

Located adjacent to the primary entrance, the lobby is integrated into the main corridor and provides direct access to the office, community room, auditorium, and a central internal stairwell, located near the tower (Attachment 1, Photograph 15). While it shares the same wall and floor finishes as the corridor, the space is somewhat more expressive in its design. Notable features include a vaulted

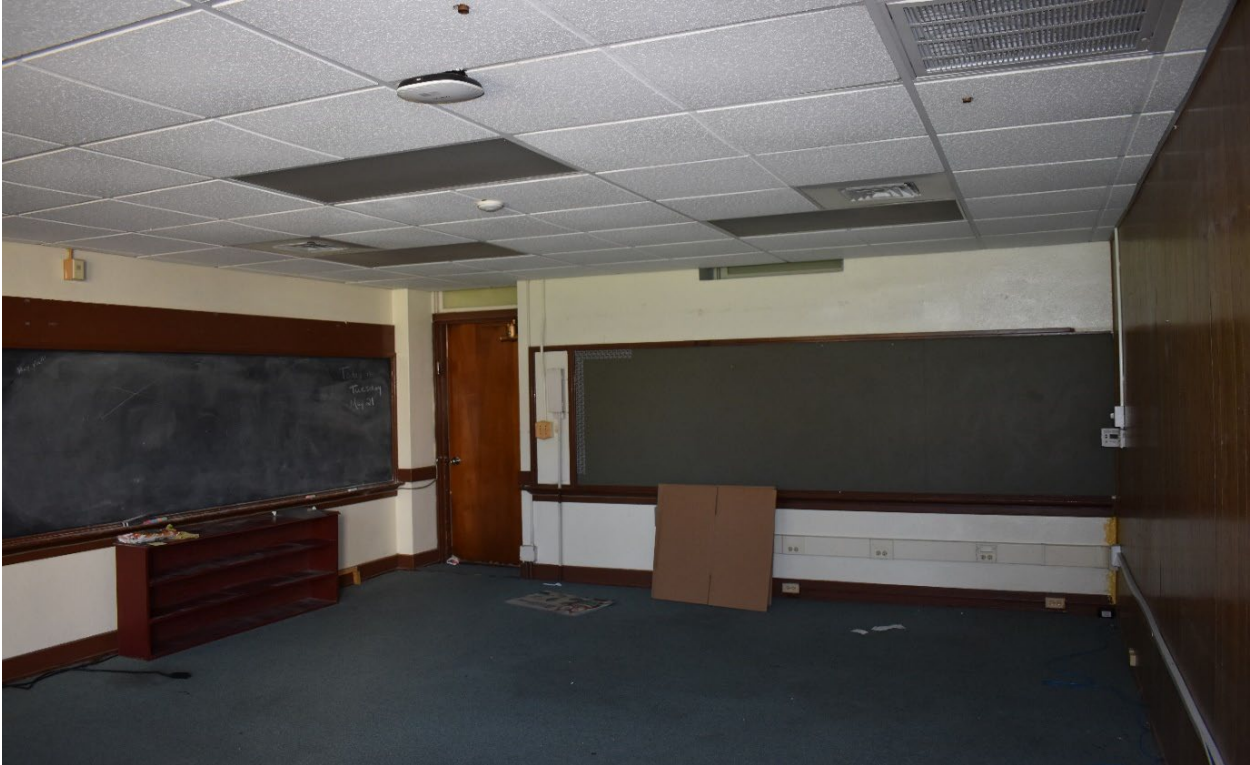
Photograph 16. Overview of Representative Classroom with Non-historic Partition at Left of Frame

Classrooms front both sides of the corridors on both the first and second floors. Generally, classrooms have been subject to a similar set of alterations, including subdivision of the space with non-historic partition walls, installation suspended ceiling with acoustical tiles, replacement of original wood panel doors with solid wood doors, installation of carpet and interior wall treatments, and changes to the historical tripartite glazing of transom and internal clerestory lights, usually with a single pane (Attachment 1, Photograph 16). Even so, the classrooms retain several historical features, including original door and internal light openings, wood chalkboard frame and chalk tray assemblies, built-in cabinet with glazed upper door (Attachment 1, Photograph 17). In addition, the non-historic suspended ceilings have been constructed in a manner that provides clearance to the upper ends of the window, leaving essentially all exterior-facing original classroom windows and sills intact.

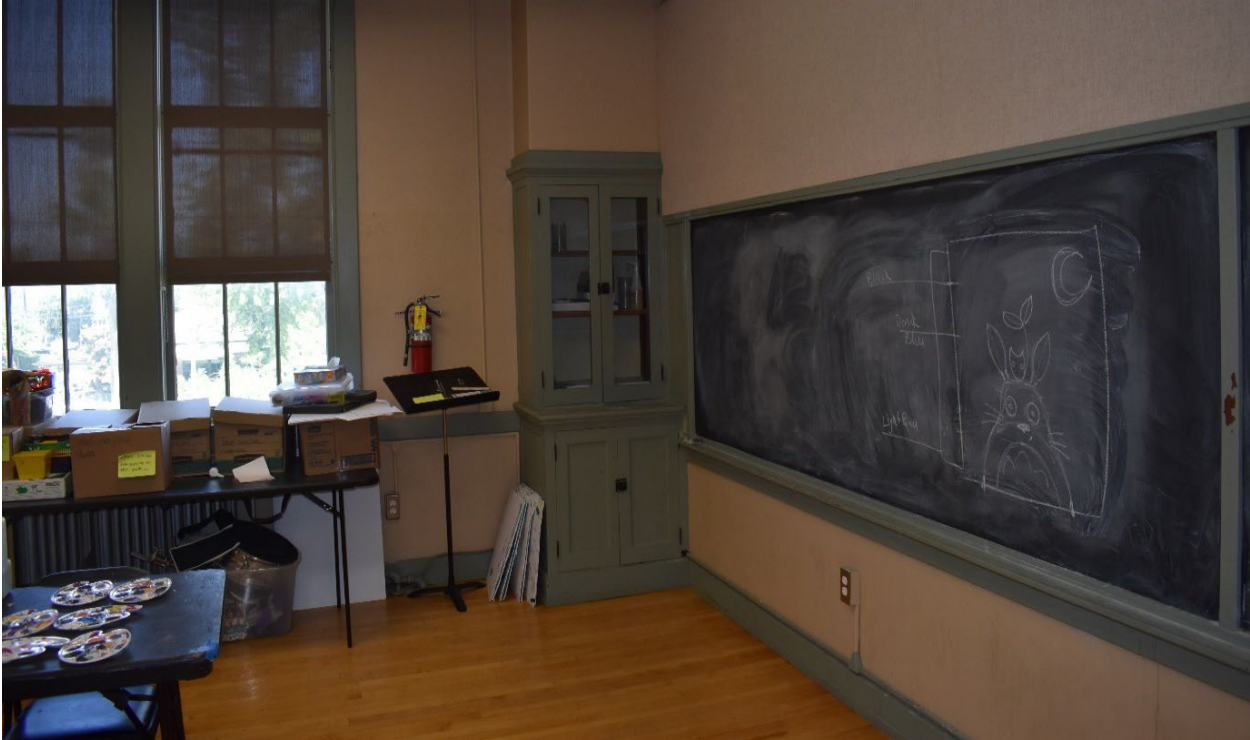
Photograph 17. Representative View of Classroom with Historical Windows, Built-In Cabinet, and Chalkboard Assembly

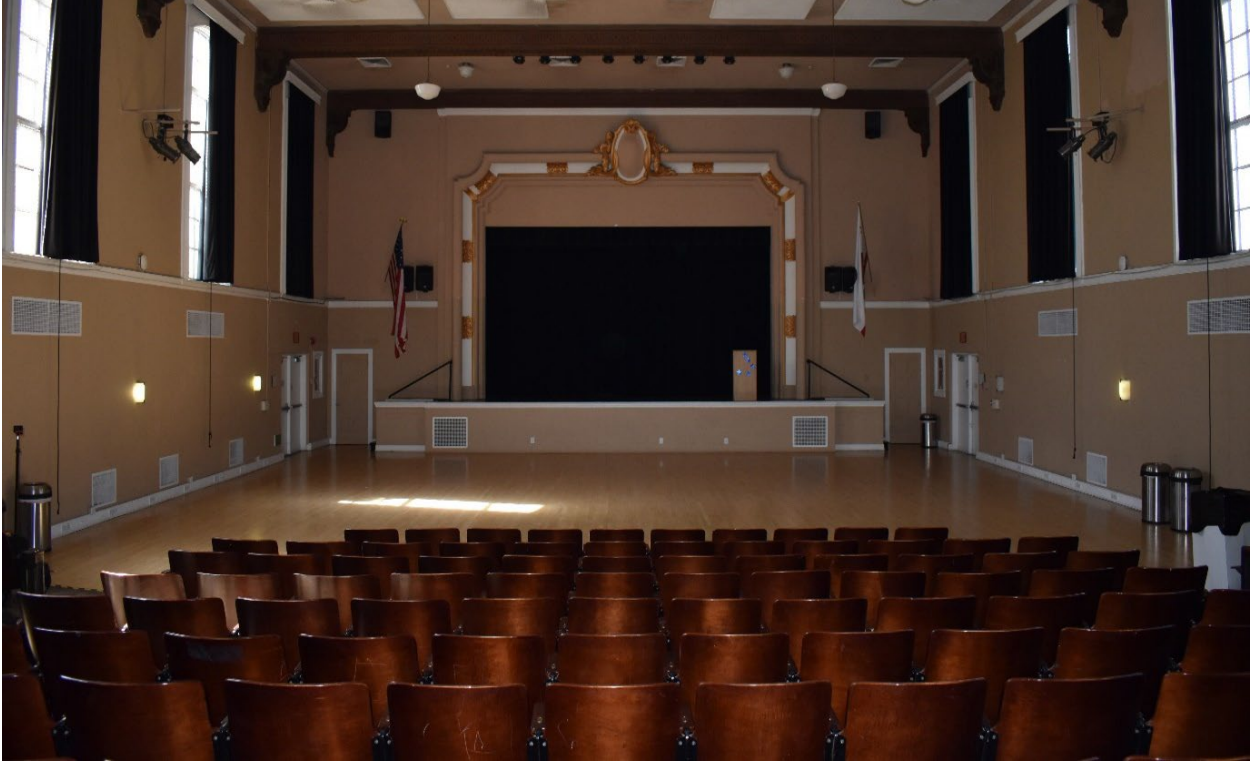
Photograph 18. Auditorium, Facing the Stage

The auditorium is located at the rear (south) of the building (Attachment 1, Photograph 18). Accessed via solid wood doors on the south side of the main corridor, opposite the office, the space occupies nearly the entirety of the building's south wing. The auditorium is a cavernous rectangular space that extends the full height of the building. At the rear (north) of the room, near its interior entrances, three sections of permanent theater seating are anchored to a stepped exposed concrete floor (Attachment 1, Photograph 19). The chairs consist of ornamental metal legs with wood arm rests (each leg/armrest assembly shared by two adjacent chairs), wood backs, and swing-up wood seats. The aisles that segment the seating areas slope gradually to the wood-clad dance floor, situated between the front rows of seating and the stage. The wood stage is flanked by straight wood staircases and surrounded with a proscenium with elaborate molding with organic and scroll motifs (Attachment 1, Photograph 20). Natural light enters the room through series of arched wood multi-light windows on the side walls of the room. Above the windows, heavy ceiling beams with aniconic painted designs span the width of the room, supported at the ends by molded brackets. The upper rear of the room is dominated by a non-original system of overlapping stained wood planks, which appears to form an acoustical treatment. A historical projection booth extends slightly from the rear wall, supported by molded brackets. Aside from the wood-panel treatment at the rear of the room and the apparent removal of an original balcony seating area, visual observation and a review of the original building plans, indicates the auditorium remains a high degree of integrity to its historic design.

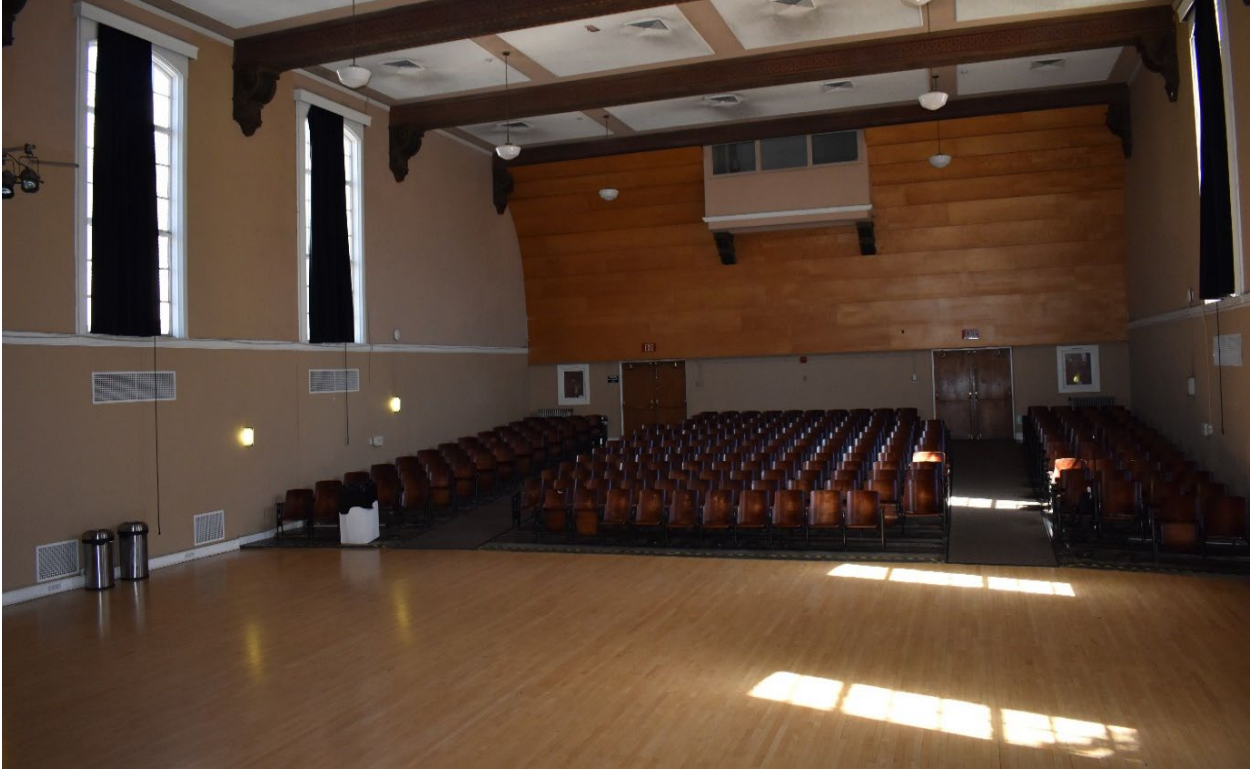
Photograph 19. Auditorium, Facing Rear

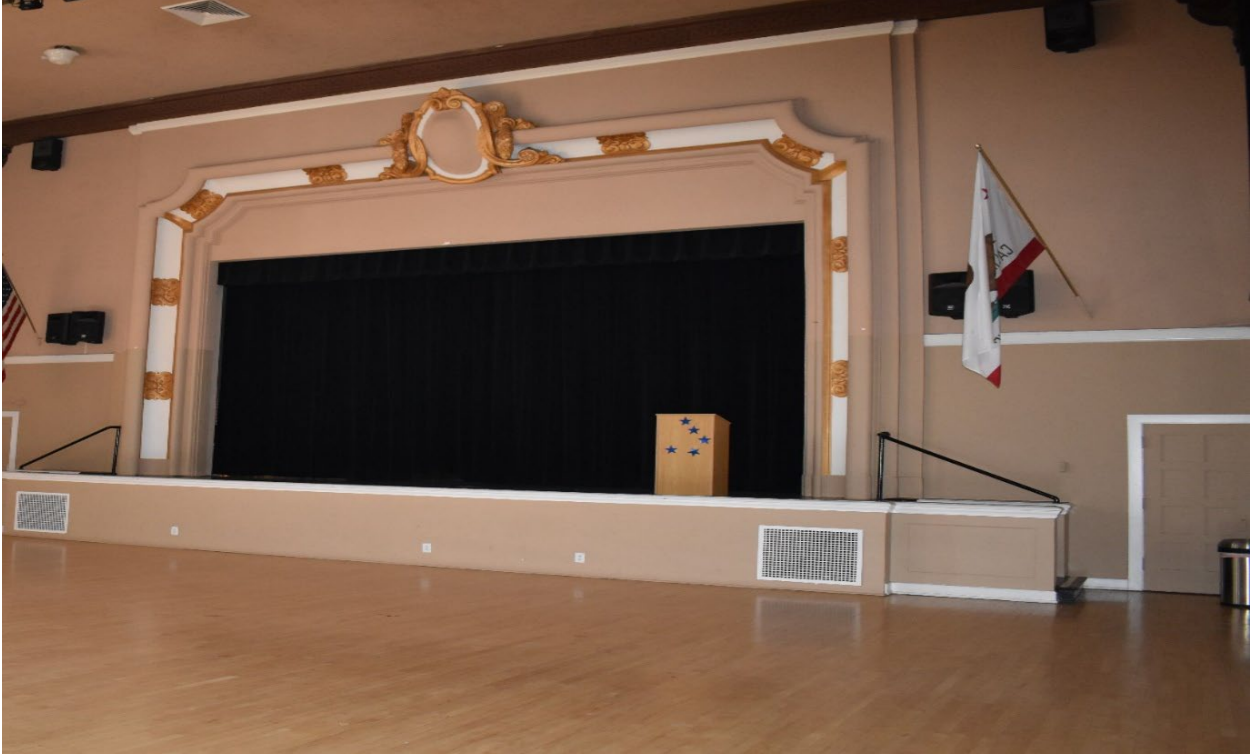
Photograph 20. Auditorium, Stage and Proscenium

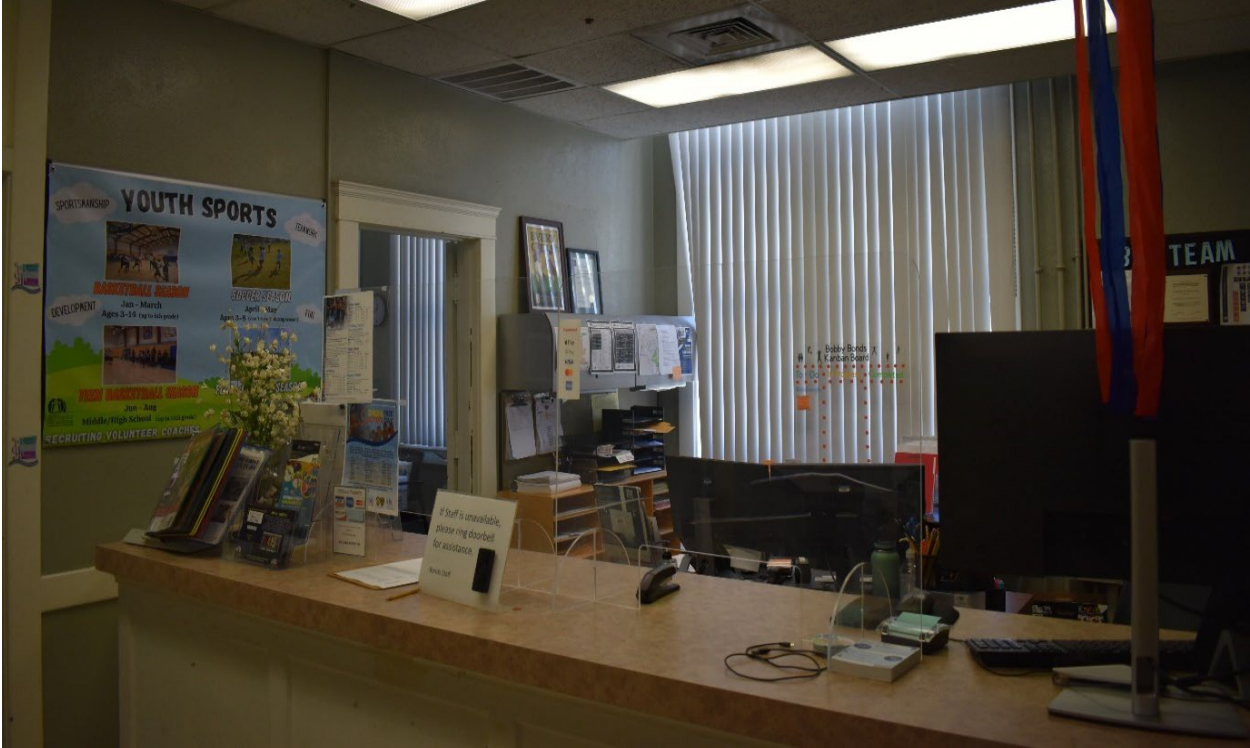
Photograph 21. Office interior, Featuring Modern Reception Counter

The office is located immediately adjacent to the lobby and main (north) entrance (Attachment 1, Photograph 21). Access is made from an arched portal with glazed double doors and a large, arched transom light. Finishings in the publicly accessible reception area include such historical features as wood-panel doors with tripartite transom lights and a safe built into one of the interior walls. Alterations include the linoleum flooring, a suspended ceiling, and a modern reception counter. Private offices beyond the reception area were not accessible during the site survey.

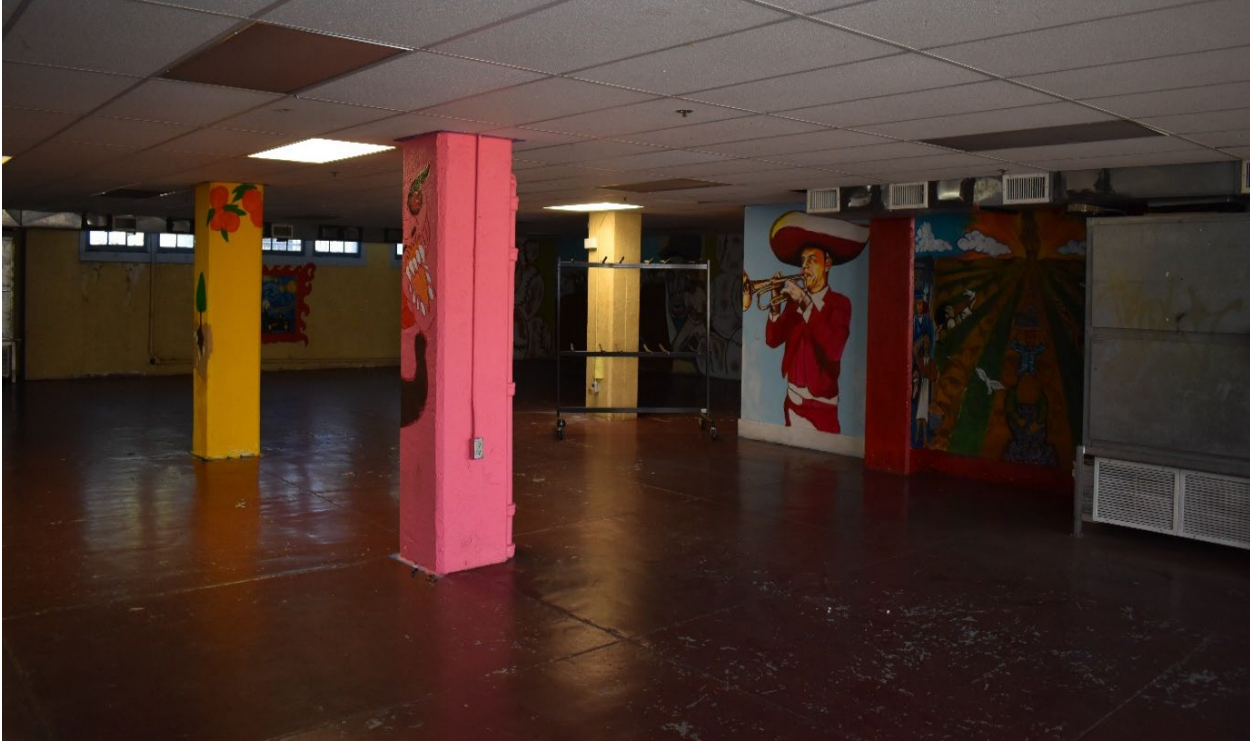
Photograph 22. Cafeteria

Aside from the dressing rooms beneath the auditorium, the survey for this study accessed two basement-level interior spaces, the cafeteria and a utility room. The cafeteria is accessed internally from a concrete stairway leading to a historical set of glazed wood doors, while external ingress is made via solid wood double doors at a subgrade access area at the south of the building. The cafeteria interior is characterized by concrete floors, a non-historical suspended ceiling, exposed square columns, and historical wood-sash windows of multiple sizes and configurations (Attachment 1, Photograph 22).

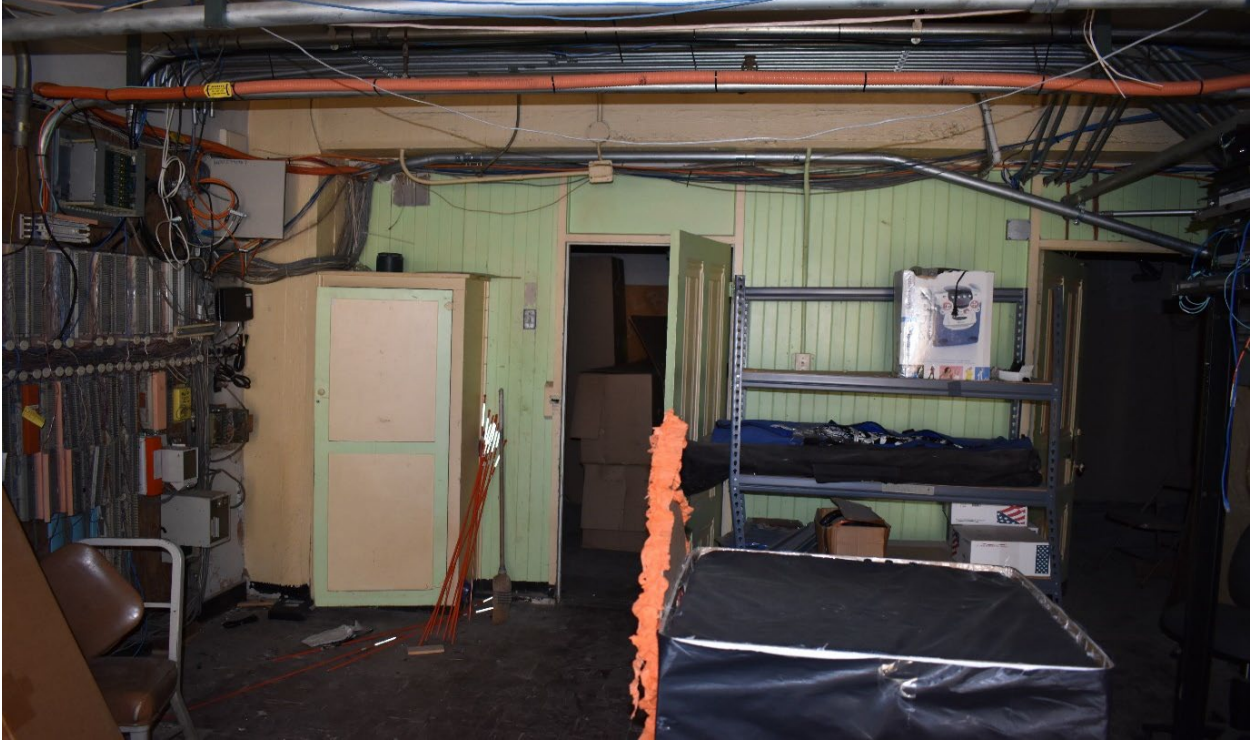
Photograph 23. Utility Room

The utility room is entered from the south-elevation exterior subgrade access area (Attachment 1, Photograph 23). Historical features include wood-sash windows and a variety of wall cladding materials, such as vertical wood planks and panels, scored brick, and exposed structural concrete. The concrete floor is partially covered in non-historic linoleum. The space has been notably altered with the installation of several ducts, metal cable conduits, and equipment racks.
