WINDOW REFURBISHMENT AND REPLACEMENT

Design Criteria and Considerations

CESAR CHAVEZ COMMUNITY CENTER

WINDOW REFURBISHMENT AND REPLACEMENT MATRIX

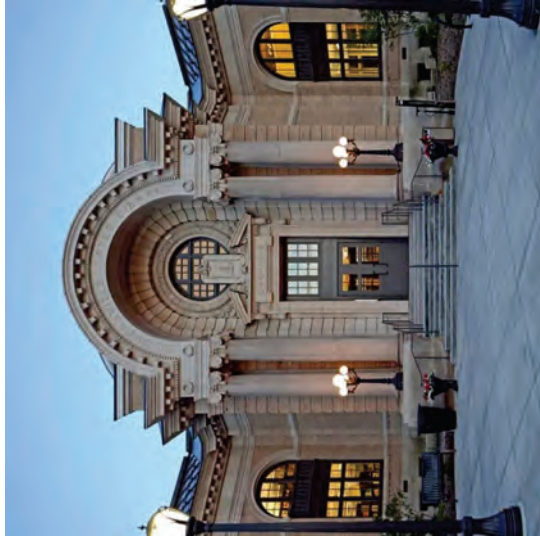
ANDERSEN WINDOWS 'E-SERIES': GLOVERSVILLE, NY PUBLIC LIBRARY

Aluminum clad wood windows (composite) have been installed successfully on architecturally significant historic building across the country. The buildings pictured here on the National Register of Historic places were renovated with aluminum clad wood windows.

Sash and muntin color, size, profile, and configuration are customizable. Windows designed specifically for each project insure that the new windows are compatible with the historic architecture.

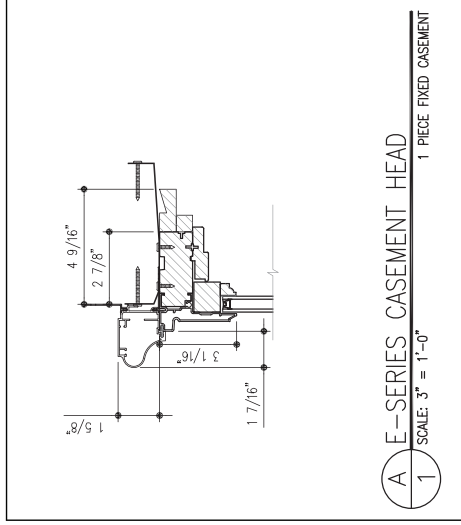
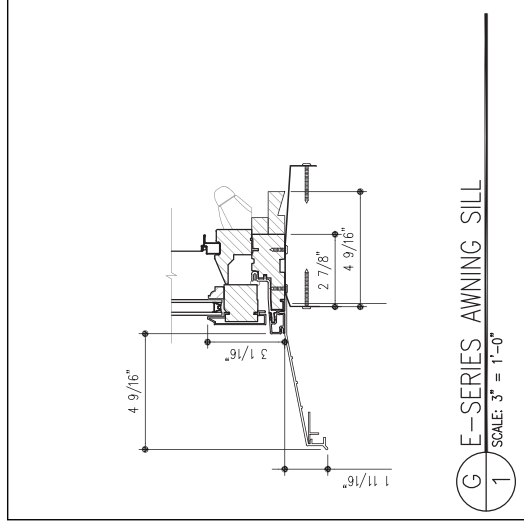
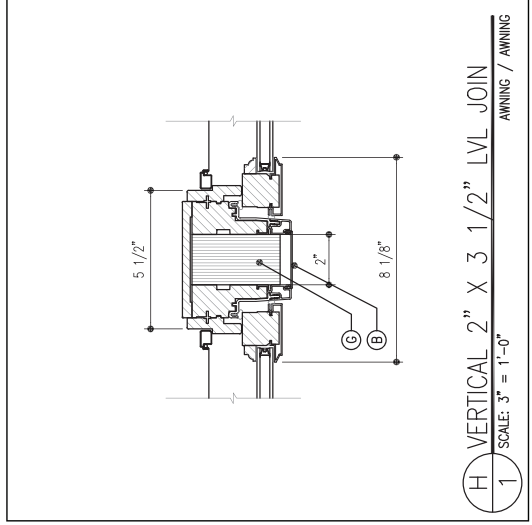
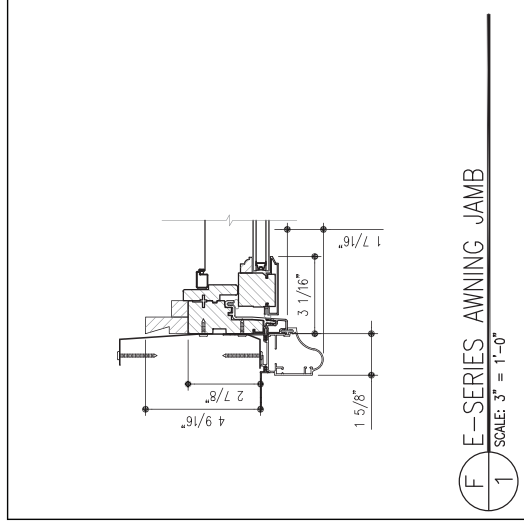
ANDERSEN 'E-SERIES' DETAILS FOR CESAR CHAVEZ COMMUNITY CENTER

The design team is working with window manufacturers to prepare details which demonstrate their capacity for customization and historical accuracy. The Andersen 'E-Series' details at left depict the assembly and level of detail proposed for replacement windows at Cesar Chavez Community Center.

The exterior aluminum cladding color would be specified to match the color of the existing wood windows.

Trim, sash, and muntin profiles would be engineered to be a very close match to those of the existing wood windows.

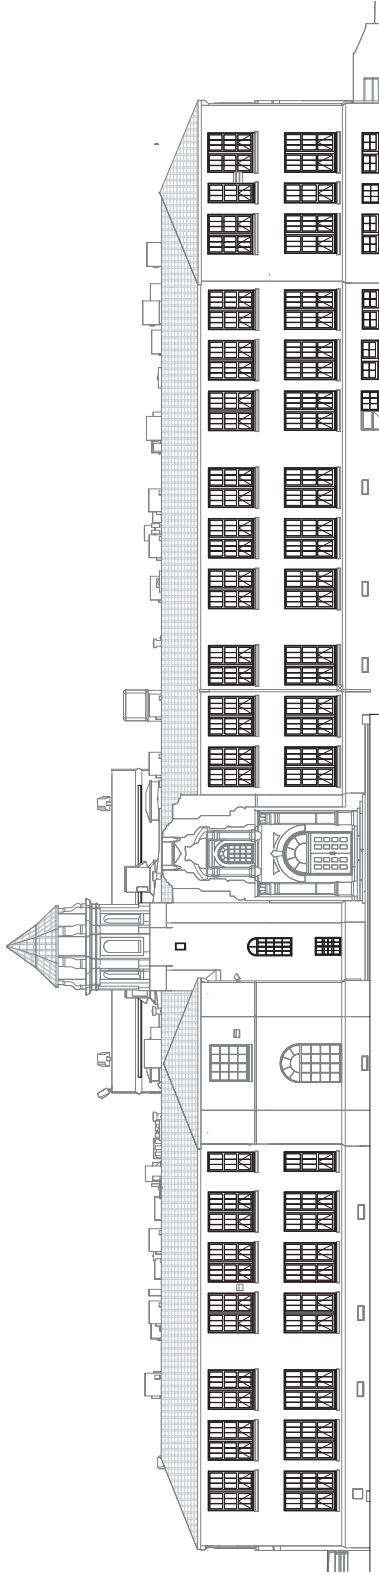
NORTH ELEVATION

Wood windows	113	(28 types)
Metal windows	18	(5 types)
Total	131
