**Santa Ana River Tributary Restoration Projects  
Jurisdictional Delineation Report**

# **Santa Ana River Tributary Restoration Projects, Early Implementation Services for the Upper Santa Ana River Habitat Conservation Plan Jurisdictional Delineation Report**

## **1.0 Summary**

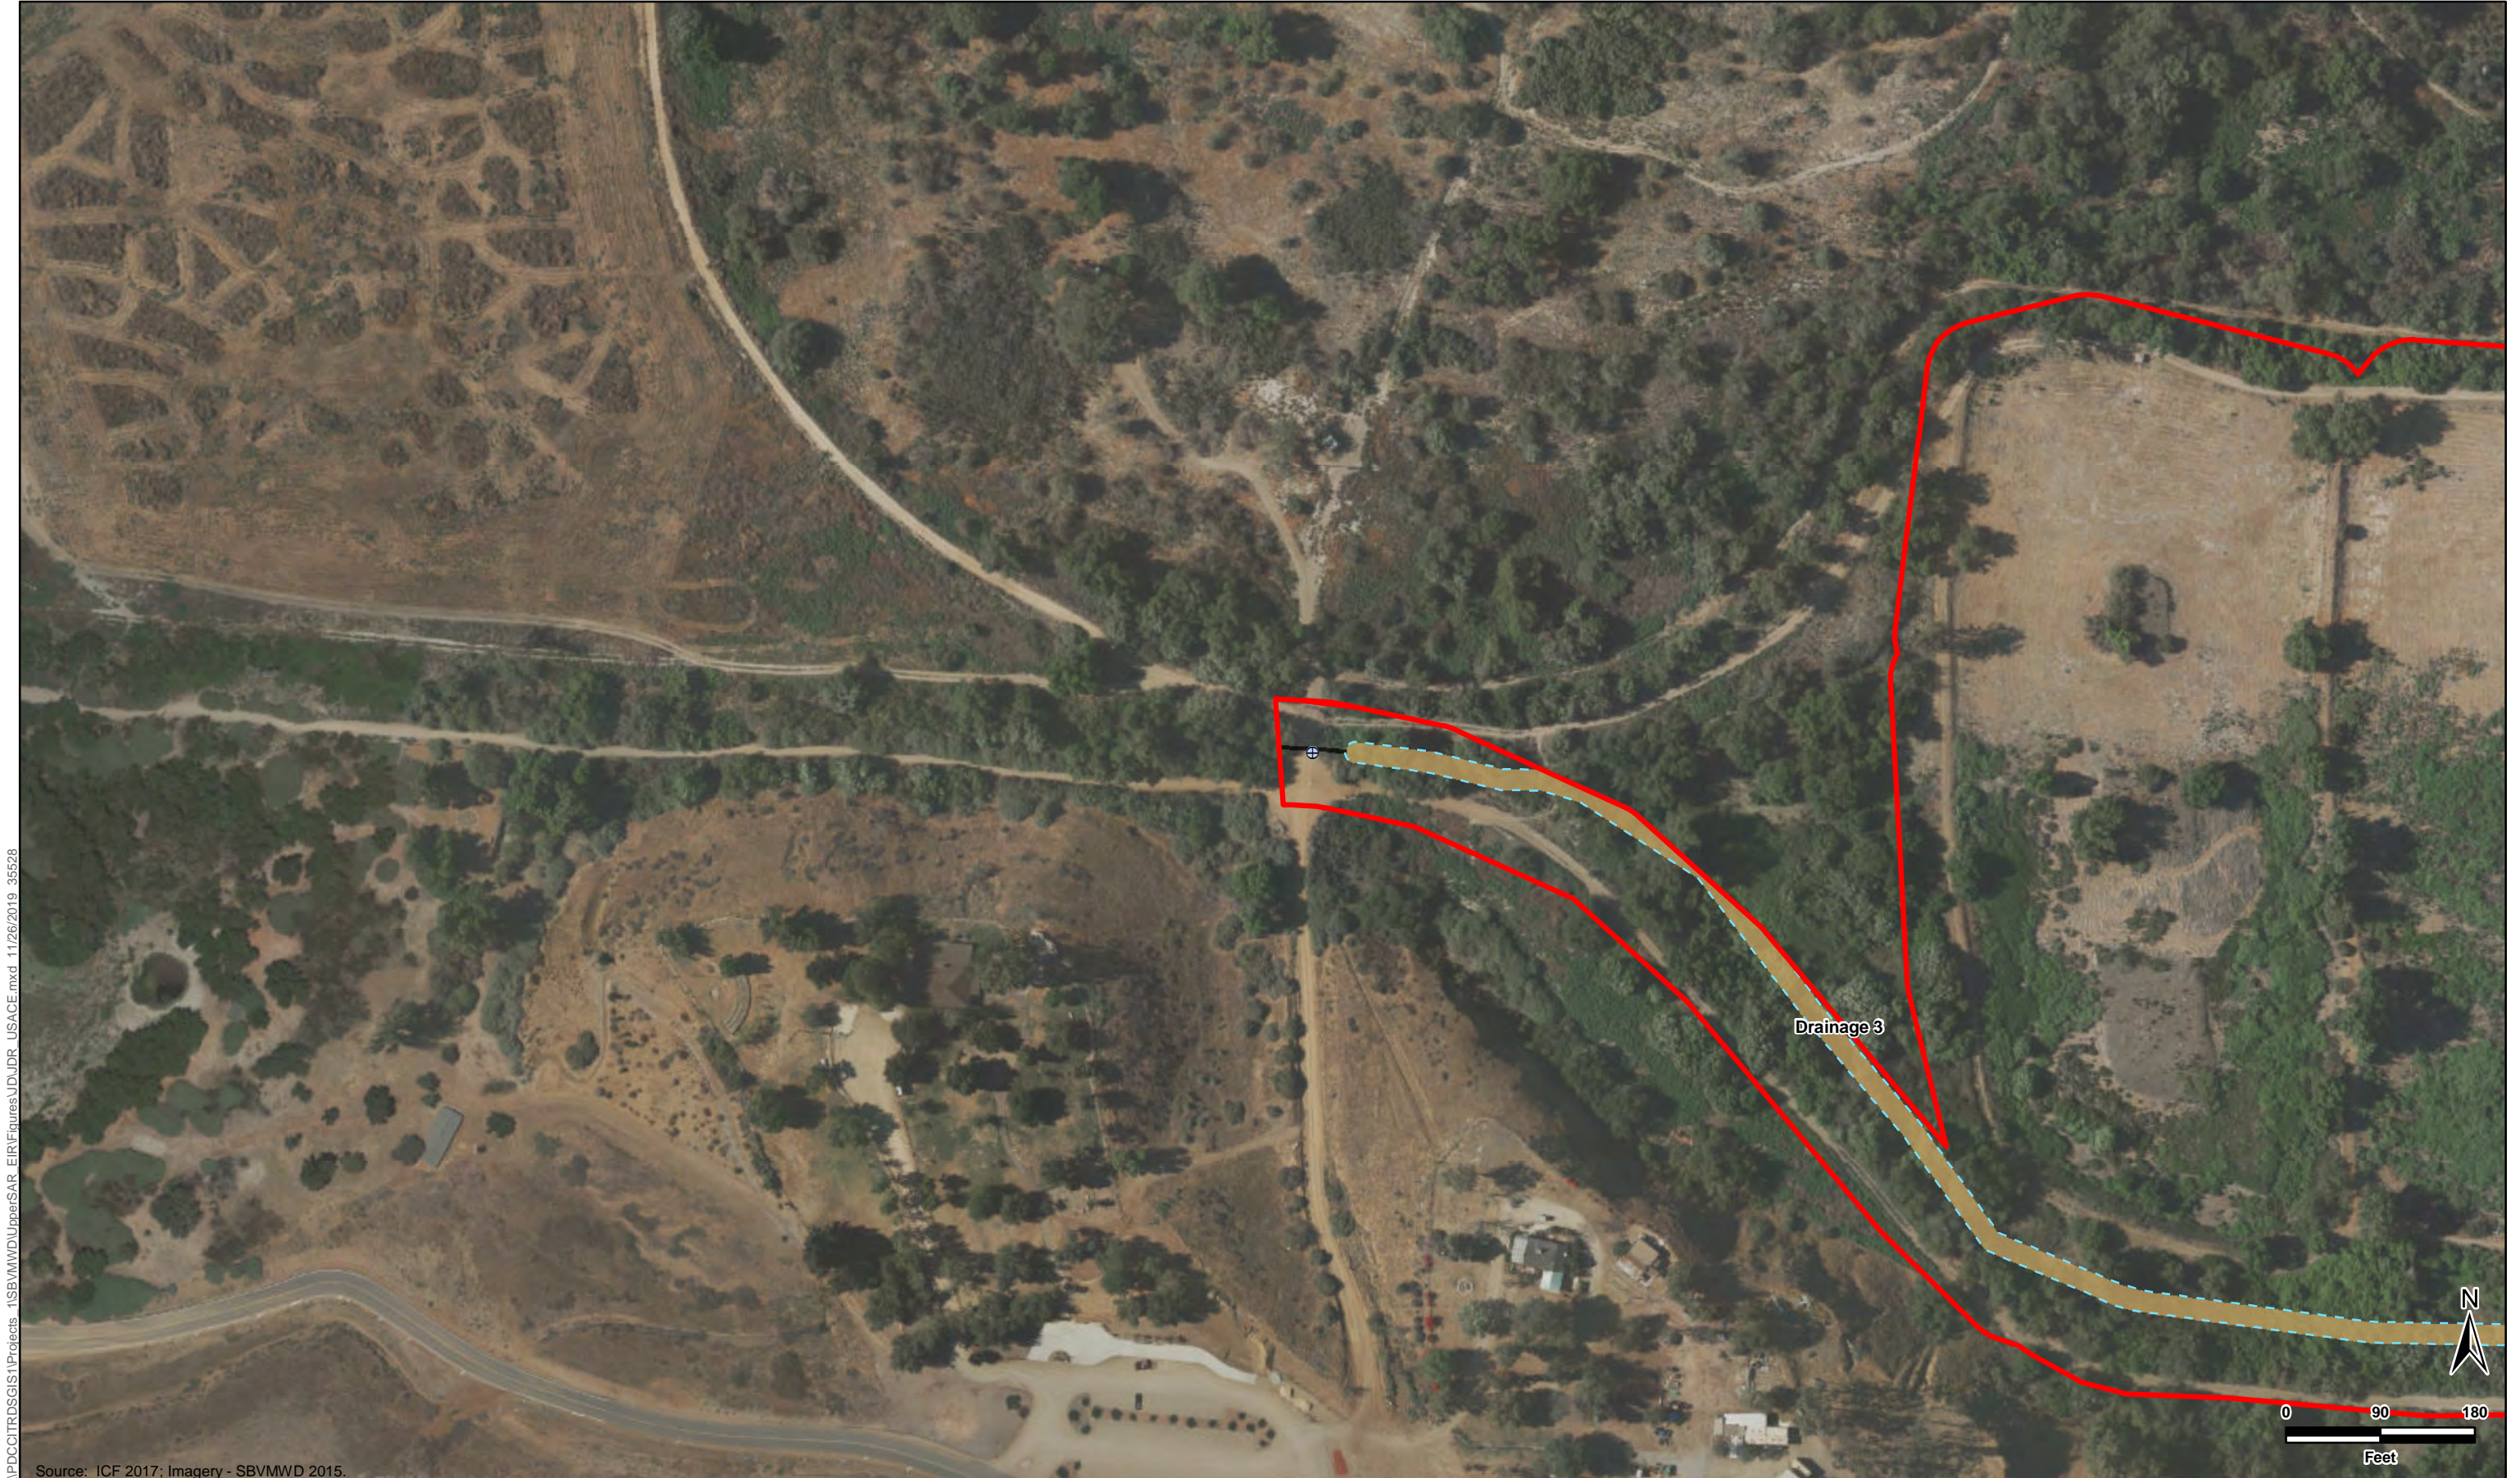
**Figure 3 Sheet 3 Hidden Valley Wetlands Site  
Jurisdictional Waters of the U.S  
Upper Santa Ana River Restoration Project**

A manmade canal (Drainage 3) runs along the southern project boundaries (Figures 3 and 6, Sheets 3, 4, and 5). Drainage 3 is a canal that was constructed to supply recycled water for the wetland ponds (including Depressions 3 through 6). This channel starts at an outlet where recycled water historically had been diverted into Drainage 3 from Drainage 1. However, following a major storm in 2010, the headworks infrastructure was damaged and water has not been actively pumped within this channel since then (Danelski 2014). Currently, this canal is hydrologically supported by the surrounding hillsides and stormwater runoff from the adjacent trails.

Depressions 3 through 6 are constructed depression pond features located at the western portion of the survey area (Figures 3 and 6, Sheet 3). Analysis of historic aerial imagery indicated that these features were constructed over 40 years ago and actively maintained as ponds until a major storm in 2010. After this storm, the headworks infrastructure was damaged and water has no longer been

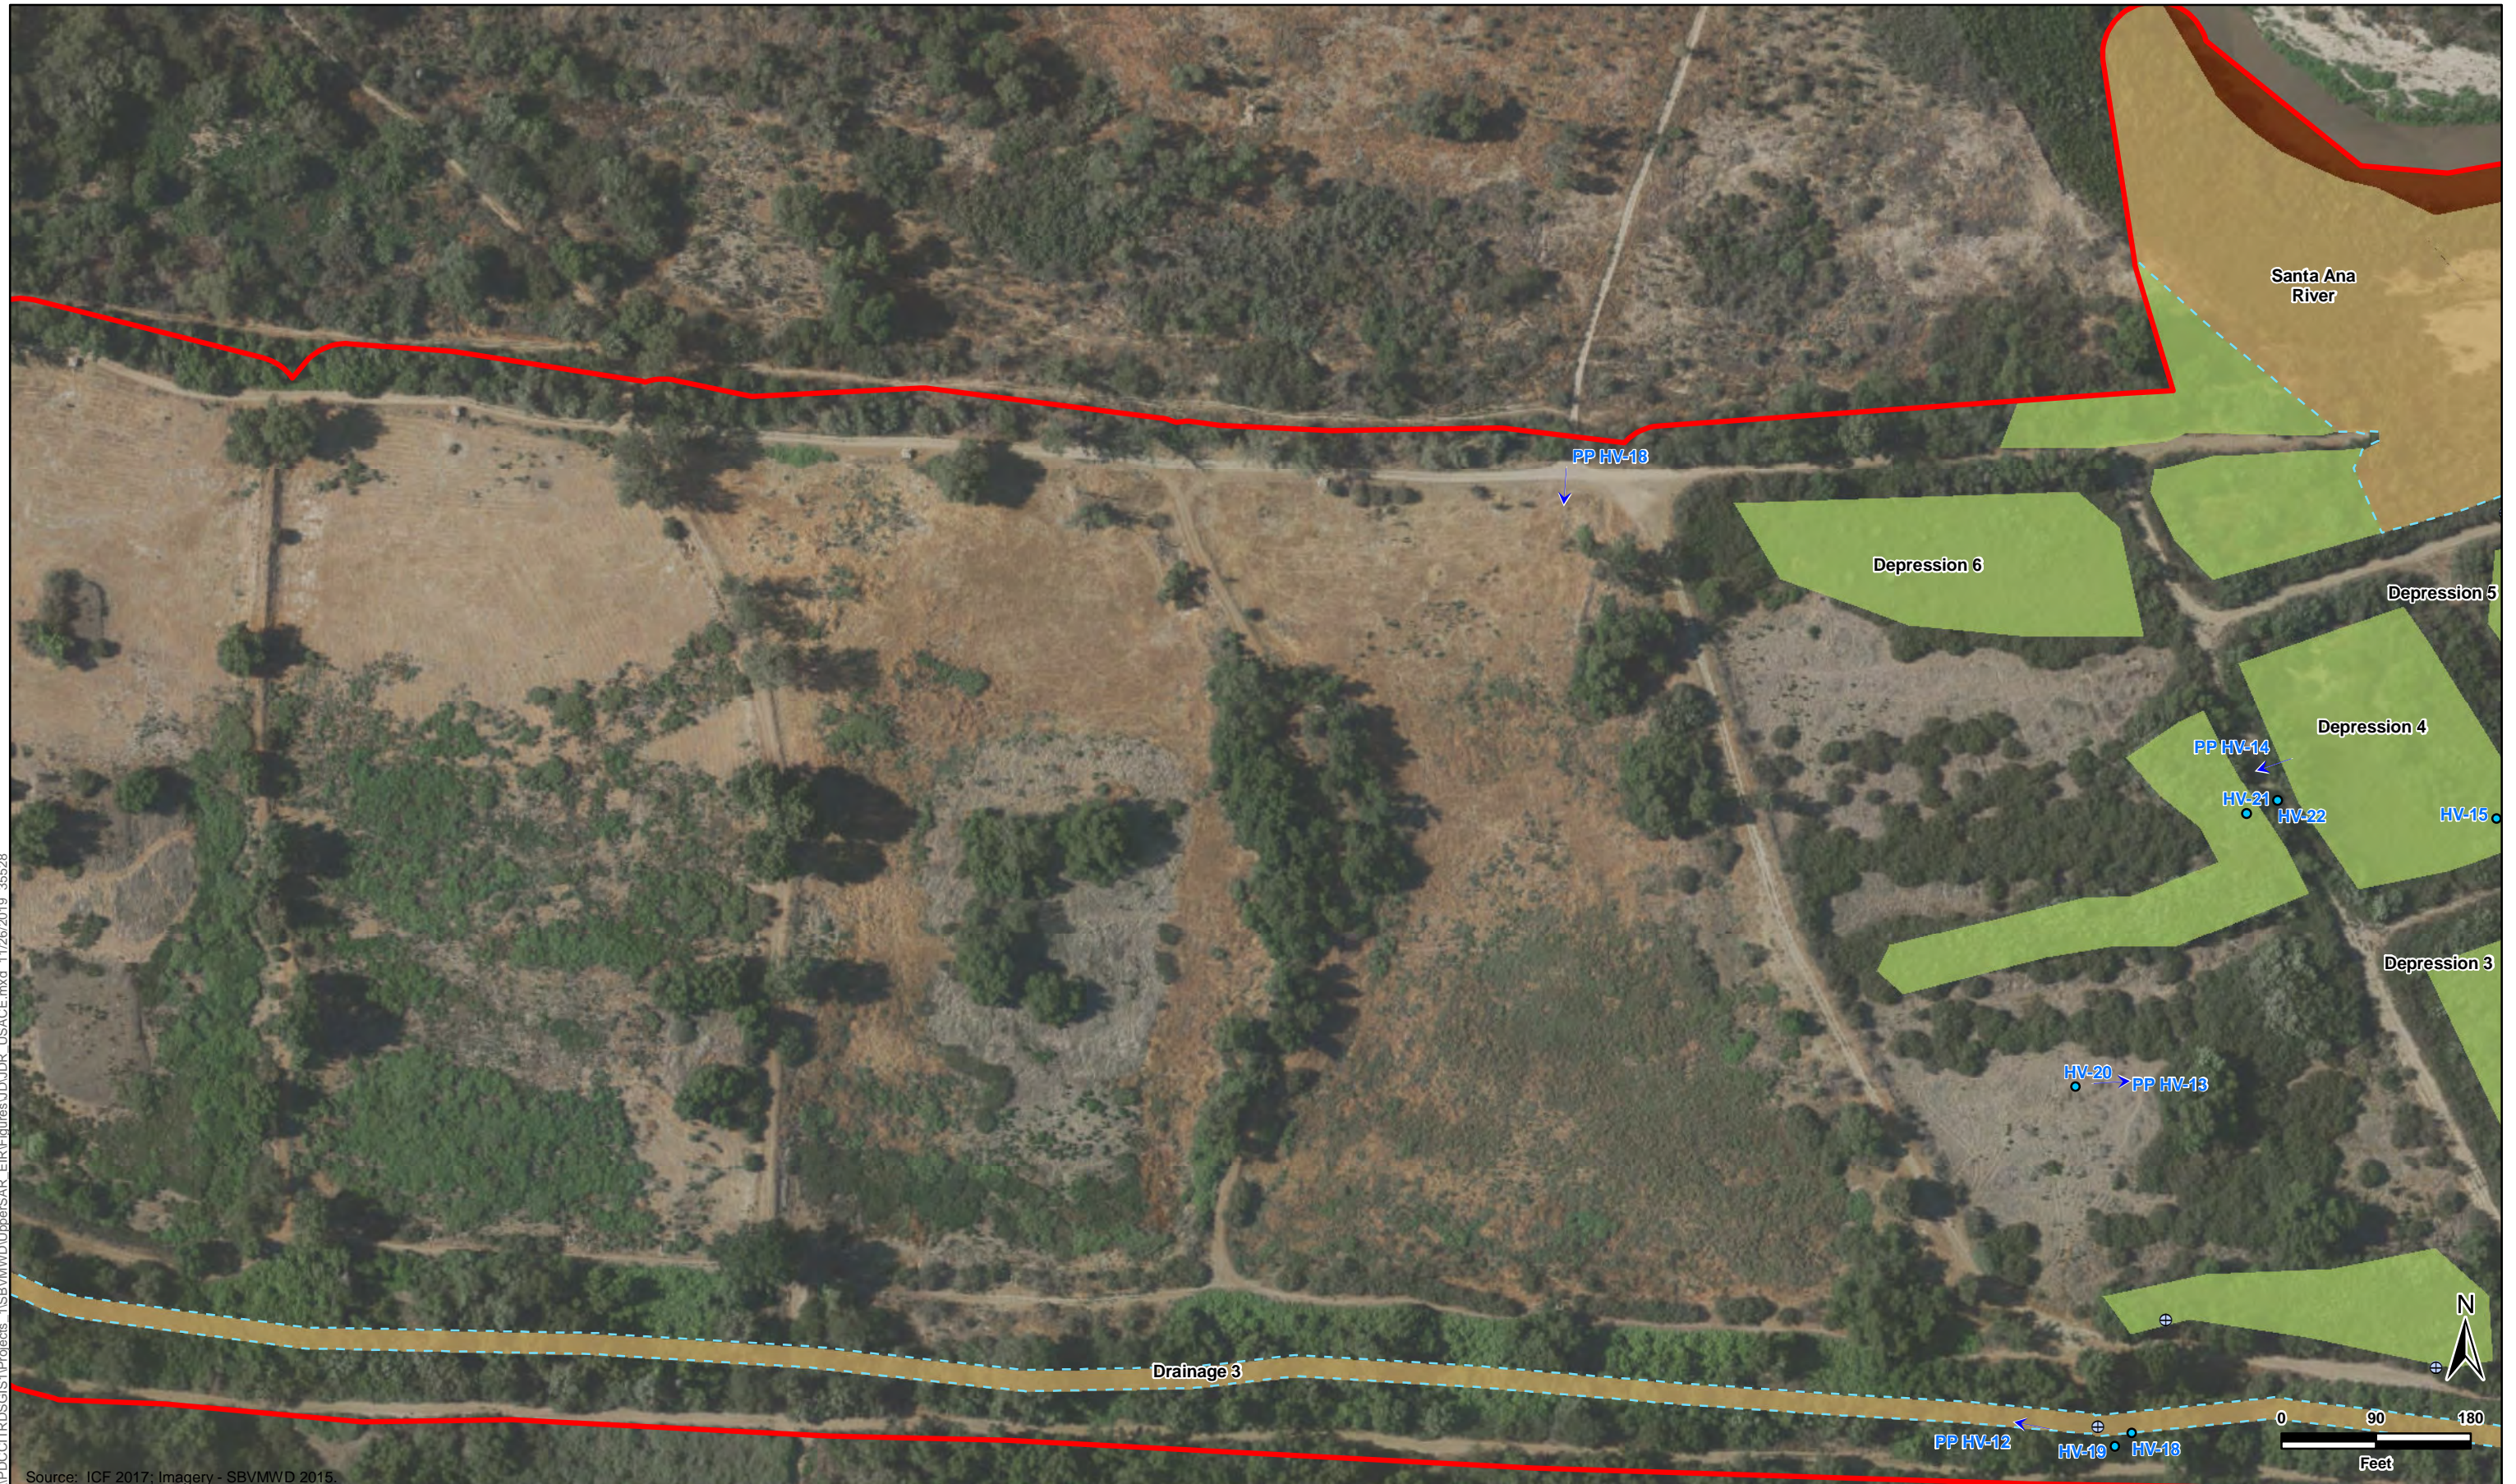
**Figure 3 Sheet 4 Hidden Valley Wetlands Site  
Jurisdictional Waters of the U.S  
Upper Santa Ana River Restoration Project**

riparian canopy is open. OHWM indicators observed included shelving and sediment sorting. The canal enters a culvert about 1,300 feet west of the headworks (Figures 3 and 6, Sheet 4), then traverses southwest for 1,600 feet, general paralleling the access road, before entering another culvert at the southwestern corner of the site (Figures 3 and 6, Sheet 3). The canal then outlets about 60 feet north of the inlet where it flows northwest until joining the Santa Ana River at the northwestern corner of the site. This downstream segment is a more confined channel compared to the upstream segment and supports wetland habitat and a riparian canopy throughout. The center portion of the drainage that does not support vegetation (low-flow area) is considered CDFW streambed, whereas the majority of this area is considered CDFW riparian.

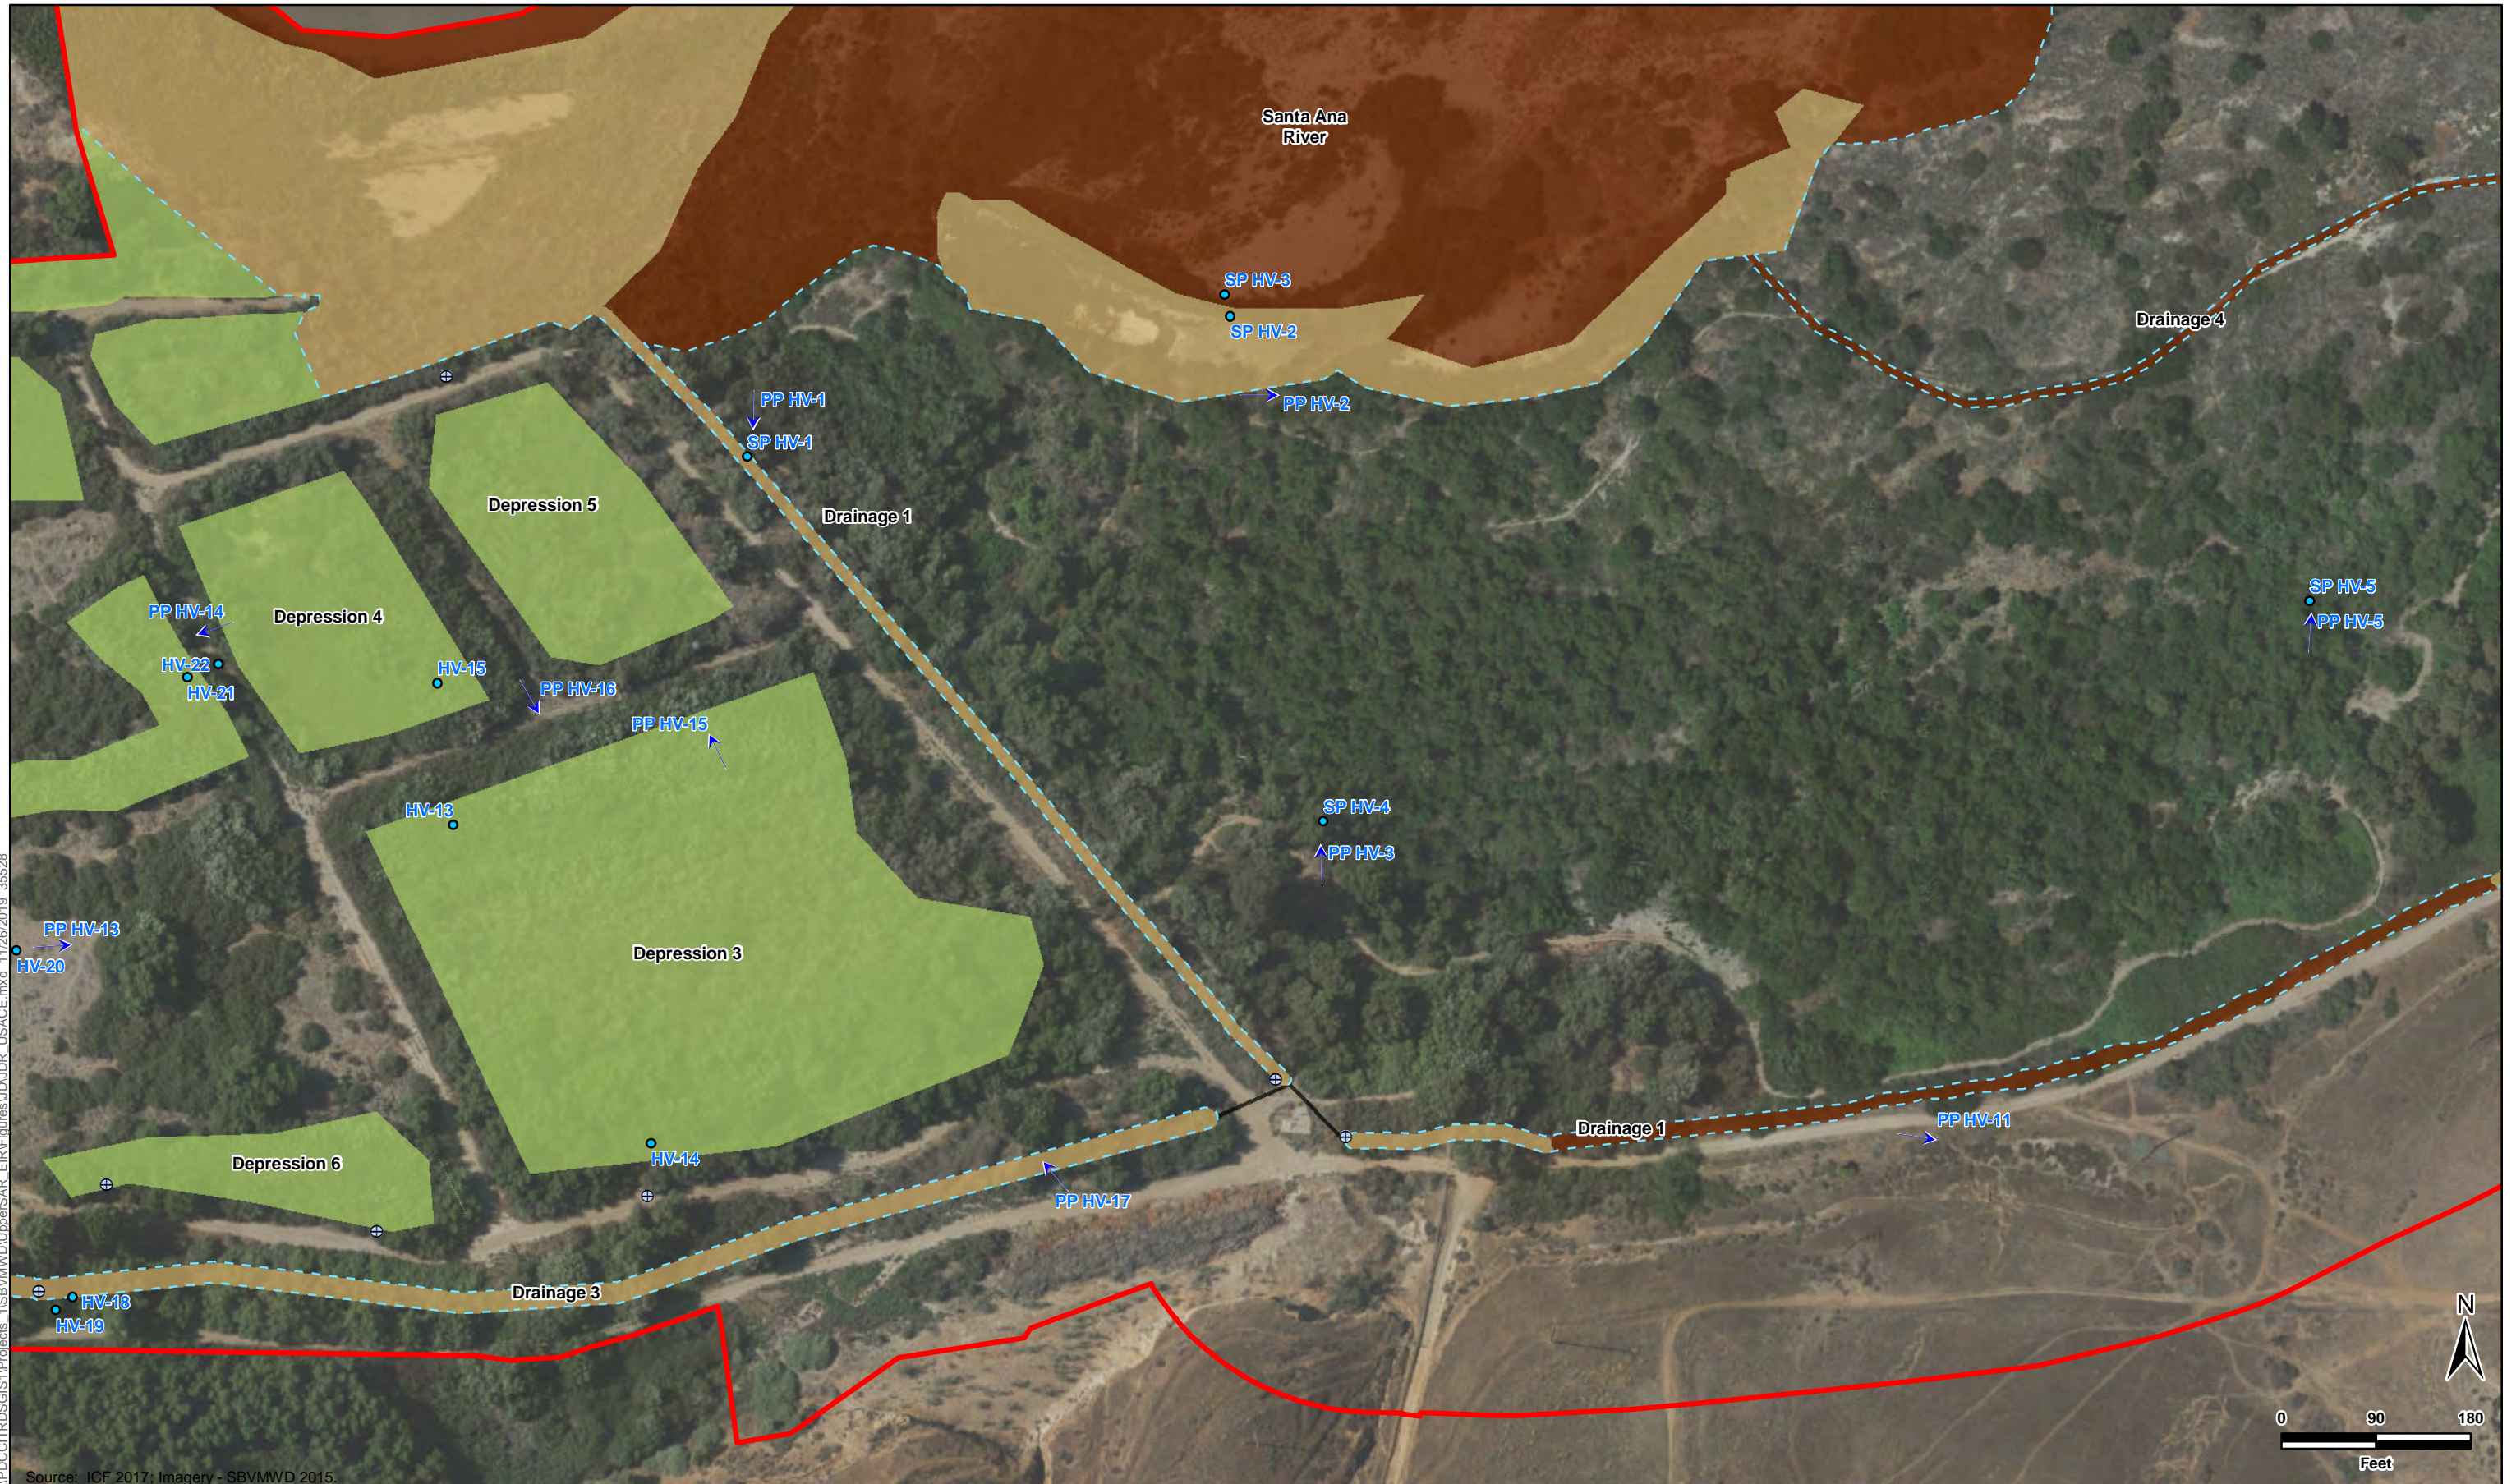
**Figure 3 Sheet 5 Hidden Valley Wetlands Site  
Jurisdictional Waters of the U.S  
Upper Santa Ana River Restoration Project**

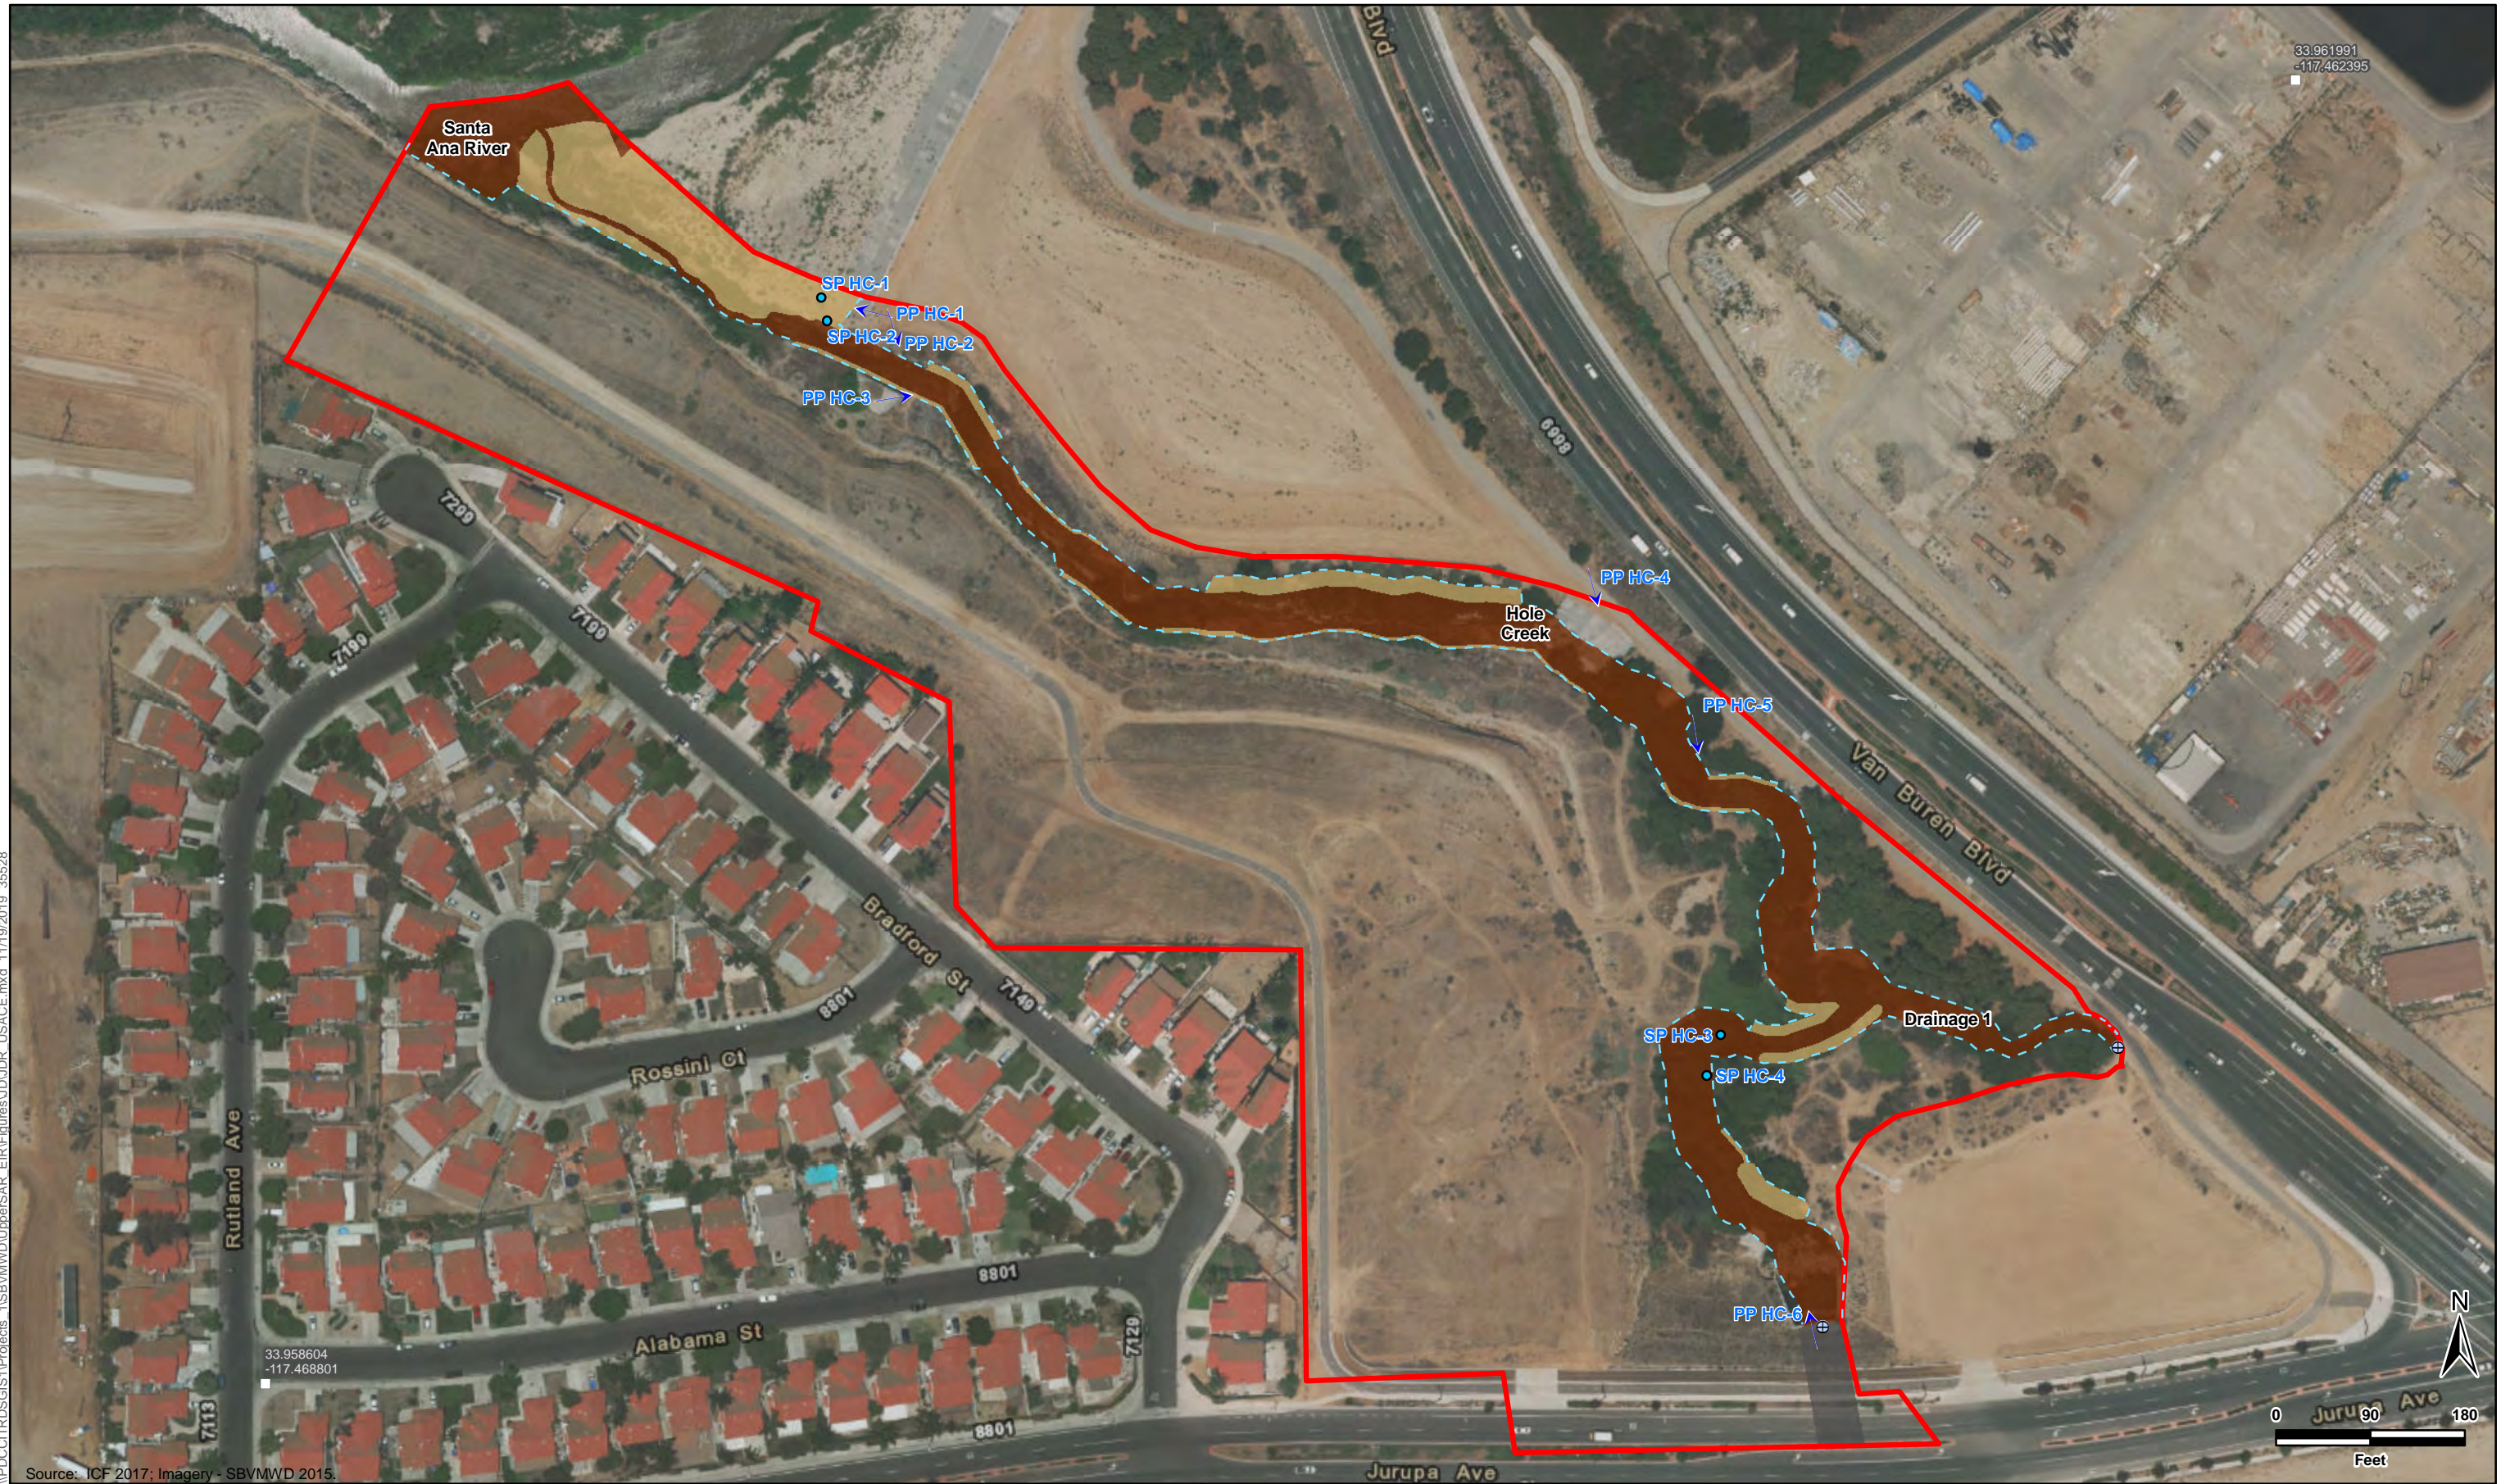
**Figure 4 Lower Hole Creek Site  
Jurisdictional Waters of the U.S  
Upper Santa Ana River Restoration Project**

Hole Creek is confined within a small and steep valley and is divided into an upper reach (“Upper Hole Creek”) and lower reach (“Lower Hole Creek”) by Jurupa Avenue, where the stream passes under the road through a large 40-foot concrete box culvert with extensive downstream protections. The Lower Hole Creek site begins downstream of Jurupa Avenue where the stream passes under the road through a large 40-foot concrete box culvert with extensive downstream protections and contains three features. A summary of each feature is provided below. Waters of the U.S. under the jurisdiction of USACE are shown on Figure 4, Waters of the State under the jurisdiction of RWQCB are shown on Figure 7, and CDFW jurisdictional waters are shown on Figure 10.

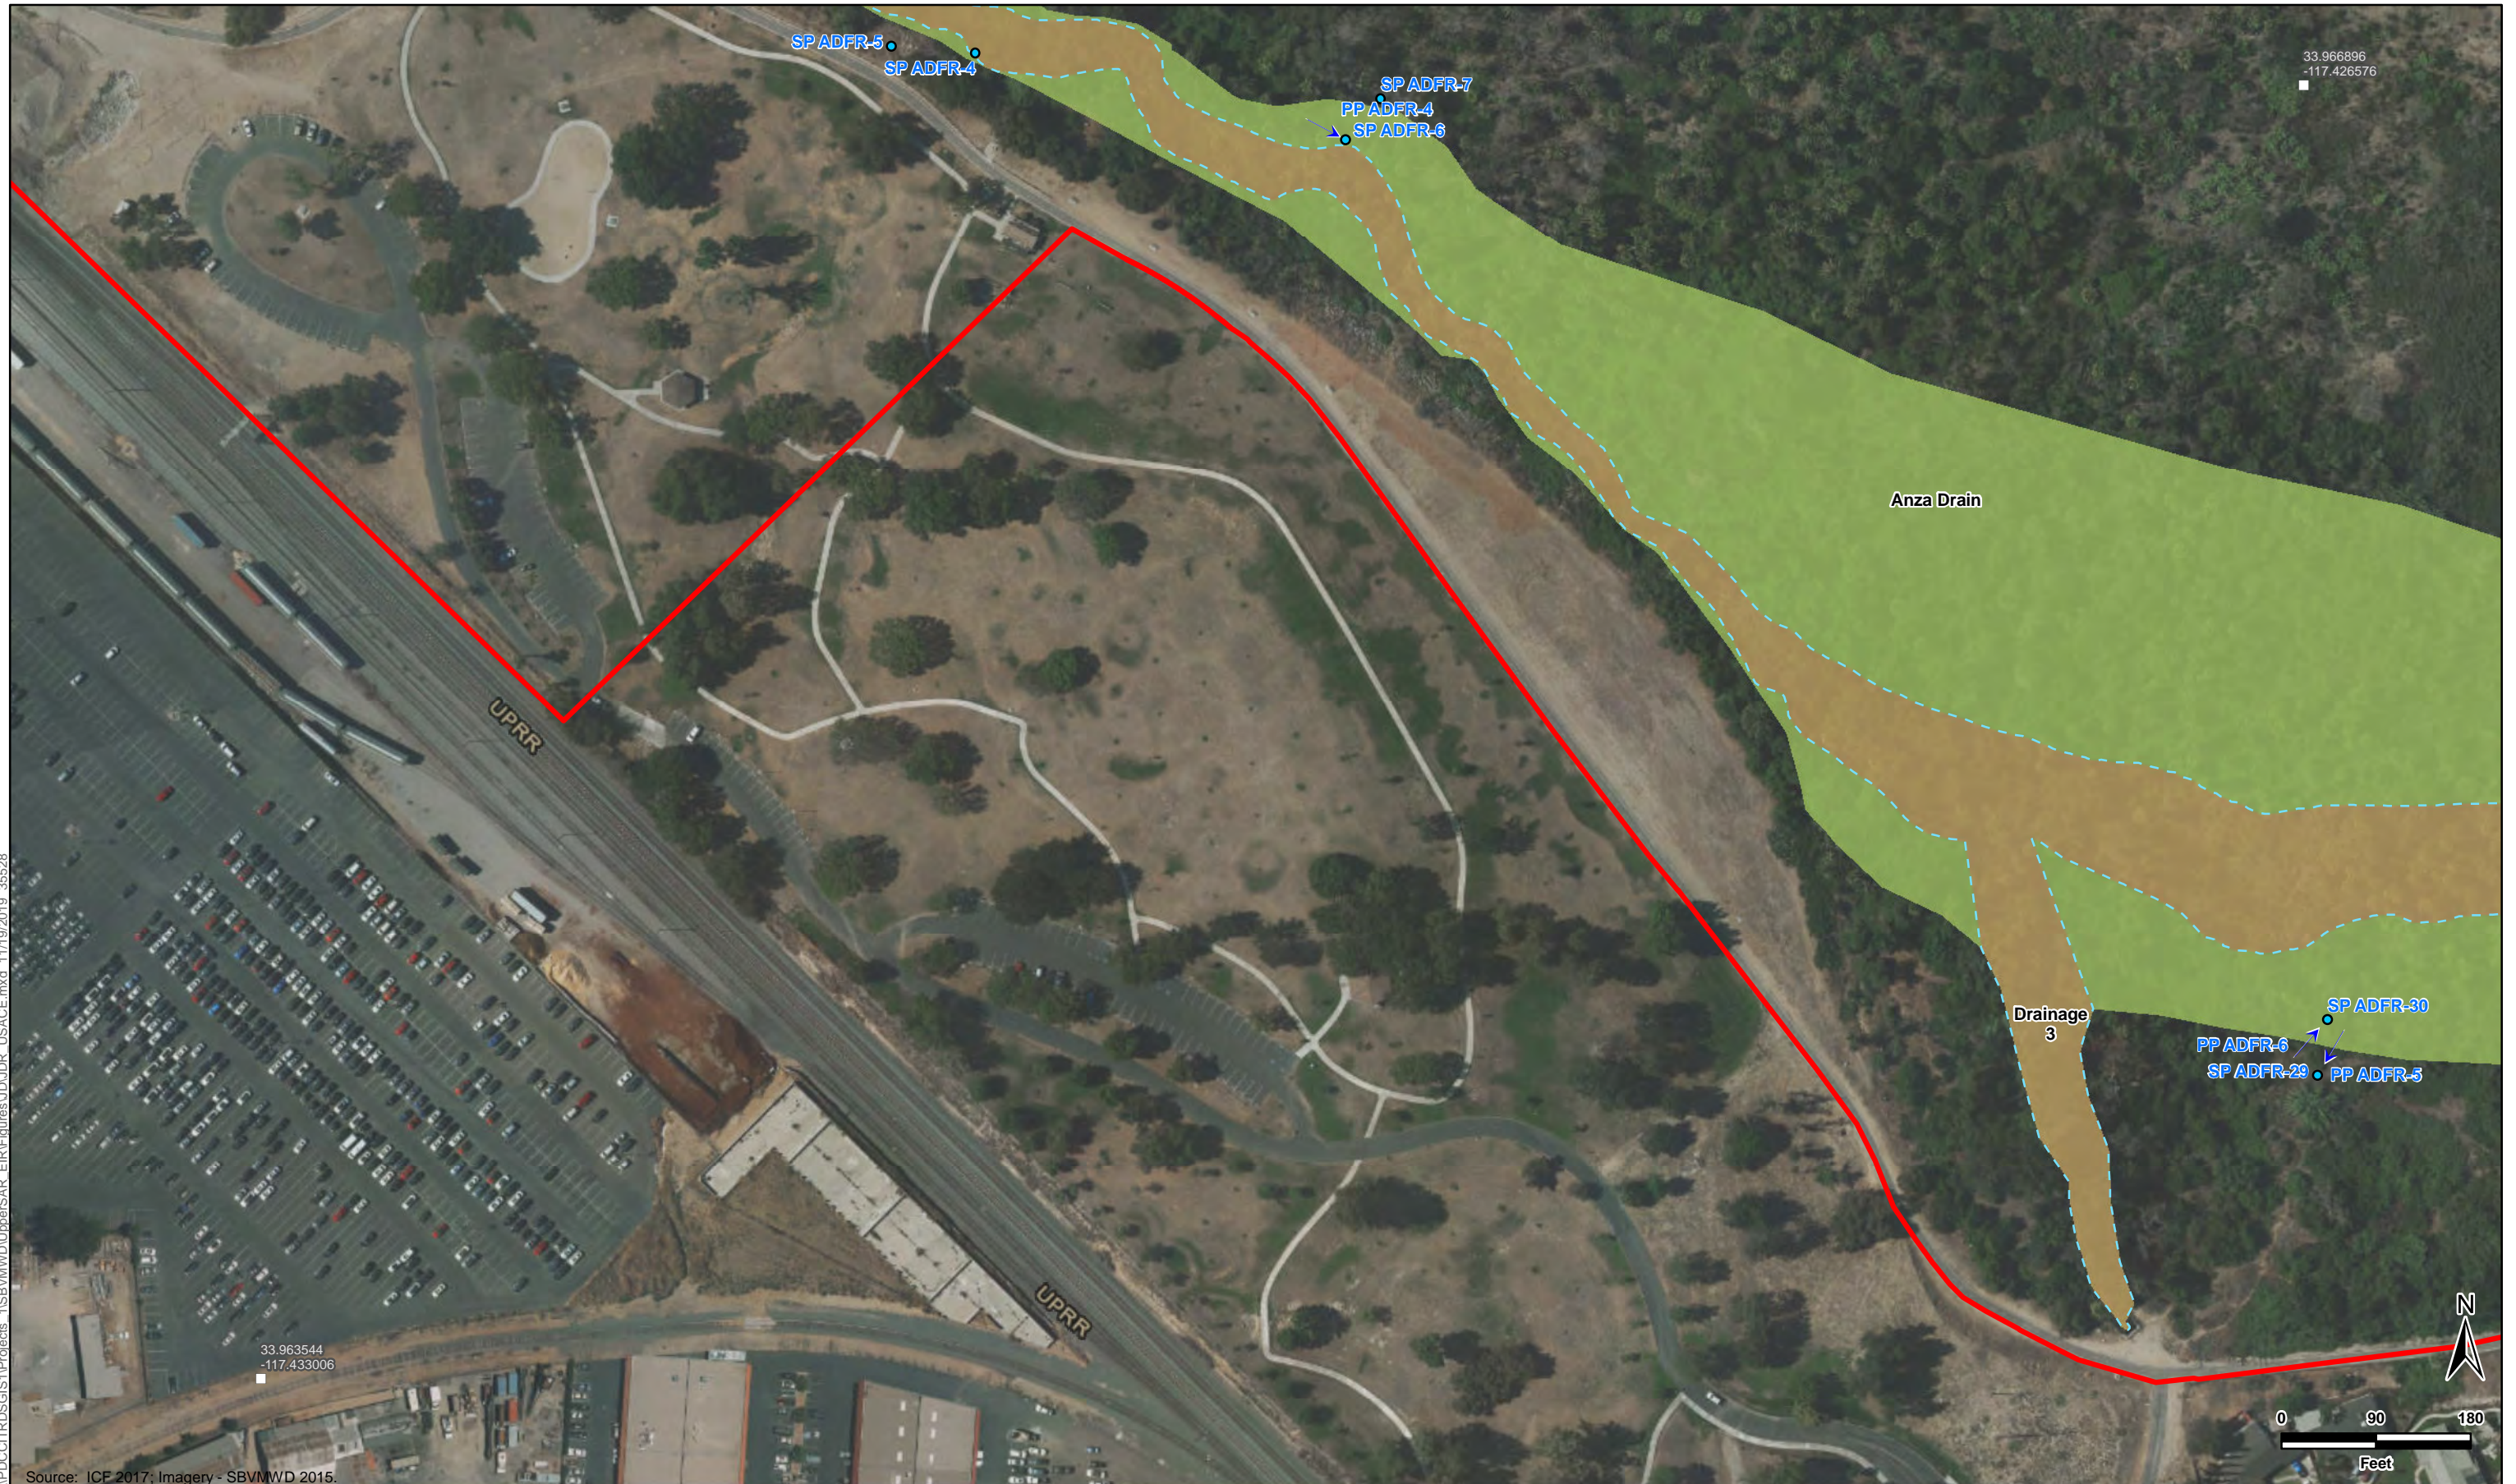
**Figure 5 Sheet 7 Anza Drain and Old Farm Road Site  
Jurisdictional Waters of the U.S  
Upper Santa Ana River Restoration Project**

Flows originate from a large 20-foot concrete box culvert under the Santa Ana River bike trail (Figures 5 and 8, Sheet 9, and Figure 8, Sheet 9) and a concrete box culvert that enters from the southeast corner of Anza Narrows Park (Figures 5 and 8, Sheet 7). Surface water was present during the survey at the upstream and downstream segments of this drainage. Surface flow is consistently weak from Anza Drain outlet until the middle segment of this drainage, at which point additional groundwater springs help sustain flow and creates more of a single thread perennial channel (Figures 5 and 8, Sheets 8 and 9).
