**Santa Ana River Tributary Restoration Projects  
Jurisdictional Delineation Report**

# **Santa Ana River Tributary Restoration Projects, Early Implementation Services for the Upper Santa Ana River Habitat Conservation Plan Jurisdictional Delineation Report**

## **1.0 Summary**

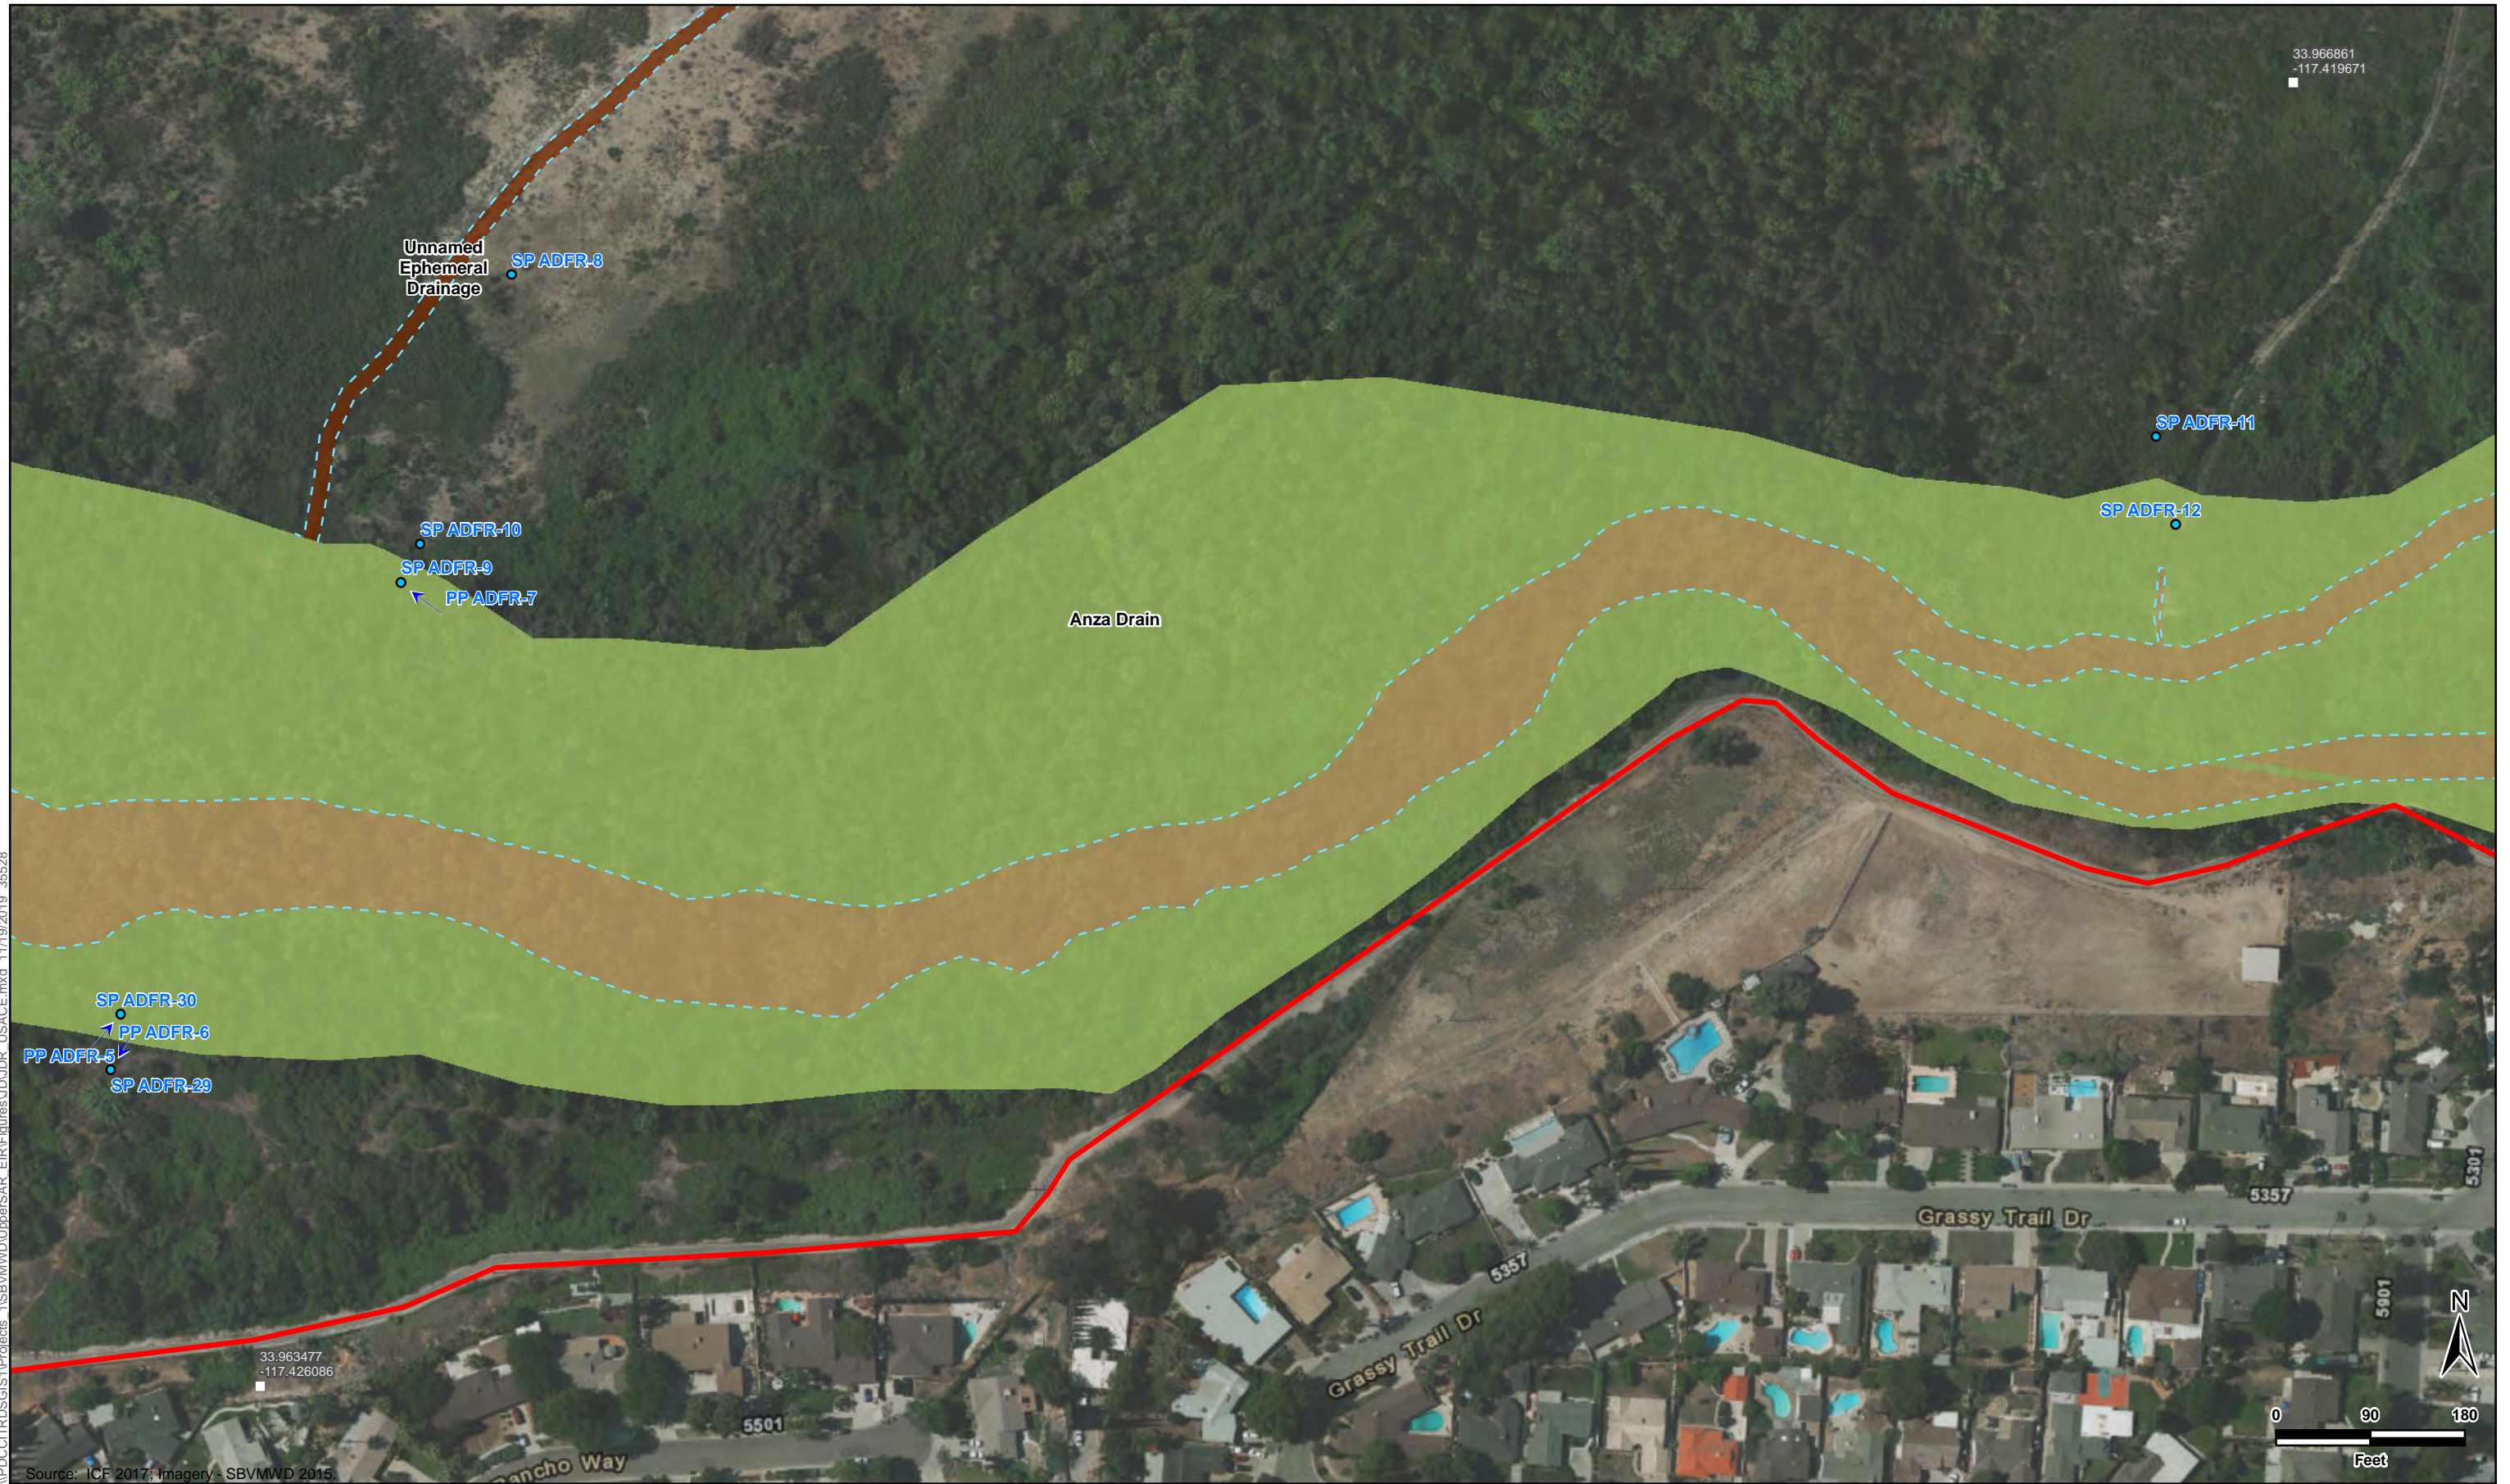
**Figure 5 Sheet 8 Anza Drain and Old Farm Road Site**  
**Jurisdictional Waters of the U.S**  
**Upper Santa Ana River Restoration Project**

Flows originate from a large 20-foot concrete box culvert under the Santa Ana River bike trail (Figures 5 and 8, Sheet 9, and Figure 8, Sheet 9) and a concrete box culvert that enters from the southeast corner of Anza Narrows Park (Figures 5 and 8, Sheet 7). Surface water was present during the survey at the upstream and downstream segments of this drainage. Surface flow is consistently weak from Anza Drain outlet until the middle segment of this drainage, at which point additional groundwater springs help sustain flow and creates more of a single thread perennial channel (Figures 5 and 8, Sheets 8 and 9).

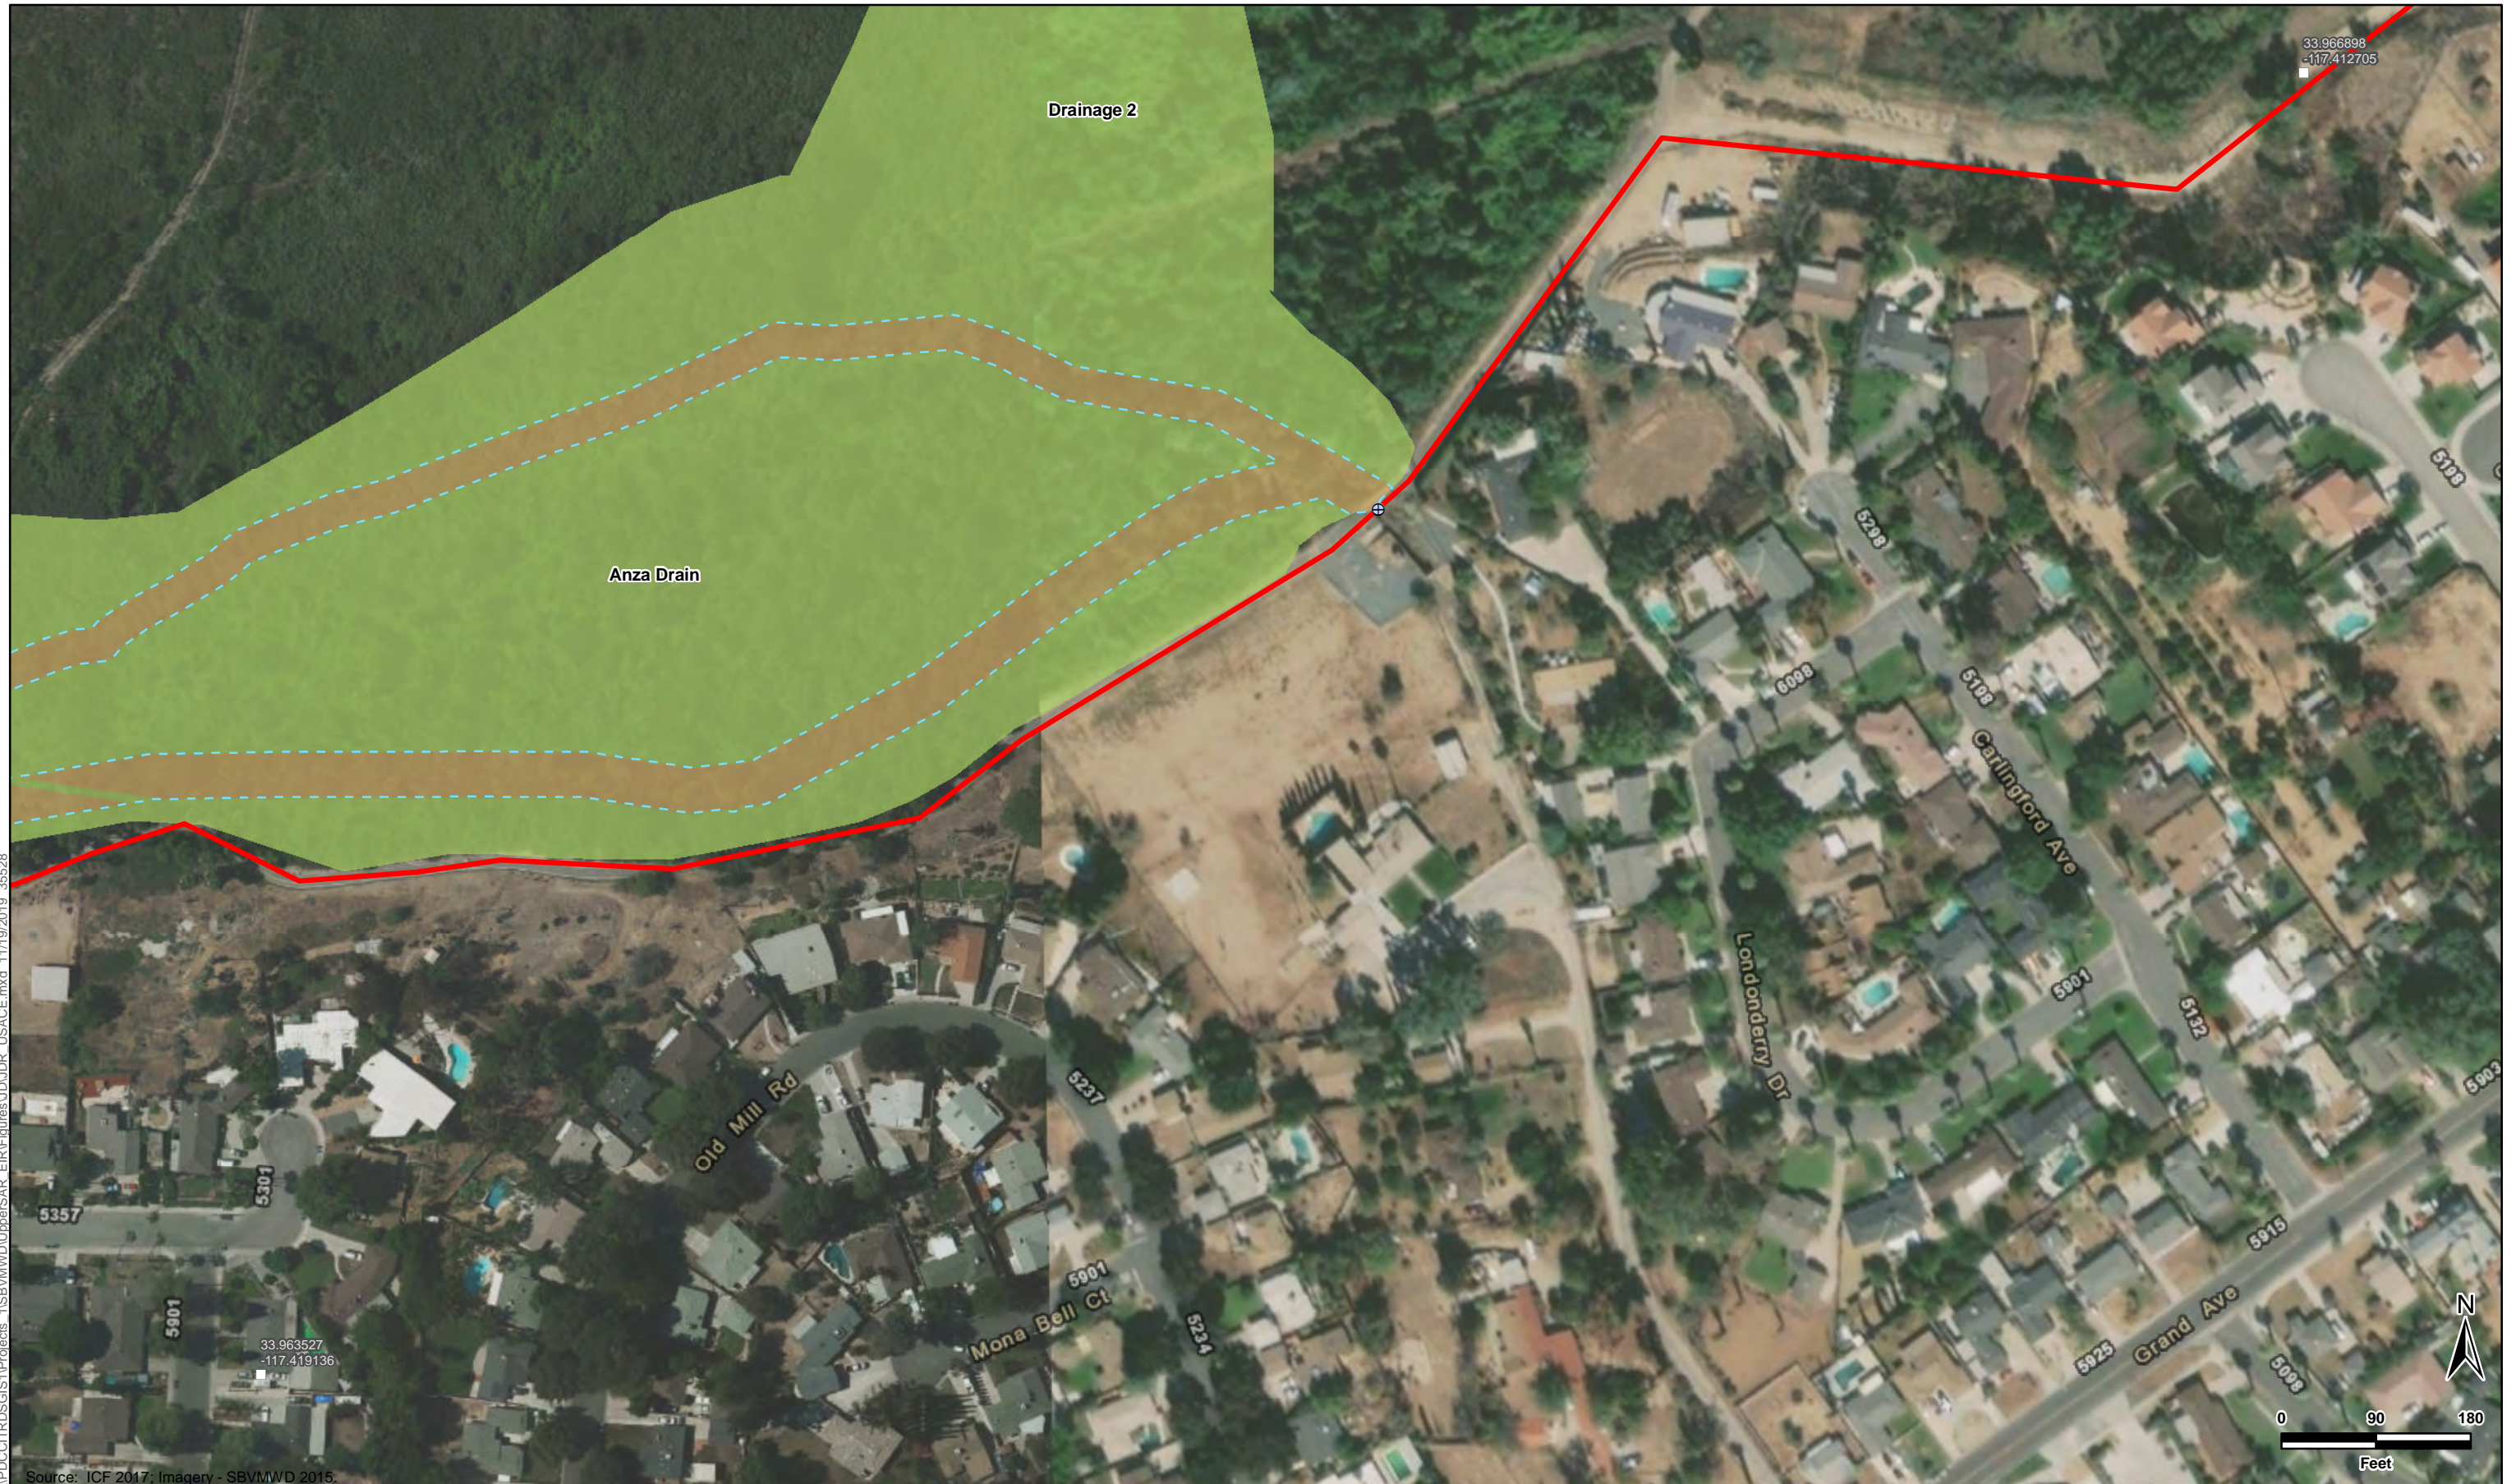
**Figure 5 Sheet 9 Anza Drain and Old Farm Road Site  
Jurisdictional Waters of the U.S  
Upper Santa Ana River Restoration Project**

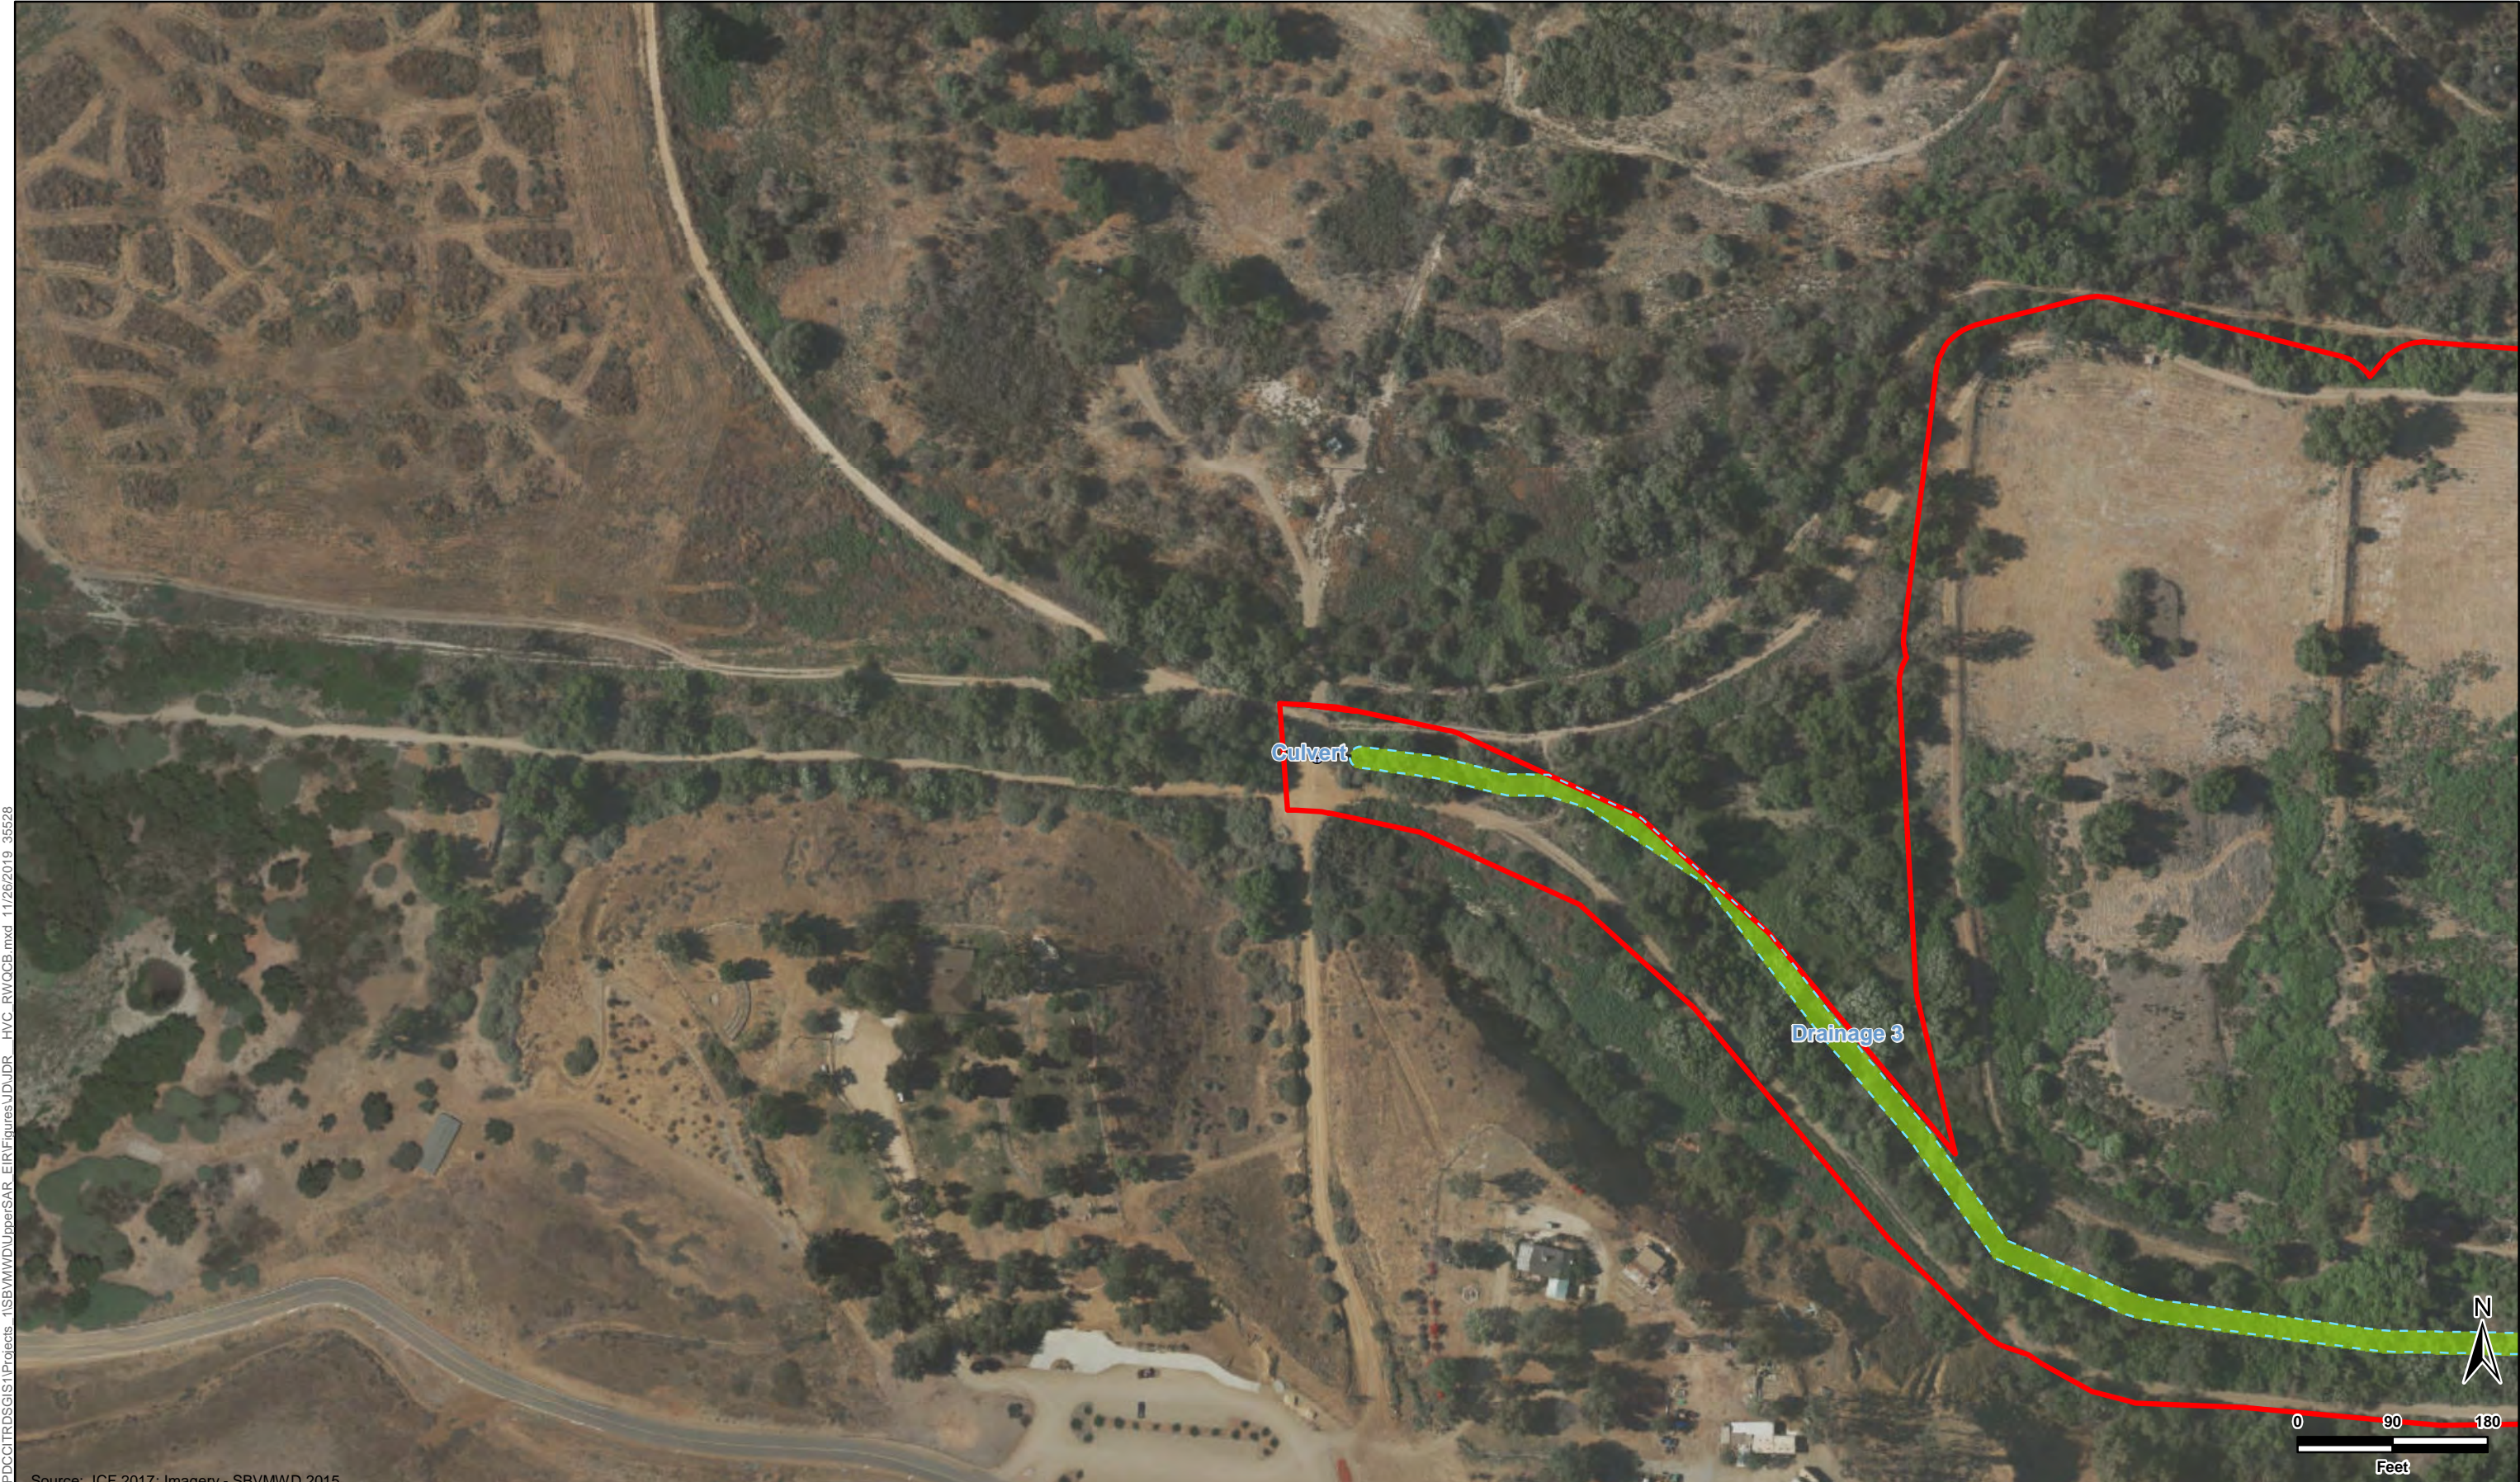
**Figure 6 Sheet 3 Hidden Valley Wetlands Site  
Jurisdictional Waters of the State  
Upper Santa Ana River Restoration Project**

A manmade canal (Drainage 3) runs along the southern project boundaries (Figures 3 and 6, Sheets 3, 4, and 5). Drainage 3 is a canal that was constructed to supply recycled water for the wetland ponds (including Depressions 3 through 6). This channel starts at an outlet where recycled water historically had been diverted into Drainage 3 from Drainage 1. However, following a major storm in 2010, the headworks infrastructure was damaged and water has not been actively pumped within this channel since then (Danelski 2014). Currently, this canal is hydrologically supported by the surrounding hillsides and stormwater runoff from the adjacent trails.

Depressions 3 through 6 are constructed depression pond features located at the western portion of the survey area (Figures 3 and 6, Sheet 3). Analysis of historic aerial imagery indicated that these features were constructed over 40 years ago and actively maintained as ponds until a major storm in 2010. After this storm, the headworks infrastructure was damaged and water has no longer been

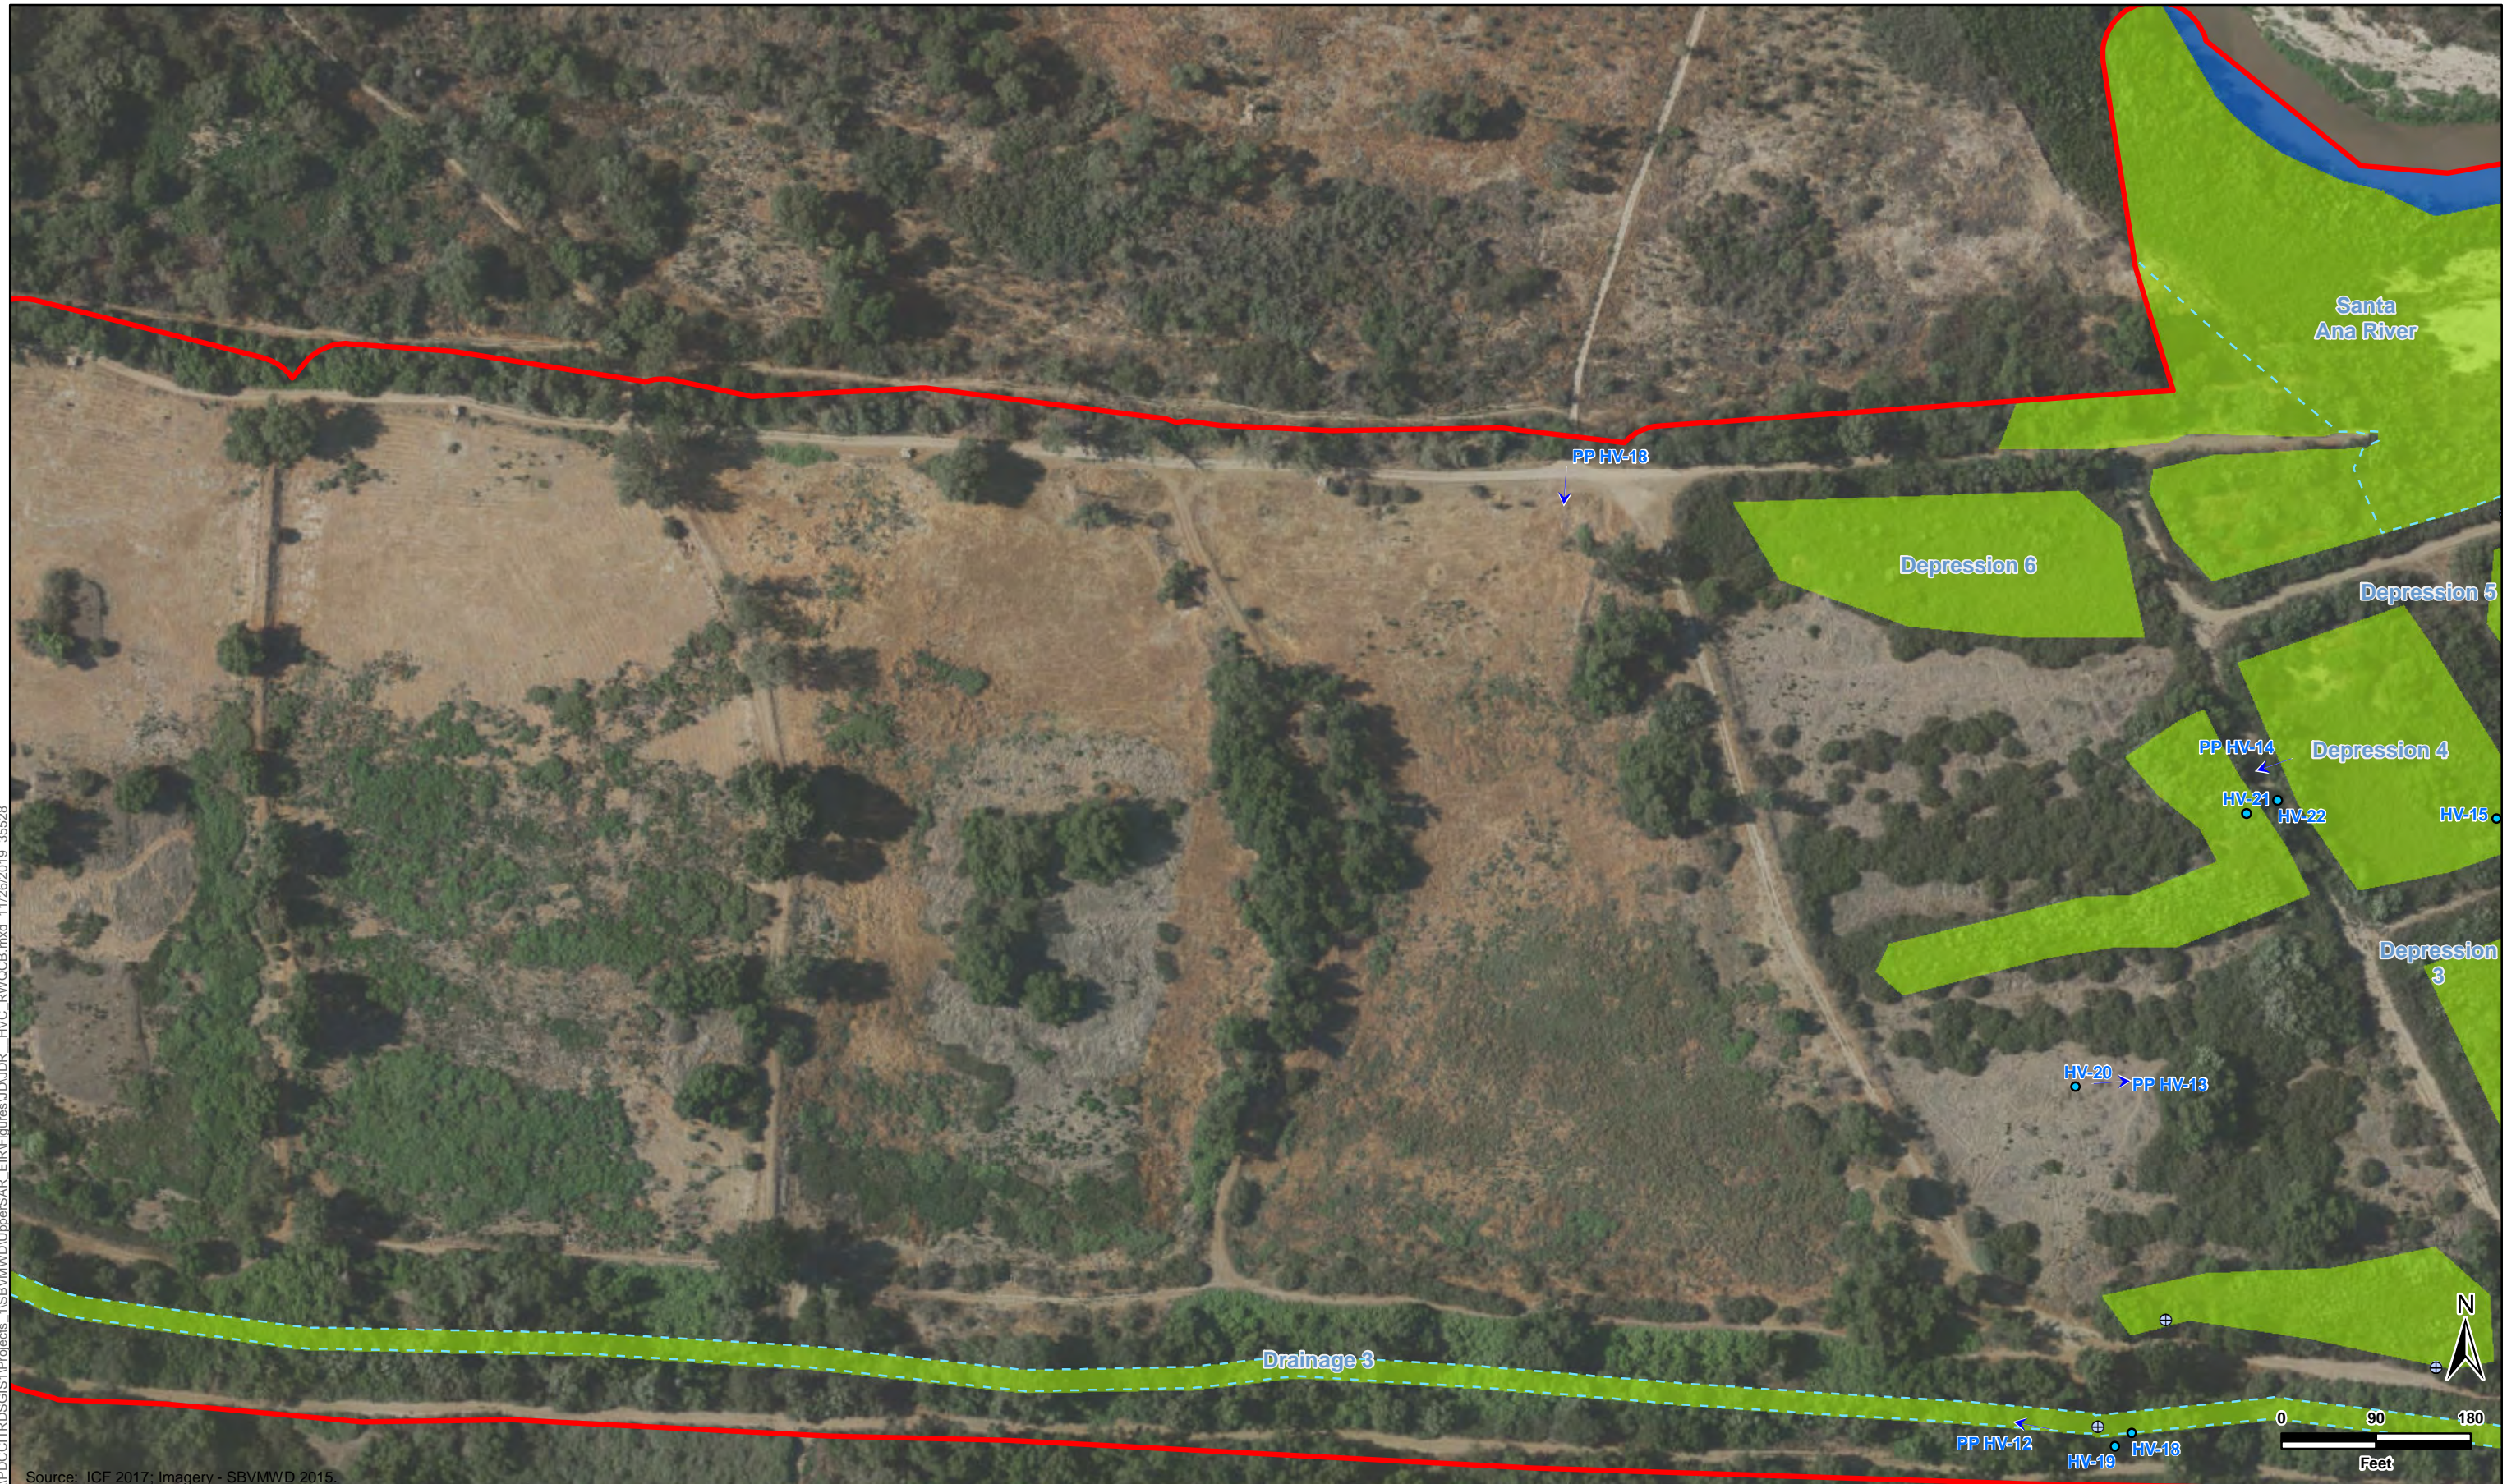
**Figure 6 Sheet 4 Hidden Valley Wetlands Site  
Jurisdictional Waters of the State  
Upper Santa Ana River Restoration Project**

riparian canopy is open. OHWM indicators observed included shelving and sediment sorting. The canal enters a culvert about 1,300 feet west of the headworks (Figures 3 and 6, Sheet 4), then traverses southwest for 1,600 feet, general paralleling the access road, before entering another culvert at the southwestern corner of the site (Figures 3 and 6, Sheet 3). The canal then outlets about 60 feet north of the inlet where it flows northwest until joining the Santa Ana River at the northwestern corner of the site. This downstream segment is a more confined channel compared to the upstream segment and supports wetland habitat and a riparian canopy throughout. The center portion of the drainage that does not support vegetation (low-flow area) is considered CDFW streambed, whereas the majority of this area is considered CDFW riparian.

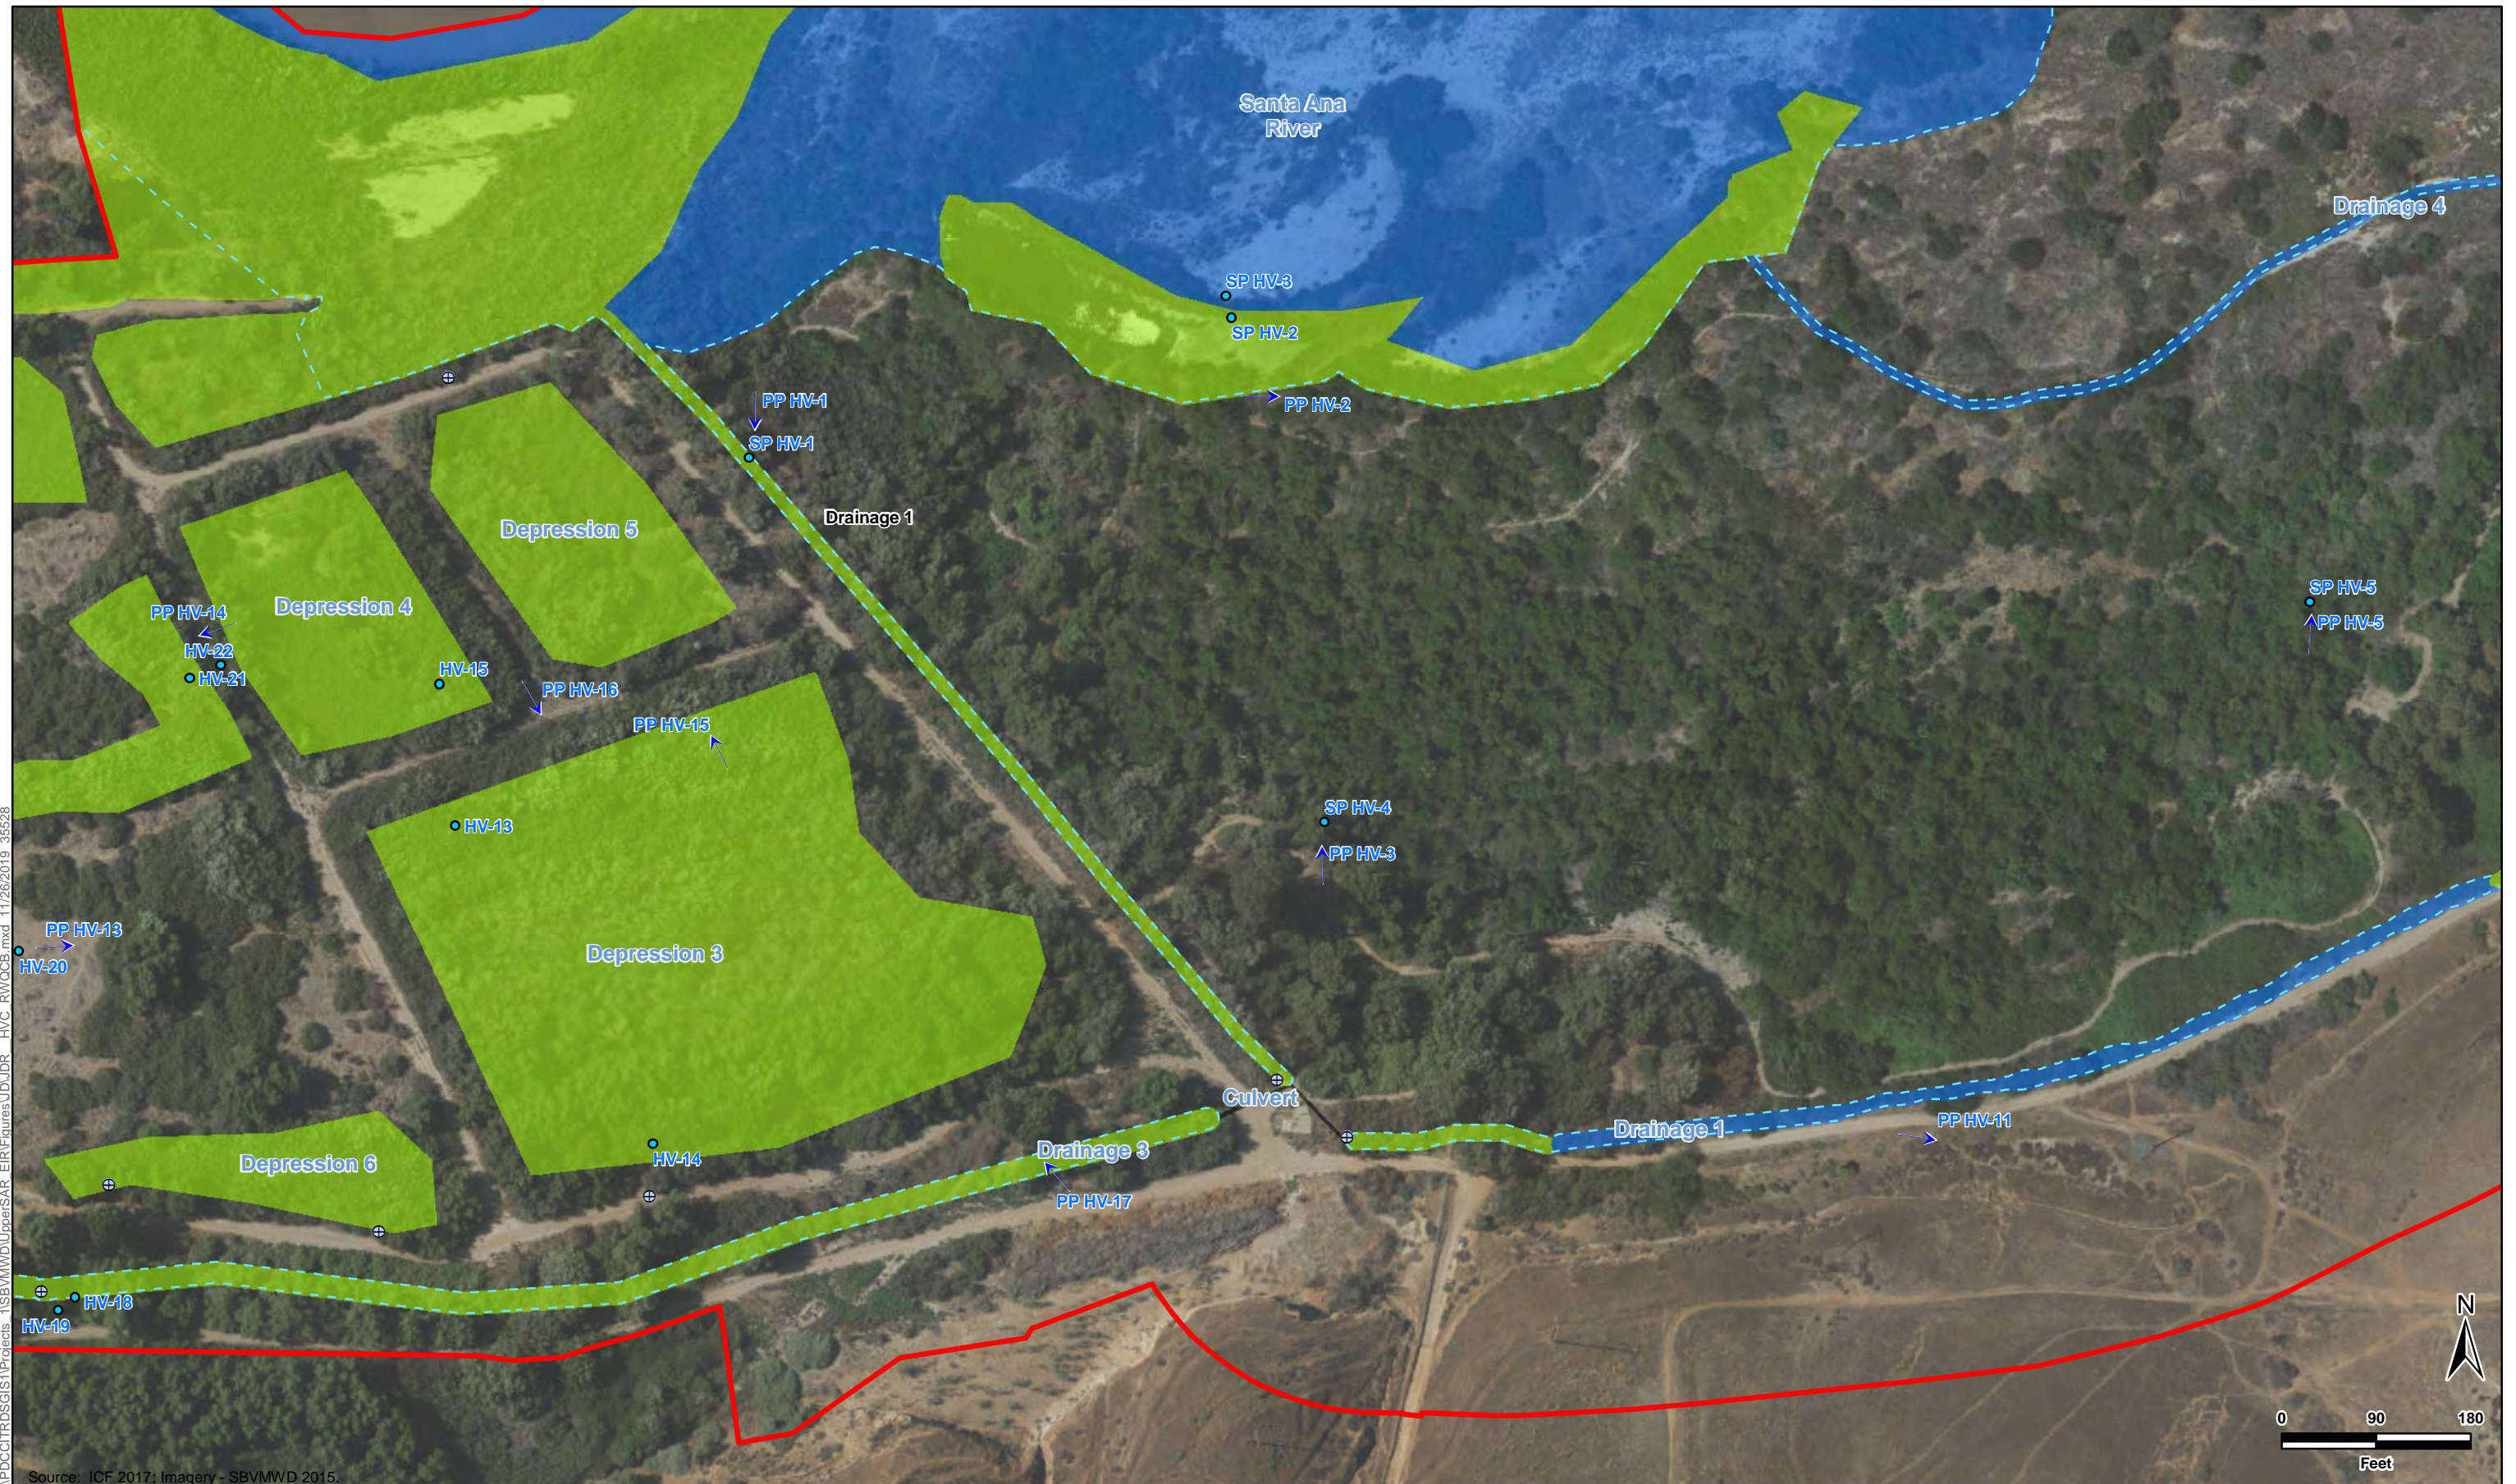
**Figure 6 Sheet 5 Hidden Valley Wetlands Site  
Jurisdictional Waters of the State  
Upper Santa Ana River Restoration Project**
