DATE: April 27, 2026
TO: Scott Watson
Historic Preservation Officer
City of Riverside
SUBJECT: HH&IC PROJECT SOIS ANALYSIS - HARADA HOUSE

SUBJECT: HH&IC PROJECT DESIGN CONSULTATION - HARADA HOUSE ACCESSIBILITY

SUBJECT: HH&IC PROJECT DESIGN CONSULTATION - HARADA HOUSE EXTERIOR DOORS AND BUG SCREENS

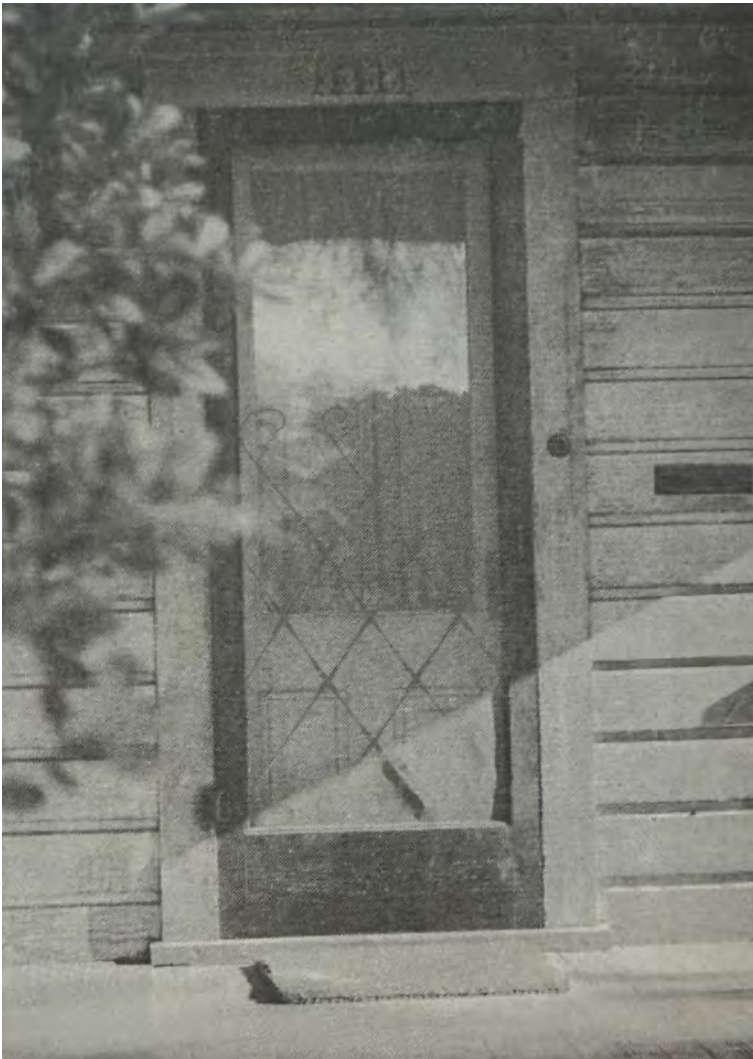
Original Front Main Entry Screen Door (Rawitsch 2012:282)

Related Features	To the right of the entry, an extant historic metal doorbell is installed in the door casing and a historic copper alloy mail slot with hinged flap formerly installed through the west wall is missing.
Recommendation	The historic door and hardware should be repaired/restored as needed. The modern screen should be replaced with a salvaged, matching historic screen and hardware (preference) or a new, custom constructed screen that closely matches the original Harada House screen door and salvaged

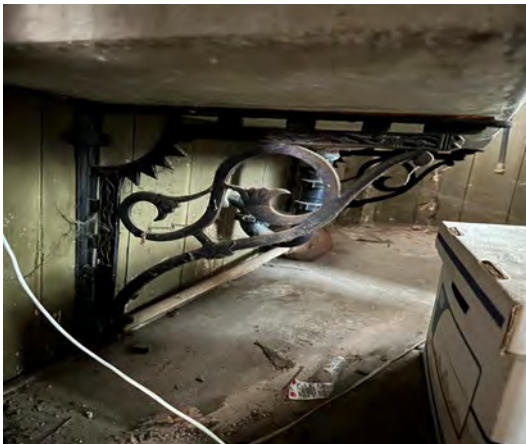
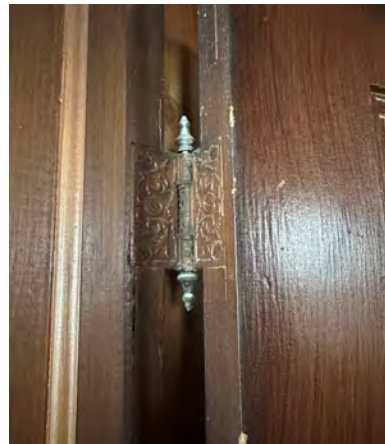
Harada House Botanical Designs in Metalwork

Where designs in metal are less confined, angular or spreading, botanical motifs tend to dominate, such as seen in the Harada House laundry tub brackets, although botanical design can be present in the smallest of square and rectangular metal hardware, such as is seen in the at least one pair of Harada House door hinges:

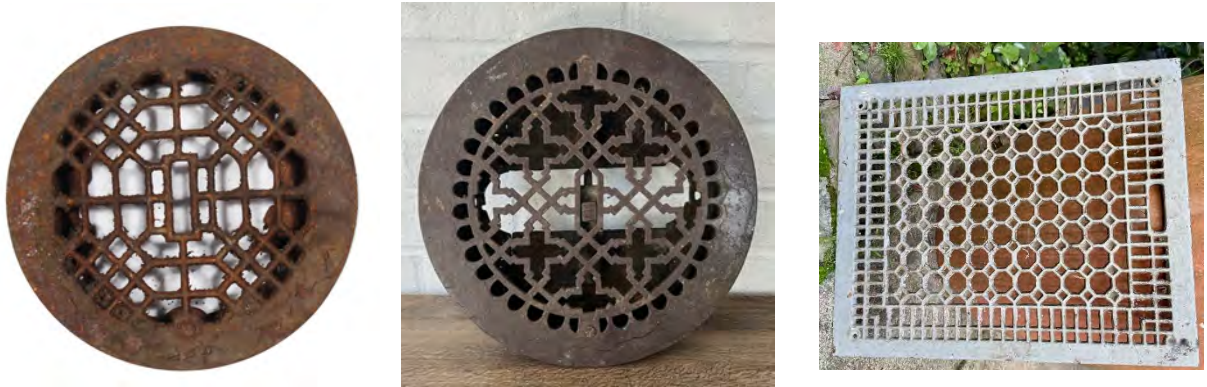
Cast iron late-Victorian round wall vents and 1890s Victorian Furnace vent grate cast iron

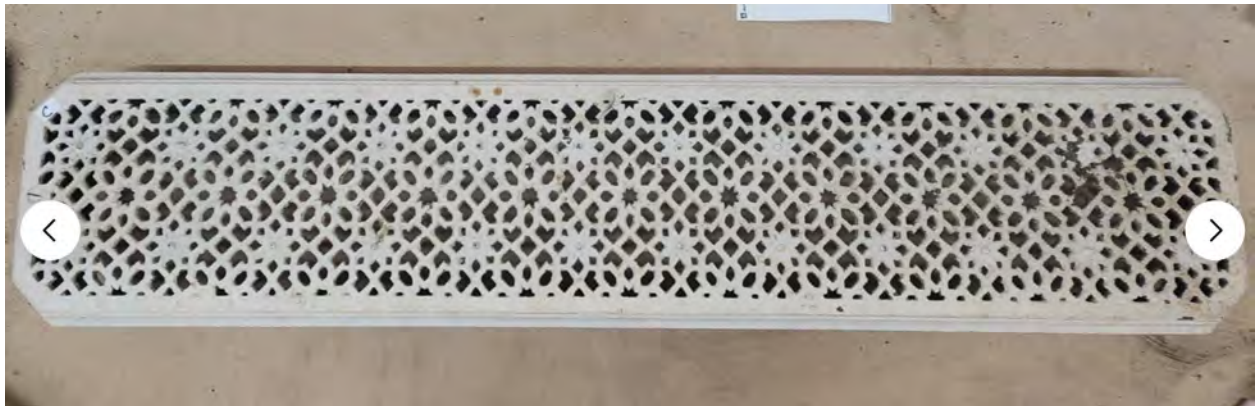
1890 Victorian Era Radiator Grate Cast Iron

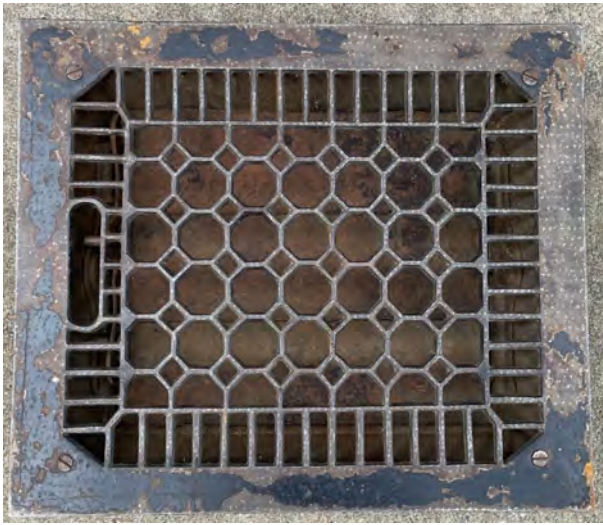
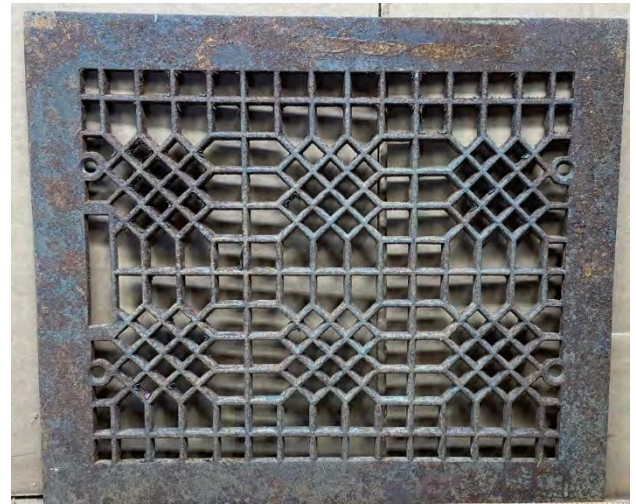
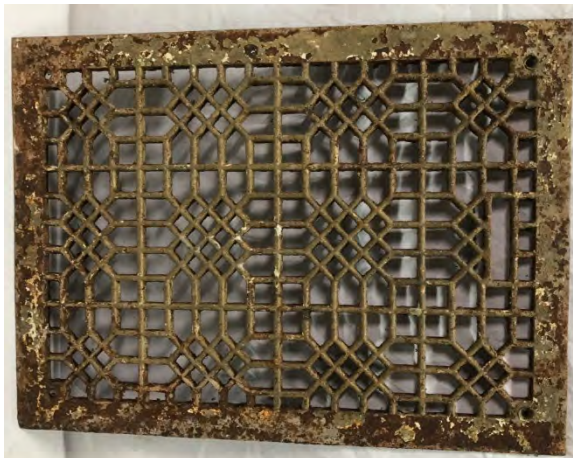
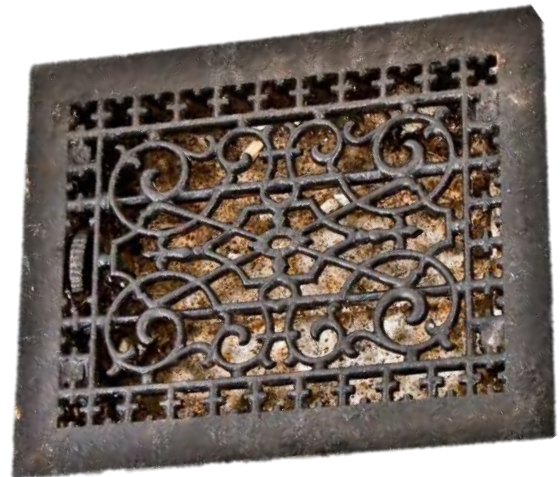
Early 1900s cast iron cold air return floor grates

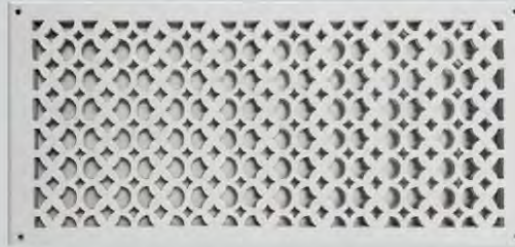
Air Return Grill:
Size 9"x20"

Model:
VR-100

Metal:
Cast Aluminum & Cast Iron

Available Colors:
Black, Brown & White

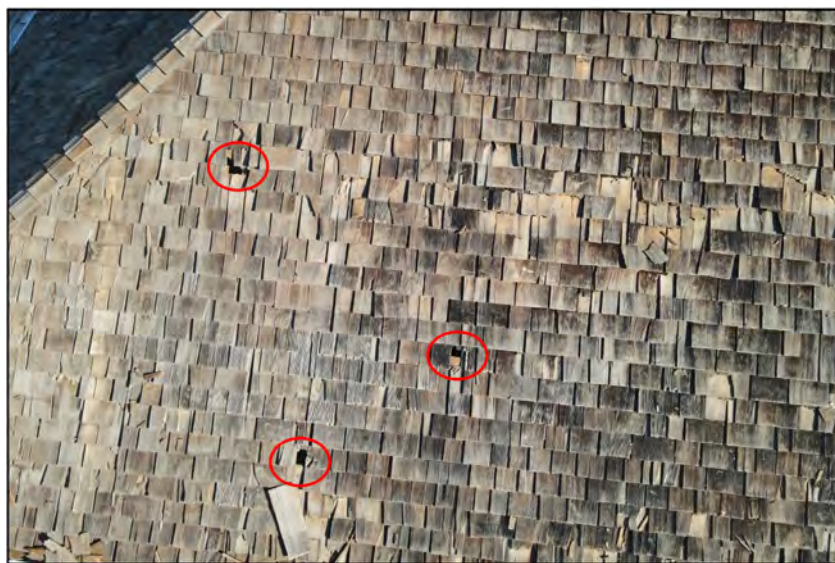
Harada House Main Roof South (ISA Site Analysis: Harada House Phase I)

A cost estimate under the previous team provided for “fire-treated wood shingle,” suggesting this was the preferred or recommended material specification. JMRC concurs with the use of natural wood as the most authentic and historically appropriate material and aesthetic. In further examining earlier photos of the roof, it appears the original roofing material is most likely hand split wood shake rather than wood shingle, the difference being greater thickness, dimension, texture and irregularity with shake. Further, the rustic patina developed over the natural weathering process indicates that the species is cedar, which first fades the surface to a silvery gray due to ultraviolet exposure then deepens to a darker gray over time due to the effects of microfungi and moisture.

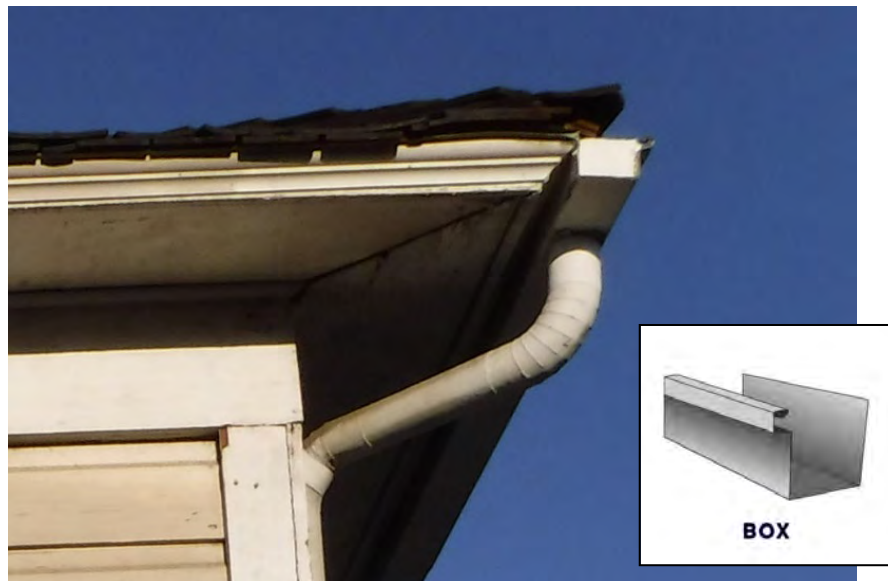
Existing Harada House Gutters and ca. 1960s-1970s Box Type Gutters (inset)

Existing installed gutters were replicated in 2006 from then-extant, simple ca. 1960s-1970s box gutters; no gutters are extant on the rear.

The basic box type (in general, K-style) that we use today, and the one on the Harada House now, are similar to the historic box ones integrated into roof/cornice but began being hung from the eaves in the mid-1940s at the very earliest and became common by 1960, or no earlier than mid-1950s. Photo evidence in Rawitsch 2012 show this gutter type was installed by 1976; it was these gutters that likely replaced the first 1916-1930s iteration of hanging eave trough gutters. This later aesthetic also appears to have been the prototype for the 2006 replication effort.

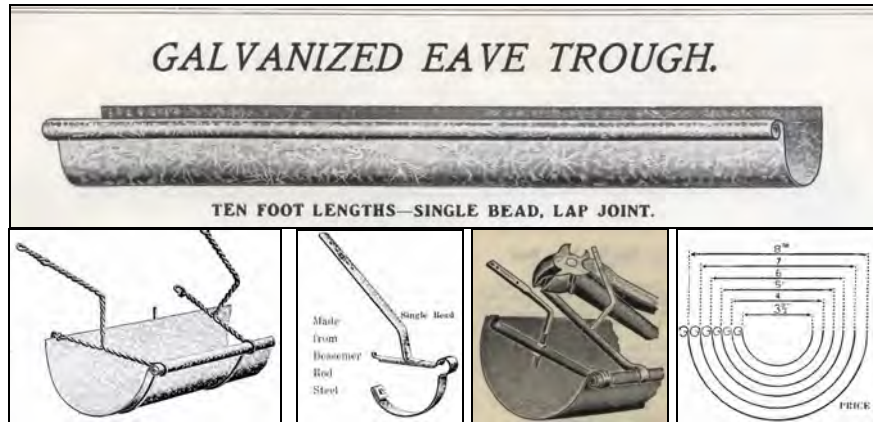
Hanging Half-Round Eave Troughs Available in 1905 and 1924

Given the time period, the type of gutters manufactured and commercially available, and the house's cornice line style, early gutters installed on the Harada House would have been one of two types: box gutter or eave trough. The more decorative box gutters were integrated with the roof structure and part of the roof edge/cornice line trim architecture with no visible hangers. The half-round eave trough utilized a visible, heavy-gauge twisted wire or curved bracket attachment to hang from the eave edge.

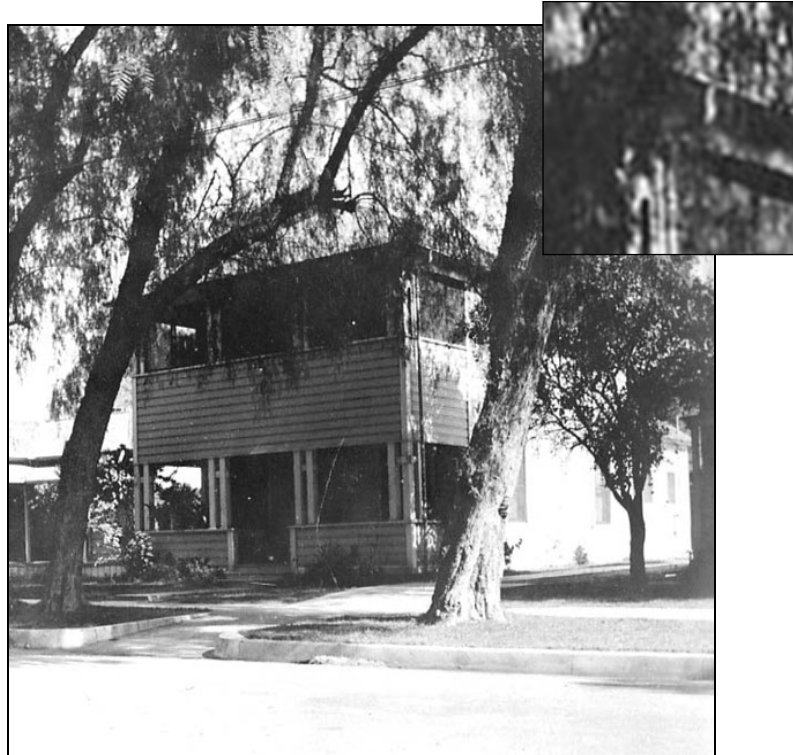
Harada House ca. 1932 Showing Eave Trough Gutters

It is unlikely the Harada House had gutters originally as they are not visible in the newspaper photograph of the one-story house form. The contract for the second story addition commissioned by the Harada family in 1916 was not available for review; however, gutters were installed by ca. 1932. Closer examination of the ca. 1932 historic photo reveals that these ca. 1916-1932 gutters were the hanging eave trough type. Copper gutters and downspouts would have been out of place on such a modest home, suggesting these were likely galvanized iron or steel, tin, lead plated copper, or terne (tin/lead) and painted or unpainted.
