Attachment 2  
**Photo Log**

# Hidden Valley Wetlands Site Photo Points

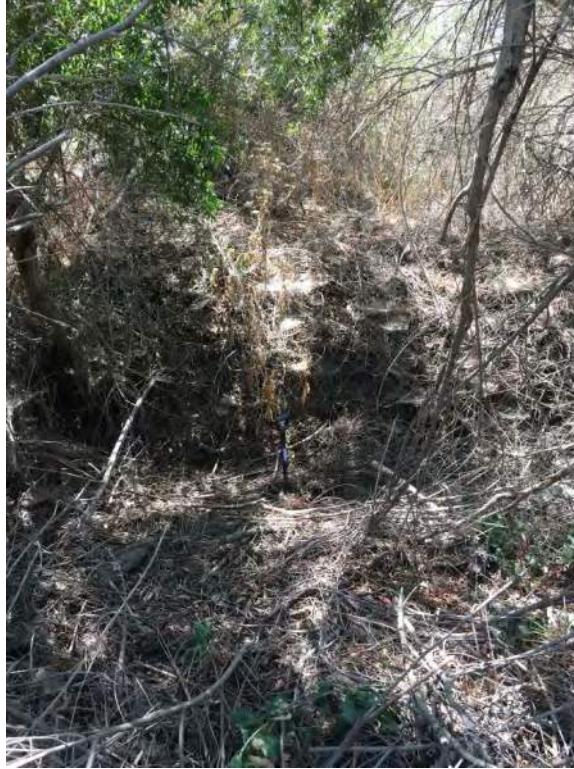
**Photo Point  
"PP HV-1"**

Description:  
Taken at sample pit "SP  
HV-1," in pit. Wetland  
within OHWM of  
Drainage 1, near project  
site eastern boundary.

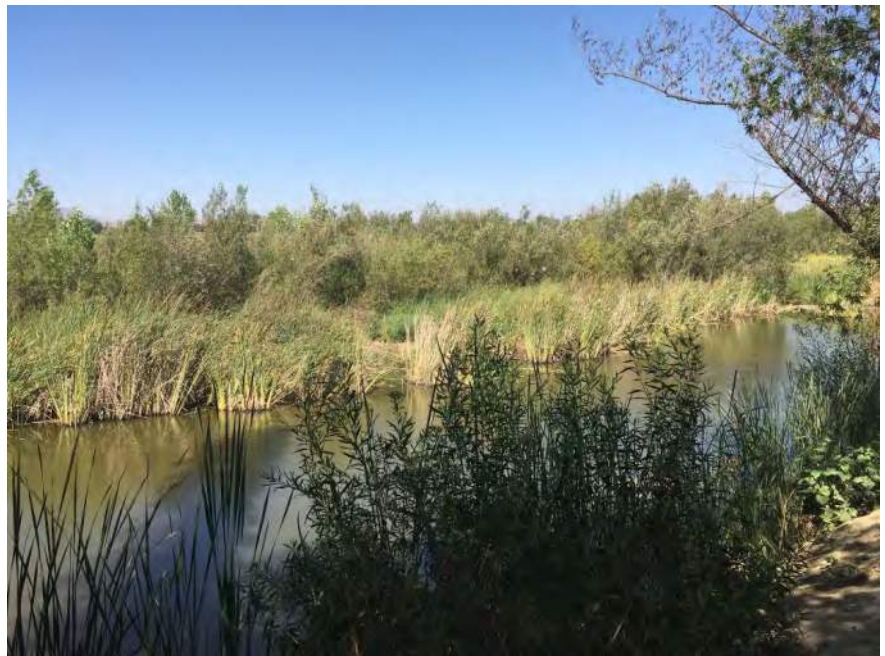
**Photo Point  
"PP HV-2"**

Description:  
Fringing wetland at  
Depression 2, from  
southwest bank.

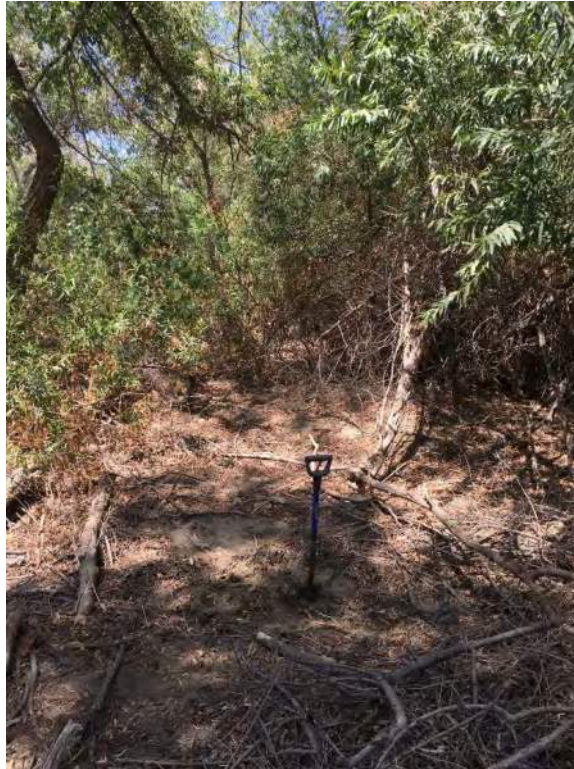
**Photo Point  
"PP HV-3"**

Description:  
Taken at sample pit "SP HV-4," out pit, in densely forested area, north of Drainage 1. Confirmation that it did not meet three-parameter wetland. CDFW riparian.

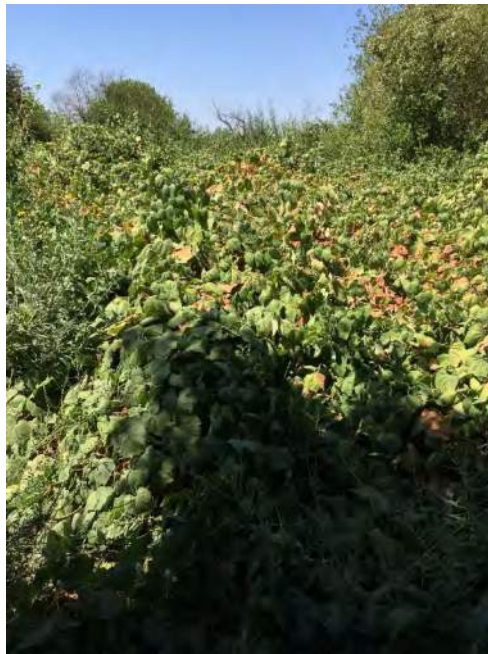
**Photo Point  
"PP HV-4"**

Description:  
Outside of Waters of the U.S. (including wetlands). CDFW riparian area dominated by wild grape.

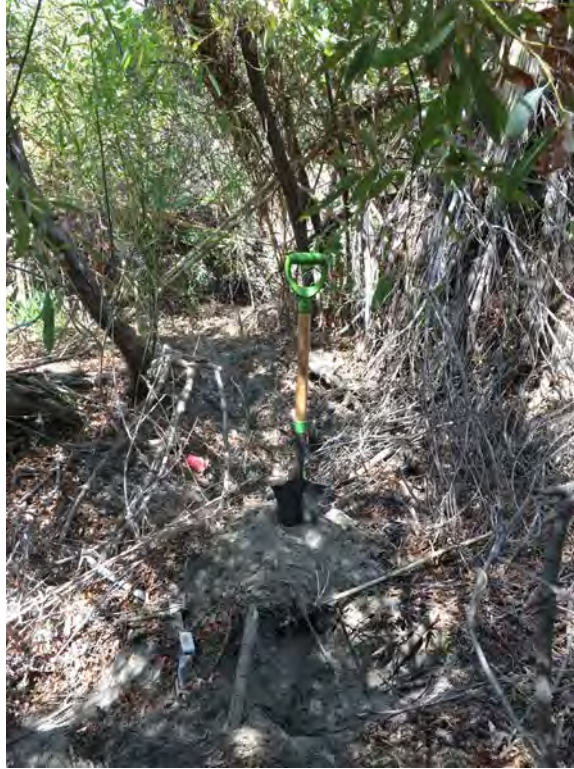
**Photo Point  
"PP HV-5"**

Description:  
Taken at sample pit "SP  
HV-31," out pit.

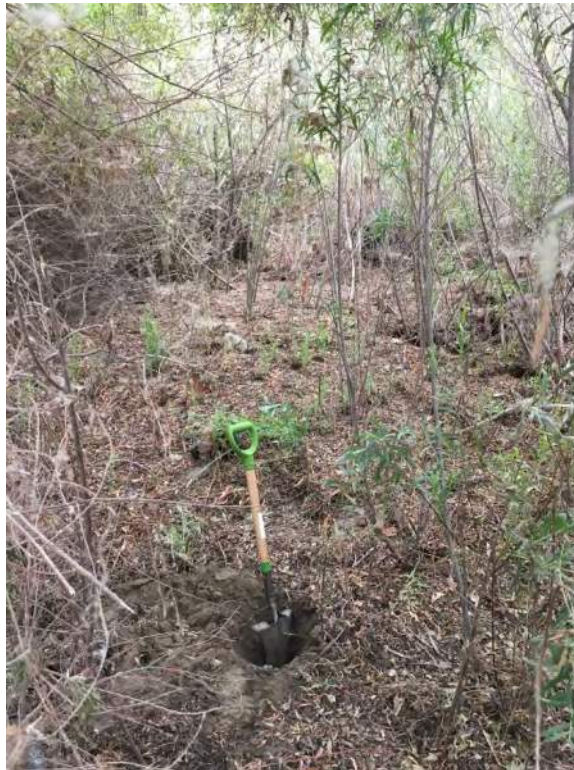
**Photo Point  
"PP HV-6"**

Description:  
Taken at sample pit "SP  
HV-6," in pit. Wetland  
within OHWM of  
upstream segment of  
Drainage 1, along  
southern project site  
boundary.

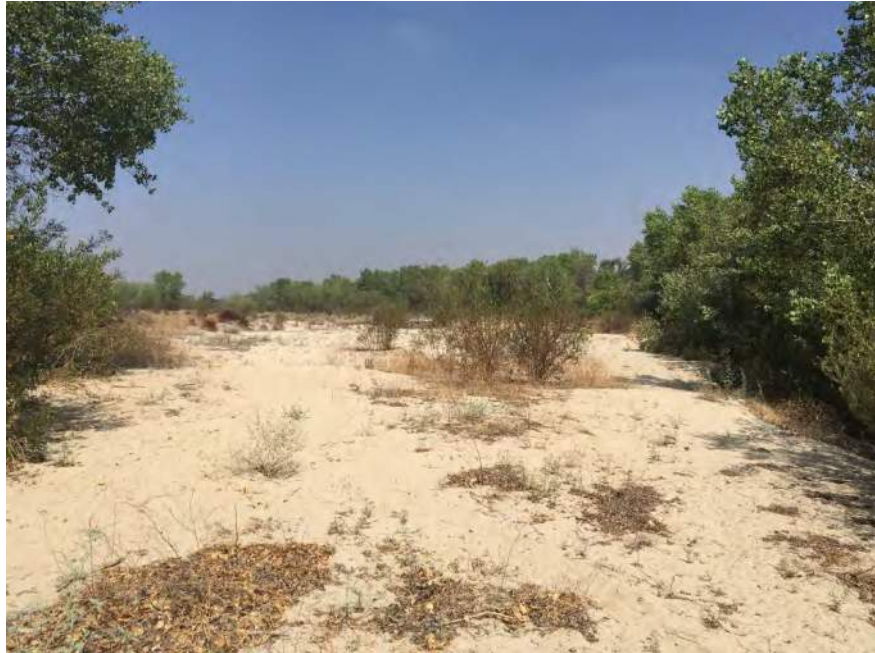
**Photo Point  
"PP HV-7"**

Description:  
Looking across open sandy terrace where Santa Ana River formerly flowed. Although wrack was observed, it was determined to be a relic of when the river flowed within this area.

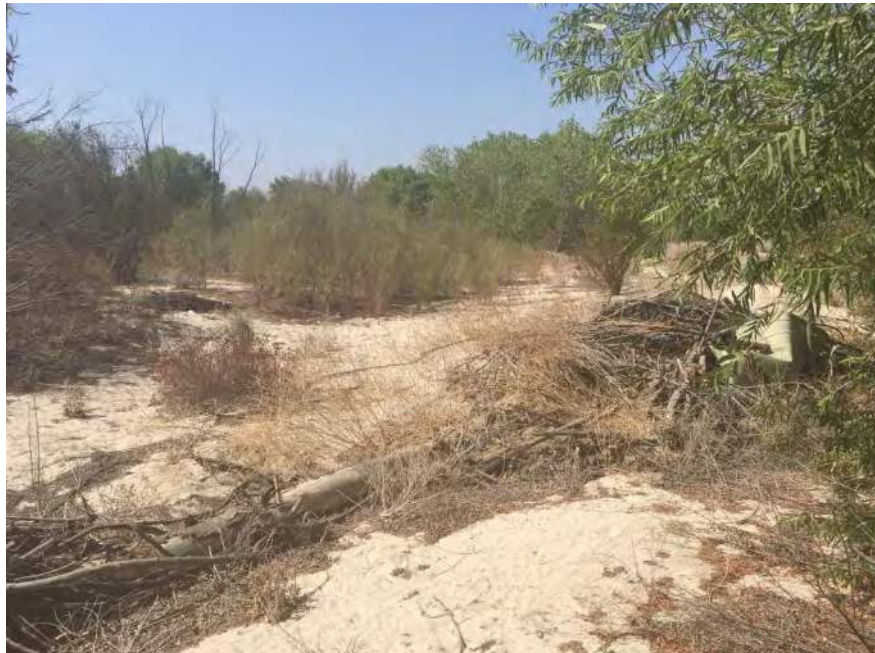
**Photo Point  
"PP HV-8"**

Description:  
Looking across open sandy terrace at lower elevation than photo point #1.

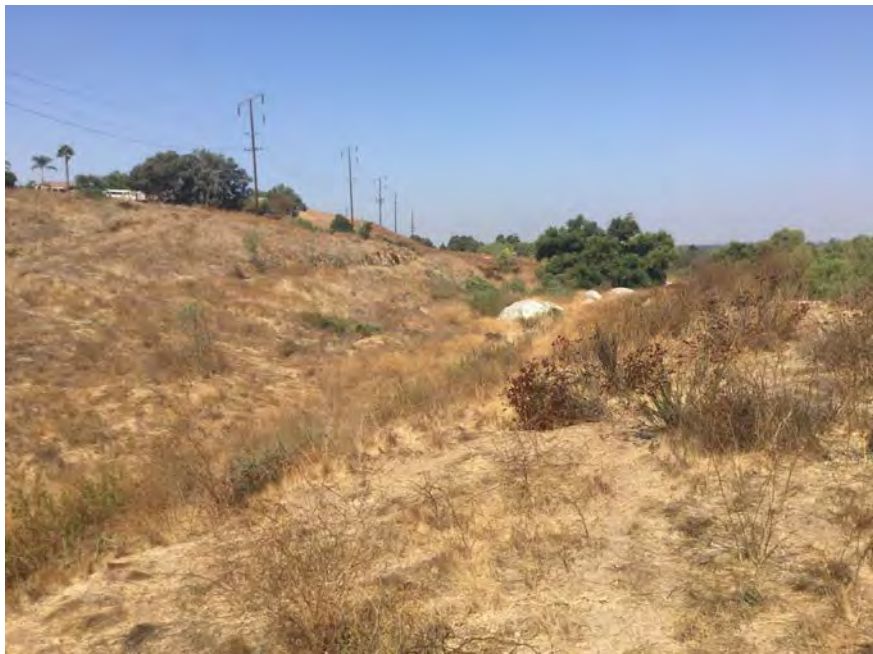
**Photo Point  
"PP HV-10"**

Description:  
Facing downstream of  
Drainage 2, a  
nonwetland tributary to  
the Santa Ana River.

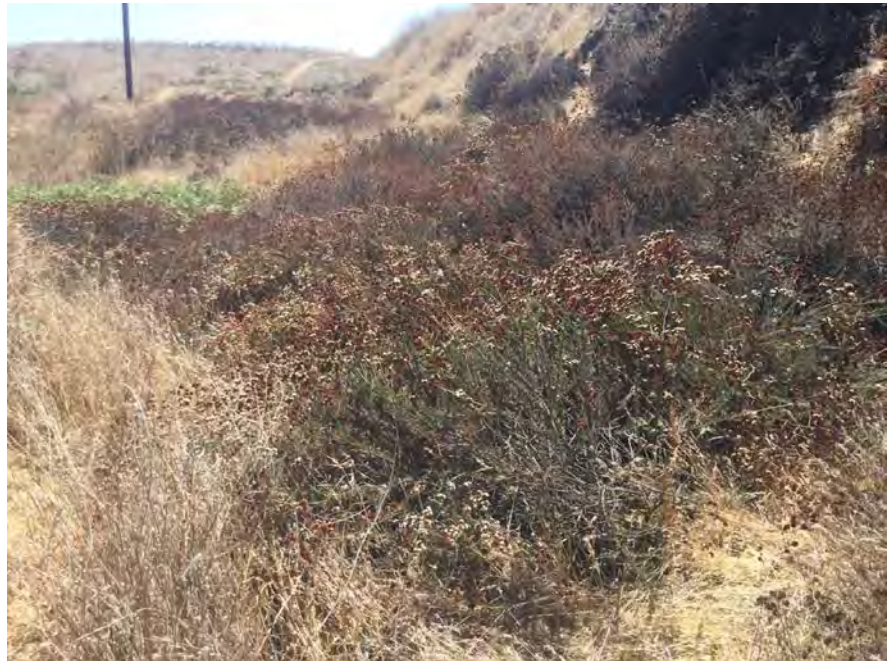
**Photo Point  
"PP HV-11"**

Description:  
Photo of downstream  
portion of erosional  
feature. As this feature  
enters the survey area,  
there no longer is a  
definable feature.

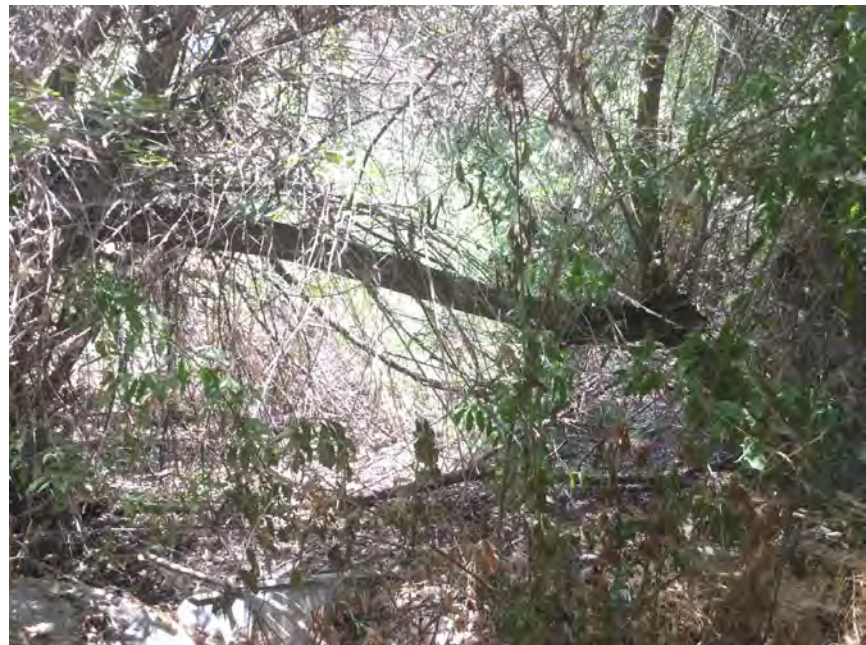
**Photo Point  
"PP HV-12"**

Description:  
View of Drainage 3 that  
supports wetlands  
throughout the center of  
the drainage. Tributary  
to the Santa Ana River.

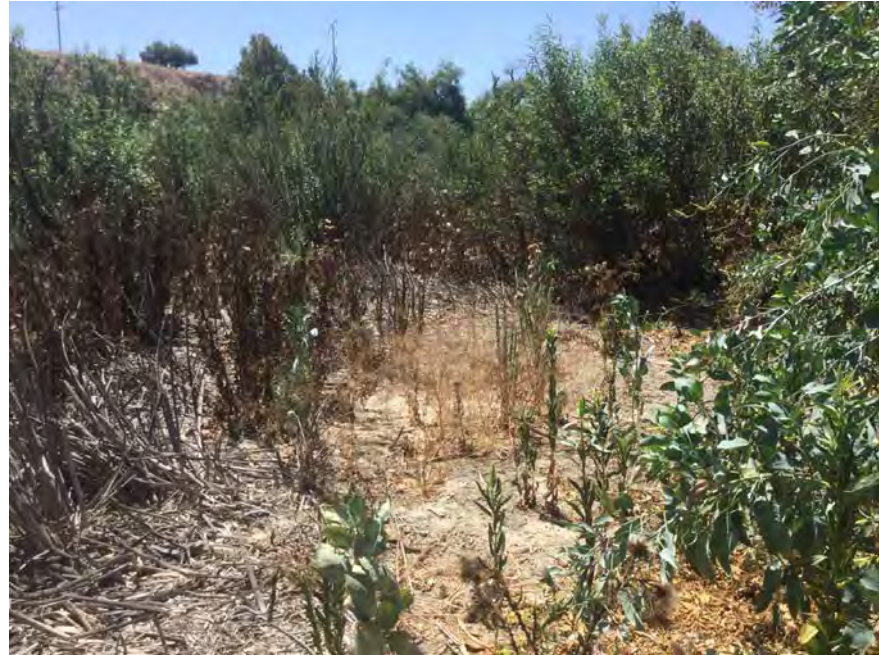
**Photo Point  
"PP HV-13"**

Description:  
View of portion of old  
pond area that is now  
reverting back to upland  
habitat.

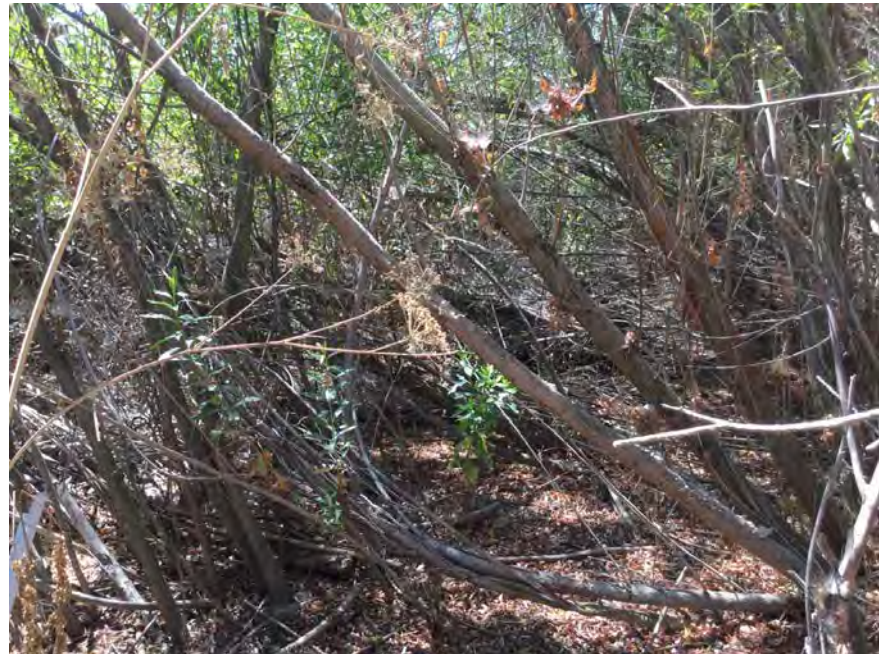
**Photo Point  
"PP HV-14"**

Description:  
View of old pond area  
that received trail  
stormwater runoff and  
may support more  
groundwater to allow  
the area to continue to  
support wetland  
vegetation.

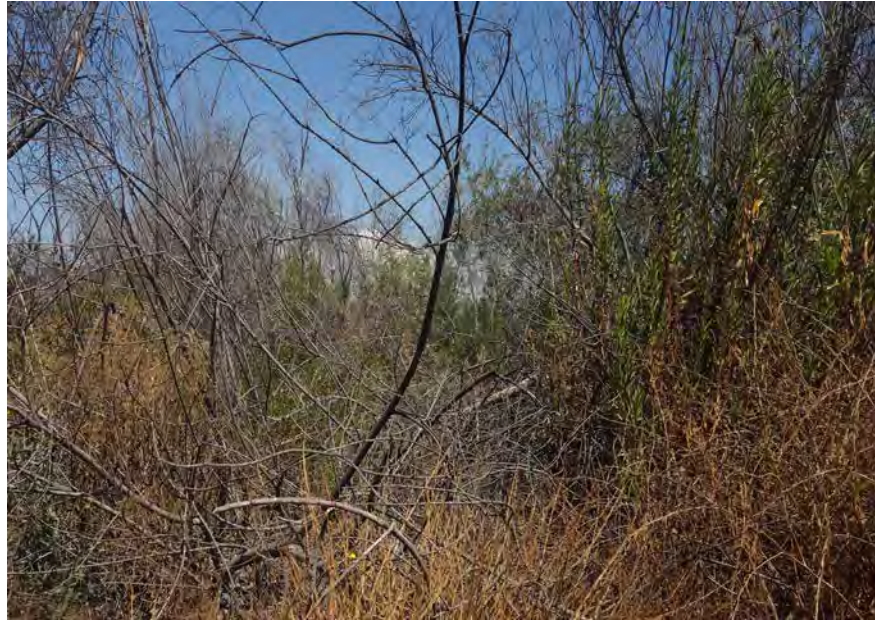
**Photo Point  
"PP HV-15"**

Description:  
View of one of the pond areas that still support wetland vegetation. Near the center of the pond, mulefat is dying off.

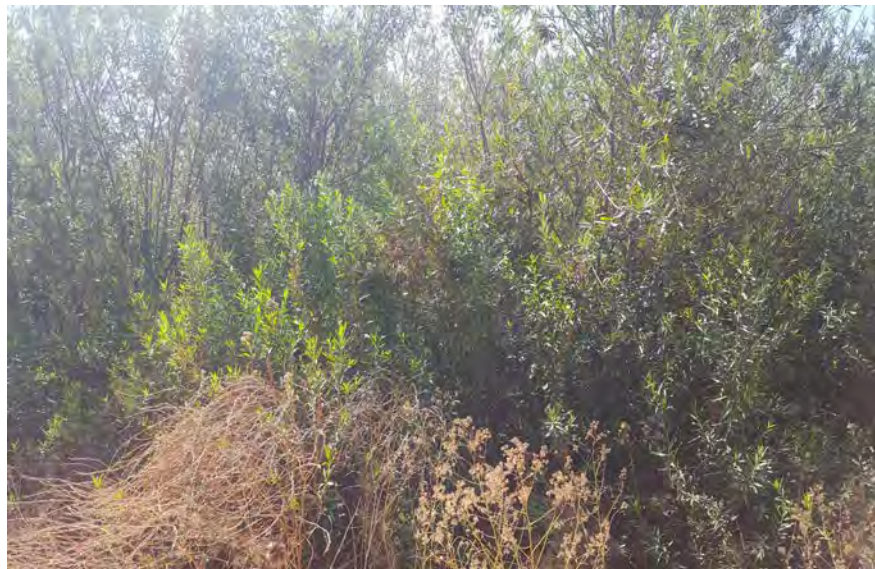
**Photo Point  
"PP HV-16"**

Description:  
View of the largest pond that still supports wetland vegetation. Near the center of the pond, mulefat is dying off.

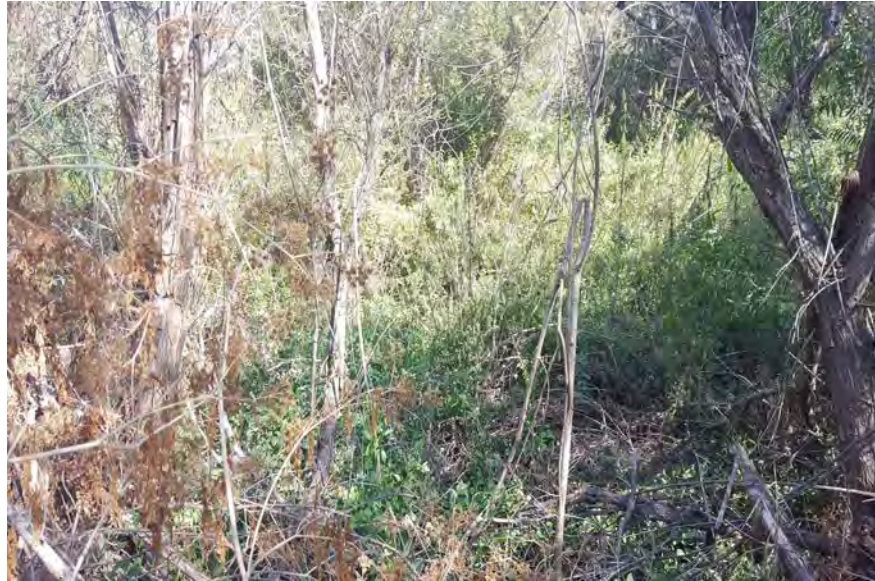
**Photo Point  
"PP HV-17"**

Description:  
View of the largest pond that still supports wetland vegetation. Near the center of the pond, mulefat is dying off.

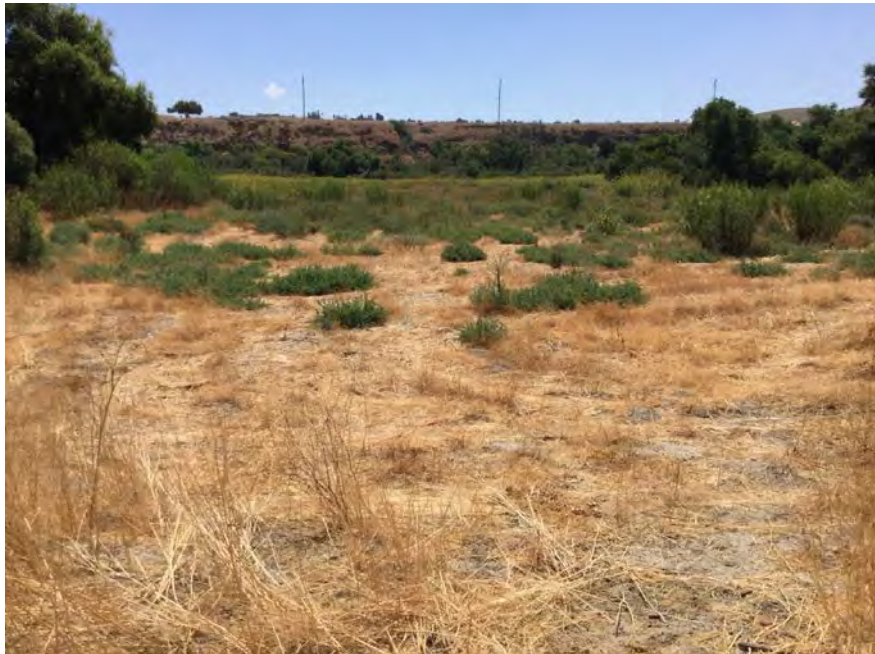
**Photo Point  
"PP HV-18"**

Description:  
View of one of the older pond areas that no longer supports wetland habitat.

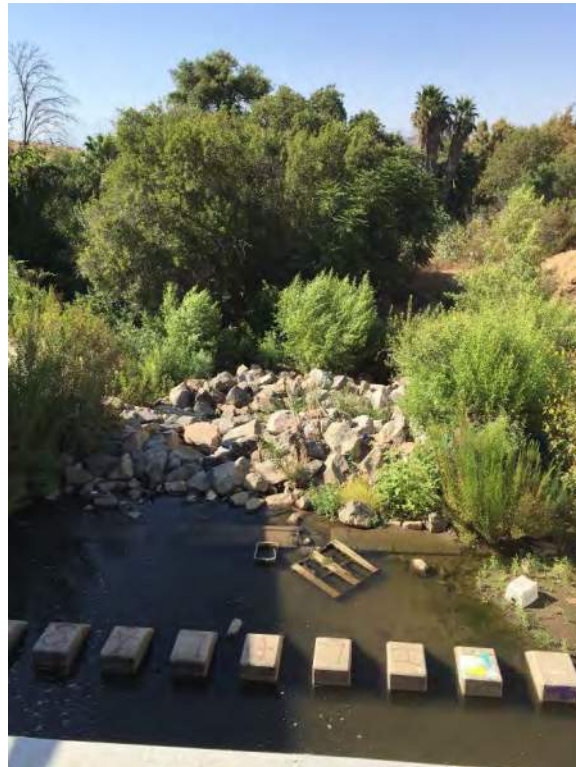
**Photo Point  
"PP HC-6"**

Description:  
Looking downstream of  
Lower Hole Creek at  
dragon's teeth structure  
from Jurupa Avenue  
culvert.

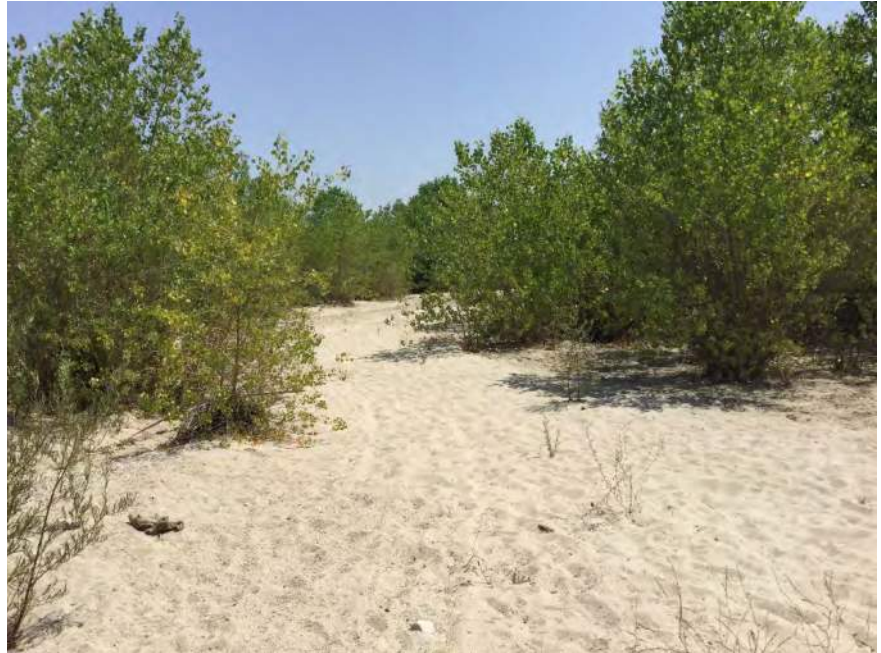
**Photo Point  
"PP ADFR-1"**

Description:  
Within OHWM of Santa Ana  
River near western project  
site boundary.

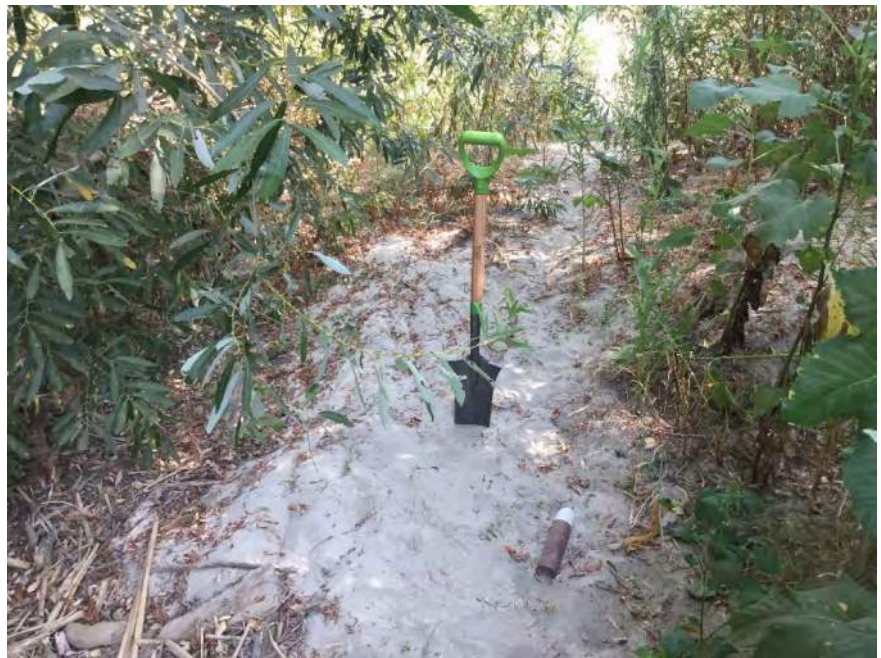
**Photo Point  
"PP ADFR-2"**

Description:  
Taken at sample pit "SP  
ADFR-32," in pit. USACE  
wetland, within OHWM of  
Santa Ana River.

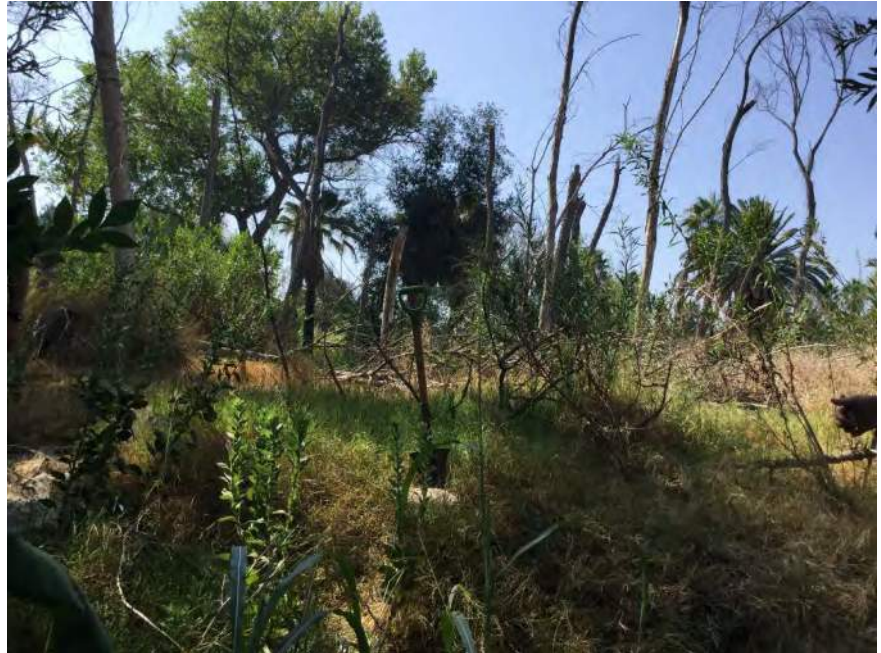
**Photo Point  
"PP ADFR-3"**

Description:  
Taken at sample pit "SP  
ADFR-33," out pit. Upland,  
outside OHWM of Santa  
Ana River, looking toward  
densely vegetated forest.

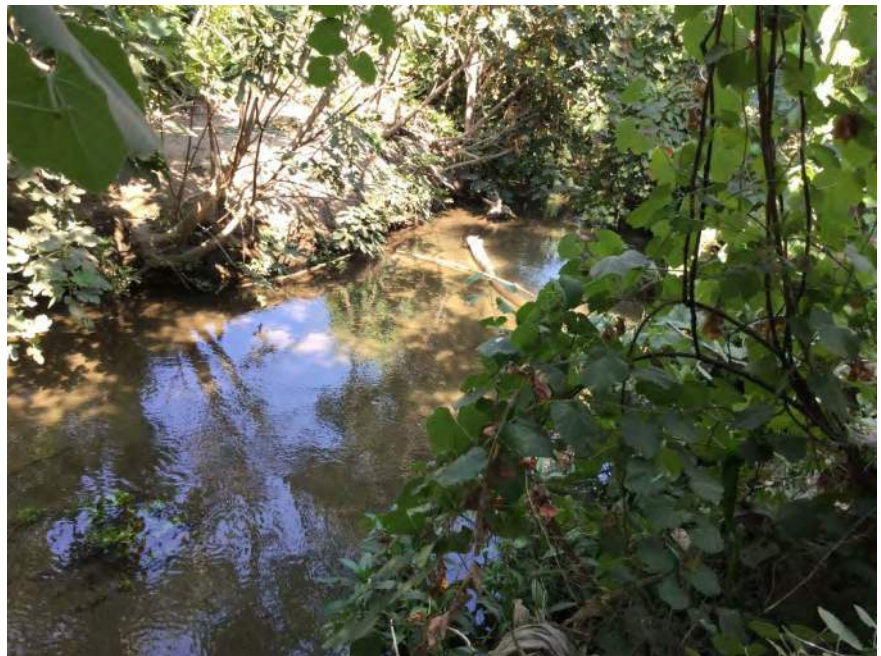
**Photo Point  
"PP ADFR-4"**

Description:  
Taken from sample pit "SP  
ADFR-6." Looking  
downstream along Anza  
Drain.

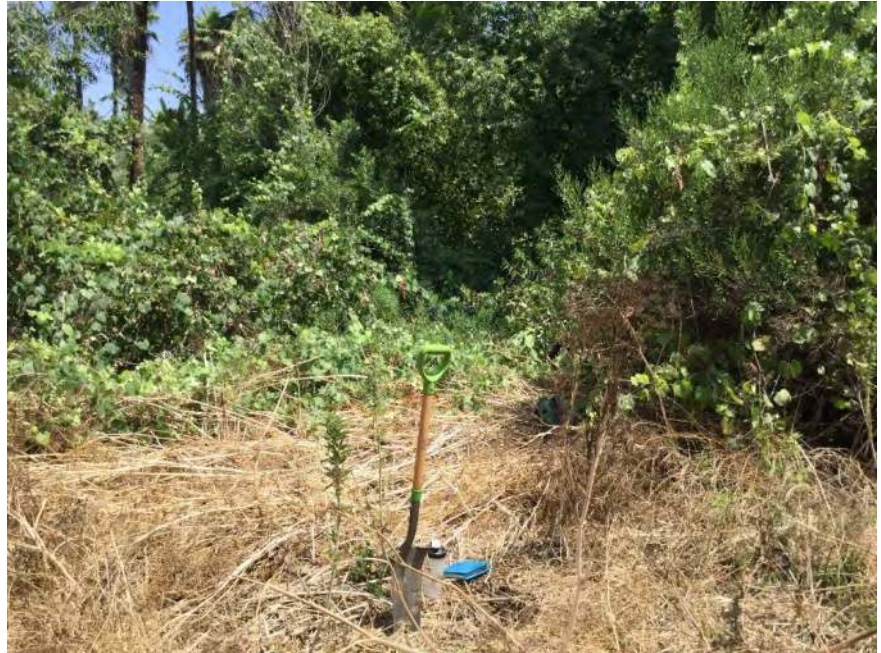
**Photo Point  
"PP ADFR-5"**

Description:  
Sample point "SP ADFR-29,"  
upland pit, looking toward  
heavily forested area. Large  
drop in elevation occurs at  
the forested areas.

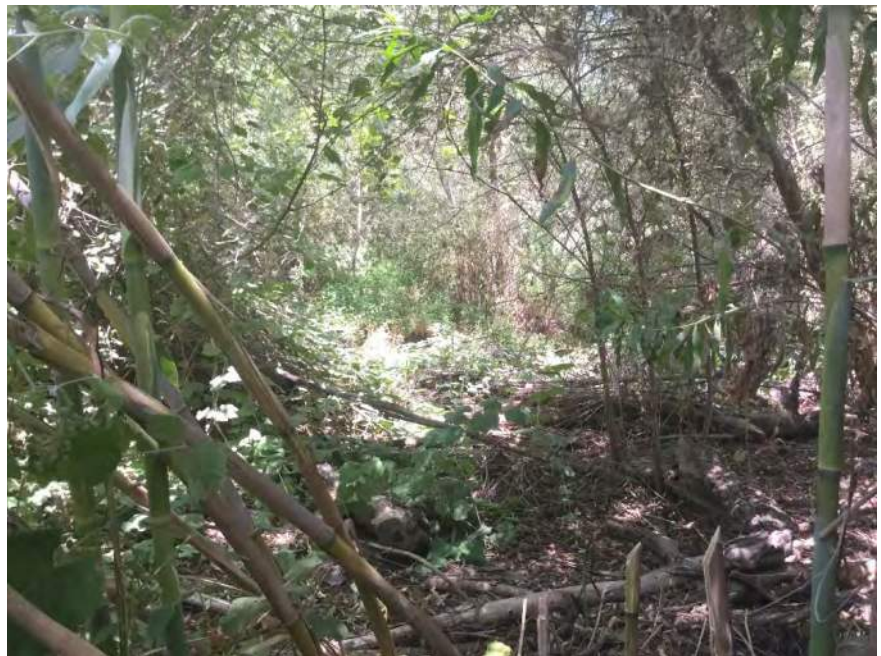
**Photo Point  
"PP ADFR-6"**

Description:  
Taken at sample pit "SP  
ADFR-30." USACE wetland,  
occurring with the OHWM  
of Anza Drain. Ten feet  
lower in elevation than  
sample pit "SP ADFR-29."  
Near location where Anza  
Drain channel becomes  
barely defined and braids at  
low flows.

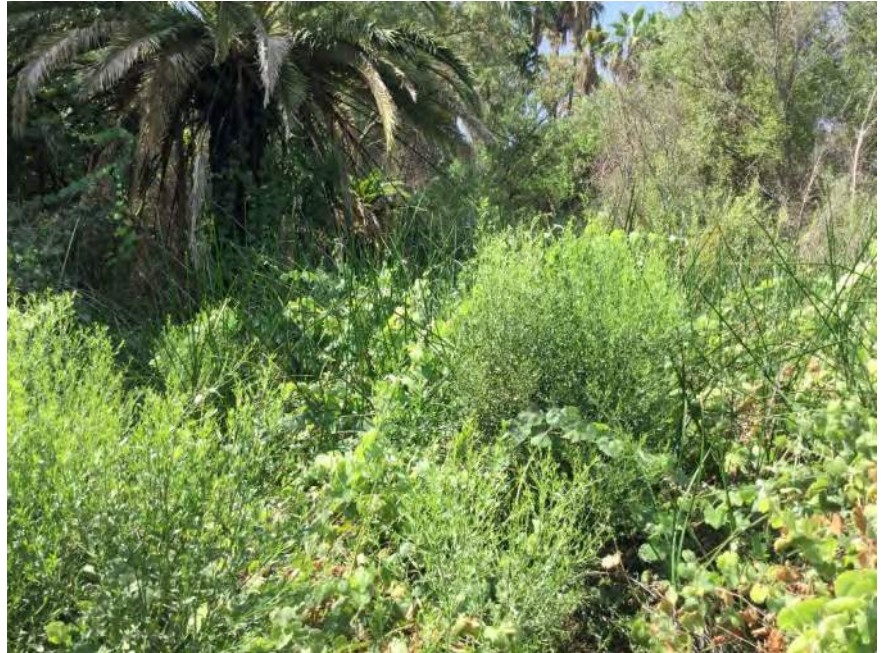
**Photo Point  
"PP ADFR-7"**

Description:  
Taken at sample pit "SP  
ADFR-9," in pit, inside  
USACE wetland, outside  
OHWM. Looking south at  
wetland area; Anemopsis  
covers the ground.

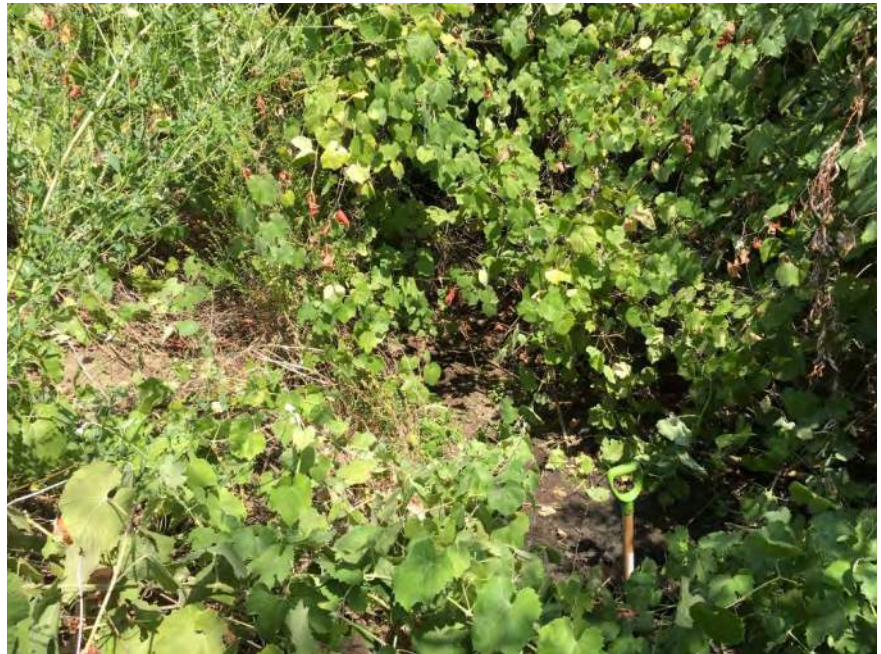
**Photo Point  
"PP ADFR-8"**

Description:  
Taken at sample pit "SP  
ADFR-31," in pit. USACE  
wetland, within OHWM of  
Old Farm Road channel.

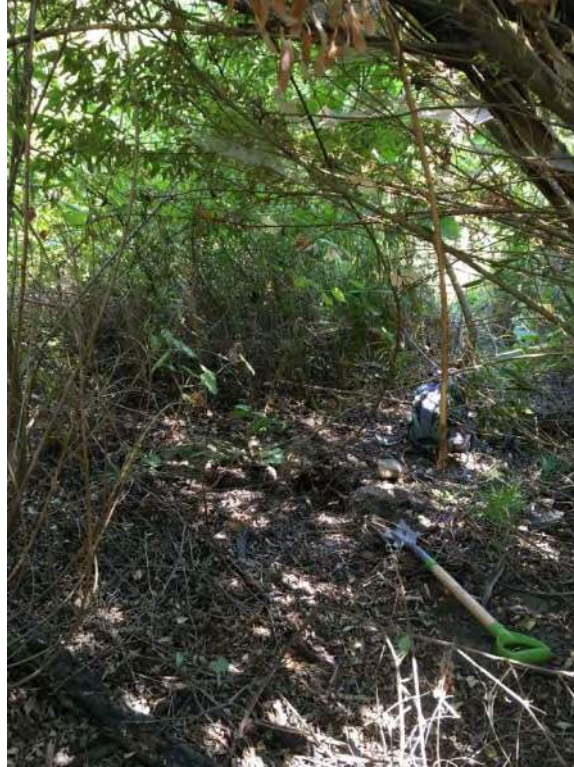
**Photo Point  
"PP ADFR-11"**

Description:  
Taken at sample pit "SP  
ADFR-25," in pit. USACE  
wetland, within OHWM of  
Old Farm Road channel.

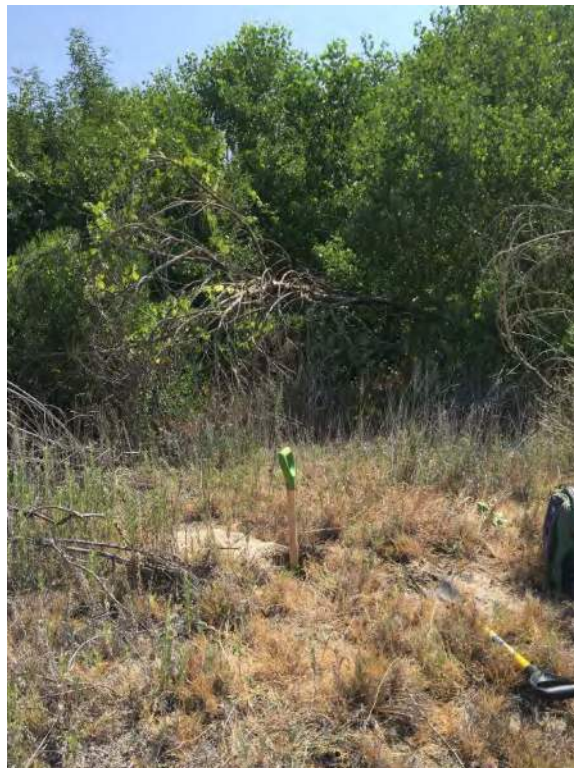
**Photo Point  
"PP ADFR-12"**

Description:  
Taken at sample pit "SP  
ADFR-24," out pit. Looking  
toward riparian corridor.

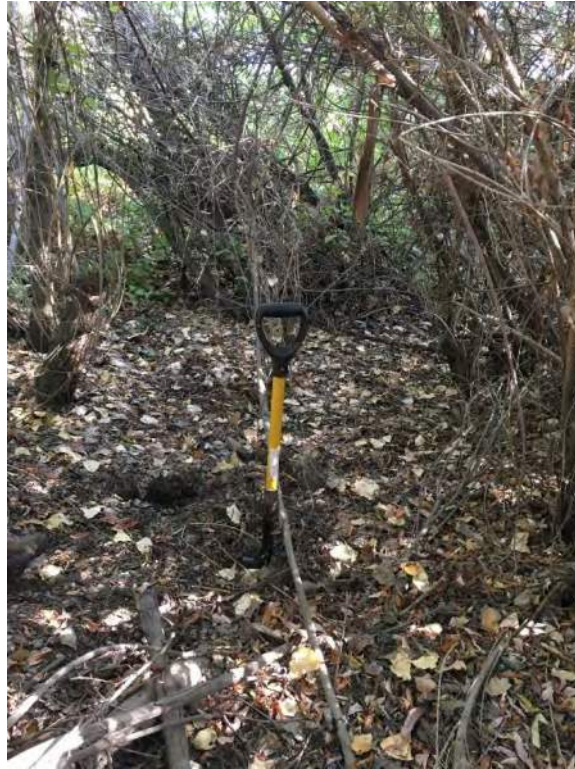
**Photo Point  
"PP ADFR-13"**

Description:  
Taken at sample pit "SP  
ADFR-23," in pit. USACE  
wetland, within OHWM of a  
tributary (Drainage 2) from  
Old Farm Road channel.

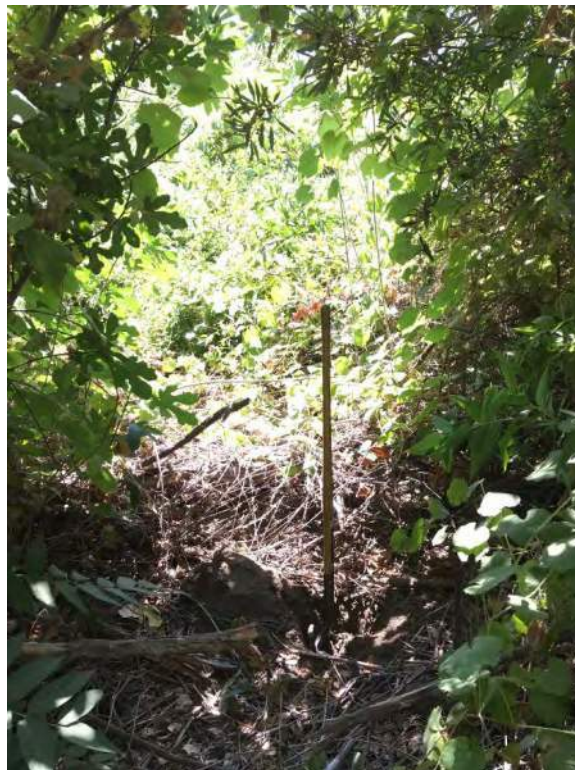
**Photo Point  
"PP ADFR-14"**

Description:  
Taken at sample pit "SP  
ADFR-17," out pit. USACE  
non-wetland water, within  
OHWM of Old Farm Road  
channel, did not meet  
three-parameter wetland.

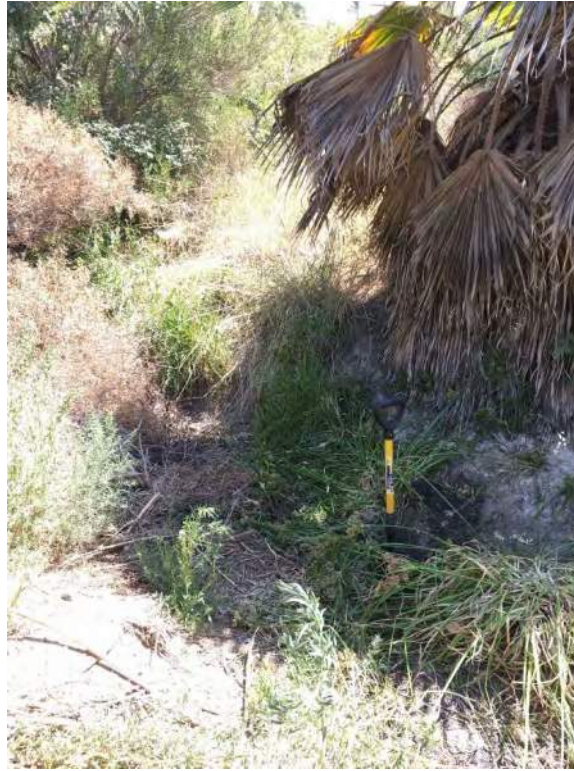
**Photo Point**  
**"PP ADFR-15"**

Description:  
Taken at sample pit "SP  
ADFR-21," out pit. Area did  
not support a three-  
parameter wetland;  
however, was a nonwetland  
water.
