Determination of Biologically Equivalent or Superior Preservation (DBESP)

The Exchange

Determination of Biologically Equivalent or Superior Preservation

January 2019

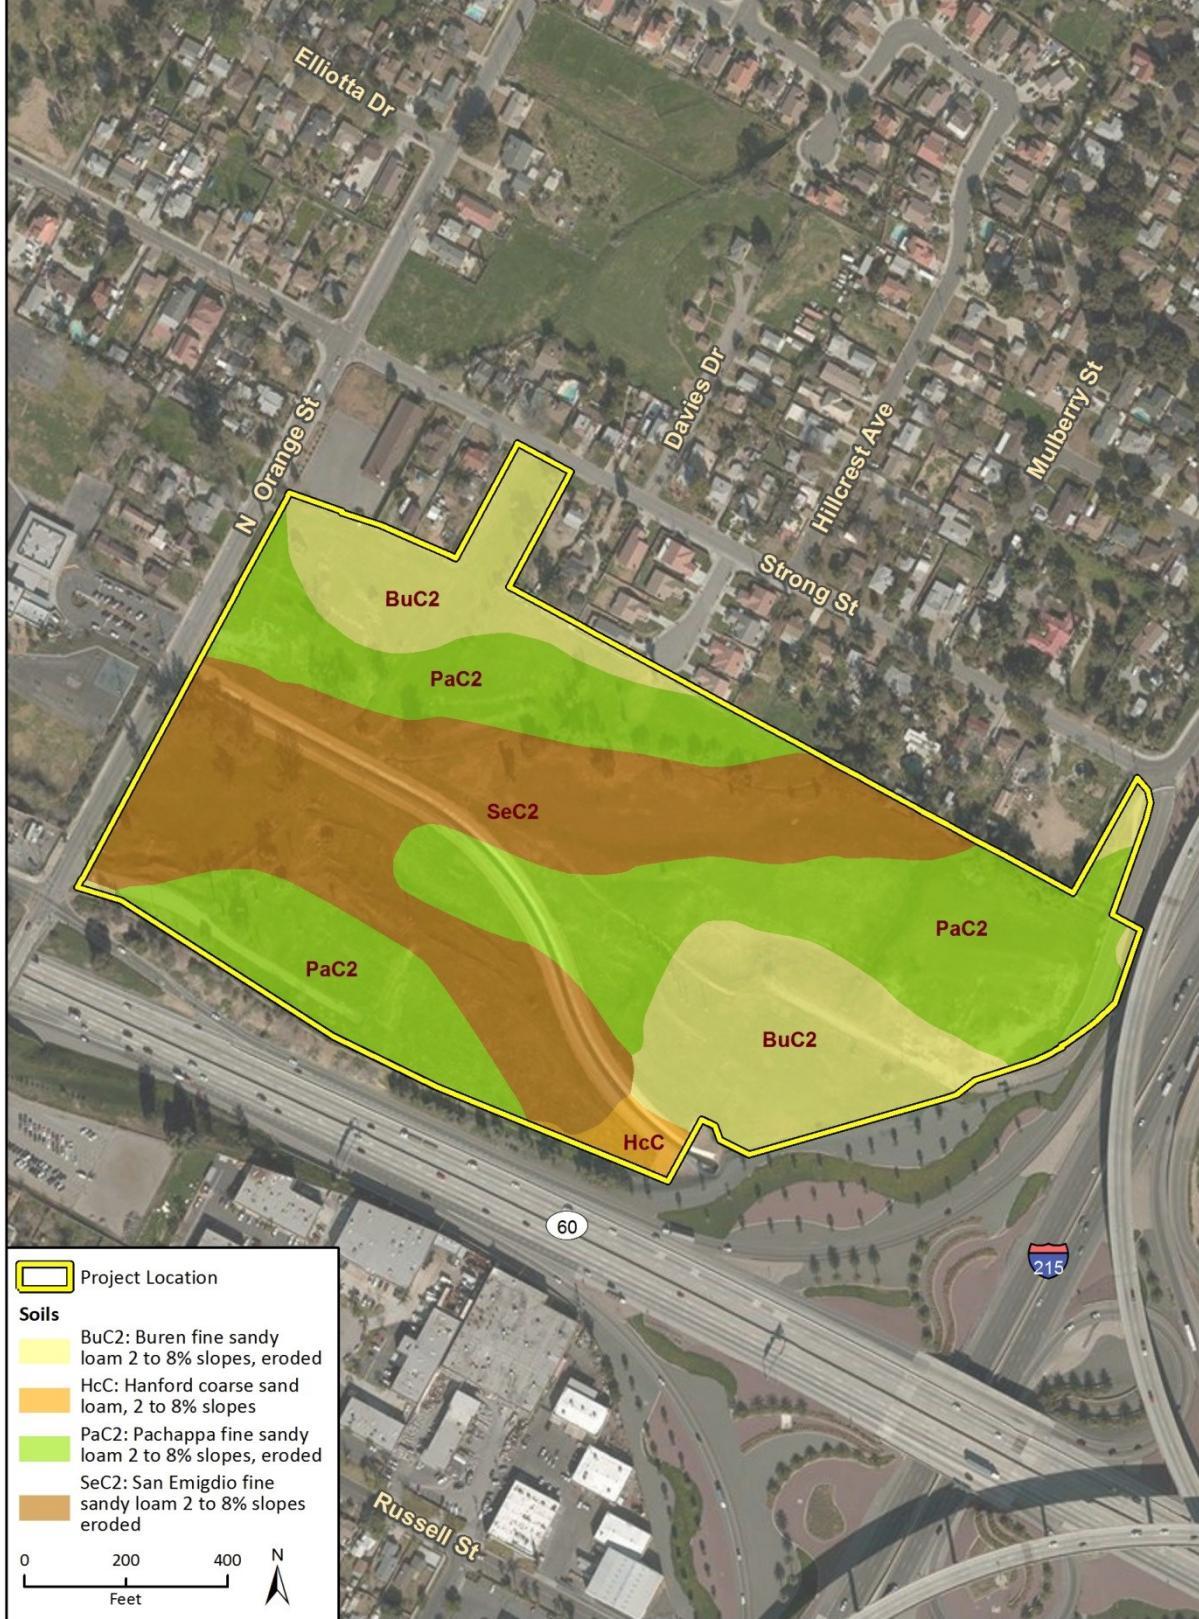
Figure 2 USDA Soils Map

- Buren fine sandy loam, 2 to 8 percent slopes, eroded (BuC2) occurs on the southeastern edge and northern edge of the project site. Buren Soil Series consists of well-drained, slow to moderately slowly permeable soils. These soils are on gently to strongly sloping alluvial fans and terraces. They formed in alluvium derived mostly from basic igneous rocks and partly from other crystalline rocks. The principal uses of soil series is used for the production of citrus, small grains, and pasture. Natural vegetation associated with this soil series typically consists of annual grasses and forbs with chaparral shrubs on eroded terrace slopes.

- Hanford course sandy loam, 2 to 8 percent slopes (HcC) occurs on a very small area at the southern tip of the project site. Hanford Soil Series consists of very deep and well drained soils that formed in moderately coarse textured alluvium dominantly from granite. Hanford soils are

typically found on stream bottoms, floodplains, and alluvial fans at elevations of 150 to 3,500 feet and have slopes of 0 to 15 percent. Hanford soils are used for growing a wide range of fruits, vegetables, and general farm crops. They are also used for urban development and dairies. Vegetation in uncultivated areas is typically annual grasses and associated herbaceous plants.

- Pachappa fine sandy loam, 2 to 8 percent slopes, eroded (PaC2) occurs on the northern, eastern, and southwestern portions of the project site. Pachappa Soil Series consist of well drained (minimal) Noncalcic Brown soils developed from moderately coarse textured alluvium. They occur on gently sloping alluvial fans and flood plains under annual grass-herb vegetation. This soil series is mostly used for alfalfa, small grains and row crops as well as dry farm small grains. Yields are normally good. This soil type typically supports annual grasses, herbs and shrubs.

- San Emigdio fine sandy loam, 2 to 8 percent slopes, eroded (SeC2) occurs on the central and western portions of the project site. San Emigdio Soil Series consists of very deep, well drained soils that formed in dominantly sedimentary alluvium. San Emigdio soils are on fans and floodplains and have slopes of 0 to 15 percent. The San Emigdio soils are typically used for growing citrus fruit, alfalfa, truck crops, dryland grain, and some areas are in home sites. Uncultivated areas are annual grasses and forbs.

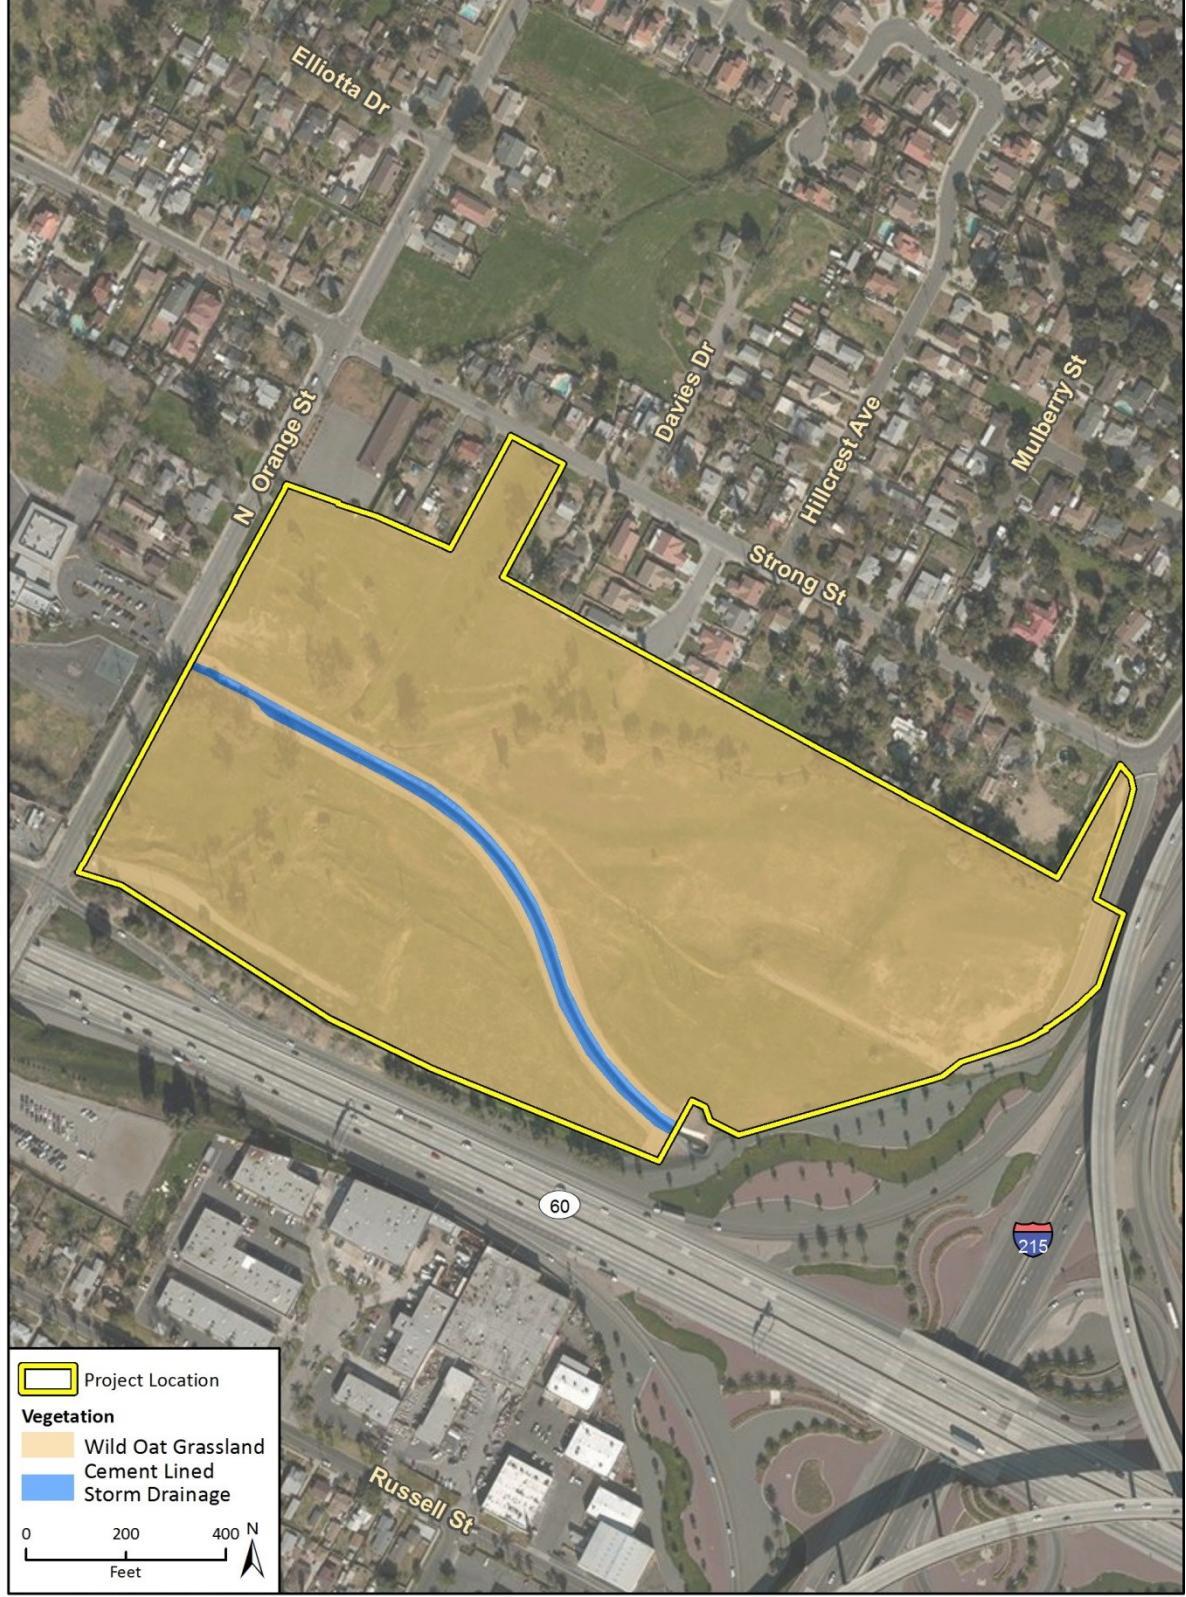
Figure 3 Vegetation

The dominant plant community on the project site is Wild Oat Grassland (Avena barbata Herbaceous Semi-Natural Alliance) as described in the Manual of California Vegetation (Sawyer et al. 2009; Figure 3). This community is dominated by slender wild oat (Avena barbata), ripgut brome (Bromus diandrus), red brome (Bromus madritensis ssp. rubens), and soft chess (Bromus hordeaceus). Patches of non-native and ruderal (weedy) species occur throughout the grassland and include Russian thistle (Salsola tragus), perennial mustard (Hirschfeldia incana), castor bean (Ricinus communis), and dense patches of sorghum (Sorghum halepense). Trees line a soft-bottomed drainage in the northeastern portion of the site and include blue gum (*Eucalyptus globulus*), Mexican fan palm (Washingtonia robusta), Peruvian pepper (Schinus molle) and several coast live oak (Quercus agrifolia). Blue gum and coast live oak also occur sporadically in the western portion of the project site. Other species observed in the soft-bottom drainage include olive tree (Olea europaea), opuntia cactus (Opuntia sp.), common sunflower (Helianthus annuus), jimsonweed (Datura wrightii), milk thistle (Silybum marianum), horseweed (Erigeron canadensis), western ragweed (Ambrosia psilostachya), and field bindweed (Convolvulus arvensis). The habitats on the site are heavily disturbed by developments, disking, grading, vehicle traffic, and trash and debris from homeless encampments on and near the project site.

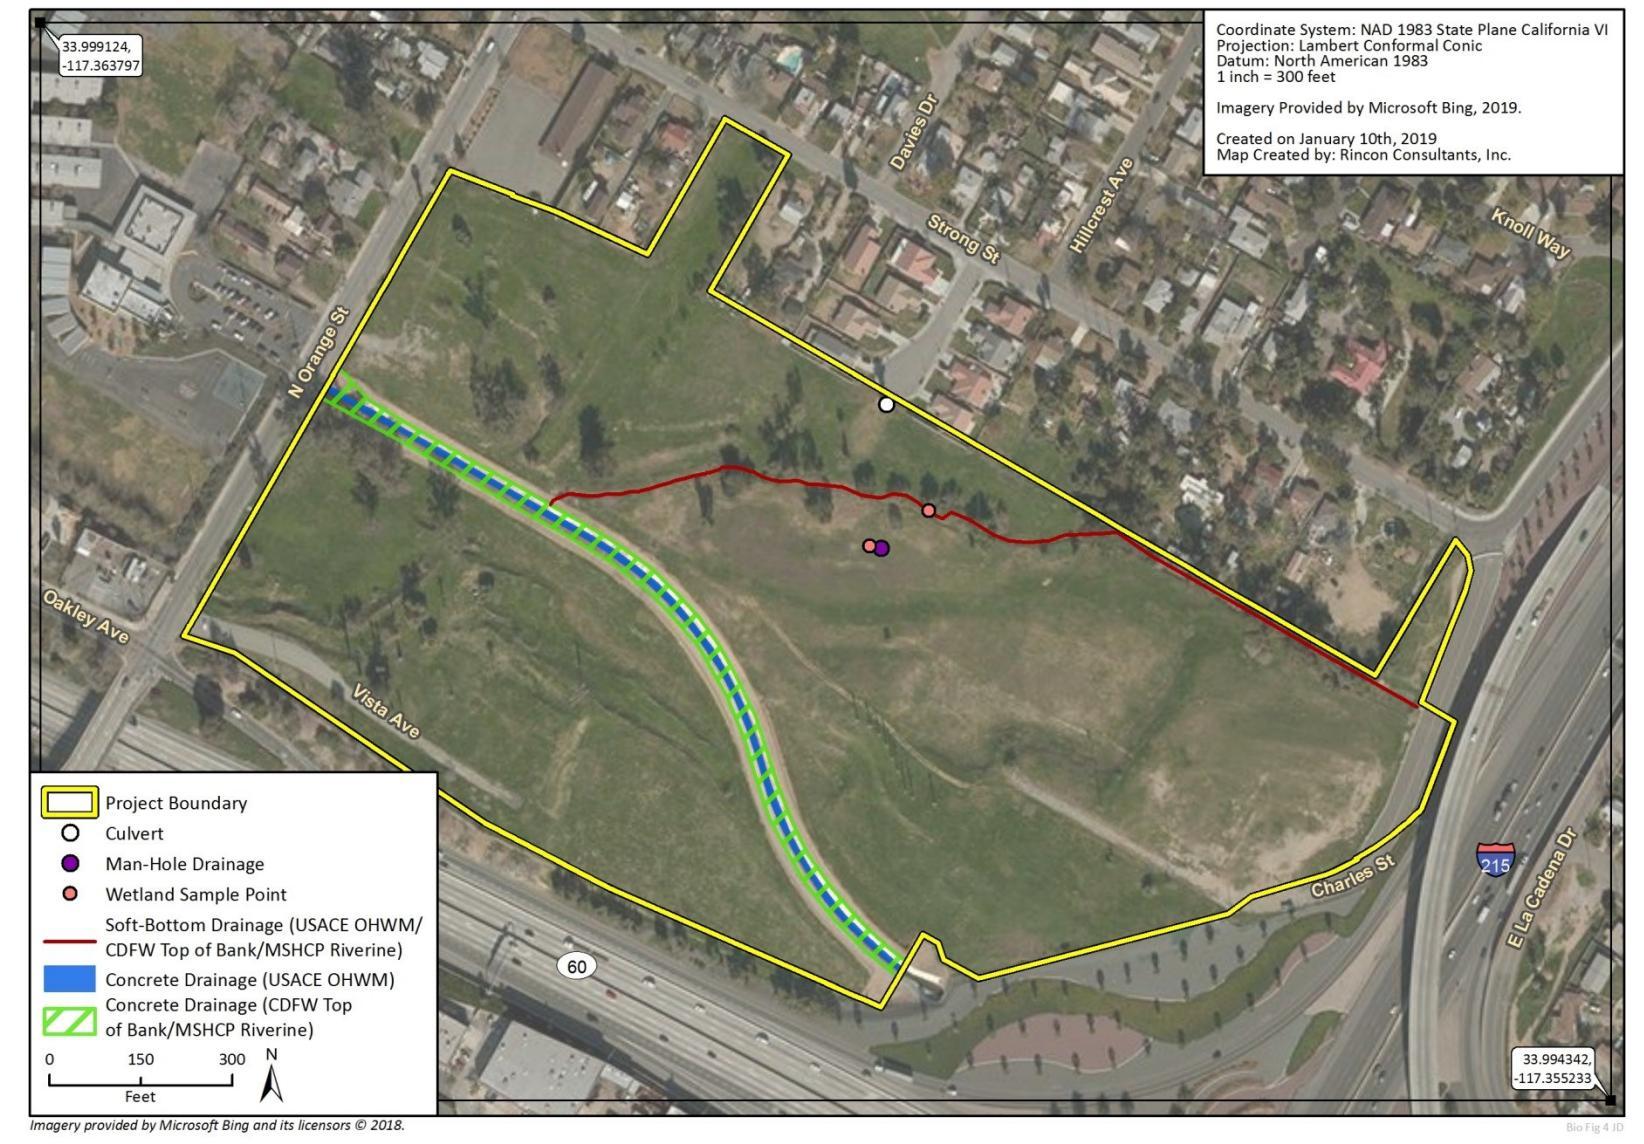
Figure 4 Jurisdictional Delineation

Based on the finding of Rincon's Jurisdictional Delineation Report, two jurisdictional waters occur in the project site: the concrete drainage channel and the soft-bottomed channel. A summary of the findings of jurisdiction are below in Table 1 and the limits of jurisdiction are shown in Figure 4 below.

The soft-bottom drainage channel was likely constructed to direct stormwater flow from the urban area to the north into the concrete drainage channel on the project site. The soft-bottom drainage flows directly into the concrete drainage channel via surface flow and an adjacent underground culvert. A wetland sample point was taken in the center of the channel and the findings were negative for hydric soils (see Figure 4).

Near the center of the soft-bottom drainage channel, where a dirt access road crosses, there is a depression adjacent to the channel (Figure 4). A man-hole occurs in the low-point of the depression that drains overflows into an underground culvert that is connected to the concrete-lined drainage channel approximately 450 feet to the southwest. At the time of the field survey, the soil in the depression was not moist and vegetation had been removed near the man-hole drainage exposing the inlet. A sample point was taken in the depression to determine if the feature met the USACE criteria for wetland WoUS, which it did not. The soils within the sample point were non-hydric and were consistent with fill material soils. The depression supports dense mats of sorghum, milk thistle,

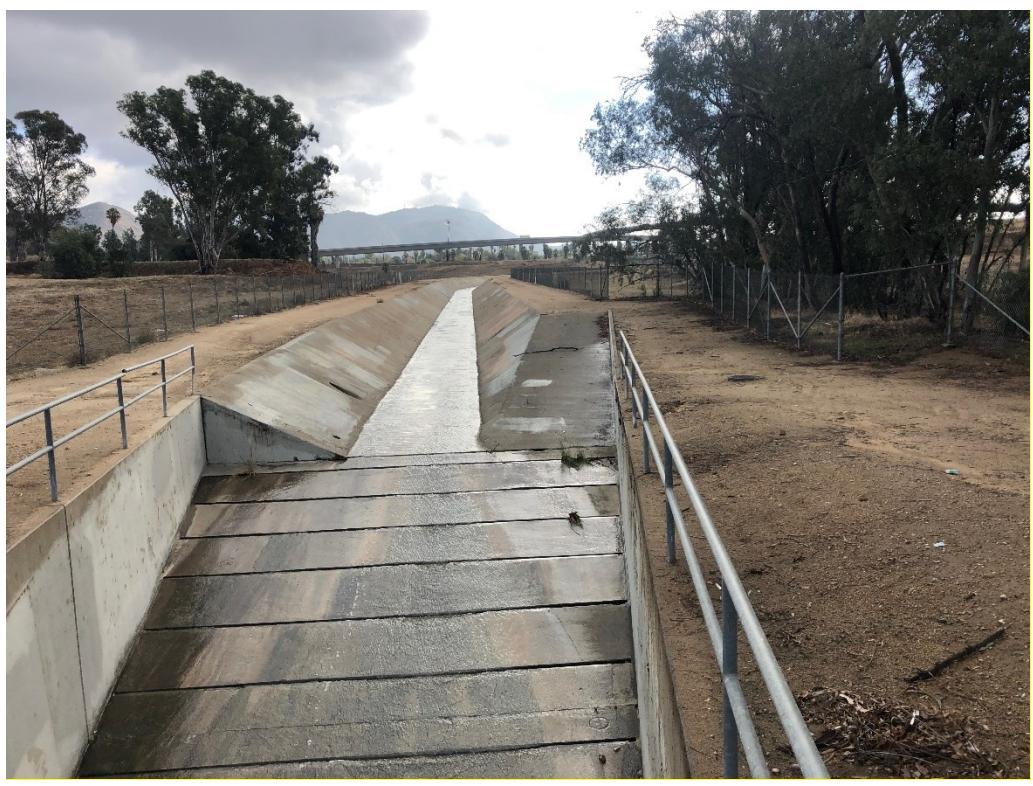
Photograph 1. Upstream view of concrete drainage channel as it exits the site and flows into an underground drain on the western side.

The concrete drainage channel contains intermittent water flows and is part of the stormwater system for eastern Riverside. The drainage transects the length of the project site from east to west. It is likely that the water flow width can vary seasonally. At the time of the site visit, the width was approximately nine feet and covered the entire channel bottom in a thin sheet of water. The top of bank for this feature is defined as the area at the top of the concrete sloped edges of the channel, which has a 30-foot width. The project site portion of the drainage is 1,394 linear feet long.

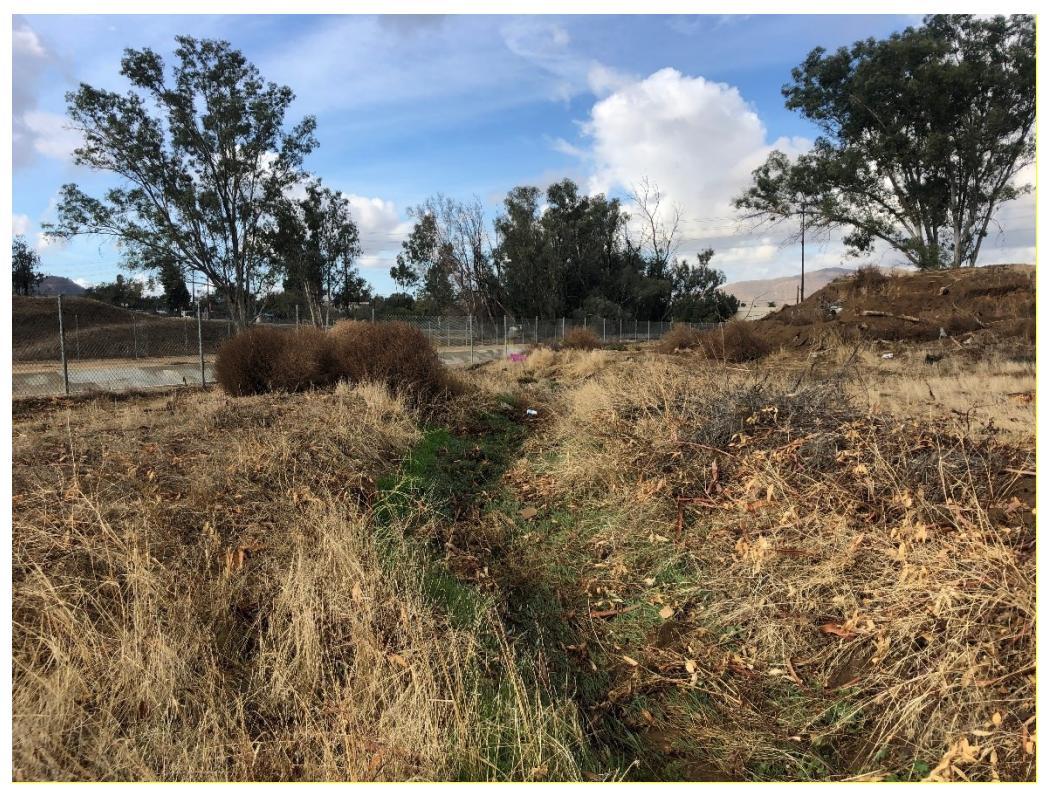
Photograph 2. View of view soft-bottom channel, looking downstream toward the confluence with the concrete channel, photo facing southwest.

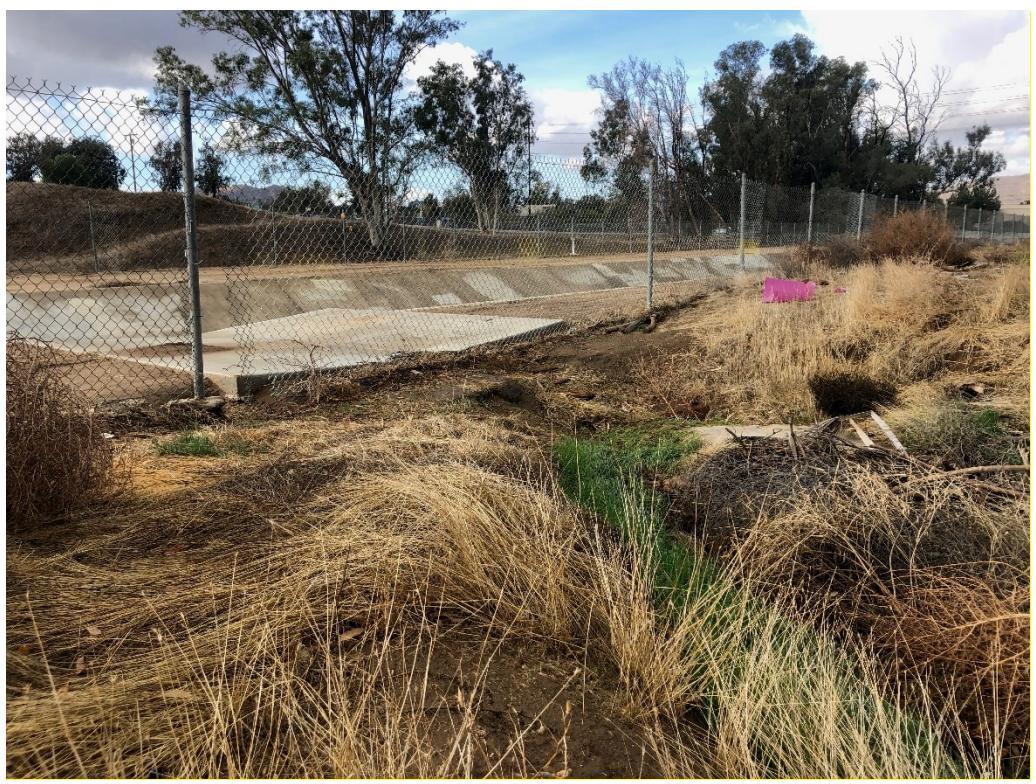
Photograph 3. View of the soft-bottom drainage confluence with the concrete channel, photo facing southwest.

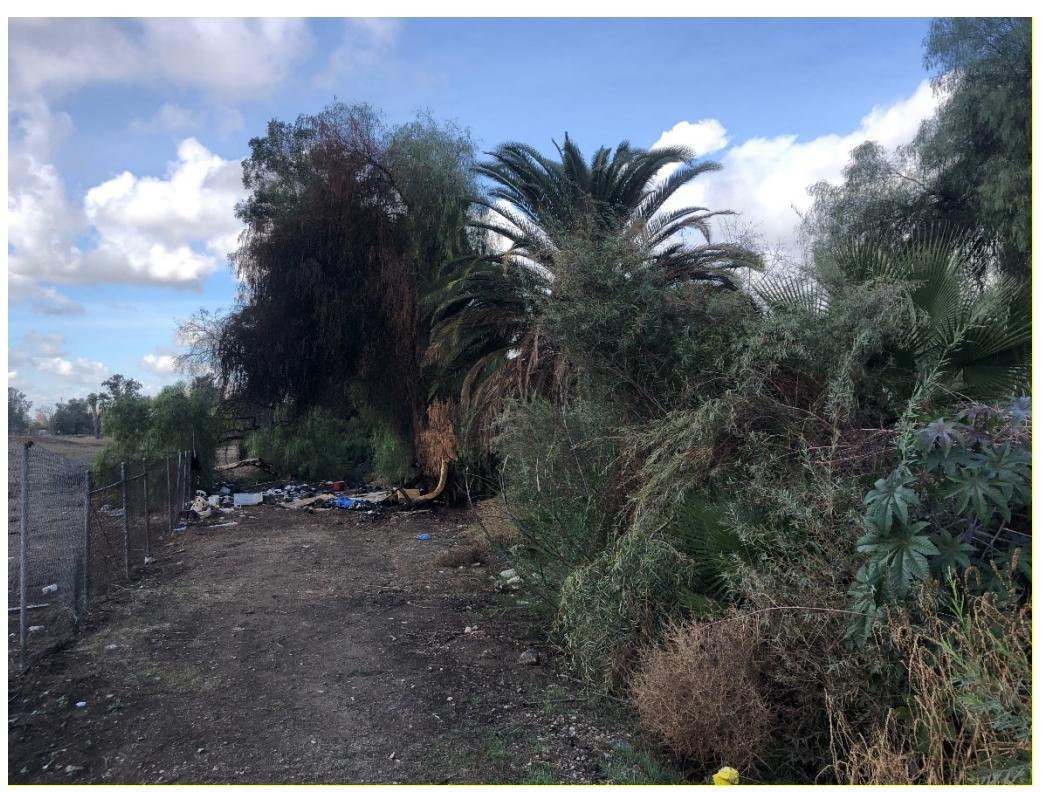
Photograph 4. View of beginning of the soft-bottom drainage as it enters the project site, photo facing west.

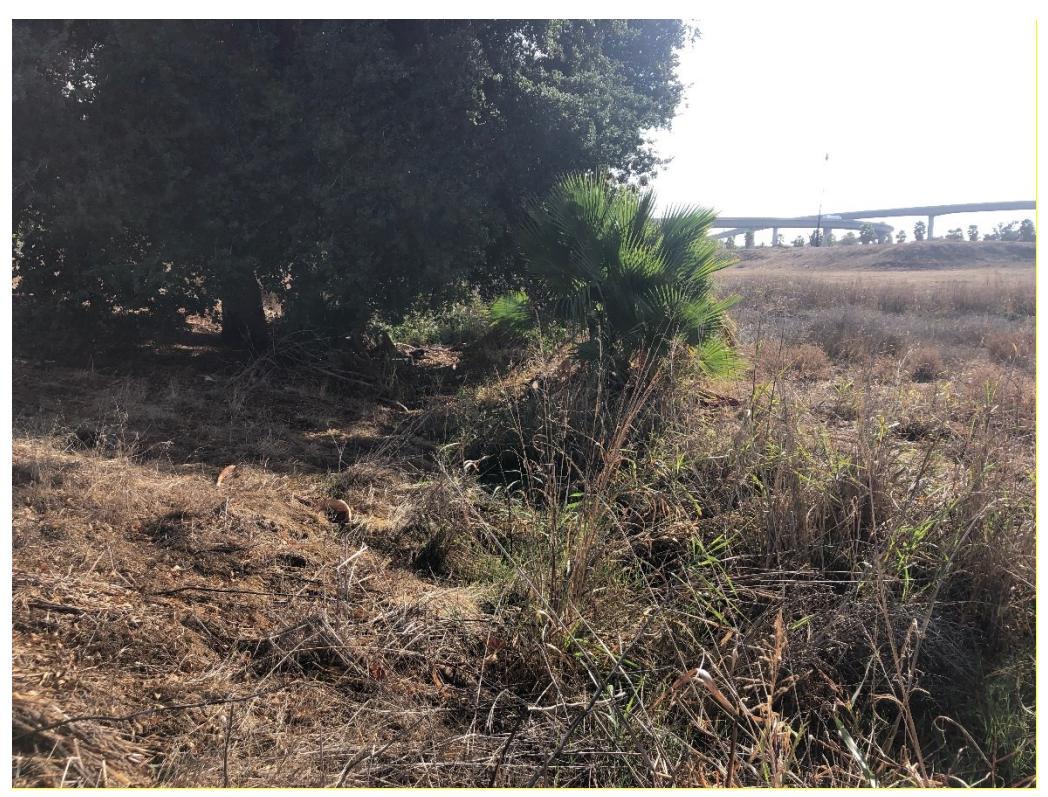
Photograph 5. Representative view of the habitat and vegetation along the soft-bottom drainage.

The soft-bottom drainage is mostly vegetated by slender wild oat, Brome grasses, short pod mustard, and Russian thistle in the channel, edges, and surrounding areas, with some small patches of bare ground near the culvert outlet. A variety of landscaping plants occurs in the drainage and is largely associated with the residences to the north. Landscaping plants include opuntia cactus (*Opuntia* sp.), Peruvian pepper tree, Mexican fan palm, and olive tree, among other landscaped species. Vegetation near the topographic low point is much denser and includes sorghum, common sunflower, milk thistle, western ragweed, field bindweed, and horseweed. Coast live oak trees are also found sporadically along the drainage. None of the species observed were facultative, facultative wetland, or obligate wetland species (Lichvar et al. 2016).
