C.H.J. Incorporated

Job No. 07489-3

Subject: Grading Plan Review and Update to Geotechnical Investigation
 Proposed Industrial Development - Sycamore V
 Lance and Sierra Drives
 Riverside, California

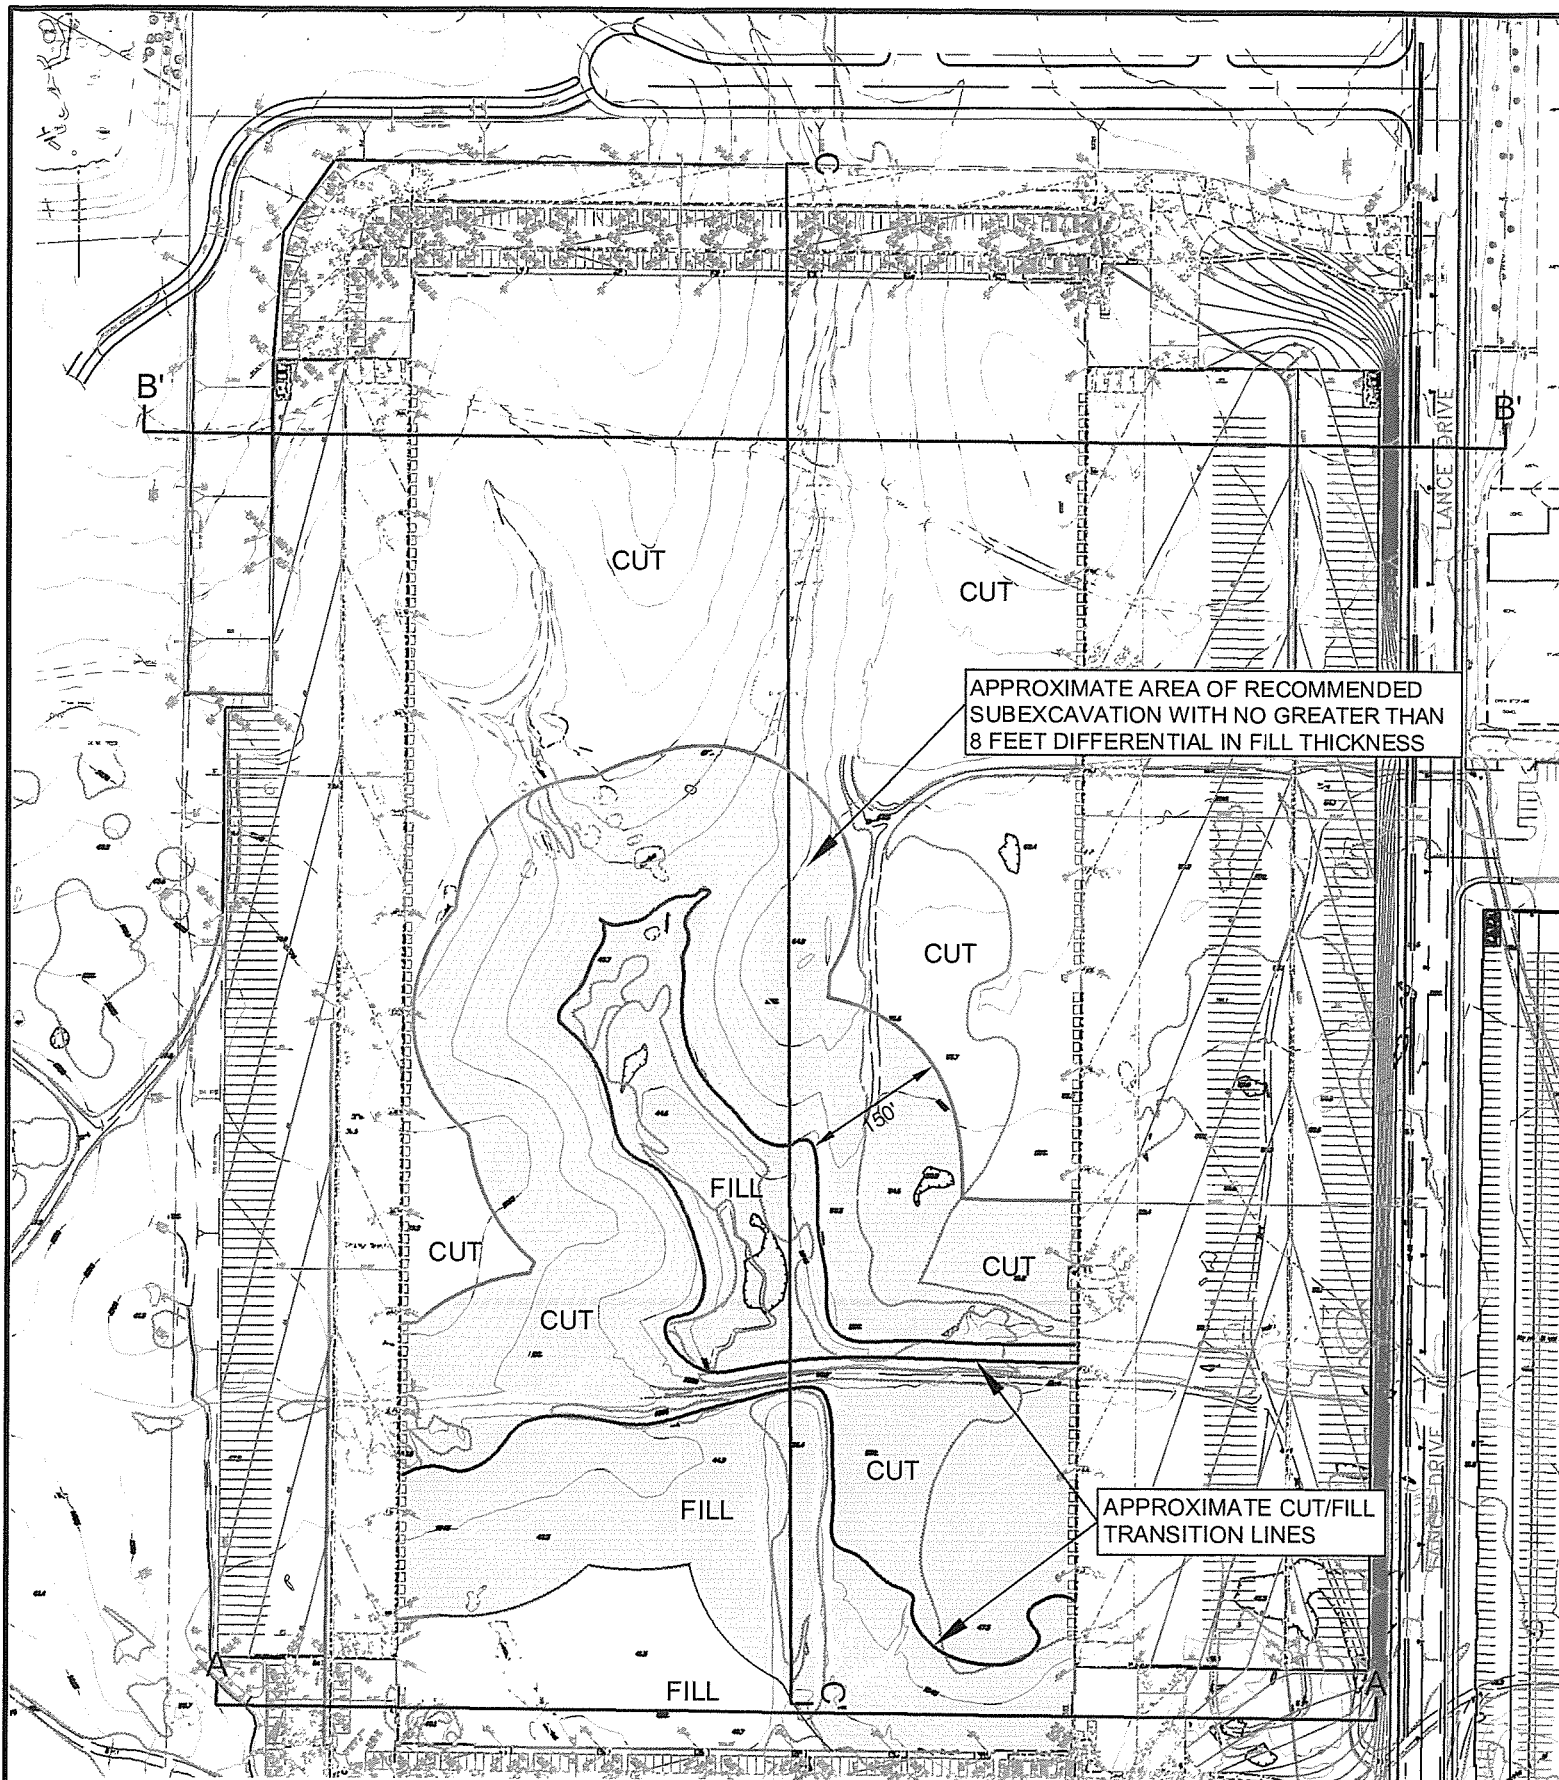
16 feet, when alluvial/colluvial removals are included. Cut-fill transition lines are present in the southern and central portions of the proposed building (Enclosure 1). In order to mitigate the potential for differential settlement across the cut/fill transition area, the pad area including areas underlain by bedrock, should be subexcavated to provide no greater than 8 feet difference in the fill mat thickness within 150 feet of the cut/fill transition line. The 150-foot distance from the transition line is also shown on Enclosure 1. The attached draft cross sections illustrate the cut/fill transition, areas of fill, bedrock cut areas, and potential fill depths beneath footings in rock areas. Our geotechnical investigation recommended a minimum fill thickness of 18 inches beneath all structure footings.

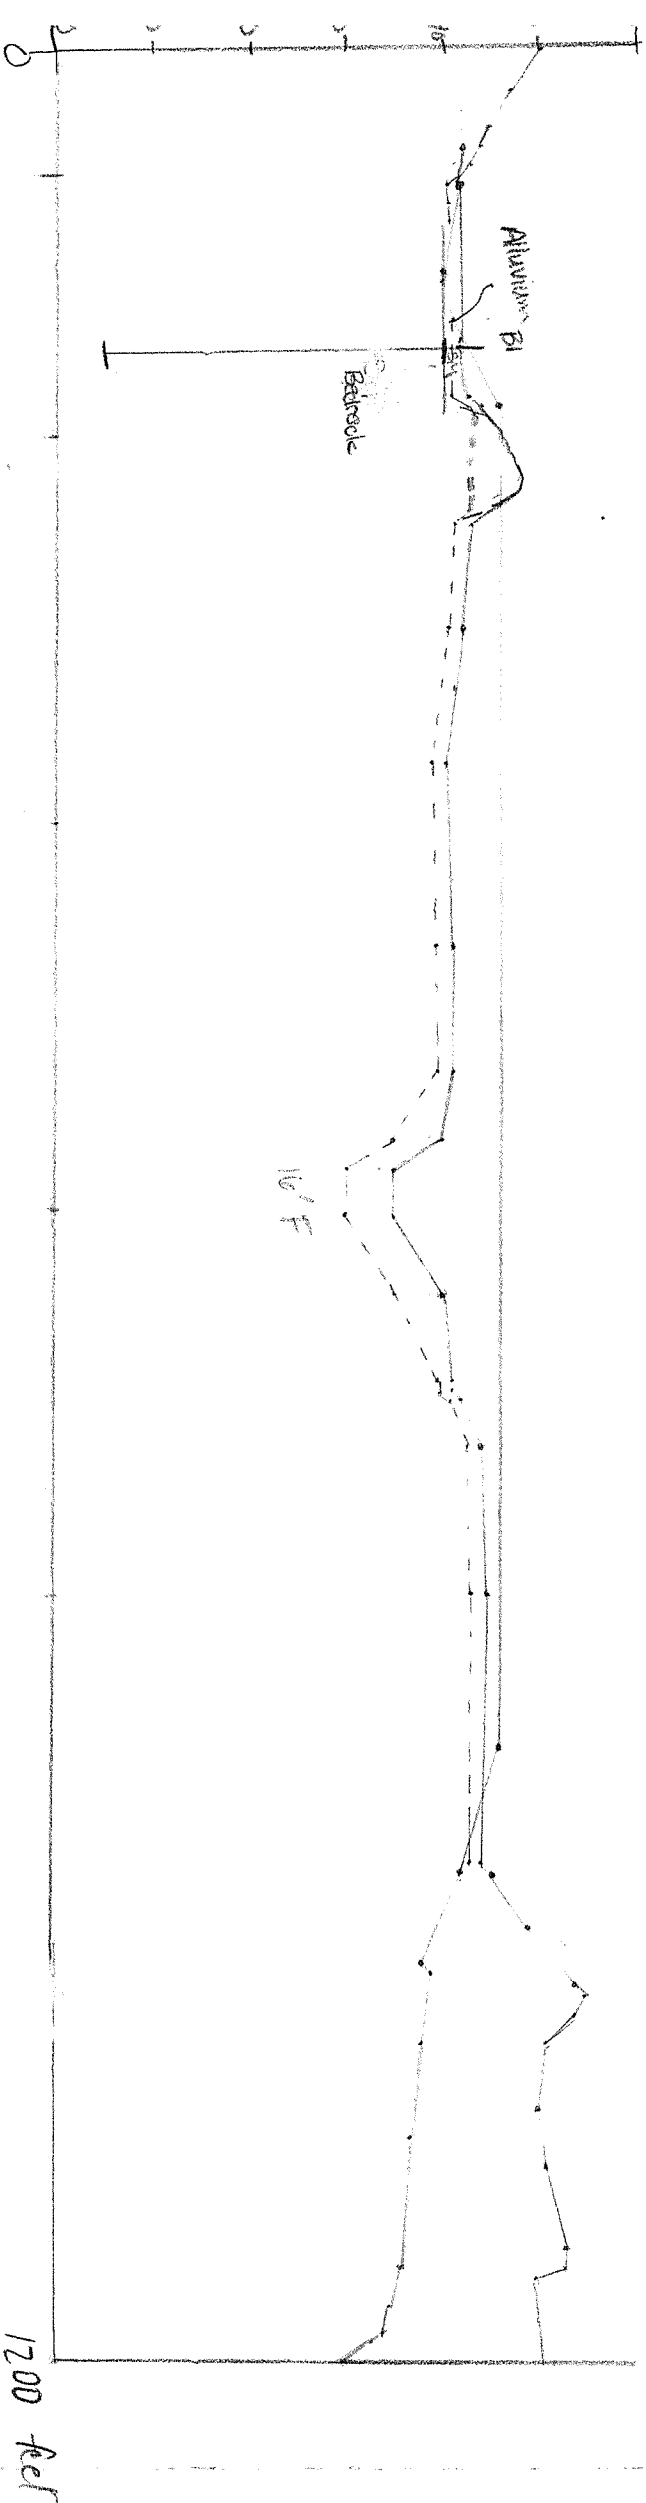
Job 07489-3

- Existing Elevation
- - - Proposed Grade
- - - Potential Removal Depth (CHS, July 20, 2007)
- - - Potential Footing Overex per CHS (July 20, 2007)

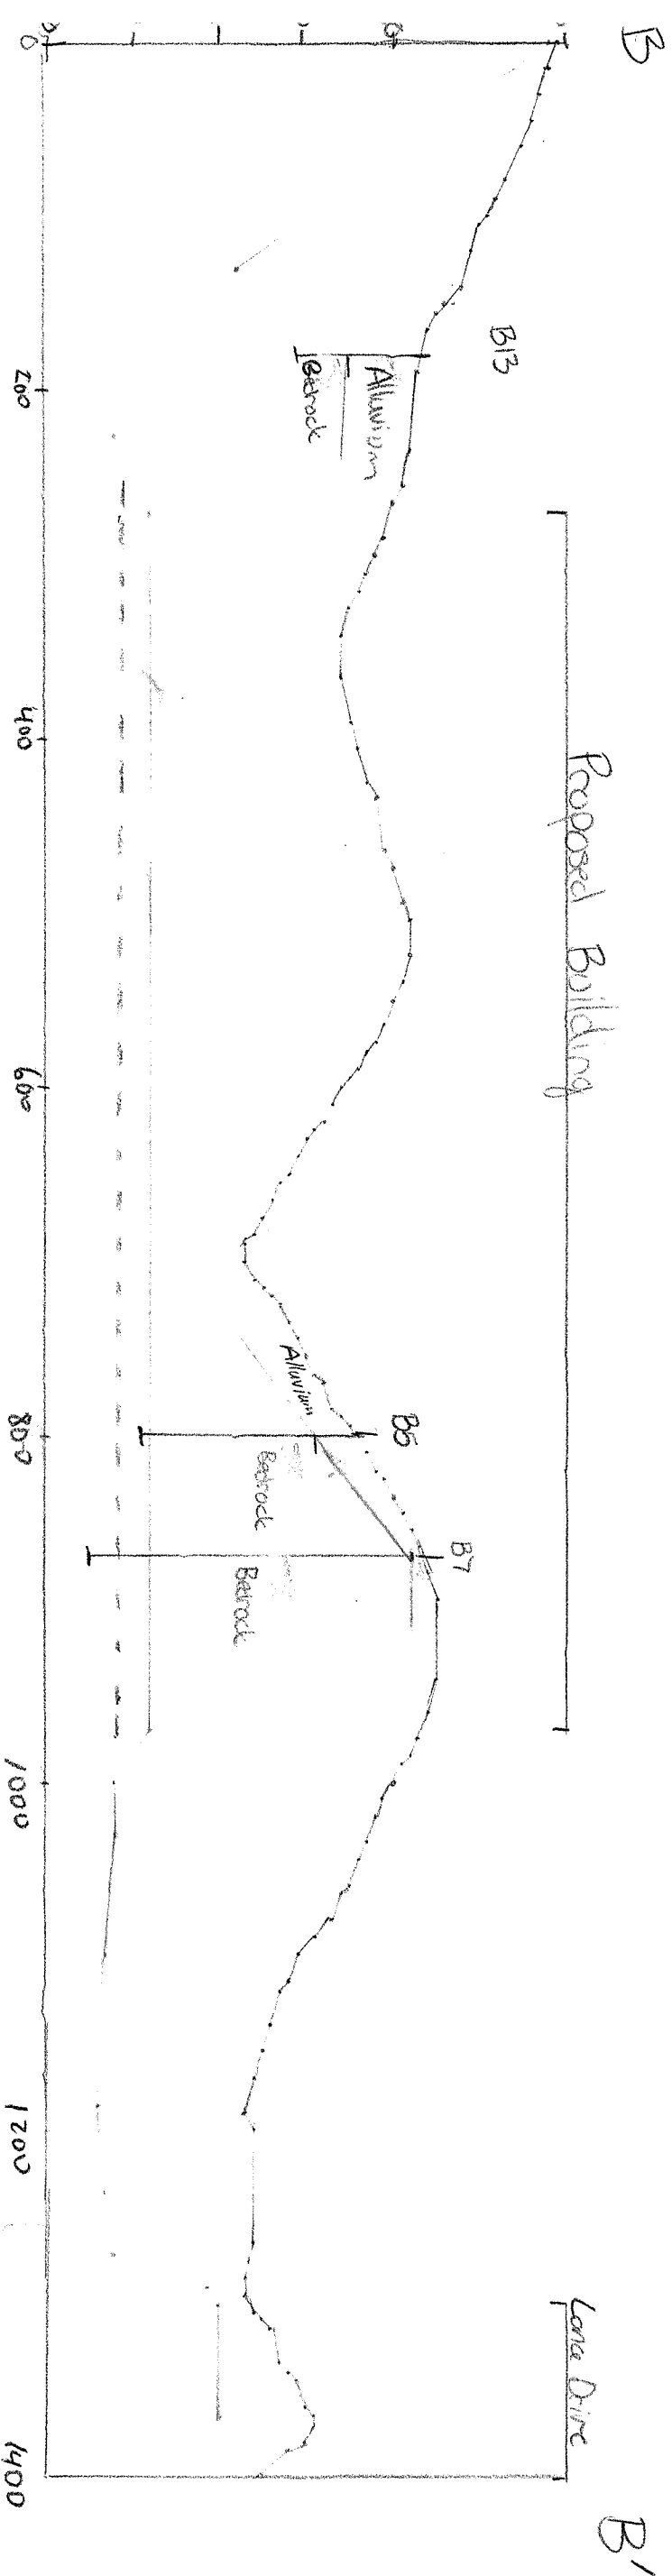
88-07649-3

— Existing Elevation
— Proposed Grade
--- Potential Polym Over
per CHS (July 20, 2007)

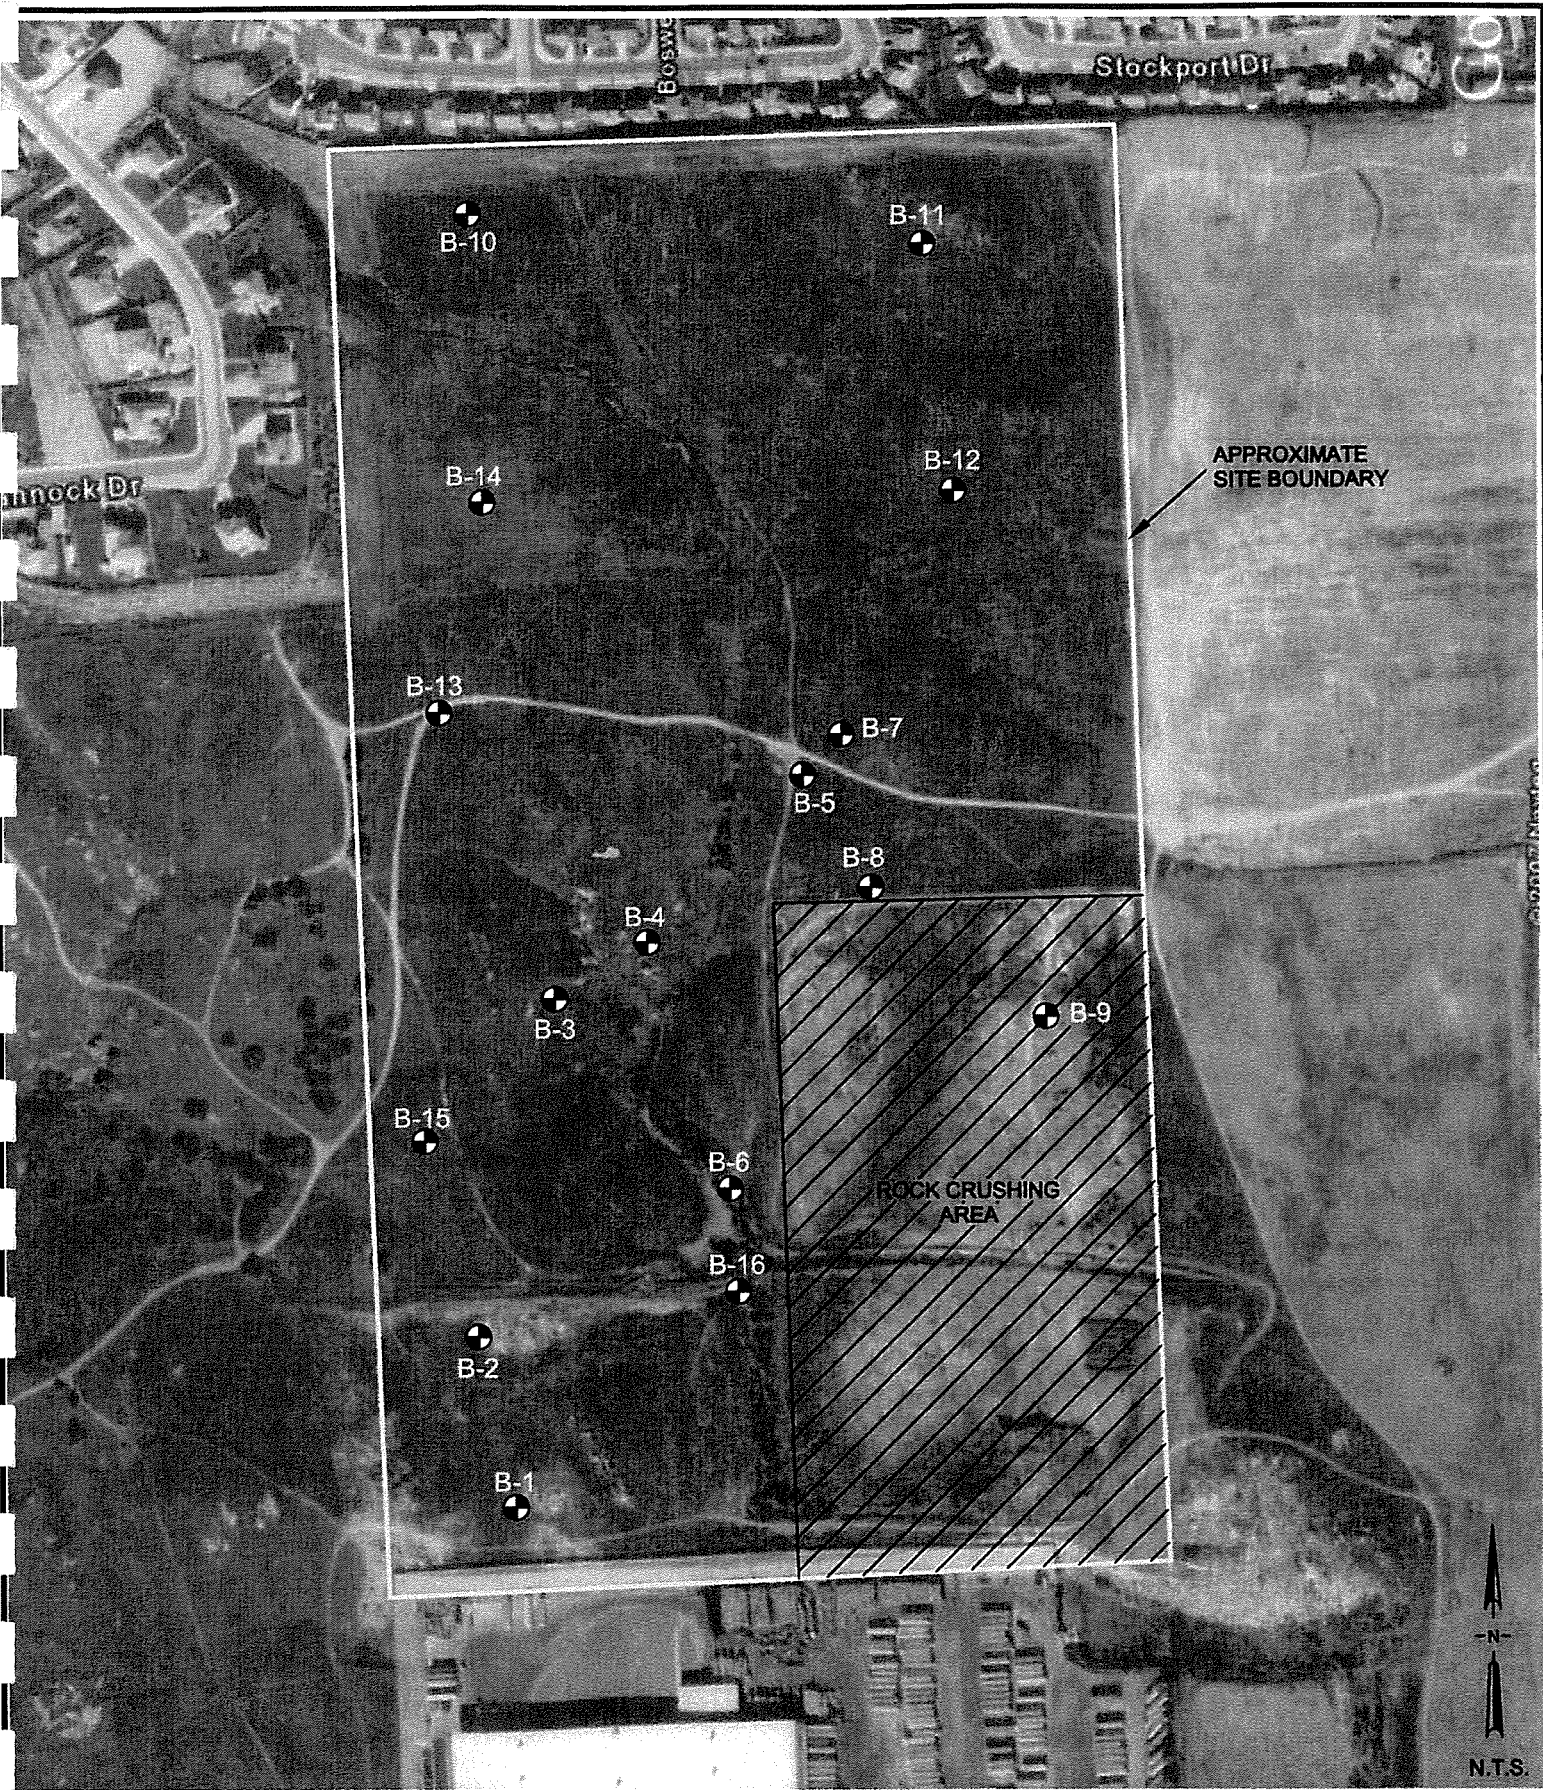
ENCLOSURE
"A-2"
 JOB NUMBER
 07489-3

The soil conditions underlying the subject site were explored by means of 16 exploratory borings drilled to a maximum depth of 37 feet below the existing ground surface with a truck-mounted CME 55 drill rig equipped for soil sampling. The approximate locations of our exploratory borings are indicated on the attached Plat (Enclosure "A-2").

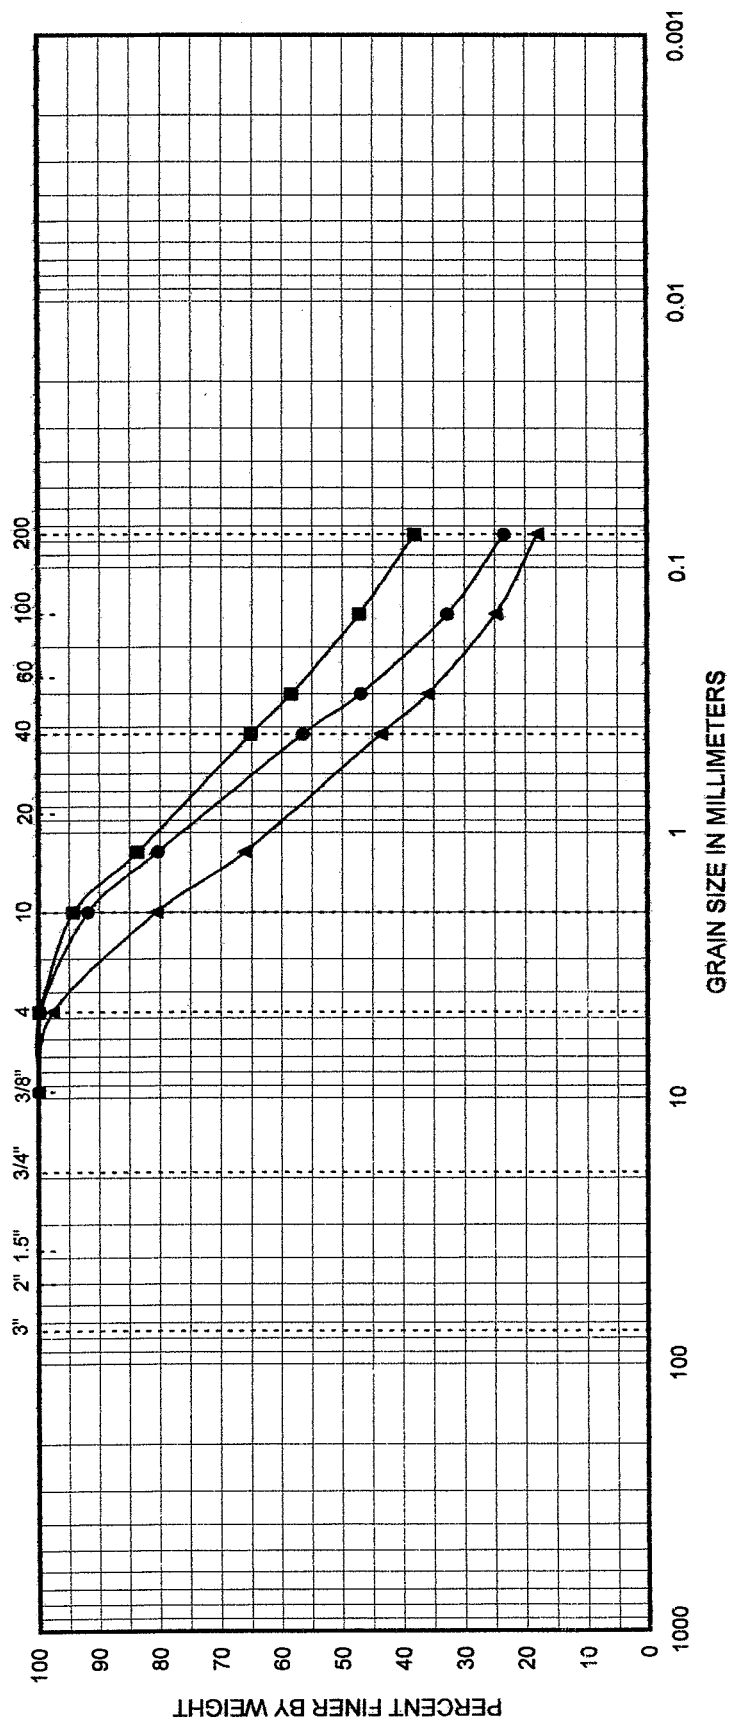
GRAIN SIZE DISTRIBUTION

Cobbles & Boulders			Gravel		Sand			Silt			Clay	
			Coarse	Fine	Coarse	Medium	Fine	D ₁₀ (mm)	D ₃₀ (mm)	D ₆₀ (mm)	C _u	C _o
Symbol	Boring No.	Depth (ft)	Classification									
●	3	0.5	(SM) Silty Sand, fine to medium with coarse									
■	5	0.5	(SM) Silty Sand, fine to medium with coarse									
▲	8	0.5	(SC) Clayey Sand, fine to coarse

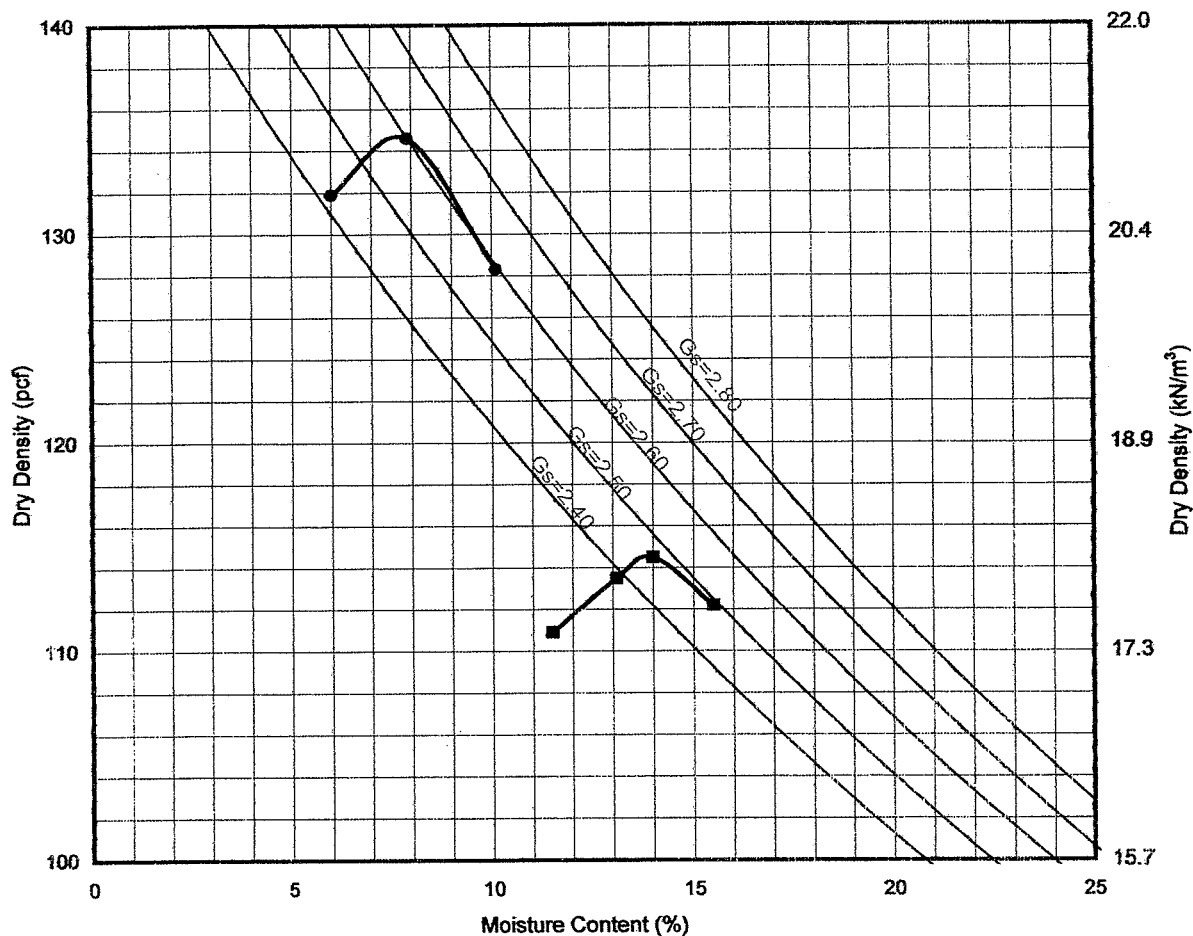
Optimum Moisture - Maximum Density Determination Test (ASTM D 1557)

Boring No.	Depth (ft)	Soil/Sample Type	γ_{max} (pcf)	w_{opt} (%)
• 5	0.5	(SM) Silty Sand, fine to medium with coarse	134.5	8.0
■ 8	0.5	(SC) Clayey Sand, fine to coarse	114.5	14.0

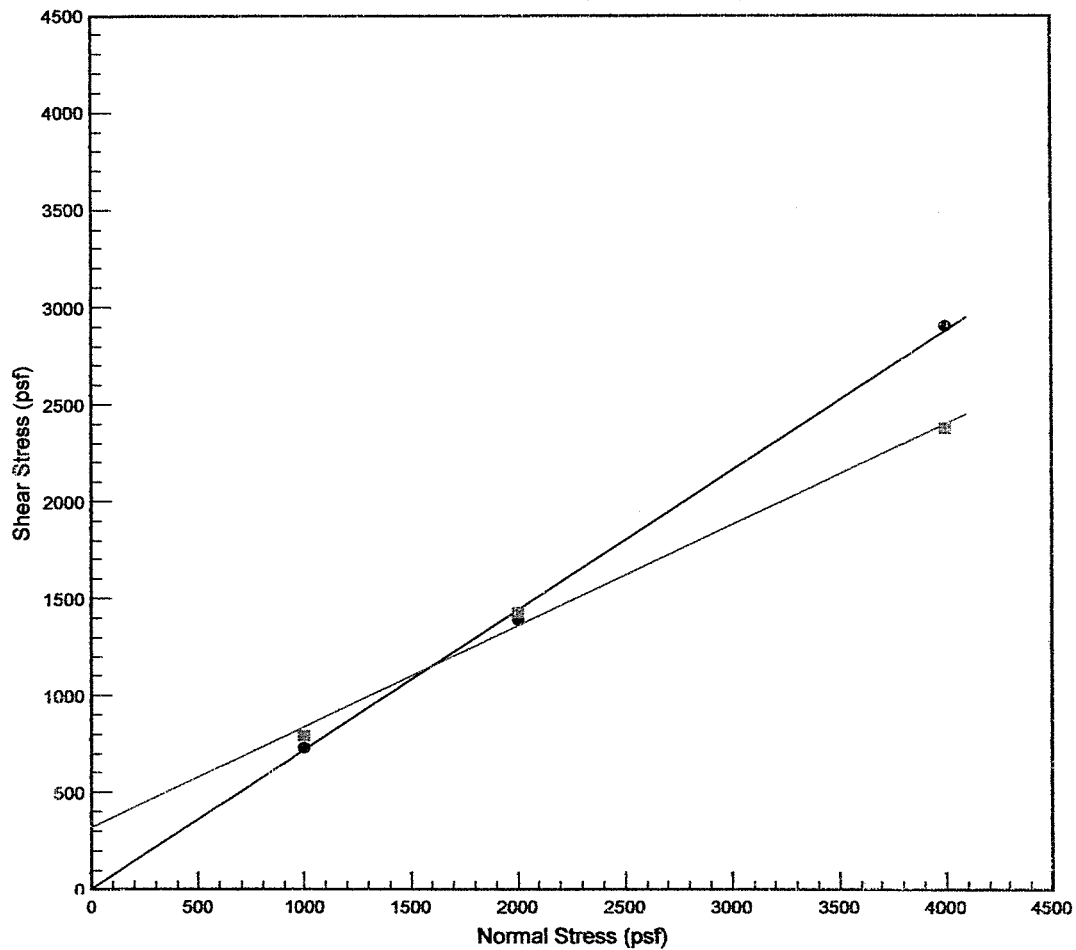
Direct Shear Test (ASTM D 3080)

Boring No.	Depth (ft)	Soil/Sample Type	γ_d (pcf)	MC(%)	C (psf)	$\phi(^{\circ})$
3	0.5	(SM) Silty Sand, fine to medium with coarse	121	8.0	0	35.8
8	0.5	(SC) Clayey Sand, fine to coarse	103	14.0	318	27.5

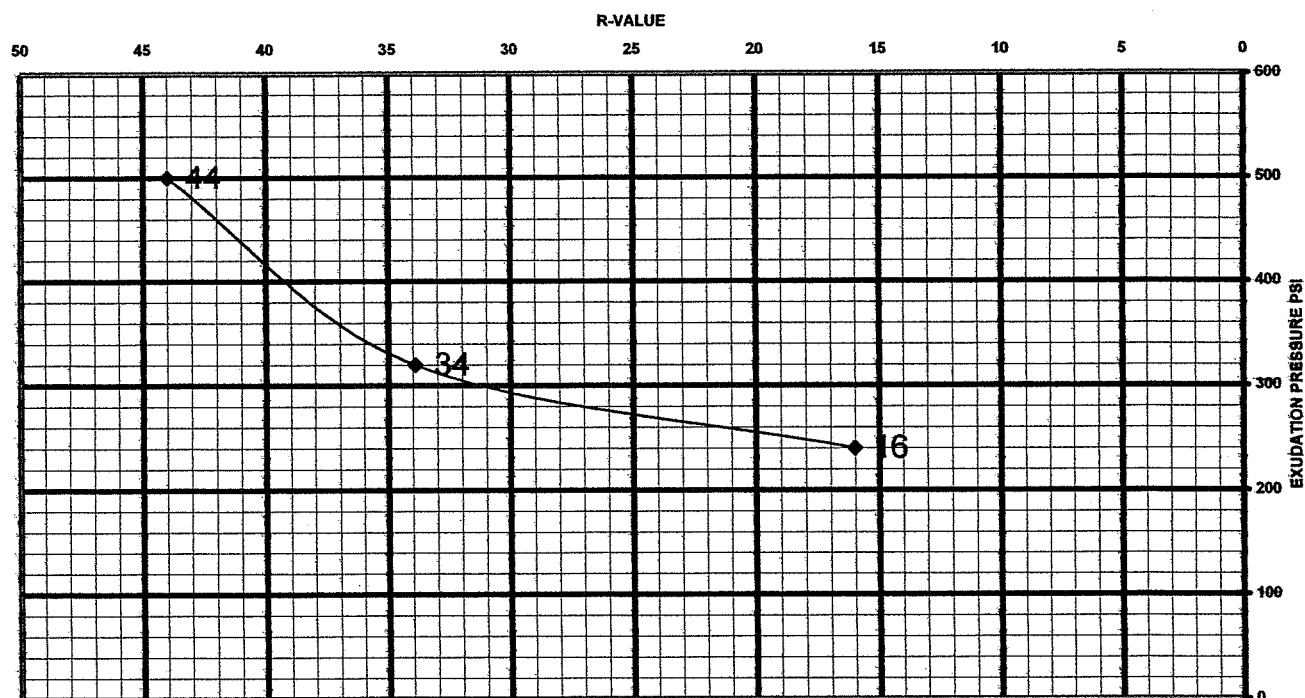
EXUDATION CHART

R-Value: **31**

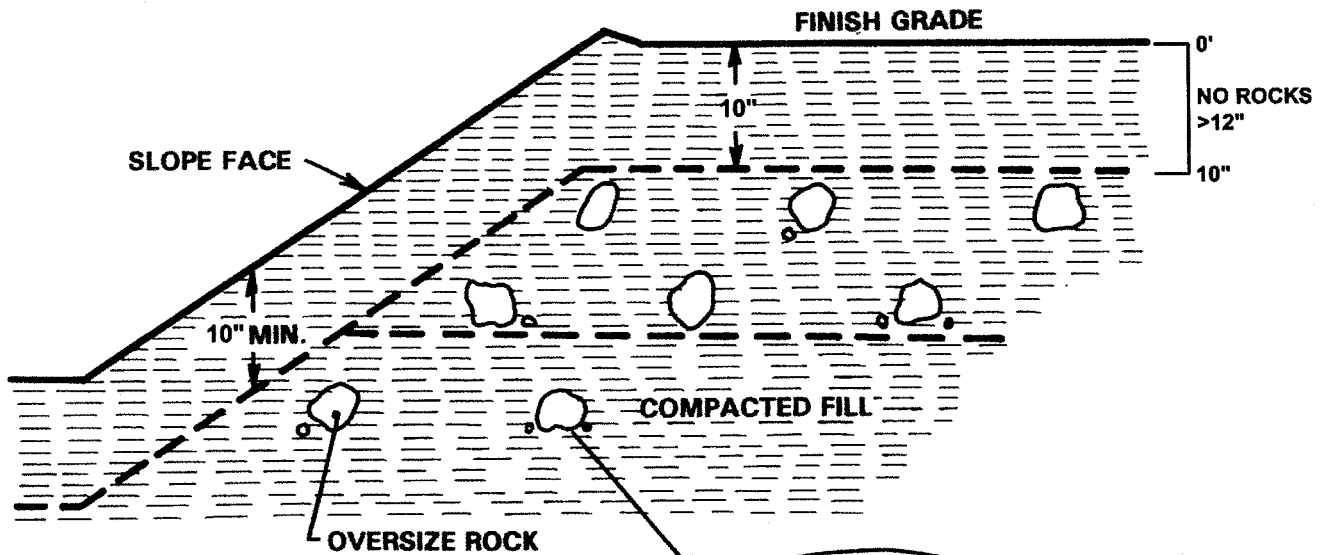
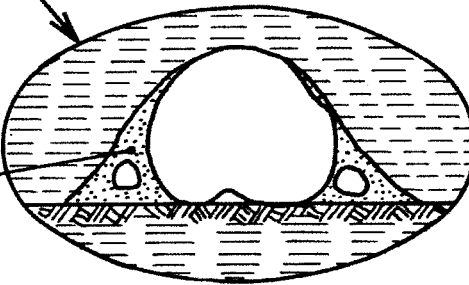
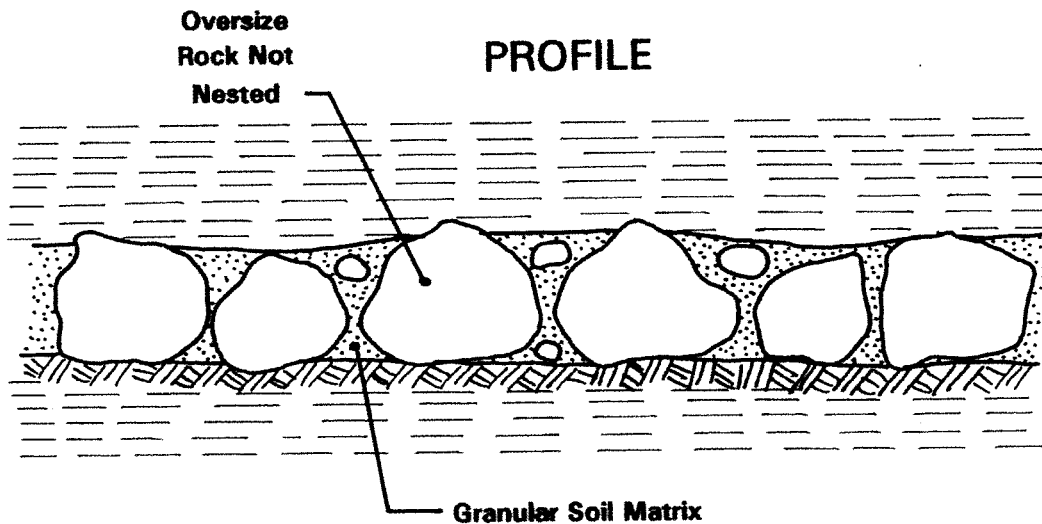
ROCK DISPOSAL DETAIL

GRANULAR SOIL
To fill voids,
densified by flooding

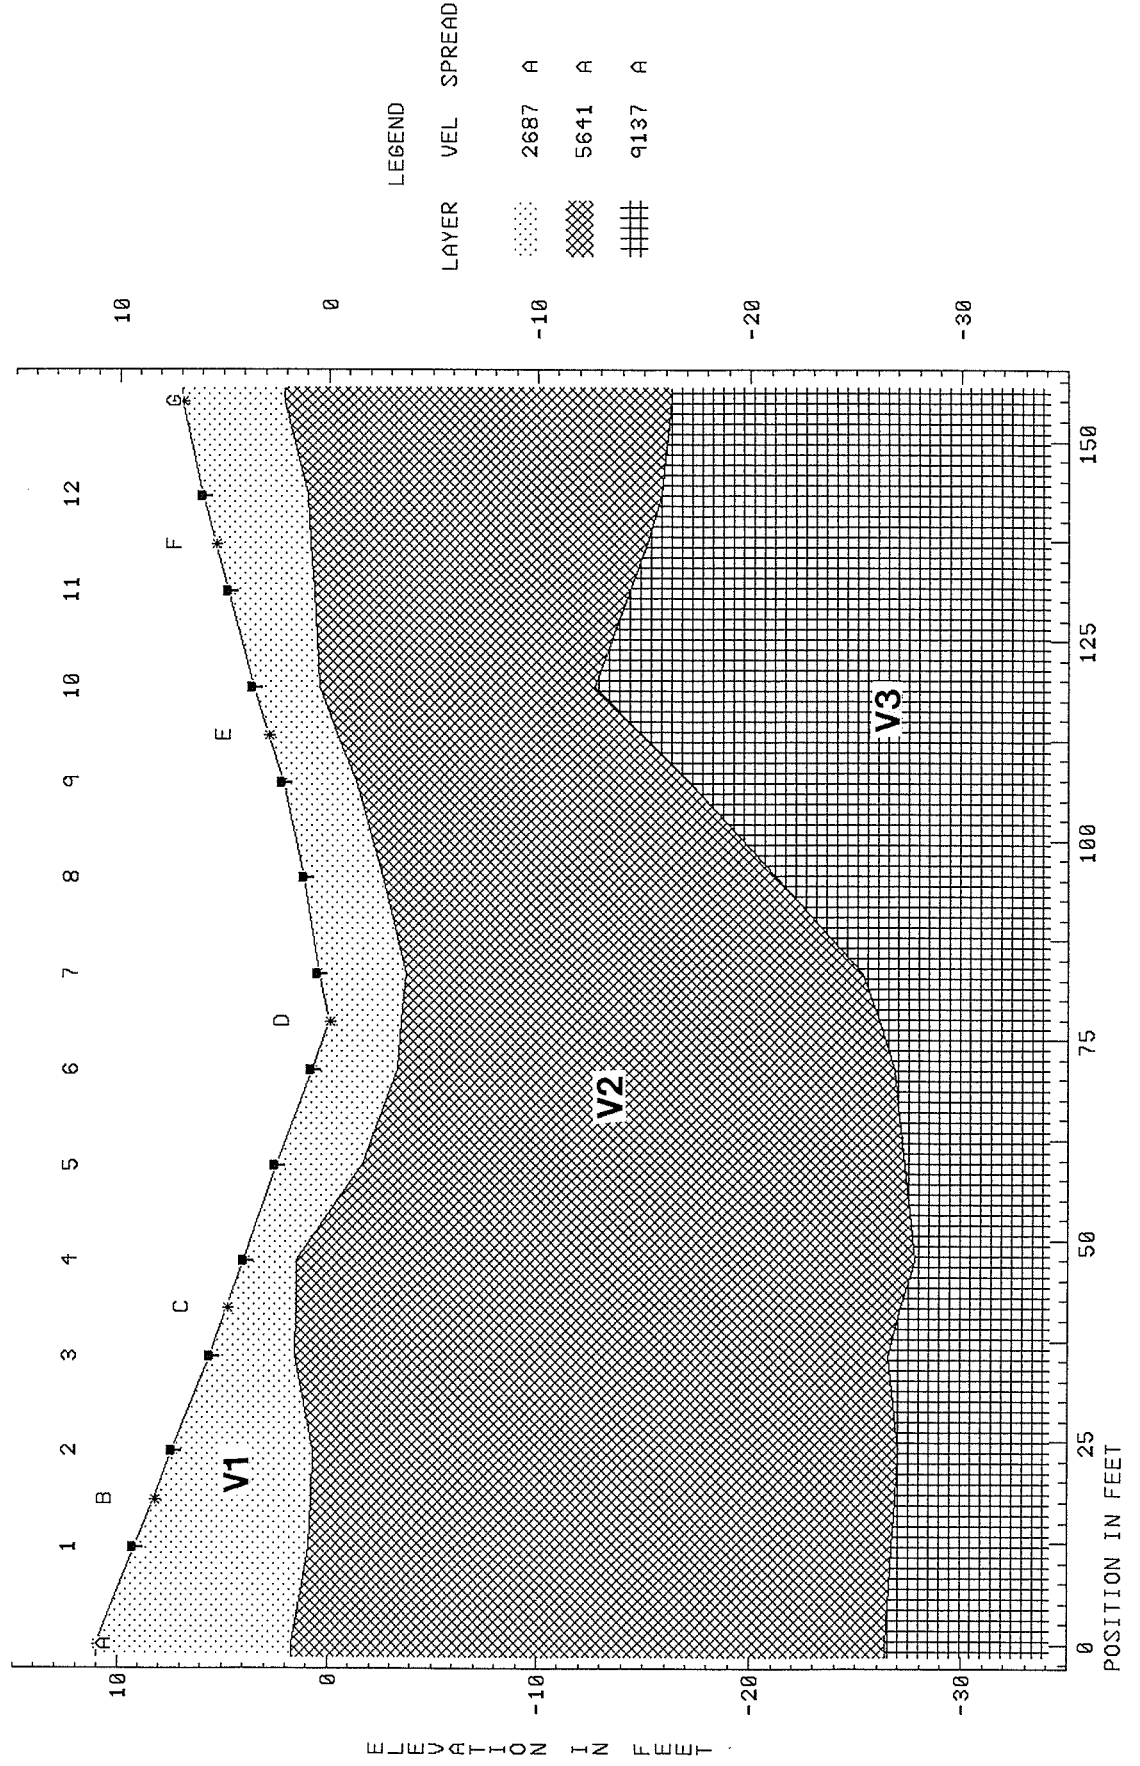
FILE 2224-12.SIP
SEISMIC LINE S-12

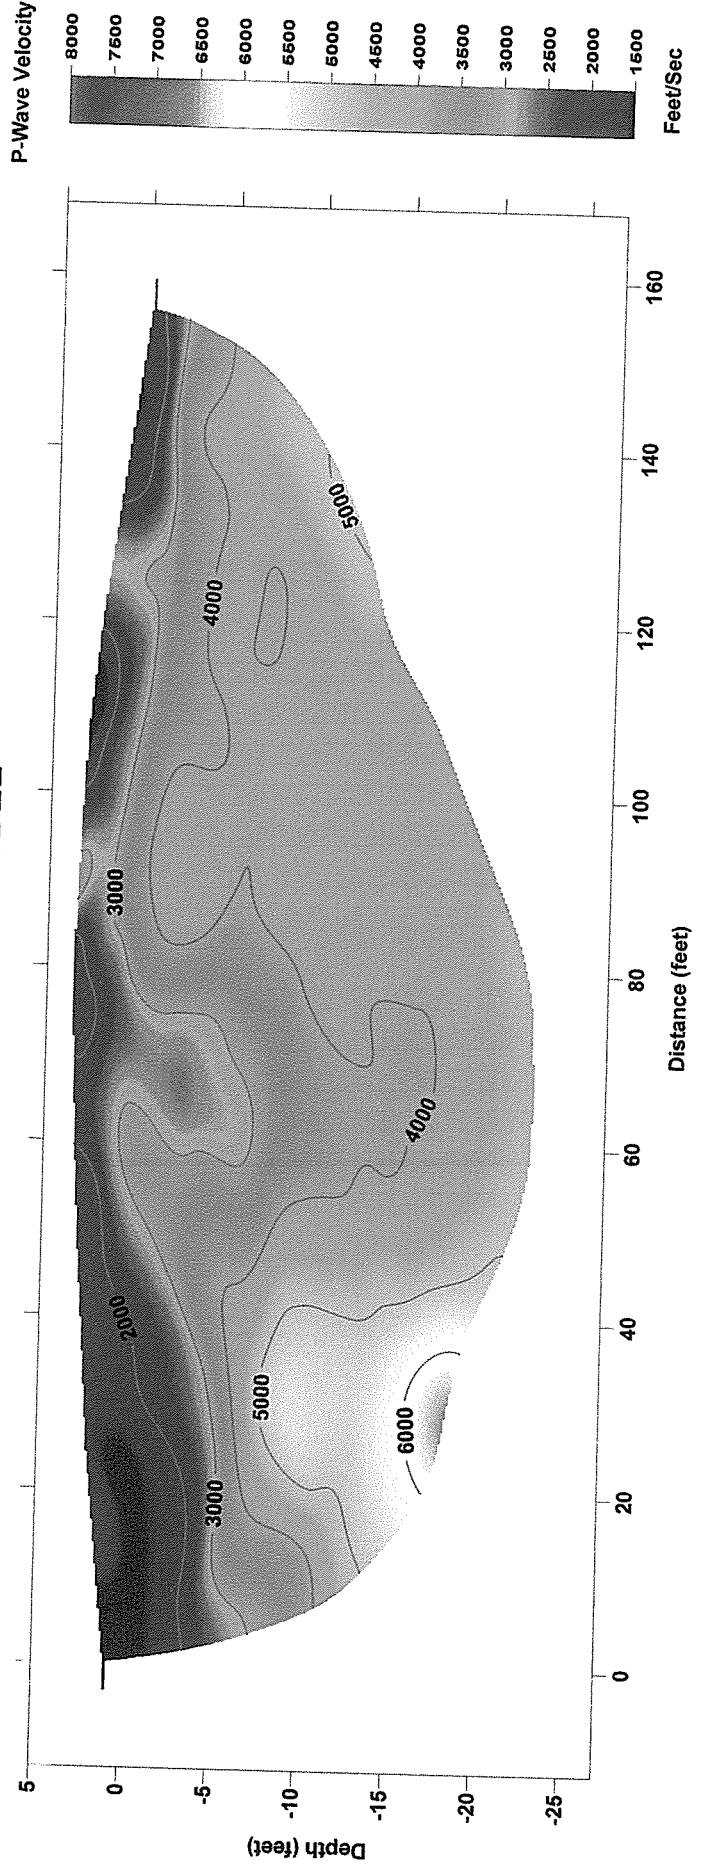
SEISMIC LINE S-2

TOMOGRAPHIC MODEL

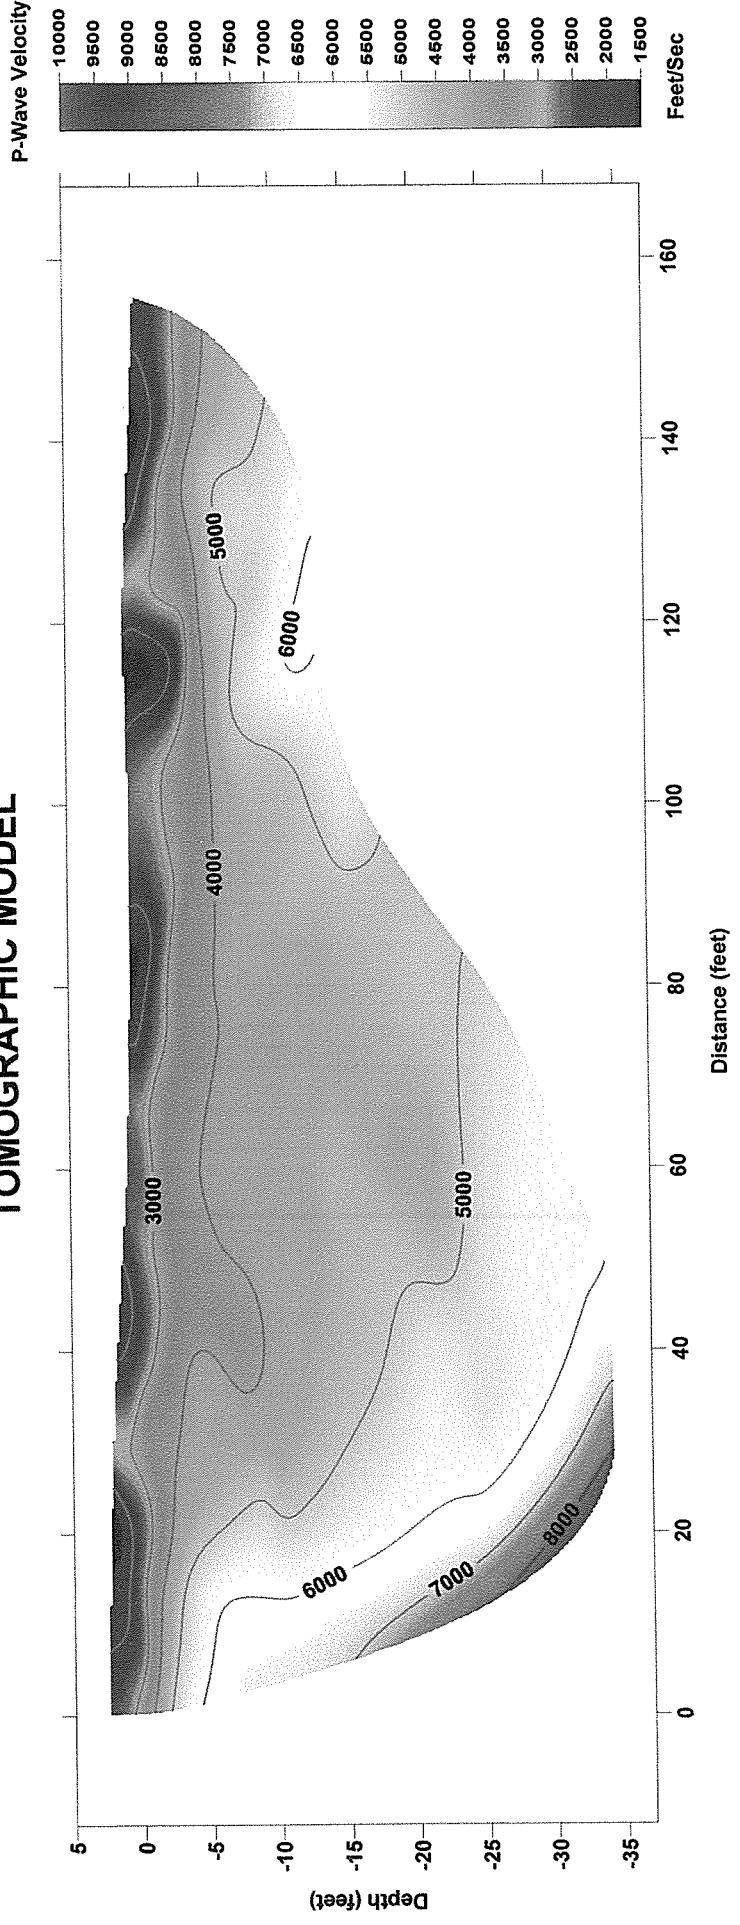
SEISMIC LINE S-3

TOMOGRAPHIC MODEL

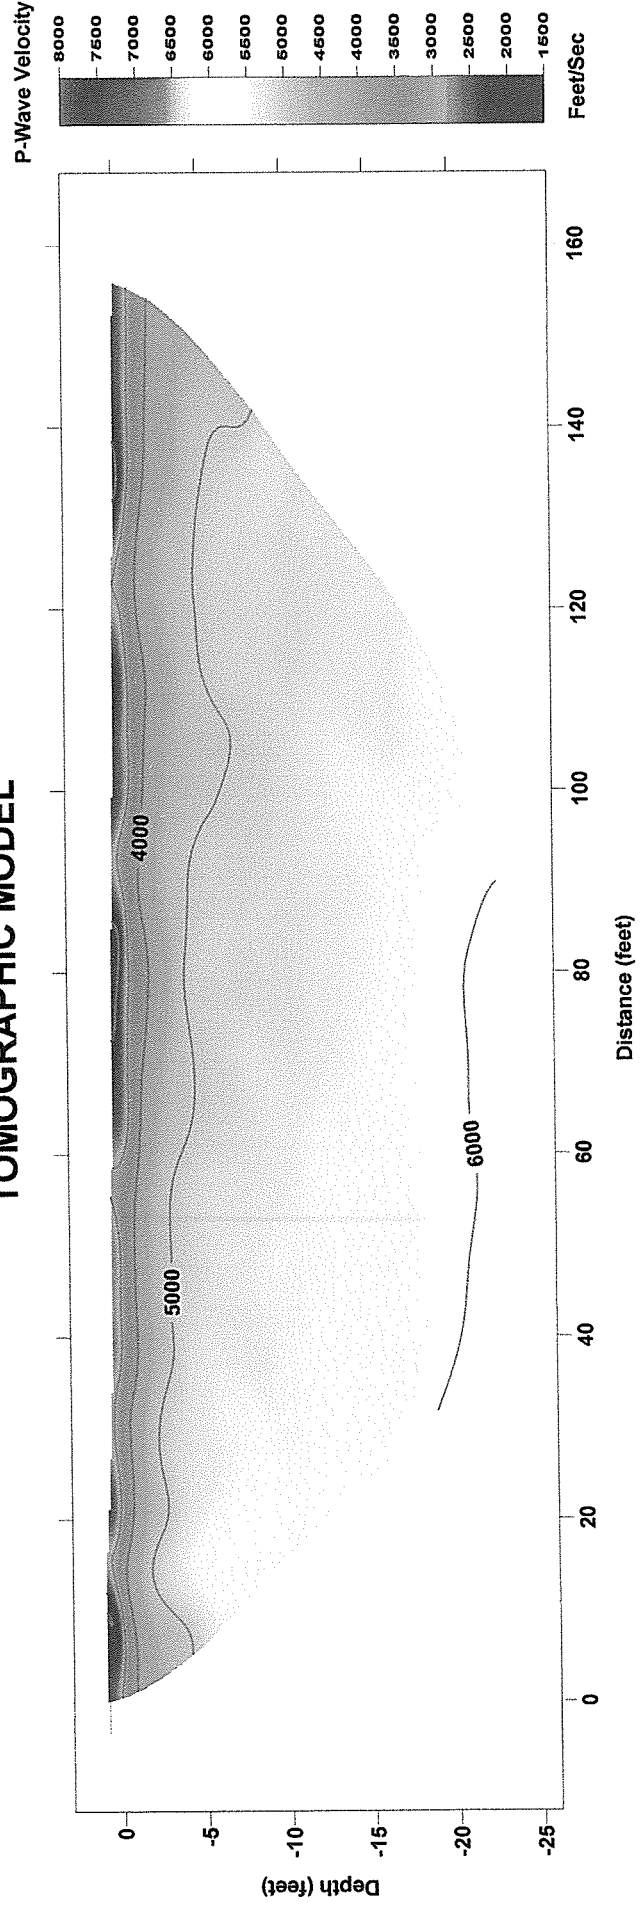
SEISMIC LINE S-4

TOMOGRAPHIC MODEL

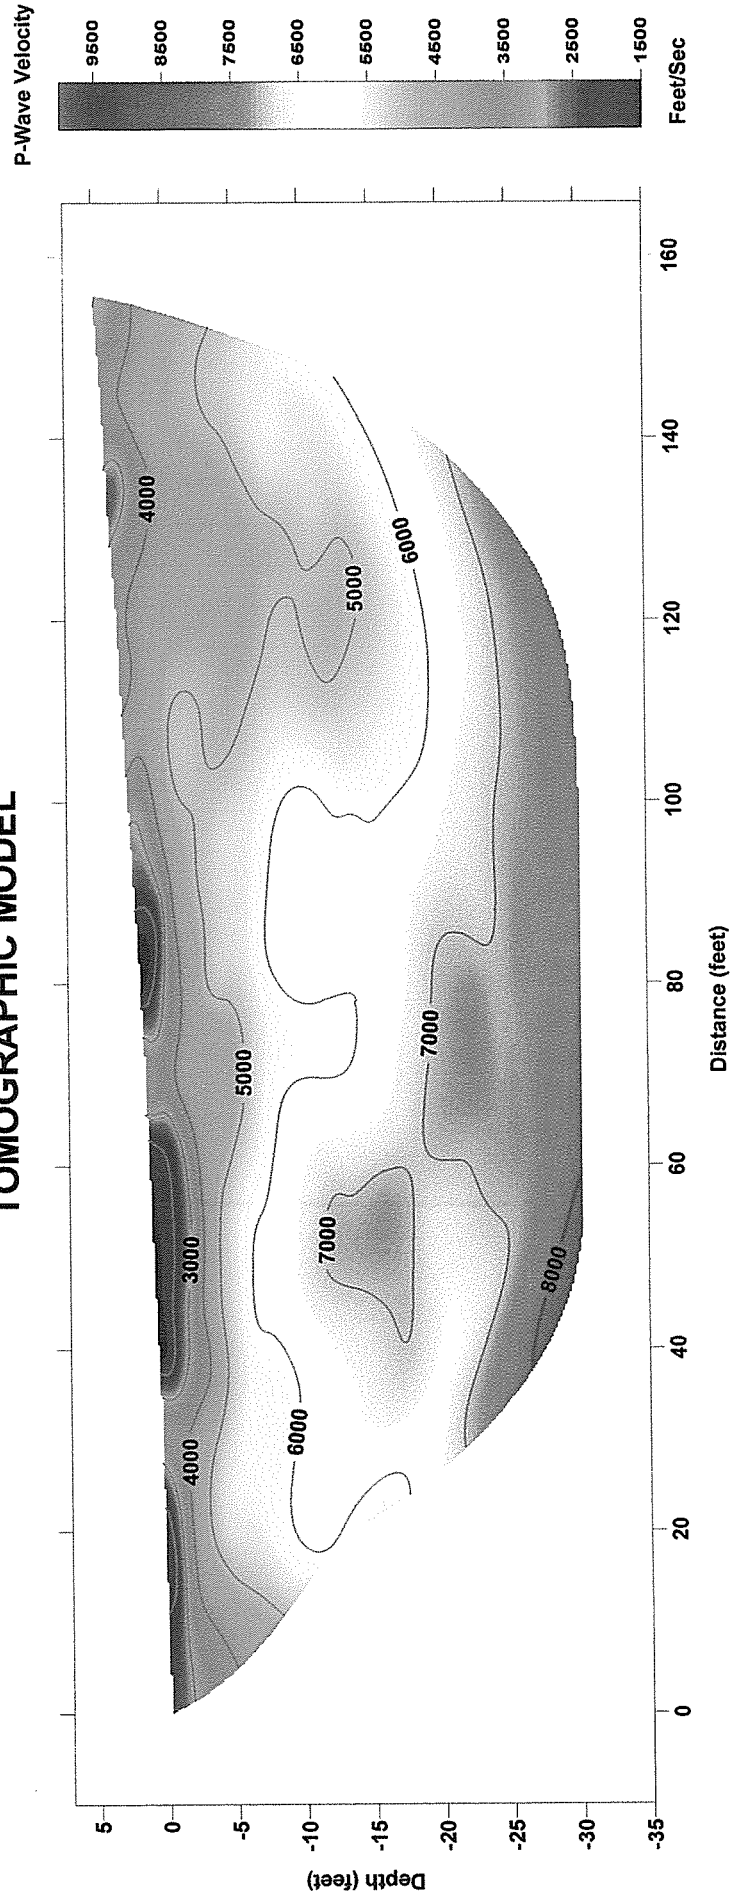
SEISMIC LINE S-5

TOMOGRAPHIC MODEL
