C.H.J. Incorporated

Job No. 07489-3

Subject: Grading Plan Review and Update to Geotechnical Investigation
 Proposed Industrial Development - Sycamore V
 Lance and Sierra Drives
 Riverside, California

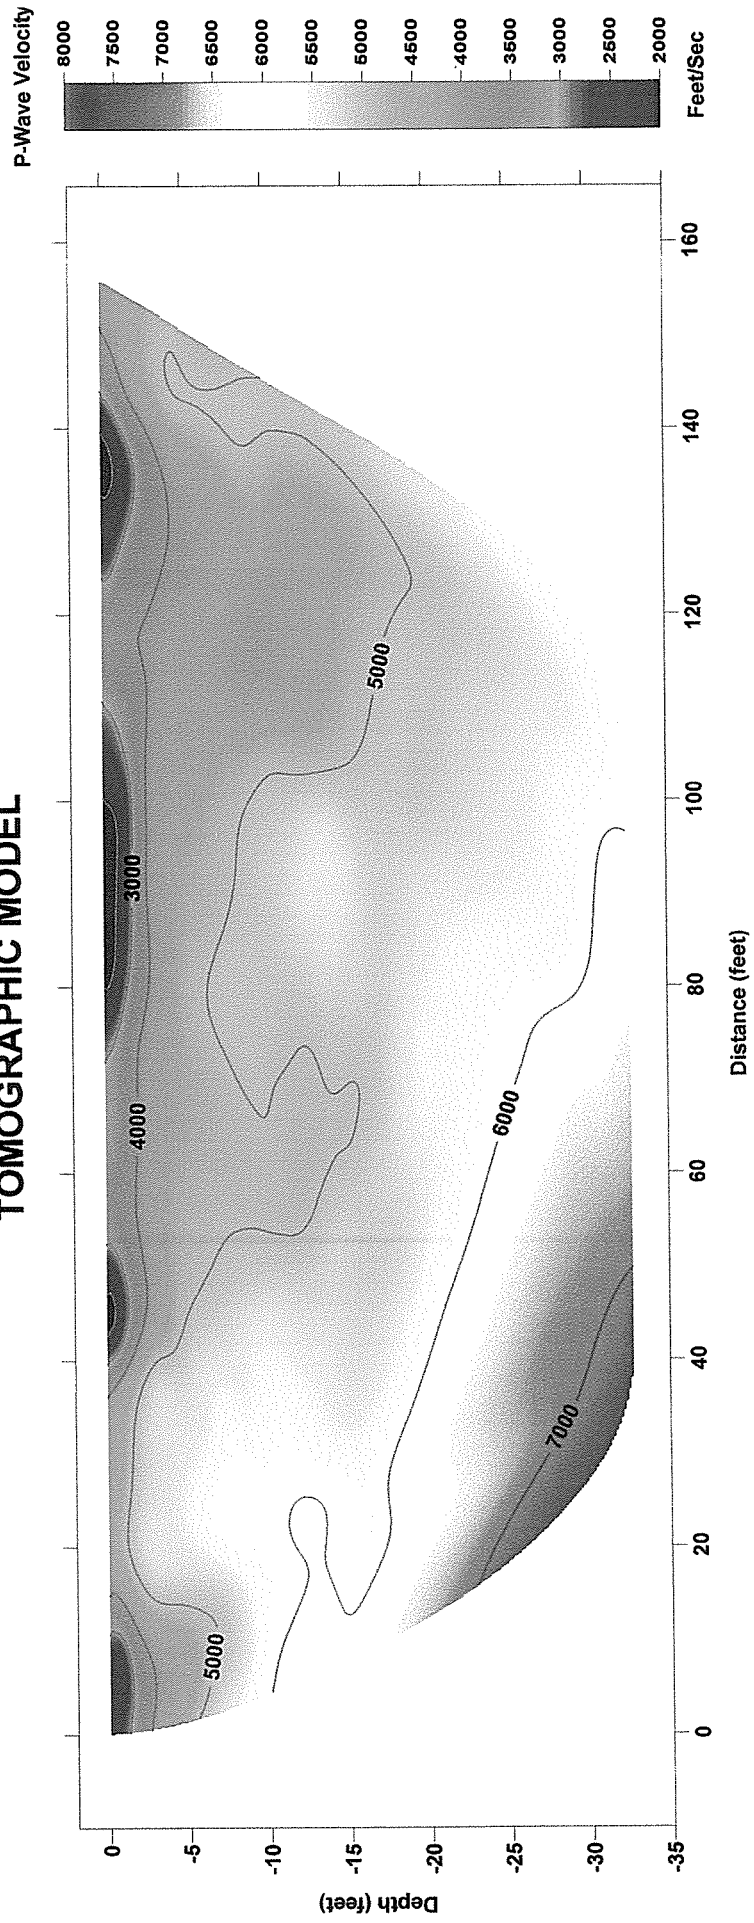
SEISMIC LINE S-6

TOMOGRAPHIC MODEL

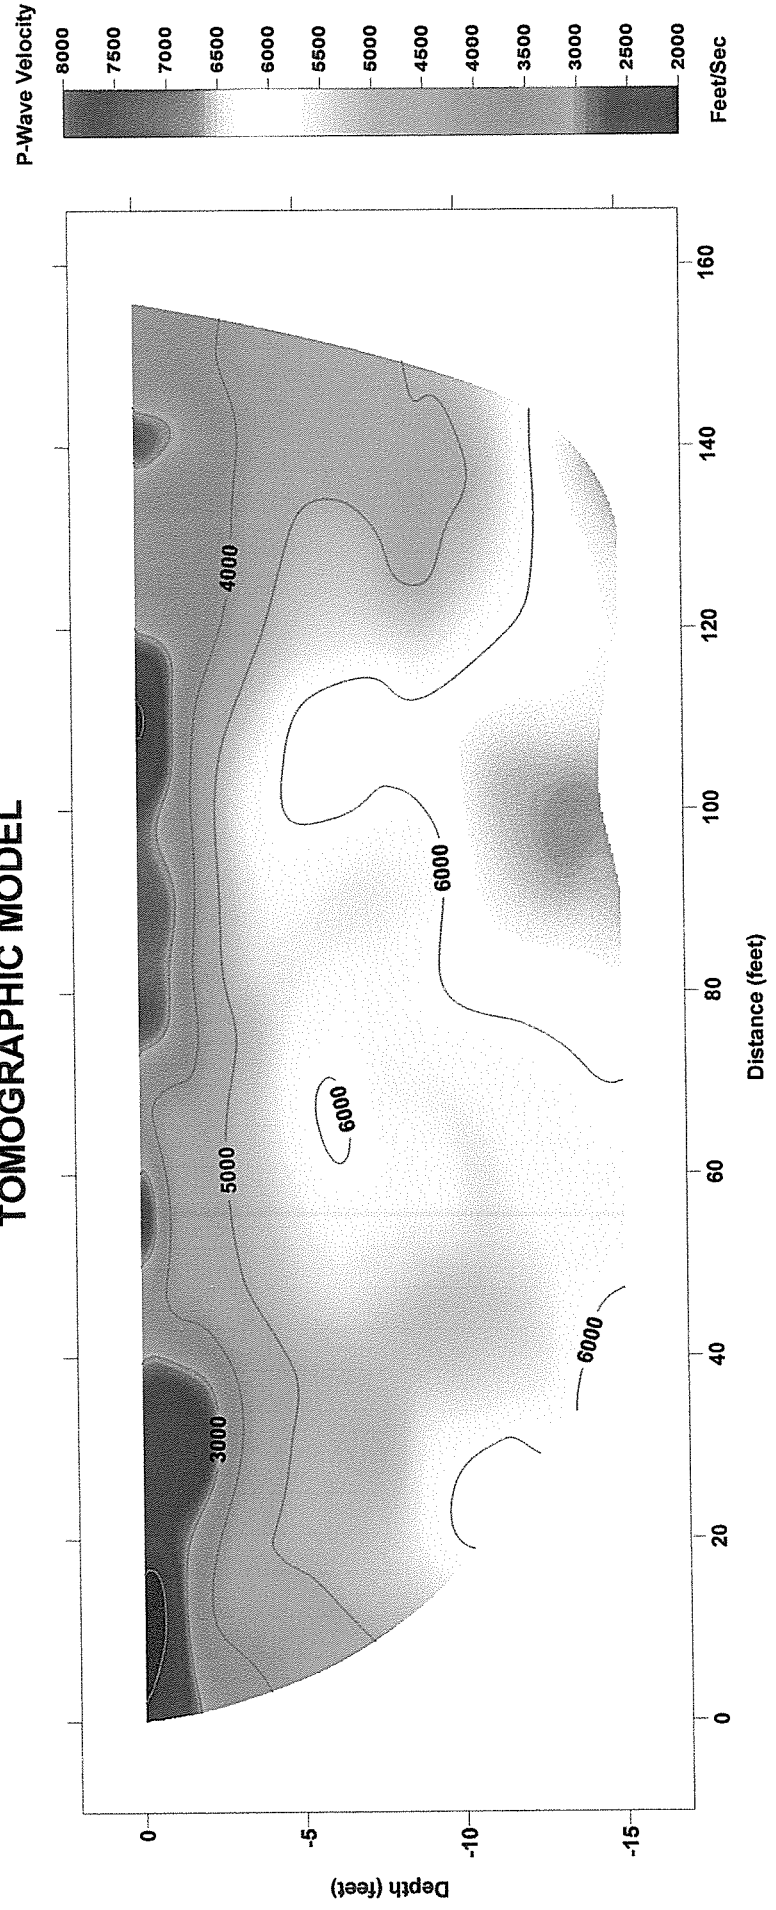
TOMOGRAPHIC MODEL

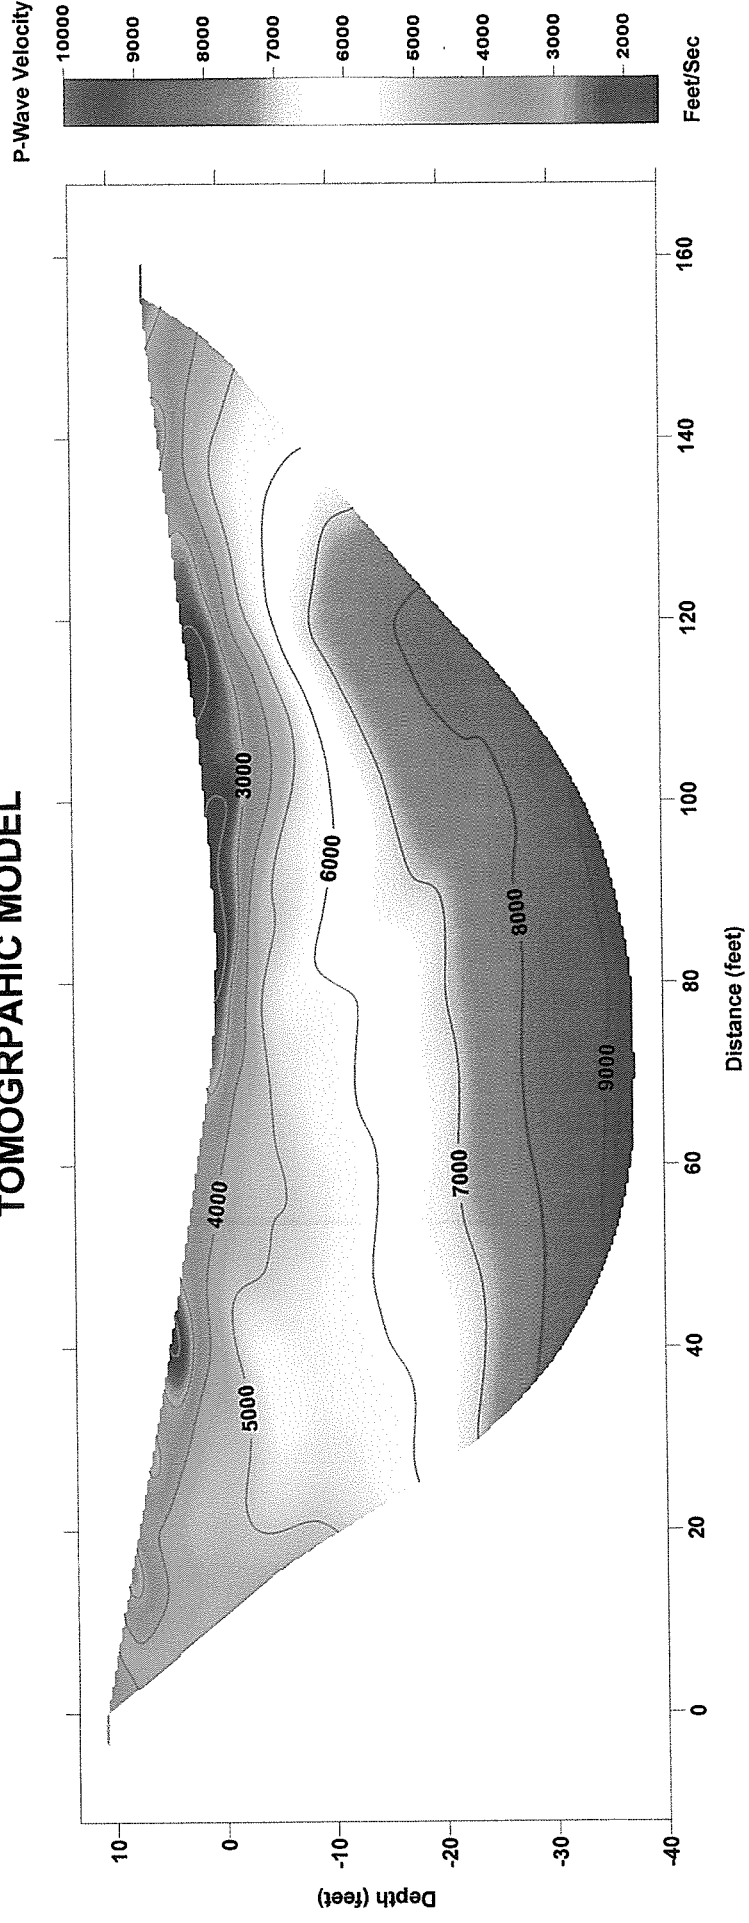
TOMOGRAPHIC MODEL
