TO: TRANSPORTATION COMMITTEE MEMBERS DATE: OCTOBER 11, 2018
FROM: PUBLIC WORKS DEPARTMENT WARDS: 3, 4, AND 5
SUBJECT: DISCUSSION OF ROUNDABOUTS ALONG VICTORIA AVENUE

Review the potential to construct roundabouts along Victoria Avenue, with primary attention given to the intersection of Victoria Avenue and Washington Street.

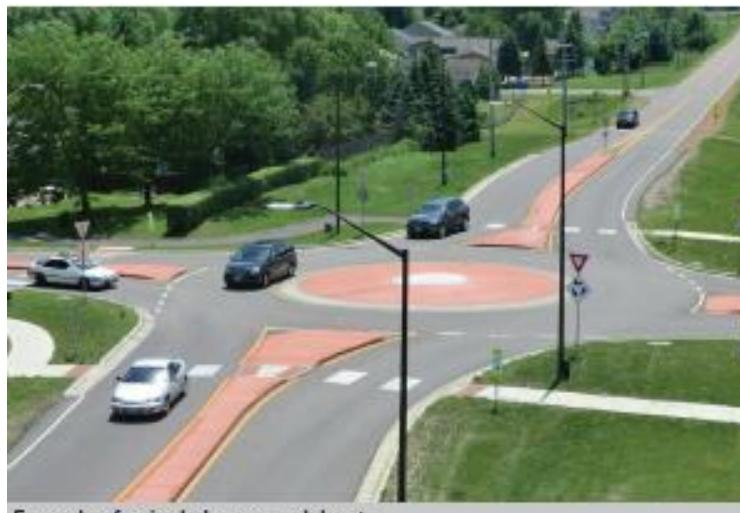
Roundabouts are circular intersections, characterized by a raised central island and additional raised medians to guide motorists through the intersection in a counter-clockwise motion. Roundabouts are designed to maintain an even vehicle speed throughout the intersection, allow for 'yield' operations as motorists enter the circle, and minimize vehicular conflict. Roundabouts differ from traffic circles (smaller circles that do not require the overall intersection footprint or design to change) and rotaries (large circles that are closer to a one-way road system, often with over four entry/exit legs). An image of a modern, single-lane roundabout is shown below:

Example of a single-lane roundabout.

The edge of the roundabout's central island can be traversable by trucks and emergency services vehicles, and feature a raised artistic or barrier element at the center to discourage illegal turning movements. Landscaping removed by the construction of the roundabout can be relocated (to the greatest extent possible) or replaced within a newly created central island and curb extensions at the intersection.

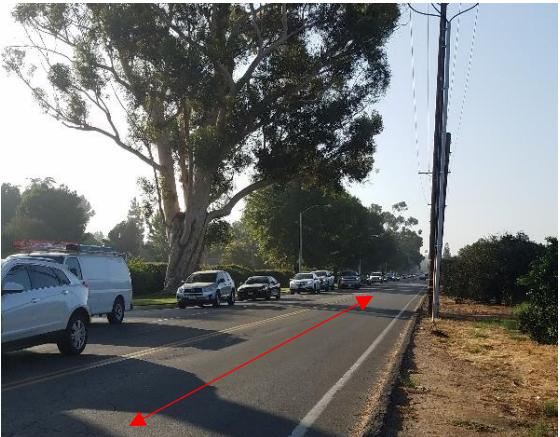
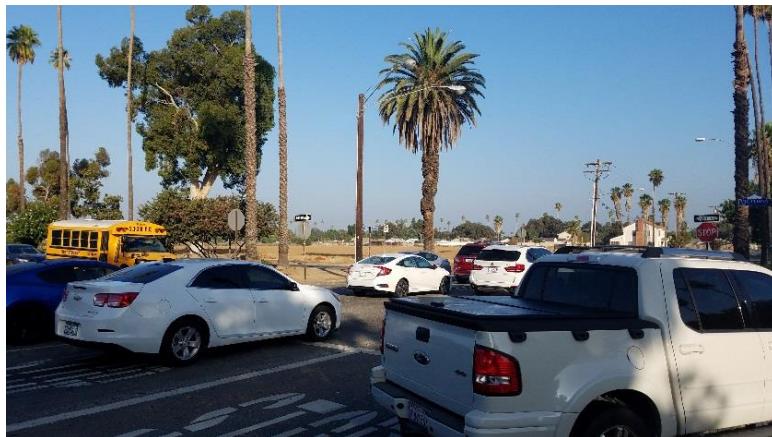
1. Actual delays measured for critical lane movements in the field under current stop-sign conditions average to 4 minutes and 47 seconds (287 seconds) during the AM Peak Hour, and 2 minutes, 57 seconds during the PM Peak Hour (177 seconds). The images below depict queueing conditions at the subject intersection:

Images of the AM Peak Hour of Traffic

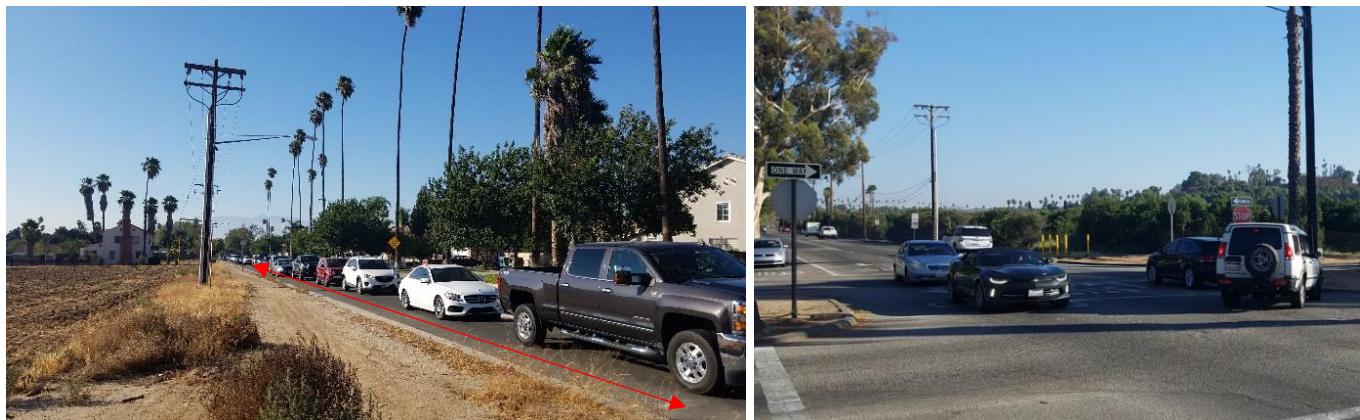
Images of the PM Peak Hour of Traffic
