# Transportation Committee

**SUBJECT: DISCUSSION OF ROUNDABOUTS ALONG VICTORIA AVENUE**

Discuss the potential to construct roundabouts along Victoria Avenue, with primary attention given to the intersection of Victoria Avenue and Washington Street.

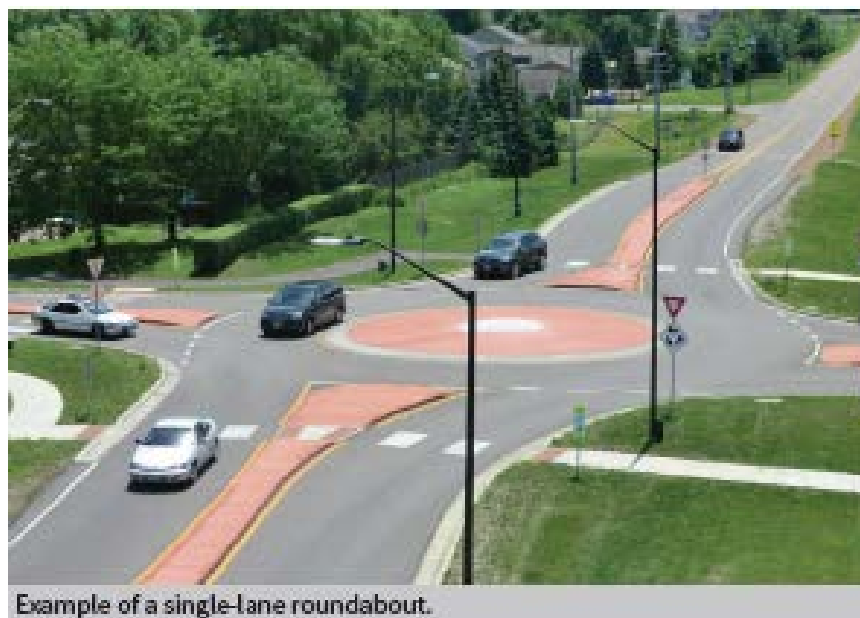
Source: FHWA

Roundabouts are circular intersections, characterized by a raised central island and additional raised medians to guide motorists through the intersection in a counter-clockwise motion. Roundabouts are designed to maintain an even vehicle speed throughout the intersection, allow for 'yield' operations as motorists enter the circle, and minimize vehicular conflict. Roundabouts differ from traffic circles (smaller circles that do not require the overall intersection footprint or design to change) and rotaries (large circles that are closer to a one-way road system, often with over four entry/exit legs). An image of a modern, single-lane roundabout is shown below:

Example of a single-lane roundabout.

The edge of the roundabout's central island can be traversable by trucks and emergency services vehicles, and feature a raised artistic or barrier element at the center to discourage illegal turning movements. Landscaping removed by the construction of the roundabout can be relocated (to the greatest extent possible) or replaced within the newly created central island and curb extensions at the intersection.

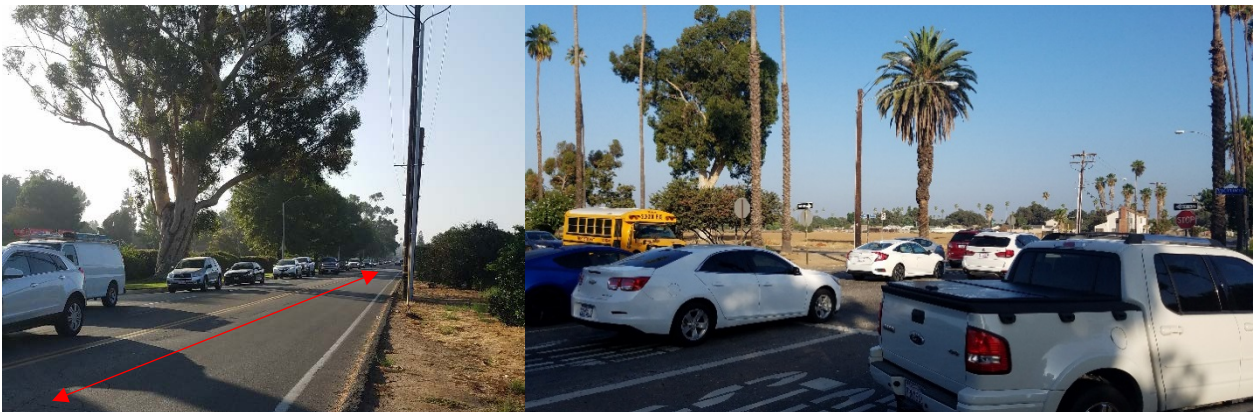
1. Actual delays measured for critical lane movements in the field under current stop-sign conditions average to 4 minutes and 47 seconds (287 seconds) during the AM Peak Hour, and 2 minutes, 57 seconds during the PM Peak Hour (177 seconds). The images below depict queueing conditions at the subject intersection:

Images of the AM Peak Hour of Traffic

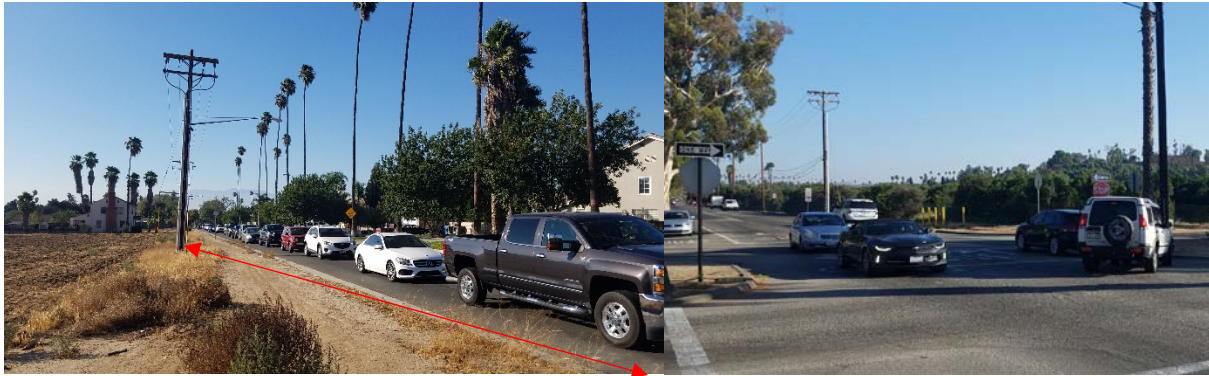
Images of the PM Peak Hour of Traffic
