State of California The Resources Agency
 DEPARTMENT OF PARKS AND RECREATION
PRIMARY RECORD

Page 1 of 2 *Resource Name or #: (Assigned by recorder) Helgeson Buick

c. Address 8001 Auto Drive City Riverside Zip 92504

B1. Historic Name: Helgeson Buick

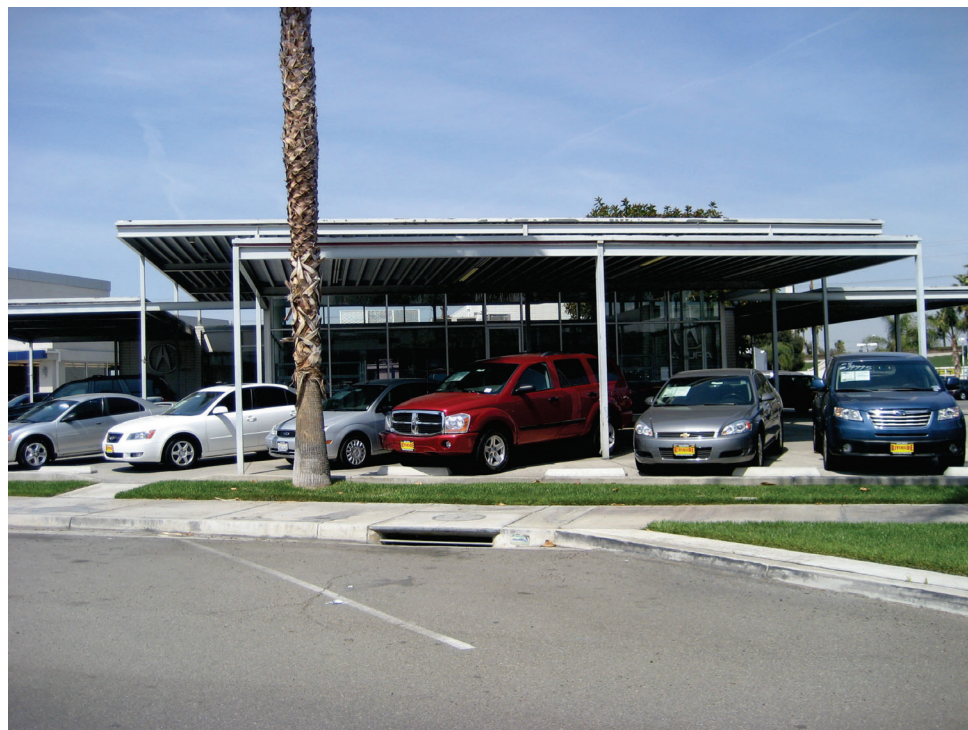
This International Style car dealership is one story in height, covered by a flat roof, and is sited diagonally on the corner of Auto and Detroit Drives. It consists of a square-plan, central interior space and four open, rectangular wings on each side. The roofs of the wings start from below the large central roof. The whole structure is composed of thin steel beams spread apart from each other as supports for the metal roof with exposed and recessed beams. The roof detail is cornice-like with the upper part of the roof slightly extending over the wide, lower beam. Landscaping includes grass and palm trees. Additions include a circular car platform on the corner, and a boxy, featureless building and trailer north and directly behind the building.

P5b. Description of Photo: (view, date, accession #) Southwest elevation
April 7, 2009
